Shoalhaven City Council  
C/- Set Consulting Pty Ltd

Stage 1 and 2 Contamination  
Assessment:  
Lot 1/DP1021332 and  
Lot 458/DP1063107  
George Evans Rd, Mundamia, NSW

P1202863JR01V01  
October 2012

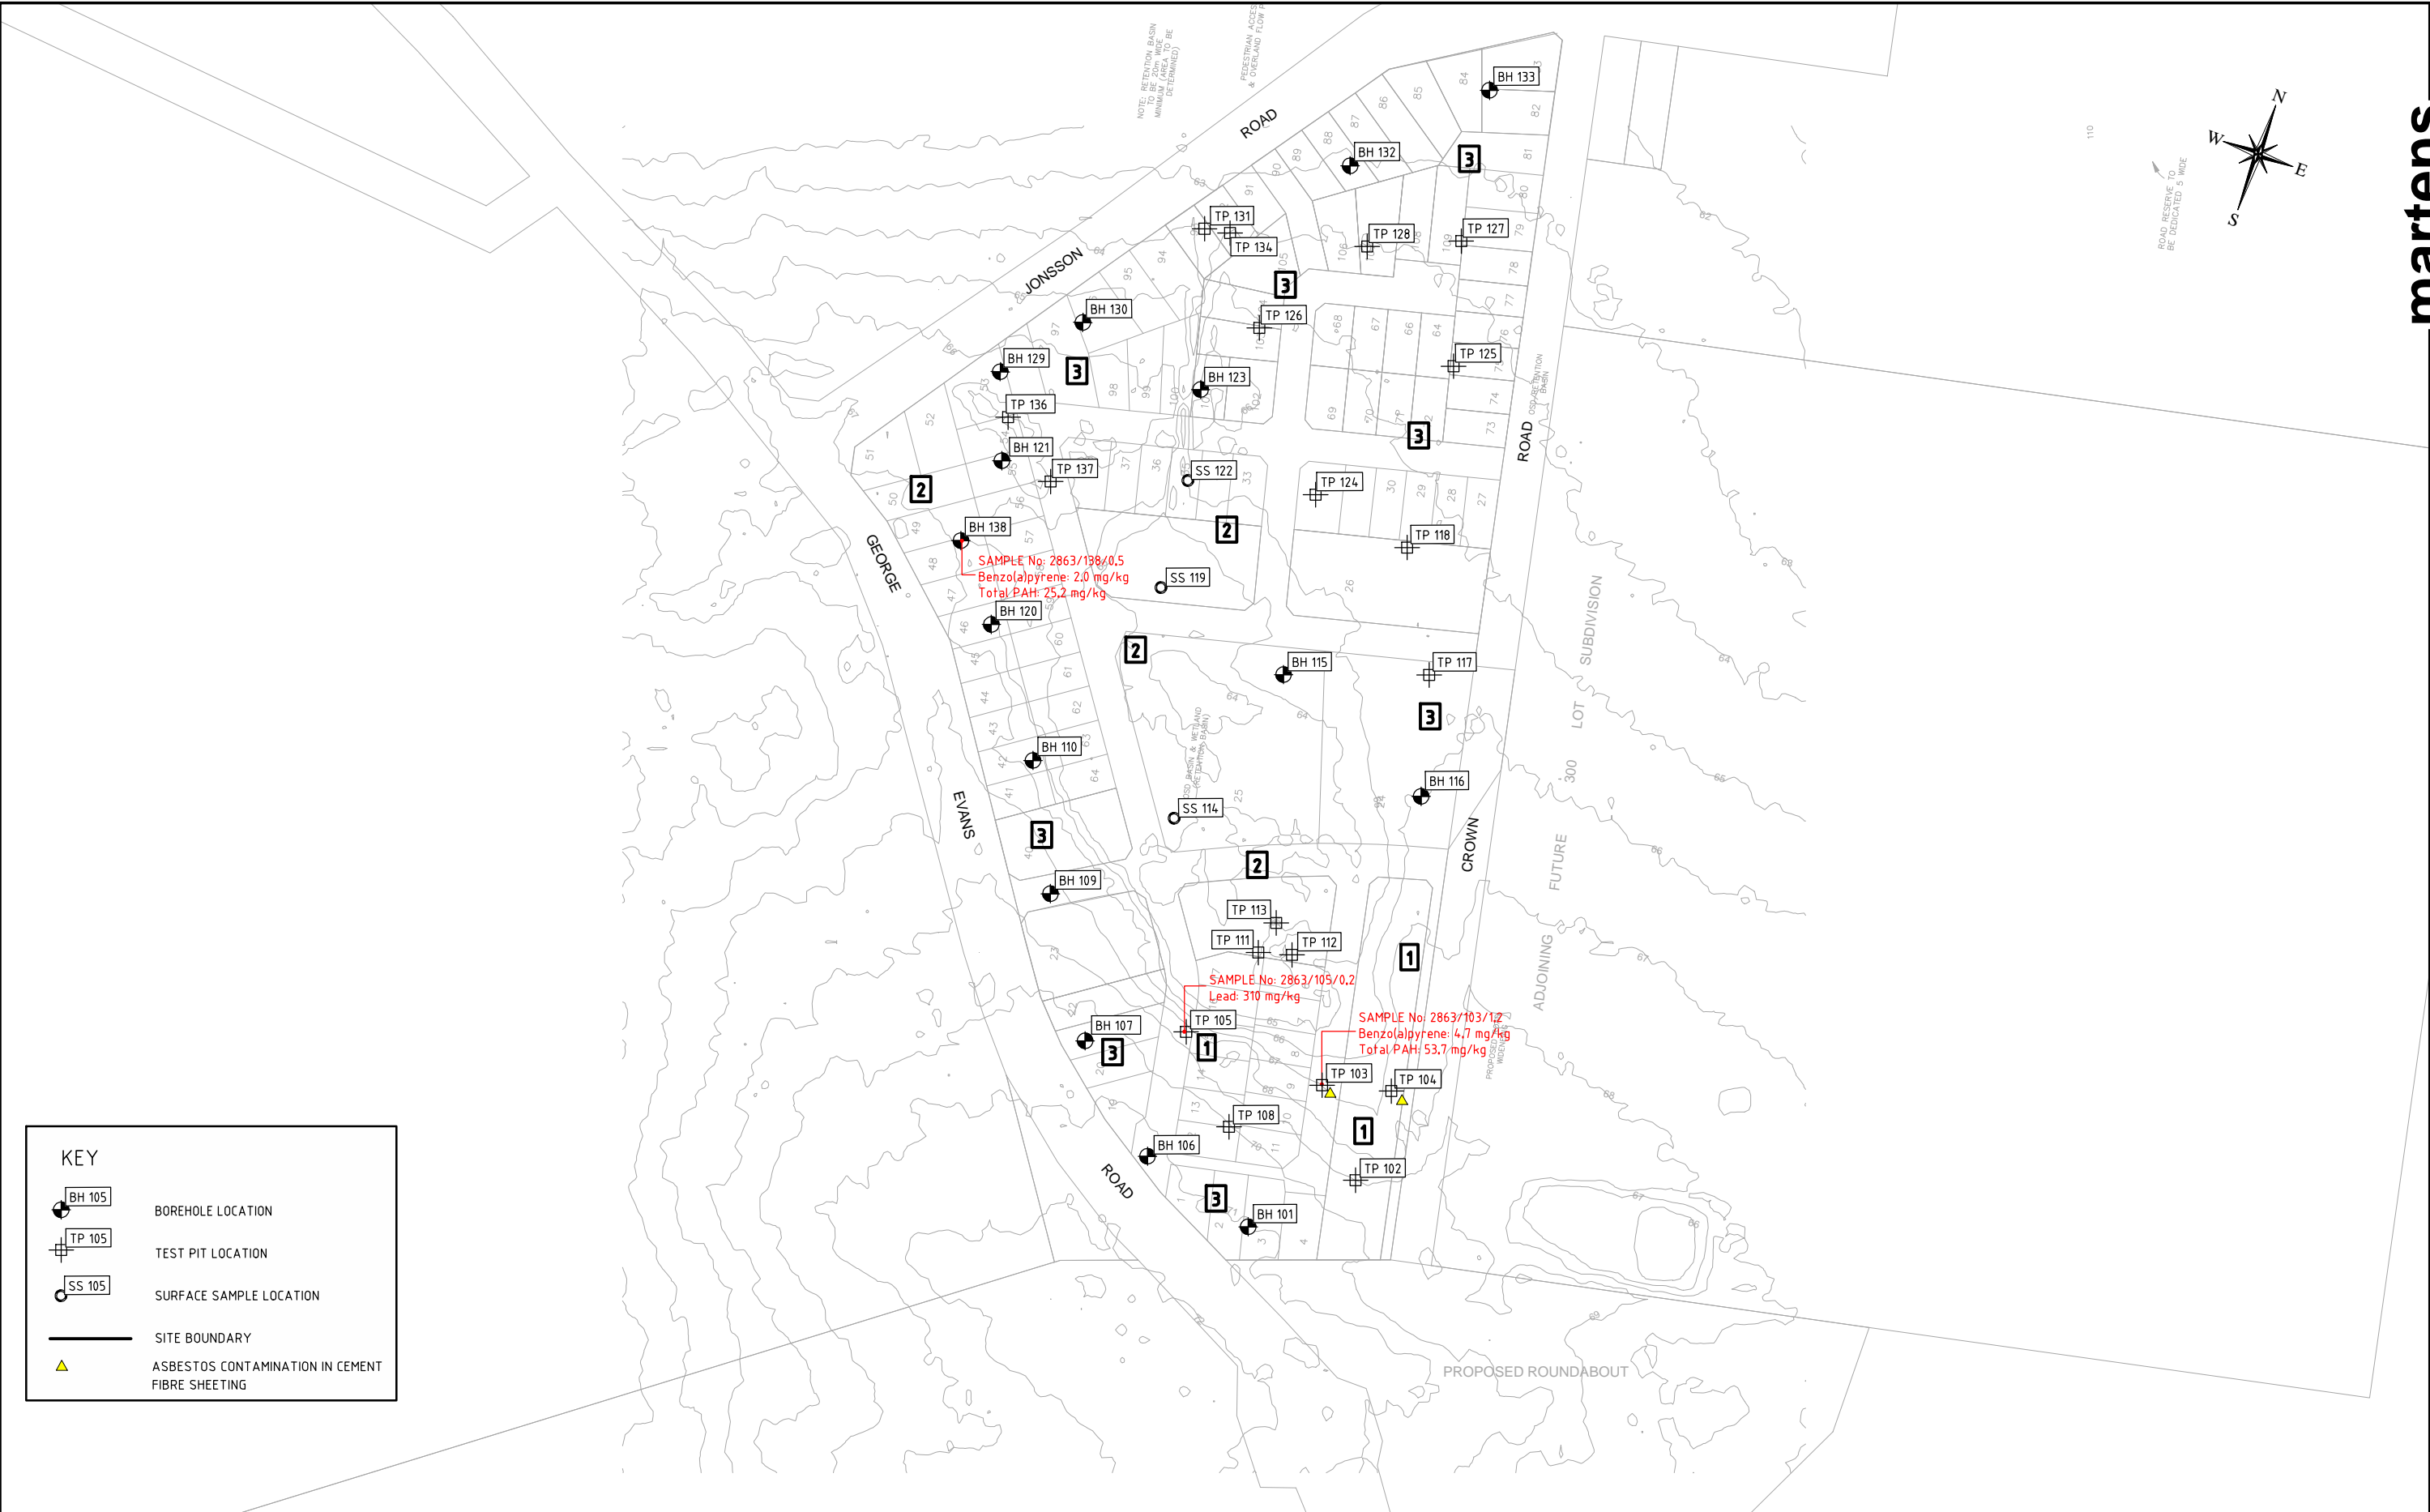
Martens & Associates Pty Ltd		ABN 85 070 240 890	Environment   Water   Wastewater   Geotechnical   Civil   Management				
Drawn:	BM	TESTING PLAN			Drawing No./ID:		
Approved:	AN				1002863JD01V01		
Date:	04.10.12						
Scale @A3:	1:3000	6/37 Leighton Place, Hornsby, NSW 2077 Australia Phone: (02) 9476 9999 Fax: (02) 9476 8767 Email: <a href="mailto:mail@martens.com.au">mail@martens.com.au</a> Internet: <a href="http://www.martens.com.au">http://www.martens.com.au</a>			Project: P1002863	File: JD01V01	Revision: A

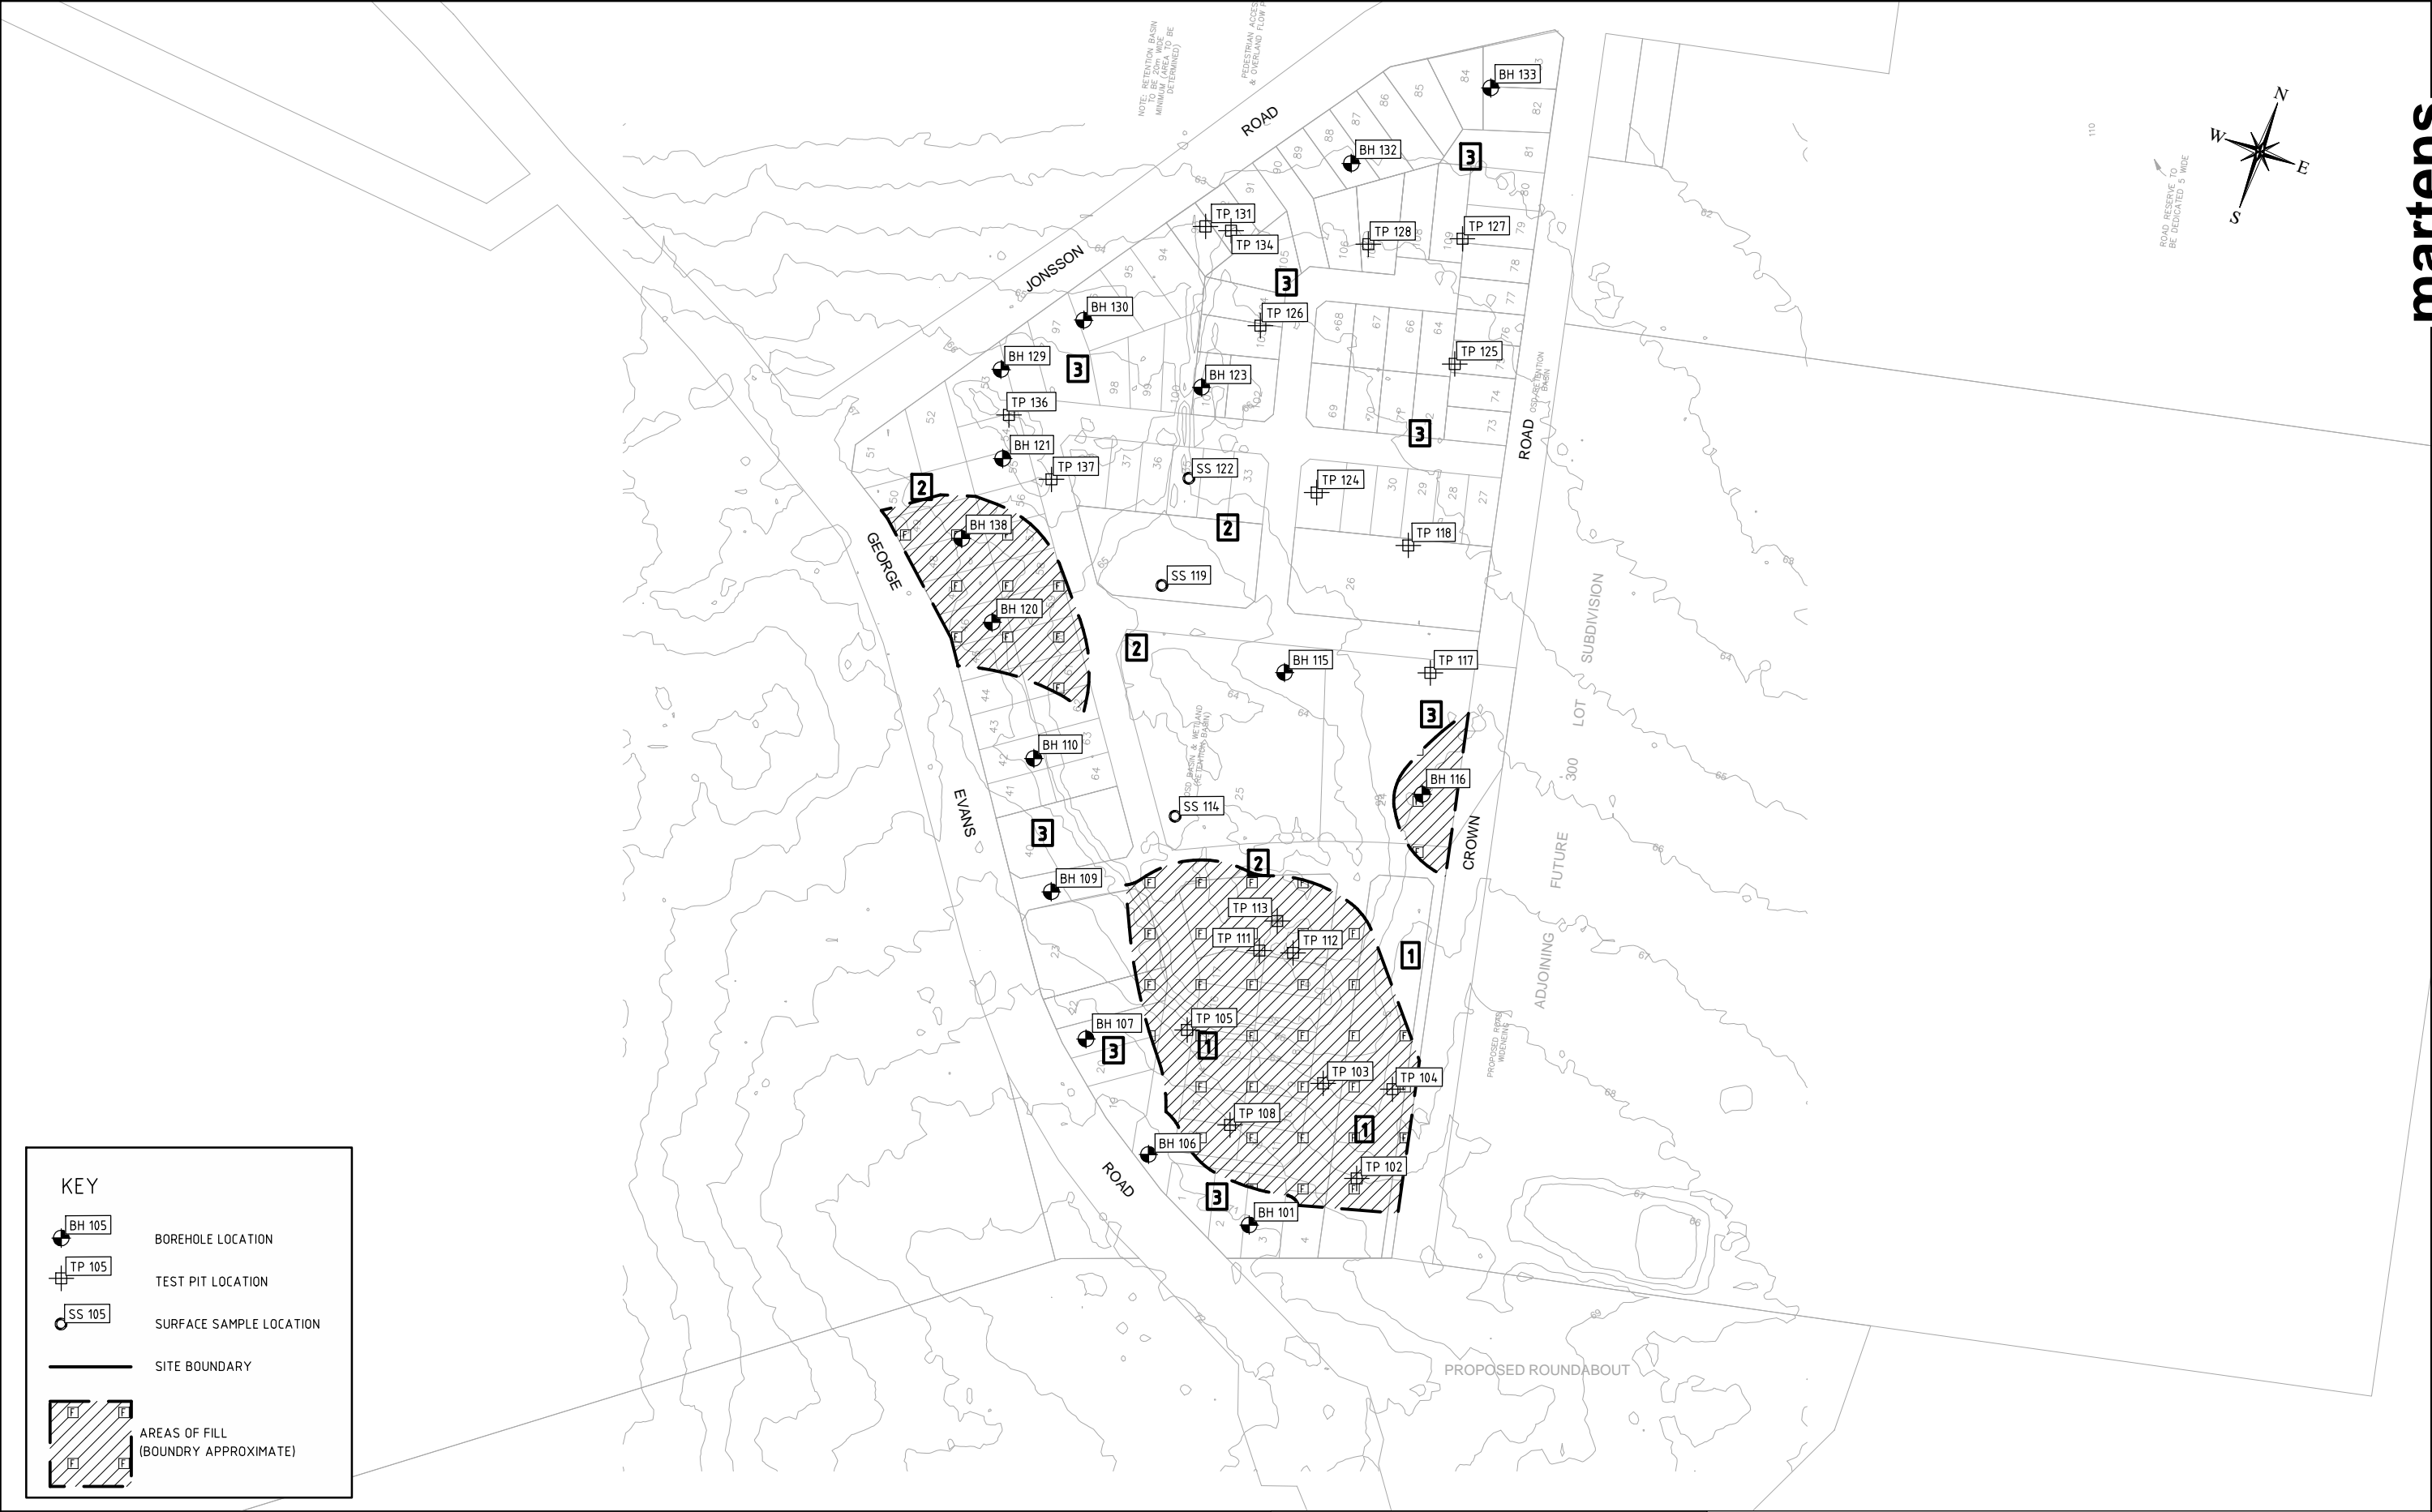
Martens & Associates Pty Ltd		ABN 85 070 240 890	Environment   Water   Wastewater   Geotechnical   Civil   Management				
Drawn:	BM		PRELIMINARY OUTLINE OF SITE FILL		Drawing No./ID:		
Approved:	AN				1002863JD02V01		
Date:	15.10.12						
Scale @A3:	1:3000						
6/37 Leighton Place, Hornsby, NSW 2077 Australia Phone: (02) 9476 9999 Fax: (02) 9476 8767 Email: <a href="mailto:mail@martens.com.au">mail@martens.com.au</a> Internet: <a href="http://www.martens.com.au">http://www.martens.com.au</a>			Project:	File:	Revision:		
			P1002863	JD01V01	A

A remediation action plan (RAP) is to be prepared for the site to assess options and make recommendations for the site's remediation. Further testing may be required to fully delineate the extent of site filling and to assess the possibility of contamination of observed groundwater. Issues of fill extend and groundwater issues may be dealt with by the RAP. Waste classification of any material to be removed from site would be required.

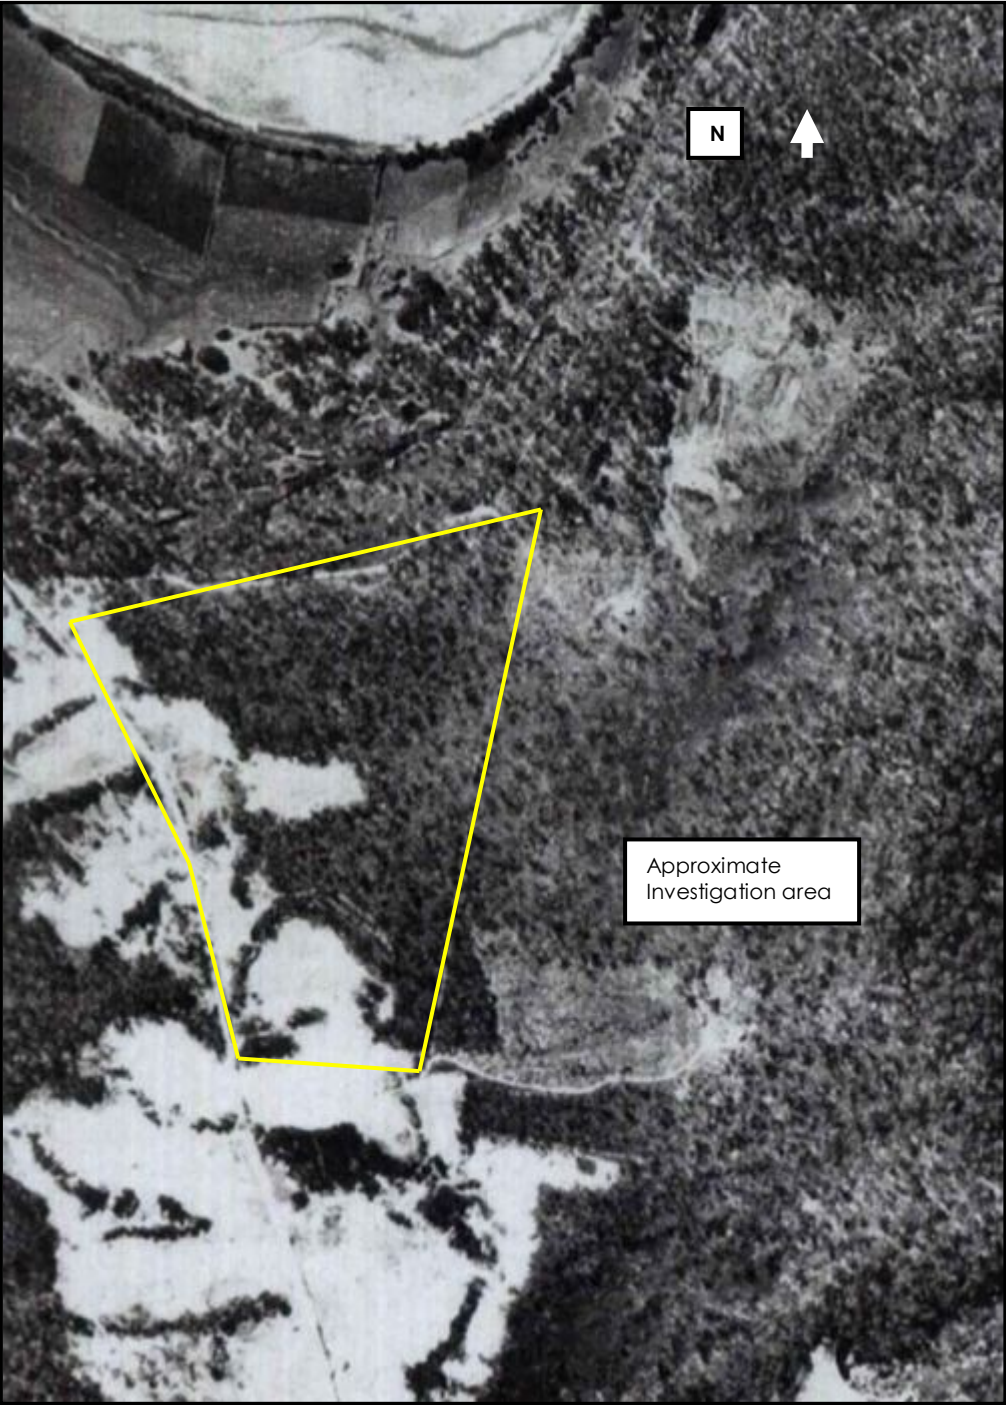
Martens & Associates Pty Ltd    ABN 85 070 240 890		Environment   Water   Wastewater   Geotechnical   Civil   Management	
Drawn:	BM	1961 Aerial Photo	Drawing No:
Approved:	AN		<b>FIGURE 1</b>
Date:	27.09.2012		
Scale:	NA		Job No: P0102863

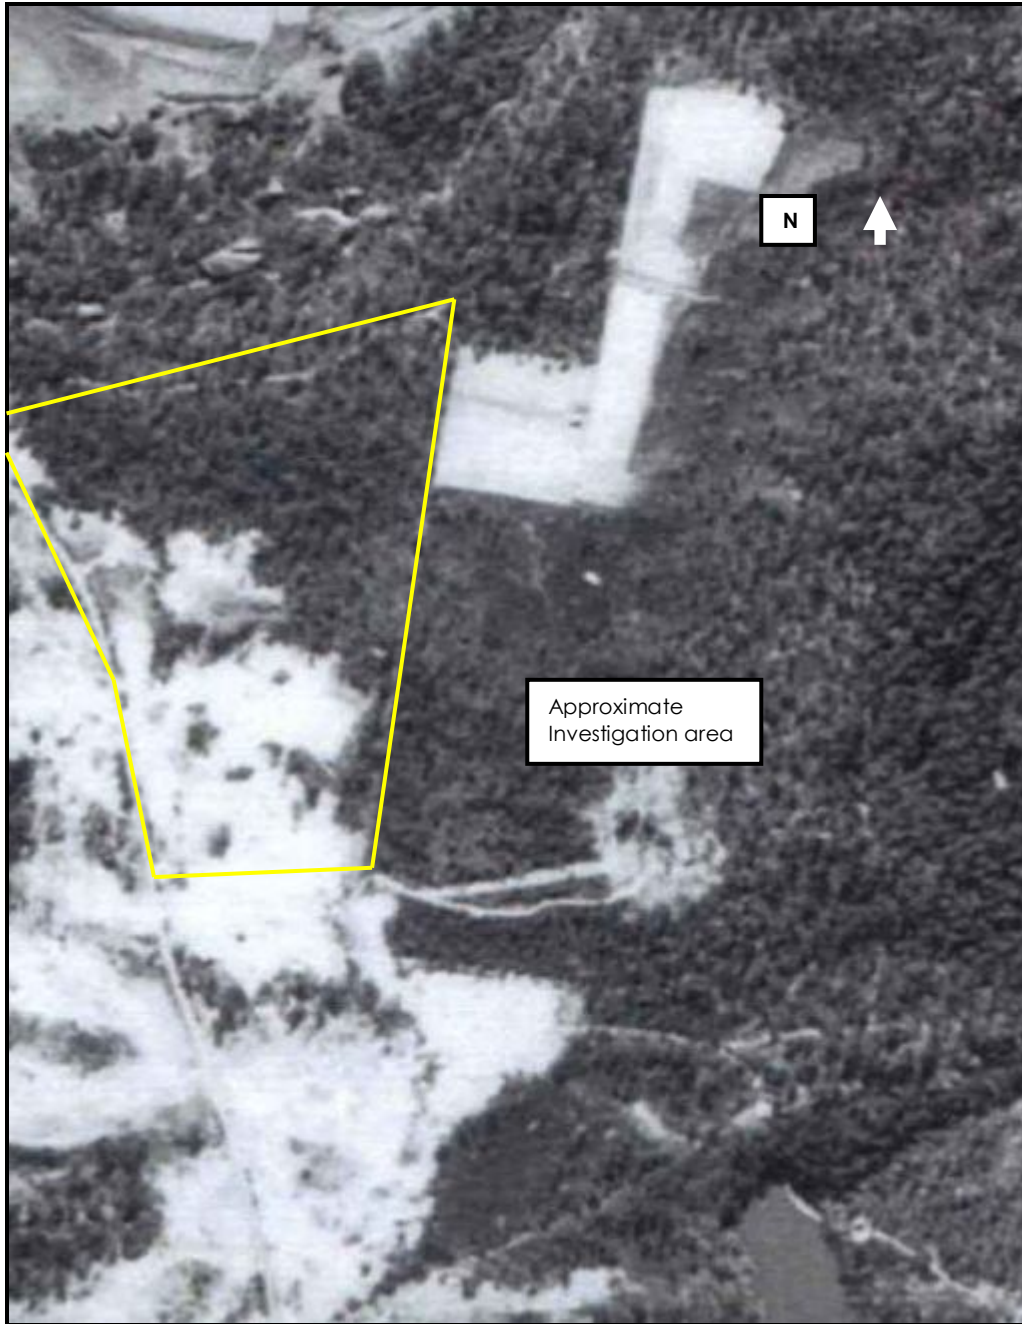
<b>Martens &amp; Associates Pty Ltd</b> ABN 85 070 240 890		<b>Environment   Water   Wastewater   Geotechnical   Civil   Management</b>	
Drawn:	BM	<b>1970 Aerial Photo</b>	Drawing No:
Approved:	AN		<b>FIGURE 1</b>
Date:	27.09.2012		
Scale:	NA		Job No: P0102863

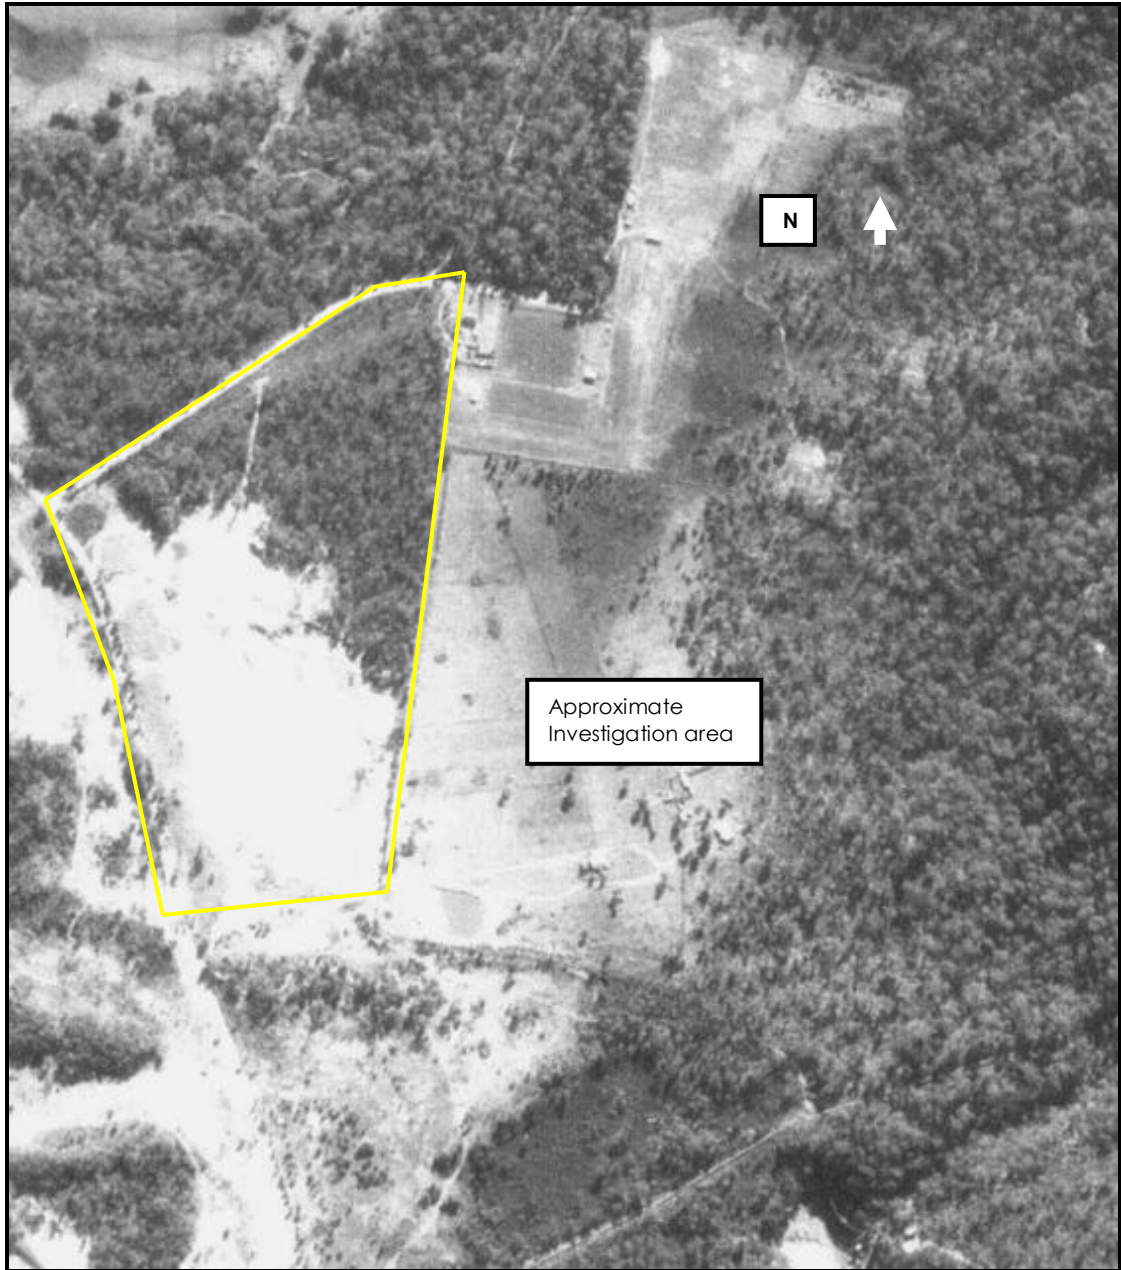
<b>Martens &amp; Associates Pty Ltd</b> ABN 85 070 240 890		<b>Environment   Water   Wastewater   Geotechnical   Civil   Management</b>	
Drawn:	BM	<b>1982 Aerial Photo</b>	Drawing No:
Approved:	AN		<b>FIGURE 1</b>
Date:	27.09.2012		
Scale:	NA		Job No: P0102863

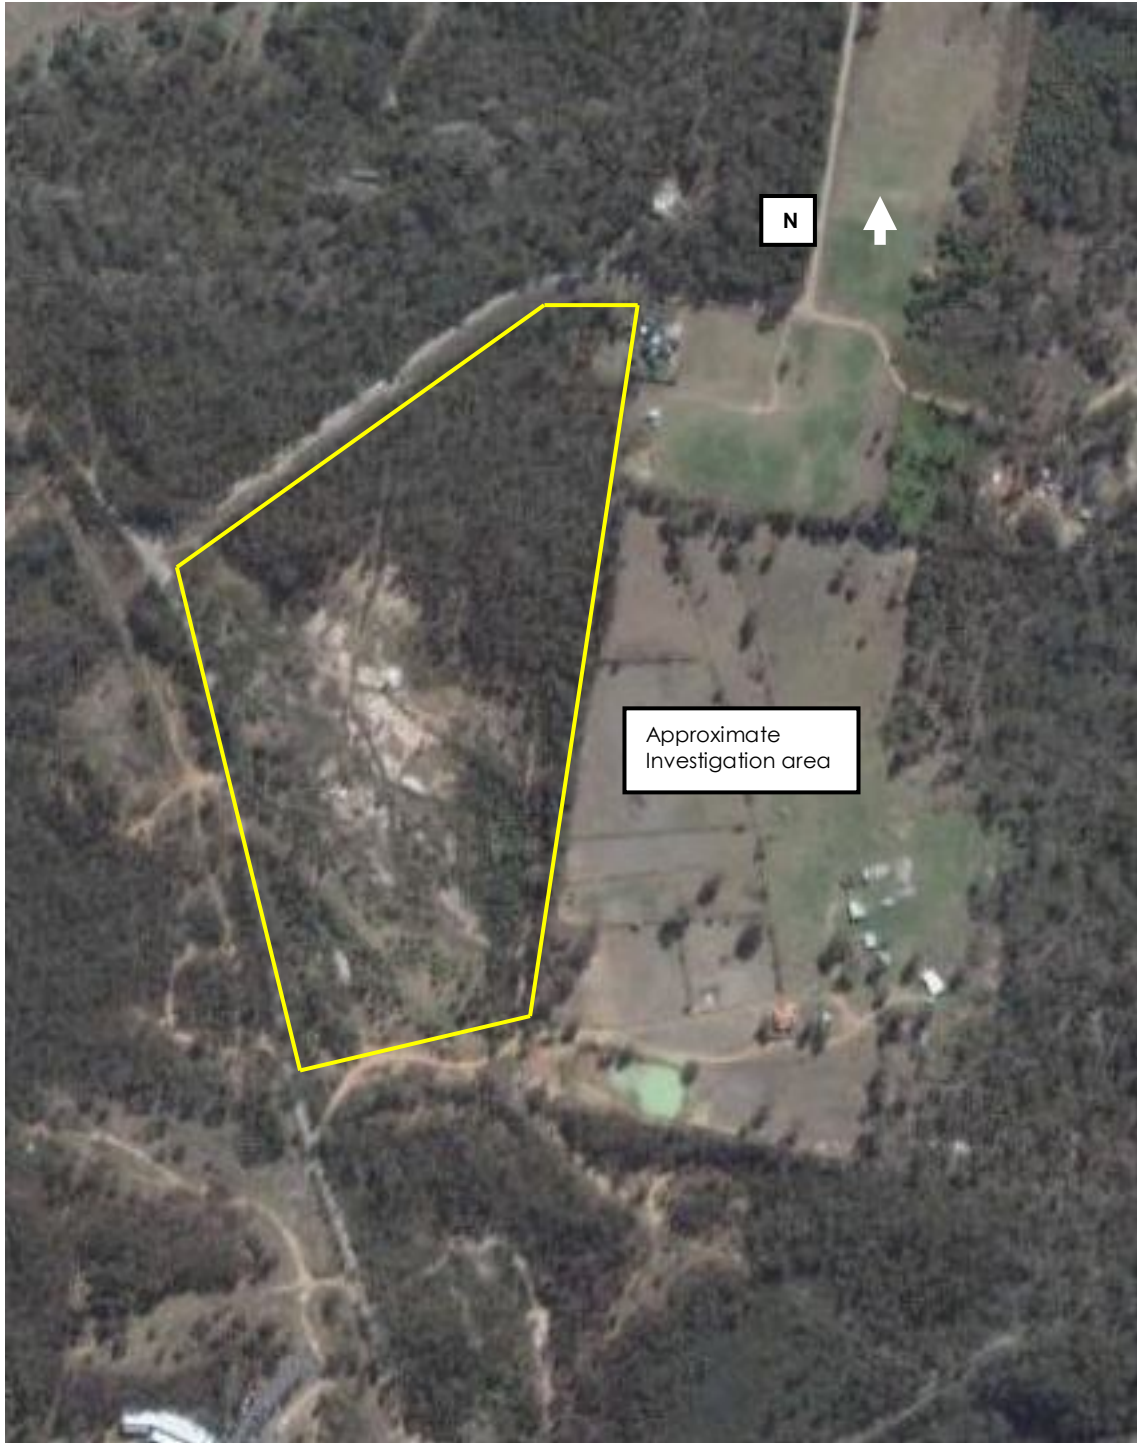
Martens & Associates Pty Ltd ABN 85 070 240 890		Environment   Water   Wastewater   Geotechnical   Civil   Management	
Drawn:	BM	2008 Aerial Photo	Drawing No:
Approved:	AN		<b>FIGURE 1</b>
Date:	27.09.2012		
Scale:	NA		Job No: P0102863

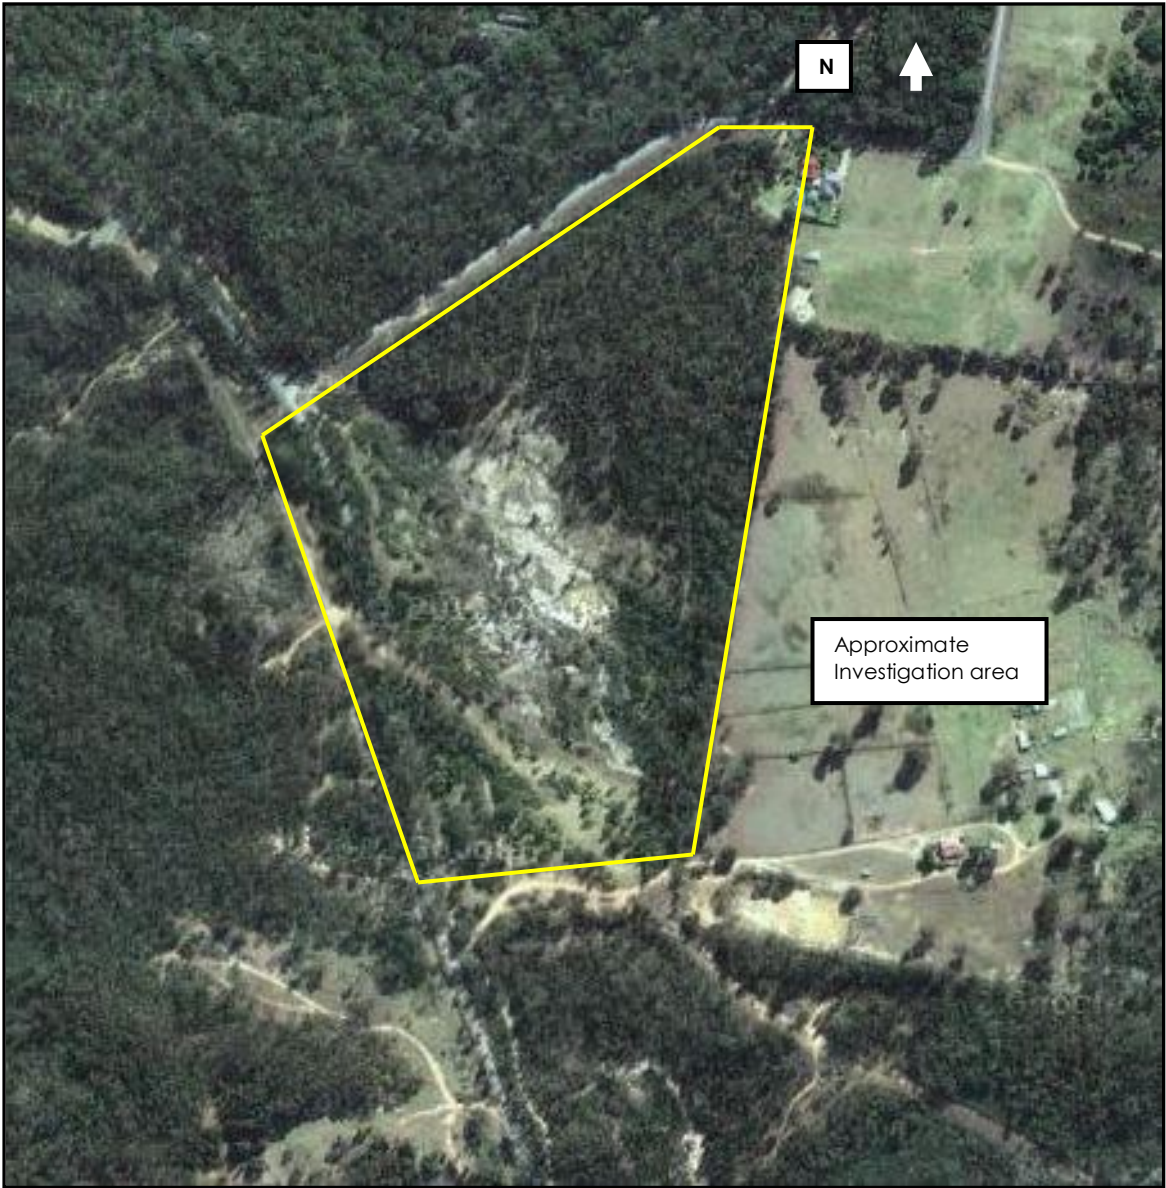
<b>Martens &amp; Associates Pty Ltd</b> ABN 85 070 240 890		<b>Environment   Water   Wastewater   Geotechnical   Civil   Management</b>	
Drawn:	BM	<b>2012 Aerial Photo</b>	Drawing No:
Approved:	AN		<b>FIGURE 1</b>
Date:	27.09.2012		
Scale:	NA		Job No: P0102863
