Shoalhaven City Council

Geotechnical Assessment- Lot 1,
DP1021332 and
Lot 458, DP1063107
George Evans Rd, Mundamia, NSW

P0102863JR02V01

December 2012

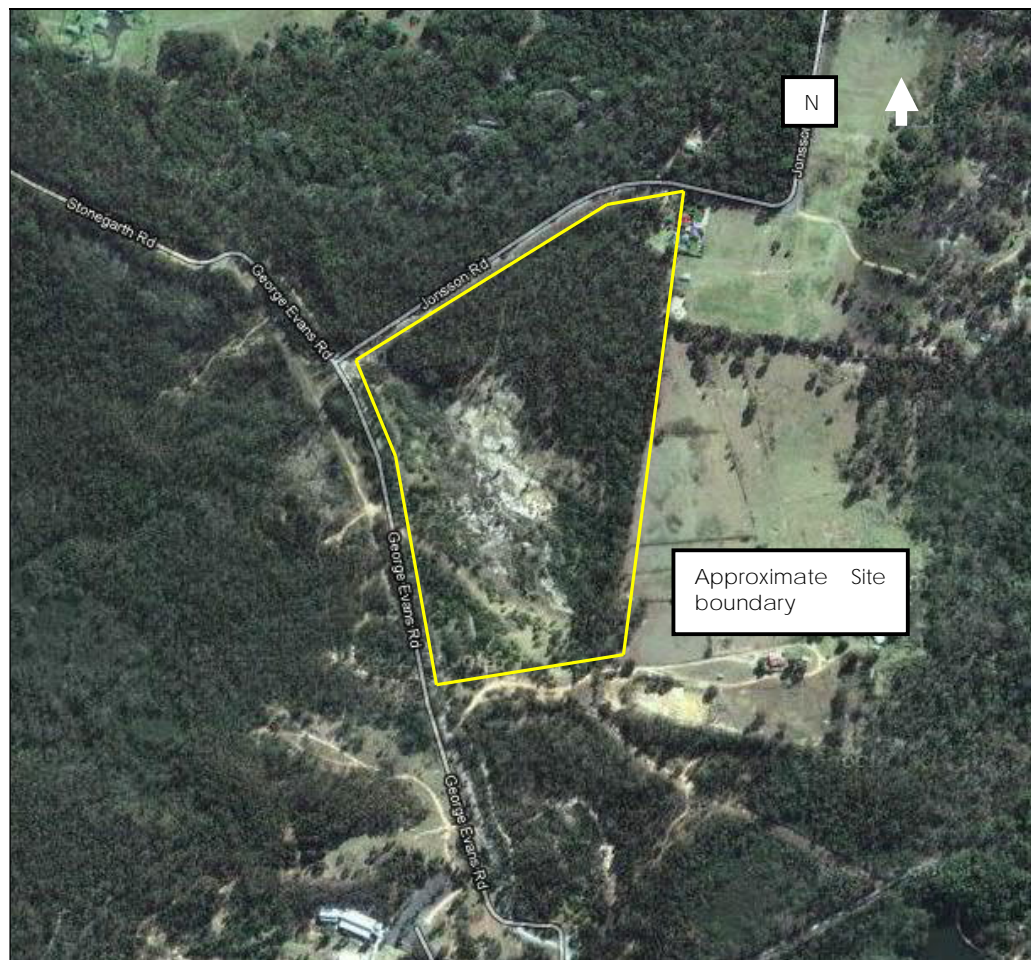
Figure 1: Site location

The 15.5ha (approx.) site is located at George Evans Road, Mundamia within the Shoalhaven Local Government Area (LGA) and is surrounded by predominantly underdeveloped bushland and rural land (Figure 1).
