## **APPENDIX E**

### **ECOLOGICAL ASSESSMENTS**

# Ecological Assessment for Proposed Berth - EB4

(Project No. 48-02)

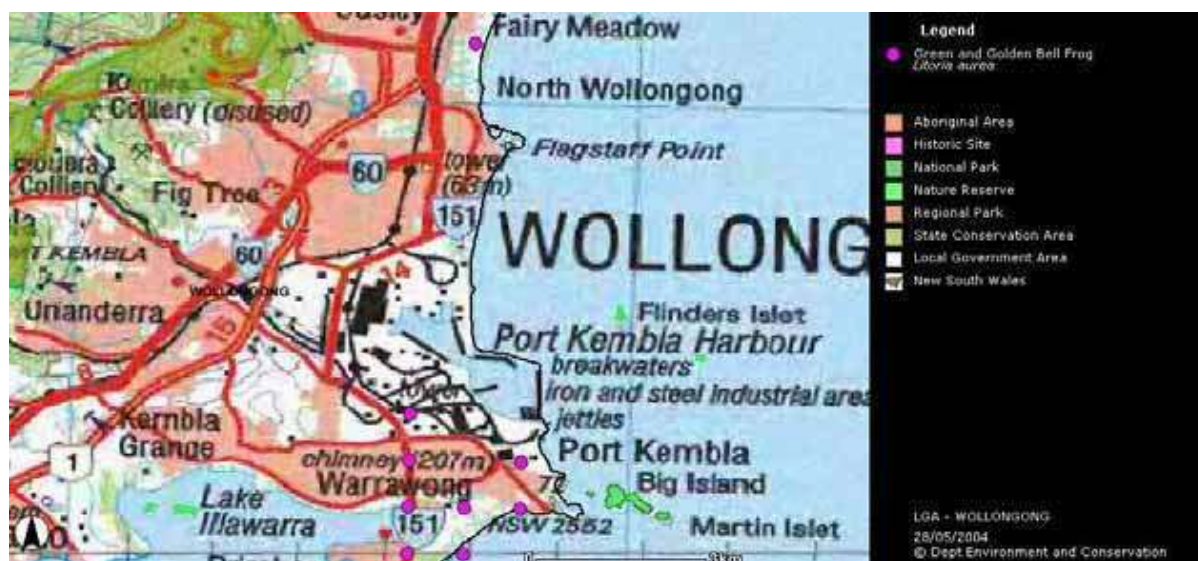
There are a number of records for the green and golden bell frog (*Litoria aurea*) approximately 2km to the south, and additional records approximately 4km to the north, of the study site (Figure 4). However, there is no suitable habitat for this species present at the study site, as the outlet of the Town Drain contains no suitable ponds that could be utilised by the green and golden bell frog.

Figure 4. Map of green and golden bell frog (*Litoria aurea*) records in the Port Kembla Harbour region. Data and mapping is from the Atlas of NSW Wildlife (NPWS 2004).

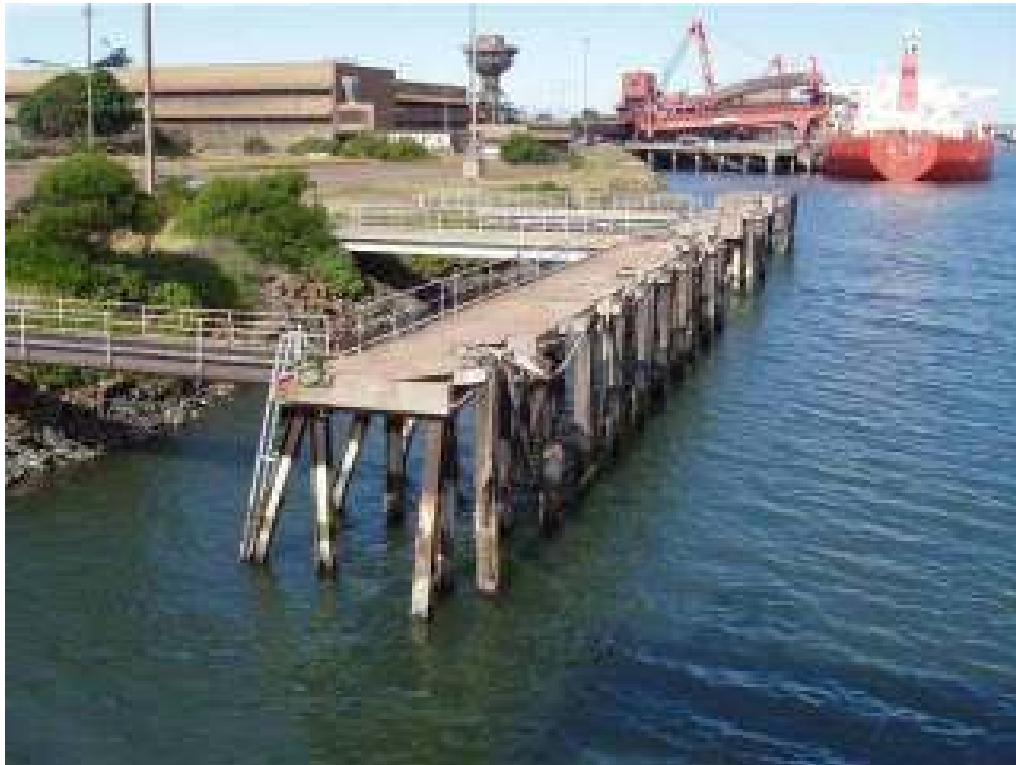
Plate 1. Current berth in eastern portion of EB4 dredge area.

The jettys in the east and northeast of the dredge area also had a number of pylons, which are a potential substrate for macroalgae (Plate 1, Plate 3, Plate 4, Plate 5, Plate 9, Plate 10). No macroalgae were observed on these pylons, although these were inspected at a distance. Clumps of barnacles and filamentous green macroalgae were observed, however, on a rope anchored at a jetty and the shore, and trailing in the water (Plate 7).

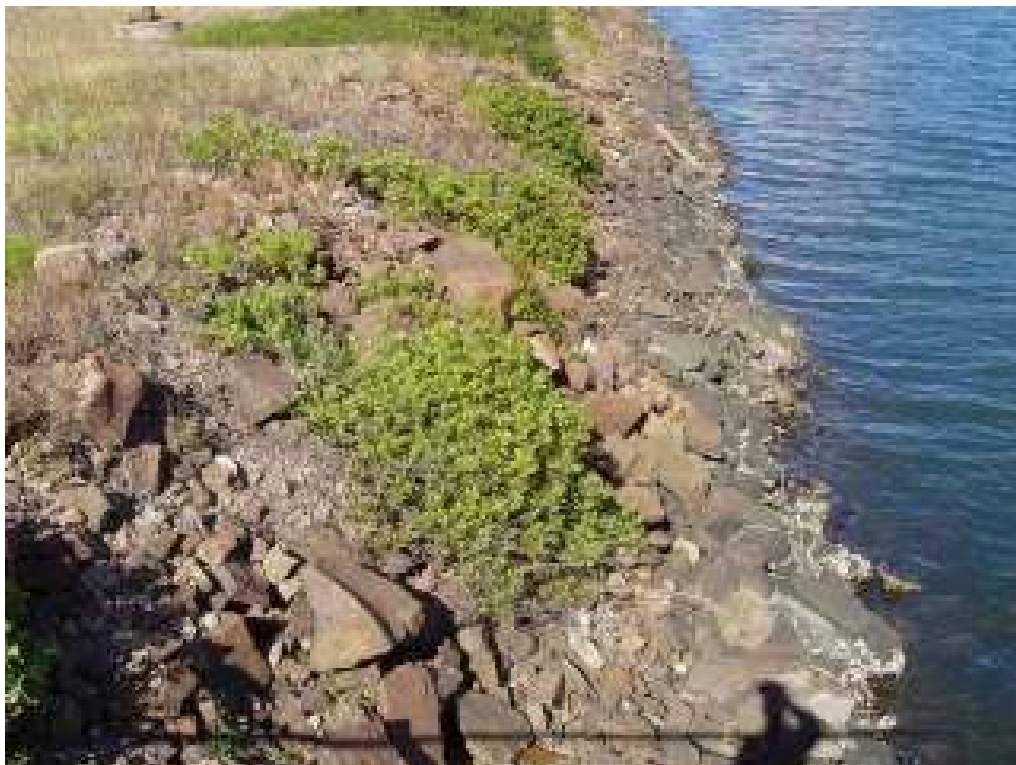
Plate 2. View of rock revetments to the south of berths in eastern portion of EB4 dredge area.

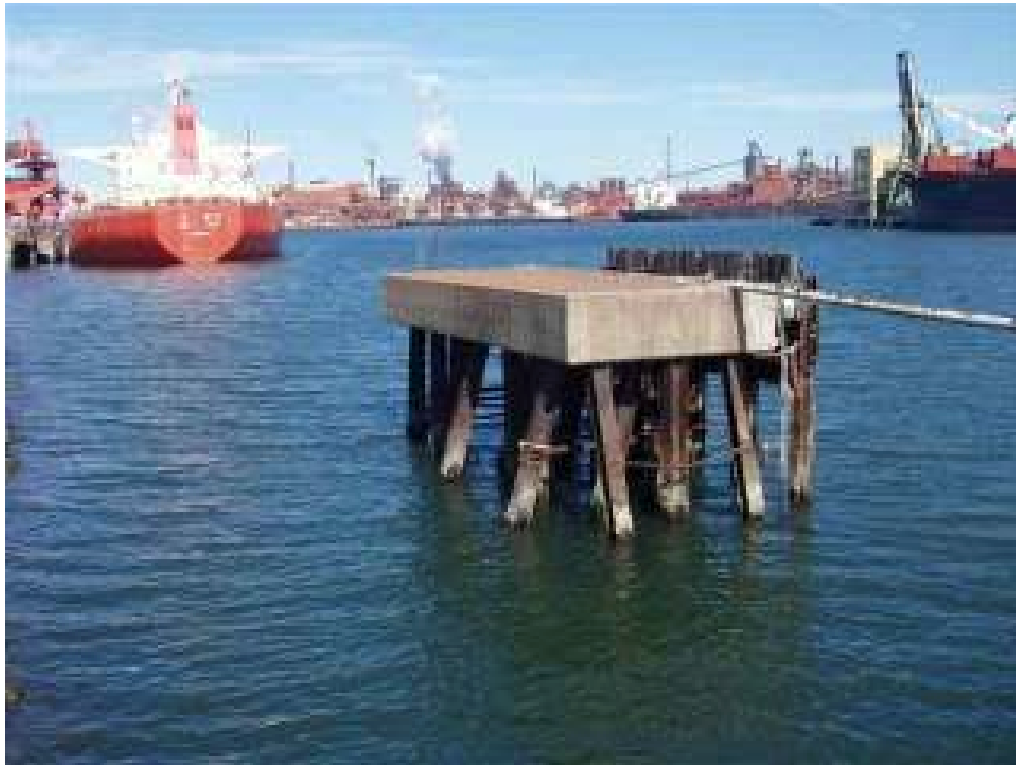
**Plate 3. Southern part of current berth (isolated from land).**

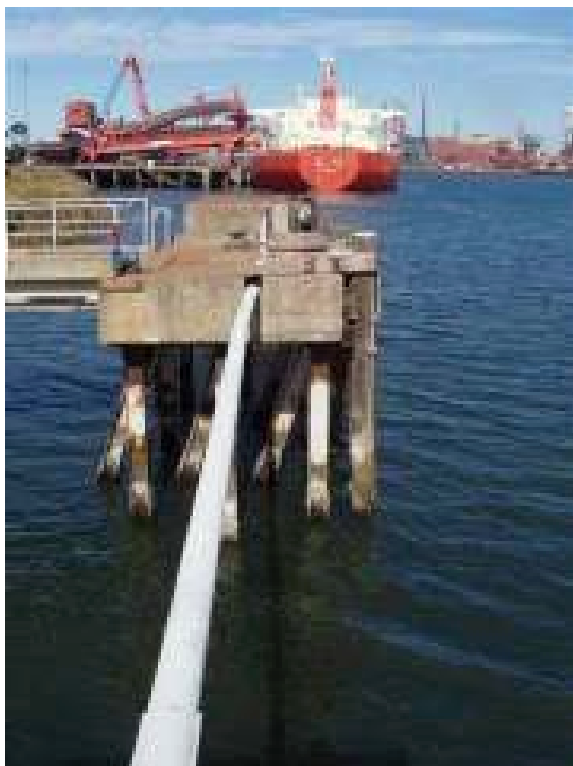
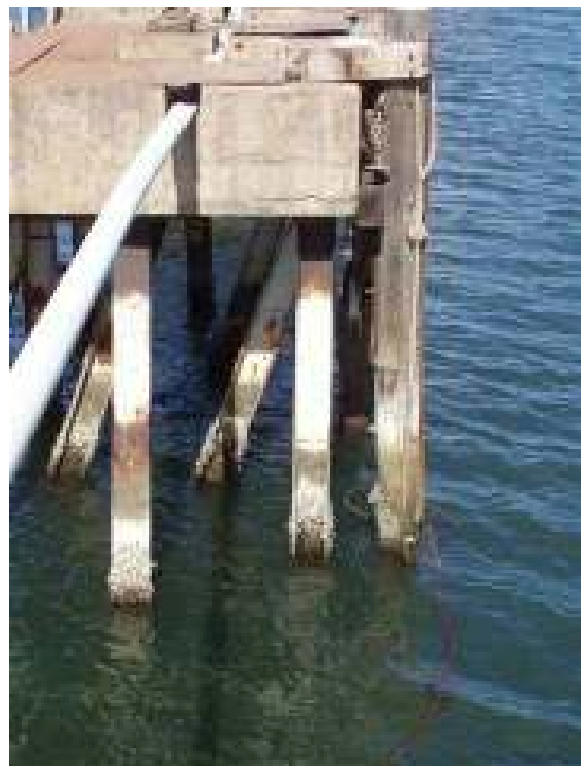
**Plate 4. Southern jetty: photograph A shows the jetty, and photograph B is a close up of the jetty piles.**

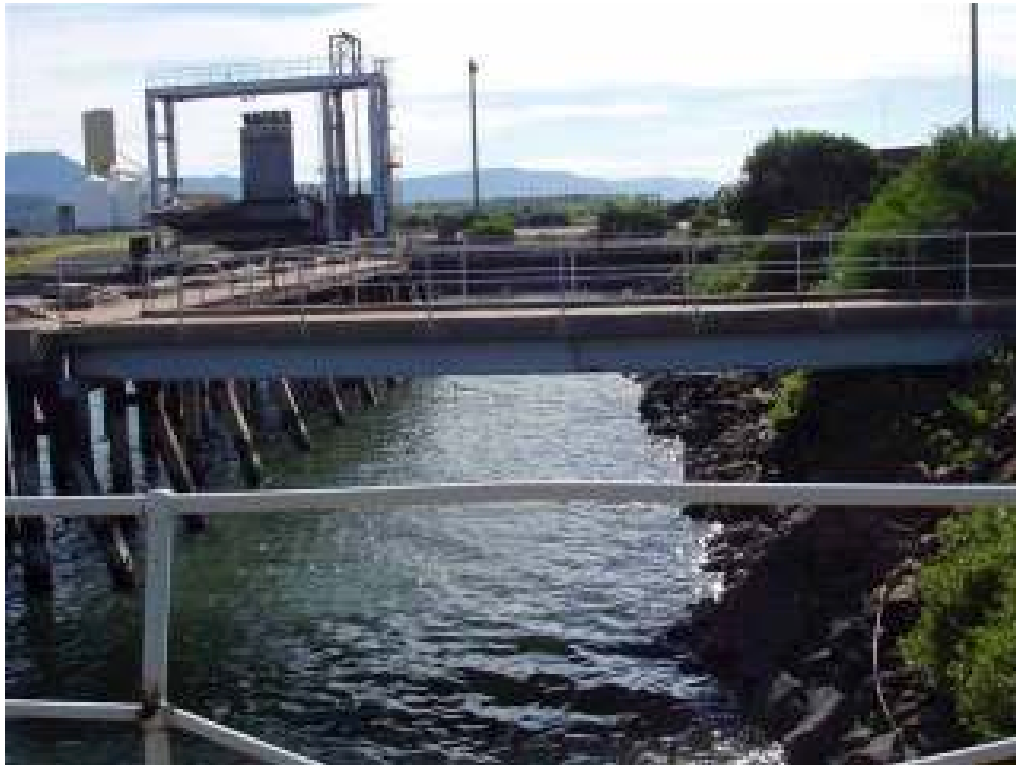
**Plate 5. View of rock revetments adjacent to the berths in eastern portion of EB4 dredge area (photograph taken facing north from southern jetty).**

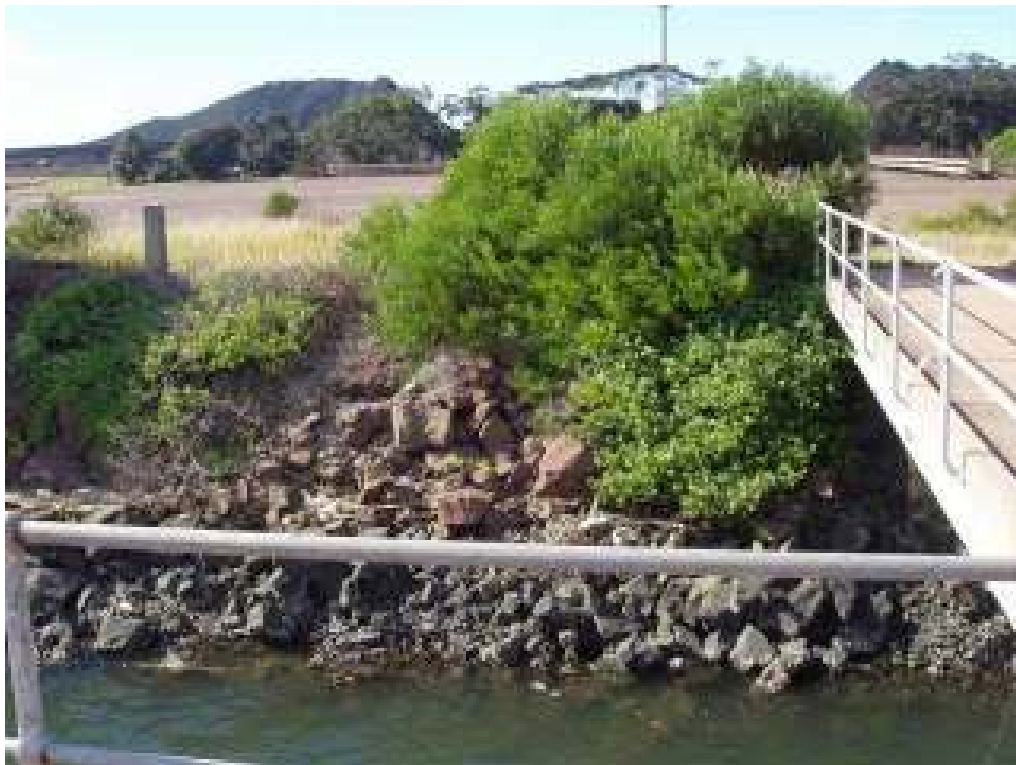
The vegetation on the rock revetments and adjacent land in the east and northeast of the dredge area was observed to consist mainly of weeds such as bitou bush (*Chrysanthemoides monilifera*), but with Sydney golden wattle (*Acacia longifolia*) also observed. Vegetation was sparse on the rock revetments near the water, but thick at the top of the revetments (Plate 1, Plate 2, Plate 5, Plate 6, Plate 8, Plate 11), and sparse on the adjacent land that was within 25m of the rock revetments.

**Plate 6. View of rock revetments adjacent to the southern jetty in eastern portion of EB4 dredge area (photograph taken facing east from southern jetty).**

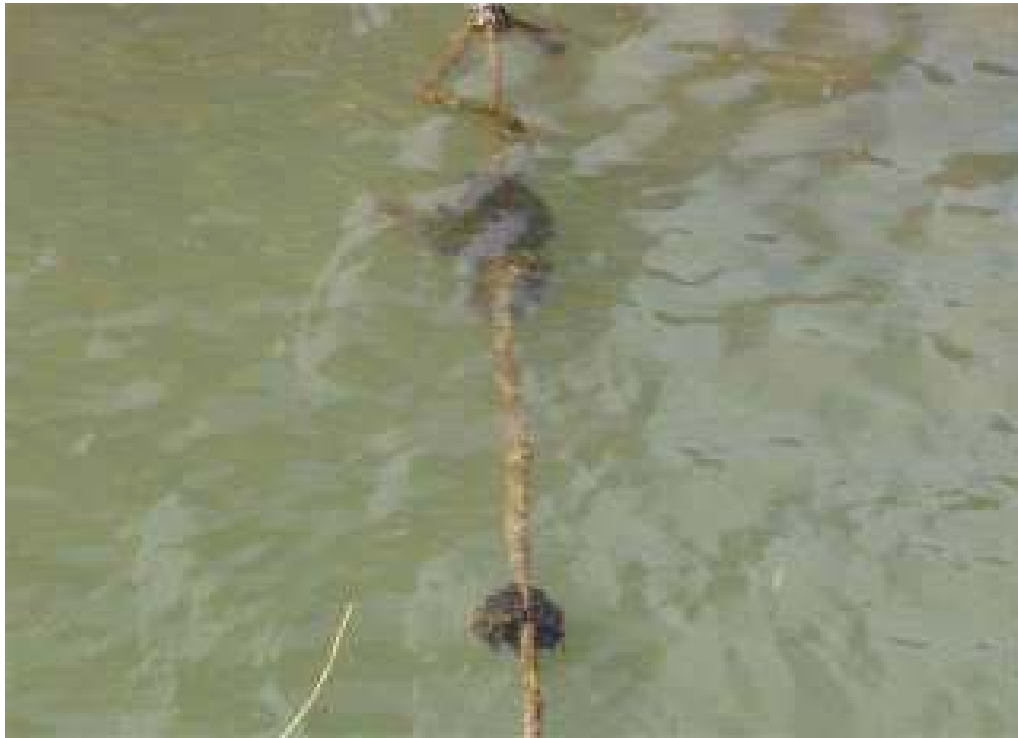
**Plate 7. Rope between eastern jetty and rock revetments (anchored at the top of the rock revetment). Clumps of barnacles and filamentous green algae are attached in to the rope.**

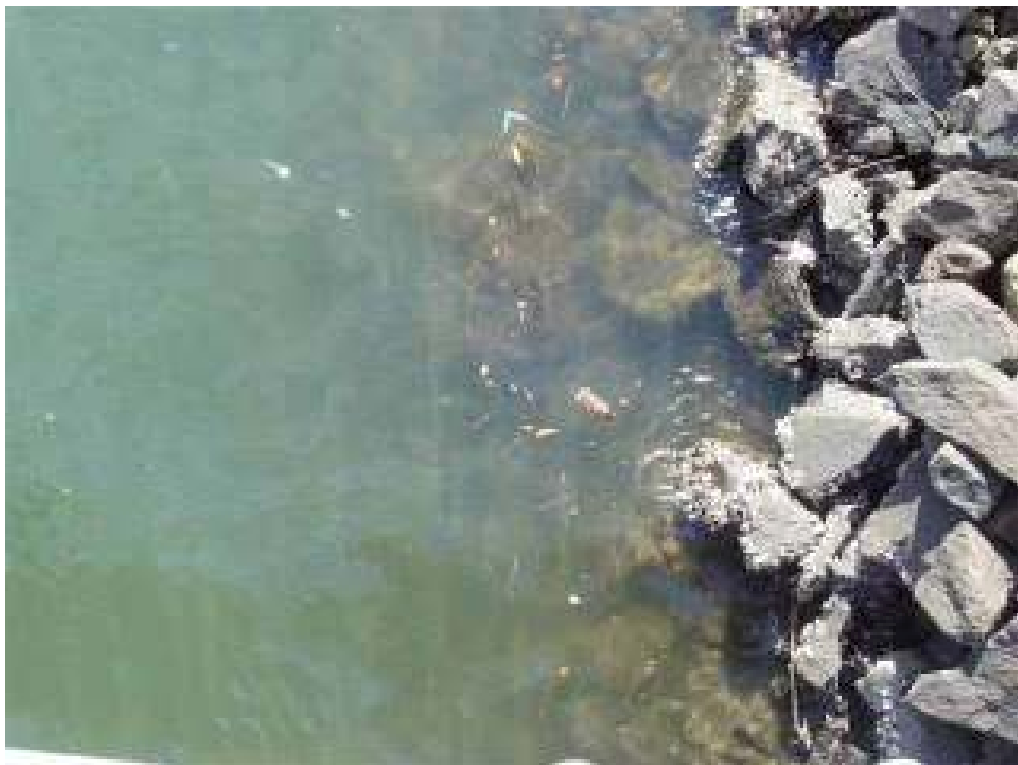
**Plate 8. View of water and rock revetments in eastern portion of EB4 dredge area. Photograph taken facing directly down from walkway on the most northern of the eastern jettys. The rock revetment is included within the EB4 overland dredge area.**

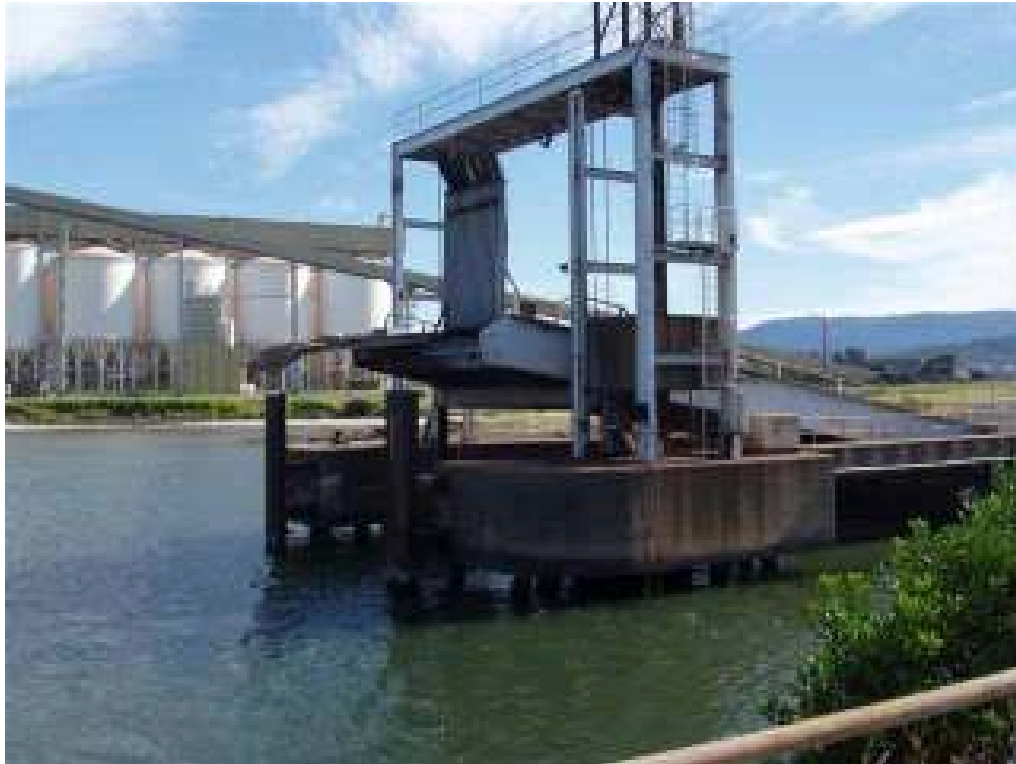
**Plate 9. Current berth in northeastern portion of EB4 dredge area.**

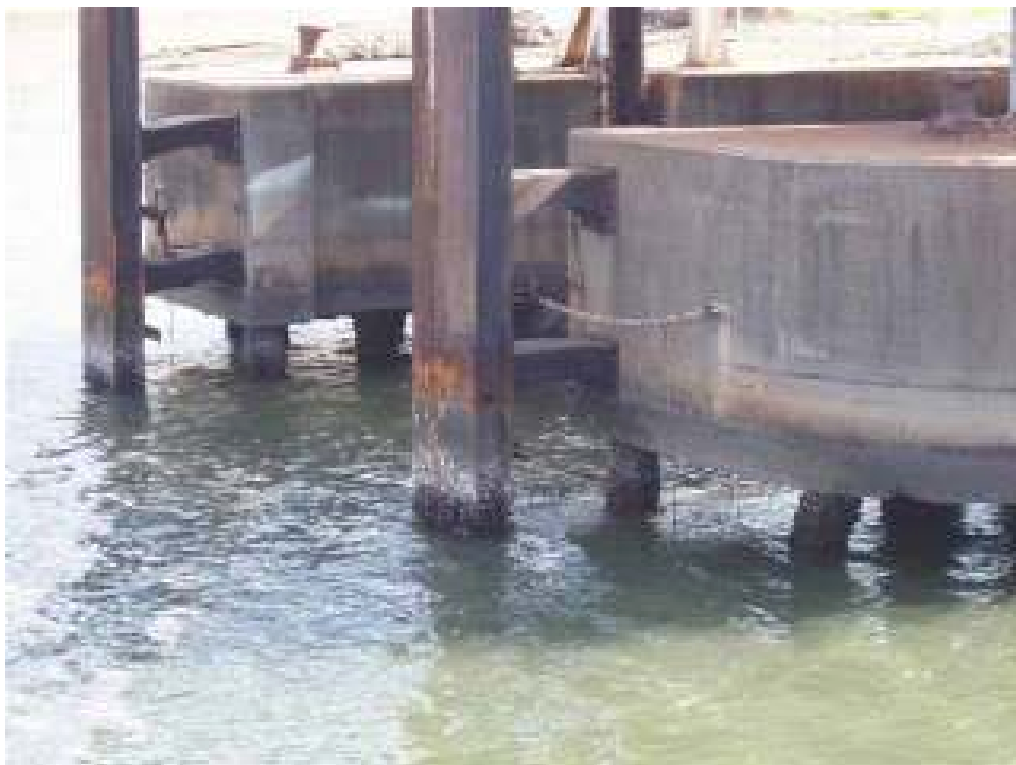
**Plate 10. Close up of pylons of current berth in northeastern portion of EB4 dredge area.**

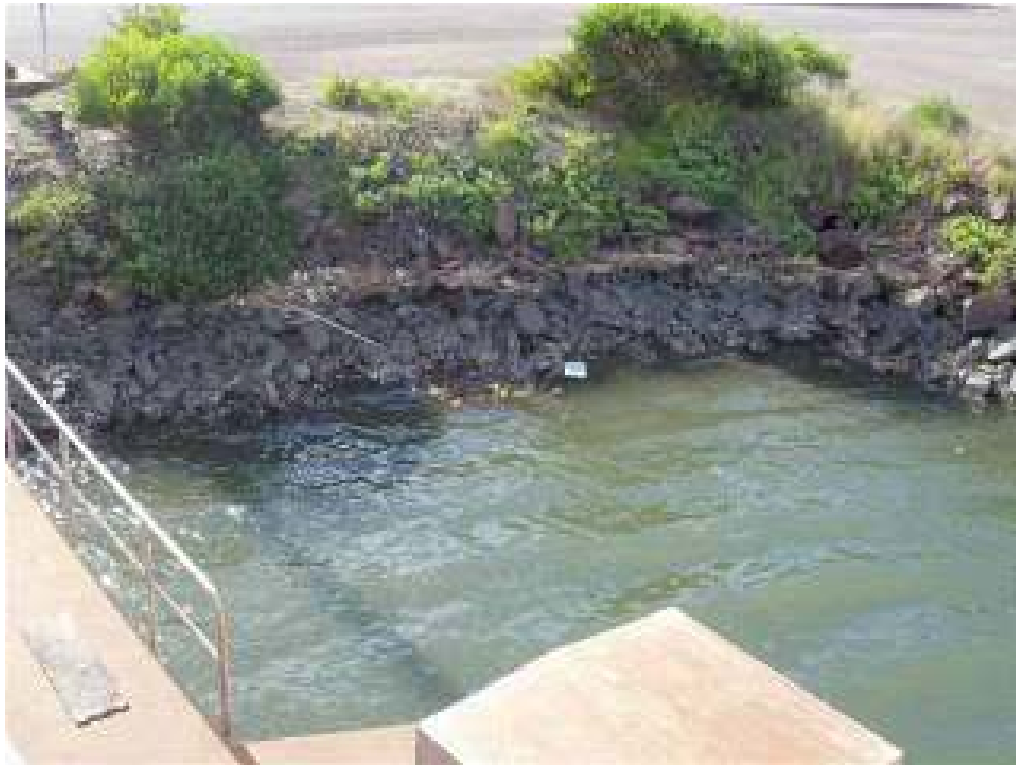
**Plate 11. Rock revetment and vegetation in northern portion of EB4 dredge area.**

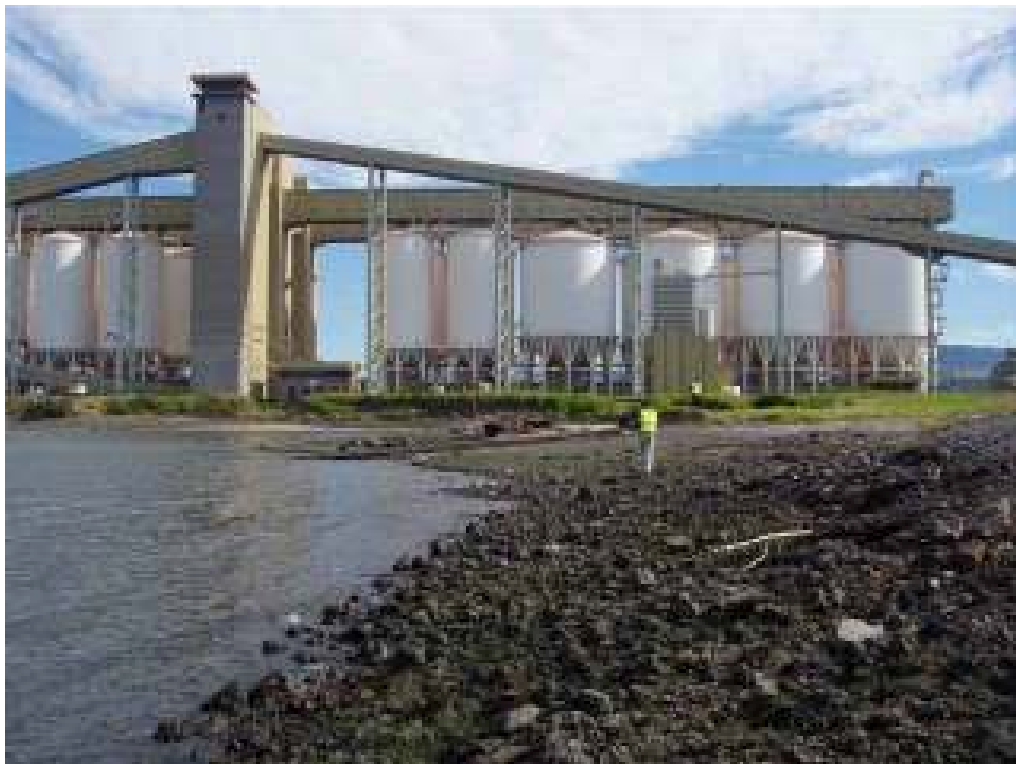
**Plate 12. Northern shoreline adjacent to the EB4 dredge area (outside of the proposed dredge footprint). In the background of the photograph are the grain silos on the western side of the basin, with the Town Drain outlet visible below the highest grain silo structure.**

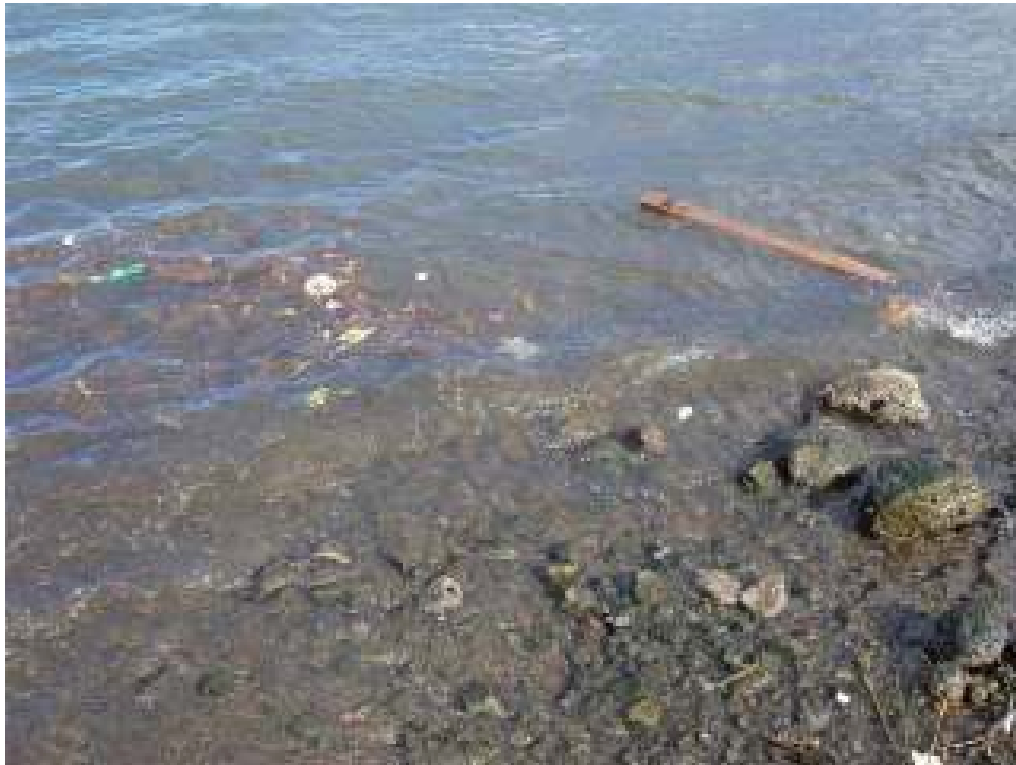
**Plate 13. Wrack and debris along the northern shoreline.**

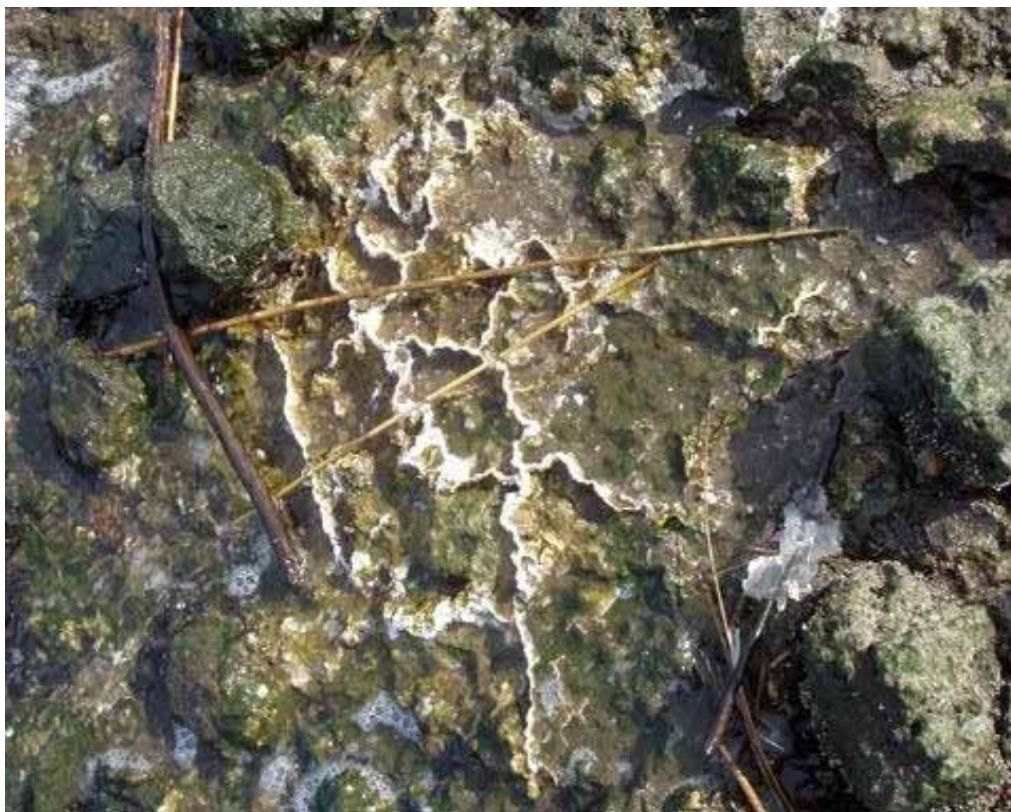
**Plate 14. Debris and crystallised gypsum along the northern shoreline (white lines visible on the rocks).**

Evidence of the industrial nature of the site was apparent from crystallised gypsum which was observed along the rock revetment and northern shoreline (Plate 14).

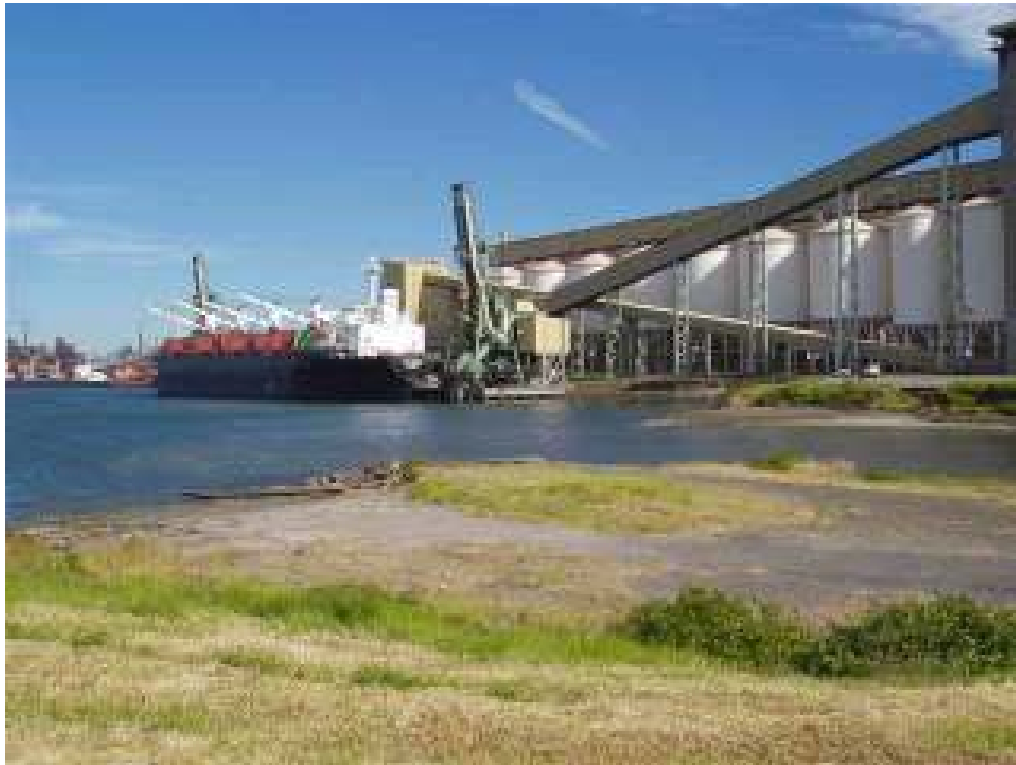
**Plate 15. Spit of land in northwestern portion of EB4 overland dredge area (eastern part of Town Drain outlet).**

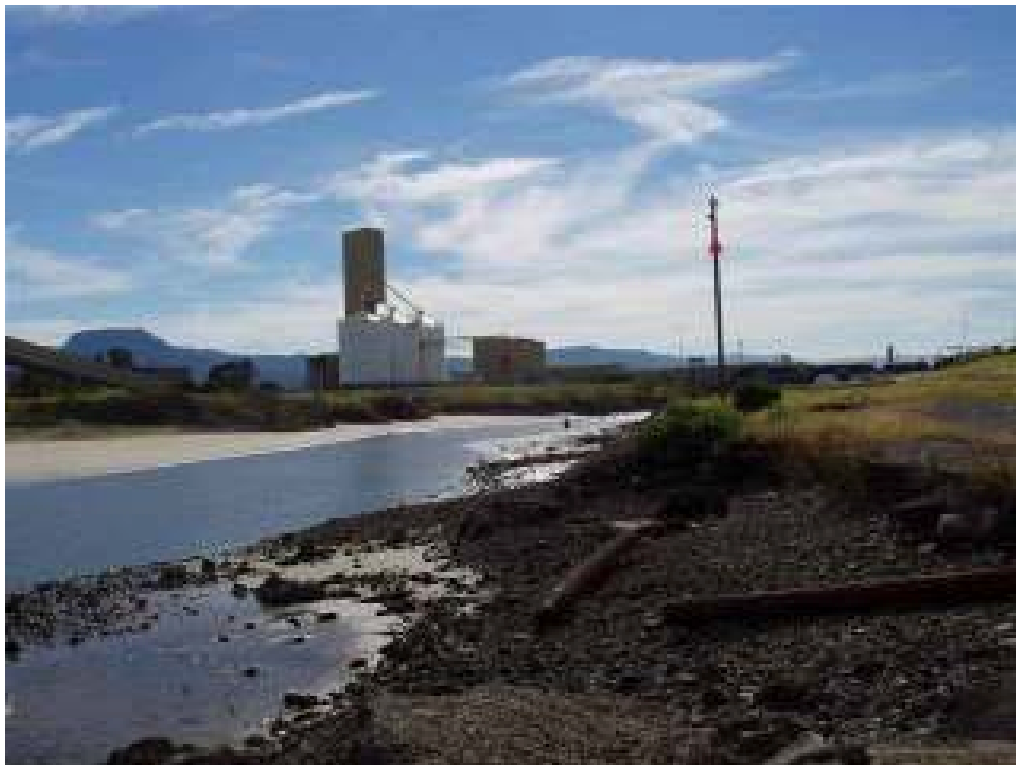
**Plate 16. Looking northwest from the proposal site of EB4 (this is where the Eastern Basin meets the Town Drain).**
