Ecological Assessment for Proposed Berth - WB1

(Project No. 48-02)

Report prepared for:
Port Kembla Port Corporation

Ecological Assessment for Disposal of Dredge Material in Port Kembla Outer Harbour

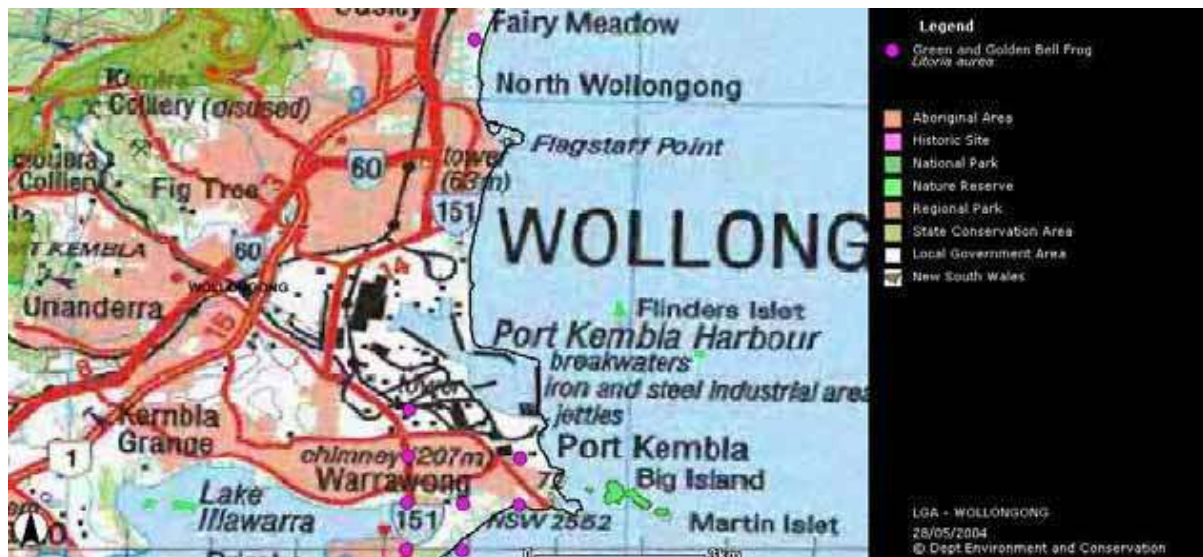
Figure 4. Map of green and golden bell frog (*Litoria aurea*) records in the Port Kembla Harbour region. Data and mapping is from the Atlas of NSW Wildlife (NPWS 2004).

There are a number of records for the green and golden bell frog (*Litoria aurea*) approximately 2km to the south, and additional records approximately 4km to the north, of the study site (Figure 4). There are no records of green and golden bell frogs within the catchment of Tom Thumb Road Drain, but it is unknown whether or not surveys for this species have been conducted. Potential habitat may be present within the rehabilitated catchment approximately 1.5km to the north. Tom Thumb Road Drain itself has a narrow area of vegetation which is heavily weed dominated and most water flow appearing to be subsurface flow. The drain is thus considered to be unlikely to suitable habitat for the green and golden bell frog. It is unknown whether Tom Thumb Road Drain is utilised for dispersal by this species, although this appears to be unlikely given the low habitat quality of the site, and no known populations to the north.

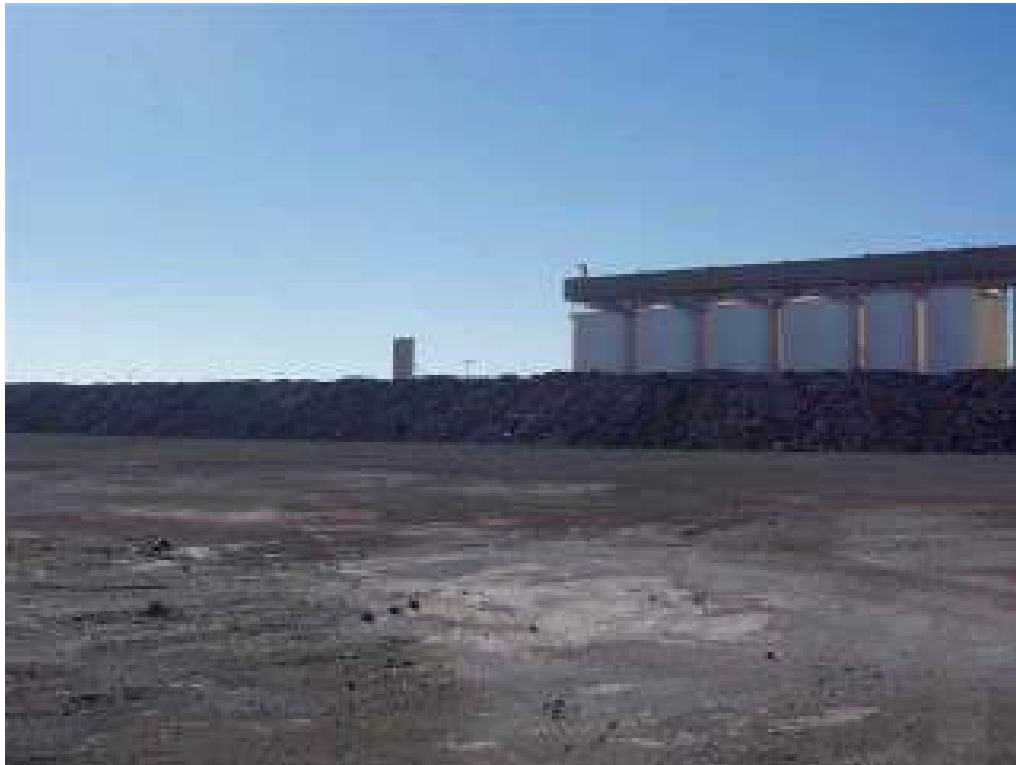
Plate 1. Northeastern portion of WB1 overland dredge area.

No vegetation was present in the remainder of the site which was compacted fill (Plate 1, Plate 2).

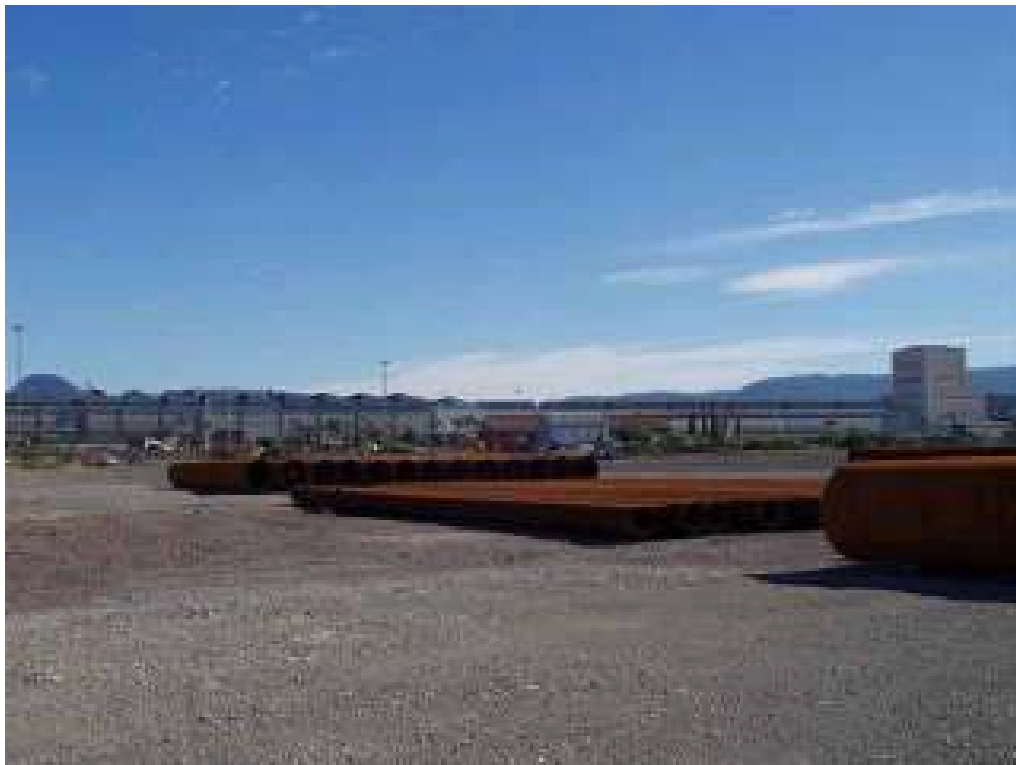
Plate 2. Northwestern portion of WB1 overland dredge area.

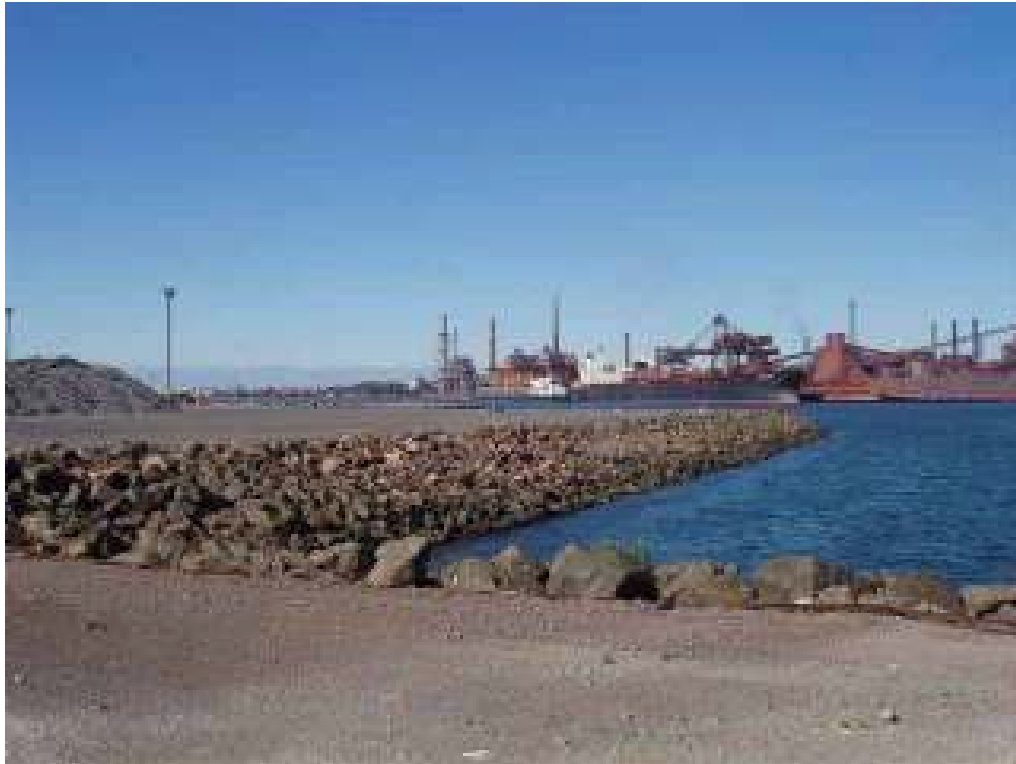
Plate 3. Rock revetment on the eastern boundary of the WB1 dredge area.

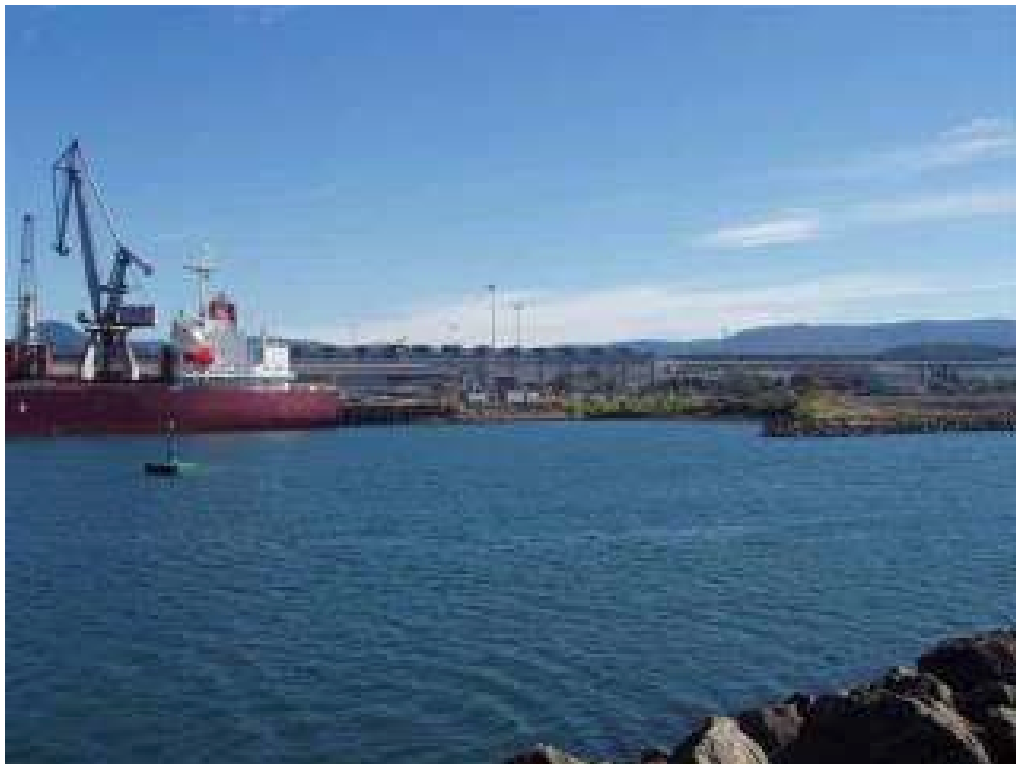
Plate 4. Western boundary (on left hand side) and northern rock revetments (on right hand side) for the WB1 dredge area.

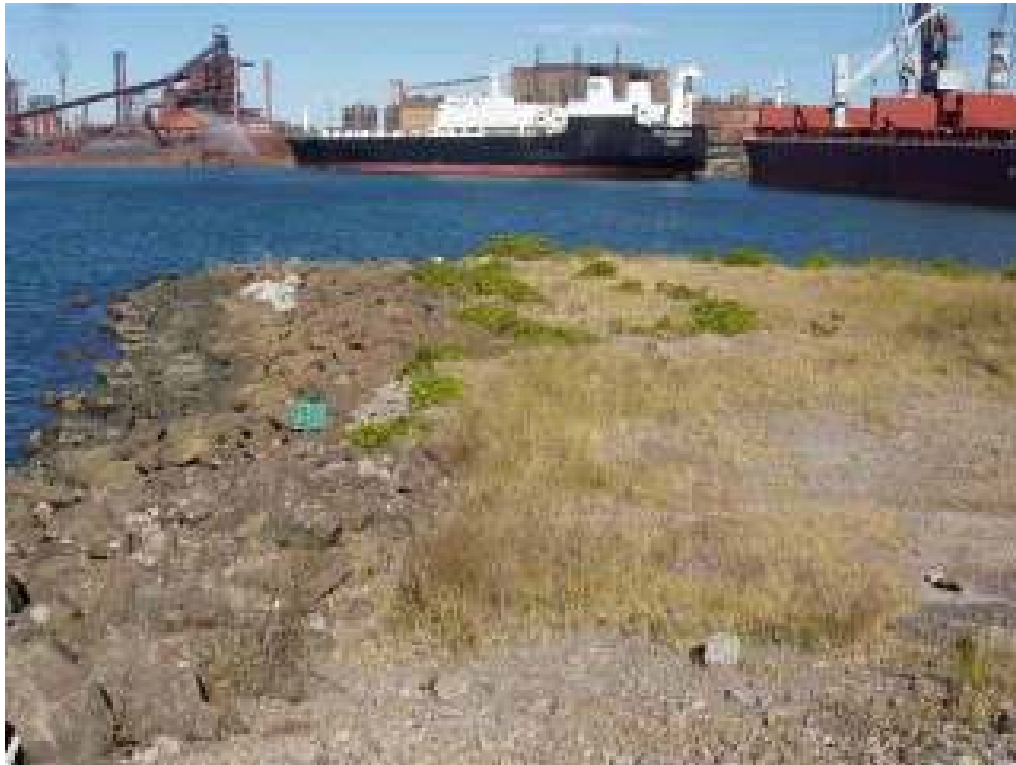
Plate 5. Promontory on the northern rock revetment.

The vegetation on the rock revetments and adjacent land was observed to consist almost exclusively of weeds, but with some opportunistic native knobbly club-rush (*Isolepis nodosa*) also observed. Vegetation was extremely sparse on the rock revetments (Plate 3, Plate 4), and sparse on the adjacent land that was within 25m of the rock revetments (Plate 5).

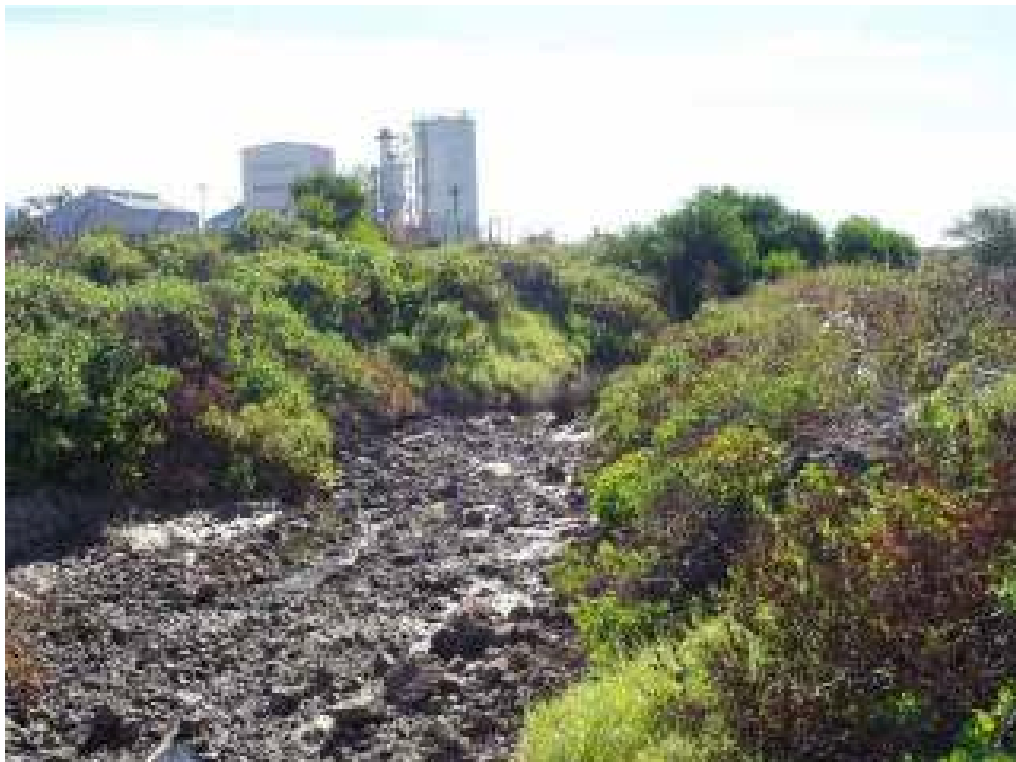
Plate 6. Outlet of Tom Thumb Road Drain into Port Kembla Harbour.

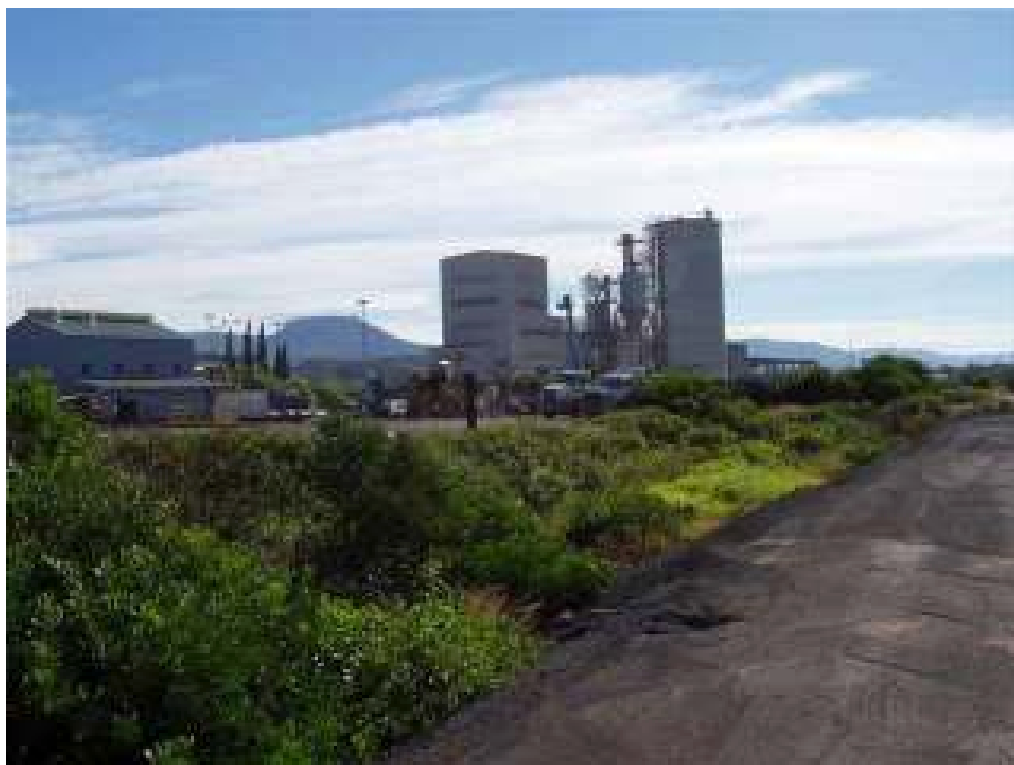
Plate 7. Overland portion of Tom Thumb Road Drain (picture taken on WB1 site facing northwest).

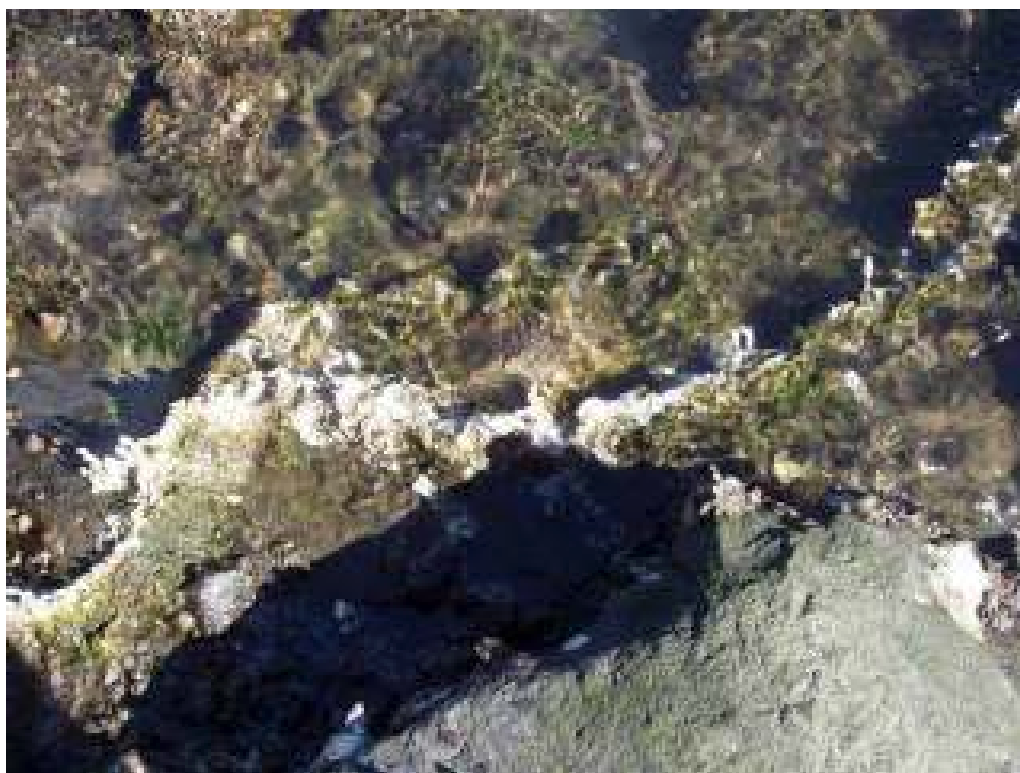
Plate 8. Crystallised gypsum (white line from left to right visible on the rocks) along the rock revetments on the eastern boundary of the dredge area. Numerous molluscs are also visible.

Evidence of the industrial nature of the site was apparent from crystallised gypsum which was observed along the rock revetments (Plate 8).
