St. Vincent's Hospital
Caritas Site

299 Forbes Street, Darlinghurst NSW

Heritage Impact Statement

August 2006

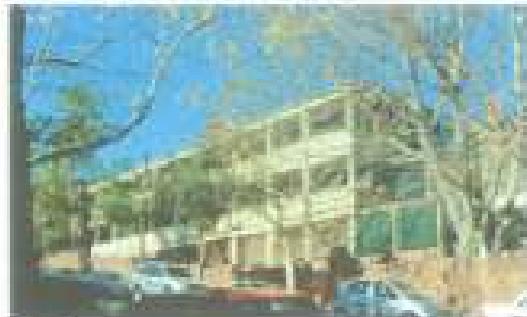
Figure 3
Showing Burton Street from the west, with the rear (1882) wing contained within the perimeter fence.
(Source: Graham Brooks & Associates, July 2000)

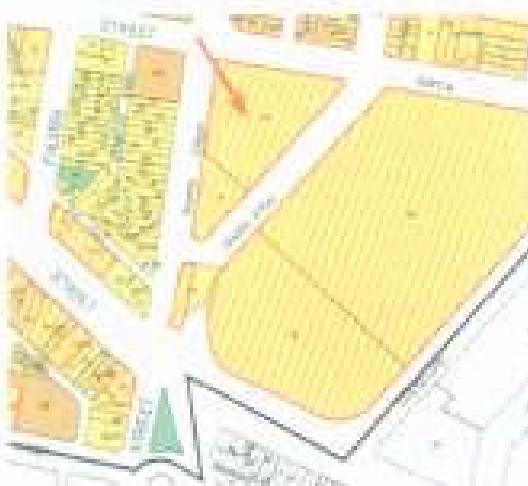
Figure 4
City of Sydney Heritage Conservation map, shows the site fully enclosed as an area of group significance.
Source: City of Sydney - July 2008.

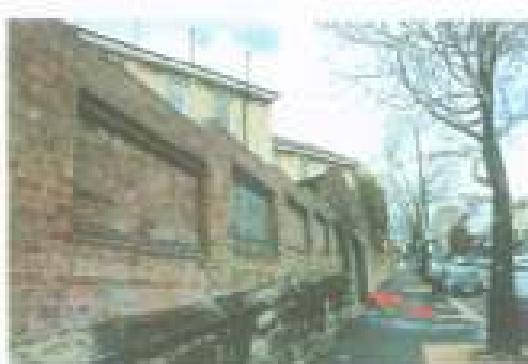
Figure 5
Showing the side and rear sections and along Bourke Street of the rear of the building. The Bourke Street end is intersected by two driveways.
Source: Graham Brooks & Associates, July 2008.

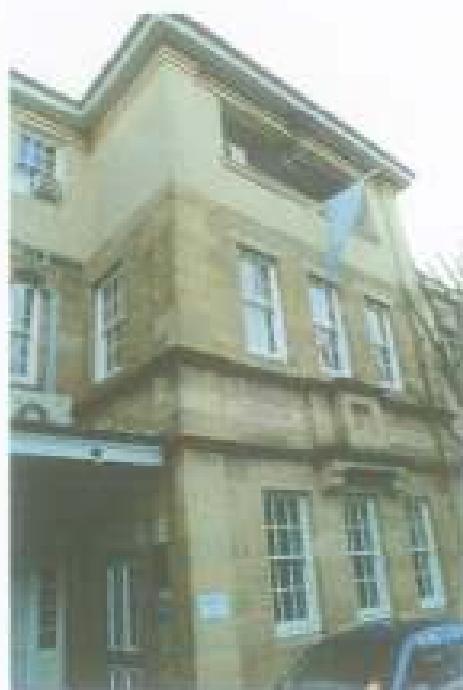
Figure 2
Central portion of the front facade of the main building, which displays the first floor addition and attached Carex cottage.
Source: Graham Brooks & Associates, July 2000.

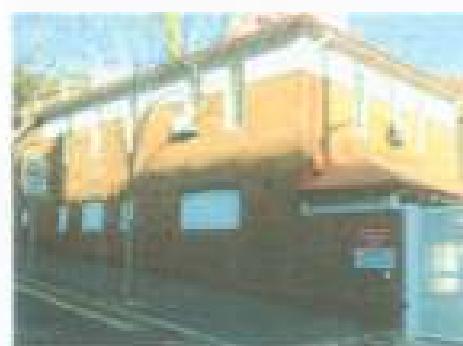
Figure 4
The old kitchen block at the northwest corner of the site and facing northwesterly along Burton Street.
Source: Graham Brooks & Associates, July 2000.

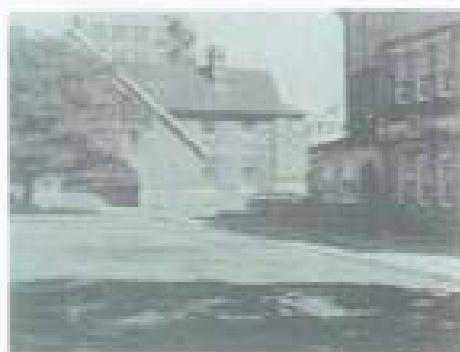
Figure 11
From a newspaper clipping in the early 1900s soon after the flood of the year. Note the closed-in separation spaces. Until this time the enclosed stone walls of the upper floor of the building appears to have been as Darlinghurst Reception Centre. It seems that the concrete steps were added on over several years.
(Source: St Vincent's Archives, 2016-2009)

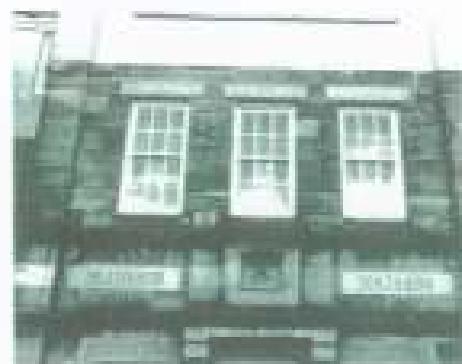
Figure 13
Stone engraving with 'Foveaux' removed in this photo when roof and then cover completely affected on the reverse side. Note the other appearance of the subdivision above, which was probably placed in the late 1920s.
(Source: St Vincent's Archives, July 2009)

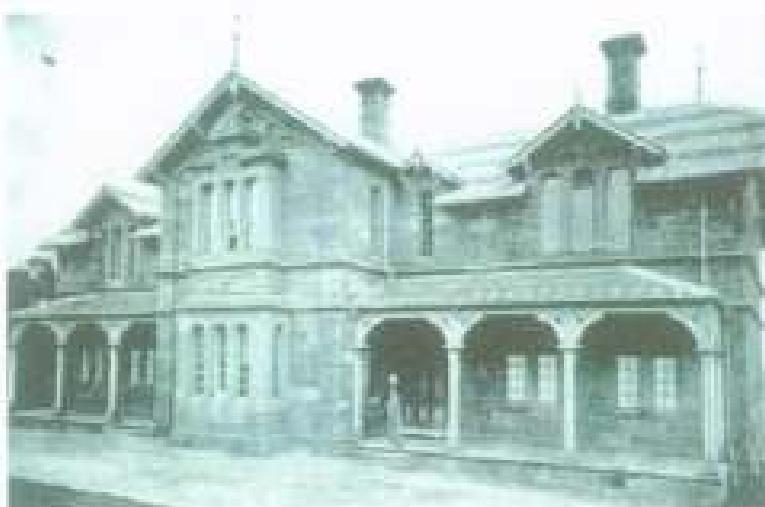
Figure 14
The Receiving House as it originally appeared. It was designed into two equal portions, male and female, each when built (about 1857) accommodated the mental less, non-delinquent patients and called the Ward House. (Source: Item 1, Box 18, State Library of NSW.)

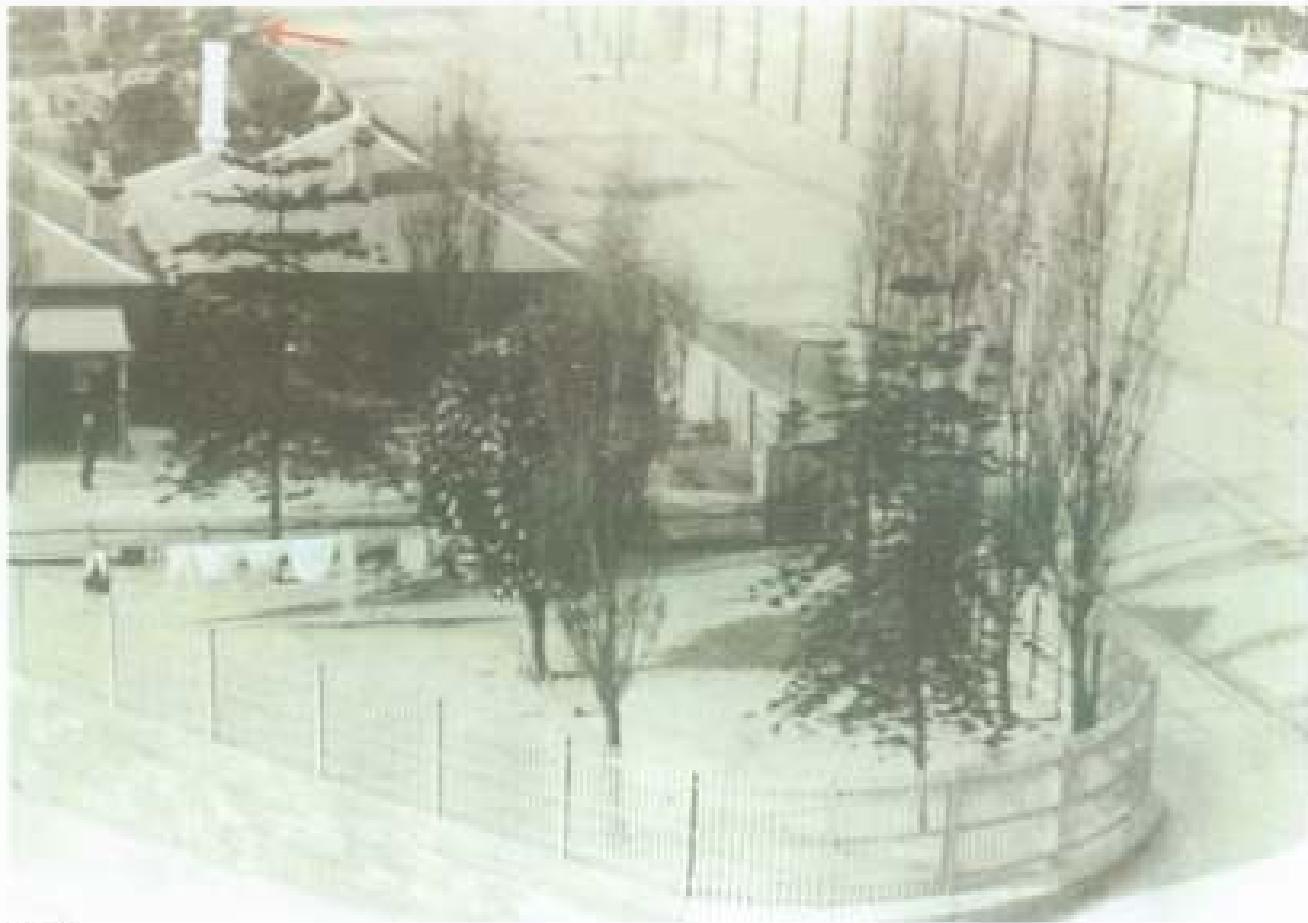
Figure 26:
Historical photograph (1880s) of the Darley Dale Police Station at the upper end of the property, as it appears from a vantage point height. The Reception House Front gardens are hidden. The Police staff would be situated towards the back of the photograph (opposite indicating the direction). The temple was placed behind the main entrance. There is a sign hanging outside the gates referring to the Police Station, an officer stands in duty at the front doorway, with passes in evidence behind. The police station survives in the first area of conservation zone, originally incorporating parts of what would later become the Castle Cottages site. The rest of the gate is seen on the opposite side of Forbes Street.
(Source: PCCMVA, Matlock Library, accessed July 2006)

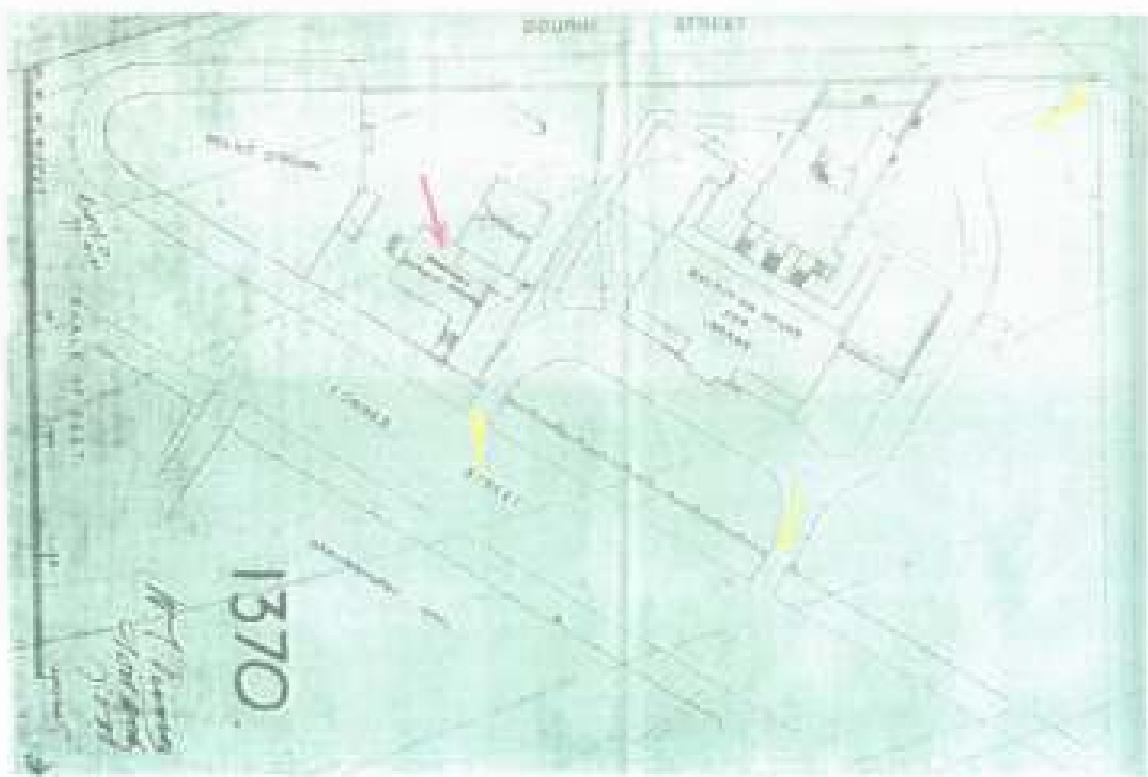
Figure 2a:

This 1881 site plan indirectly represents the site during the first five years or so of the twentieth century. It clearly shows the then-new Darlinghurst Police Station in its original configuration. It also indicates a proposed 'Linenry Court' on a site (marked with a yellow arrow) at the 'Ward House'. This area covers the land on which the Captain's Cottage is presently sited. It also shows existing buildings around the north front and south end of the road. It is noted that the whole site is otherwise quite clear and the houses were at the northern corner in 1901. This stage indicates how it has looked since. These areas probably constructed after 1907. The three pathways, with their suddenly substantive gate posts are also indicated (yellow arrows). (State: City of Sydney Archives, mounted 2006)

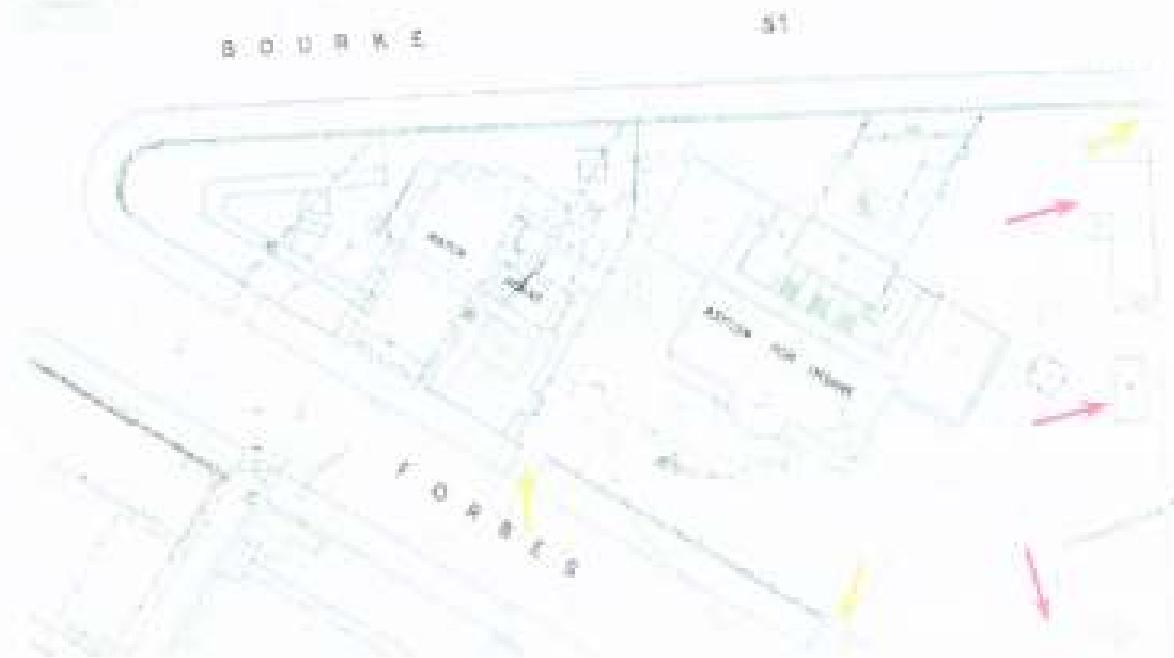
Figure 2b:

This site plan from Sydney, shows probably represents the site in the late 1920s (July 1923). Note that it still reflects the area between Darlinghurst Police Station and the Residential House as the 'Ward House', and the area formerly include part of what is now the Captain's Cottage site. At the bottom right and far right of the plan, the original streetside and the eastern back gate is evident, as is the later (post 1923) rear section (The Police principal gateway), with these gateways are also in residential (public) service. (State: City of Sydney Archives, mounted 1998)

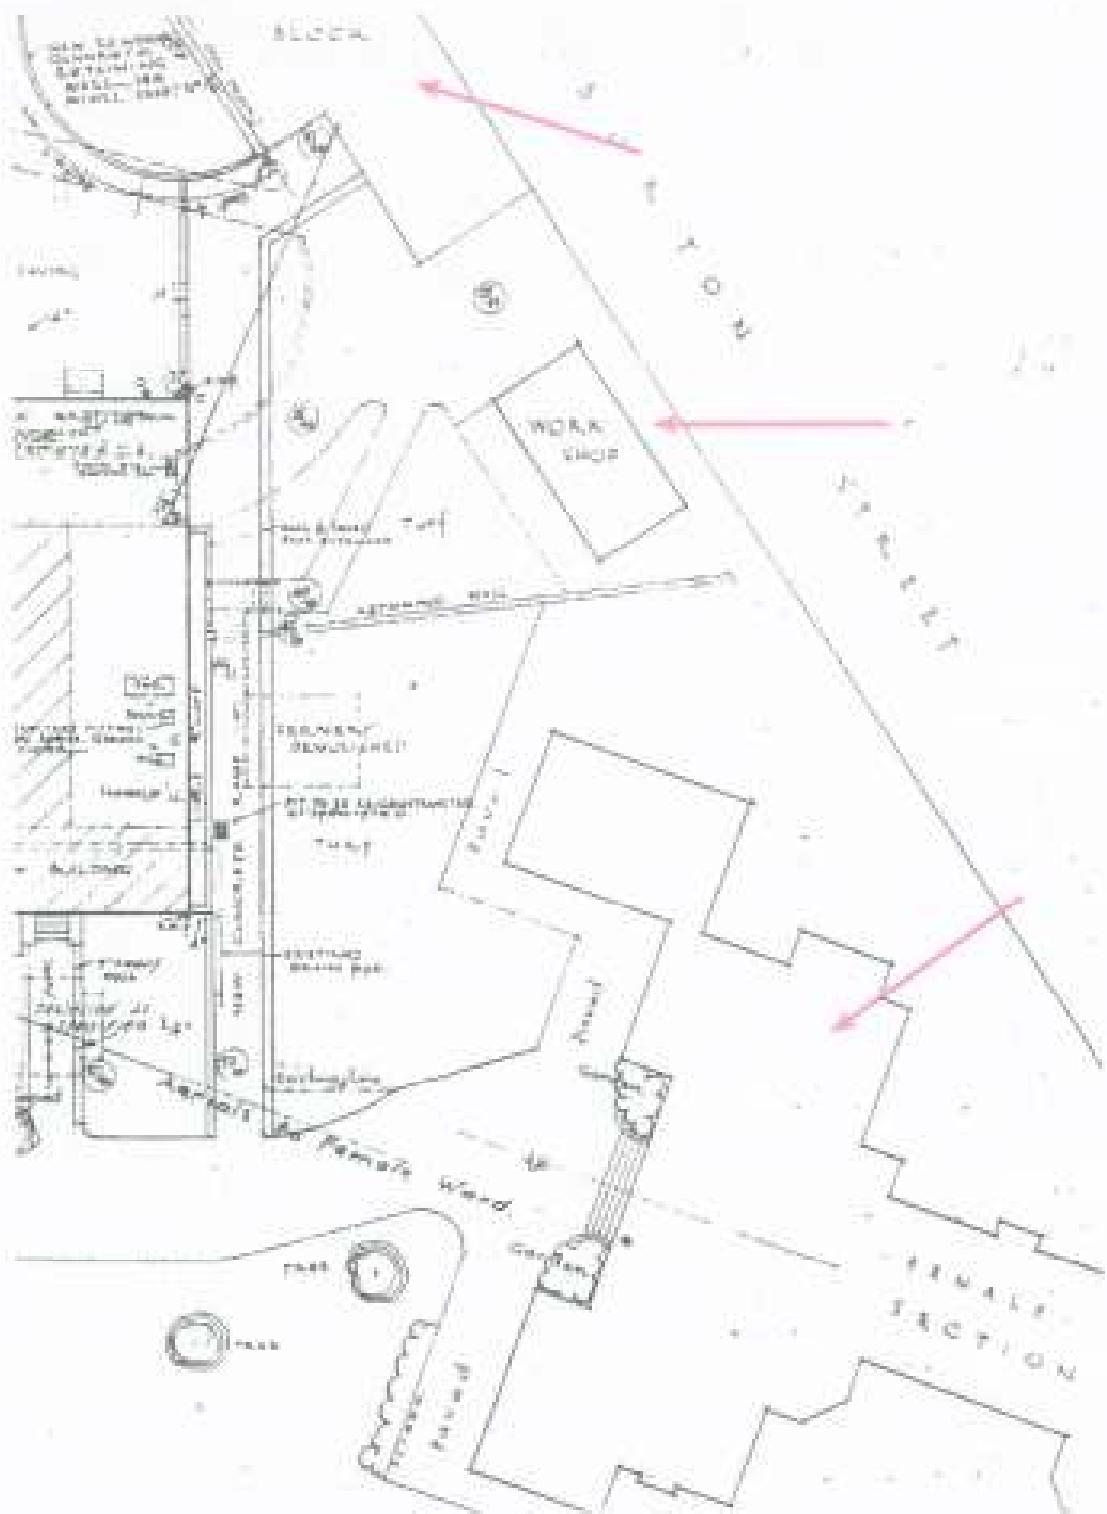
Figure 21. This 1908 map indicates in detail a number of properties that were available at the time. It clearly shows the presence what is referred to as the 'Burke section'. This was most probably the 1890 house (marked with a cross) which occupied houses in 1942, when that section was renamed 'Burke'. The map also shows the Burke section is surrounded by Sturt Street. It notes the ground with open land, including agricultural areas.

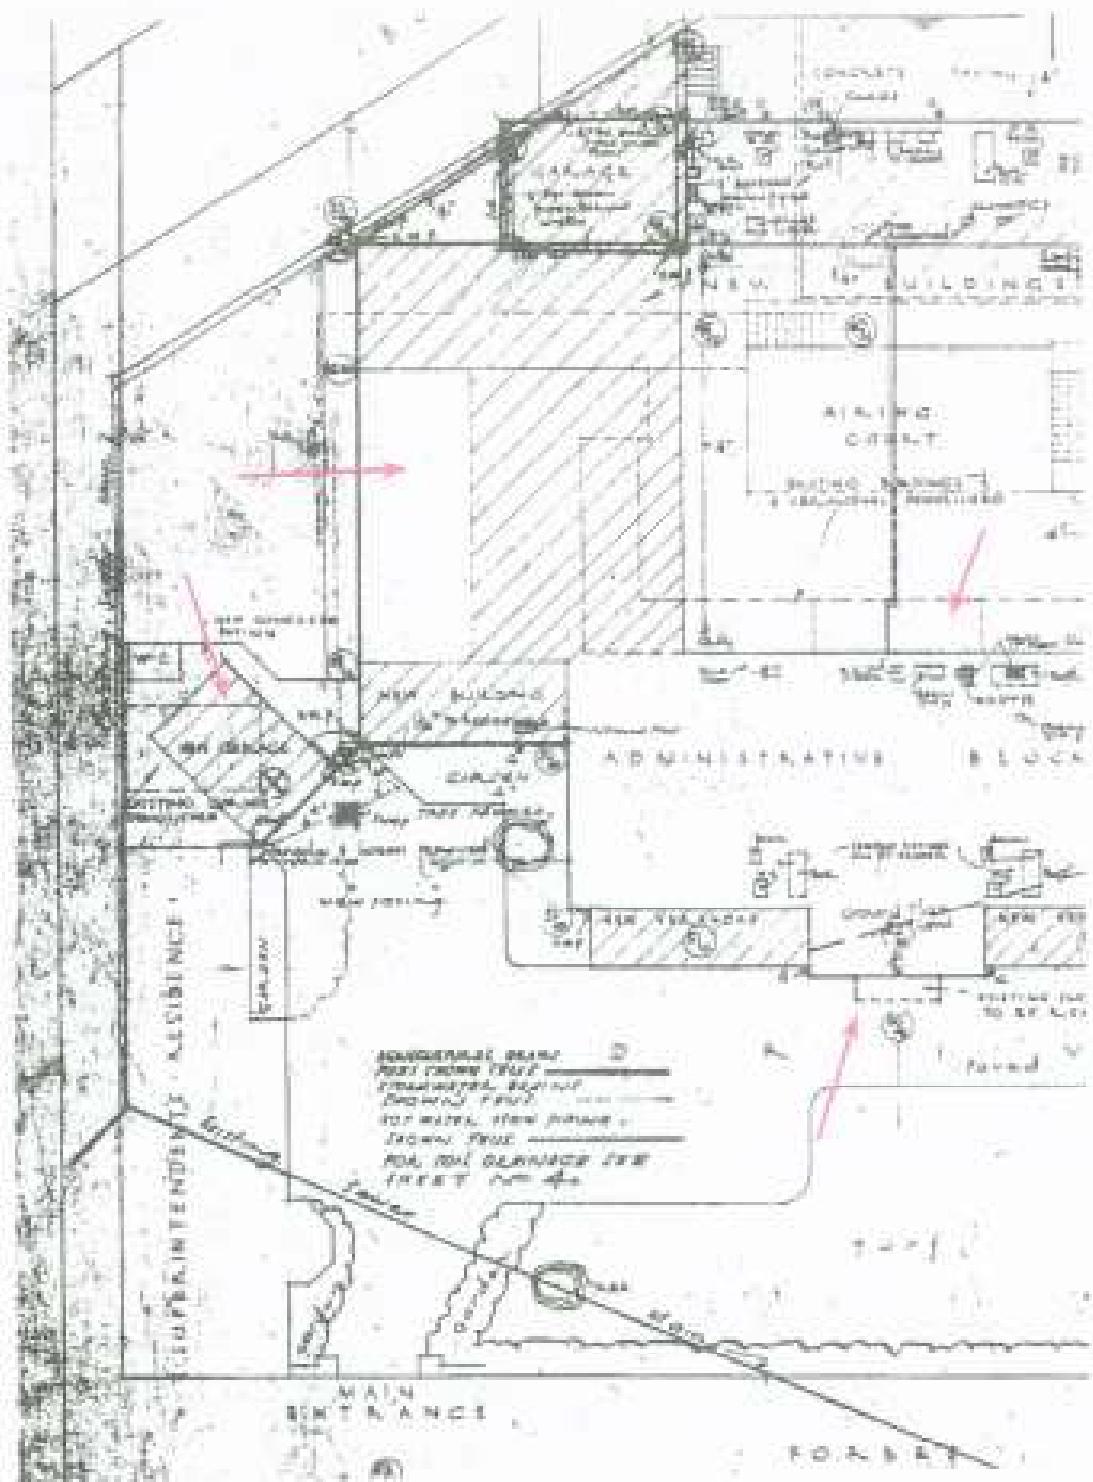
Figure 22
This 1956 site plan shows listed a number of alterations that were undertaken at that time. It clearly shows the proposed demolition of the central bay on the front facade, the replacement of the front verandah, the construction of new gates at the college entrances and pathways around the courtyard area of the main building. It is likely that the two floor additions were also undertaken at that time. The general wall front and the verandah side are similar to the west on the ground floor wings which are part of the plan. The plan also notes the growth with some below, including established trees.
(Source: City of Guelph Archives, Item# 2001)

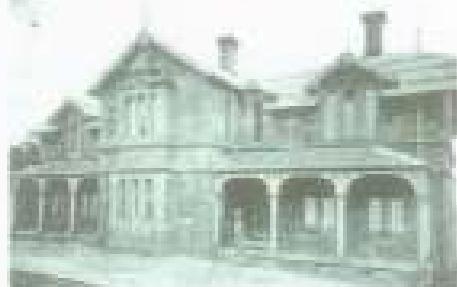
Figure 34
The Darlinghurst Reception House as it appears measured as a residence, prior to 1900, in present grounds.
Source: Ann J. Day Collection, July 2000.

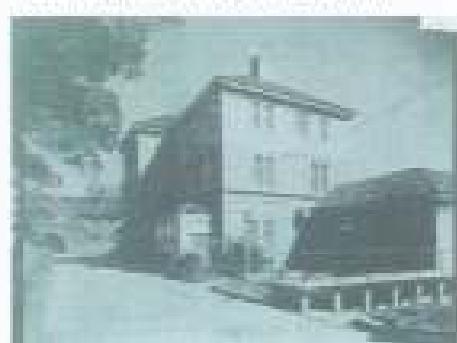
Figure 36
Image of the Darlinghurst at the time of handover in 1982
Source: St Vincent's Archives, Sourced July 2000

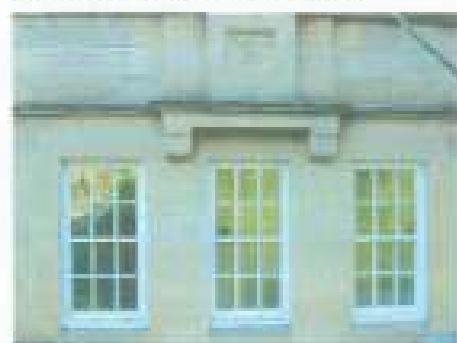
Figure 37
Showing three-paned doors from base, undertaken in the mid 1890s. This is unlikely when the 1870s were well past.
Source: Graham Brown & Associates, July 2000.

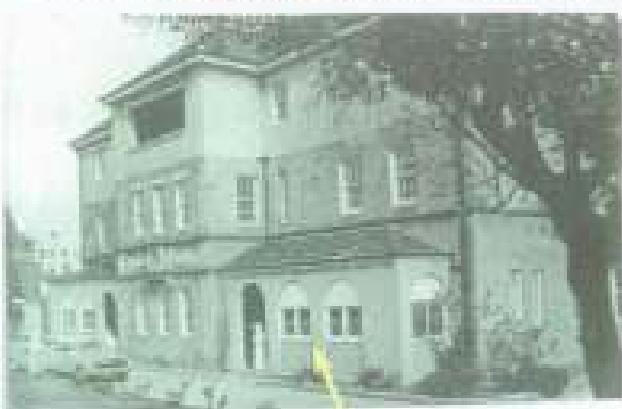
Figure 38.
Image taken around 1960 of the front facade of the Caritas, showing intact or unaltered. These photographs have since been reproduced and facilitate visual site management and in other areas. Both the former and current representations are a compromise which is clearly out of character.

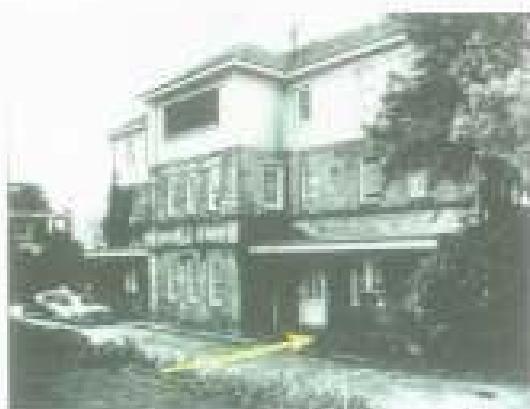
Figure 39.
Image taken in the 1990s, showing the renovated exterior with new windows.

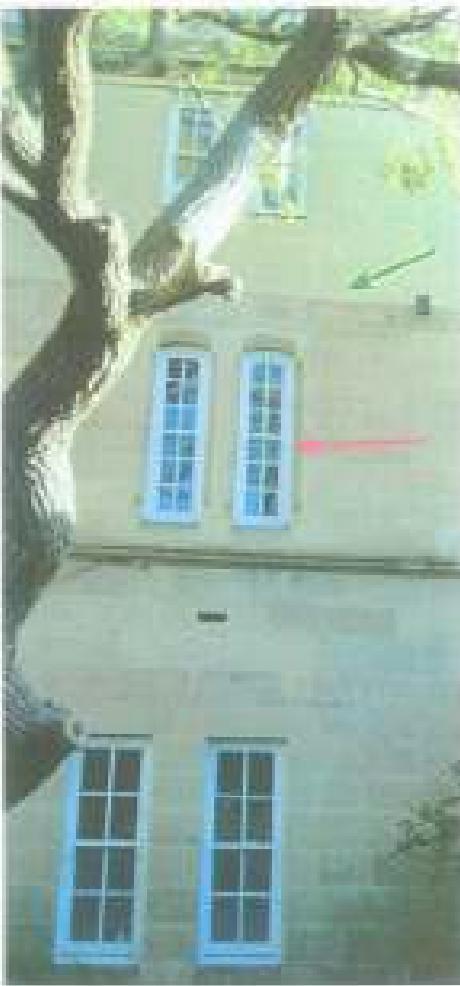
Figure 40.
Image of the lower part of the main building, showing (prior to the stated difference in the caption) indicates what is the 'old' look and showing (as far as it remains), the original Regency windows, which are a uniform four and three throughout the building.

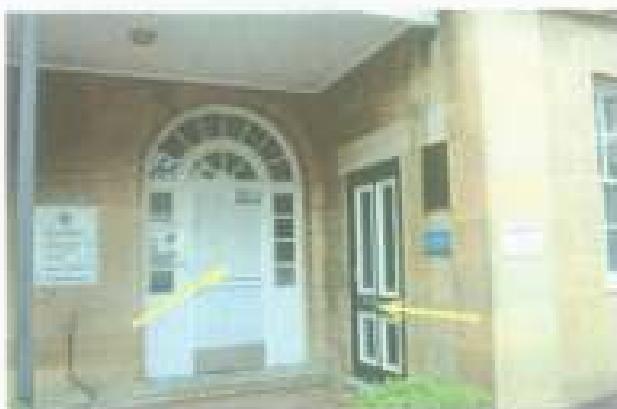
Figure 40:
Front entrance-area, showing original door and flanking elements, under a more recently constructed extension. The green door on the right is a more's addition, serving as a fire escape. The stone work on the two upper levels presents with a great degree of intricacy and detail. It is compromised in the long annuity of modern concrete fire escape floors. A number of individually elegant features have survived various stages of change.
(Source: Graham Brooks & Associates, July 2009)

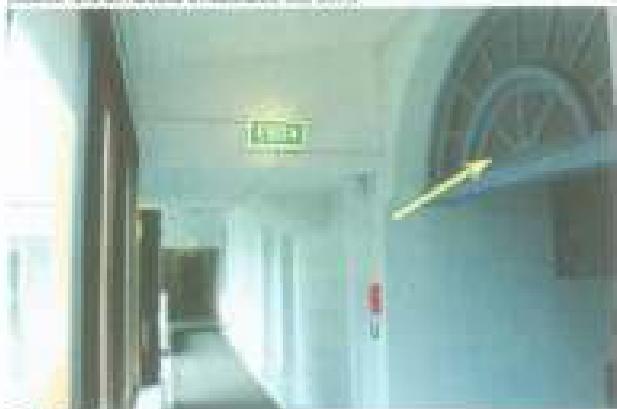
Figure 41:
Passageways around the internal courtyard are a mixture of design and construction and. Original elements include the fireplace, the timber ceiling and the stone walls. Most of the courtyard perimeter was saved in during the restorations of the early 1980s. It is a mixture of aluminium framed windows and larger timber sash flanking. Many of the interior partitions have been reconfigured in an ad hoc fashion according to need during different areas. They must share a considerable measure of aesthetic presentation and sympathy with original components.
(Source: Graham Brooks & Associates, July 2009)

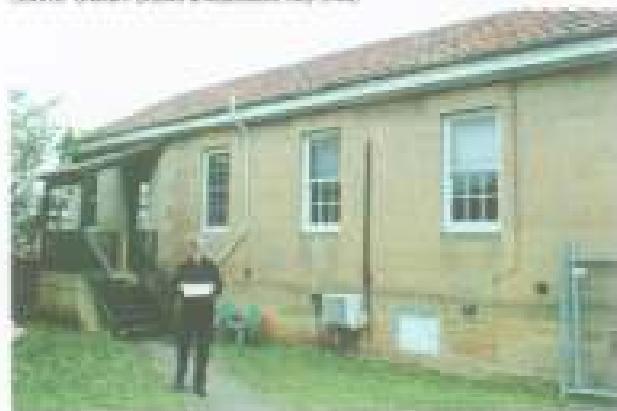
Figure 42:
Central rear wings were added in the later 1980s, being shown in the 1988 plan as proposed. The external walls are in large part an isolation. Basic requirements, being constructed in reinforced concrete, but with some stone elements incorporated, such as pilasters and pilasters. While the overall appearance of the buildings is highly uniform, they have been undertaken in a poor state of repair.
(Source: Graham Brooks & Associates, July 2009)

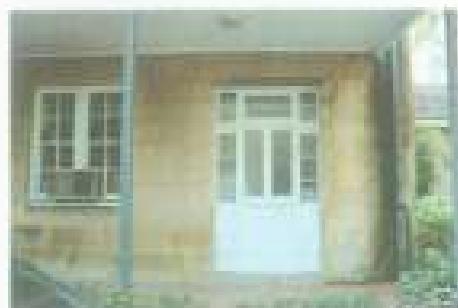
Figure 43:
Detail of front, exterior, showing various modifications, including door and window replacements, fire flying, paint and rendering.
(Source: Graham Brooks & Associates, July 2009)

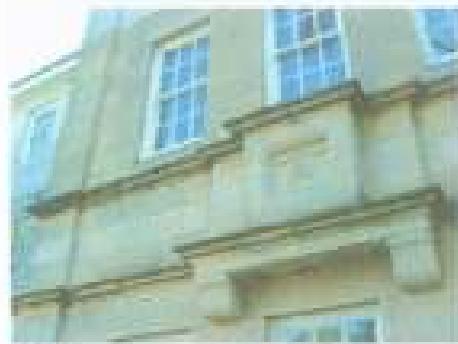
Figure 44:
Central blocks are substantially modified in the mid 1980s, including removal of original bay and provision of various new openings, including the Gardevoir Room (early 1987).
(Source: Graham Brooks & Associates, July 2009)

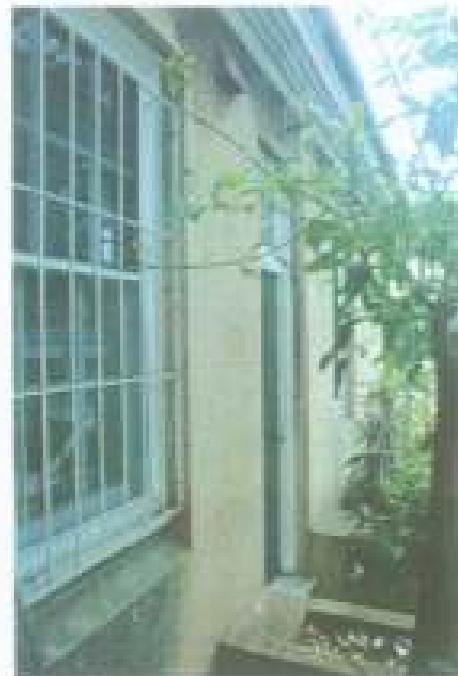
Figure 45:
External wall of the wing addition are replaced in a lighter face brick finish. They were originally constructed in the 1980s and generally remain in good order.
(Source: Graham Brooks & Associates, July 2009)

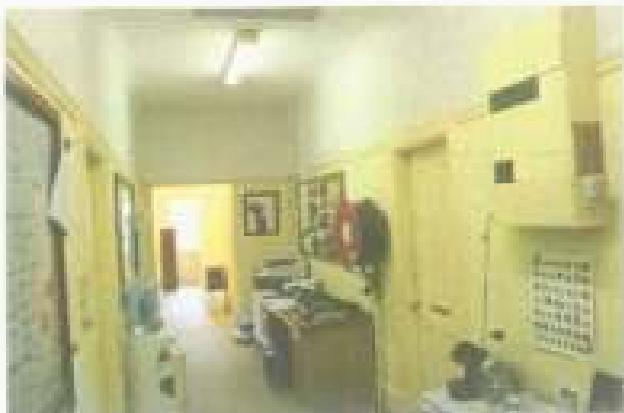
Figure 48.
Showing office space on the current third floor. Throughout the entire building the interior spaces arrangements have been substantially reconfigured a number of times over the past decades to suit particular needs. This includes changes to walls and doorways, the walls, roofs, pipes and cables, many of the original windows were replaced, probably in the mid 1980s when substantial work was undertaken on the roofspace.
(Source: Graham Brooks & Associates, July 2000)

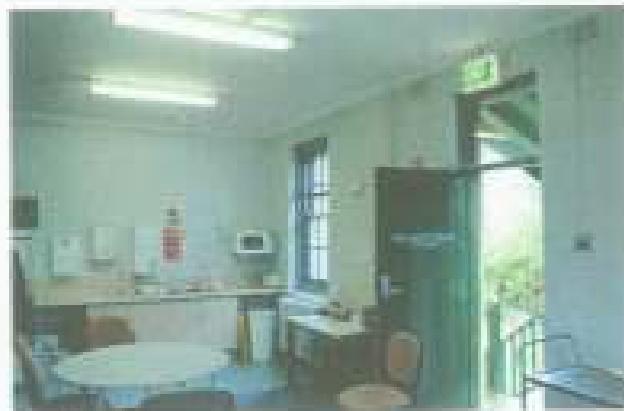
Figure 50.
Interior view of the south wing area, showing the general adaptations made over time for utility room operations, including modifications to doorways, installation of various fixtures, plumbing and so forth.
(Source: Graham Brooks & Associates, July 2000)

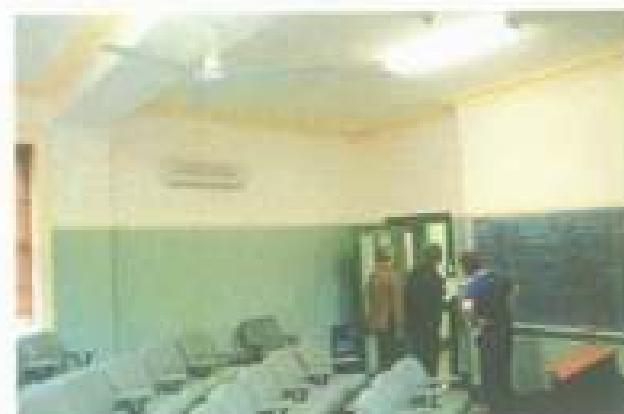
Figure 52.
The lecture theatre is a good example of the many interior re-configurations that have taken place. Note removal of wall, new ceilings, tiled flooring, installation of other services such as air-conditioning, fire safety equipment and so forth. The original windows were replaced in the 1980s.
(Source: Graham Brooks & Associates, July 2000)

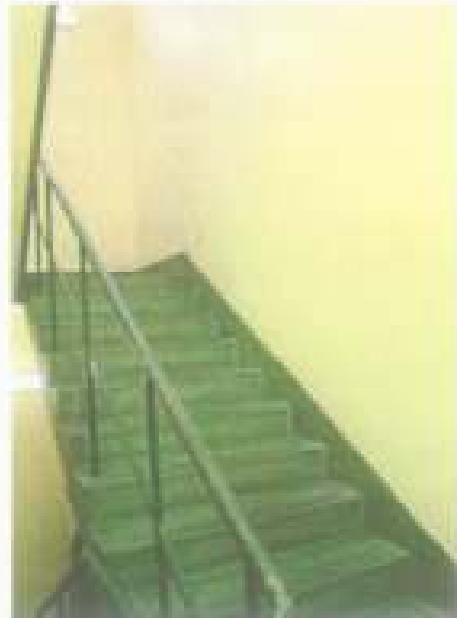
Figure 54.
Central main central staircase, also known as the main staircase. This is another of the first of multi-storey sections that was built within the building. The one it replaced was an exceptionally narrow single storey staircase.
(Source: Graham Brooks & Associates, July 2000)

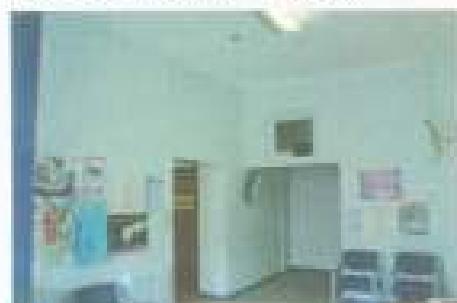
Figure 55.
Typical example of service facilities. Note kitchen, laundry and storage areas and services.
(Source: Graham Brooks & Associates, July 2000)

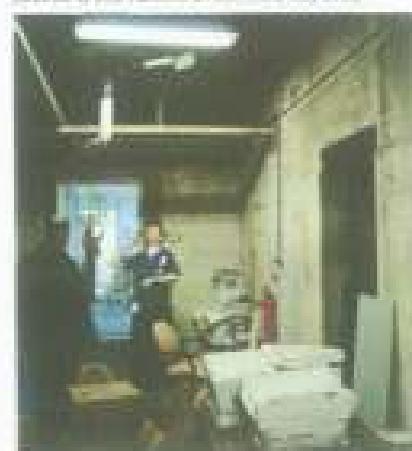
Figure 57.
Basement which has a mixture of functional and storage areas and contains some remnants of earlier journaling services.
(Source: Graham Brooks & Associates, July 2000)

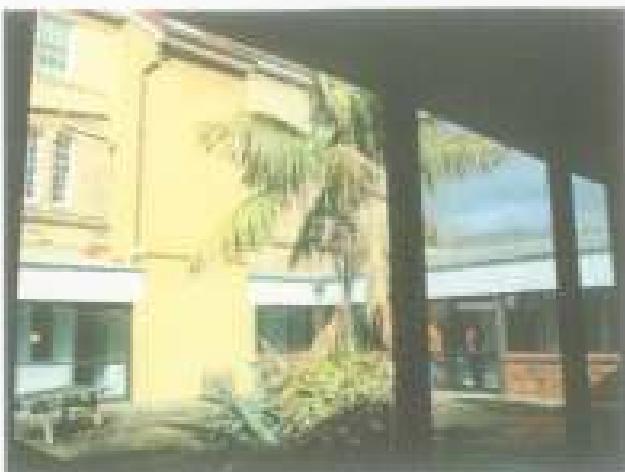
Figure 54
Interior courtyard housing elements meet matching. The view shows the reuse of quoins, brickwork and reductioins of this complex. This third floor addition is seen, meeting contemporaneity, modern masonry work, aluminum window components and paving installations.
(Source: Graham Brooks & Associates, July 2009)

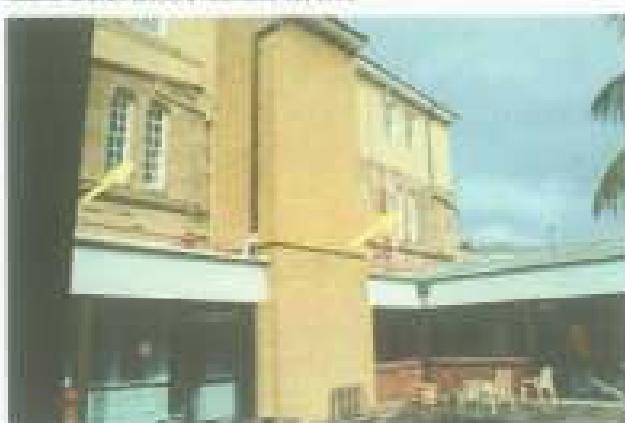
Figure 55
Interior courtyard housing elements meet matching. The original 1880s, whitewash Park Green replaced at the rear and the sides of the building. The sandstone was probably added in the 1900s reconstruction. The top floor windows appear to be of that era. The lower-in courtyard walkways in of wood, tileplank, corrugated, aluminium, glass and floor deck. Plumbing and other services are highly visible.
(Source: Graham Brooks & Associates, July 2009)

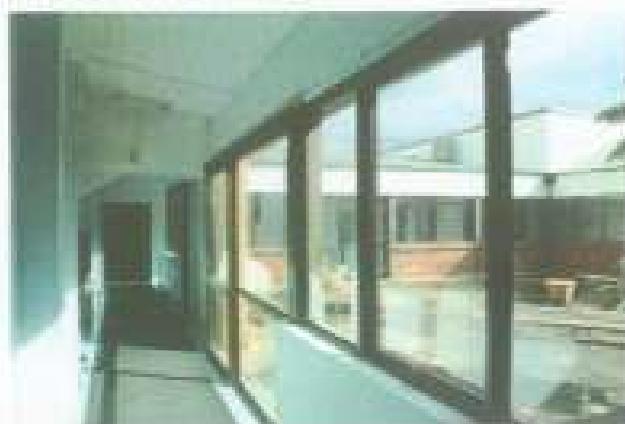
Figure 56
Interior courtyard view. Again showing the mix of building components and mixing an original and modern paving.
(Source: Graham Brooks & Associates, July 2009)

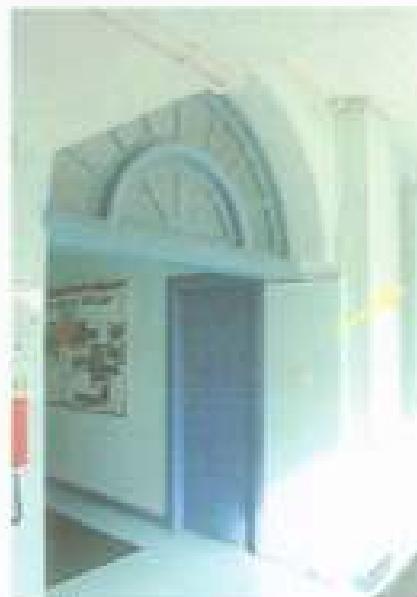
Figure 57
Reinforced brightly coloured within the main building, an arched doorway to the courtyard; now whitewashed light and interventions such as the jalousie.
(Source: Graham Brooks & Associates, July 2009)

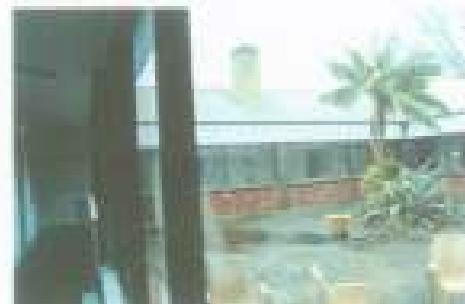
Figure 58
Interior courtyard. The single story component at terrace level early addition. It is now a bathroom facility.
(Source: Graham Brooks & Associates, July 2009)

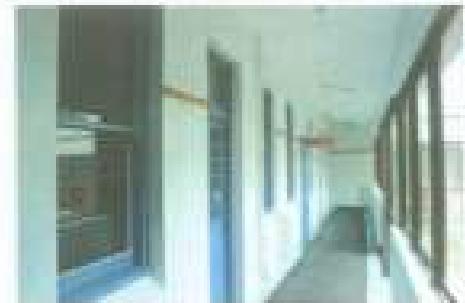
Figure 59
Modern veranda and doorway entered the central court yard, previously during from the building works of the early 1900s. Some evidence of the original verandah remains in the center ceiling, columns, wall and doorway.
(Source: Graham Brooks & Associates, July 2009)

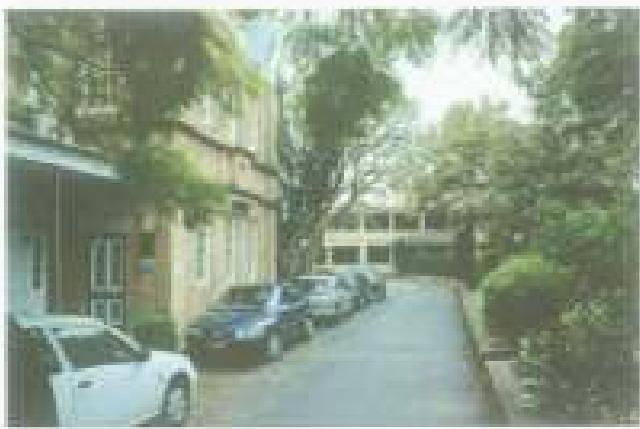
Figure 8A
Front entrance-area, with old main building to the right; paved areas are extensive; however the track and pathed area from the former garage has been reduced, leaving substantial security berths.
(Source: Graham Brooks & Associates, July 2009)

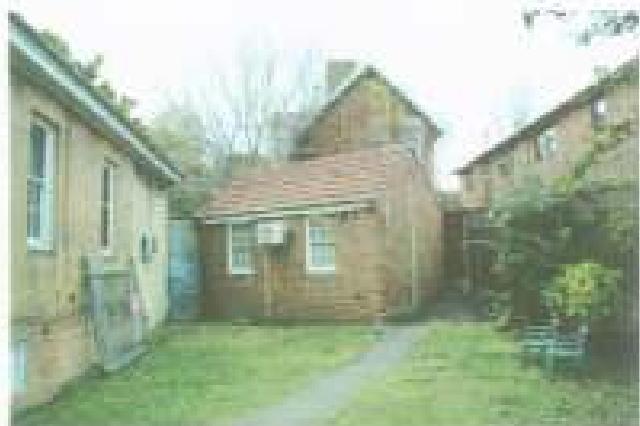
Figure 8C
Left wing of the main house with the Garage Cottage and garage. Note further extension to the wing area, Garage in case of mobile storage.
(Source: Graham Brooks & Associates, July 2009)

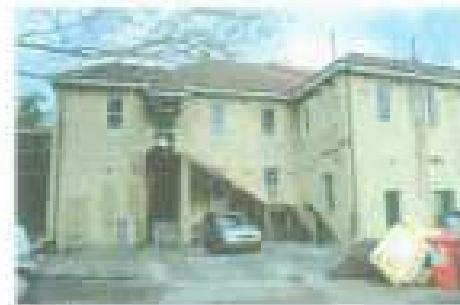
Figure 9B
Two-storey building at the rear of the main building (extending to the rear 1100x11m surrounded by extensive concrete paving.
(Source: Graham Brooks & Associates, July 2009)

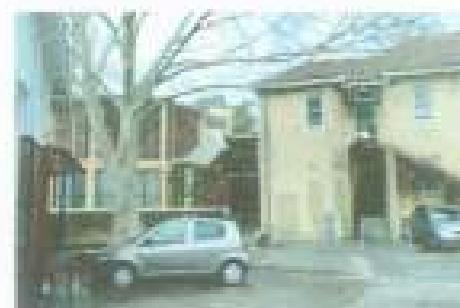
Figure 9C
View from the rear of the compound with kitchen block to the left, the 1100x11m extends the centre and the rear part of other complex to the right, apart from the garden area inside the front entrance-way and some smaller garden buildings, the whole compound presents with substantial concrete paving.
(Source: Graham Brooks & Associates, July 2009)

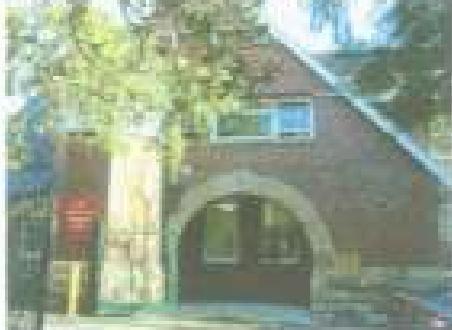
Figure 81
The cottage comprises a mixture of building materials including sandstone, brick, tiles, glass and timber.
Source: Odhran Ó Siadhail, July 2009

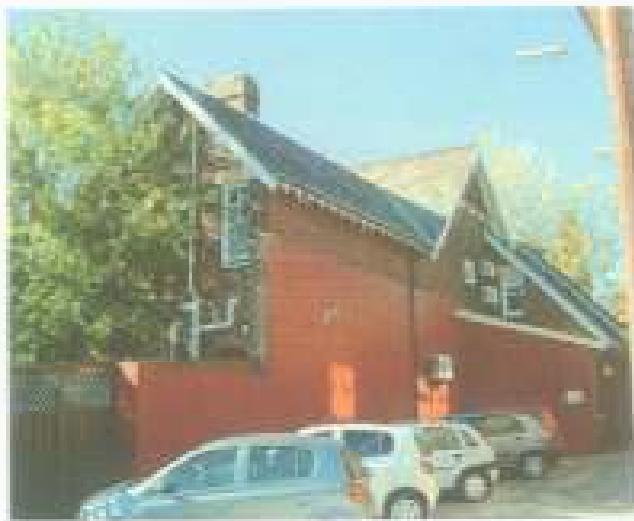
Figure 13.
South side (west) of the Carlton Cottage terraces, with a 'blown-off' gable end which corresponds with the end boundary. Additional garage areas were at one time situated along the building, at the red painted area where the bars are placed.
(Source: Graham Brooks & Associates, July 2000)

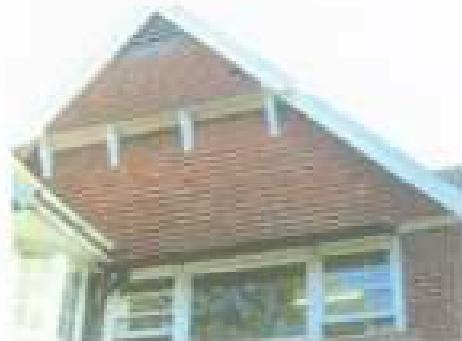
Figure 15.
Ornate treatments such as timber-framed, branching form panels, bay windows, and other reveals components are typical of early twentieth century Arts and Crafts style.
(Source: Graham Brooks & Associates, July 2000)

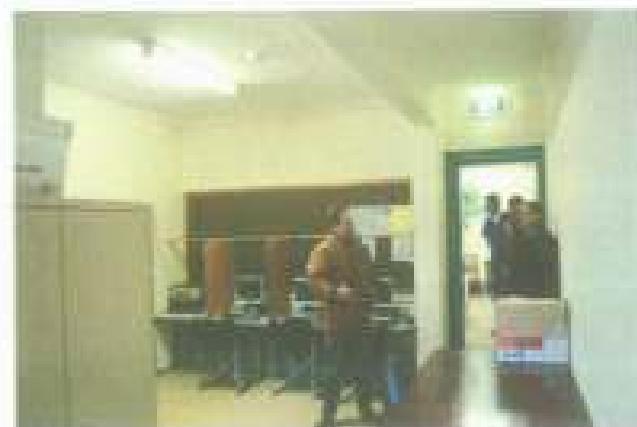
Figure 17.
The interior of the Carlton Cottage has undergone substantial modification and re-decoration and incorporation of various services. This supports later dates and refurbishment.
(Source: Graham Brooks & Associates, July 2000)

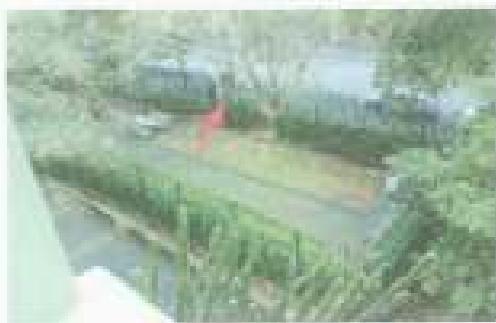
Figure 78:
Garden wall top, rear of West House (Grenville Parked Street), showing garden perimeter fence, accompanied by the original security arrangement, and hideously topical stone return.
(Source: Graham Brooks & Associates, July 2006)

The perimeter fencing which comprises stone and timber and brick elements (and exhibits a number of fine stone columns) should be carefully repaired and enhanced. There is also a particular foreground presence of the site in its Foster Street aspect which contains a range of quality built elements, trees and gardens in a manner which has a potential public and welcoming aspect. This setting serves as substantial base for enhancement. Similarly, the established trees form an integral feature of the street and are considered to have high significance.

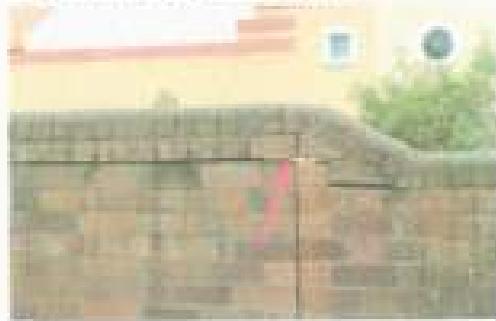
Figure 79:
The state of repair of this perimeter wall is at present poor to the point
(Source: Graham Brooks & Associates, July 2006)

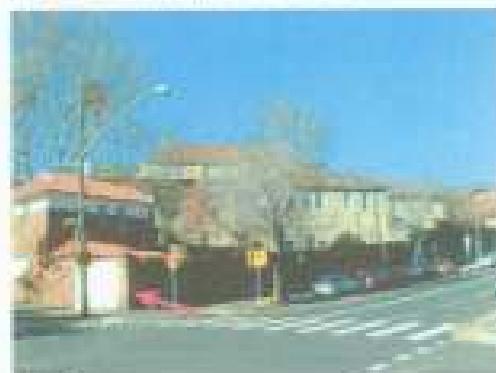
Figure 81:
Typical stone corner column at junction of Bourne and Sturton
Boulevards, constructed by owners.
(Source: Graham Brooks & Associates, July 2006)

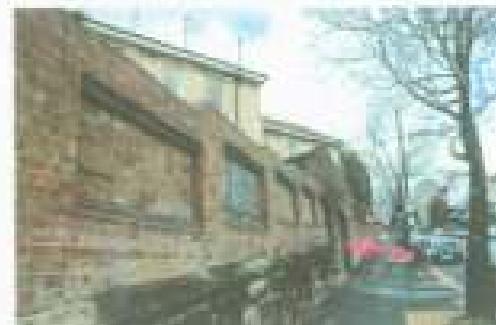
Figure 82:
Front brick and stone and stone and stone block with matching coping top
(Source: Graham Brooks & Associates, July 2006)

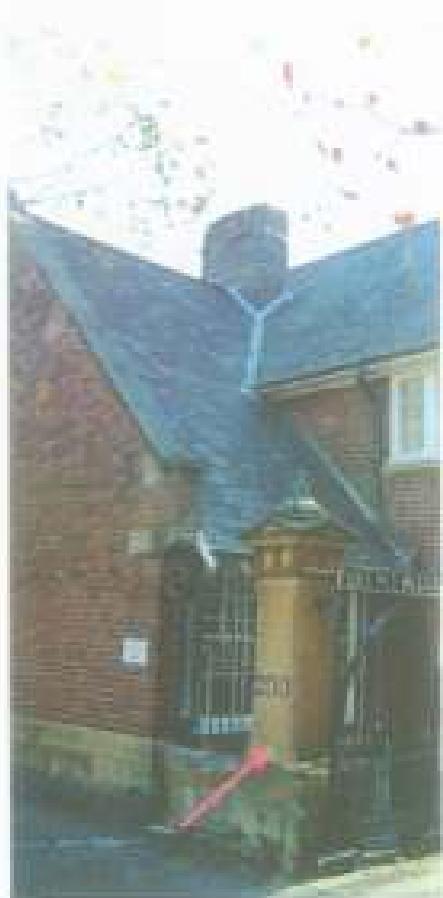
Figure 83:
Example of prominent stone column with which respects the
stone, face brick and iron fencing around the perimeter of the
compound. The fencegate has been living as a heritage item
listed City of Sydney Council
(Source: Graham Brooks & Associates, July 2006)

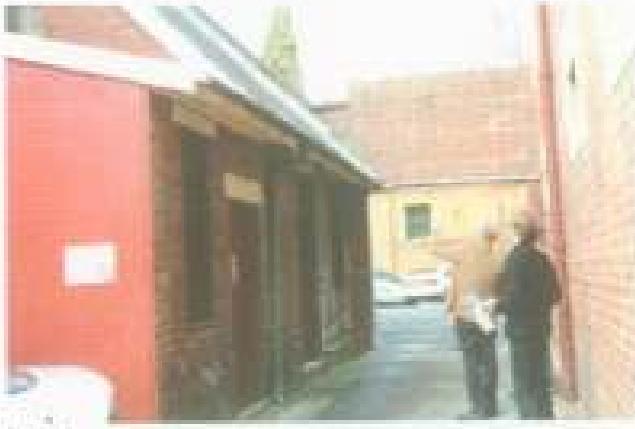
Figure 87
This section of the Carter Cottage area formed part of the former Station Master's Compound by storage and stable buildings. The visible section immediately to the left is situated on Crown land, but under the same roof that as the northern part of the Cottage.
(Source: Graham Brooks & Associates, July 2009)

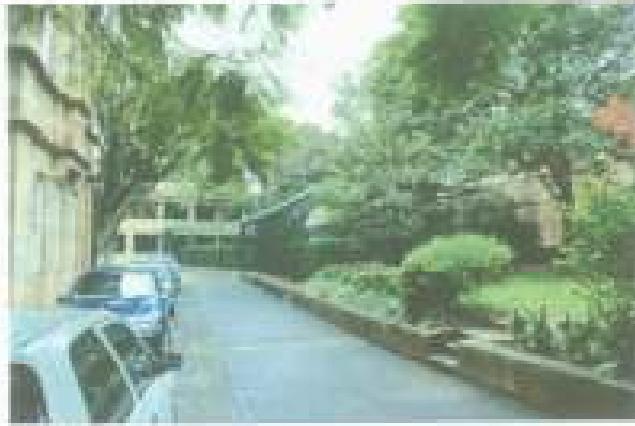
Figure 88
View along the front (east side) of the Men Building, looking north towards the rear (1980) steps, now situated on an area that once contained the 1857 porch. The ground space is currently complicated by diverse mature hawthorn undergrowth, but previously was a formal terrace towards Pulteney Street. It is characterized by a band of well-maintained trees and shrubs.
(Source: Graham Brooks & Associates, July 2009)

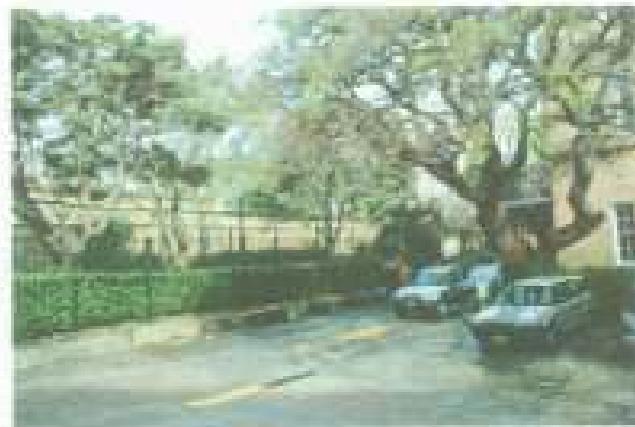
Figure 89
New domestic parking bays in the survey area of the site, showing current extensive concrete paving and tertiary lighting, but forewarning the possibility of a pressure-poor atmosphere.
(Source: Graham Brooks & Associates, July 2009)

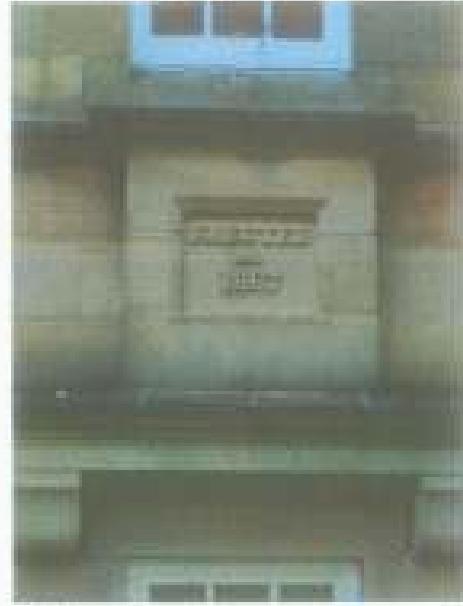
Figure 90
The original Canadian survey plaque from 1857 on the cresting stone over the Carter River House. This stone however, seems to have been used during the extensive building work when the plaque was set after 1929.
(Source: Graham Brooks & Associates, July 2009)

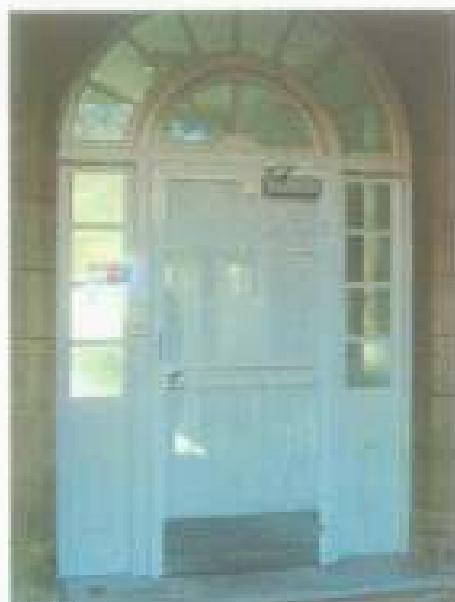
Figure 59
Regency-style arched window, main building.
Source: Green Group & Associates, July 2000.

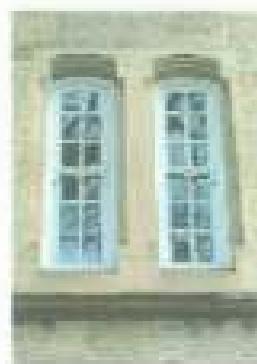
Figure 60
Regency-style triple window openings and whitewashed mullions.
Source: Green Group & Associates, July 2000.

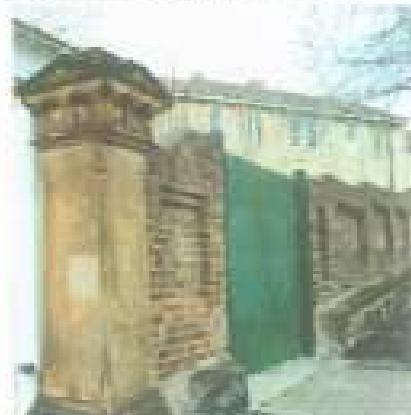
Figure 61
Tall, weathered timber post which represents the original fence arrangement around the perimeter of the site.
Source: Green Group & Associates, July 2000.
