St. Vincent's Hospital
Caritas Site

299 Forbes Street, Darlinghurst NSW

Heritage Impact Statement

August 2006

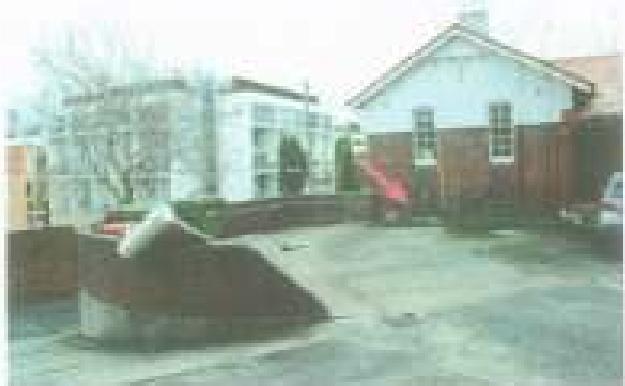
Figure 99
Example of levelling areas in the rear (west) of the site, with missing rail. As indicated by the arrows, these raised areas from various patches disrupted the original integrity of the reflected buildings.
(Source: Graham Brooks & Associates, July 2008)

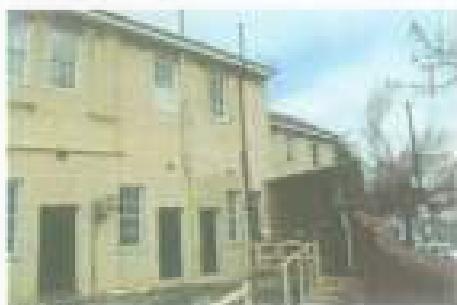
Figure 100
1960s extension and perviousness of rear of the west block. (Source: Graham Brooks & Associates, July 2008)

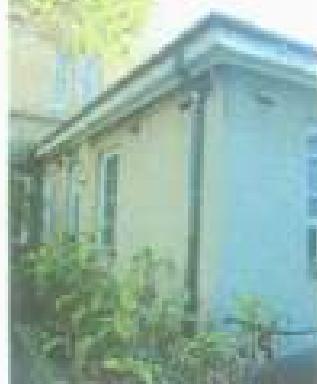
Figure 101
1960s extension/pervious rendering block. (Source: Graham Brooks & Associates, July 2008)

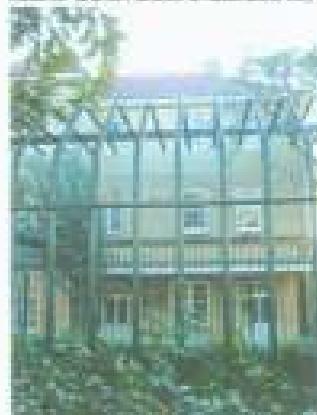
Figure 102
Example of current security fencing arrangement. (Source: Graham Brooks & Associates, July 2008)

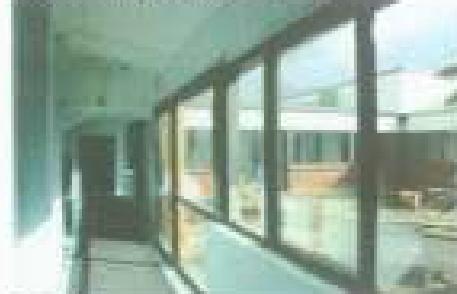
Figure 103
Interior of housing extension around the interior courtyard. (Source: Graham Brooks & Associates, July 2008)

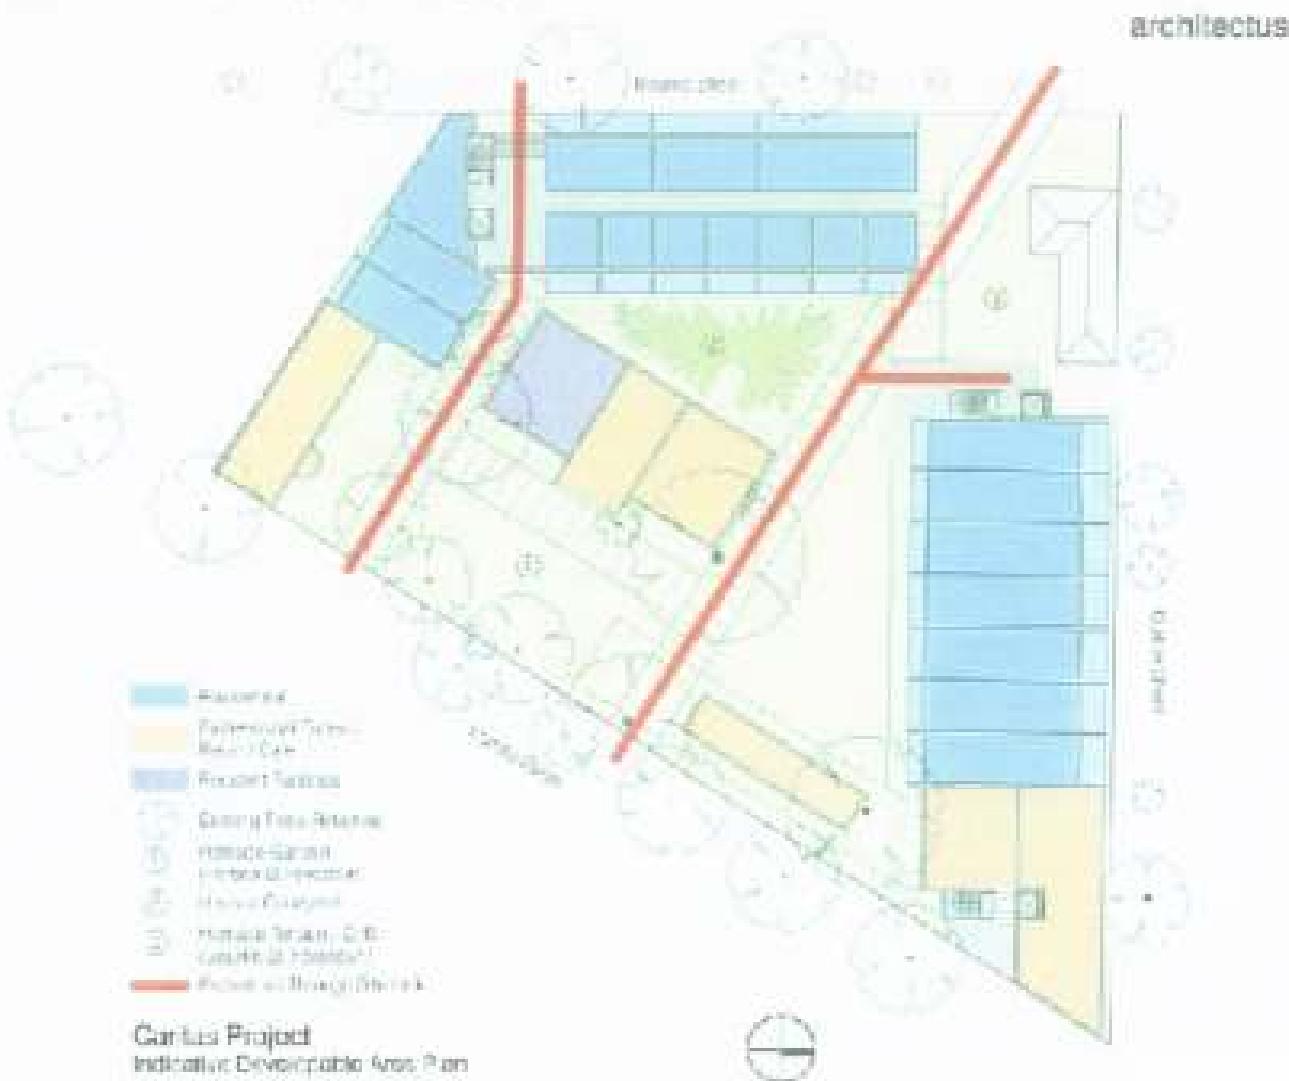
Figure 6.0: Current Concept Proposal
The Indicative Development Plan proposes a mix of Residential, Commercial and Professional environments. The proposed heritage buildings and elements are retained under the proposal including the Castle Main House, the Castle Office, the perimeter walls and towers and the Old Kitchen (local contributive building). The proposal maintains the character of a former courtyard area. It has a prominent orientation towards Purfleet Street, with an open, landscaped and mixed heritage area to assist for public engagement and increased visibility of the site. The proposed development clearly will fit with the surrounding residential area and the former Chippingham Police Station, by presenting a series of vertical slimmers in sympathy with the alignment of the surrounding houses. It consists of a mix of brickwork and contemporary fabric and finishes which are harmonious.

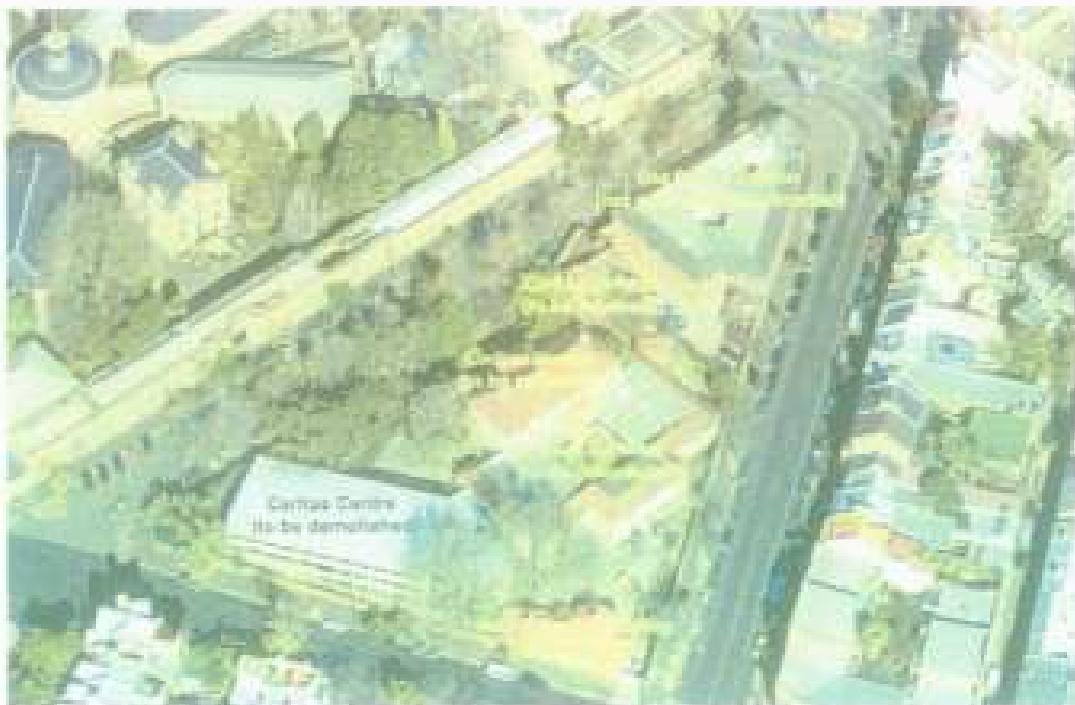
Figure 102
Aerial view of site, showing the proposed demolition and reworking. The Innovative Development Plan provides a mixture of Residential, Commercial and Professional opportunities. The principal heritage buildings and elements will be retained within the proposal including the Castle Main House; the Castle Cottage, the perimeter walls and tiling and the Coachhouse/Breakfast Room building. The proposed replaces the absence of a central courtyard area. It will have a principal entrance towards Fifehill Drive, with an open carriageway and road frontage which is well suited for public engagement and enhanced visibility of the site. The proposed reworking, blends well with the surrounding residential areas and the former Darlingside Police Station, by presenting a series of vertical alignments in sympathy with the alignment of the surrounding surfaces. It constitutes a blend of historic and contemporary forms and materials which are then compatible.

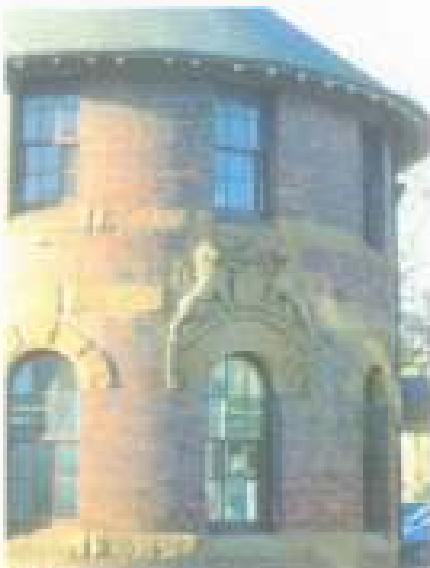
Figure 104
View of the eastern section of the Police Station at the eastern corner, showing detail conditions unpermitted.
(Source: Graham Brooks & Associates, July 2008)

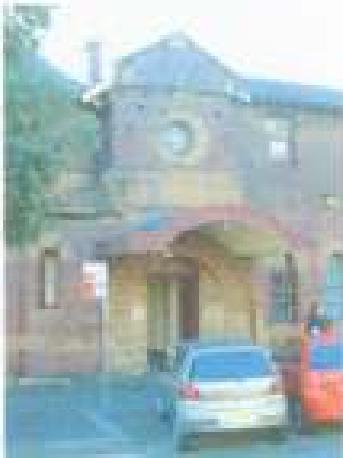
Figure 105
Auto repairer shop, The Doctor and Nurse on Aborigines Avenue, former Police Station being one of the principal stations in the area during 1900.
(Source: Graham Brooks & Associates, July 2008)

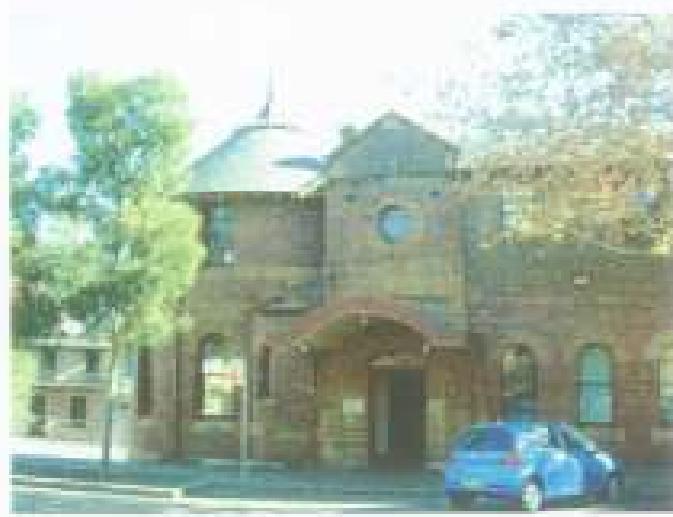
Figure 106
View of the main entrance of the former Derrington Police Station showing the arched arch in the front entrance and stairs.
(Source: Graham Brooks & Associates, July 2008)

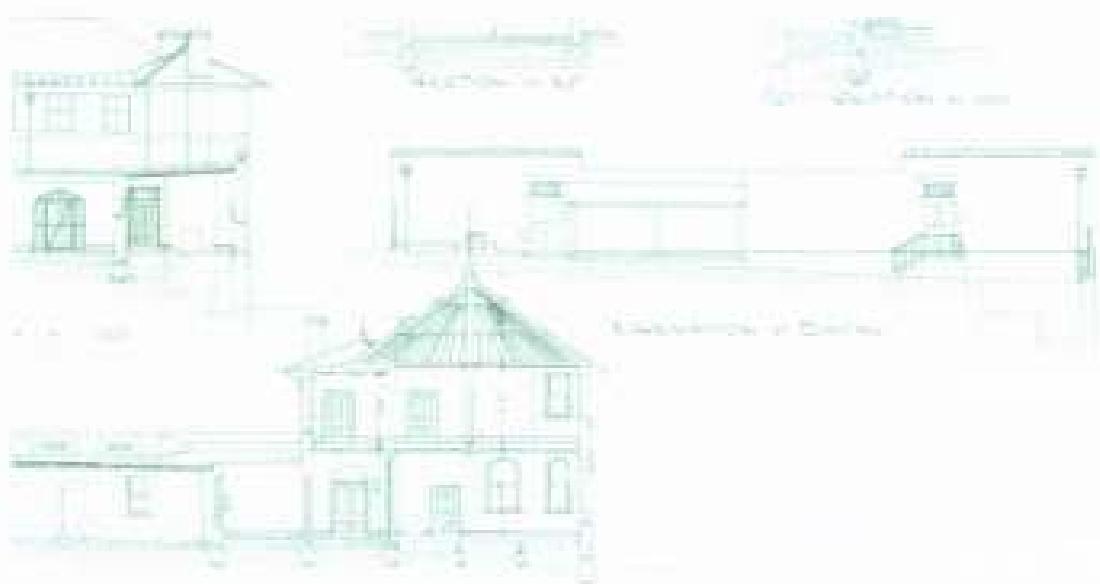
Elevation A BRIAR STREET

Architectural Drawings, W.H. Long and W.M. Morris
Cover of original drawings made at the State Archives, however the first plan was at the plan drawn up by
W.L. Merritt, the Department Architect, and dated 19 July 1900. It seems that the State was constructed
in 1901.
Source: State Archives, Kingwood, Illinois, July 2008.
