GOLDSCHMID,  
RITTER & ASSOCIATES  
ARCHITECTS  
INTERIOR DESIGNERS  
PLANNERS  
CONTRACTORS

## Introduction

### 1.1 Context of the Report

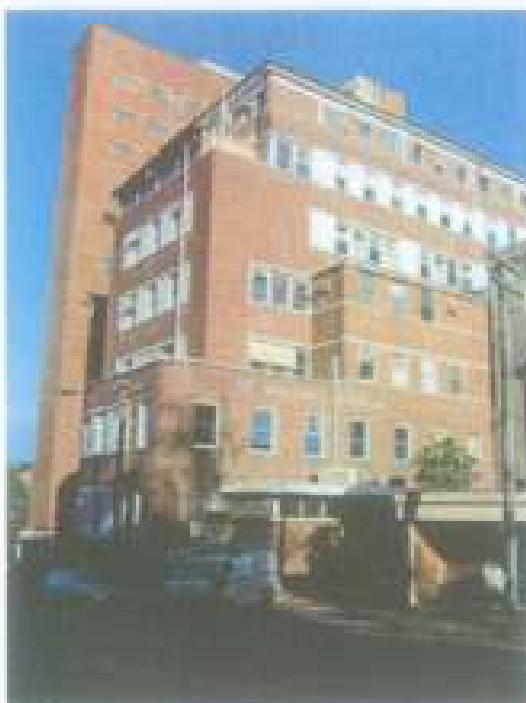
**Figure 1:**  
The O'Brien Wing, from Burton Street, looking west. The building is in the modern style of the late 1900s, characterised by plain horizontal banding.  
(Source: Graham Brooks & Associates, July 2008)

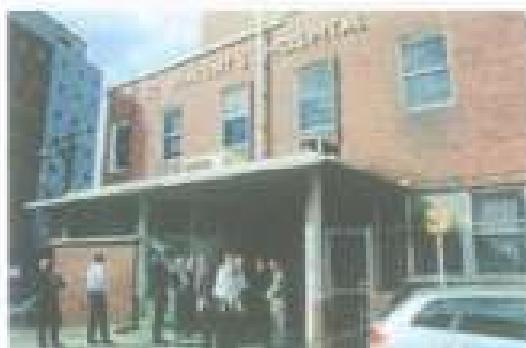
**Figure 2:**  
The one access entrance way to the O'Brien wing, which presents in a relatively poor state of repair, and witness some of the accretions necessary for contemporary use, such as the air-conditioning units.  
(Source: Graham Brooks & Associates, July 2008)

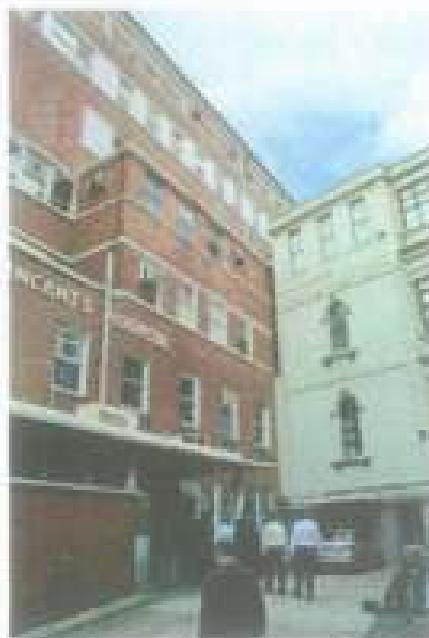
Figure 5.  
The O'Brien Wing, a terraced or three-story brick hospital wing. The image above taken from the south (Burtin Street) side, shown in junction with the Dr. Lucy Building at what was previously the entrance to the former industrial block.

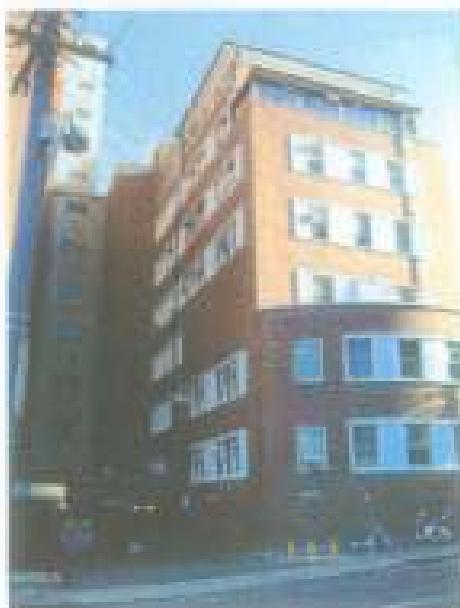
**Figure 11**  
The image above shows the junction between the O'Brien Wing and the O'Brien Wing Extension (T-Wing) with emergency vehicle access under the junction.  
(Source: Dianna Brooks & Associates, July 2009)

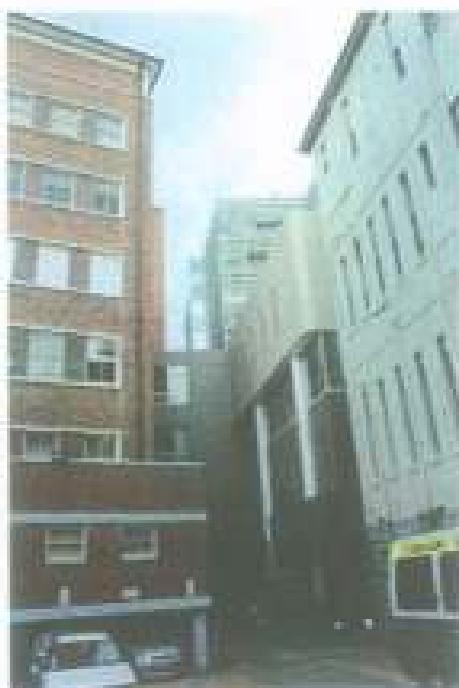
**Figure 12**  
An image of another junction between the O'Brien Wing and the O'Brien Wing Extension (T-Wing) from Bunker Street.  
(Source: Dianna Brooks & Associates, July 2009)

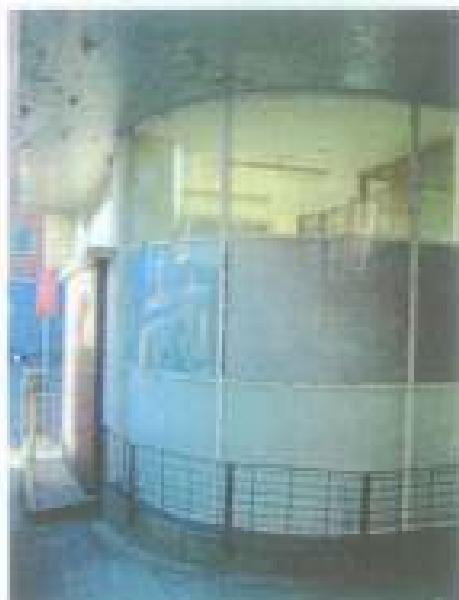
**Figure 19:**  
Front facade view of the O'Brien Wing, showing signs of deterioration, but characterized by the dark timbered trees and classical glass of the modern era design.

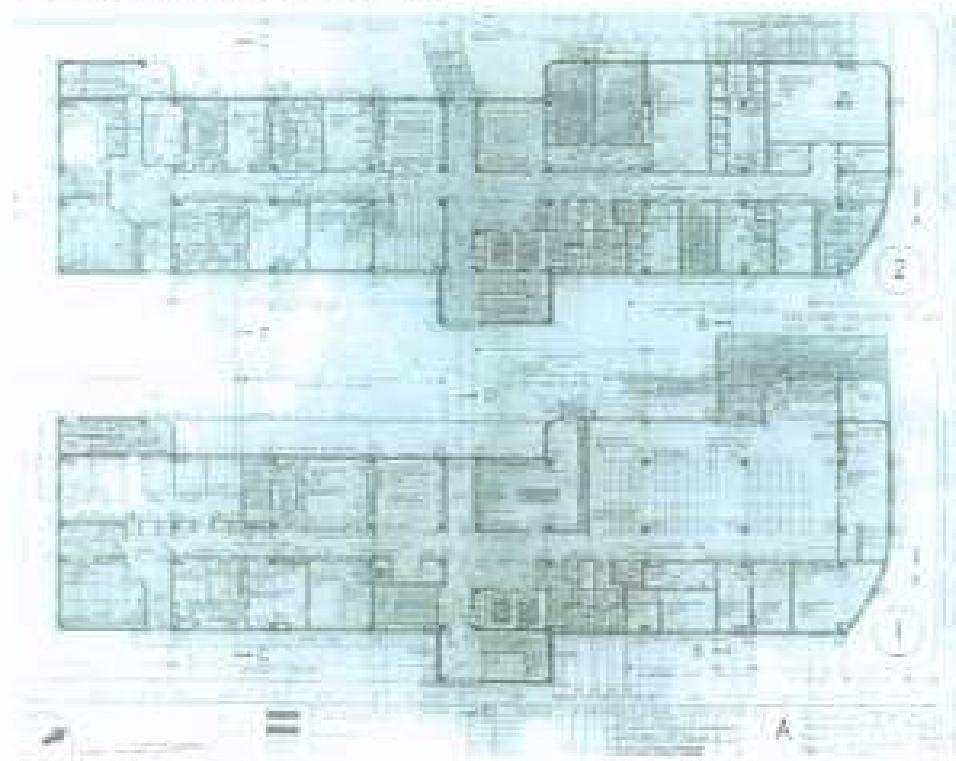
Figure 17

The ground floor and first floor plans of the proposed new building, 1160 Main. The ground floor shows the office areas (lounge area to the right, break area) and the consulting rooms to the left (board room).  
 (Source: City of Mississauga, Building City Team Plan, August 2008)

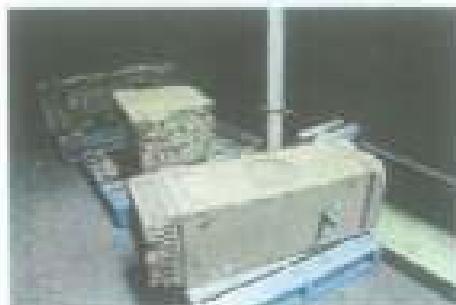
Figure 19  
Early orthographic model stone boundary markers at the corner of St. Lucia and Victoria Streets. The intention is to map, restore and replace these stone pillars in their original position as part of the proposed restoration work. (Source: Diether Drury & Associates, July 2008.)

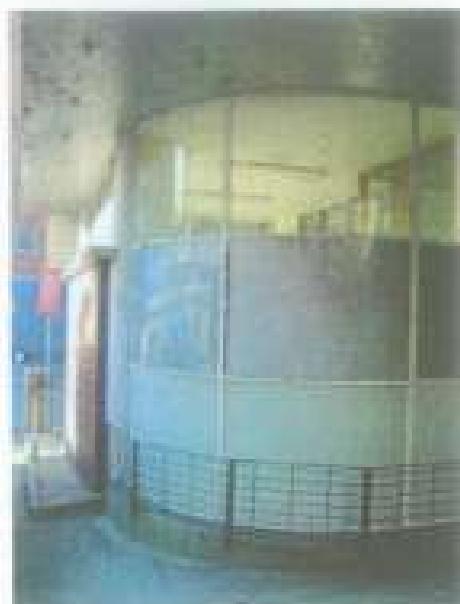
**Figure 25:**  
Upper level of the former extension to the subject building, the former Outpatients block, and the Children wing showing residual decoration of brick or terracotta and concrete below the modernised curved glass surface, the smaller concrete columns and the horizontally oriented window framing.  
(Source: Gwent Society & Archives, July 2008)

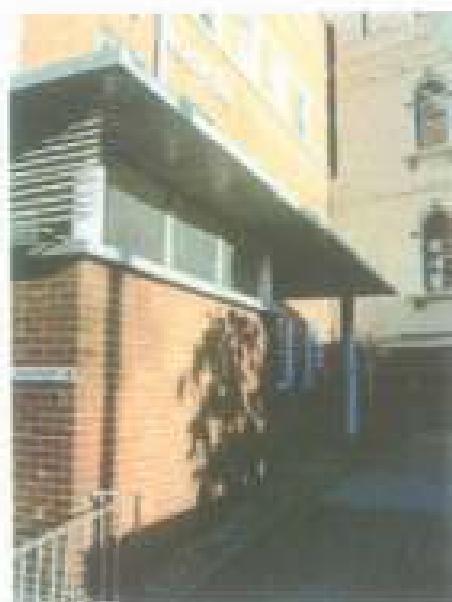
**Figure 27:**  
An image of the upper level of the subject building taken from the corner near Queen Street and showing the close proximity of the subject building to the Sir Lucy Gowing. It also indicates the generally good state of repair of the face brick and concrete work.  
(Source: Gwent Society & Archives, July 2008)

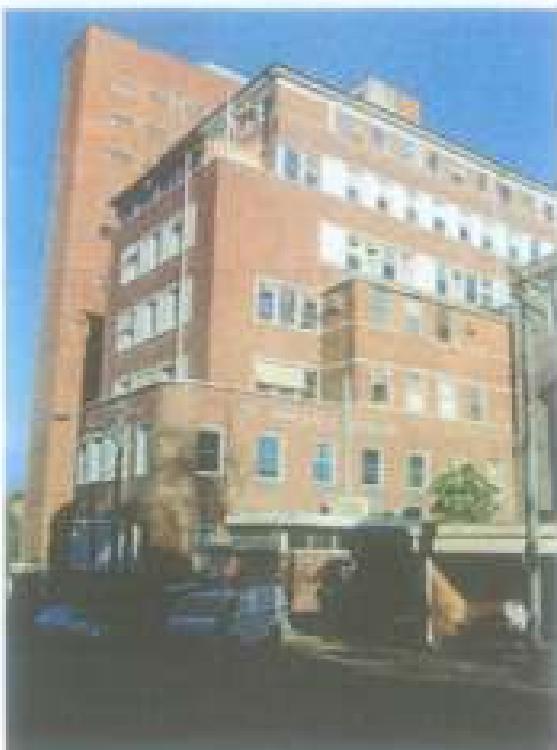
**Figure 29**  
View of the northwest corner of the building taken from Blagdon Street. This image illustrates the proposed new proportions for the development (Source: Greater Bristol & Associates, July 2008).

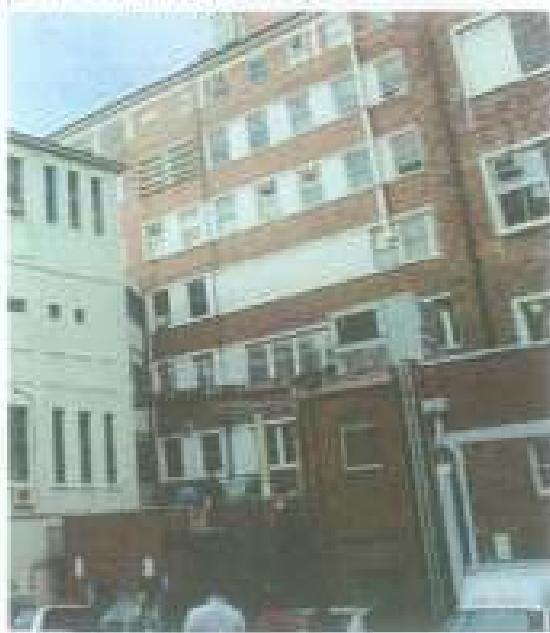
**Figure 30**  
This image illustrates one of the many junctions between the subject building and the surrounding buildings, such as Bel de Lucy and the Cadell Overstone buildings. These junctions have been created in a manner that attempts to address the original access and interior layouts. Such junctions will require carry of address in the proposed new redevelopment (Source: Greater Bristol & Associates, July 2008).

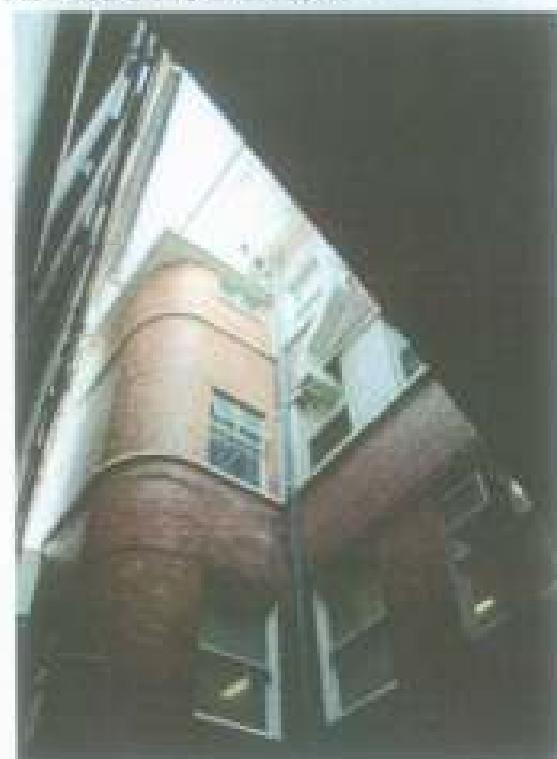
**Figure 31**  
Illustrating the connection of the intersection between the buildings, and form of the various entrances, addresses and interior allocations (Source: Greater Bristol & Associates, July 2008).
