BOREHOLE LOG

CLIENT: Stamford Property Services Pty Ltd
PROJECT: Macquarie Village
LOCATION: 110-114 Herring Road, Macquarie Park

BORE No: 113
PROJECT No: 72138
DATE: 17/12/2010
SHEET 1 OF 1

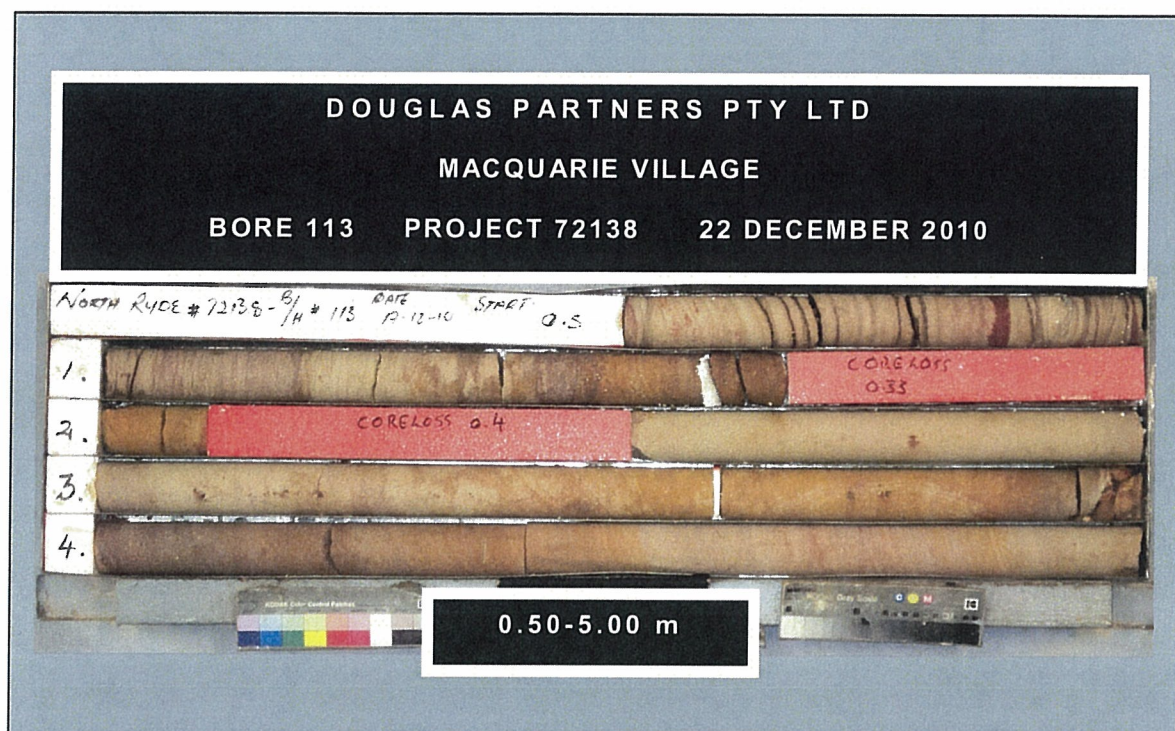
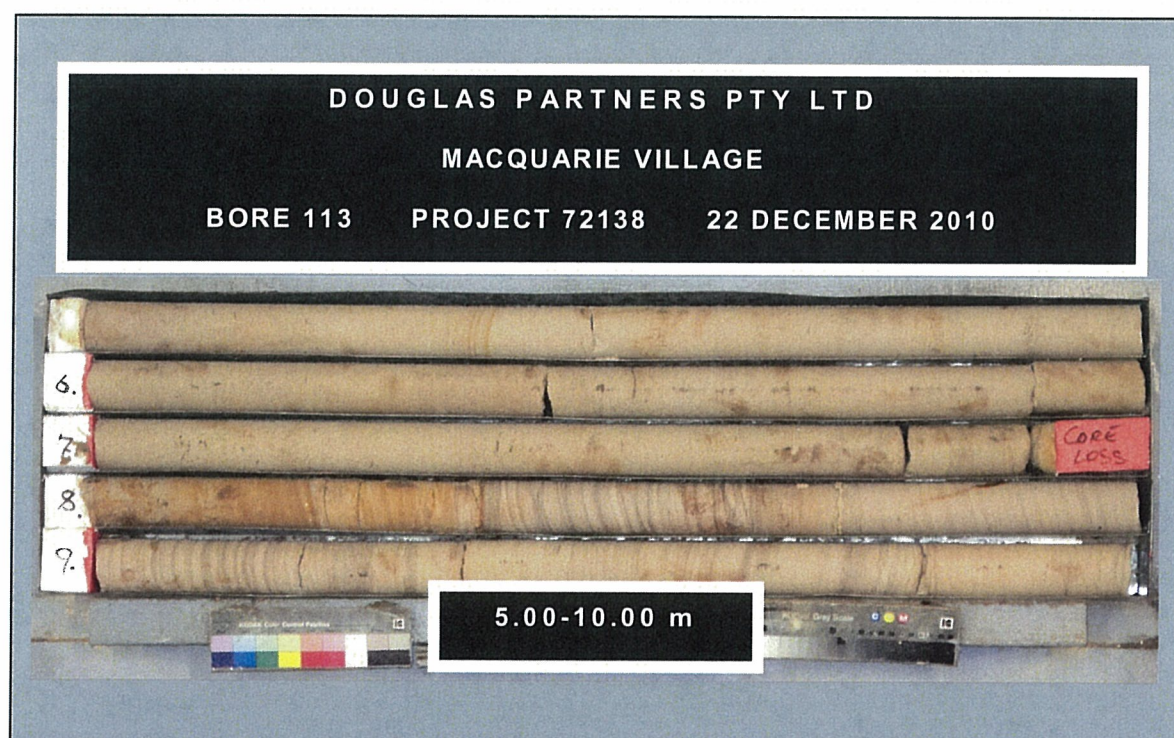
0.4	SANDY CLAY - orange brown sandy clay																A/E			
	0.5	SANDSTONE - weathered sandstone																			
1	1.2	SANDSTONE - high strength, slightly weathered, fractured to slightly fractured, light grey, medium to coarse grained sandstone																C	100	100	PL(A) = 1.4
																					PL(A) = 0.9
2	2.0	SANDSTONE - medium strength, moderately weathered to fresh, slightly fractured and unbroken, medium to coarse grained sandstone																C	48	100

2.5																				PL(A) = 0.8
3																		C	100	100	
4																		C	100	100	PL(A) = 0.8
																					PL(A) = 0.7
5																		C	100	100	PL(A) = 0.5
6																					PL(A) = 0.6
7																		C	100	100	PL(A) = 0.7
8	8.0

- distinctly laminated from 8.4m to 9.7m																C	94	100	
9																		C	100	100	PL(A) = 0.9
10	10.0

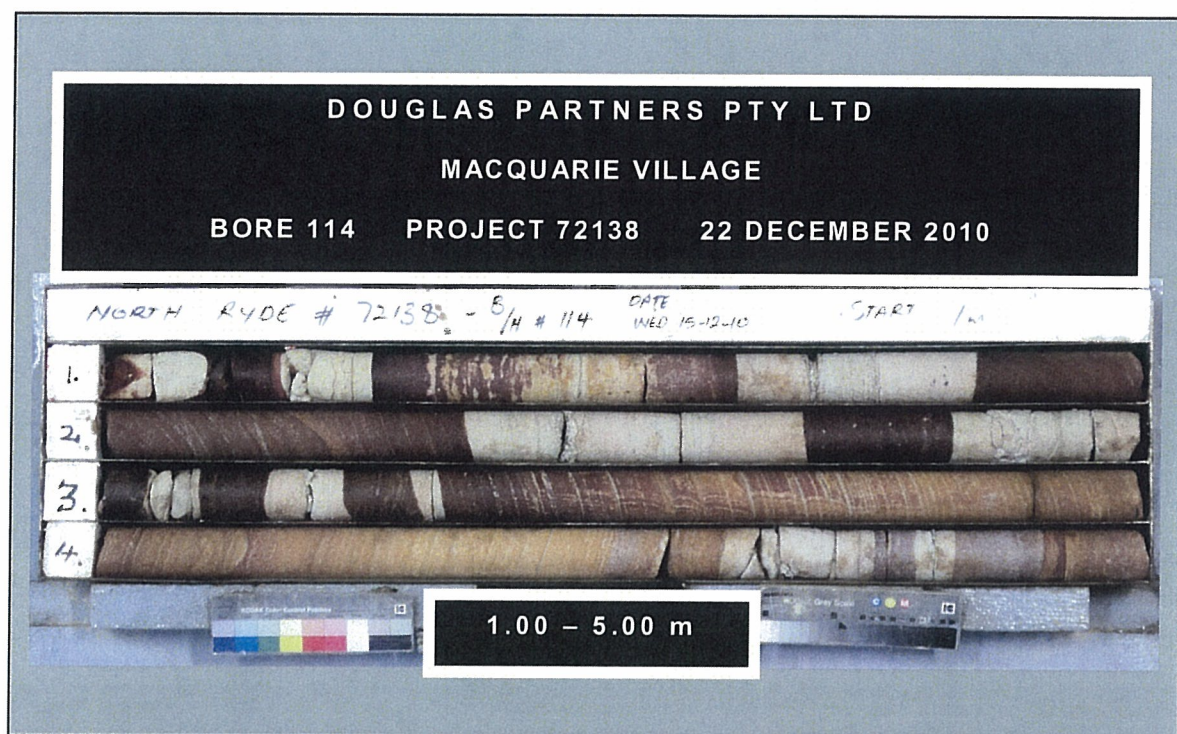
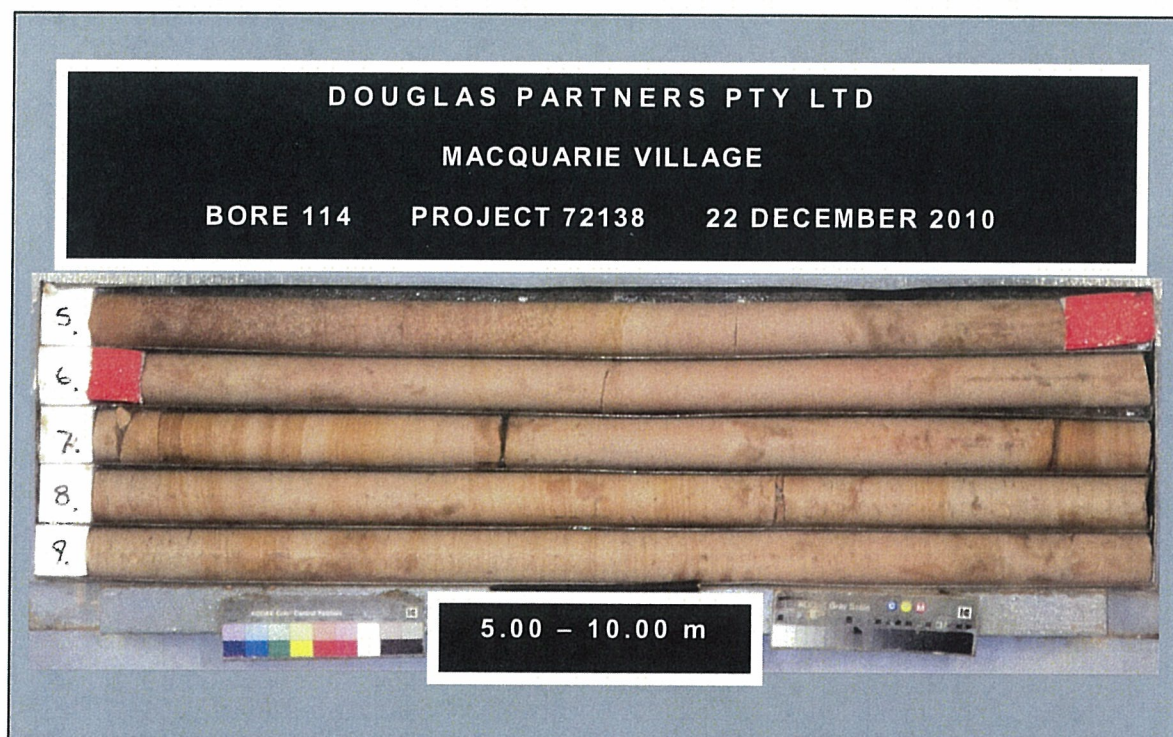
BORE No: 114
PROJECT No: 72138
DATE: 14/12/2010
SHEET 1 OF 1

0.17	CONCRETE - 170mm thick																			
		SANDY CLAY - orange brown and red, sandy clay (possible filling)																A/E			
67	0.95	SANDSTONE - weathered sandstone																A			
66	1.0	SANDSTONE - medium strength, moderately to slightly weathered, slightly fractured, purple-red and light grey, medium to coarse grained sandstone with indistinct cross beds																C	100	100	PL(A) = 0.5
65	2																	C	100	99	PL(A) = 0.7
64	3																	C	100	100	PL(A) = 0.8
63	4																	C	100	100	PL(A) = 0.8
62	5																	C	91	89	PL(A) = 1.2
61	5.5	SANDSTONE - high strength, moderately weathered then slightly weathered to fresh, slightly fractured and unbroken, orange and light orange-grey, medium to coarse grained, massive sandstone																C	100	100	PL(A) = 1
60	6.05																	C	100	100	PL(A) = 1.5
59	7																	C	100	100	PL(A) = 1
58	8																	C	100	100	PL(A) = 1.2

57	9																	C	100	100	PL(A) = 1.2
56	10																	C	100	100	PL(A) = 1.2

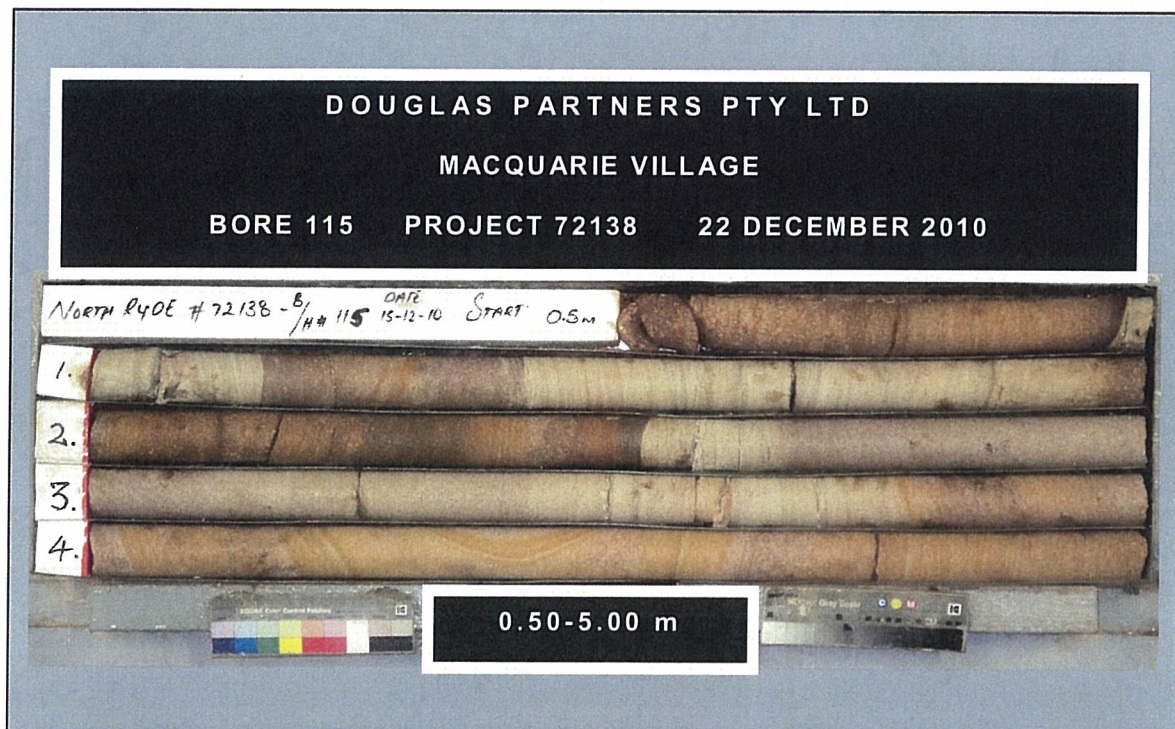
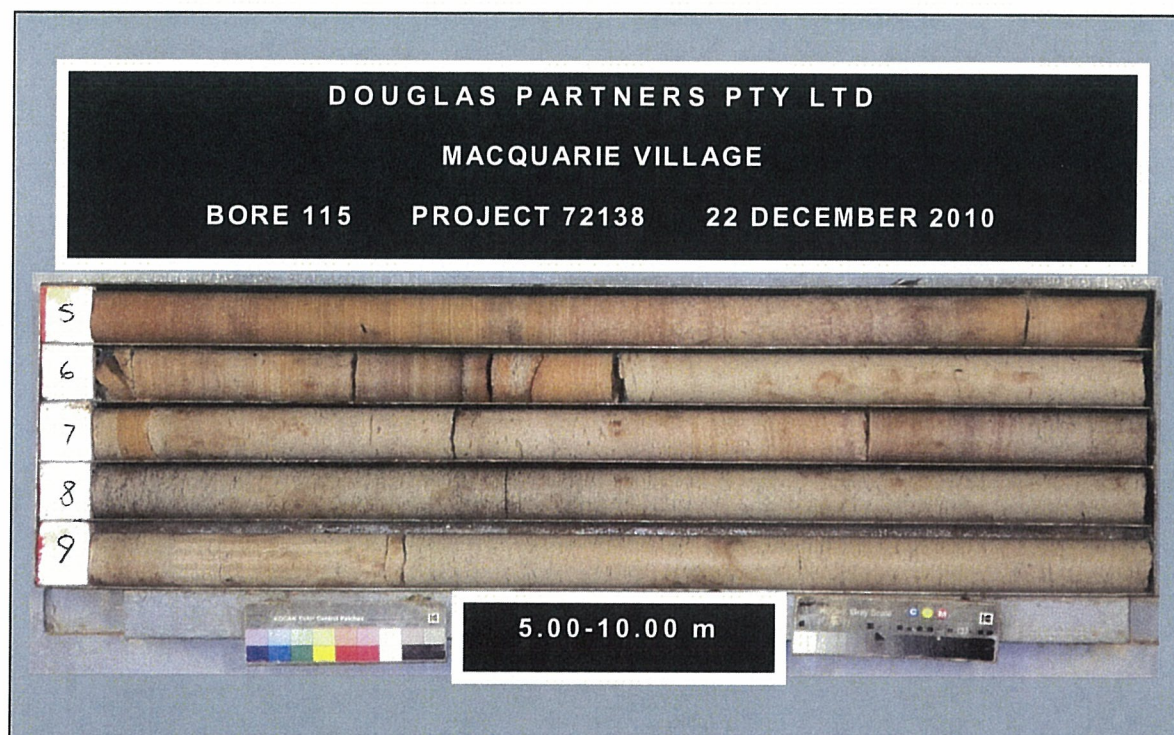
BORE No: 115
PROJECT No: 72138
DATE: 15/12/2010
SHEET 1 OF 1

60	6.5	SANDSTONE - medium strength, fresh, unbroken, light grey, medium to coarse grained sandstone																C	100	91	PL(A) = 1
59	7																				PL(A) = 0.7
58	8																	C	100	100	PL(A) = 0.9
57	9																				
57	10																	C	100	100	PL(A) = 0.9
57	10.0

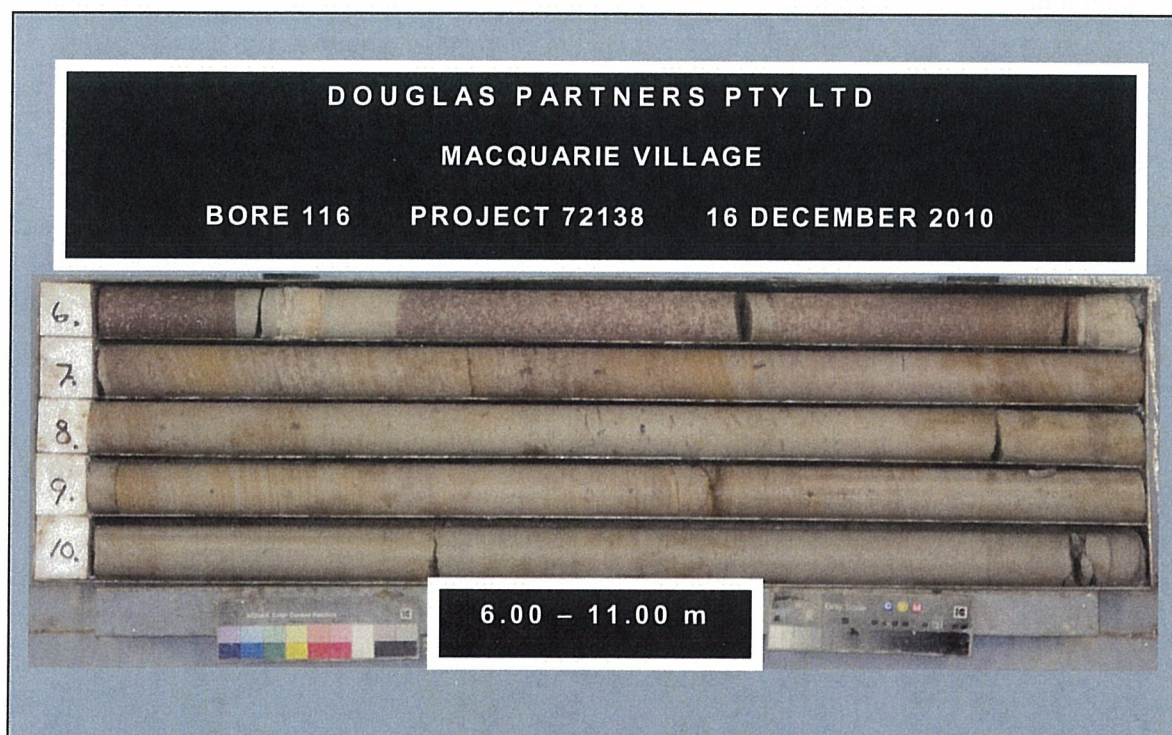
BORE No: 116
PROJECT No: 72138
DATE: 16/12/2010
SHEET 1 OF 2

RL	Depth (m)	Description of Strata	Degree of Weathering				Graphic Log	Rock Strength					Water	Fracture Spacing (m)	Discontinuities		Sampling & In Situ Testing					
			EW	HW	MW	SW		FS	FR	Ex Low	Very Low	Low			Medium	High	Very High	Ex High	B - Bedding S - Shear	J - Joint F - Fault	Type	Core Rec. %
66	0.3	CONCRETE - 300mm																				
		FILLING - yellow brown, crushed sandstone gravel filling																A/E				
65	1.0	SANDY CLAY - orange brown sandy clay (possible filling)																A/E				
64	2.1	SANDSTONE - weathered sandstone																A				
63	2.3																	A				
62	3.07	SANDSTONE - medium to high strength, slightly weathered and fresh, slightly fractured, medium to coarse grained sandstone																				PL(A) = 1.1
61	4.6	SANDSTONE - high strength, moderately weathered and fresh, unbroken, purple-red and grey, medium to coarse grained sandstone

REMARKS: Standpipe installed to 11.8m; Water level measured at 2.4m on 20/12/10, 2.6m on 22/12/10 and 2.7m on 11/1/11

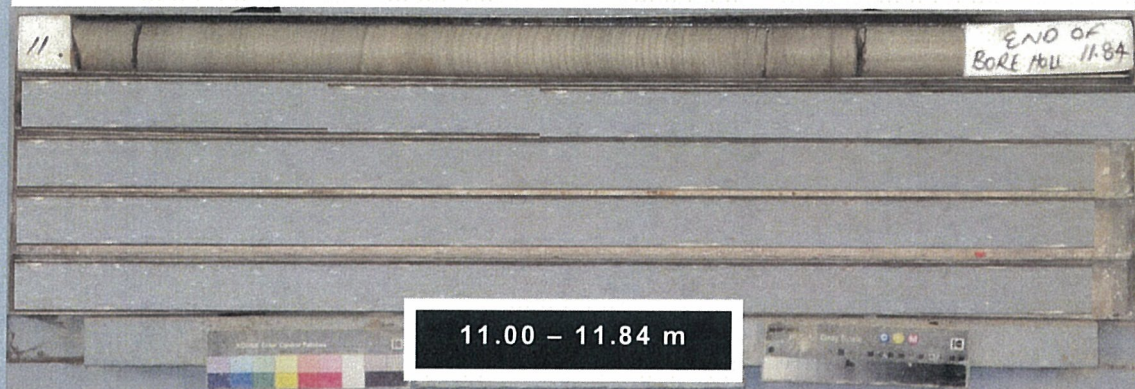
BORE 116 PROJECT 72138 16 DECEMBER 2010

MACQUARIE VILLAGE
