# **Groundwater Assessment**

## **Redevelopment of Former Brick Pit, Kirrawee**

for Henroth Investments Pty Limited  
October 2010

J1418.13R-rev0

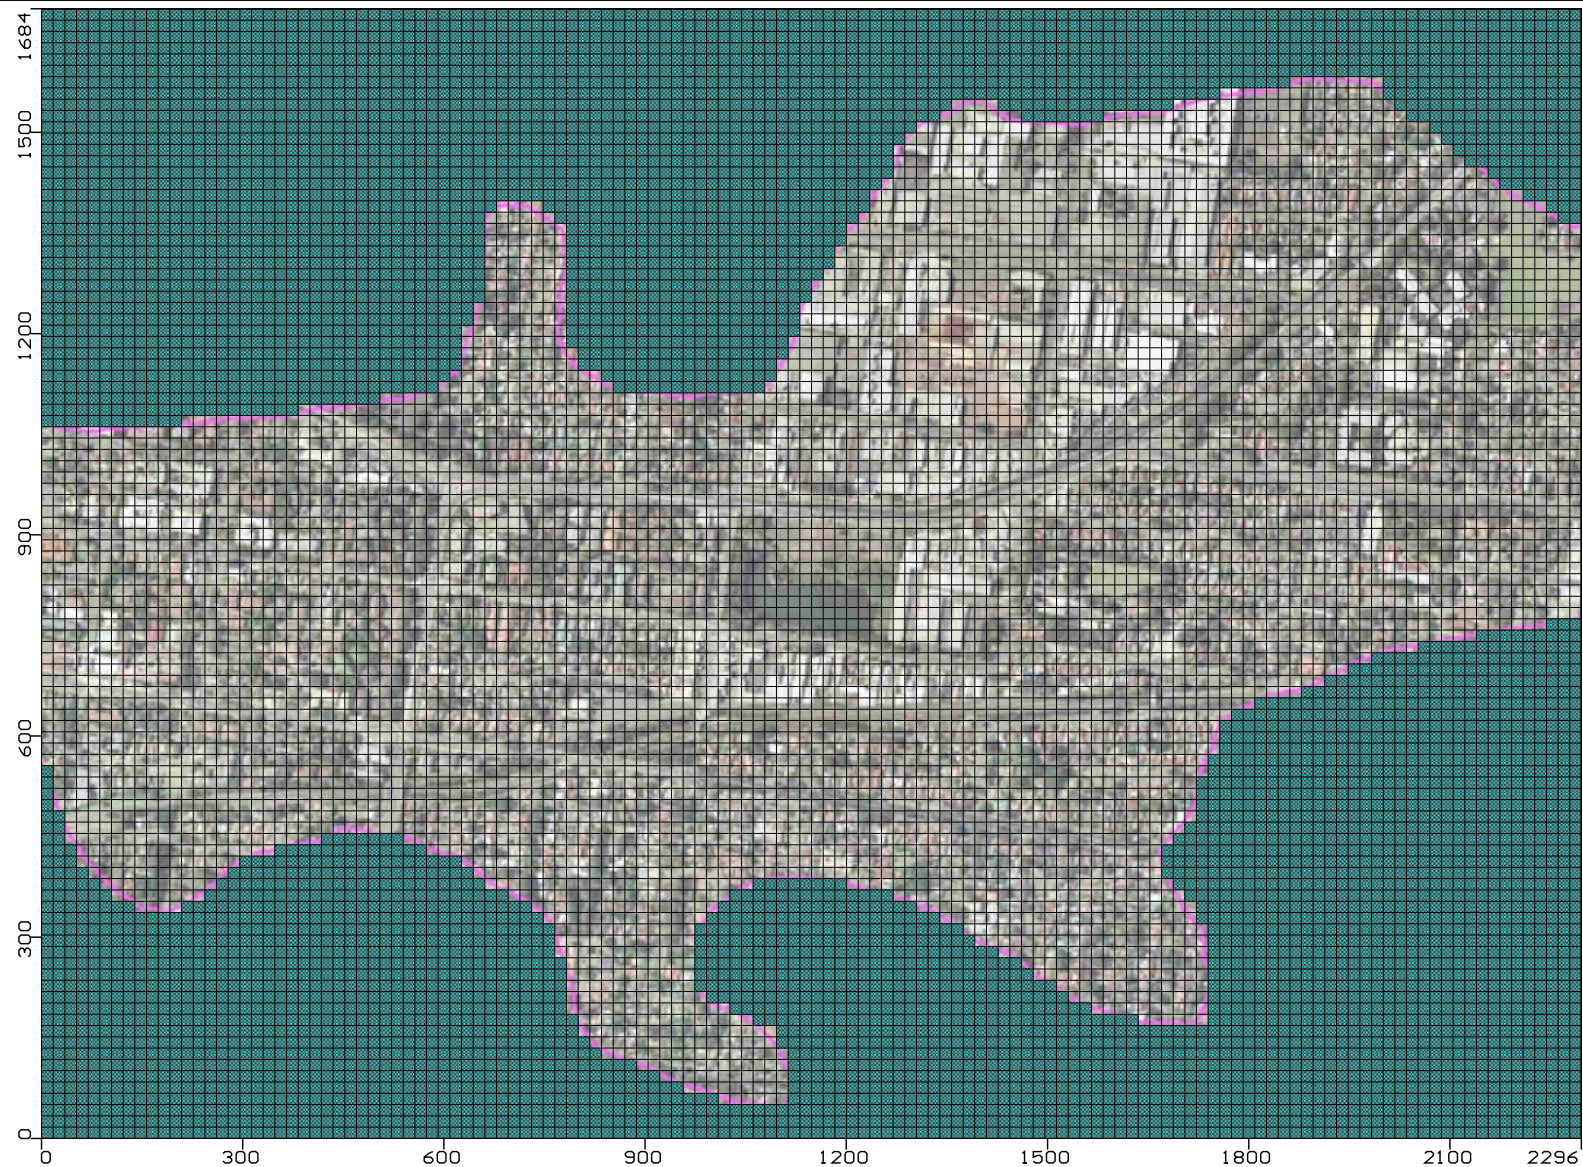
Model Grid  
Horizontal Discretisation 132 columns x 100 rows

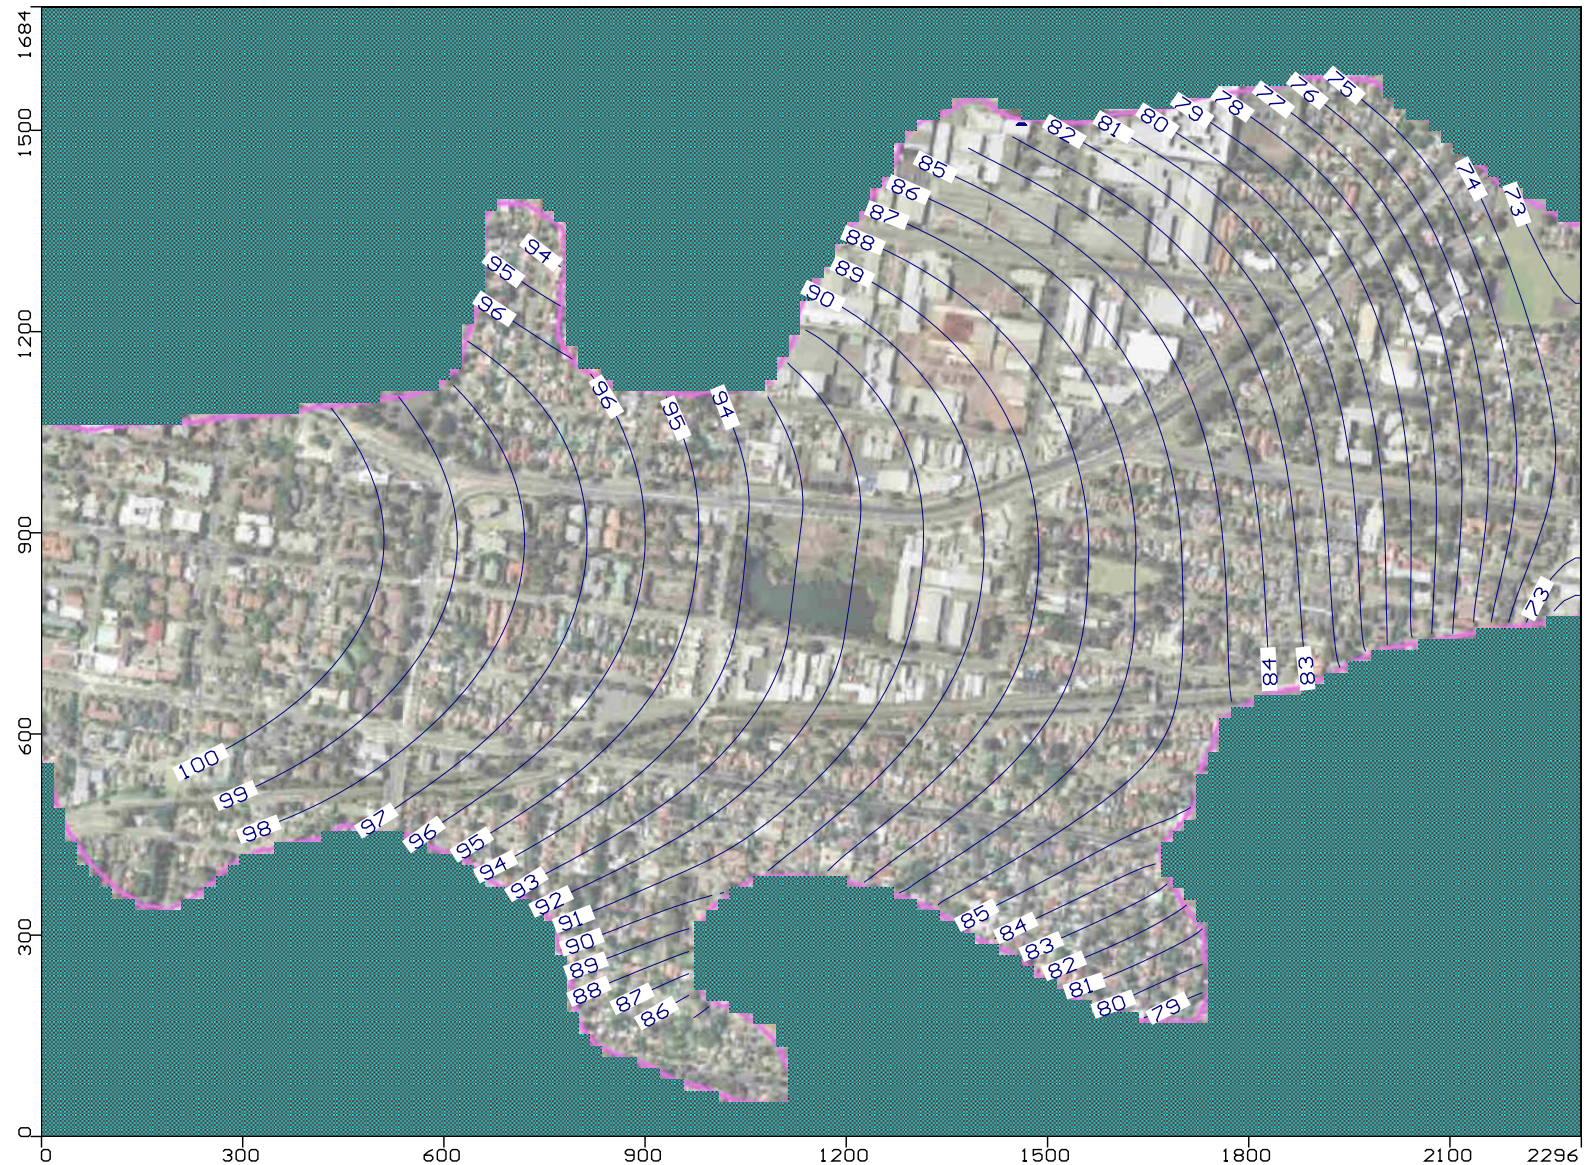
Current (quasi-steady-state) groundwater levels  
Elevation of water table, m AHD

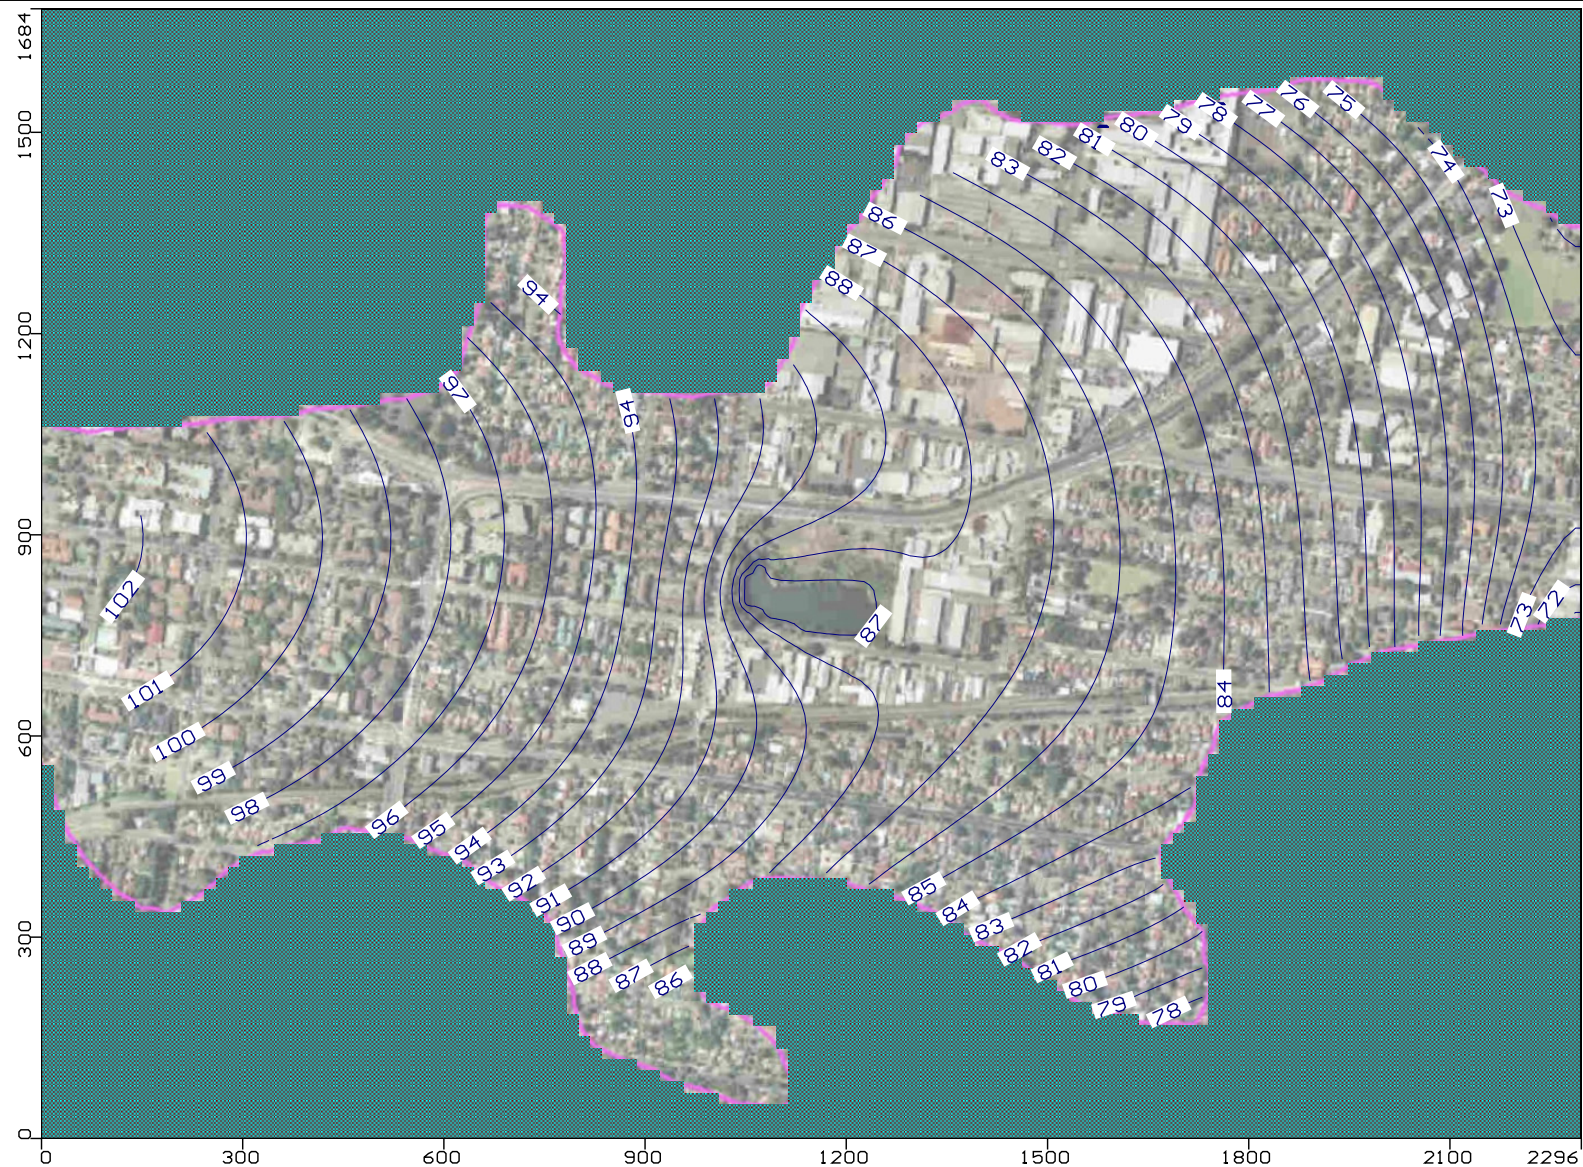
Long-term groundwater level around pit  
Post construction  
Elevation of water table, m AHD

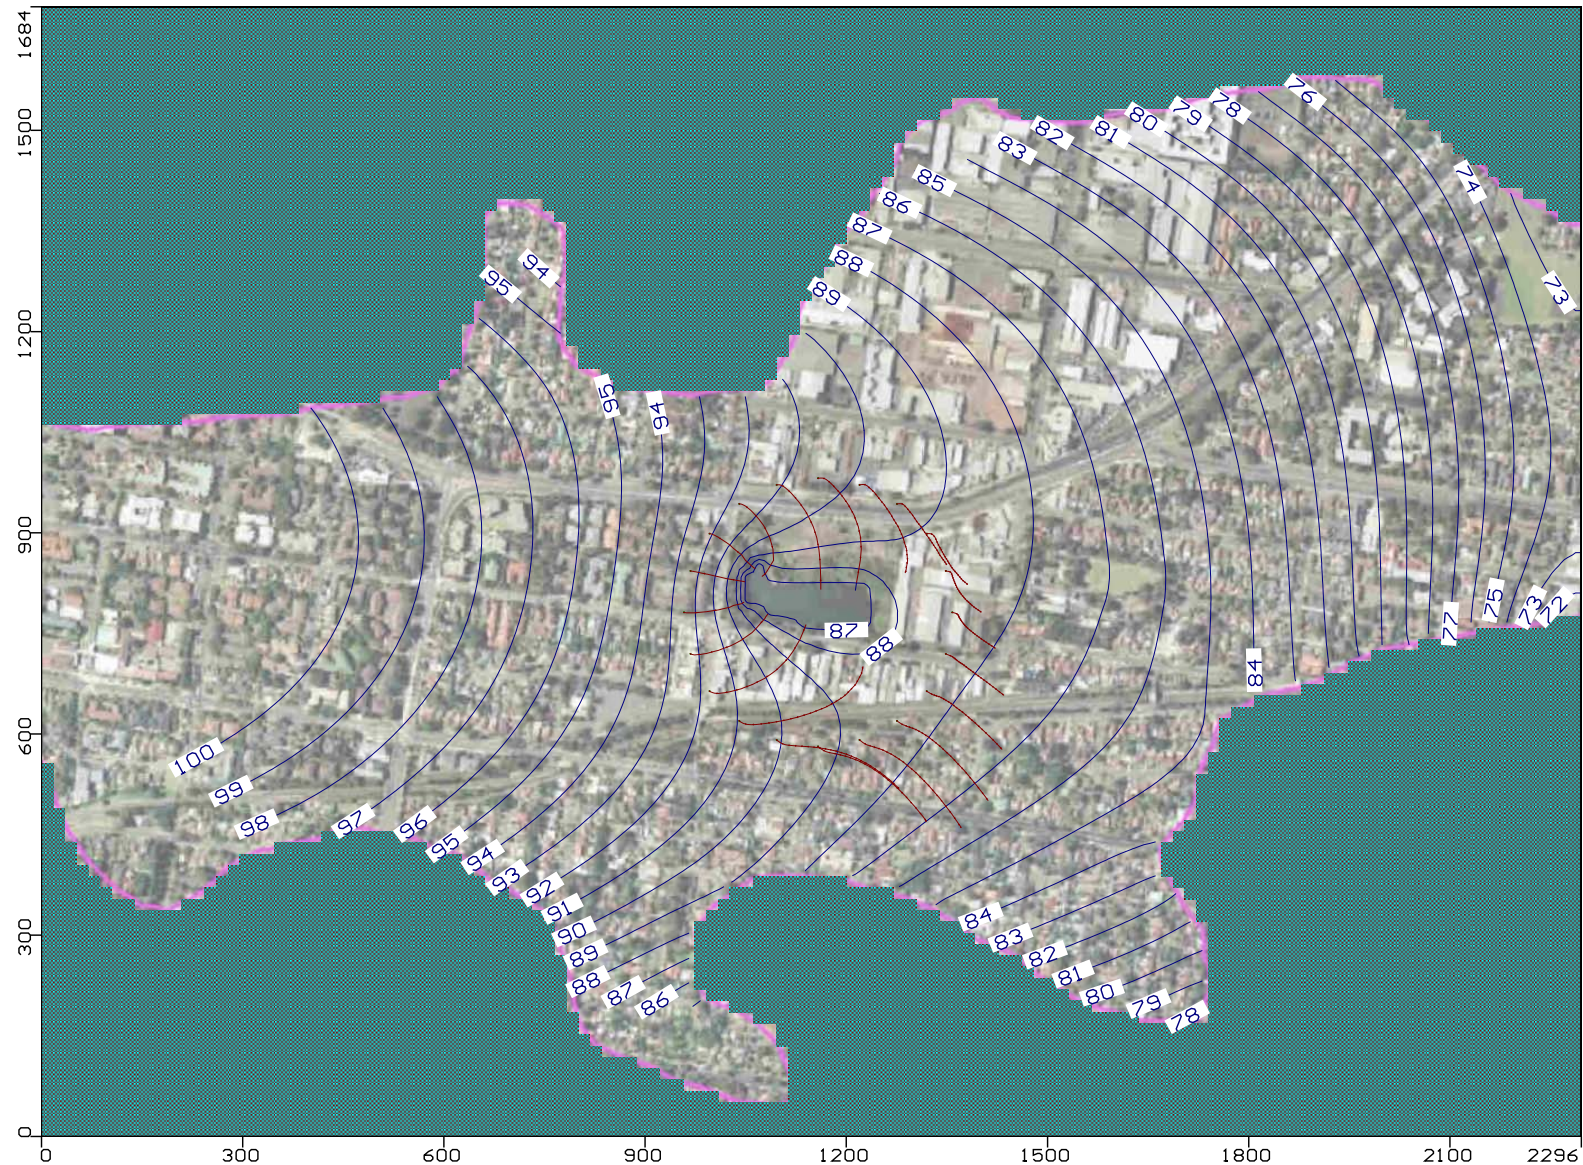
Water levels 12 months following start of dewatering  
 Contours show the level of the groundwater table in the upper (shale) aquifer in m AHD  
 Pathlines show groundwater flow directions - each tick represents 30 days travel time
