CARDINAL FREEMAN VILLAGE, ASHFIELD

REPORT REGARDING REMOVAL & REINSTATEMENT OF SANDSTONE GATE PIERS AND WROUGHT IRON GATES

J A S P E R S W A N N
PTY LTD
HERITAGE MASONRY CONSULTANT

August 2013

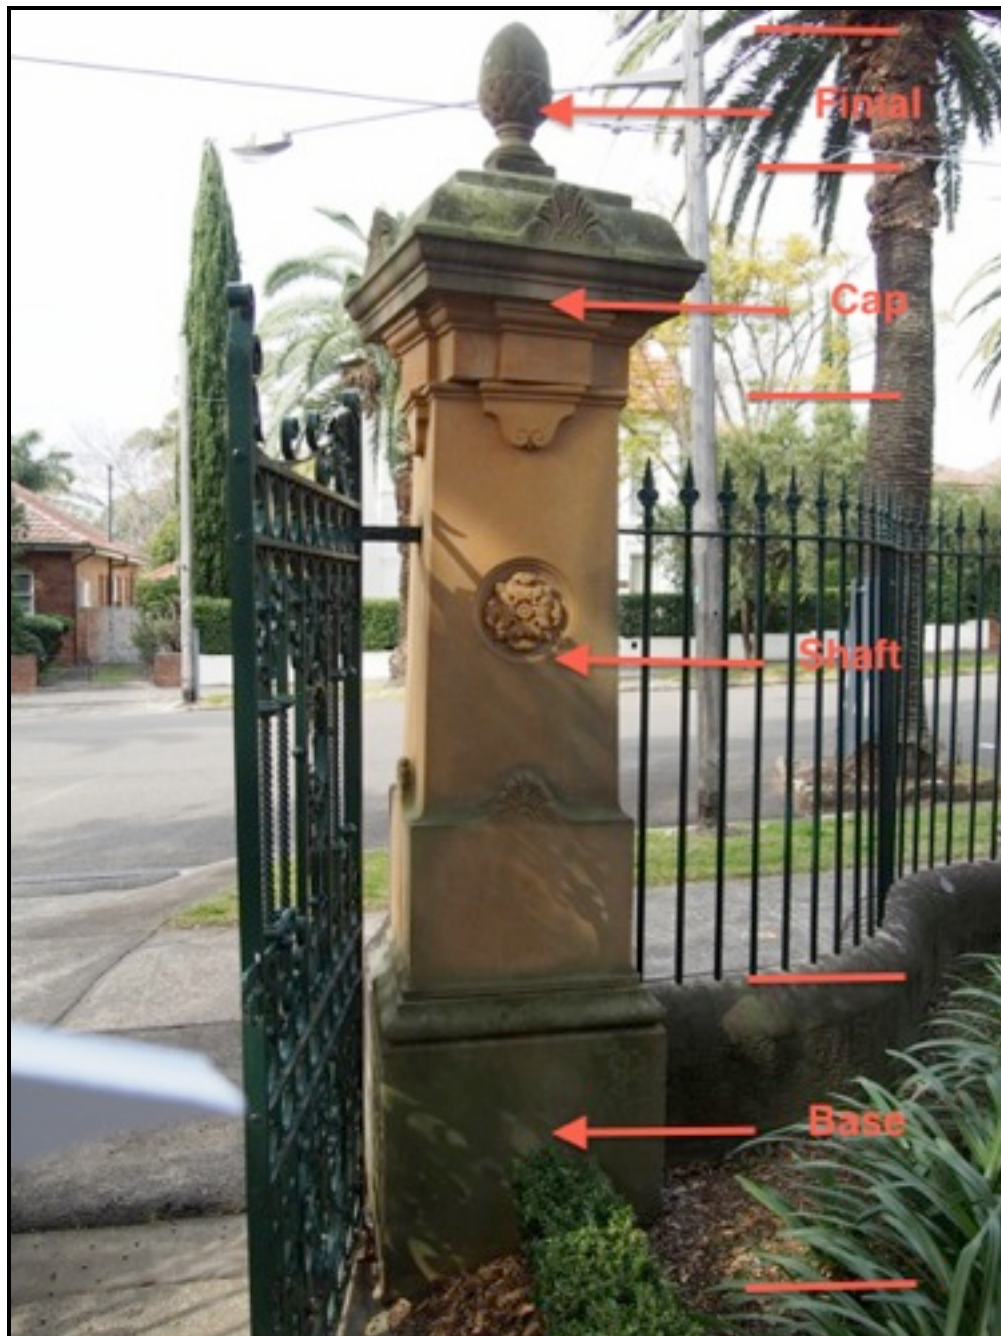
Figure 2 Identification of the elements of each stone gate pier. (Photo: Jasper Swann, 2013)

Each pier consists of four courses: the base, shaft, cap and finial, (Figure 2).

Element	Length, mm	Breadth, mm	Height, mm	Mass, Kg (Approx)
Base	760	760	900 (minimum)	1190 Kg (min)
Shaft	610	610	1590	1300 Kg
Cap	790	790	700	800 Kg
Finial	200	200	380	28 Kg

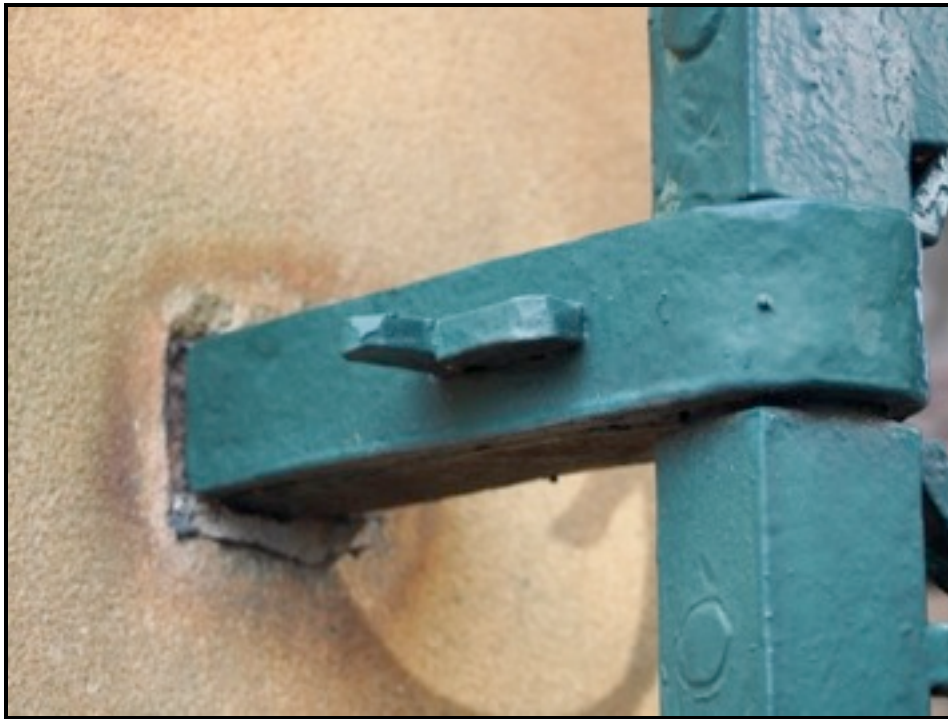
Figure 3 Cleat and hasp at gate hinge. (Photo: Jasper Swann, 2013)

- Prepare to take the weight of the wrought iron gate leaf to Pier 2 using soft slings slung from a truck-mounted hiab-crane.
- Gently loosen and free cleats at the hasp/hinge restraining the gate leaf by gently tapping with a hammer until free, (Figure 3). Carefully chip away paint if necessary and, if necessary, apply WD40 to assist in freeing the cleats. Protect sandstone from any overspray of WD40. Place the cleats and U-shaped hasp in a secure bag, labeled and securely tagged for placement in storage.
- Lift gate leaf and slew onto the bed of the truck, laid gently down in a horizontal position on 4"x4" hardwood timber skids.
- Repeat for gate leaf to Pier 3.
- Carefully remove iron ferrules from the sandstone threshold, (Figure 4), and place in secure bag with the U-shaped sleeves and cleats.
- Transport gates to storage facility, (see 7.0).

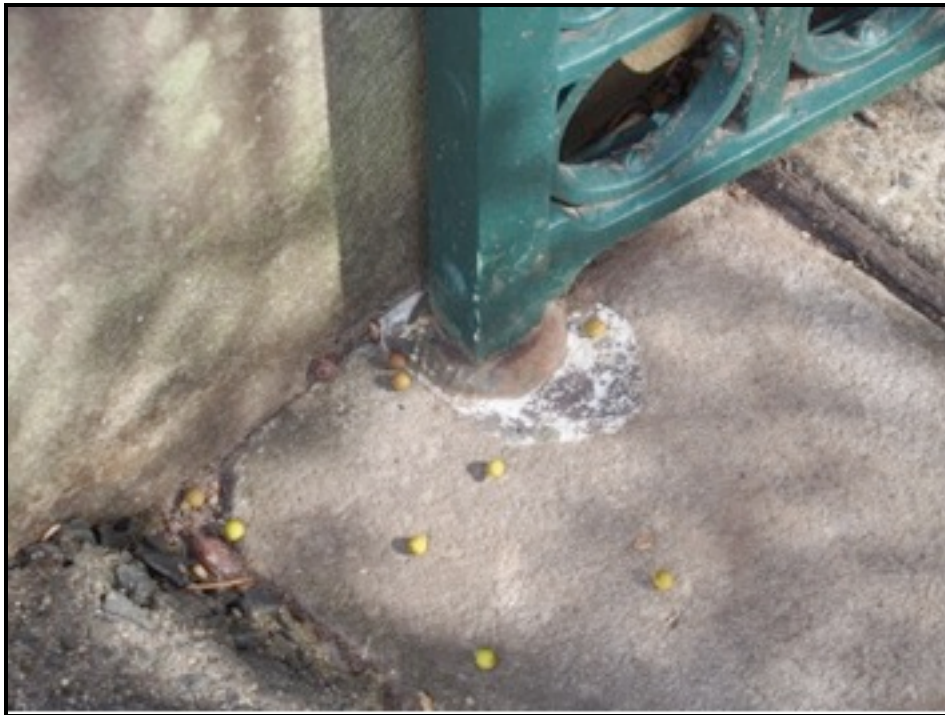
Figure 4 Iron ferrule at pivot of gate. Remove and retain in storage for future use. (Photo: Jasper Swann, 2013)

Install ferrules in threshold in correct location for housing existing gate pivots. Reinstall existing wrought iron gates.

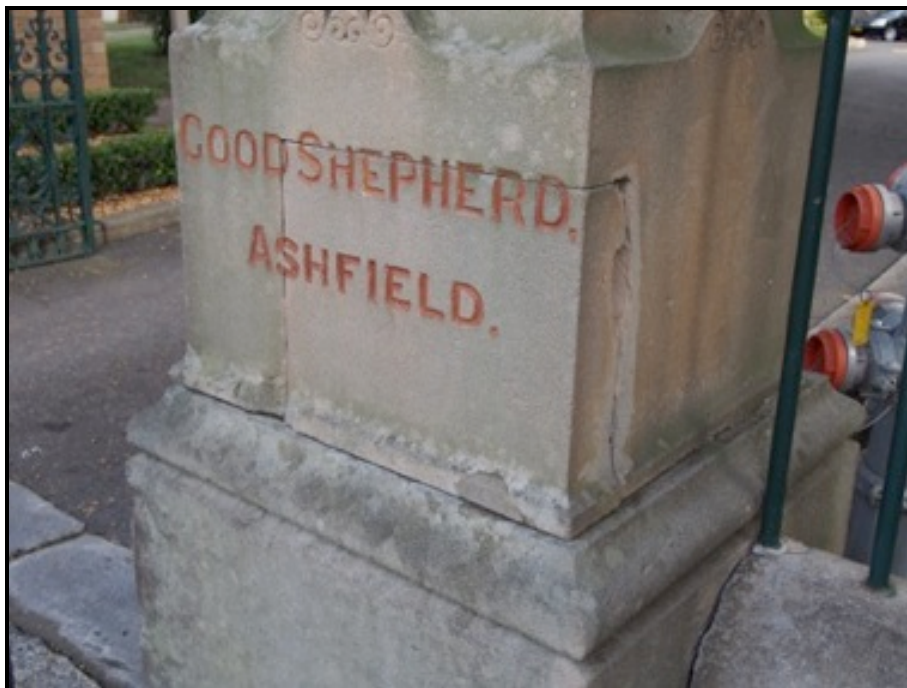
Figure 5 Existing indent in Pier 2. Care required when dismantling.
(Photo: Jasper Swann, 2013)

NOTE: Pier 2 has an indent in the lower section of the shaft, (Figure 5). Care needs to be taken that this is not displaced during the dismantling, or if loose, that it is carefully removed, identified and set aside for storage.

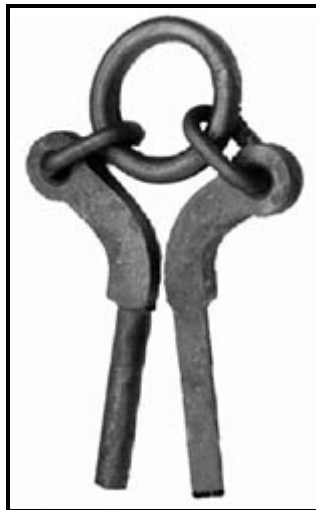
Figure 6 Split-pin Lewis Pins.

- It is assumed that there will be a square-cut Lewis hole in the centre of the base. Re-use of this hole is not recommended. Accordingly, drill 2 No. 25mm diameter x 150mm deep holes in the top bed of the base, diametrically opposed and each located 250mm from the external corner of the base. Insert a 1-Tonne rated split-pin Lewis pin, (Fig.6) into each hole. Loop a soft sling rated to a minimum 2-Tonnes through the rings of the Lewis pins. (See Figure 7, sketch SK-01 and Figure 7). Gently lift using crane until sufficient clearance is obtained under the base to allow insertion of 4"x4" timber skids under the base.

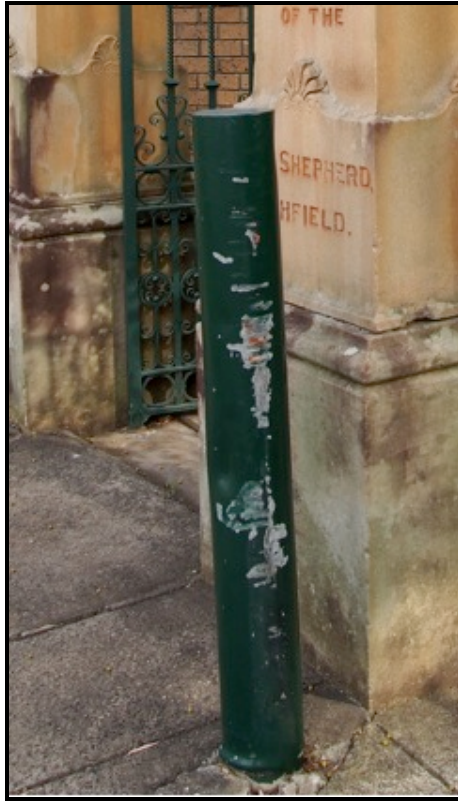
Figure 8 Existing steel bollards (2 Off) to be removed and temporarily re-instated to protect exposed ends of railing base during construction.
(Photo: Jasper Swann, 2013)

The existing steel bollards adjacent to Piers 2 & 3, (Figure 8), shall be removed by excavating around them until free. The bollards are to be set aside for re-use in the temporary protection of the exposed ends of the railing base during construction, (see 6.0).

Temporarily Install salvaged steel bollards approximately 200mm from the reveal face of the ply protection. Bollards to be set in concrete to replicate existing height above ground level.

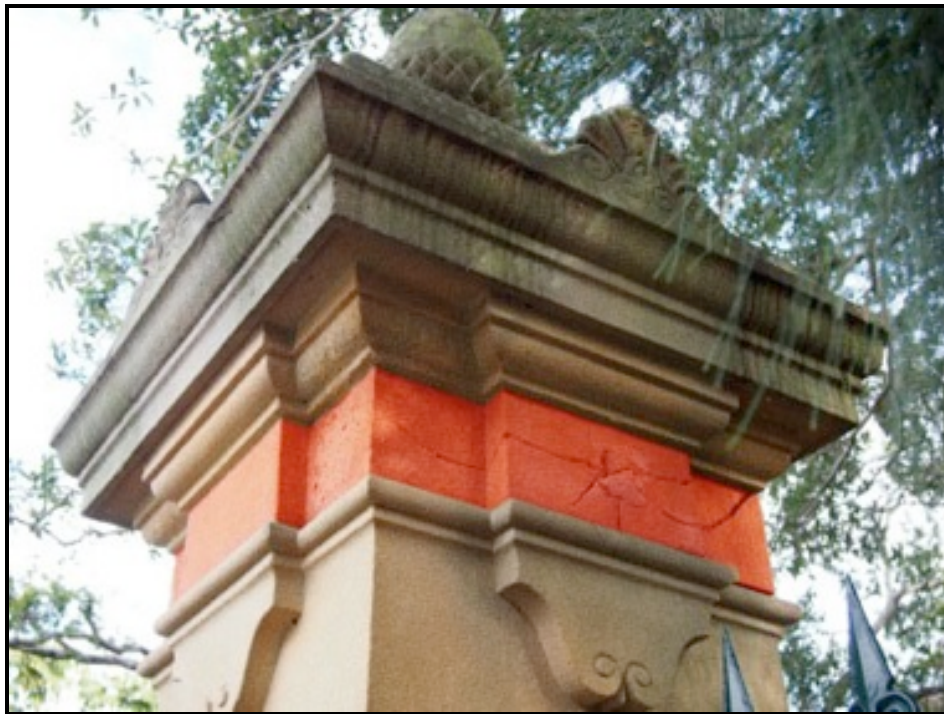
Figure 10 Install hairline indent to cap as shown in red prior to reinstatement.
(Photo: Jasper Swann, 2013)

It is recommended that an indent to the lower section of the cap to Pier 2 be installed by a banker mason prior to reinstatement, fixed to the parent stone using 4 x M10 316-Grade stainless steel dowels. The indent shall have a hairline horizontal joint under the bottom fillet, (Figure 10), not a pointed joint.
