APPENDIX 1 - REV 2

SITE ANALYSIS

BY JHLA

SANDY
BEACH
NORTH

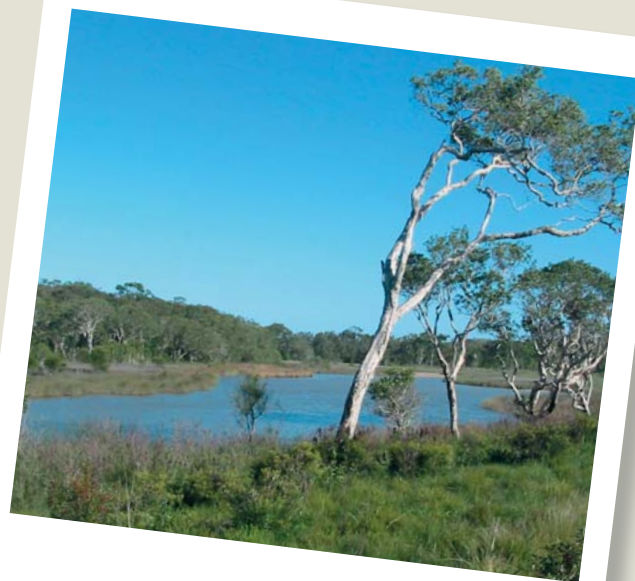
Fig 2 - Hearn's Lake

Hearn Lake is situated behind the coastal dunes along Hearn Lake Beach. It is orientated approximately north-south and receives runoff from a number of minor tributaries in addition to the larger catchment flows from Double Crossing Creek. Under normal conditions, the entrance to Hearn Lake is closed, being effectively “blocked” by the beach berm.

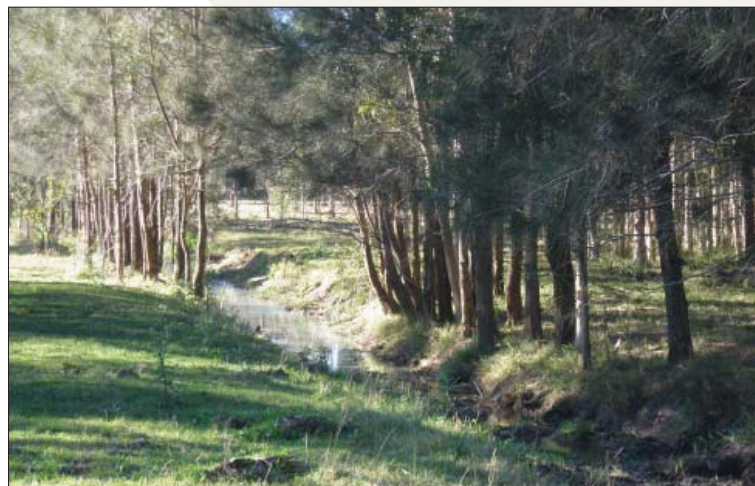
Fig 7 - Existing open stormwater drain

This southern section of the site is drained by two existing watercourses that appear to be man-made earth lined channels. These channels carry runoff from the northern section of the existing residential precinct of Sandy Beach. The banks of both channels are densely vegetated, particularly in the vicinity of their point of discharge to Hearn's Lake.

The southern area of the site is steeper but only rises to an elevation of about 5.5 mAHN. This area drains to two open channels that flow in a northerly direction and discharge runoff to Hearn Lake. These channels are man made and are understood to have been constructed in the 1980s.

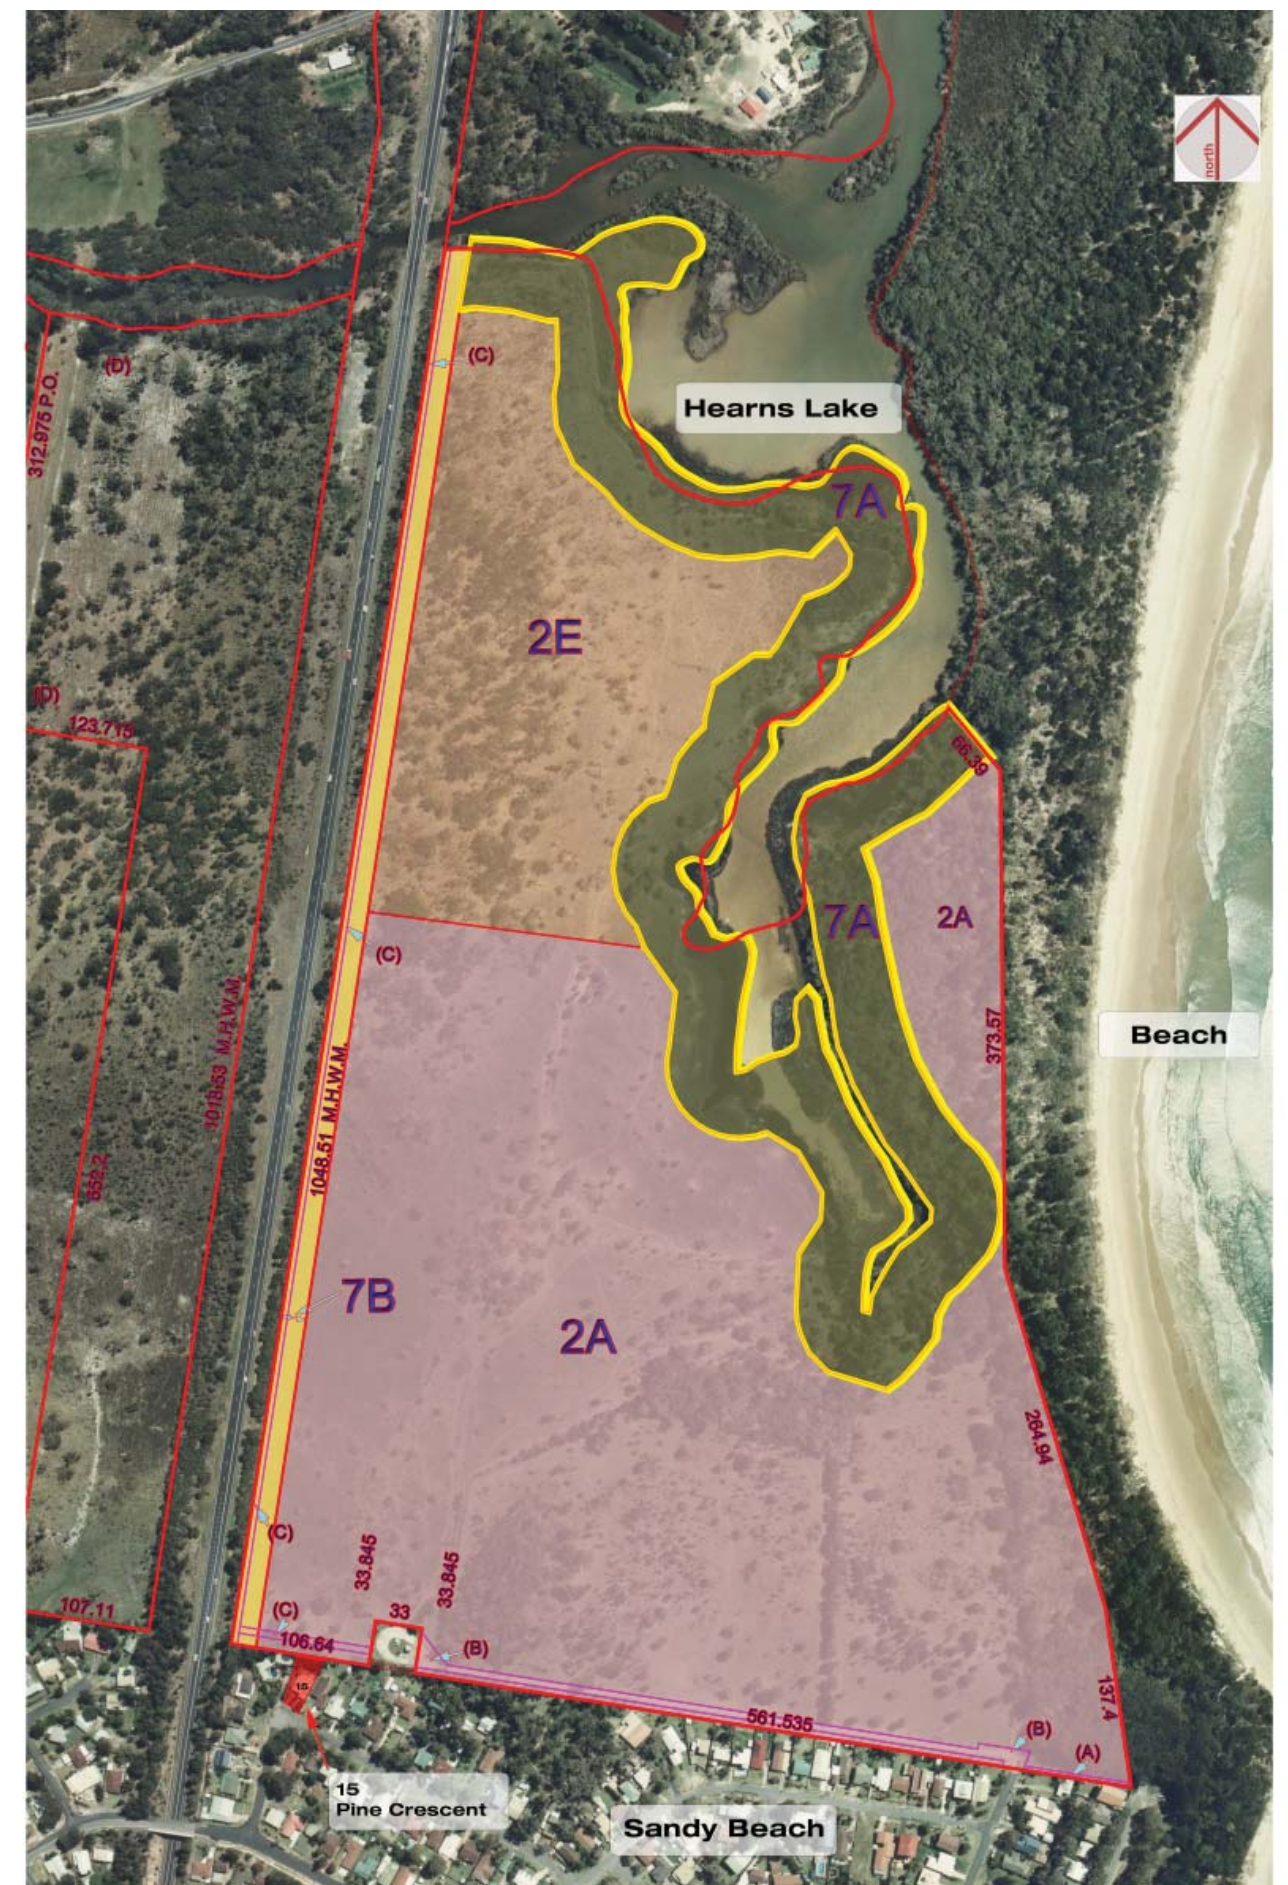
Fig 8 - Site zoning, Dimensions and Easements (Refer also to Appendix 1)

The land is zoned Part Residential 2A (low density), Part Residential 2E (Residential Tourist), Part 7A Environmental Protection Habitat and Catchments and Part 7B Environmental Protection/Scenic Buffer).

- (A) Easement for pipeline 2.5m wide
- (B) Easement Access 5m wide and variable
- (C) Easement for Rising Main 5m wide

Site Zones Boundary Dimensions Easements

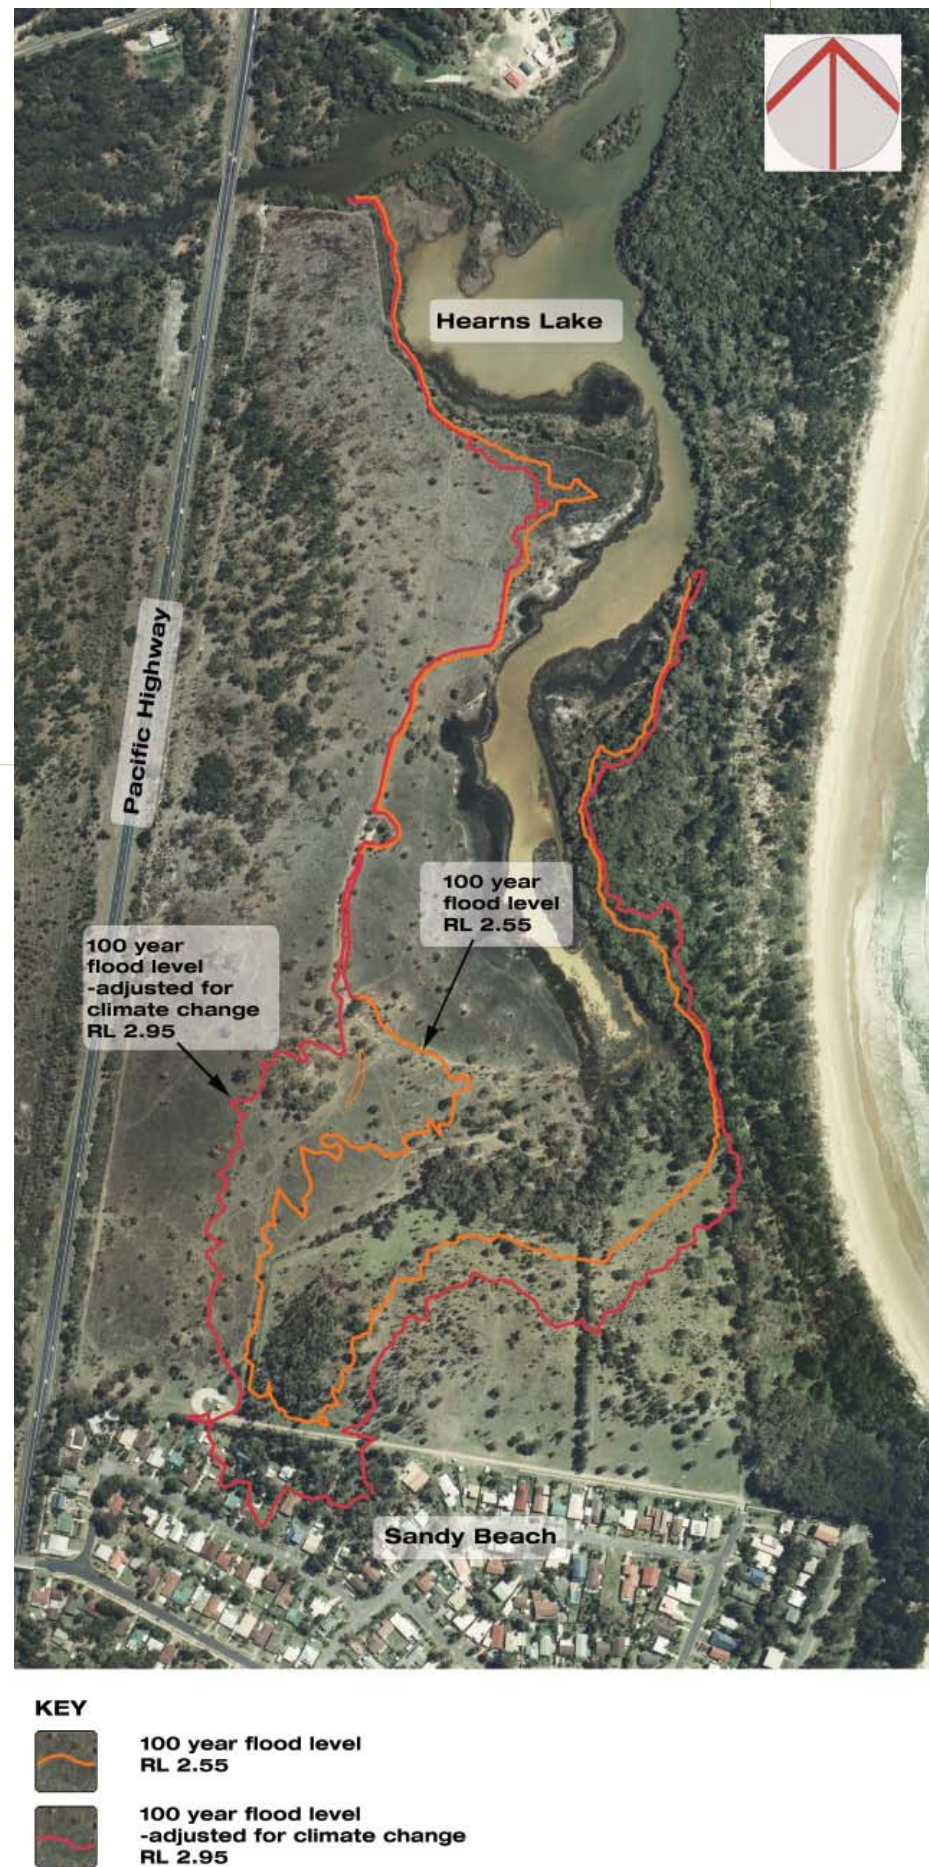
Fig 9 - Flood Levels

Two Endangered Ecological Community Areas of Swamp Sclerophyll Forest and Coastal Saltmarsh are present on the site and generally occupy some of the areas below the 1:100 year flood level.

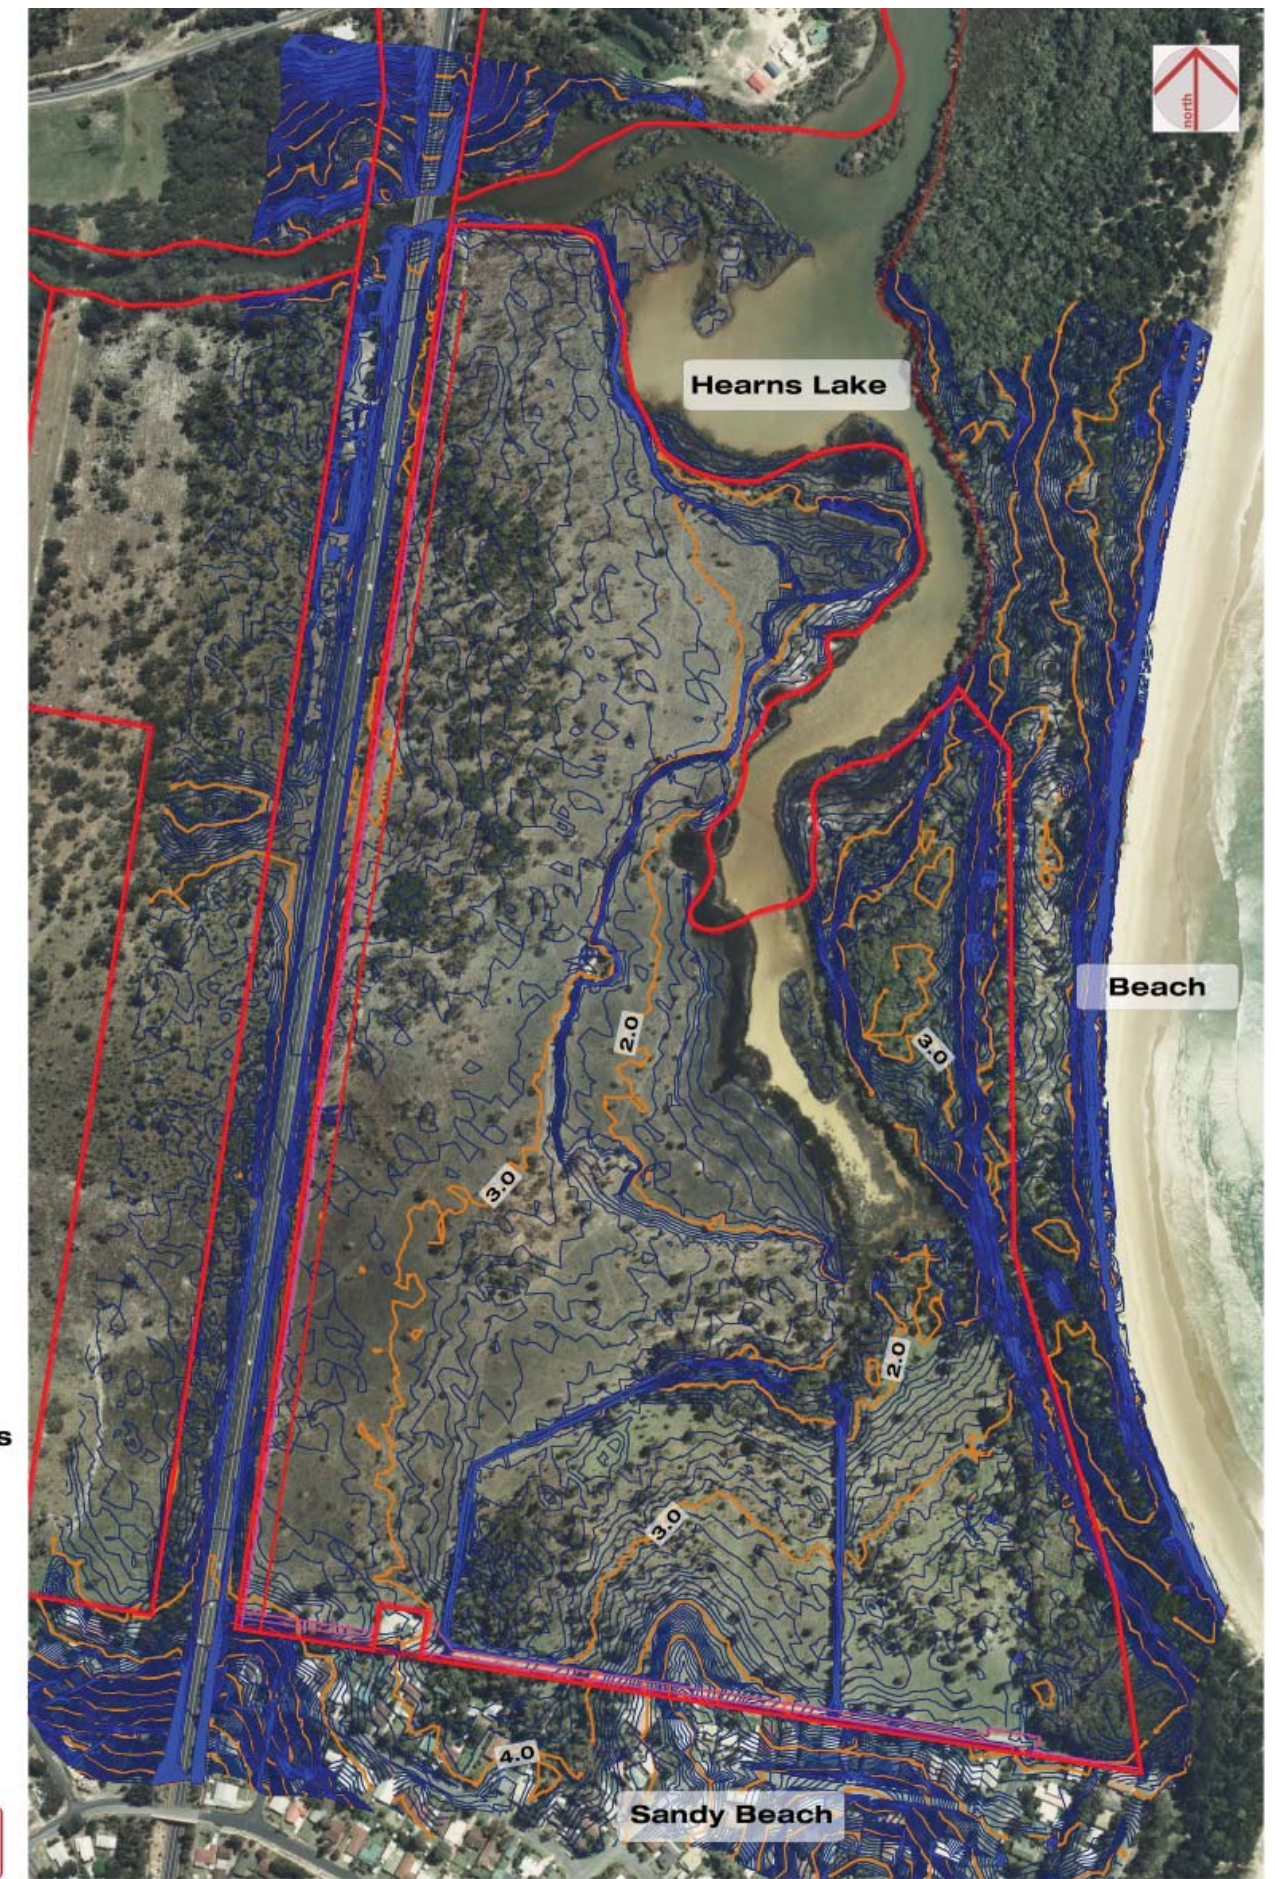
Fig 10 - Existing site contours (Refer also to Appendix 2)

The site is generally flat with the existing surface elevation across the development site varying between 0.8 mAHN near the Hearn Lake shoreline to 6 mAHN along the rear of the dunes that follow the eastern boundary of the site.

- 1m contour intervals
- 0.2m contour intervals

Existing site contours

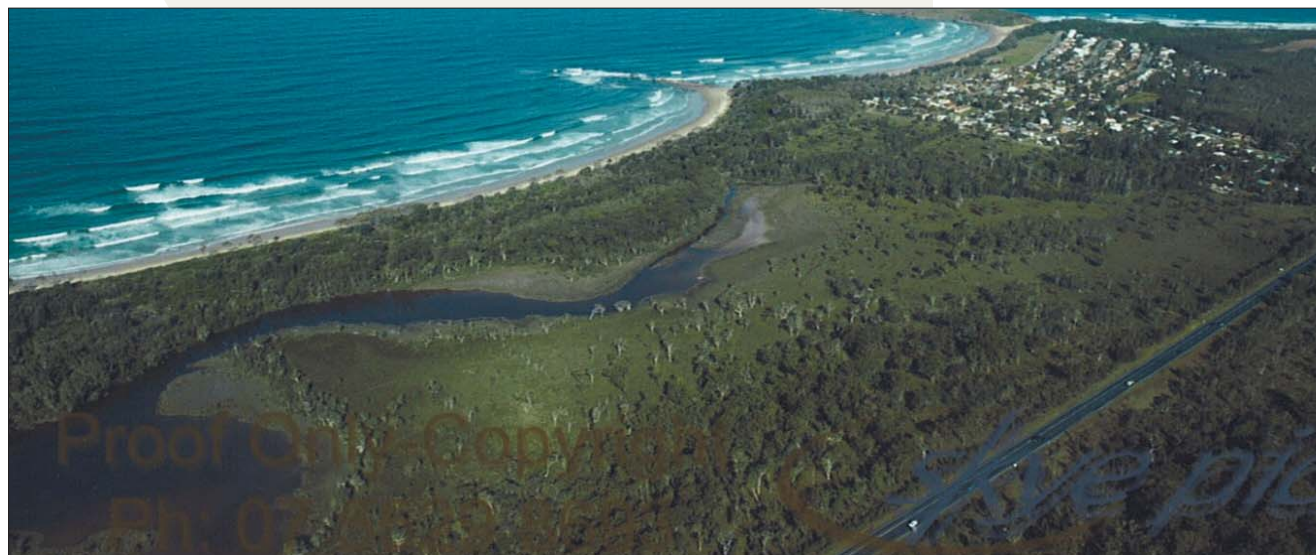
Fig 16 - The site - Looking north to south

1. RL 2.55 ICOL Extent
2. Existing vegetation
3. Coastal Hazard Line
4. Aboriginal Site - PAD1
5. Aboriginal Site - SBN1
6. Aboriginal Site - ISF2
7. Caravan Park
8. Sewer Pumping Station
9. Drainage Channels
10. Sand Dune
11. Pacific Highway
12. To Woolgoolga
13. To Coffs Harbour
14. Nos 15 and 17 Pine Crescent, Sandy Beach
15. 100m riparian setback from south-western shore of lake

Coastline hazards were determined by patterson britton & partners , based on the cumulative effects of the 100 year average recurrence interval (ari) coastal storm erosion, long term recession due to net sediment loss, and long term recession due to sea level rise (over immediate, 50 year, and 10 year planning periods).

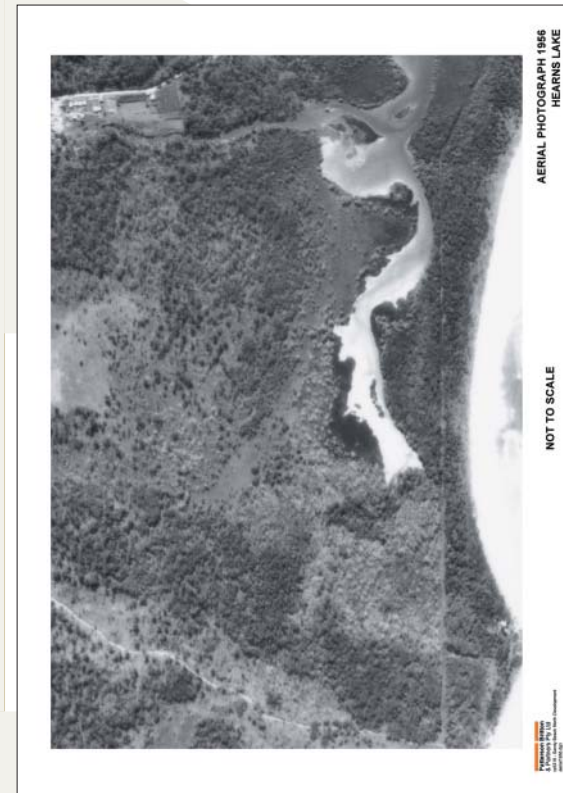
Fig 24 - 1956 Aerial

The site is currently used for grazing purposes. This combined with earlier sand mining in the coastal strip during the 1960s and 1970s past uses has resulted in a fundamentally altered and degraded ecological environment.

~ Era of coastal sandmining ~

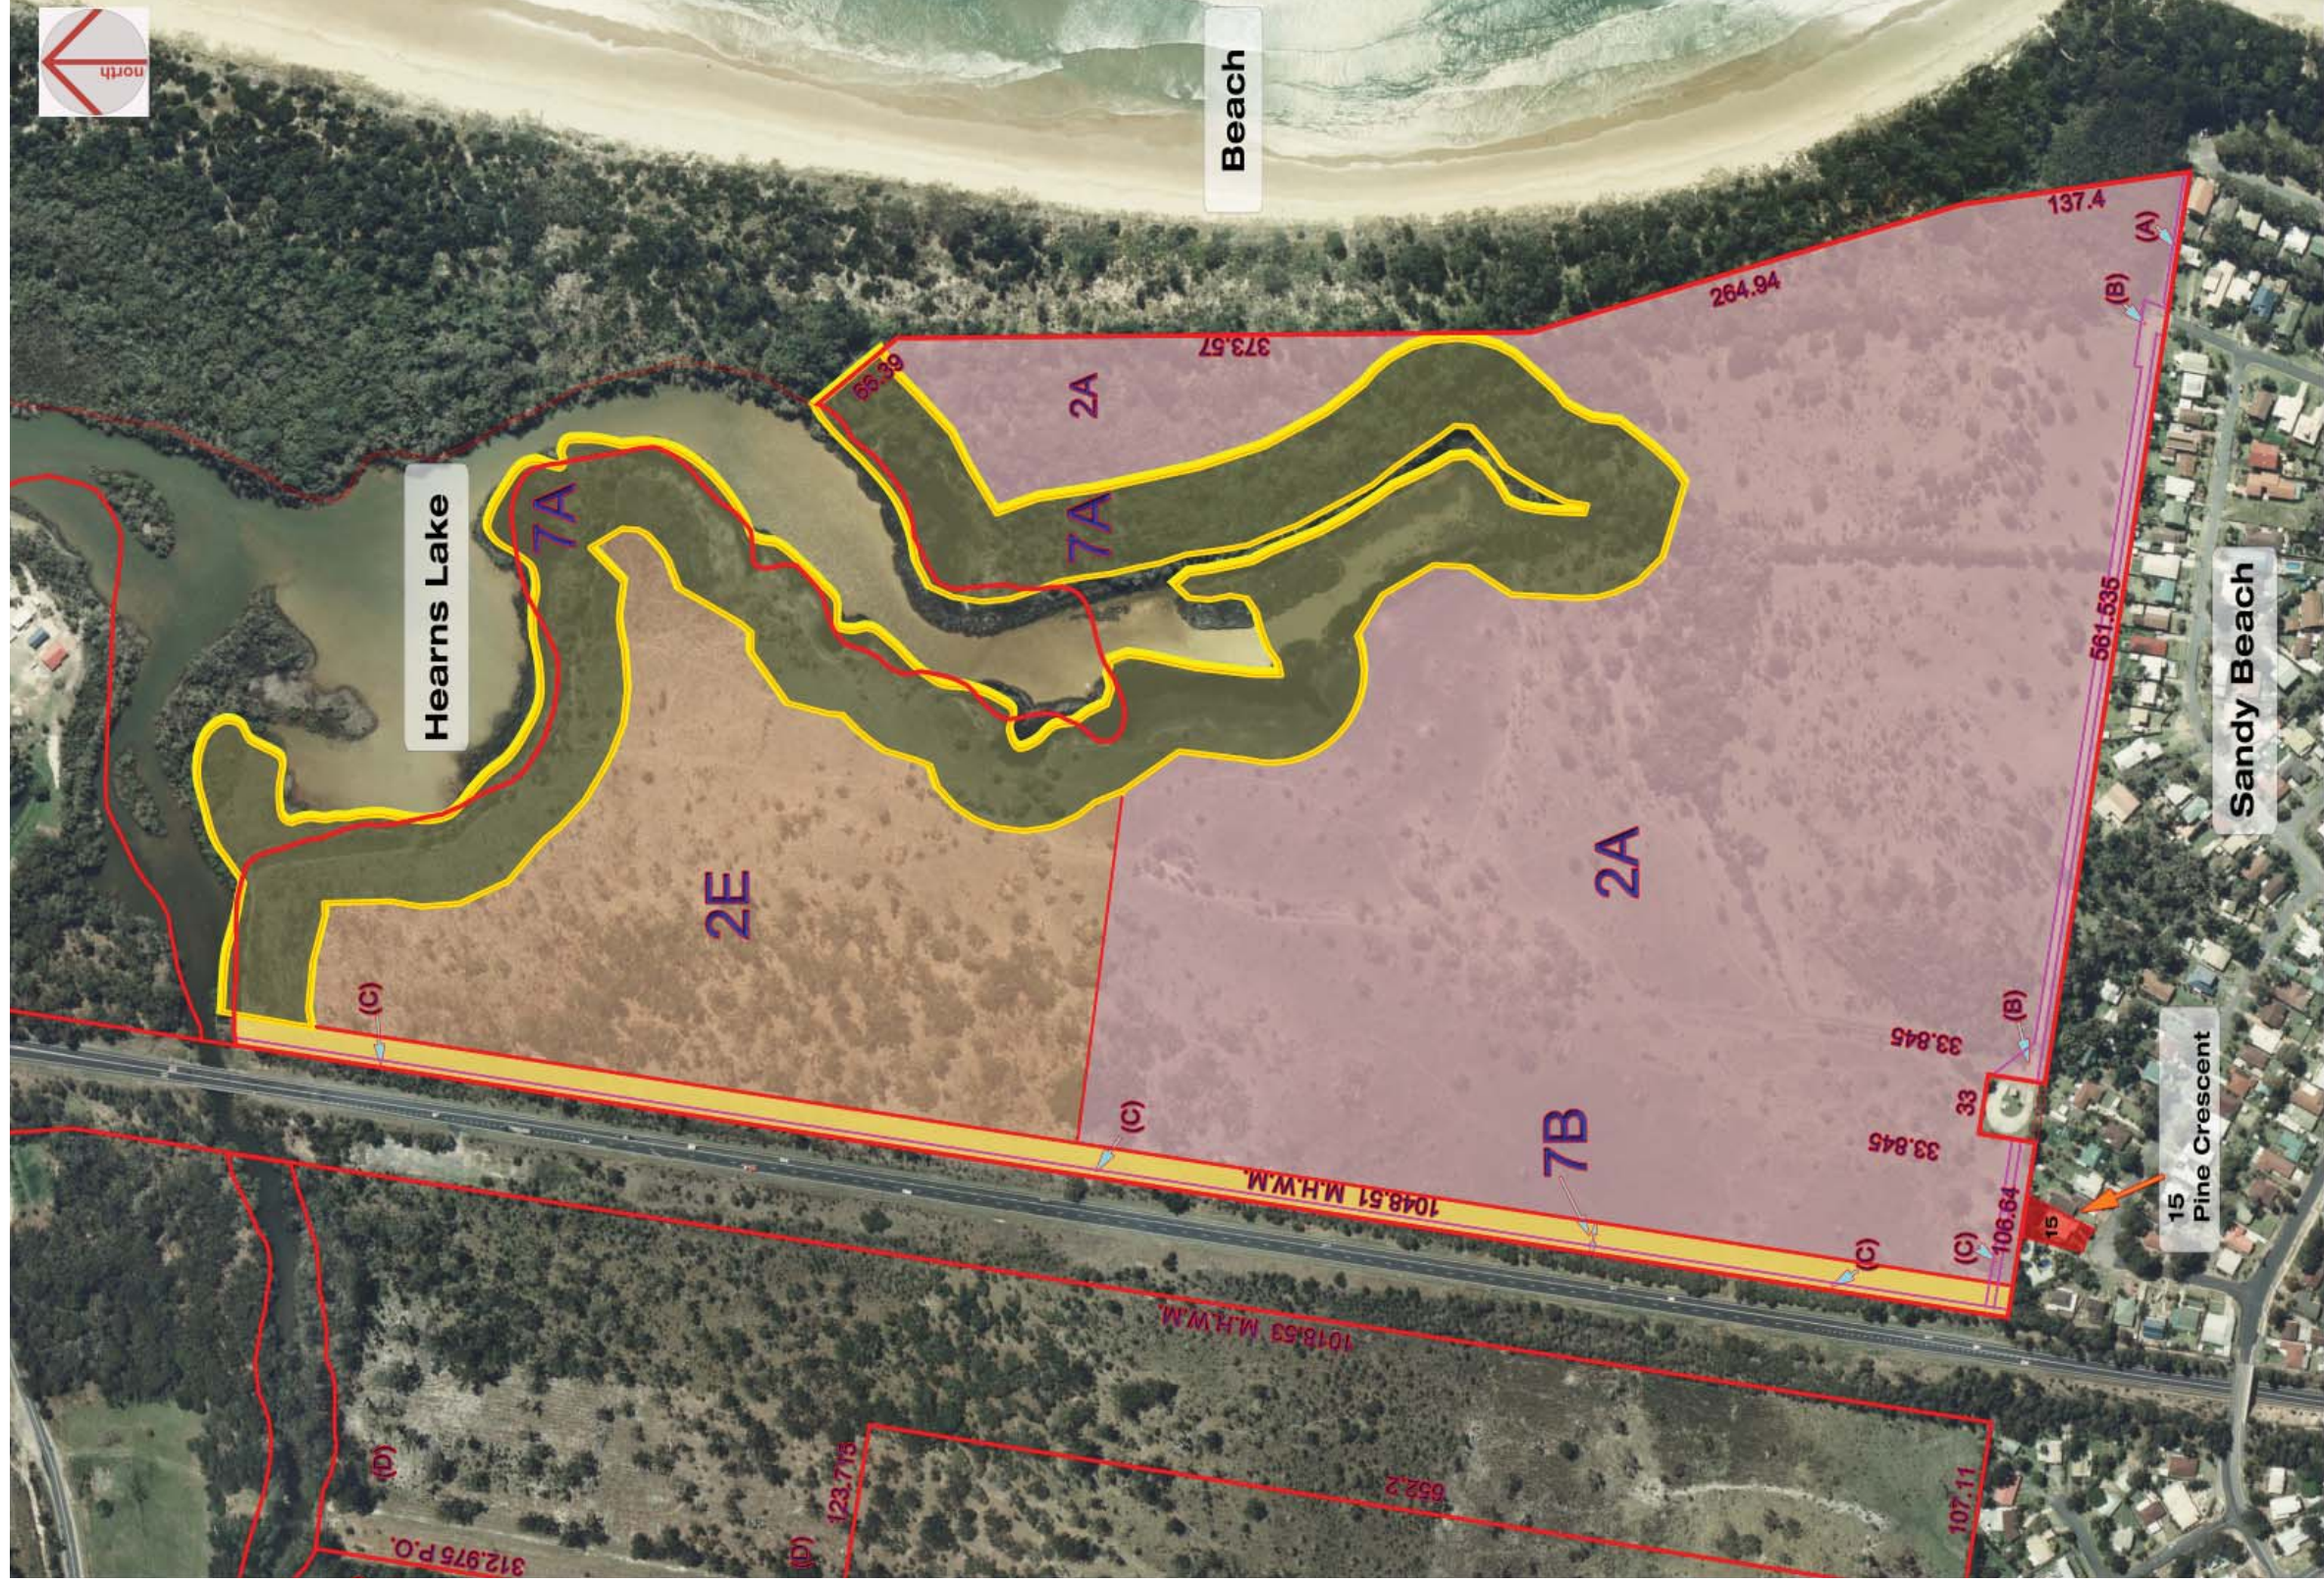
Site Zones Boundary Dimensions Easements

- (A) Easement for pipeline 2.5m wide
- (B) Easement Access 5m wide and variable
- (C) Easement for Rising Main 5m wide

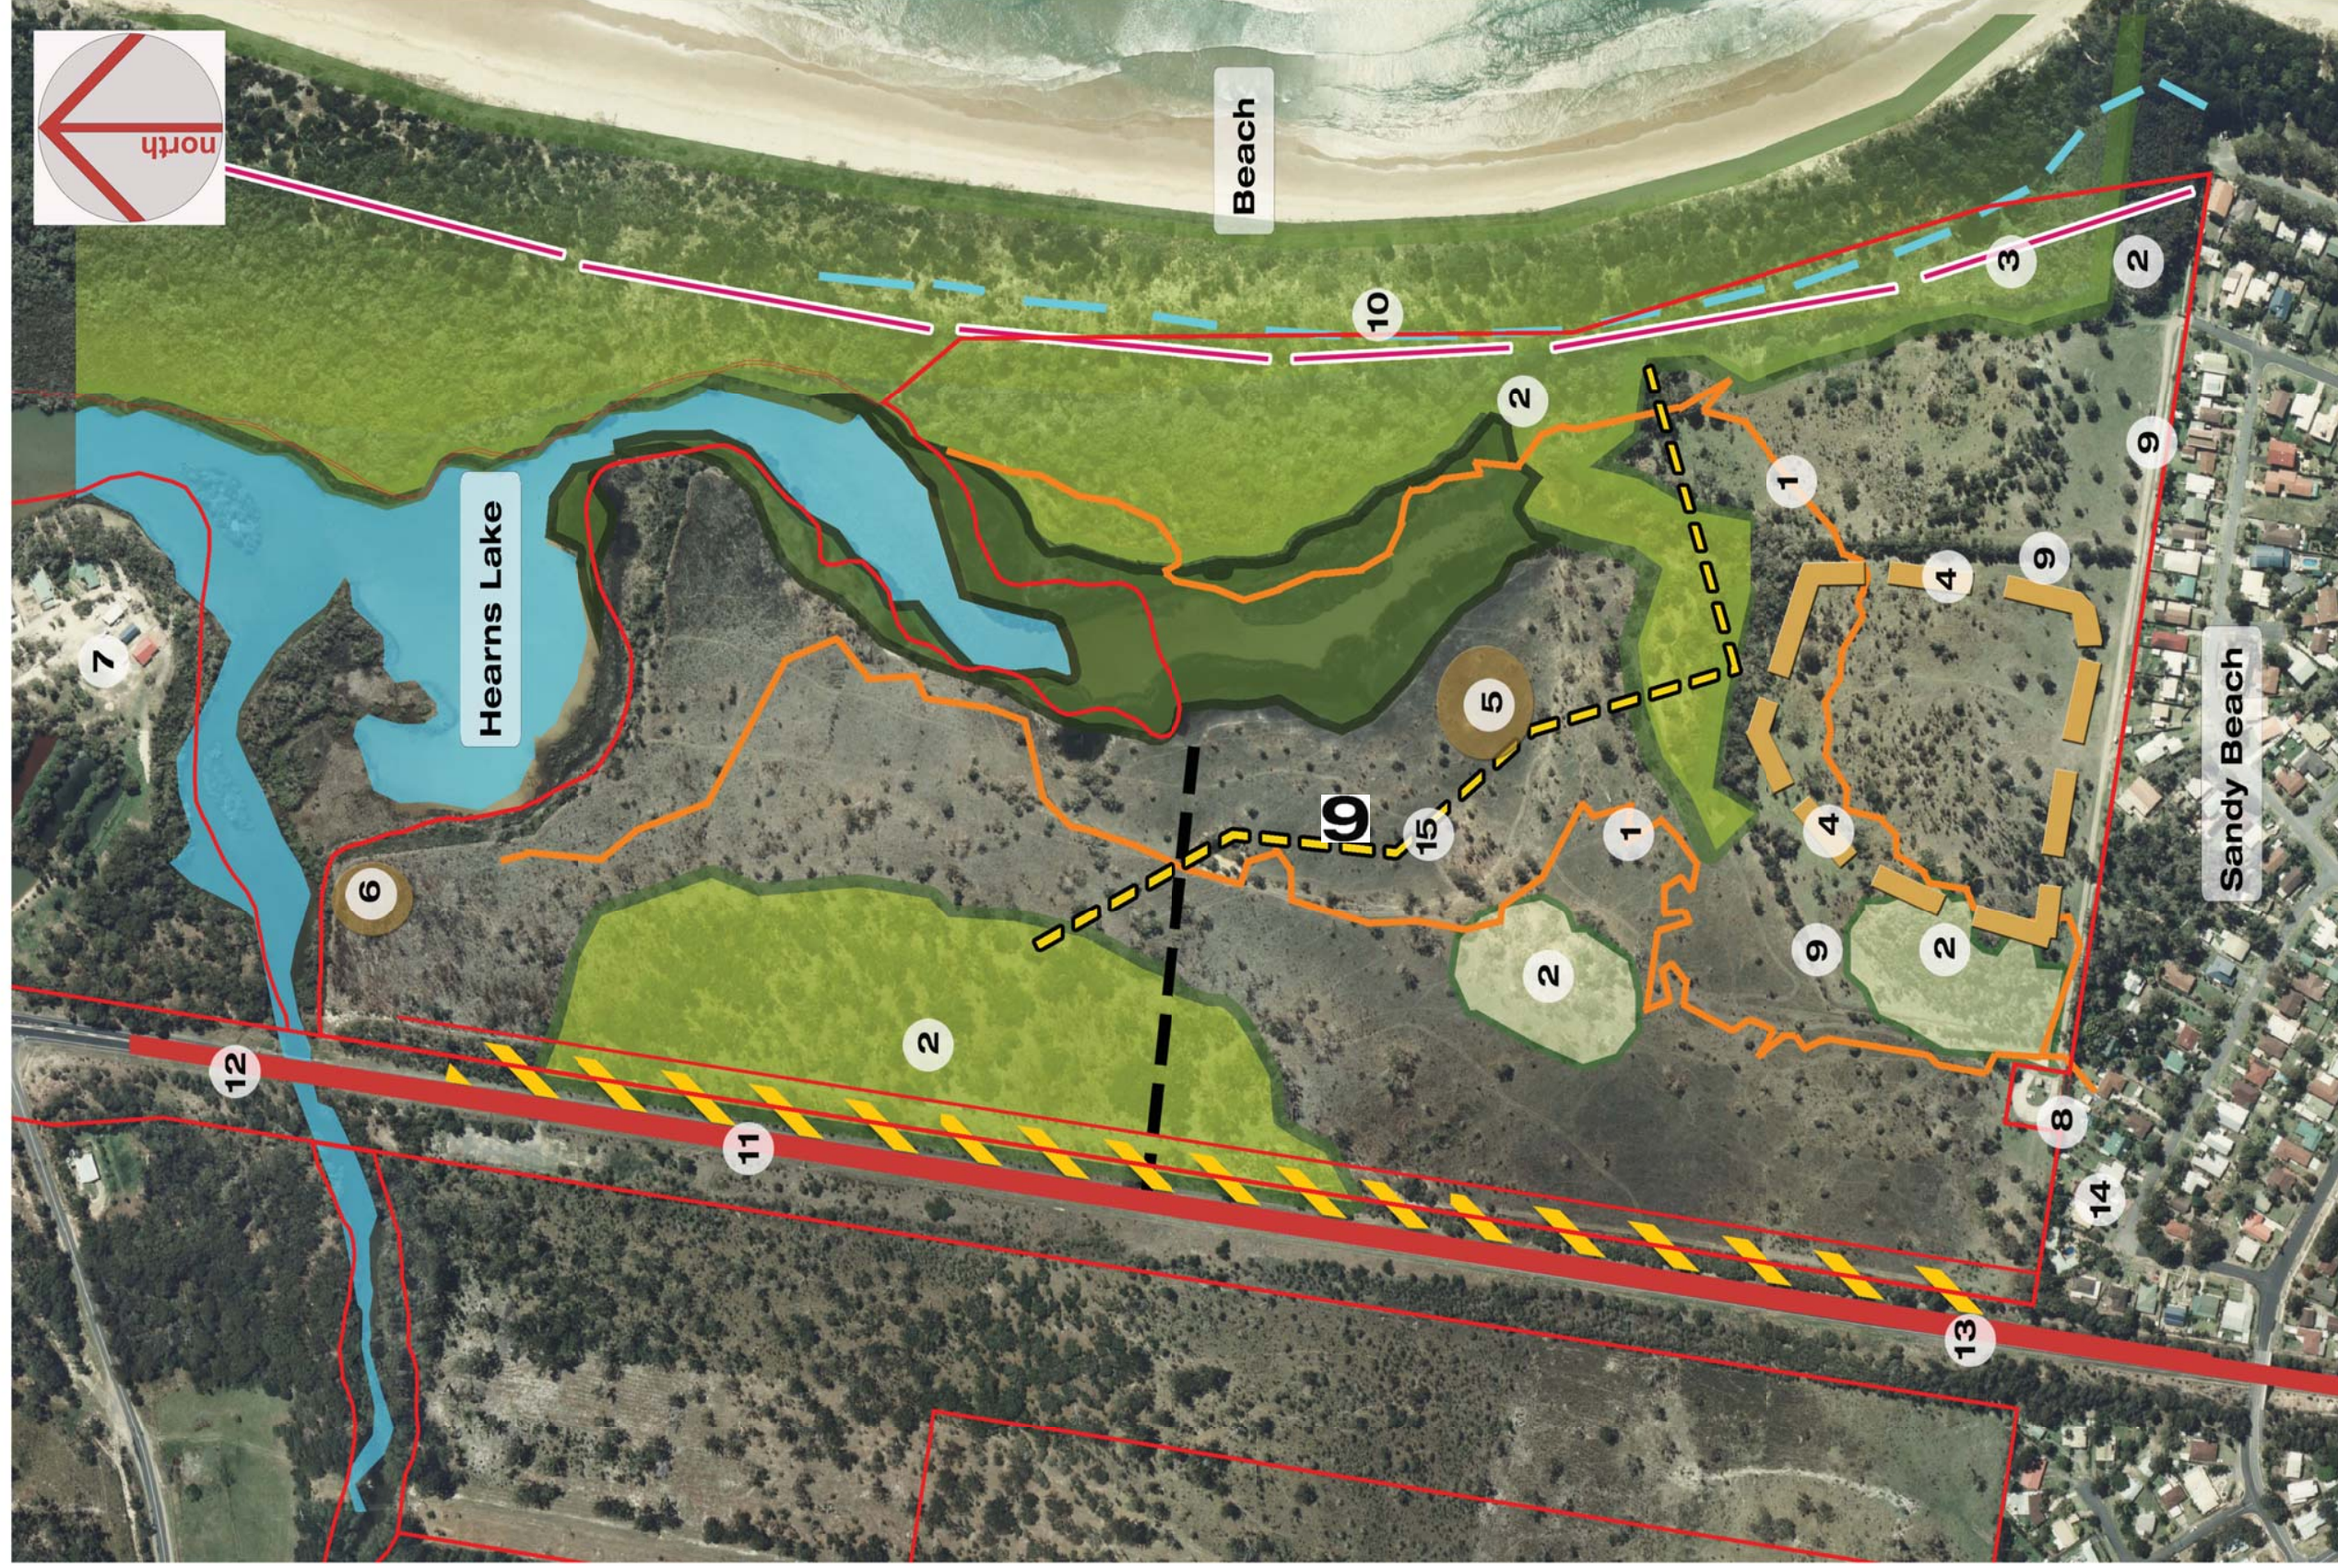
Appendix 3

1. RL 2.55 ICOL Extent
2. Existing vegetation
3. Coastal Hazard Line
4. Aboriginal Site - PAD1
5. Aboriginal Site - SBN1
6. Aboriginal Site - ISF2
7. Caravan Park

Site Analysis
