BLUEGRASS NOMINEES
PROPOSED SUBDIVISION DEVELOPMENT
Hearns Lake, Sandy Beach
PRELIMINARY GEOTECHNICAL ASSESSMENT

CH1132/1-AB
28 January 2004

**RE: PROPOSED SUBDIVISION DEVELOPMENT – HEARNS LAKE, SANDY BEACH
PRELIMINARY GEOTECHNICAL ASSESSMENT**

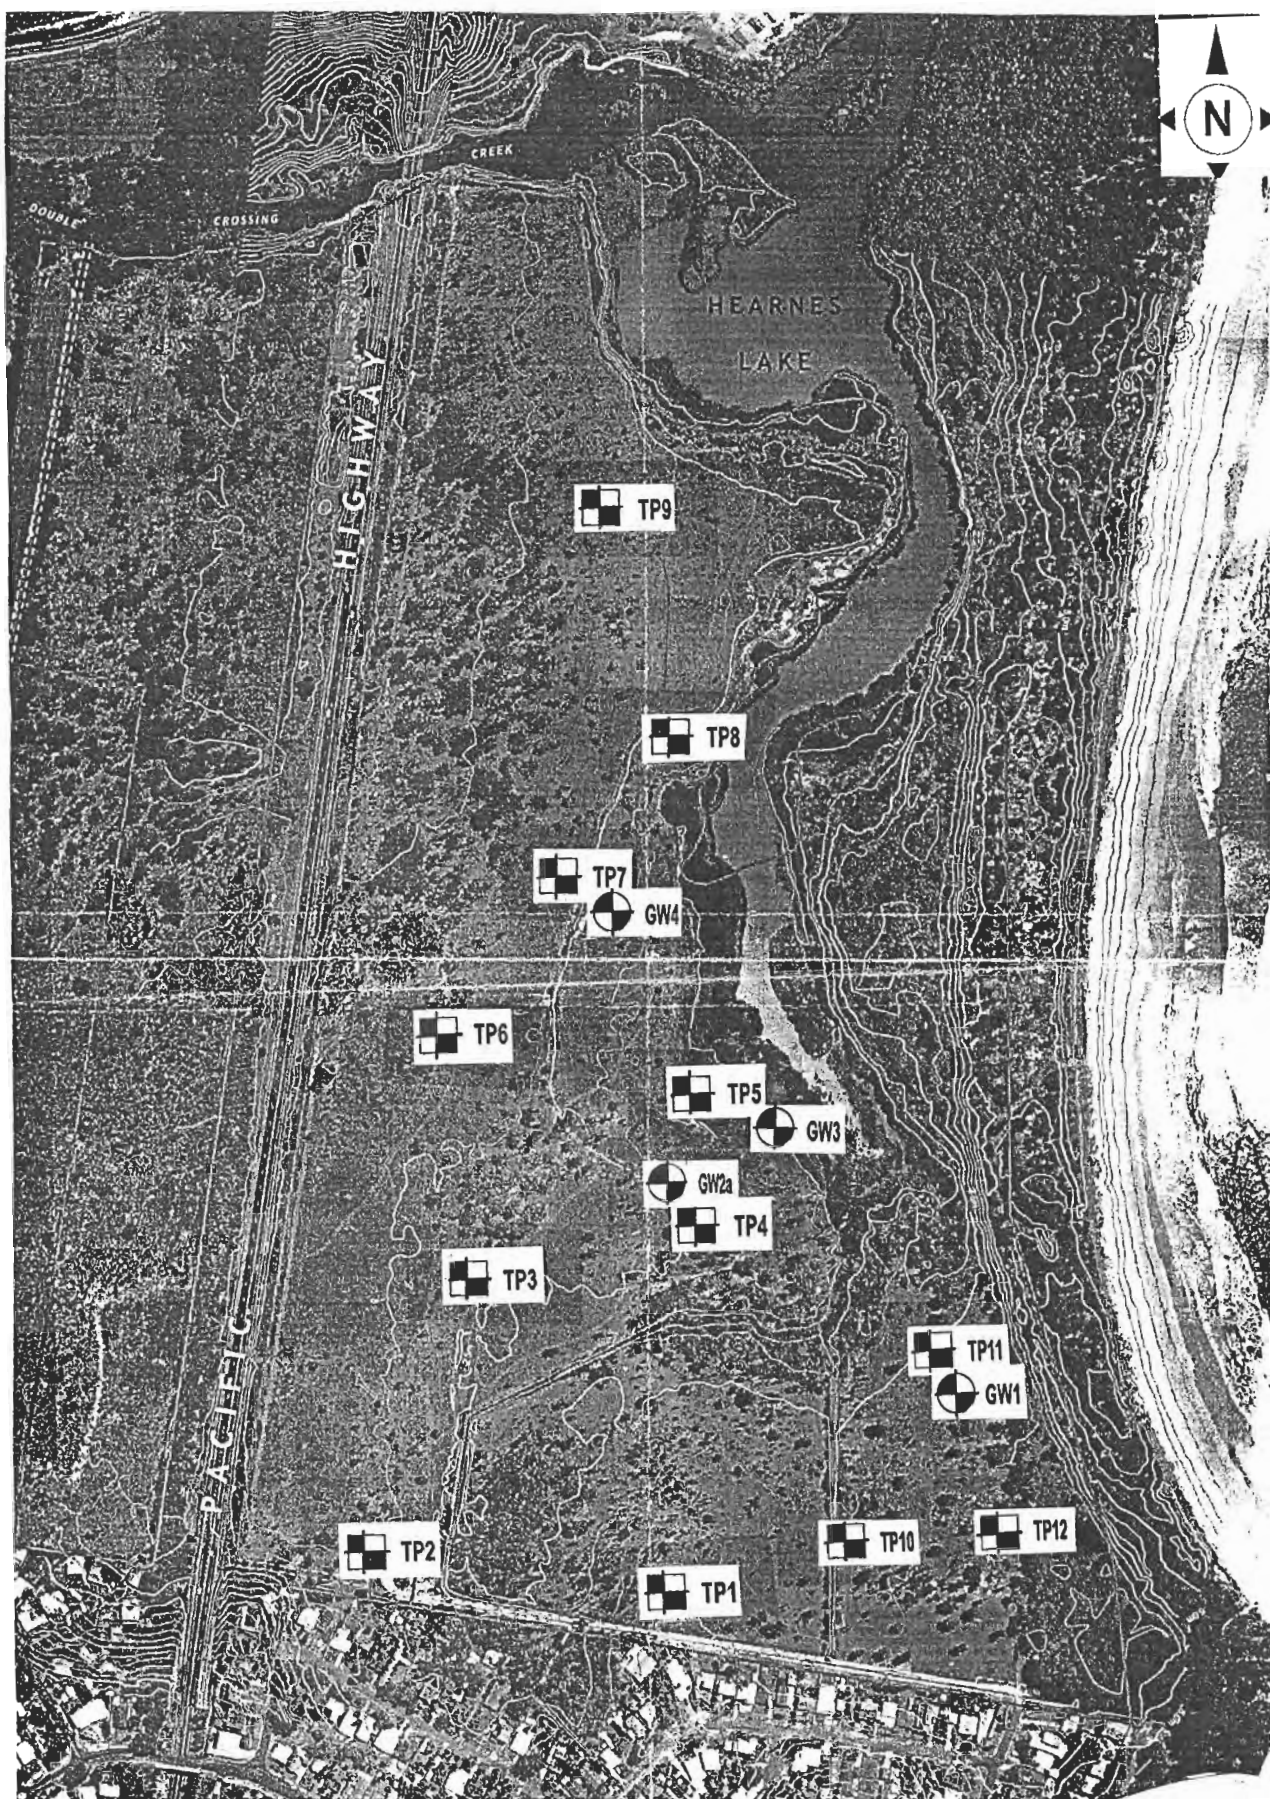
Figure 1 Site Plan

The test pits/boreholes were excavated/drilled in the full time presence of a geotechnical engineer from Coffey who located the pits/boreholes, took samples and produced engineering logs of the subsurface conditions encountered. The engineering logs are presented in Appendix A, together with explanation sheets defining the terms and symbols used in their preparation. Test pit and borehole locations are shown on Figure 1.

Coffey Geosciences Pty Ltd ASQ 106 205 515		Geotechnical Resources Environmental Technical Project Management	
Drawn	DJB	LOCALPLAN PTY LTD PROPOSED DEVELOPMENT HEARNES LAKE SANDY BEACH TEST PIT LOCATION PLAN	Drawing no:
Approved			FIGURE 1
Date	30/1/04		Job no: CH1132/1-AB
Scale	1:4000
