## Addendum – Crudine Ridge Wind Farm, Part 3A Ecological Assessment

Alternate access - Aarons Pass Road, and north site access point

Prepared for  
**Wind Prospect CWP**

14 November 2013

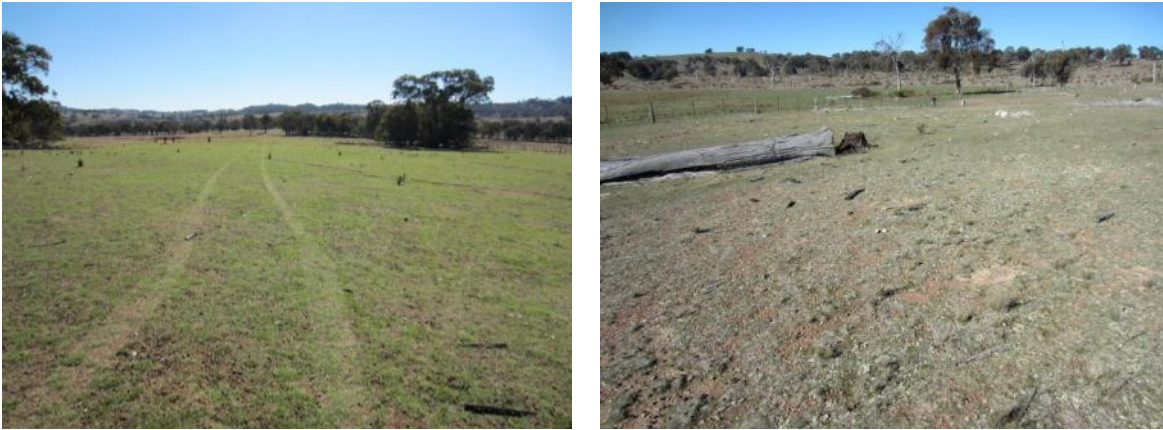
Figure 5: Photos of northern alternative site access point

Vegetation of the site is characterized by native and exotic pasture grasses. Scattered paddock trees are dominated by *Eucalyptus macrorrhyncha* (Red Stringybark) with adjacent woodland patches dominated by *Eucalyptus polyanthemos* subsp. *polyanthemos* (Red Box) and *Eucalyptus mannifera* subsp. *mannifera* over an exotic dominated understorey.

**Site Condition:** Biometric – Moderate to good - good.

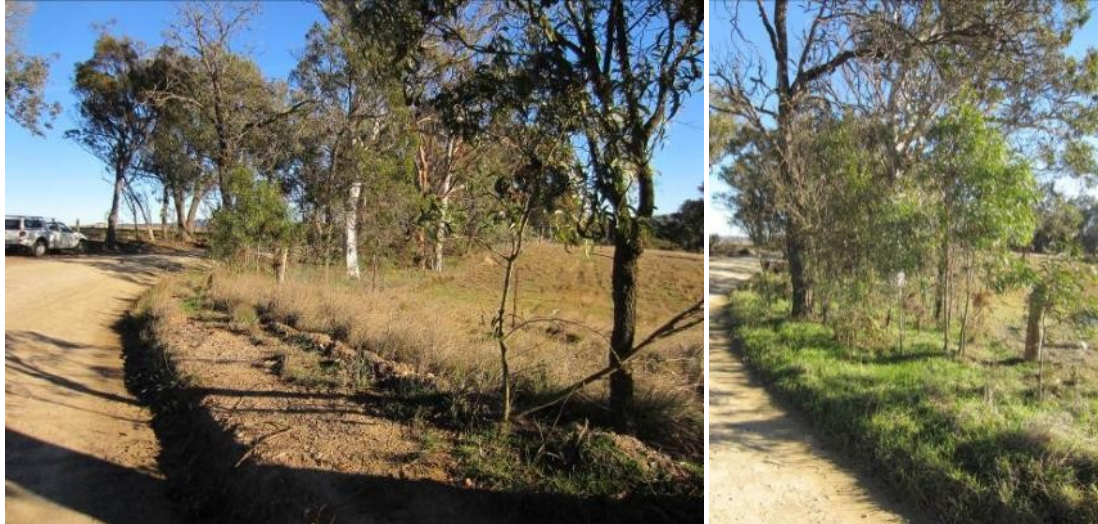
### Site ID: 1.0 km Road works

**Site condition:** Biometric Moderate to good - poor  
Mid-Western Regional Council – Modified

**Proposed works:** Remove two trees on RHS and level corner on both sides (Downer 2013).

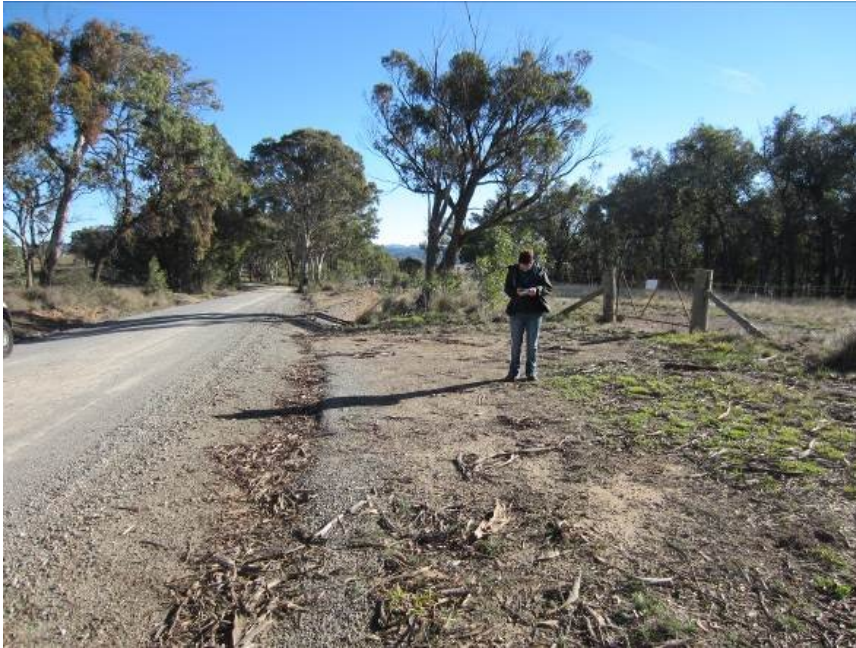
## Site ID: Passing Bay 02

**Proposed works:** Potential passing bay – RHS.

**Site condition:** Biometric – Low  
Mid-Western Regional Council – Degraded

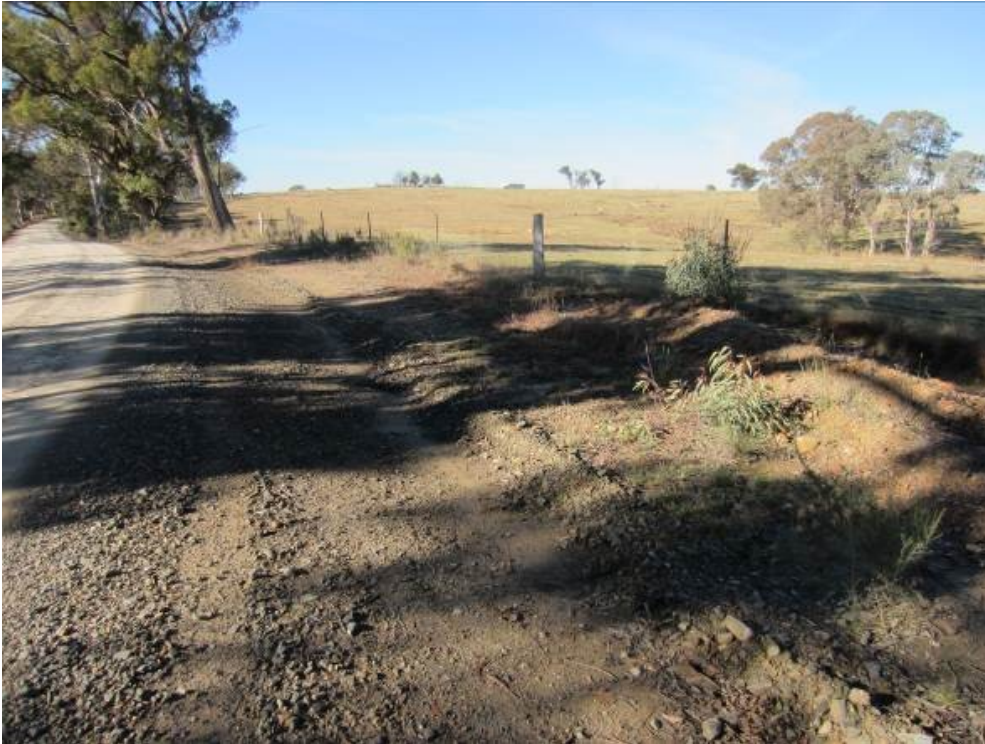
**Site ID: Passing Bay 03**

Site requires earthworks to level an area suitable for a passing bay. These works will remove shrubs and groundcover species as noted above. No impact to adjacent tree roots, but presence of drainage swale needs consideration.

**Proposed works:** Potential passing bay - RHS.

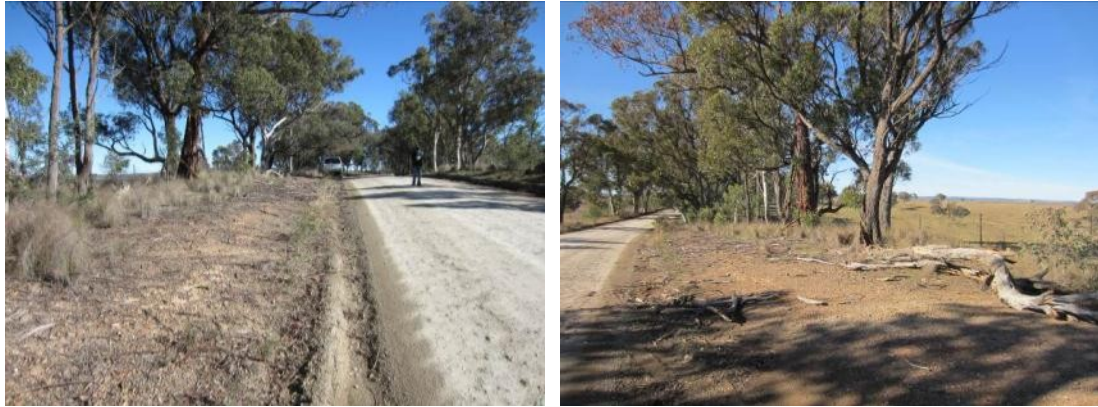
## Site ID: Passing Bay 04

**Site condition:** Biometric – Moderate to good - good  
Mid-Western Regional Council – Modified

Site requires earthworks to level an area suitable for a passing bay. These works will remove a few tussocks of *Joycea pallida* and some woody debris and litter. No impact to adjacent tree roots is considered.

**Proposed works:** Potential passing bay - LHS

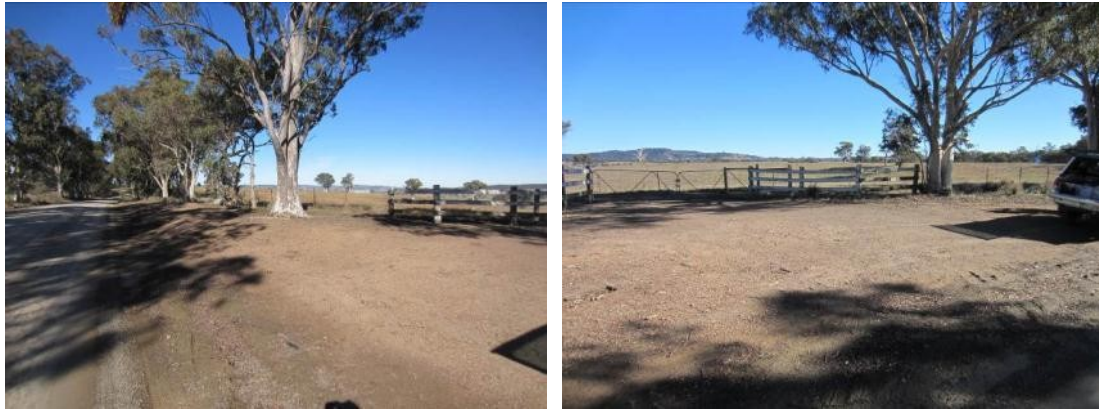
## Site ID: Passing Bay 05

**Proposed works:** Potential passing bay - LHS.

Adjacent vegetation comprises woodland of Narrow-leaved Stringy Bark (*Eucalyptus tenella*) and Scribbly Gum (*Eucalyptus rossii*) and Red Box (*Eucalyptus polyanthemos* subsp. *polyanthemos*) over a grassy understorey dominated by native species including *Joycea pallida*, *Rytidosperma caespitosum*, *Aristida ramosa*, *Austrostipa densiflora* and *Lomandra filiformis* subsp. *coriacea*.

**Site condition:** Biometric – Low  
Mid-Western Regional Council – Degraded

- Minimize impact to adjacent trees
- Install erosion and sediment control measures during construction.

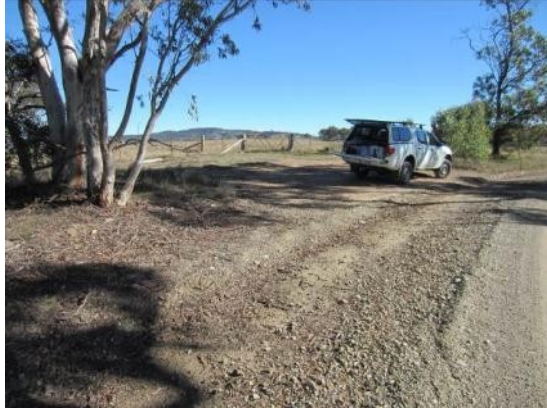
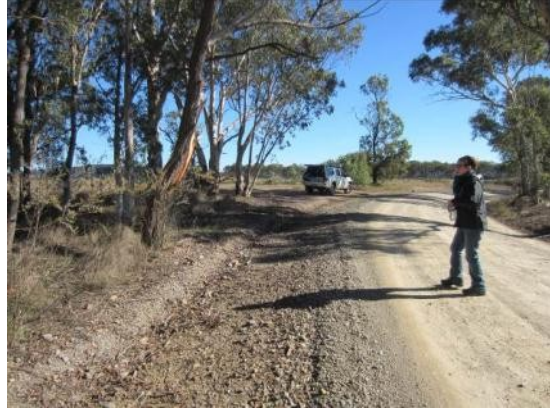
**Site ID: 2.5 km road works**

**Proposed works:** Fill and cut to widen on LHS required (Downer 2013).

Adjacent vegetation comprises woodland of Narrow-leaved Stringy Bark (*Eucalyptus tenella*) and Scribbly Gum (*Eucalyptus rossii*), over a grassy understorey dominated by native species including *Joycea pallida*, *Rytidosperma caespitosum*, *Aristida ramosa*, *Austrostipa densiflora* and *Lomandra filiformis* subsp. *coriacea*.

**Site condition:** Biometric – Moderate to good - good  
Mid-Western Regional Council – Modified

- Avoid and /or minimize impact to adjacent trees.
- Install erosion and sediment control measures during construction.

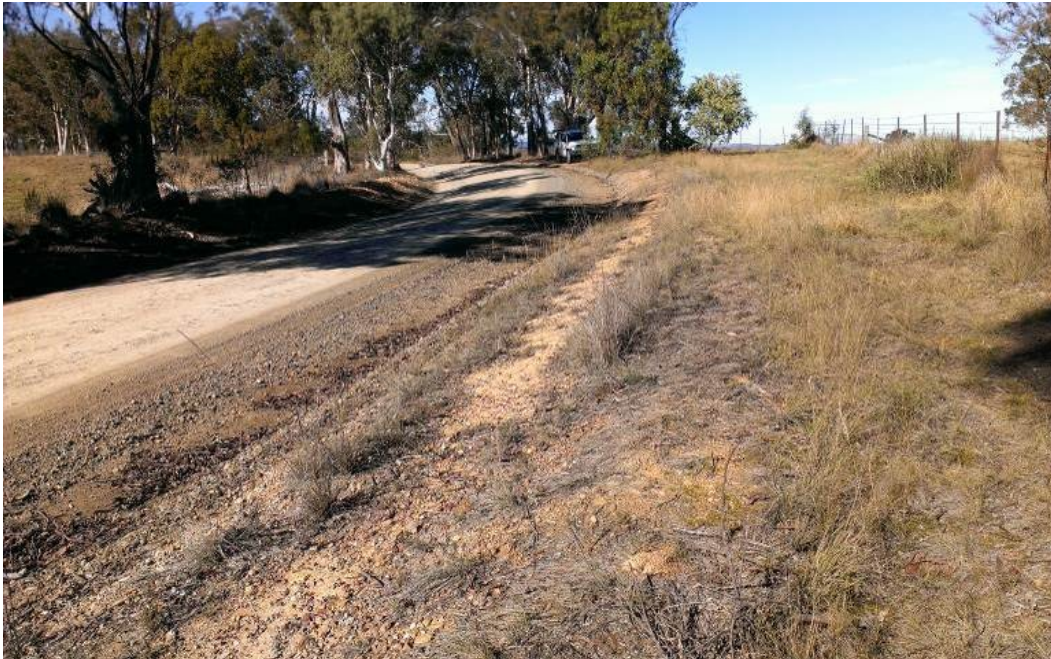
**Site ID: Passing Bay 06**

**Proposed works:** Potential passing bay – LHS

**Site condition:** Biometric – Moderate to good - good  
Mid-Western Regional Council – Modified

- Avoid and /or minimize impact to adjacent trees.
- Site requires leveling and removal of soil - install erosion and sediment control measures during construction.
- Avoid stockpiling soils material on adjacent vegetation.

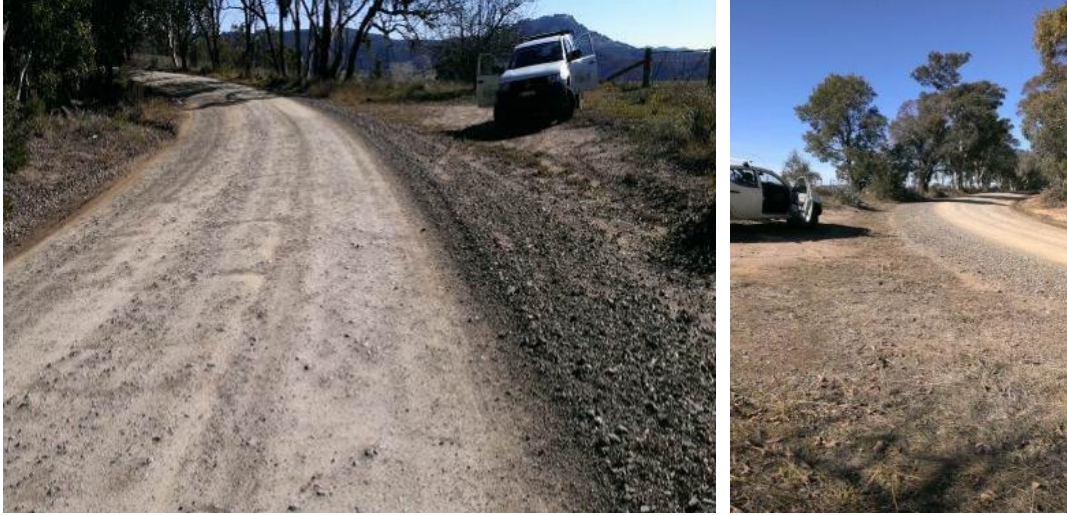
**Site ID: Passing Bay 07**

**Proposed works:** Potential passing bay – RHS.

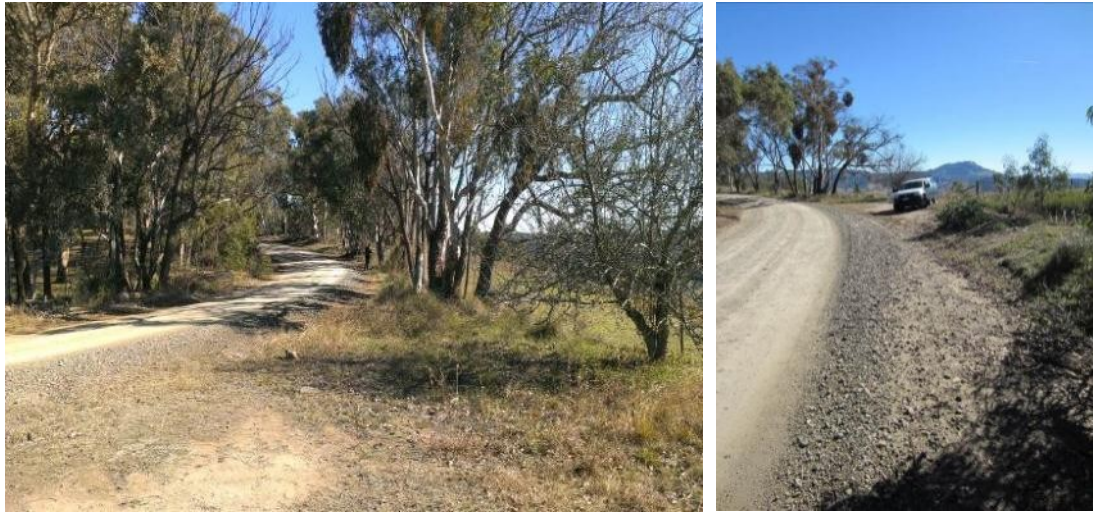
**Site ID: 2.8km road works**

**Site condition:** Biometric – Moderate to good - good  
Mid-Western Regional Council - Modified

**Proposed works:** Fill and level on outside of corner (Downer 2013).

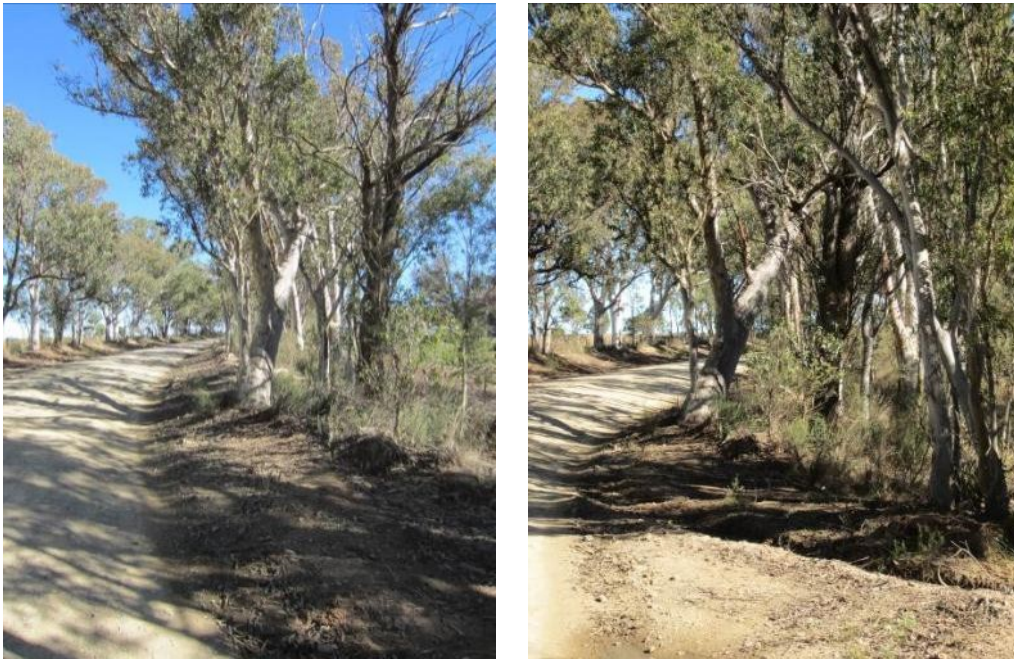
**Site ID: 3.0 km Road works**

**Site condition:** Biometric – Moderate to good - good  
Mid-Western Regional Council – Modified

**Proposed works:** Remove approximately two trees on right and level corner (Downer 2013).

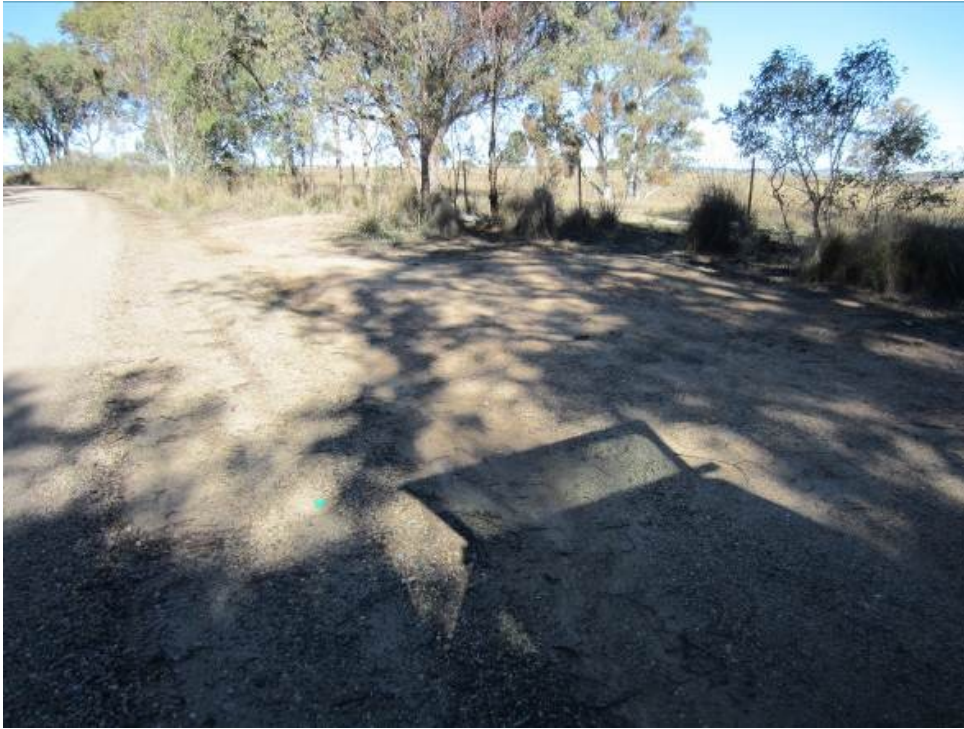
**Site ID: Passing Bay 08**

**Proposed works:** Development of passing bay - LHS.

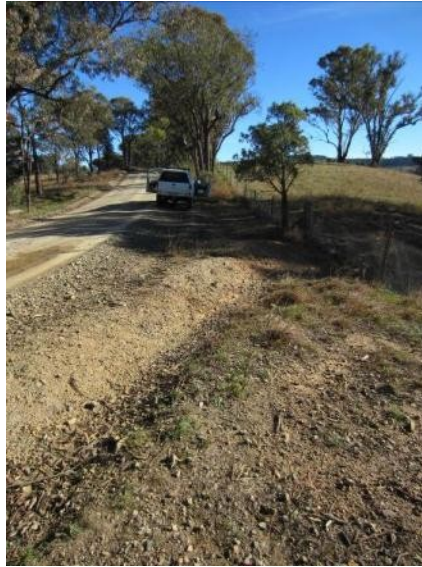
**Site ID: Passing Bay 11**

**Proposed works:** Development of passing bay – RHS

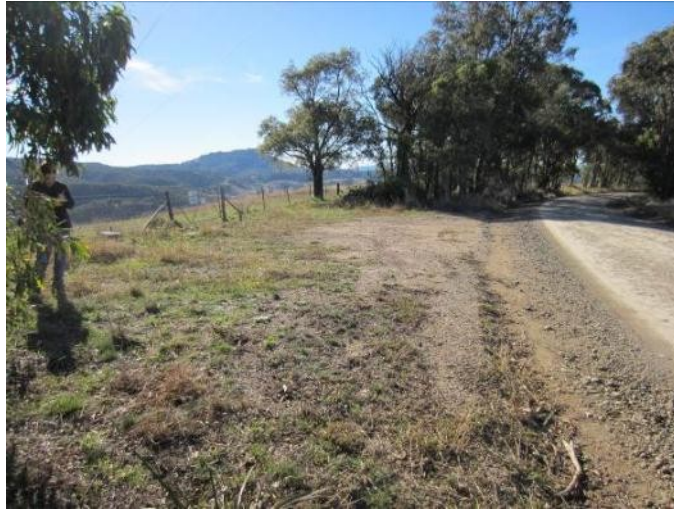
**Site ID: Passing Bay 12**

**Proposed works:** Development of passing bay - RHS

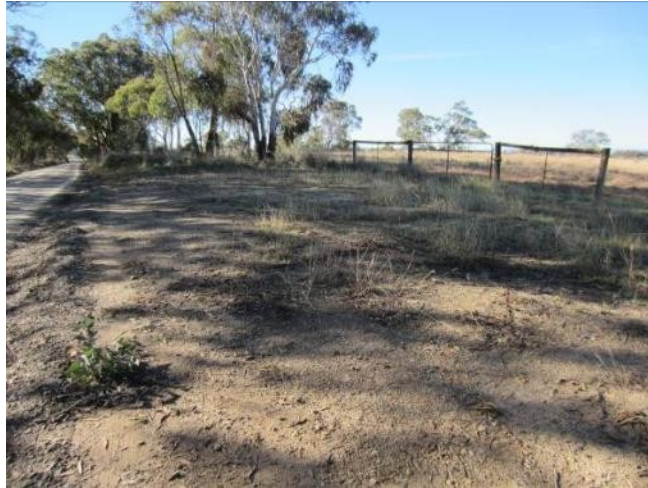
**Site ID: Passing Bay 13**

**Proposed works:** Development of passing bay - LHS

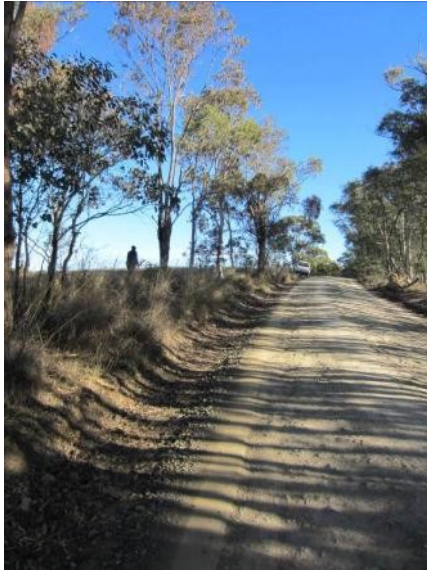
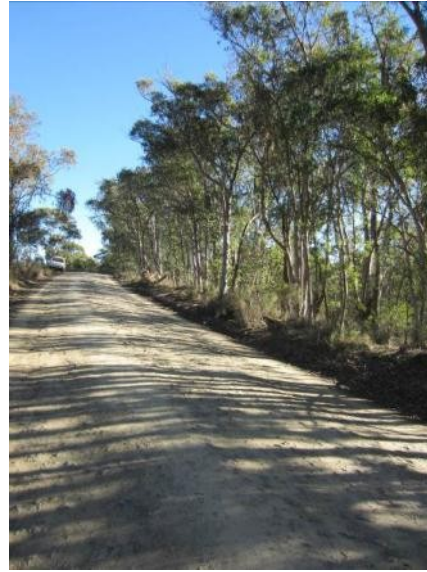
**Site ID: 5.3 km Road works - crest**

**Site condition:** Biometric – Moderate to good - good  
Mid-Western Regional Council – Near natural.

**Proposed works:** Crest of hill needs to suit vertical curve of R 200 (Downer 2013).

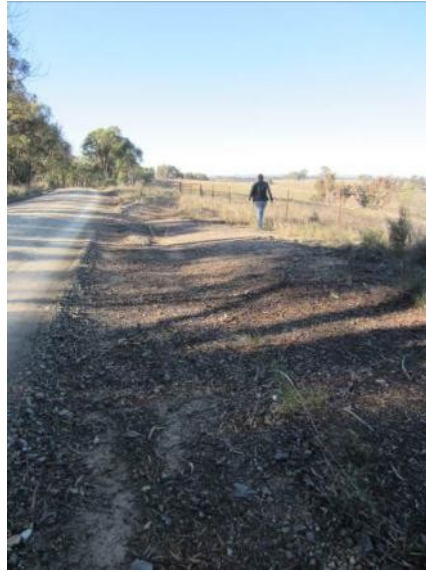
**Site ID: Passing Bay 14**

**Proposed works:** Development of a passing bay - LHS

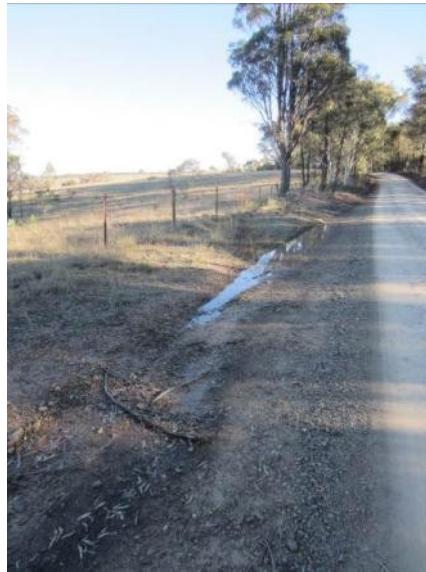
**Site ID: Passing Bay 15**

**Proposed works:** Development of a passing bay - LHS

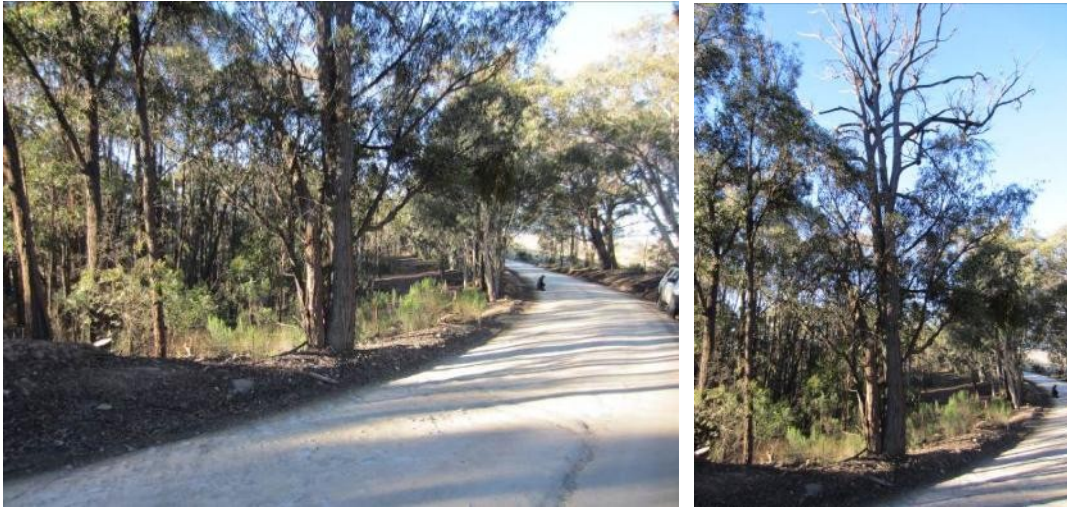
**Site ID: 6.6 km Road works**

**Site condition:** Biometric – Moderate to good - good  
Mid-Western Regional Council – Modified.

**Proposed works:** Remove approximately five trees and fill in and level inside corner. Fence post needs to be moved approximately one to two meters (Downer 2013).

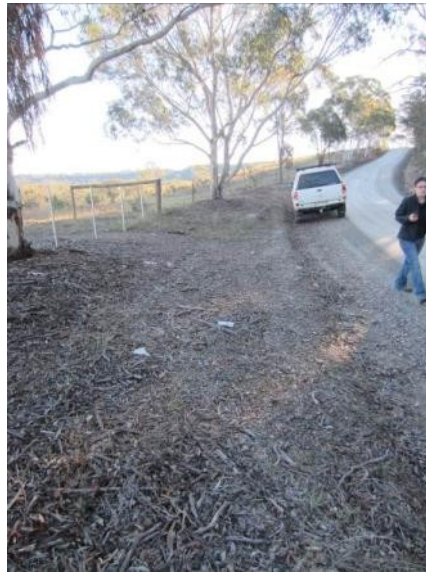
**Site ID: Passing Bay 16**

**Proposed works:** Development of a passing bay - LHS

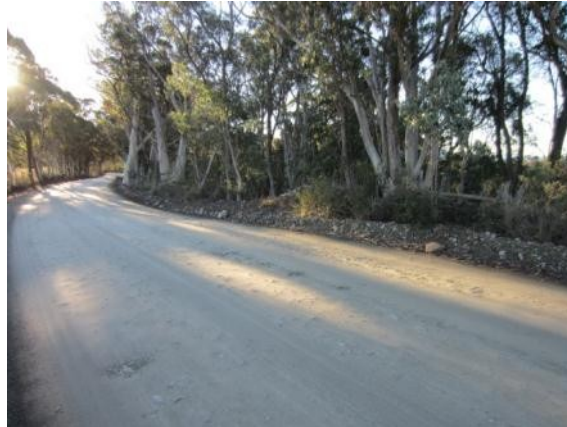
**Site ID: 6.9 km Road works**

Incline and decline of hill to suit maximum grade 15% crest to suit vertical curve of R 200. (Downer 2013).

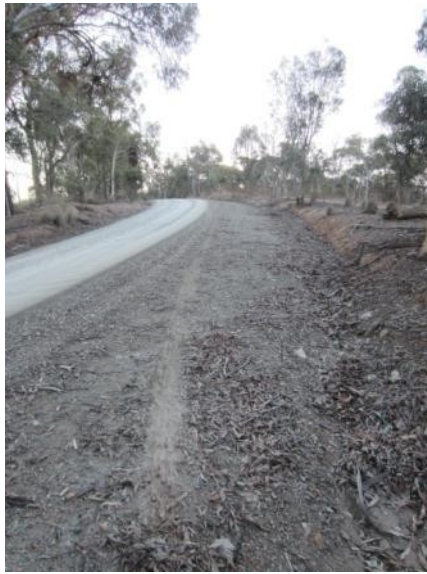
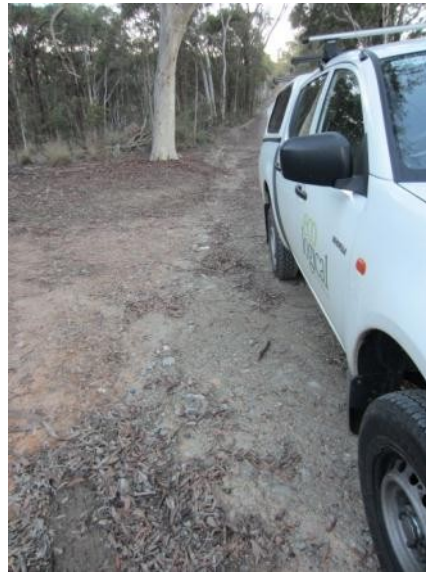
**Site ID: 7.3 km Road works**

**Site condition:** Biometric – Moderate to good - good  
Mid-Western Regional Council – Modified.

Fill in RHS corner to edge of vegetation (Downer 2013).

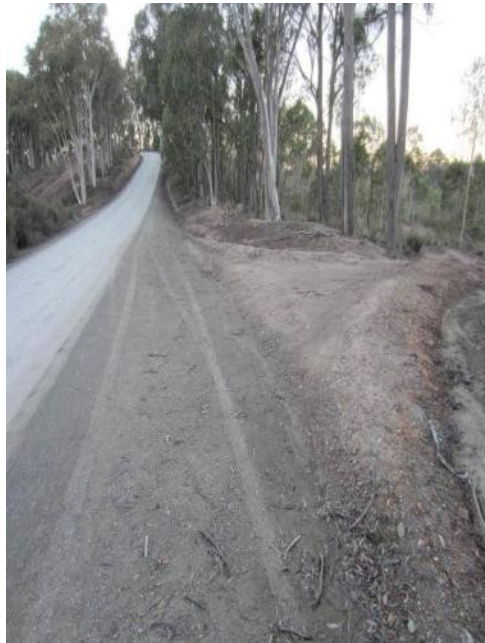
**Site ID: Passing Bay 18**

**Proposed works:** Development of a passing bay - LHS

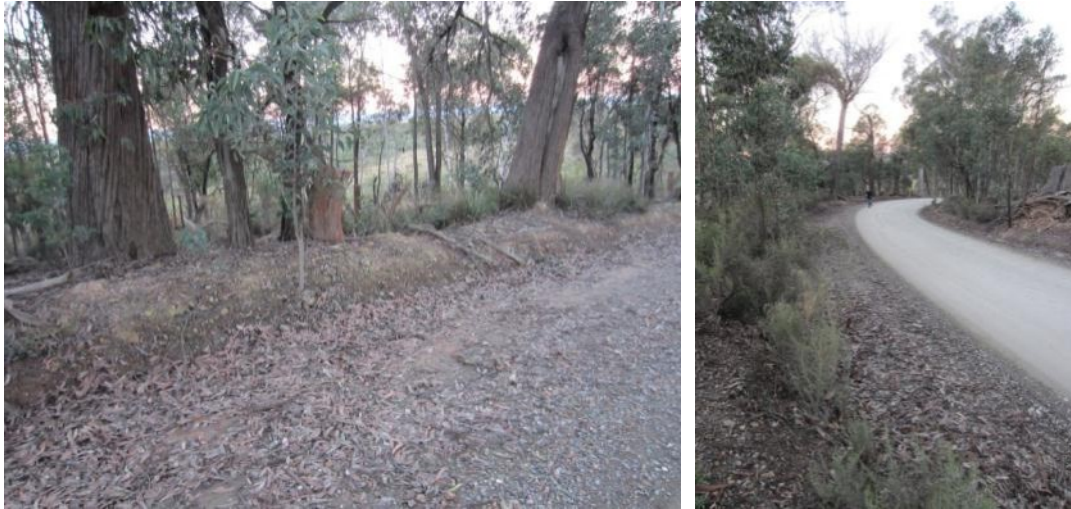
## Site ID: 7.7 km Road works

**Site condition:** Biometric – Moderate to good - good  
Mid-Western Regional Council – Near natural to modified.

Fill in RHS of corner and level camber (Downer 2013).

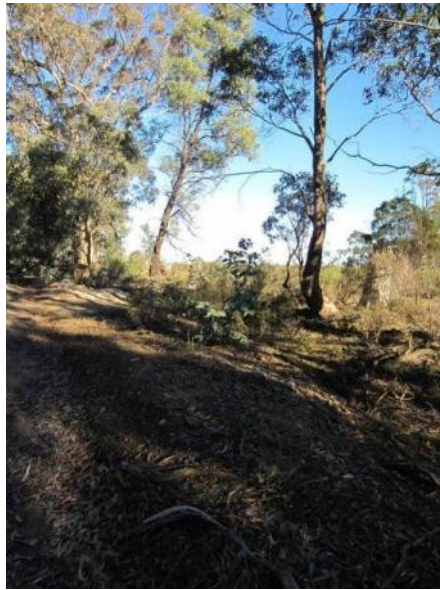
**Site ID: Passing Bay 19**

**Proposed works:** Development of a passing bay - RHS

**Comments:** Small and narrow site requiring some levelling and fill.

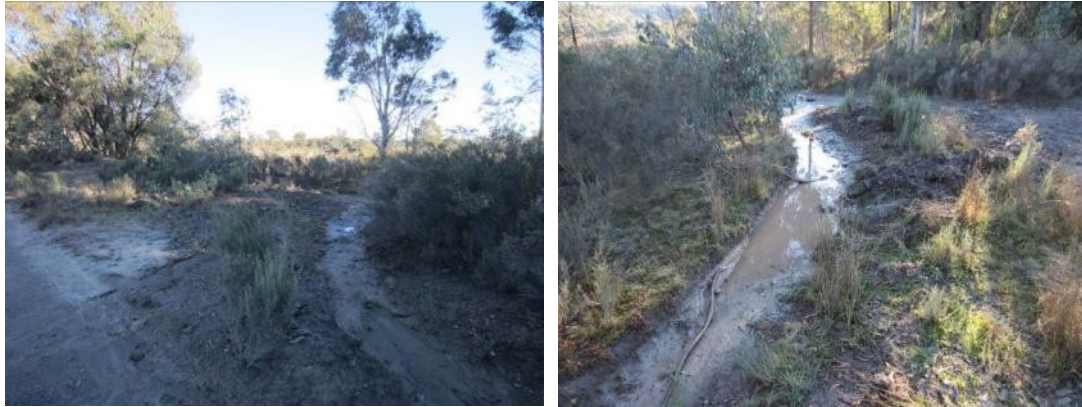
## Site ID: Passing Bay 20

**Proposed works:** Development of a passing bay - RHS

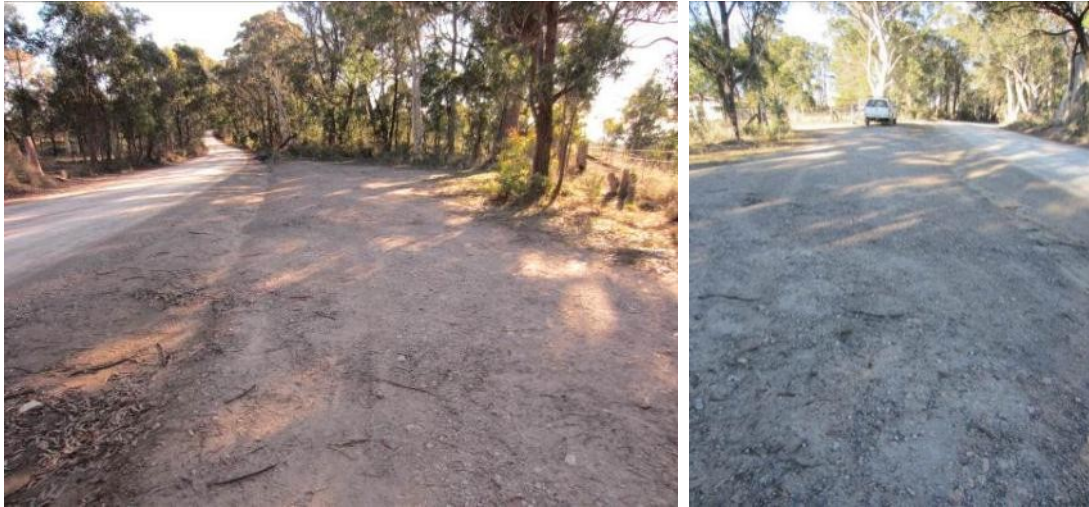
**Site ID: Passing Bay 21**

**Proposed works:** Development of a passing bay – RHS.

**Comments:** Minor levelling required. Site considered good for a passing bay as minimal impacts to surrounding vegetation.

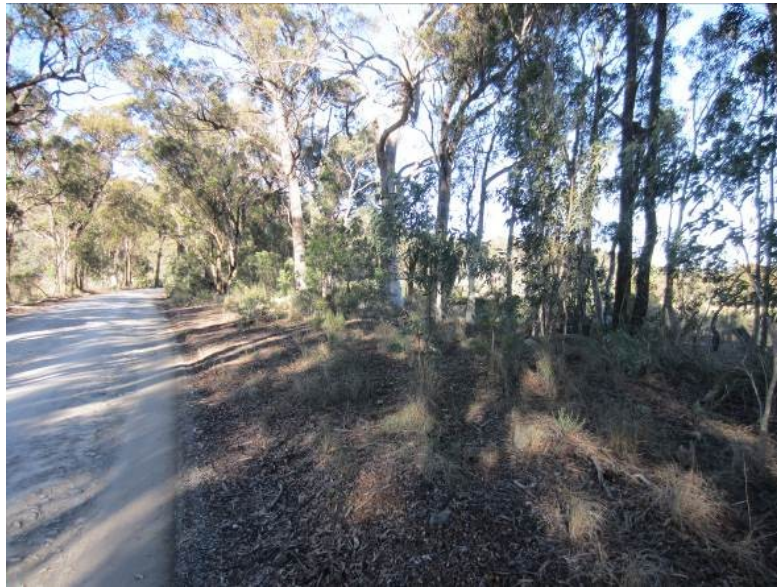
**Site ID: Passing Bay 22**

**Proposed works:** Development of a passing bay – LHS.

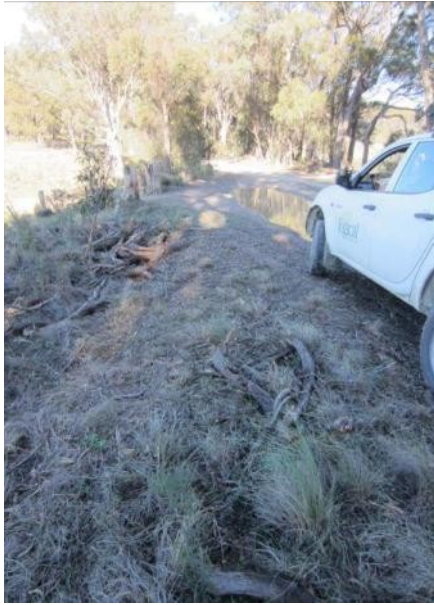
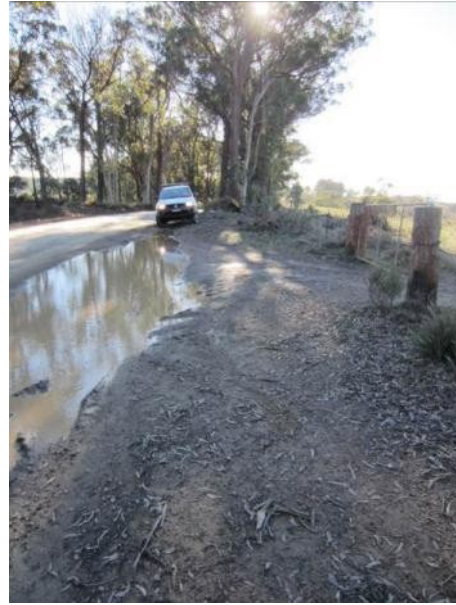
**Site ID: Passing Bay 23**

**Proposed works:** Development of a passing bay – LHS.

**Comments:** - Road verge on left hand side to be widened and would include the removal of several *Cassinia arcuata* regrowth.

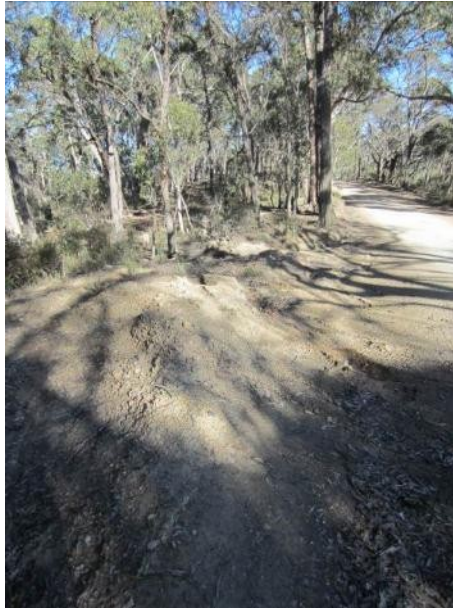
**Site ID: Passing Bay 24**

**Proposed works:** Development of a passing bay – LHS.

**Comments:** Small site with two drainage swales.

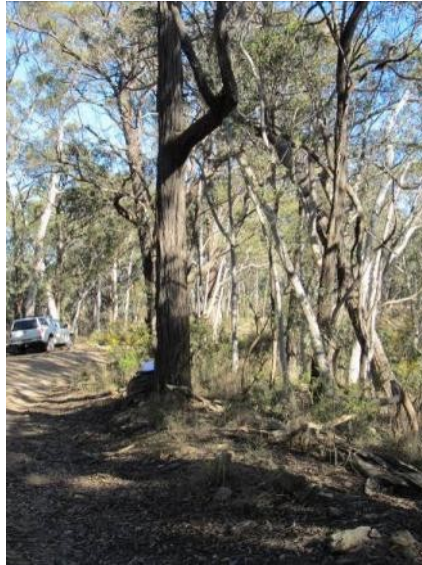
## Site ID: 12.0 km Road works

Remove trees and level RHS of corner (Downer 2013).

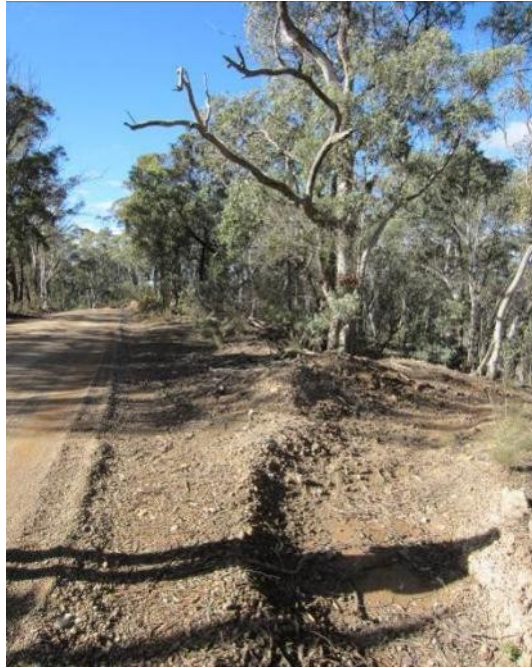
**Site ID: Passing Bay 25**

**Proposed works:** Development of a passing bay – LHS.

**Comments:** Small disturbed site with drainage swale.

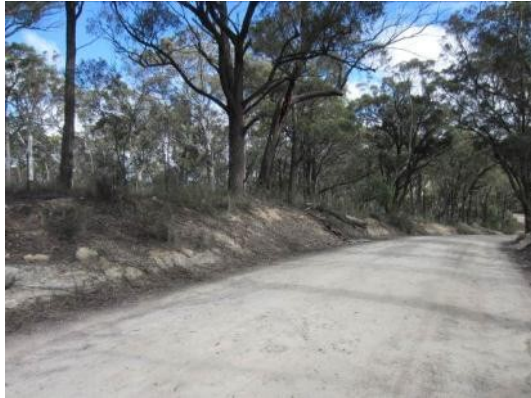
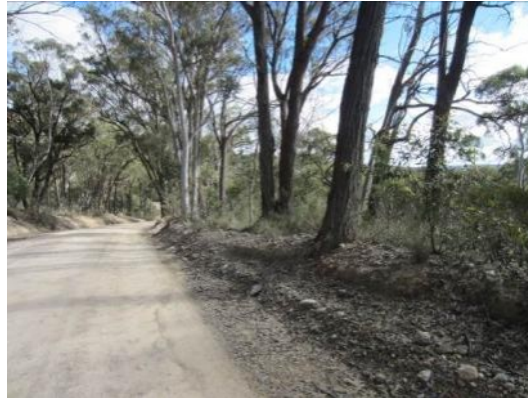
### Site ID: 12.5 km Road works

Crest to suit R 200 (Downer 2013).

**Comments:** A number of stags are present along the RHS possibly impacted by underground Telstra cabling. Some gravel piles and rubbish also present on the RHS from previous road works.

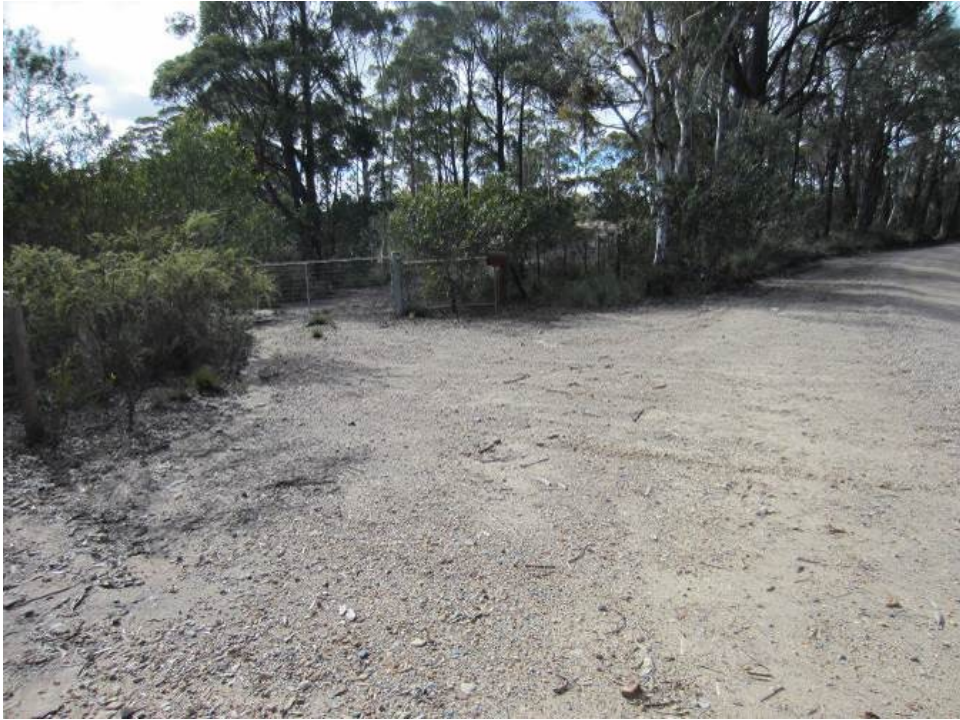
**Site ID: Passing Bay 26**

**Proposed works:** Development of a passing bay – RHS.

**Comments:** Good site with minimal vegetation cover.

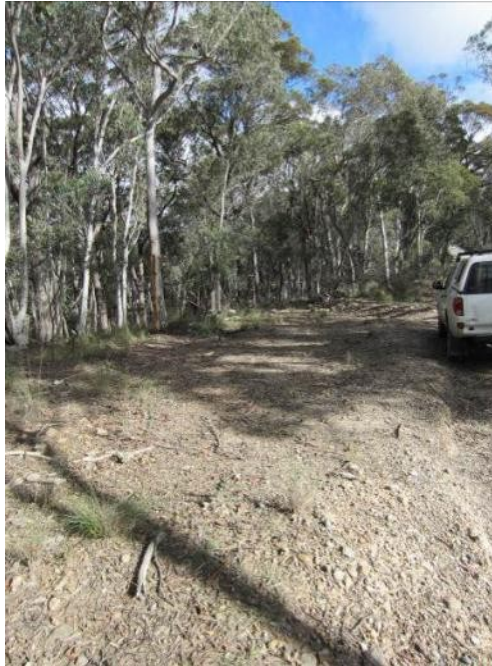
**Site ID: Passing Bay 27**

**Proposed works:** Development of a passing bay – LHS.

**Comments:** Good site with minimal vegetation cover.

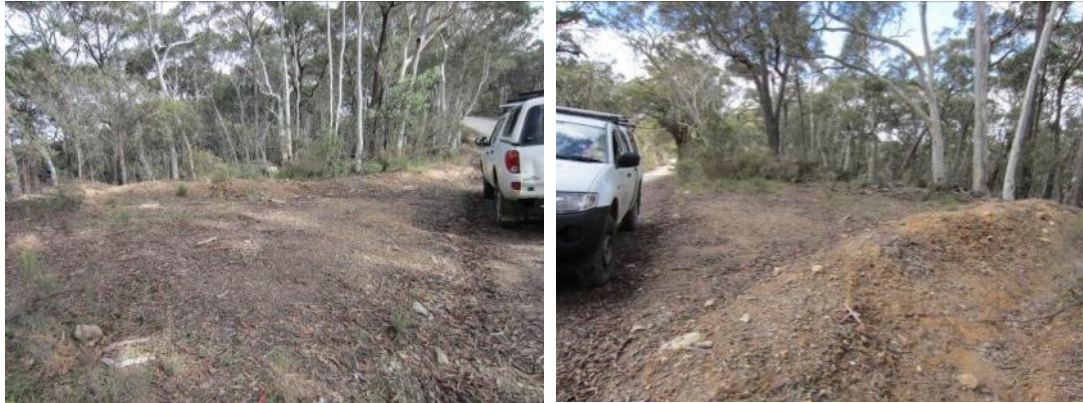
**Site ID: Passing Bay 28**

**Proposed works:** Development of a passing bay – LHS.

**Comments:** Potentially 21 trees to be removed (19 Narrow-leaved Stringybark and 2 Scribbly Gum) depending upon total impact area.

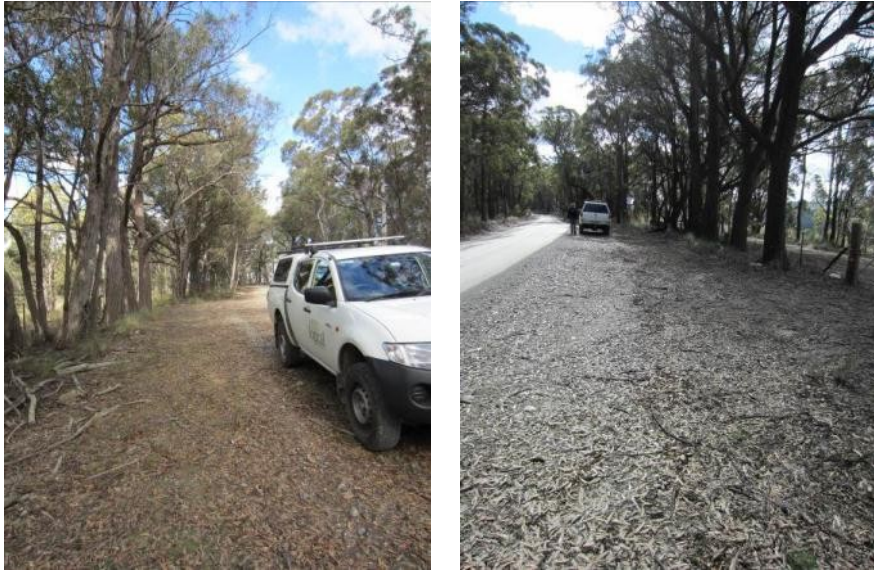
**Site ID: Passing Bay 29**

**Proposed works:** Development of a passing bay – RHS.

**Comments:** Good site requiring minimal earthworks.

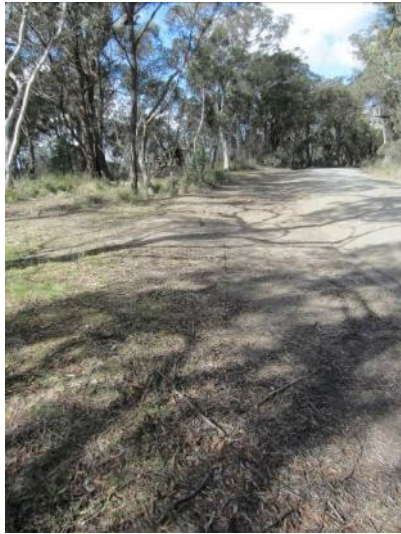
**Site ID: Passing Bay 30**

**Proposed works:** Development of a passing bay – RHS.

**Comments:** Reasonable site requiring some levelling and tree protection. Located adjacent to property entrance and home.

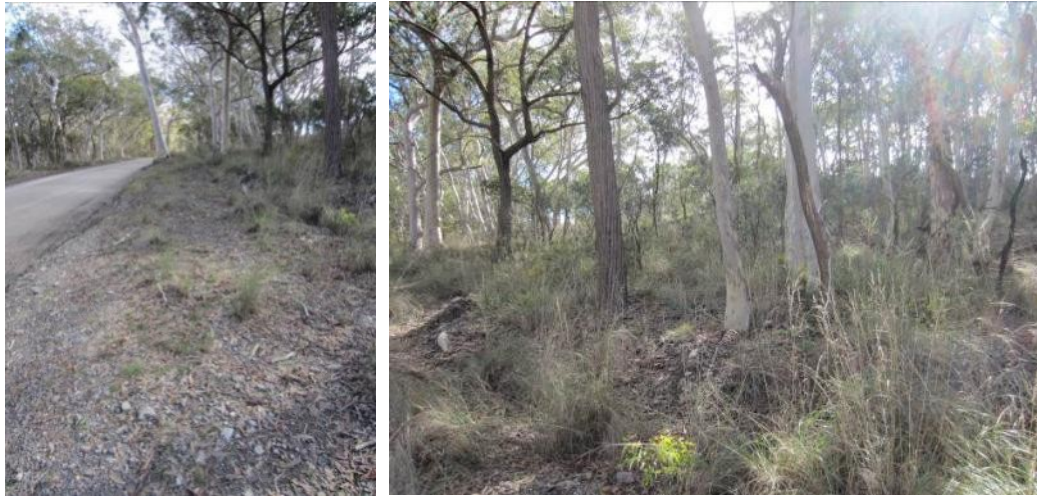
## Site ID: Passing Bay 31

**Proposed works:** Development of a passing bay – RHS.

**Comments:** This passing bay adjoins a patch of high value vegetation as recognised by Mid-Western Regional Council and currently acts as a buffer to this high value patch. The establishment of a passing bay may impact this area during earthworks, further spreading weeds. There is also a poor line of site for traffic approaching from the west.

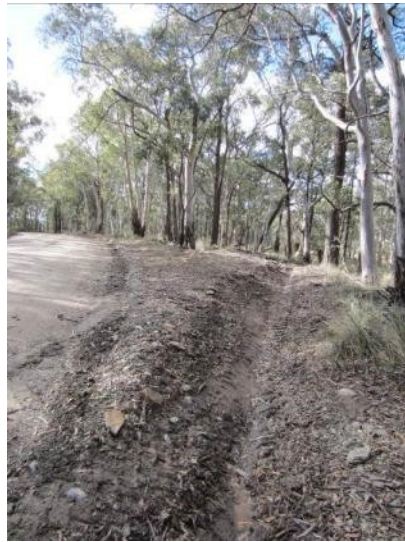
**Site ID: Passing Bay 32**

**Proposed works:** Development of a passing bay – LHS.

**Comments:** Narrow, disturbed site with evidence of previous grading and earth works associated with a drainage swale.

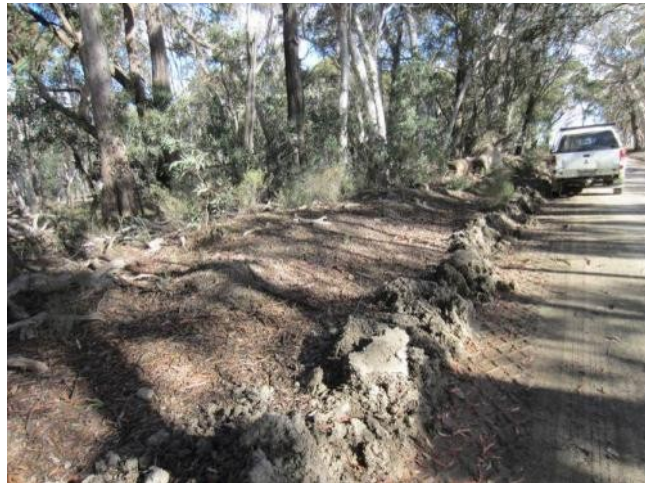
**Site ID: Passing Bay 34**

**Proposed works:** Development of a passing bay – LHS.

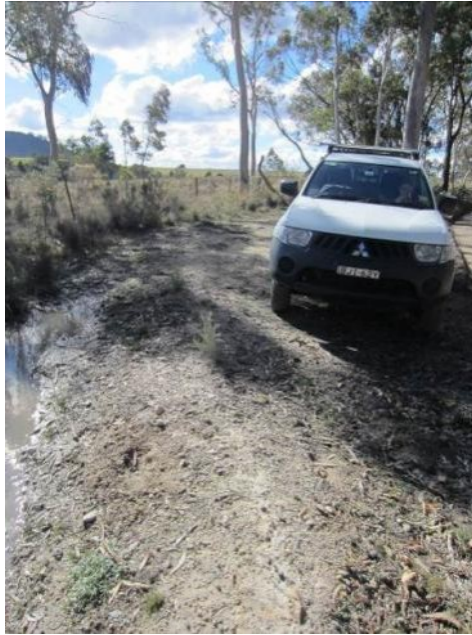
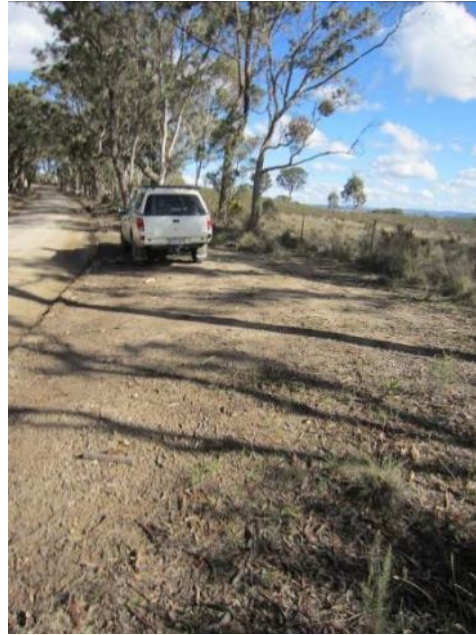
**Site ID: Passing Bay 34A**

**Proposed works:** Development of a passing bay – RHS.

**Site condition:** Biometric – Low.  
Mid-Western Regional Council – Degraded.

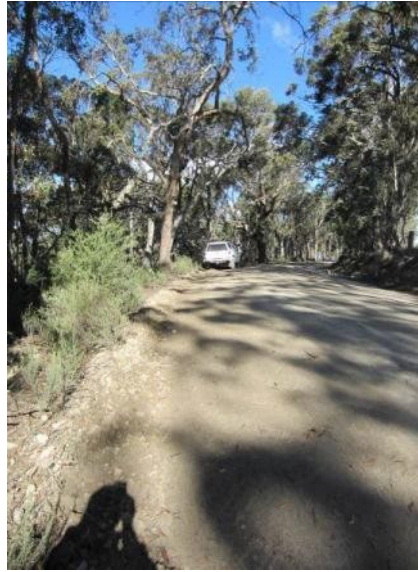
## Site ID: 15.4 km Road works

Fill and level corner (Downer 2013).

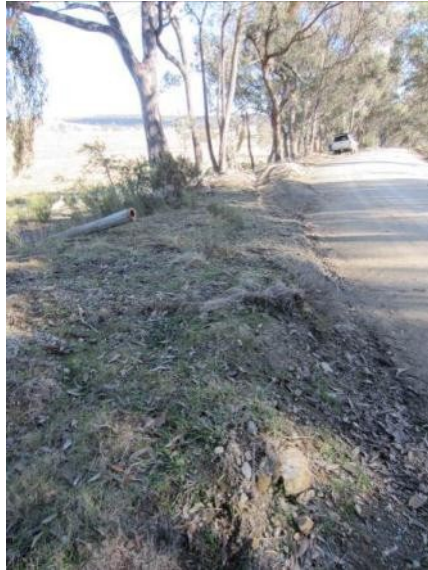
## Site ID: Passing Bay 35

Development of a passing bay – LHS.

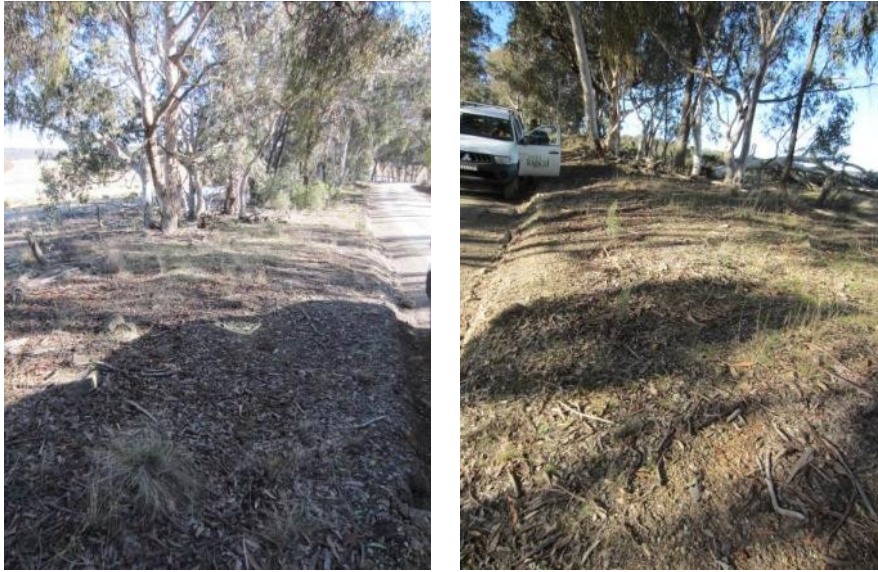
**Site ID: Passing Bay 36**

**Proposed works:** Development of a passing bay – LHS.

**Site condition:** Biometric – Moderate to good.  
Mid-Western Regional Council – Modified.

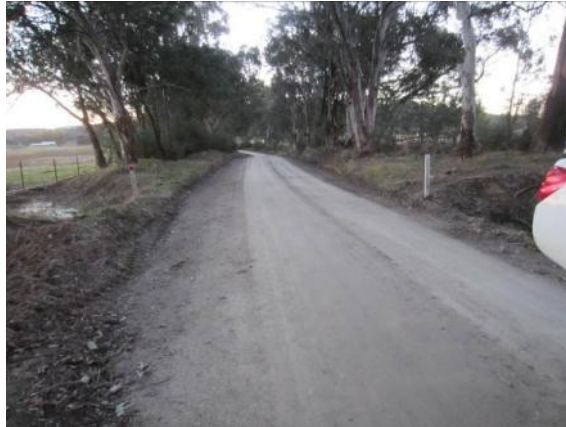
**Site ID: C1 Culvert**

**Proposed works:** Widen road at culvert.

**Site condition:** Biometric – Moderate to good – good.  
Mid-Western Regional Council – Modified.

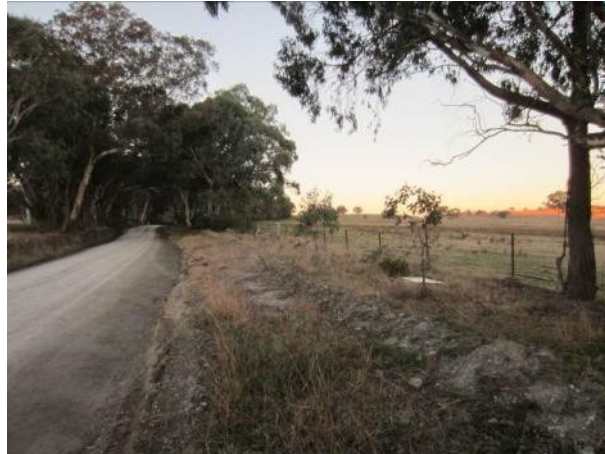
**Site ID: Passing Bay 38**

**Proposed works:** Development of a passing bay – LHS.

**Site condition:** Biometric – Moderate to good - poor  
Mid-Western Regional Council – Modified.

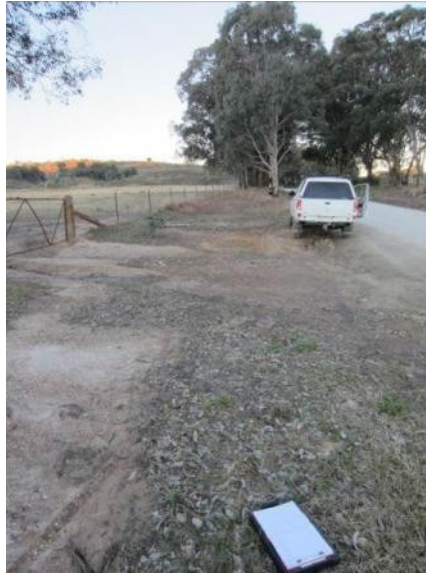
**Site ID: Passing Bay 39**

**Proposed works:** Development of a passing bay – RHS.

**Site condition:** Biometric – Low.  
Mid-Western Regional Council – Degraded.
