## Addendum – Crudine Ridge Wind Farm, Part 3A Ecological Assessment

Alternate access - Aarons Pass Road, and north site access point

Prepared for  
**Wind Prospect CWP**

14 November 2013

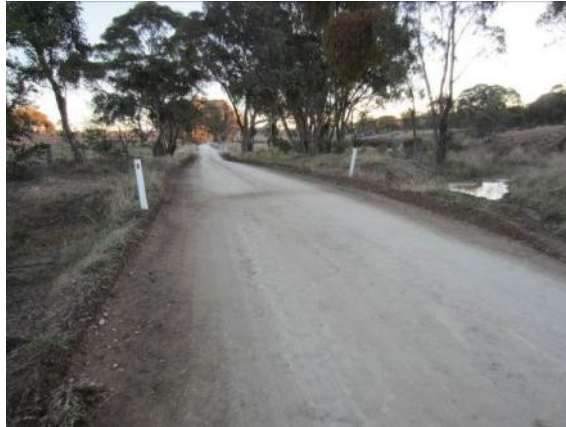
**Site ID: C3 Culvert**

**Proposed works:** Widen road and culvert.

**Site condition:** Biometric – Moderate to good – poor.  
Mid-Western Regional Council – Modified.

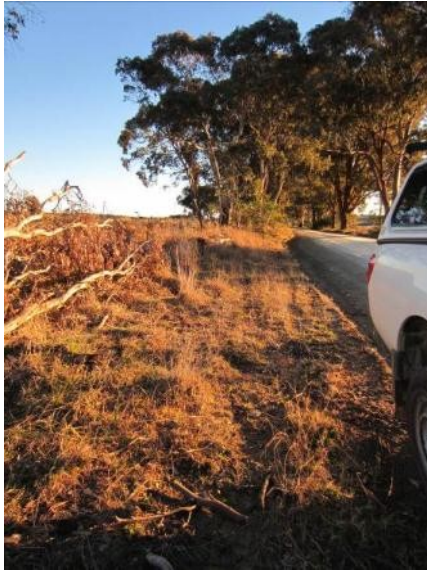
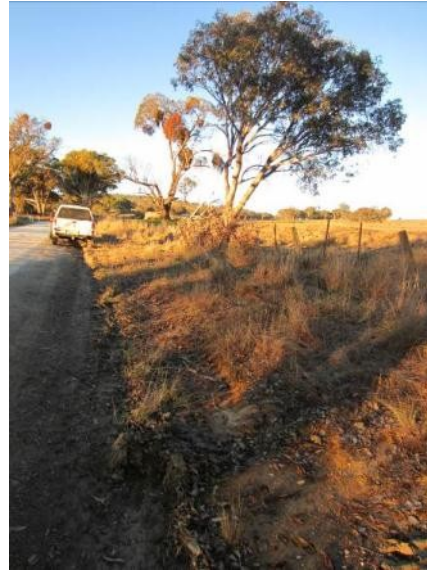
## Site ID: Passing Bay 40

**Proposed works:** Development of a passing bay – LHS.

**Site condition:** Biometric – Low.  
Mid-Western Regional Council – Degraded.

Degraded patch within White Box, Yellow Box, Blakely's Red Gum Woodland EEC.  
Mid-Western Regional Council has identified this area as being an EEC of high value.

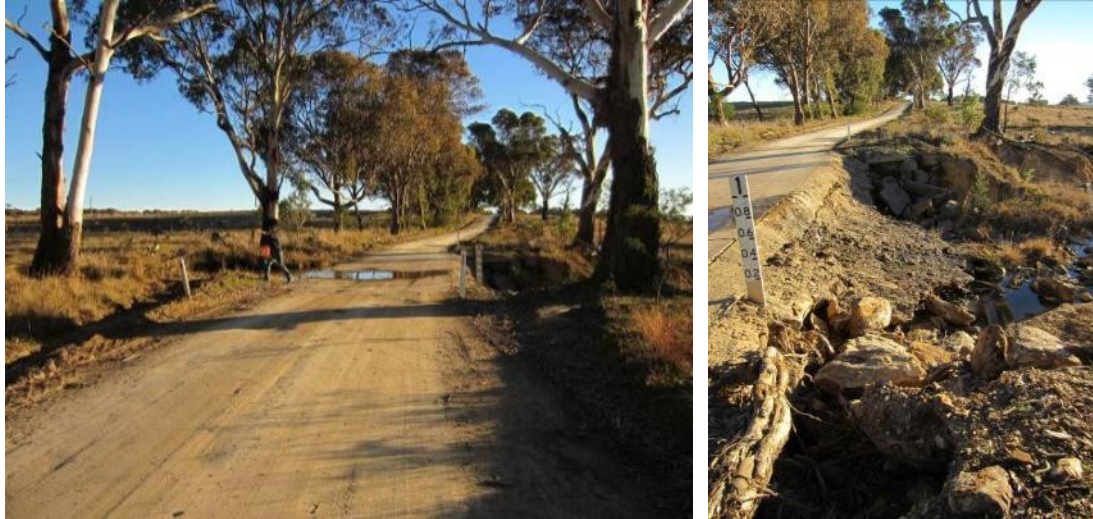
**Site ID: 17.9 km causeway**

Causeway is founded on poor sub-layer and will crack under load. Recommend full replacement (Downer 2013).

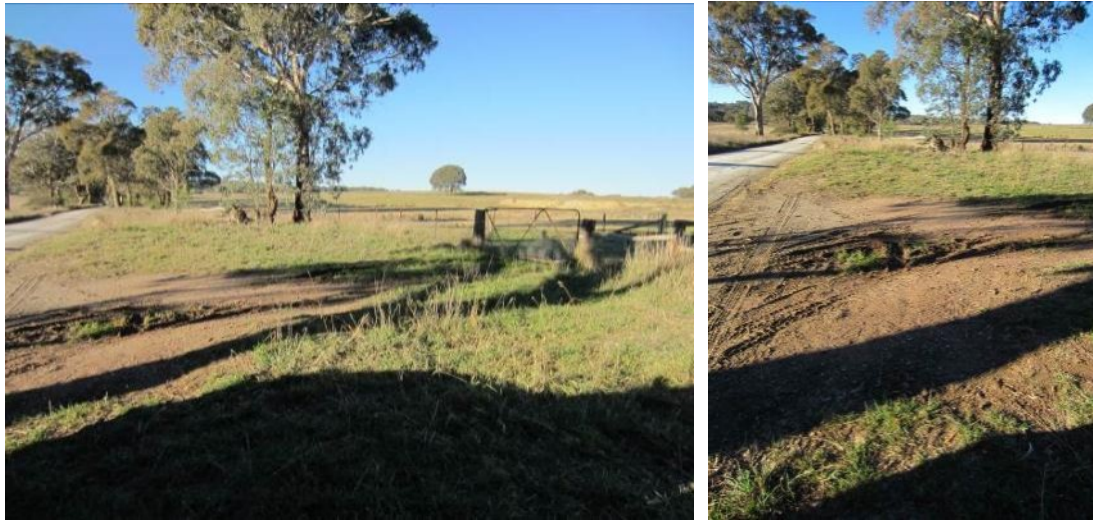
**Site ID: Passing Bay 41**

**Proposed works:** Widen road and culvert.

**Site condition:**

Biometric – Low.  
Mid-Western Regional Council – Degraded

Degraded patch of White Box, Yellow Box, Blakely's Red Gum Woodland EEC.

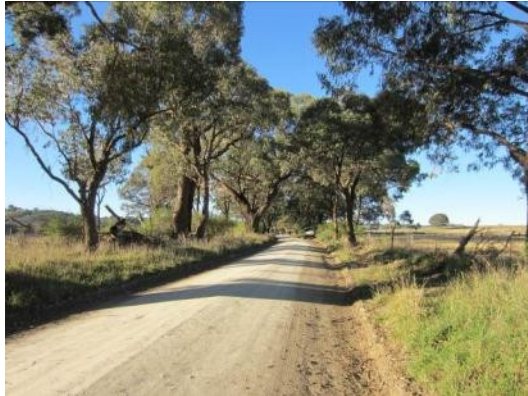
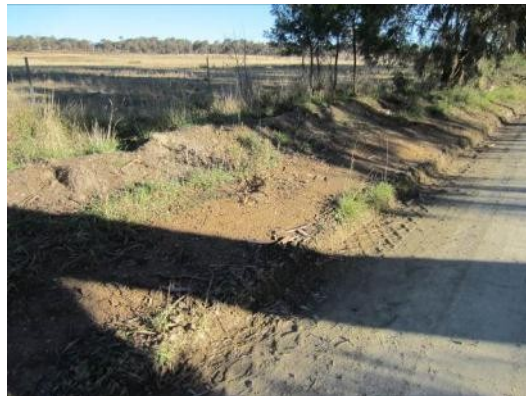
**Site ID: W1**

**Proposed works:** Widen road.

**Site condition:** Biometric – Moderate to good.  
Mid-Western Regional Council – Modified.

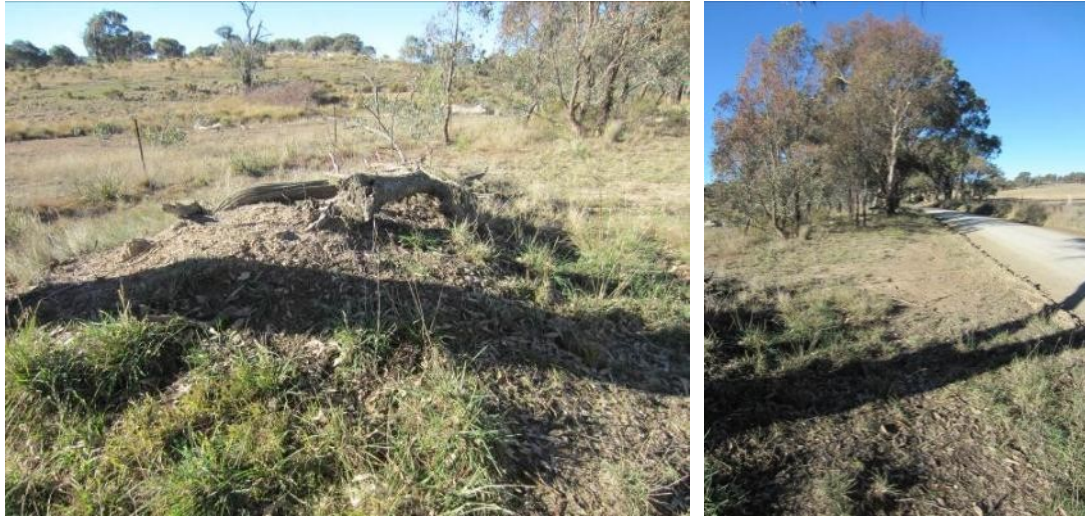
**Site ID: Passing Bay 42**

**Proposed works:** Development of a passing bay – RHS.

**Site condition:** Biometric – Low.  
Mid-Western Regional Council – Degraded

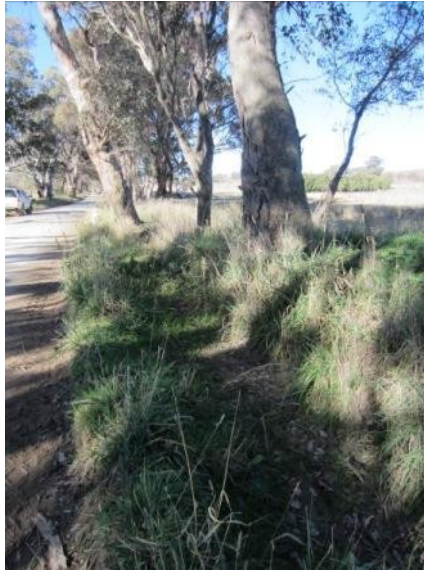
**Site ID: 19.2 km culvert**

**Proposed works:** Widen road pavement at culvert to suit to minimum 6 m.

**Site condition:** Biometric – Moderate to good.  
Mid-Western Regional Council – Modified

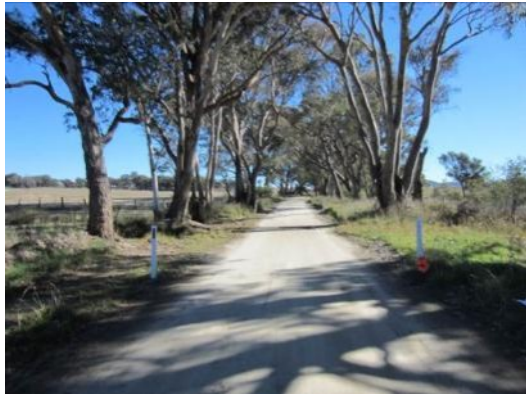
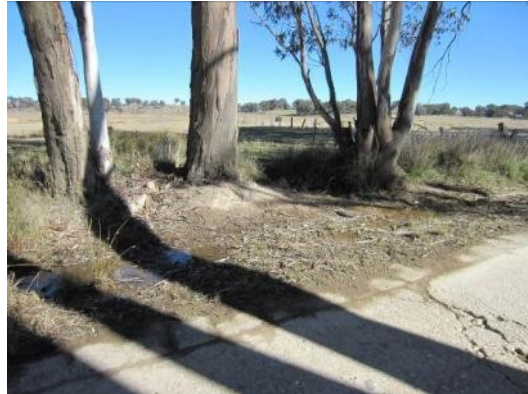
**Site ID: 19.2 km Causeway**

**Proposed works:** Causeway paving is cracked suggesting poor subgrade. Suggest replacing subgrade and repaving (Downer 2013).
