**Aarons Pass Road – Heavy Haulage Route Upgrade for the Proposed
Crudine Ridge Wind Farm - European and Aboriginal Cultural
Heritage Assessment Report**

A report to Crudine Ridge Wind Farm Pty Ltd

October 2013

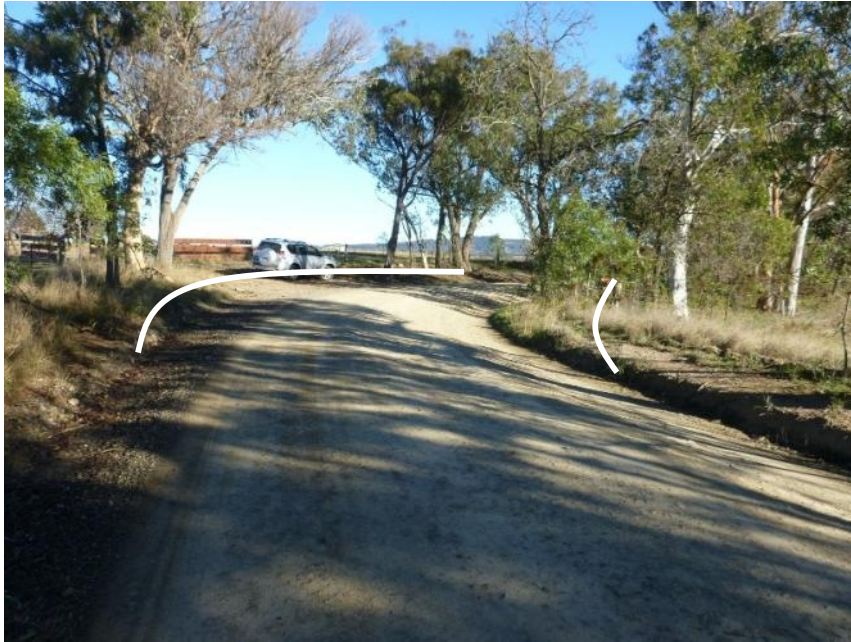
Plate 1 Location of *Upgrade 3.3* and *PB01*; looking 270°.

At this site it is proposed to remove two trees and level the corner on both sides (Plate 1). The driveway at this location is also the site of PB01 (see further below). The site is on the break of slope of a narrow, slight summit of a very gently undulating ridge crest. The area in which impacts would occur is highly disturbed by previous road works.

This site is on the Left Hand Side (LHS) – as moving east to west along Aarons Pass Road, at the driveway entrance to a farm in the area of *Upgrade 3.3* (Plate 1). The existing driveway area measures c. 10 x 8 m and is highly eroded. Minor clearing would be required.

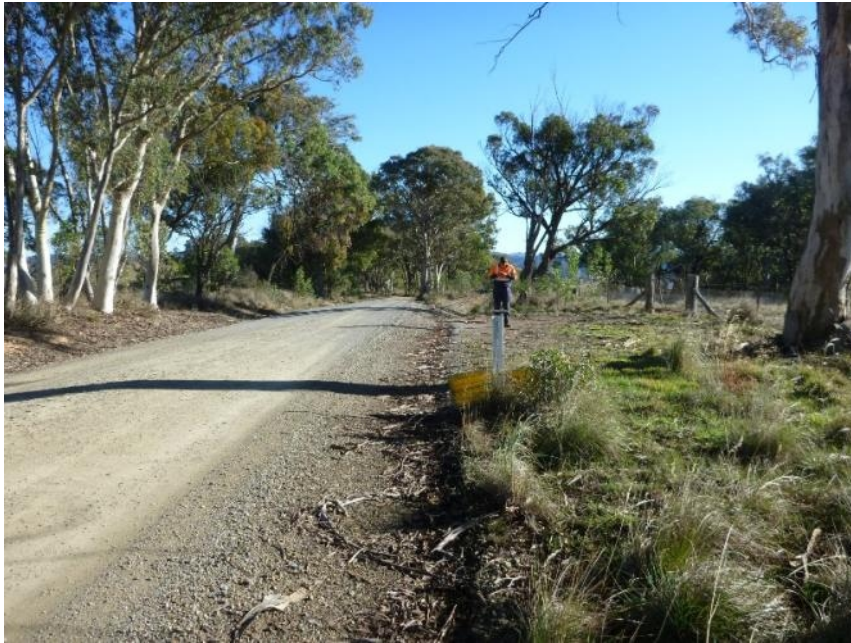
Plate 2 Location of *PB02*; looking 310°.

This site is on the Right Hand Side (RHS), at the driveway to a farm at the northern end of *Upgrade 3.3* (Plate 2). The existing driveway area measures c. 10 x 5 m and is highly disturbed. Minor clearing would be required.

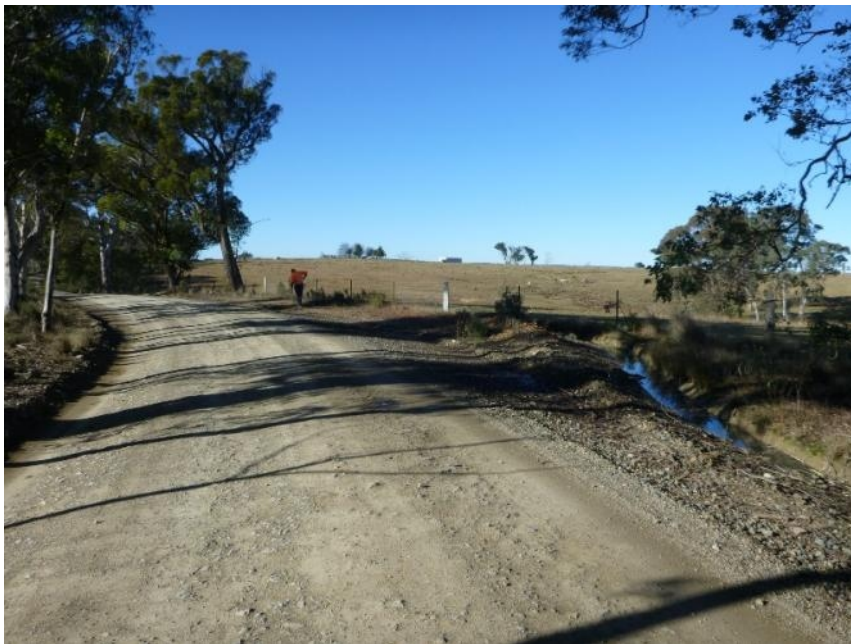
Plate 3 Location of *PB03*; looking 130°.

This site is on the LHS of the road on a narrow, very gently undulating ridge crest (Plate 3). The site is an existing area of graded clearing measuring c. 30 x 4 m. The entire area is a graded road batter and table drain; it is highly disturbed.

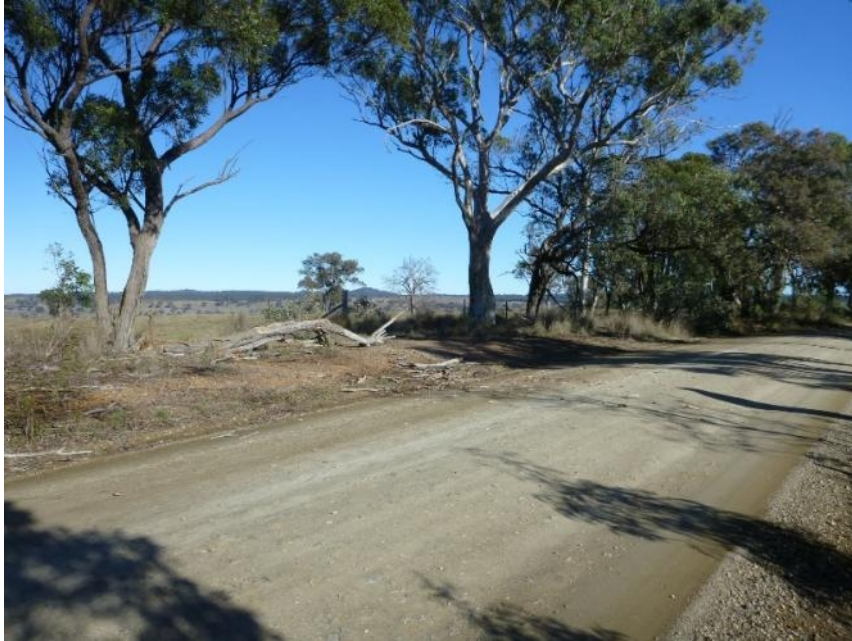
Plate 4 Location of *PB04*; looking 240°.

This site is on the LHS of the road on the slight summit of a narrow, very gently undulating ridge crest (Plate 4). The site is an existing area of graded clearing measuring c. 15 x 8 m. The entire area is a graded road batter; it is highly disturbed. Minor clearing would be required.

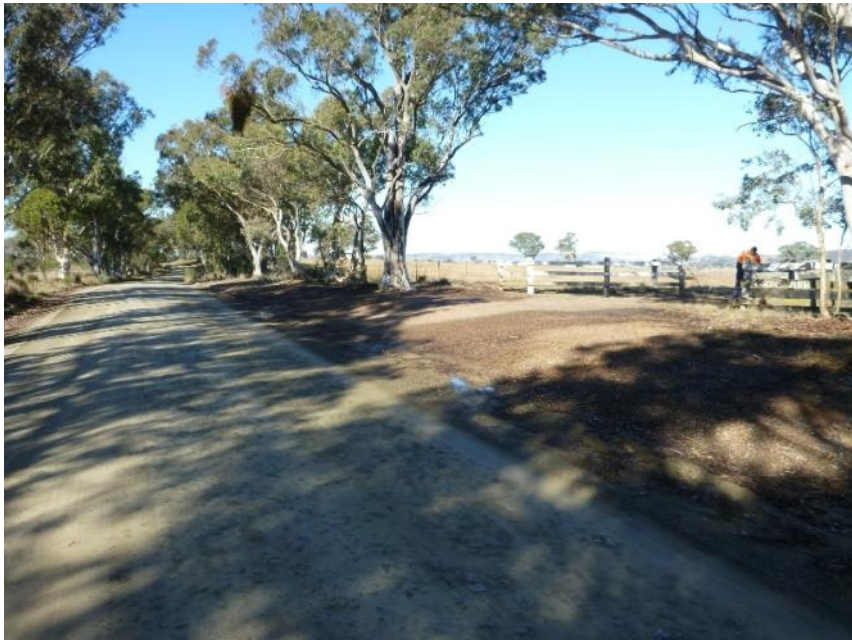
Plate 5 Location of *PB05*; looking south.

This site is on the LHS of the road at the entrance to a property. It is on a very gently undulating ridge crest (Plate 5). The site is an existing area of graded farm entrance and road batter measuring c. 40 x 10 m; it is highly disturbed.

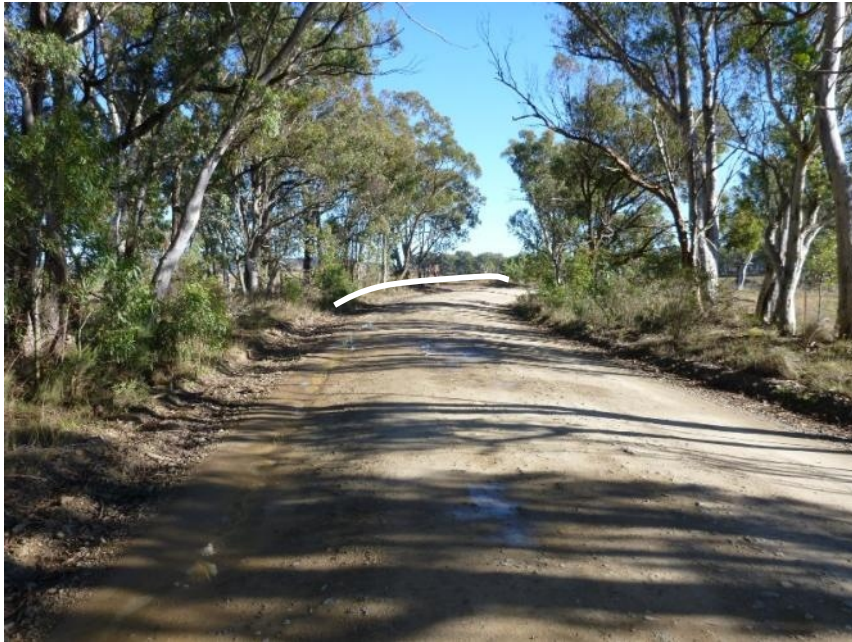
Plate 6 Location of *Upgrade 3.4*; looking 260°.

At this site it is proposed to fill and cut to widen on the LHS (Plate 6). The site is on a slight summit of a very gently undulating ridge crest. The area in which impacts would occur is highly disturbed by previous road works and the formation of a farm entrance. The majority of impacts would occur on an existing gutter, therefore previous impacts are high.

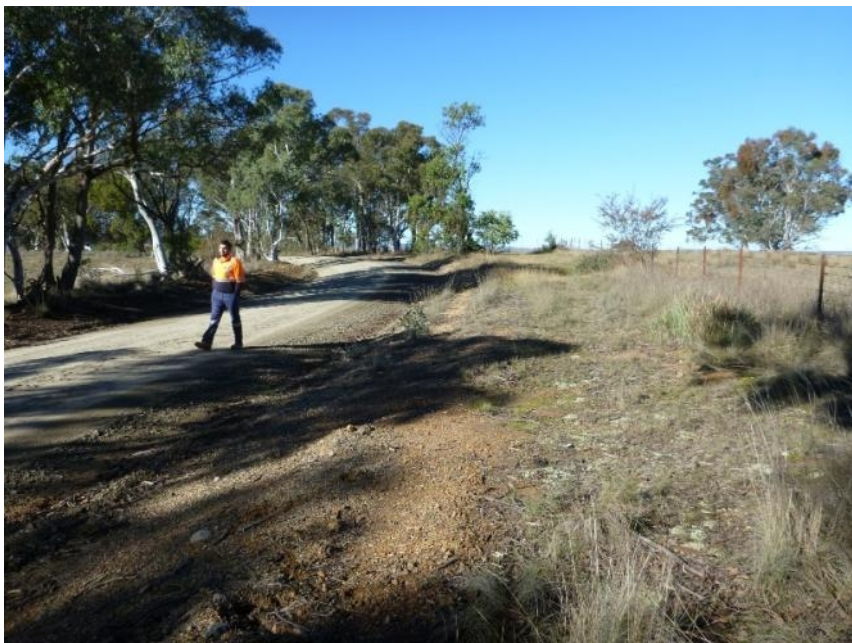
Plate 7 Location of *PB06*; looking 140°.

This site is on the LHS of the road just to the north of Upgrade 3.4. It is on a very gently undulating ridge crest (Plate 7). The site is an existing area of graded gutter and road batter measuring c. 50 x 6 m; it is highly disturbed. Some levelling would be required.

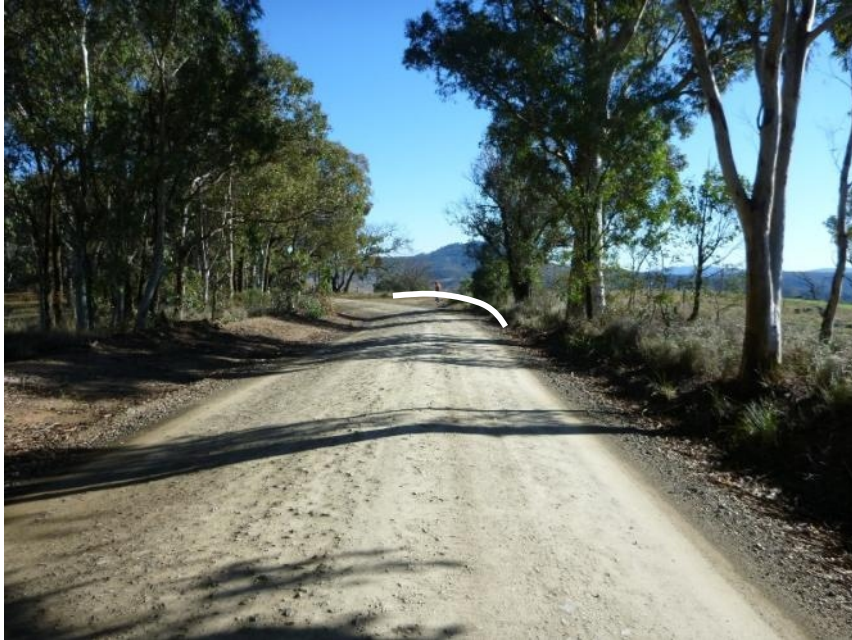
Plate 8 Location of *Upgrade 3.5*; looking 300°.

At this site it is proposed to fill and level on the RHS corner (Plates 8 and 9). The site is on a very gently undulating ridge crest. The area in which impacts would occur is highly disturbed by previous road works and the formation of a farm entrance. The majority of impacts would occur on an existing deeply excavated gutter, therefore previous impacts are high. The farm entrance at this site is also the location of proposed *PB07*.

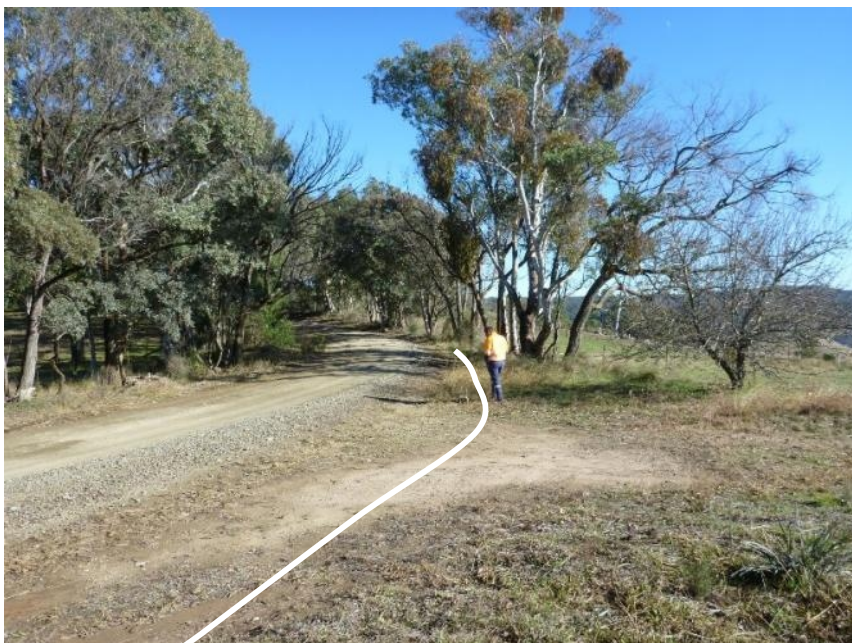
Plate 9 Location of *Upgrade 3.5* and *PB07*; looking 255°.

This site is on the RHS of the road on a very gently undulating ridge crest (Plate 9). The site is an existing farm entrance and is highly disturbed. Minor clearing would be required.

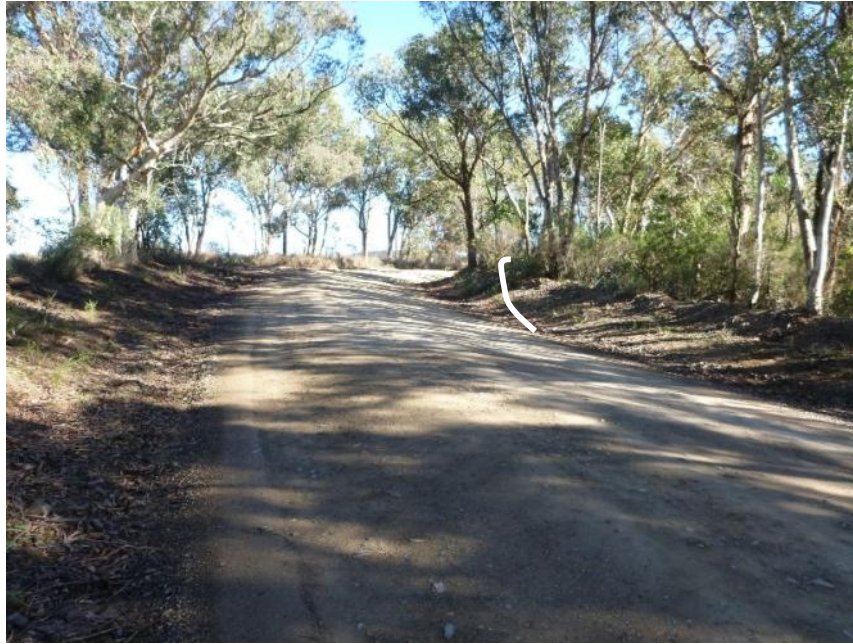
Plate 10 Location of *Upgrade 3.7*; looking 240°.

At this site it is proposed to remove two trees and level the corner on the RHS (Plate 10). The site is on a slight summit of very gently undulating ridge crest. The area in which impacts would occur is highly disturbed by previous road works.

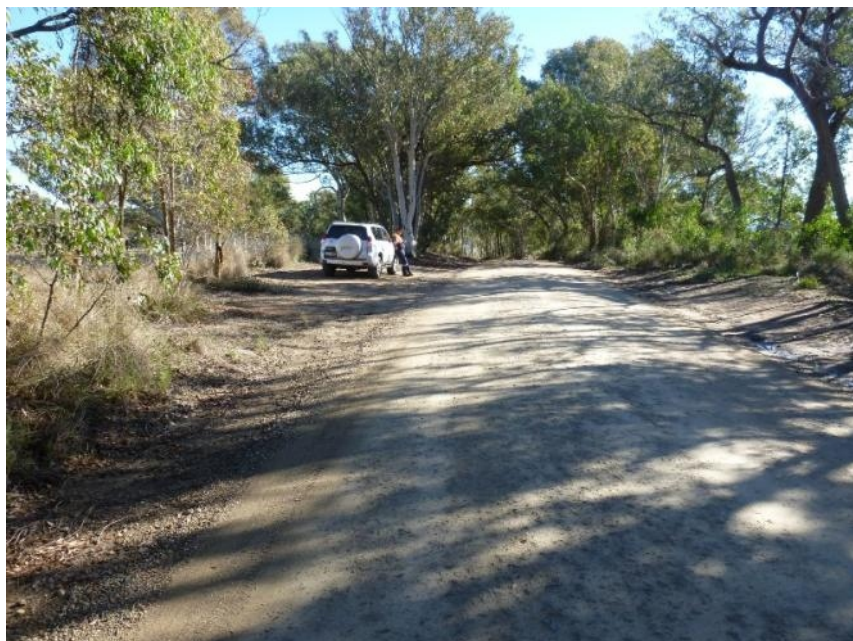
Plate 11 Location of *PB08*; looking 300°.

This site is on the LHS of the road on a slight summit of a very gently undulating ridge crest (Plate 11). The site is an existing area of graded gutter and road batter measuring c. 20 x 4 m; it is highly disturbed. Some clearing may be required.

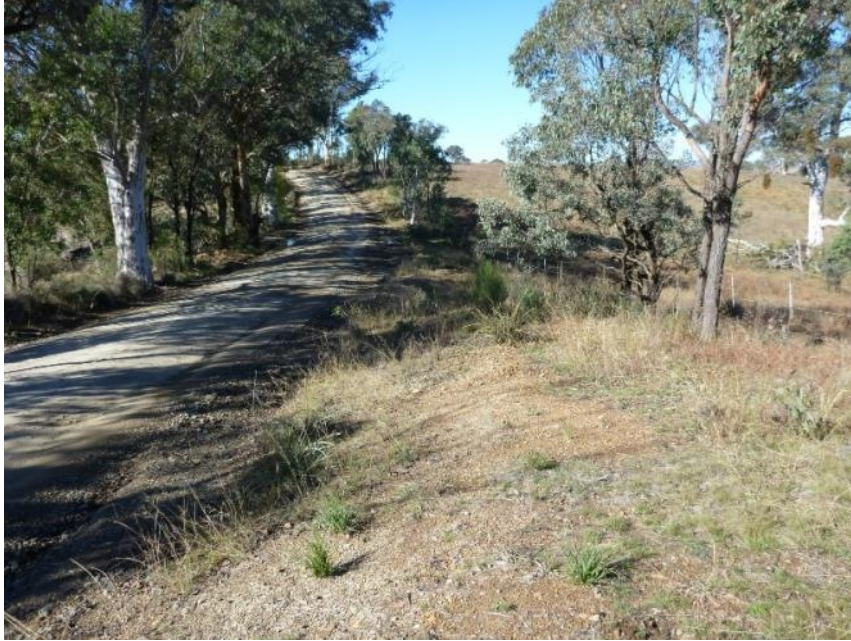
Plate 12 Location of *PB09*; looking 130°.

This site is on the LHS of the road on a slight saddle of a narrow, very gently undulating ridge crest (Plate 12). The site is an existing area of graded gutter and road batter measuring c. 25 x 5 m; it is highly disturbed. Some clearing would be required.

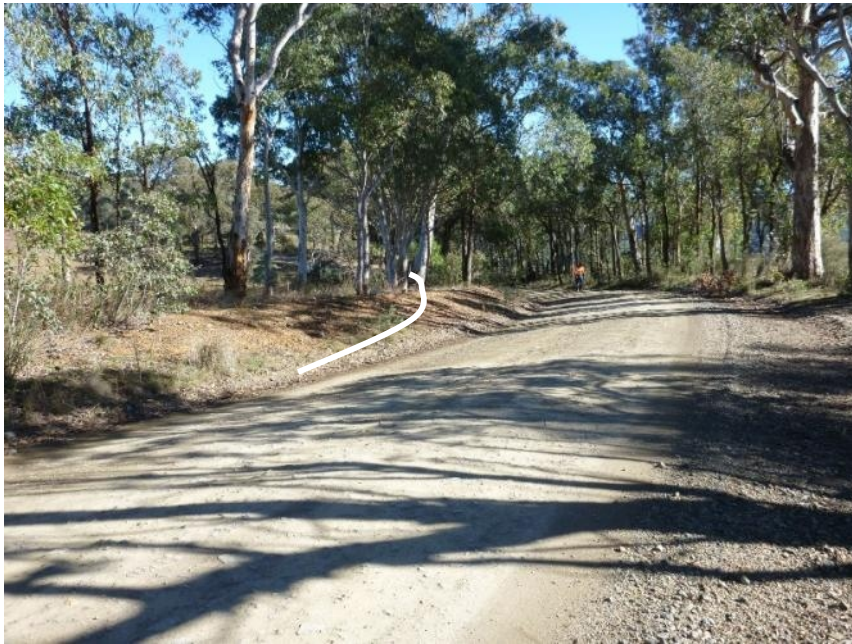
Plate 13 Location of *Upgrade 3.9*; looking 260°.

At this site it is proposed to remove c. five trees and level the inside (LHS) corner (Plate 13). The site is on a gently undulating ridge crest. The area in which impacts would occur is highly disturbed by previous road works.

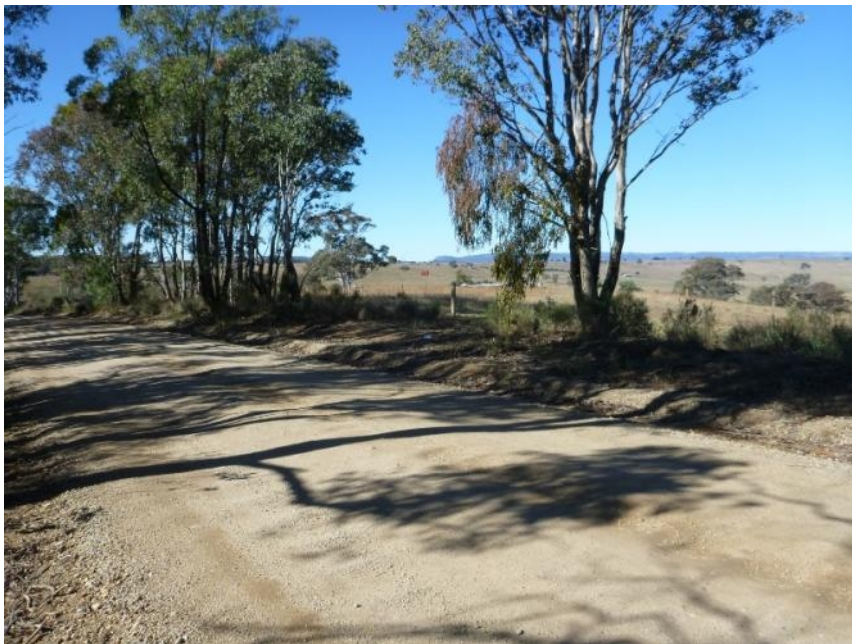
Plate 14 Location of *PB10*; looking 120°.

This site is on the LHS of the road on a slight summit of a narrow, very gently undulating ridge crest (Plate 14). The site is an existing area of graded gutter and road batter measuring c. 20 x 5 m; it is highly disturbed. The site would require some clearing and levelling.

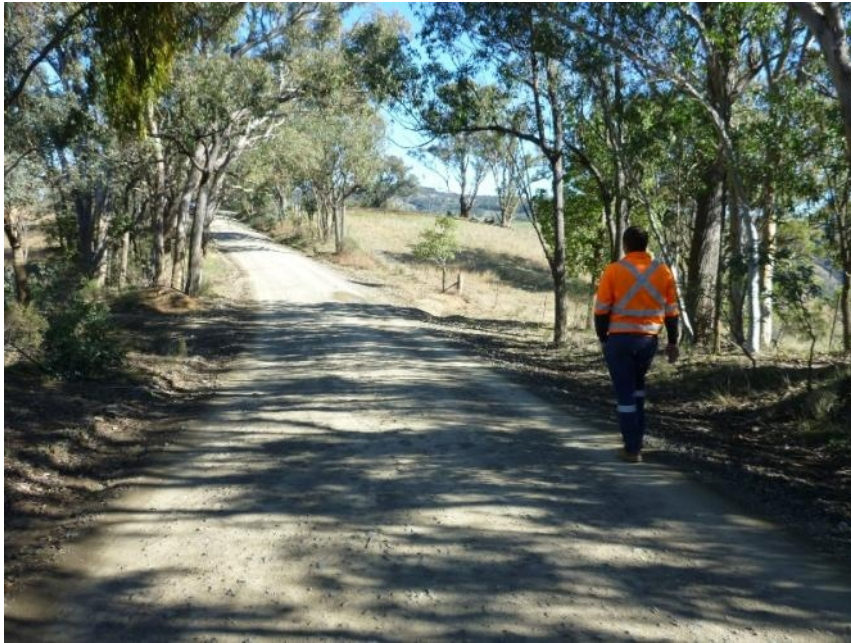
Plate 15 Location of *PB11*; looking 110°.

This site is on the RHS of the road on a slight saddle of a narrow, gently undulating ridge crest (Plate 15). The site is an existing area of clearing and graded gutter measuring c. 25 x 4 m; it is highly disturbed. The site would require minor clearing and levelling.

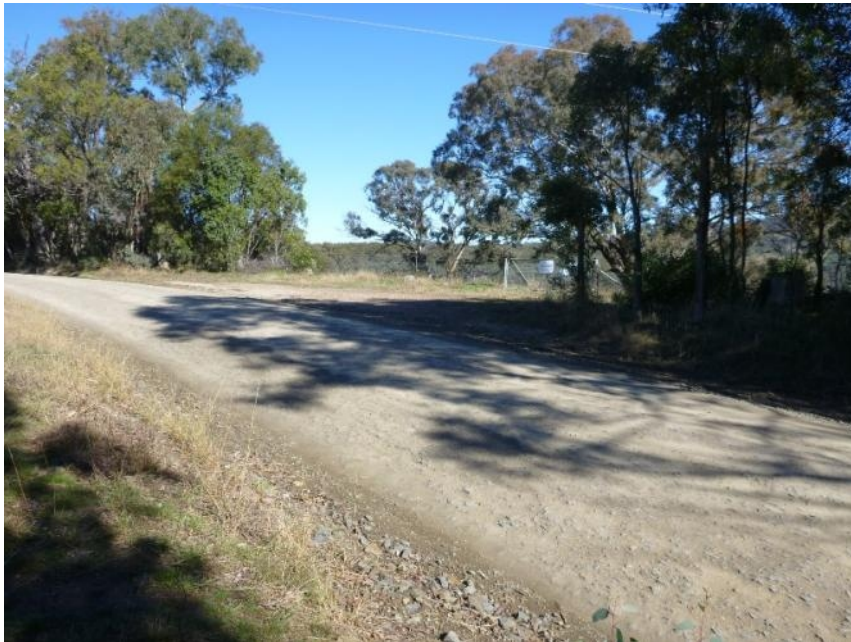
Plate 16 Location of *PB12*; looking 210°.

This site is on the RHS of the road on a slight summit of a very gently undulating ridge crest (Plate 16). The site is an existing area of clearing and farm entrance measuring c. 15 x 5 m; it is highly disturbed. The site would require minor clearing and levelling.

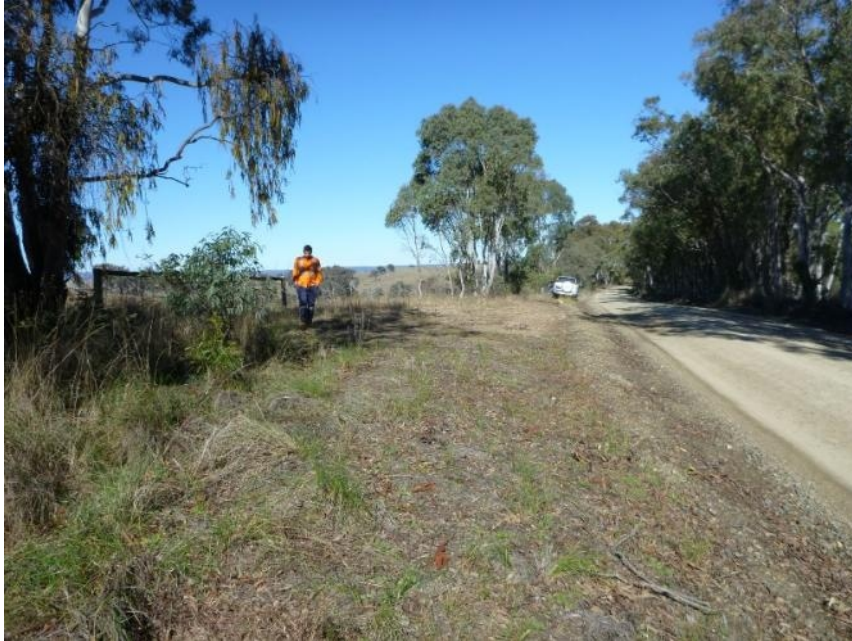
Plate 17 Location of *PB13*; looking 170°.

This site is on the LHS of the road on a narrow, very gently undulating ridge crest (Plate 17). The site is an existing area of clearing and graded farm entrance measuring c. 30 x 5 m; it is highly disturbed. The site would require some clearing and levelling.

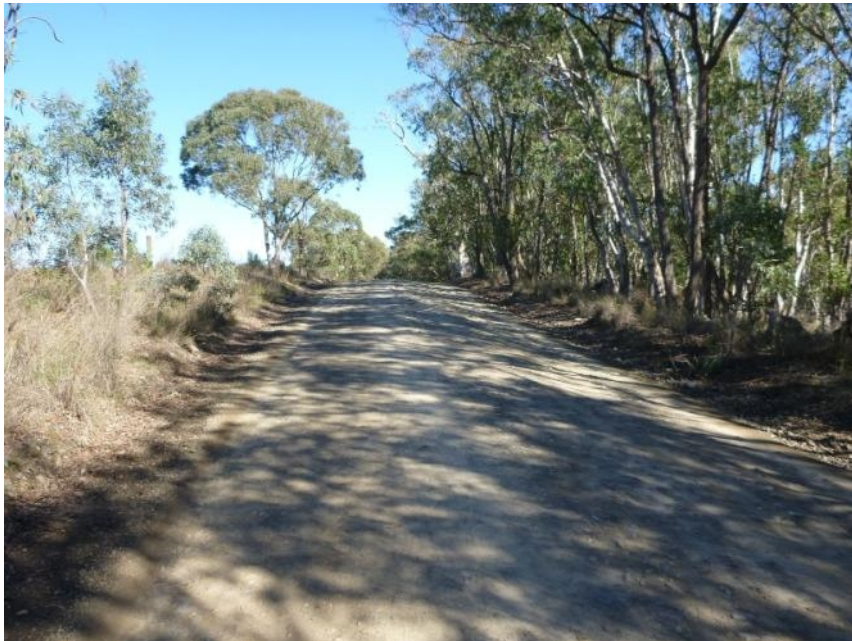
Plate 18 Location of *Upgrade 3.10*; looking 210°.

At this site it is proposed to modify (lower) the crest of the hill (Plate 18). The site is on a slight summit of a narrow, very gently undulating ridge crest. The area in which impacts would occur is highly disturbed by previous road works.

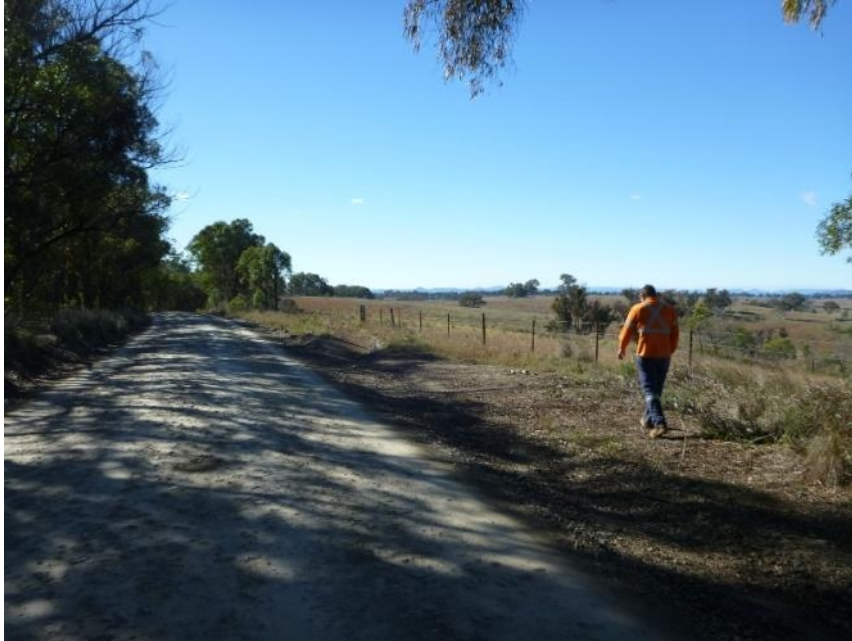
Plate 19 Location of *PB14*; looking 200°.

This site is on the LHS of the road on a narrow, very gently undulating ridge crest (Plate 19). The site is an existing area of cleared batter and graded gutter area measuring c. 30 x 4 m; it is highly disturbed. The site would require some clearing and levelling.

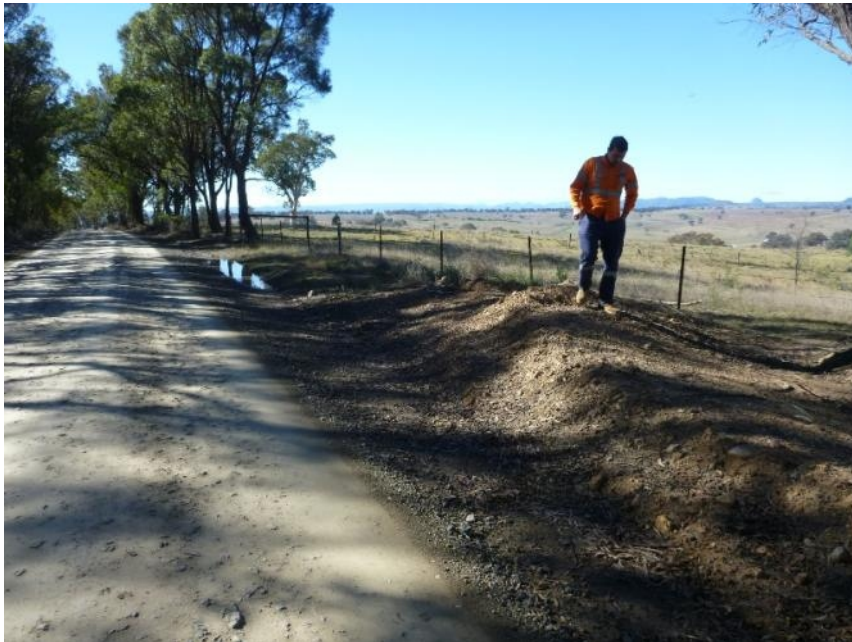
Plate 20 Location of *PB15*; looking 50°.

This site is on the LHS of the road on a narrow, very gently undulating ridge crest (Plate 20). The site is an existing area of cleared batter and graded gutter area measuring c. 30 x 4 m; it is highly disturbed. The site would require minor clearing and levelling.

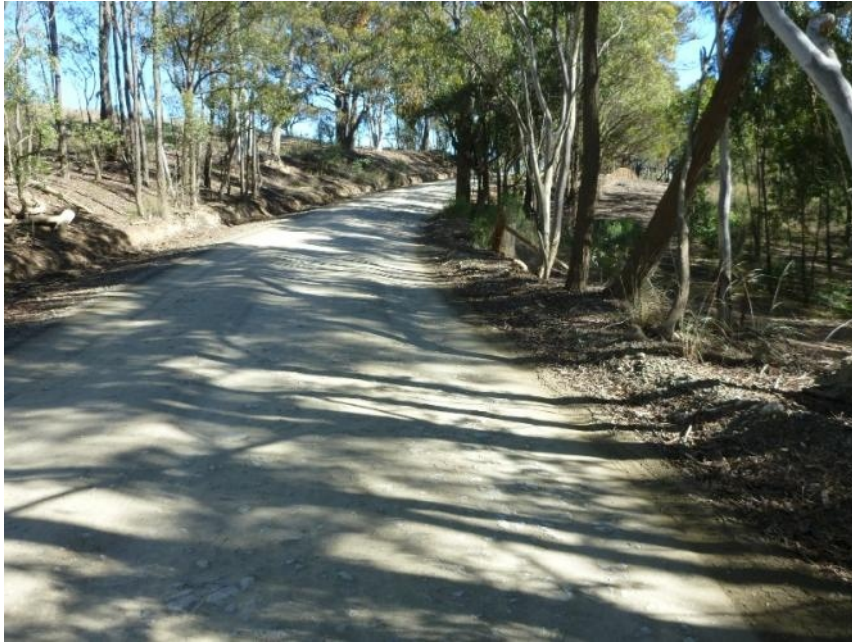
Plate 21 Location of *Upgrade 3.11*; looking 260°.

At this site it is proposed to remove c. five trees and fill and level the inside corner on the RHS (Plate 21). The site is on a break of slope of a gently undulating ridge crest and at the head of a drainage line. The area in which impacts would occur is highly disturbed by previous road works.

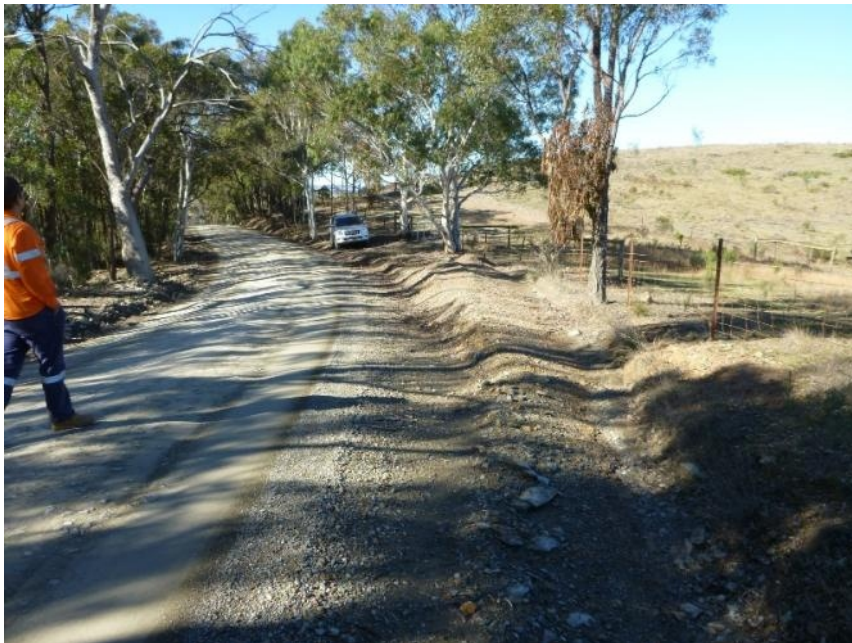
Plate 22 Location of *PB16*; looking 100°.

This site is on the LHS of the road on a narrow, very gently undulating ridge crest (Plate 20). The site is an existing area of cleared batter and graded gutter area measuring c. 25 x 3 m; it is highly disturbed. The site would require minor clearing and levelling.

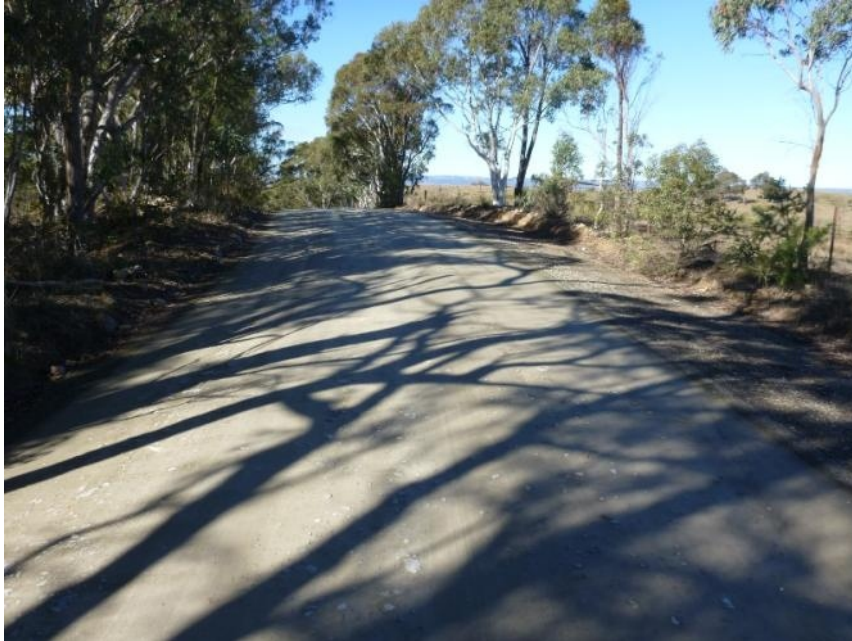
Plate 23 Location of *Upgrade 3.12*; looking 120°.

At this site it is proposed to modify the crest of the hill (Plate 23). The site is on a slight summit of a gently undulating ridge crest. The area in which impacts would occur is highly disturbed by previous road works.

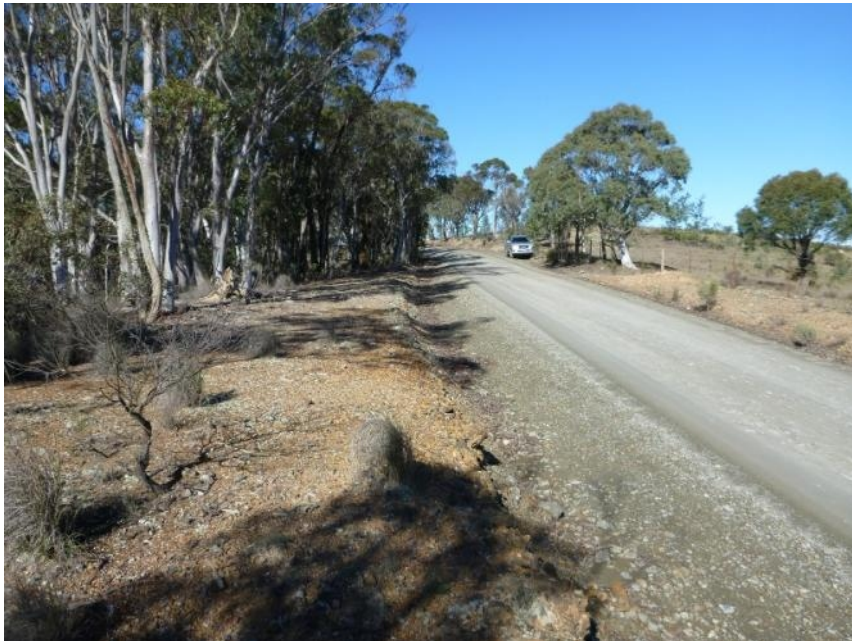
Plate 24 Location of *PB17*; looking 150°.

This site is on the RHS of the road on a narrow, very gently undulating ridge crest (Plate 20). The site is an existing area of cleared batter and graded gutter area measuring c. 30 x 4 m; it is highly disturbed. The site would require some levelling.

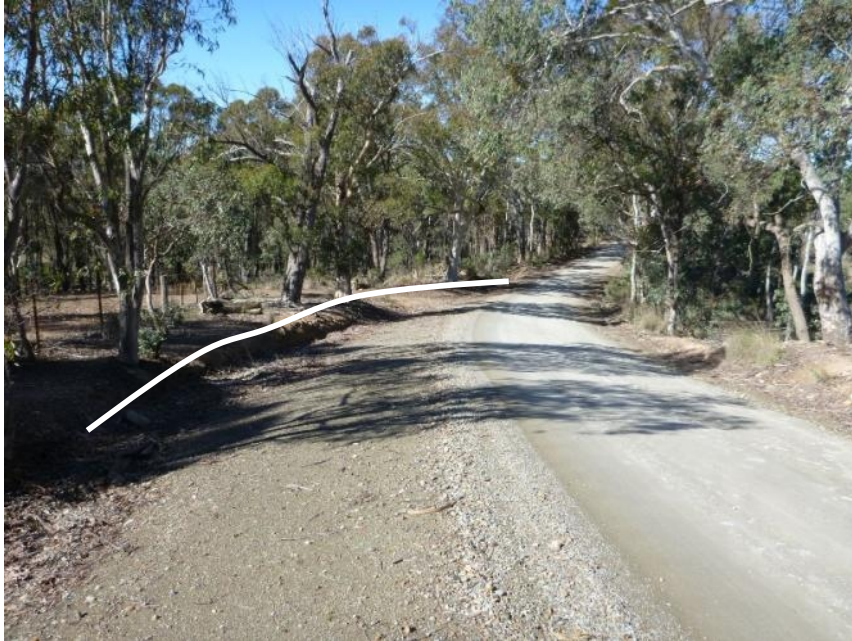
Plate 25 Location of *Upgrade 3.13*; looking 110°.

At this site it is proposed to fill the RHS corner to the edge of the vegetation (Plate 25). The site is on a slight summit of a gently undulating ridge crest. The area in which impacts would occur is highly disturbed by previous road works including an entrance to a property.

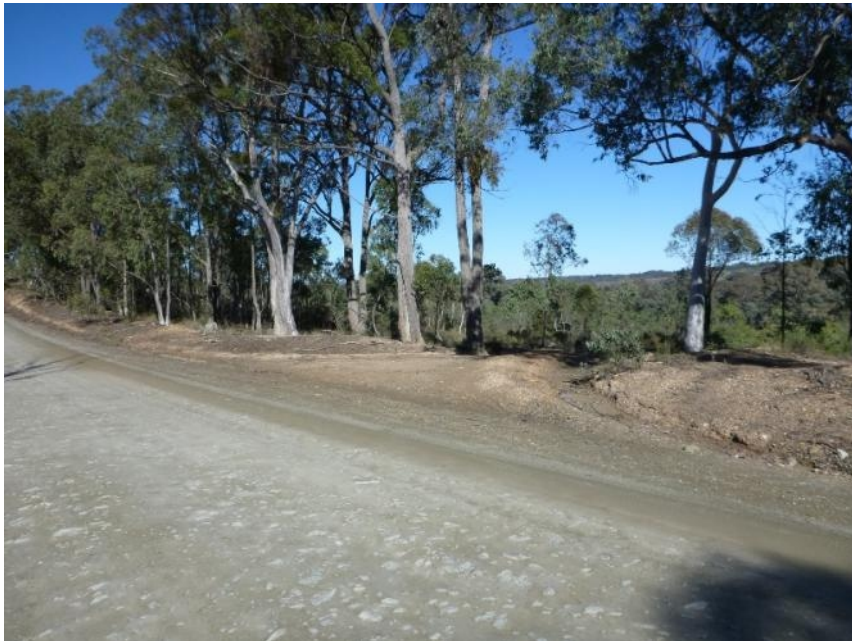
Plate 26 Location of *PB18*; looking 180°.

This site is on the LHS of the road on a saddle of a gently undulating ridge crest (Plate 26). The site is an existing area of cleared batter and graded gutter area measuring c. 20 x 8 m; it is highly disturbed. The site would require some levelling.

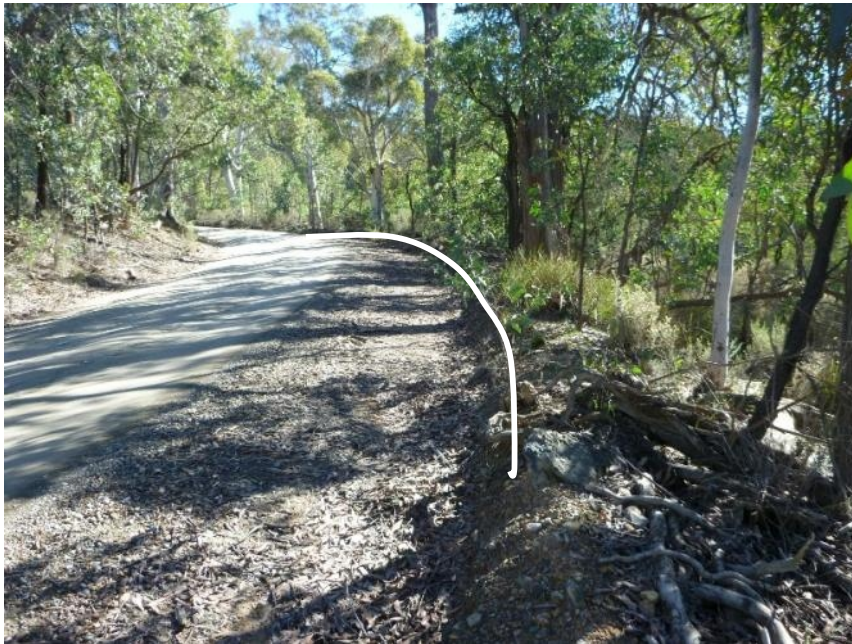
Plate 27 Location of *Upgrade 3.14*; looking 270°.

At this site it is proposed to fill the RHS corner and level the camber (Plate 27). The site is on a moderately undulating ridge crest. The area in which impacts would occur is highly disturbed by previous road works.

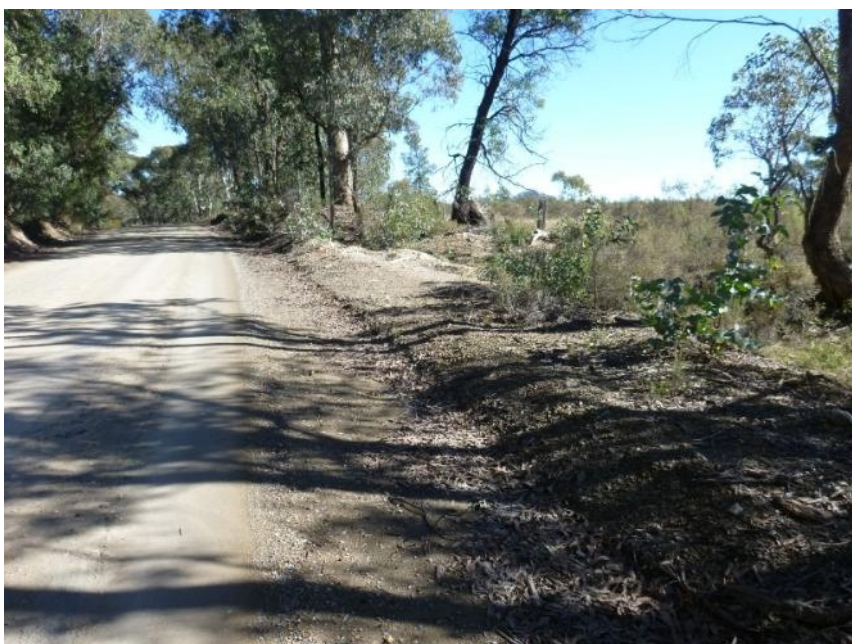
Plate 28 Location of *PB19*; looking 240°.

This site is on the RHS of the road on a slight summit of a very gently undulating ridge crest (Plate 28). The site is an existing area of cleared batter and graded gutter area measuring c. 20 x 5 m; it is highly disturbed. The site would require some clearance and levelling.

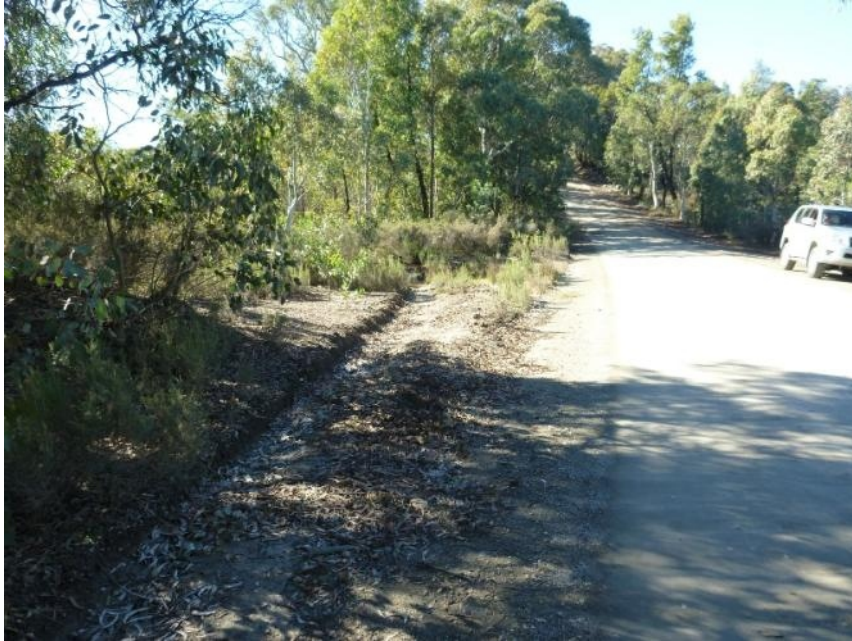
Plate 29 Location of *PB20*; looking 30°.

This site is on the RHS of the road on a slight saddle of a very gently undulating ridge crest (Plate 29). The site is an existing area of cleared batter and graded gutter area measuring c. 20 x 5 m; it is highly disturbed. The site would require some clearance and levelling.

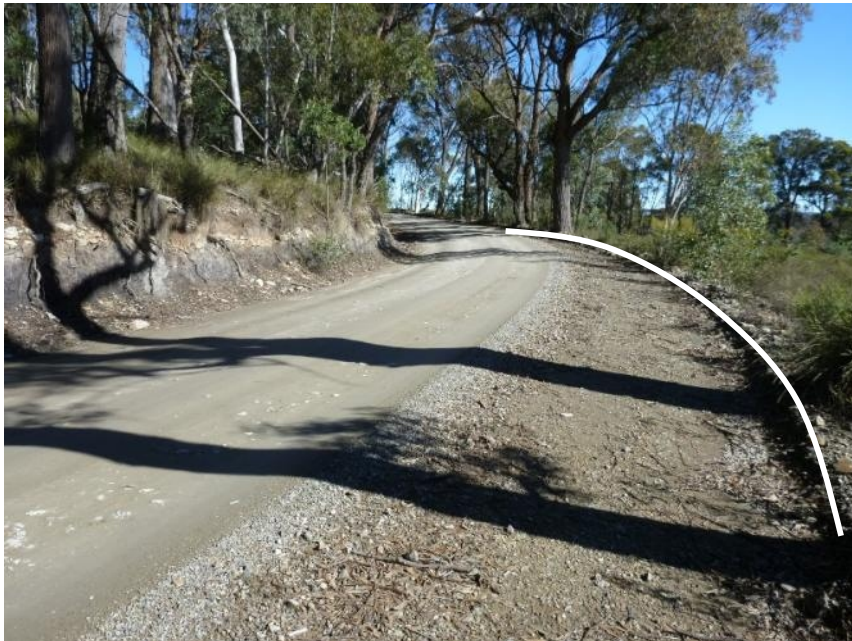
Plate 30 Location of *Upgrade 3.16*; looking 210°.

At this site it is proposed to fill the RHS corner (Plate 30). The site is on a moderate gradient simple slope. The area in which impacts would occur is excavated and highly disturbed by previous road works.

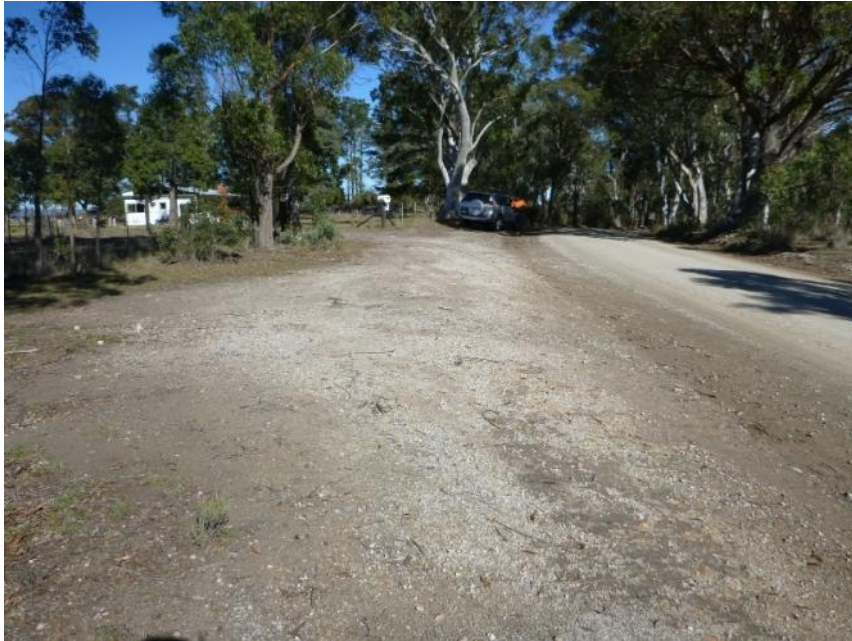
Plate 31 Location of *PB21*; looking 180°.

This site is on the LHS of the road on a wide, very gently undulating ridge crest (Plate 31). The site is an existing area of cleared and graded gutter and farm entrance area measuring c. 30 x 8 m; it is highly disturbed.

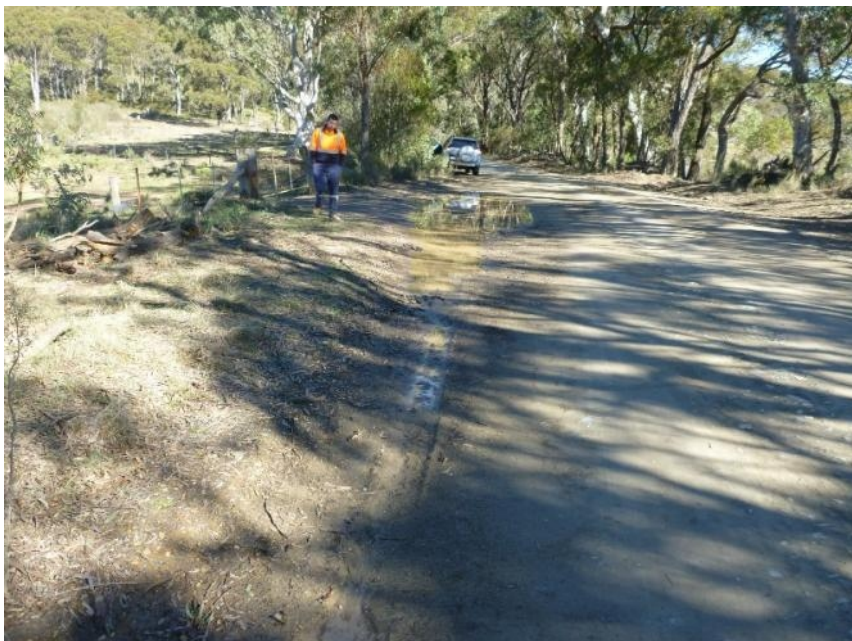
Plate 32 Location of *PB23*; looking 180°.

This site is on the LHS of the road on a narrow, very gently undulating ridge crest (Plate 32). The site is an existing area of cleared and graded gutter and batter area at a farm entrance measuring c. 20 x 4 m; it is highly disturbed. The site would require some clearance.

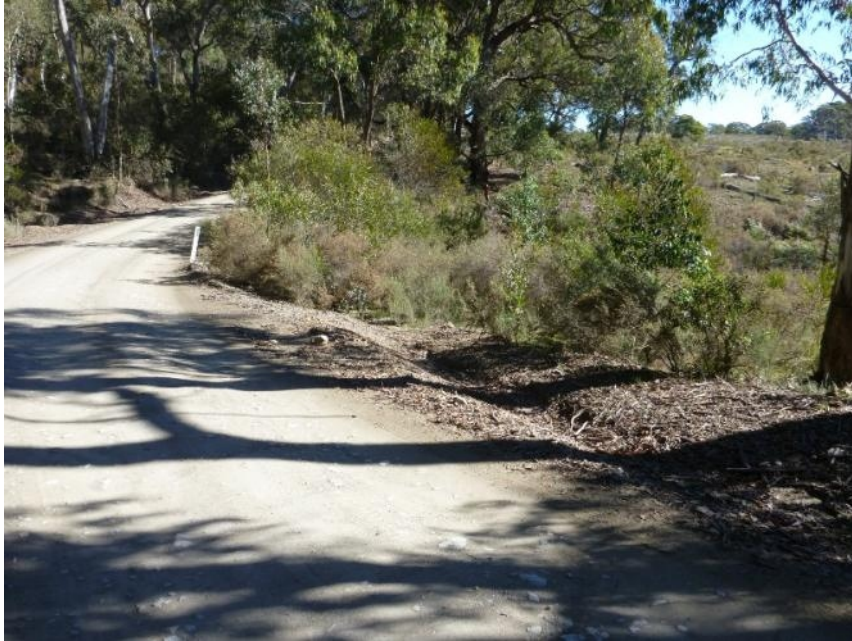
Plate 33 Location of *Upgrade 3.17*; looking 240°.

At this site it is proposed to remove trees/bushes and fill the RHS corner (Plate 33). The site is on a drainage line/simple slope. The area in which impacts would occur is excavated/filled and highly disturbed by previous road works.

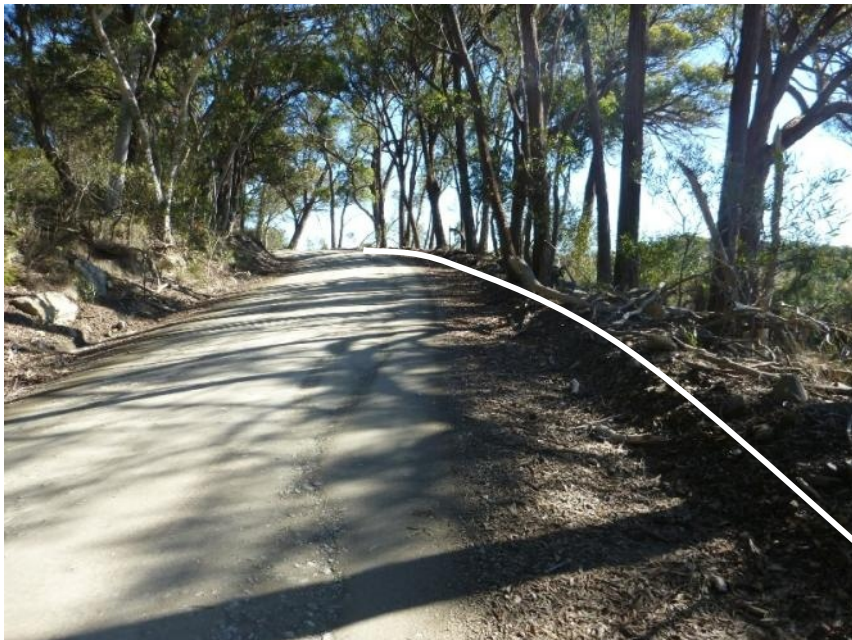
Plate 34 Location of *Upgrade 3.18*; looking 250°.

At this site it is proposed to fill and level the RHS corner (Plate 34). The site is on a simple slope. The area in which impacts would occur is benched and highly disturbed by previous road works.

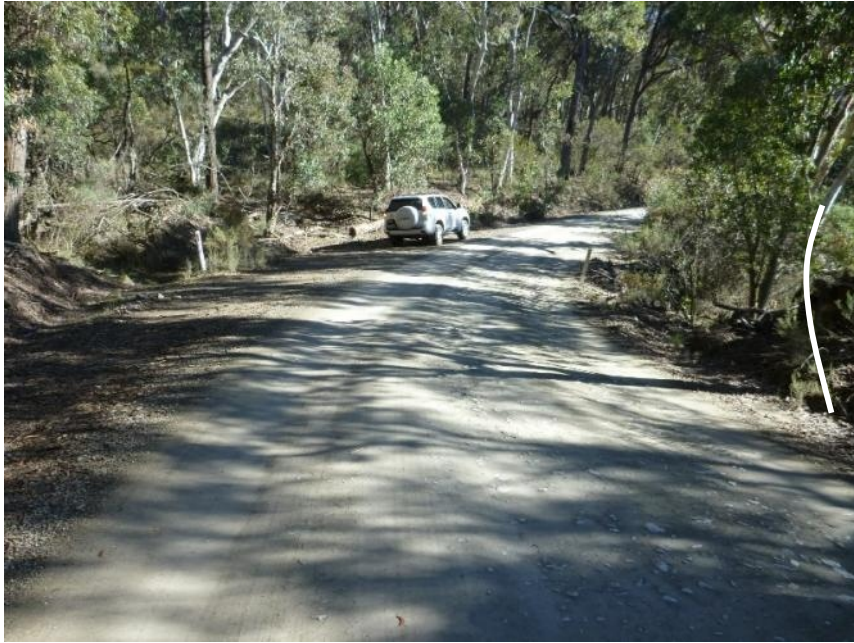
Plate 35 Location of *Upgrade 3.19*; looking 240°.

At this site it is proposed to remove trees and level on the RHS (Plate 35). The site is on a drainage line. The area in which impacts would occur is benched and highly disturbed by previous road works.

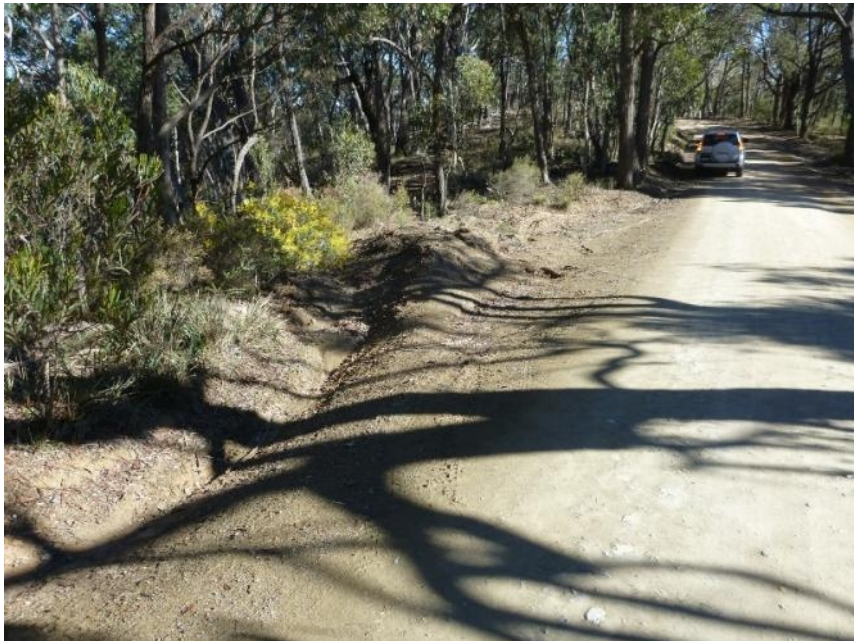
Plate 36 Location of *PB24*; looking 240°.

This site is on the LHS of the road in a slight saddle on a narrow, very gently undulating ridge crest (Plate 36). The site is an existing area of cleared and graded gutter and batter area measuring c. 20 x 3 m; it is highly disturbed. The site would require some clearance and levelling.
