Paling Yards Wind Farm

Geotechnical Exploration, Review and Advice

5/9/2011

Prepared for
Union Fenosa Wind Australia

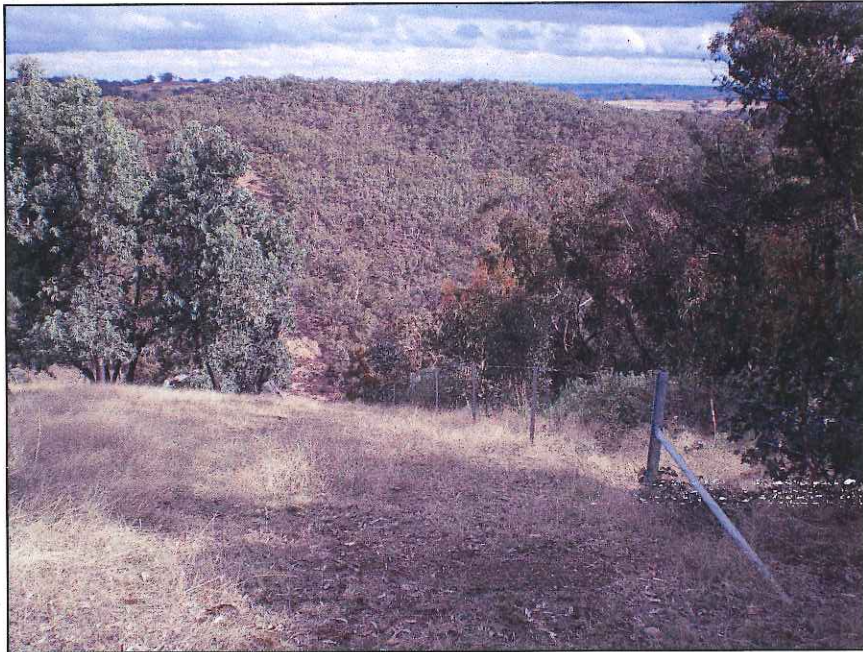
Site Condition Near Test Pit 11

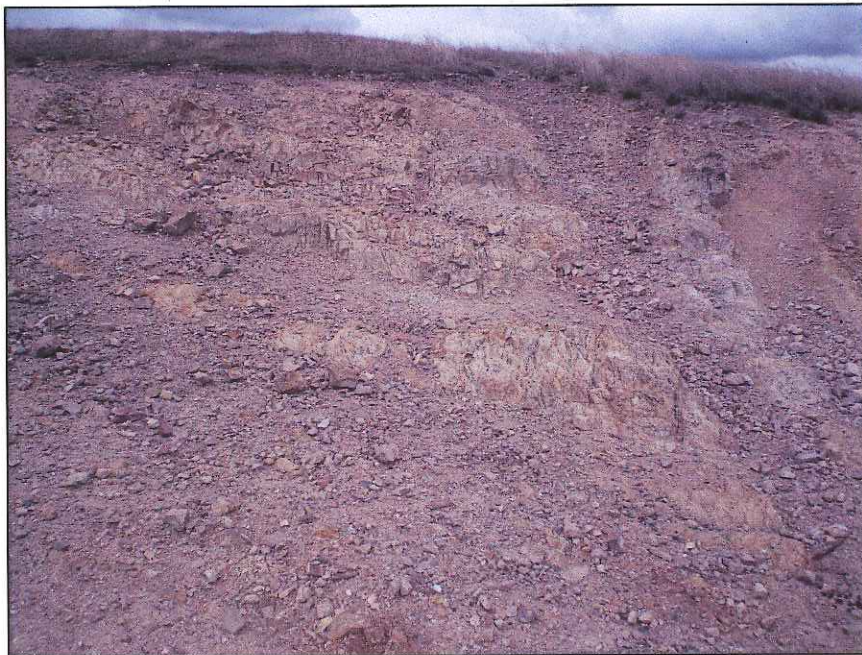
Siltstone Outcrop Near Test Pit 13

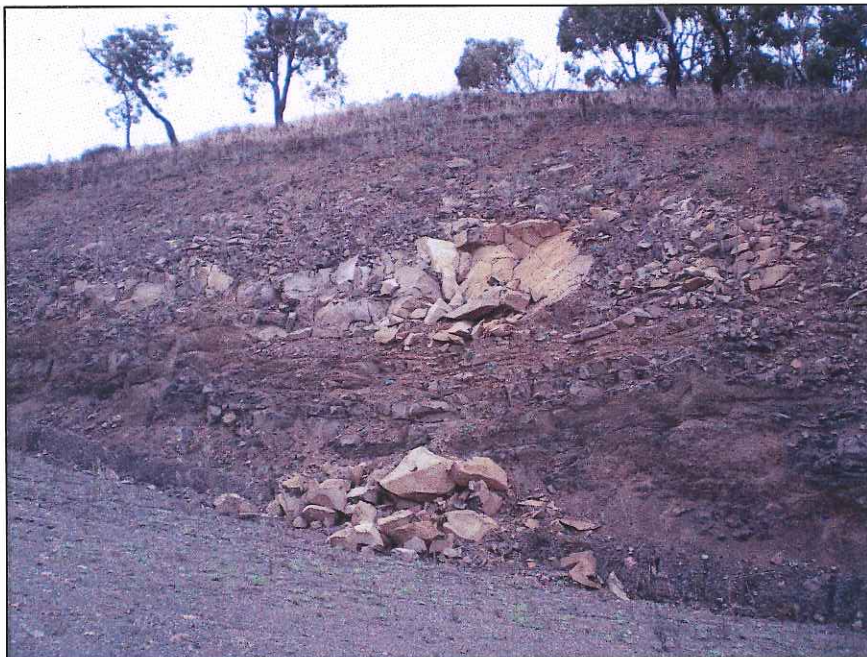
**Rock Failure Along Abercrombie Road,
Adjacent To Southern Central Site Boundary**

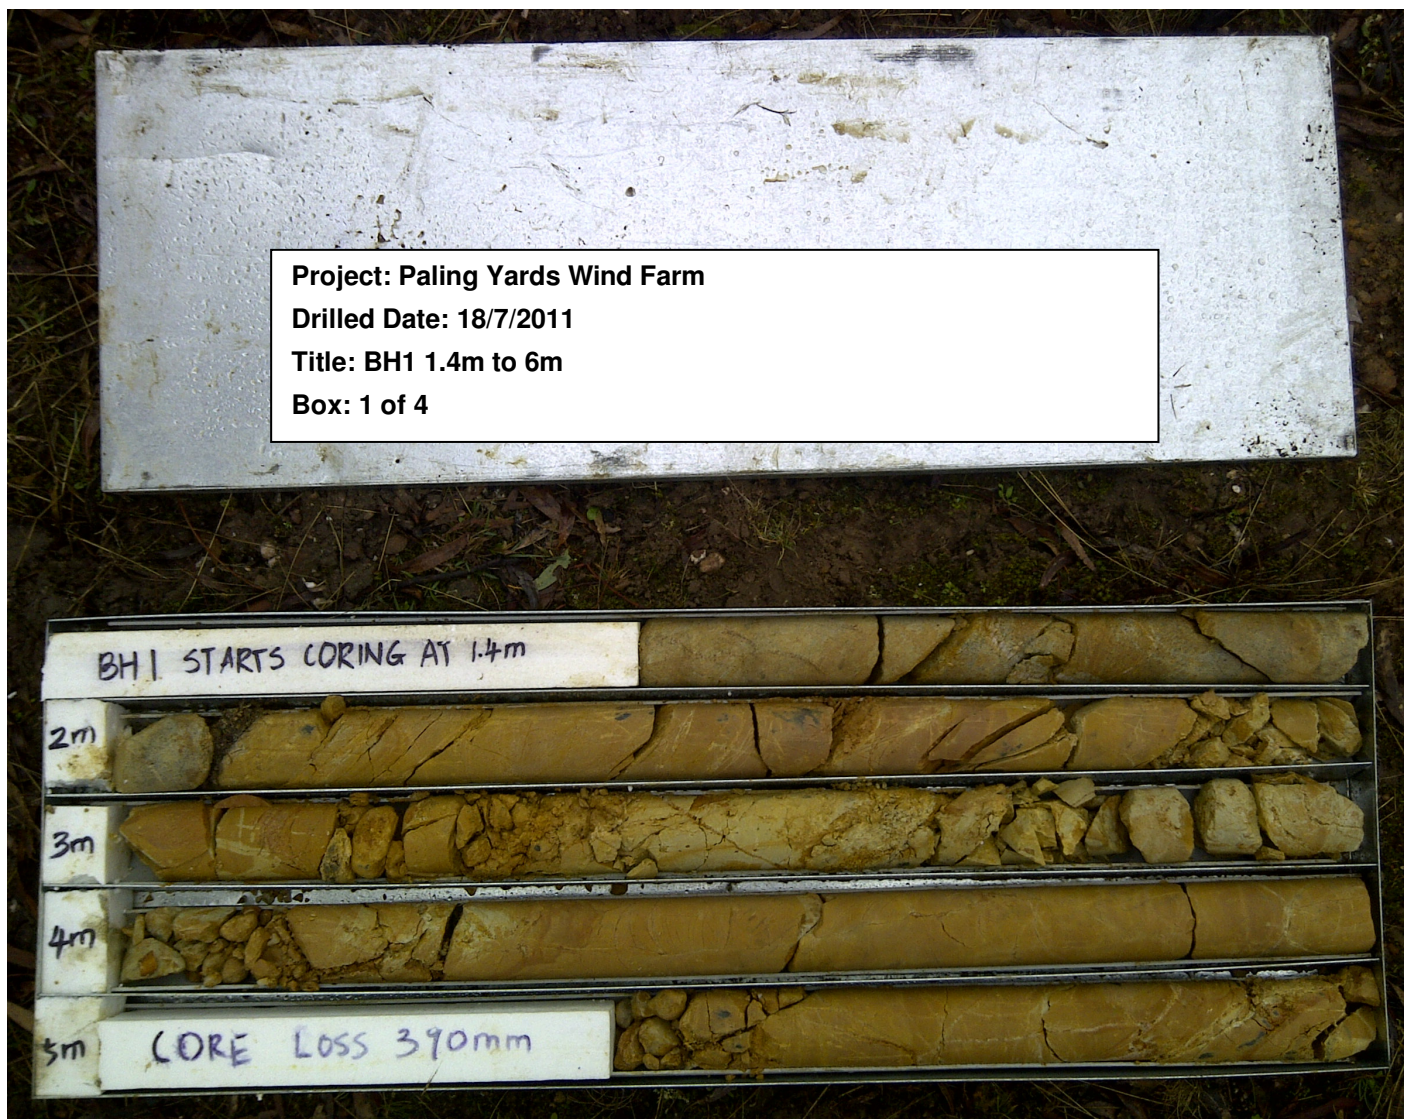
CORE PHOTOGRAPHY
BH1 1.4m to 5m
Box 1 of 4

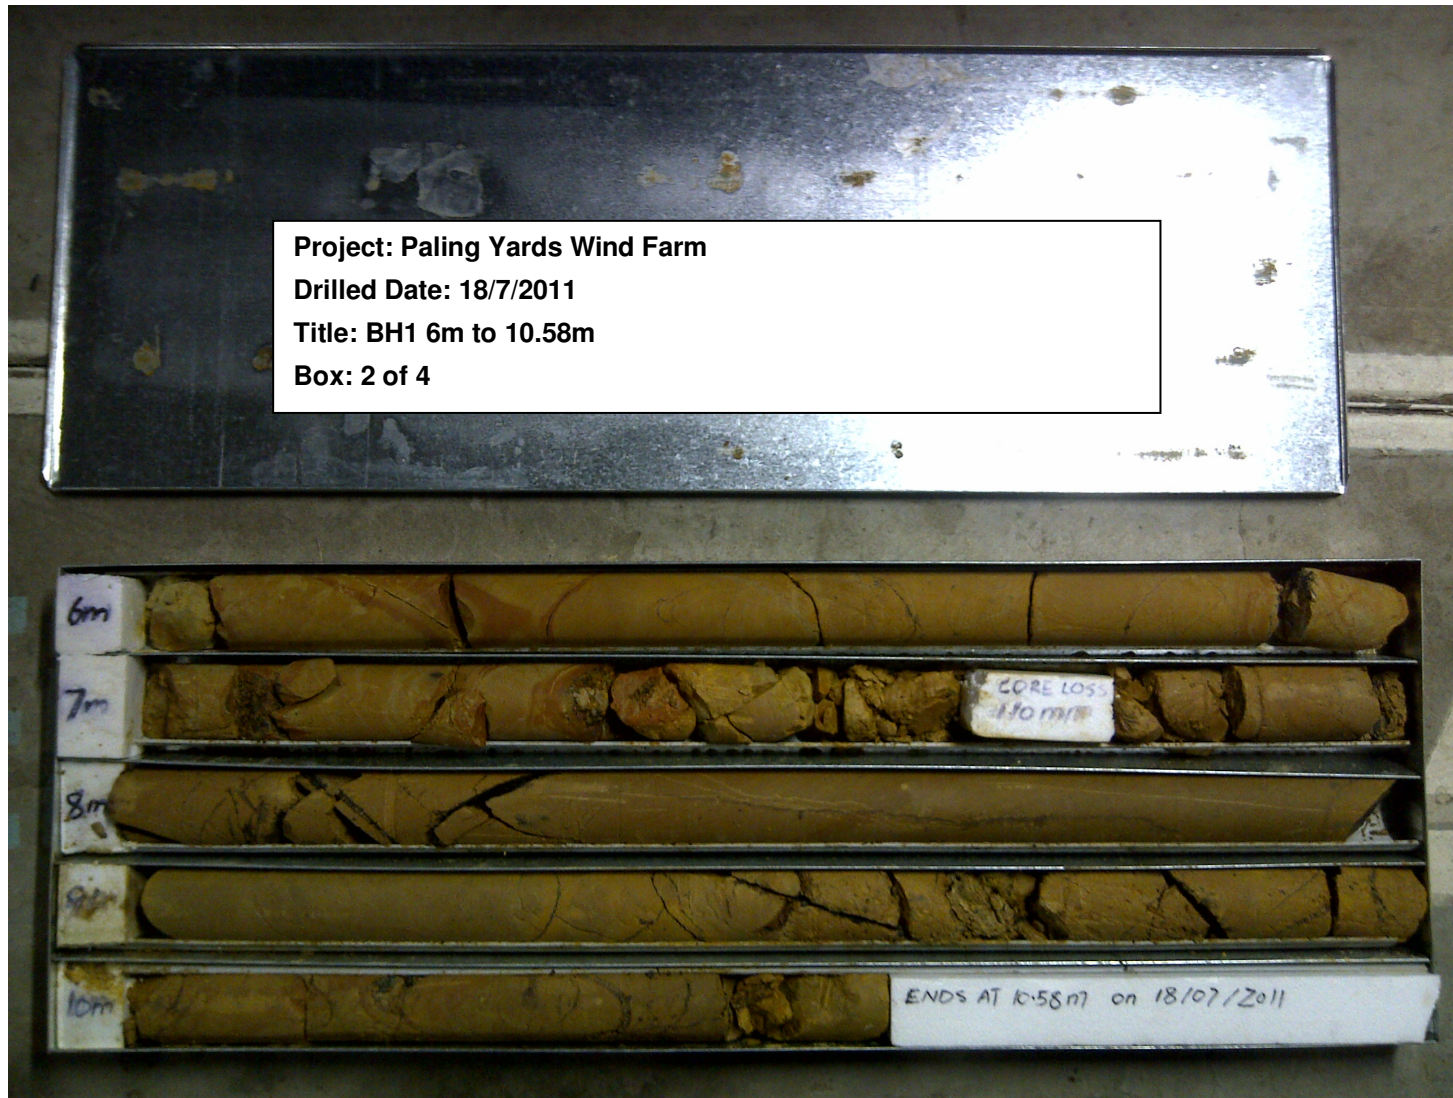
CORE PHOTOGRAPHY
BH1 6m to 10.58m
Box 2 of 4

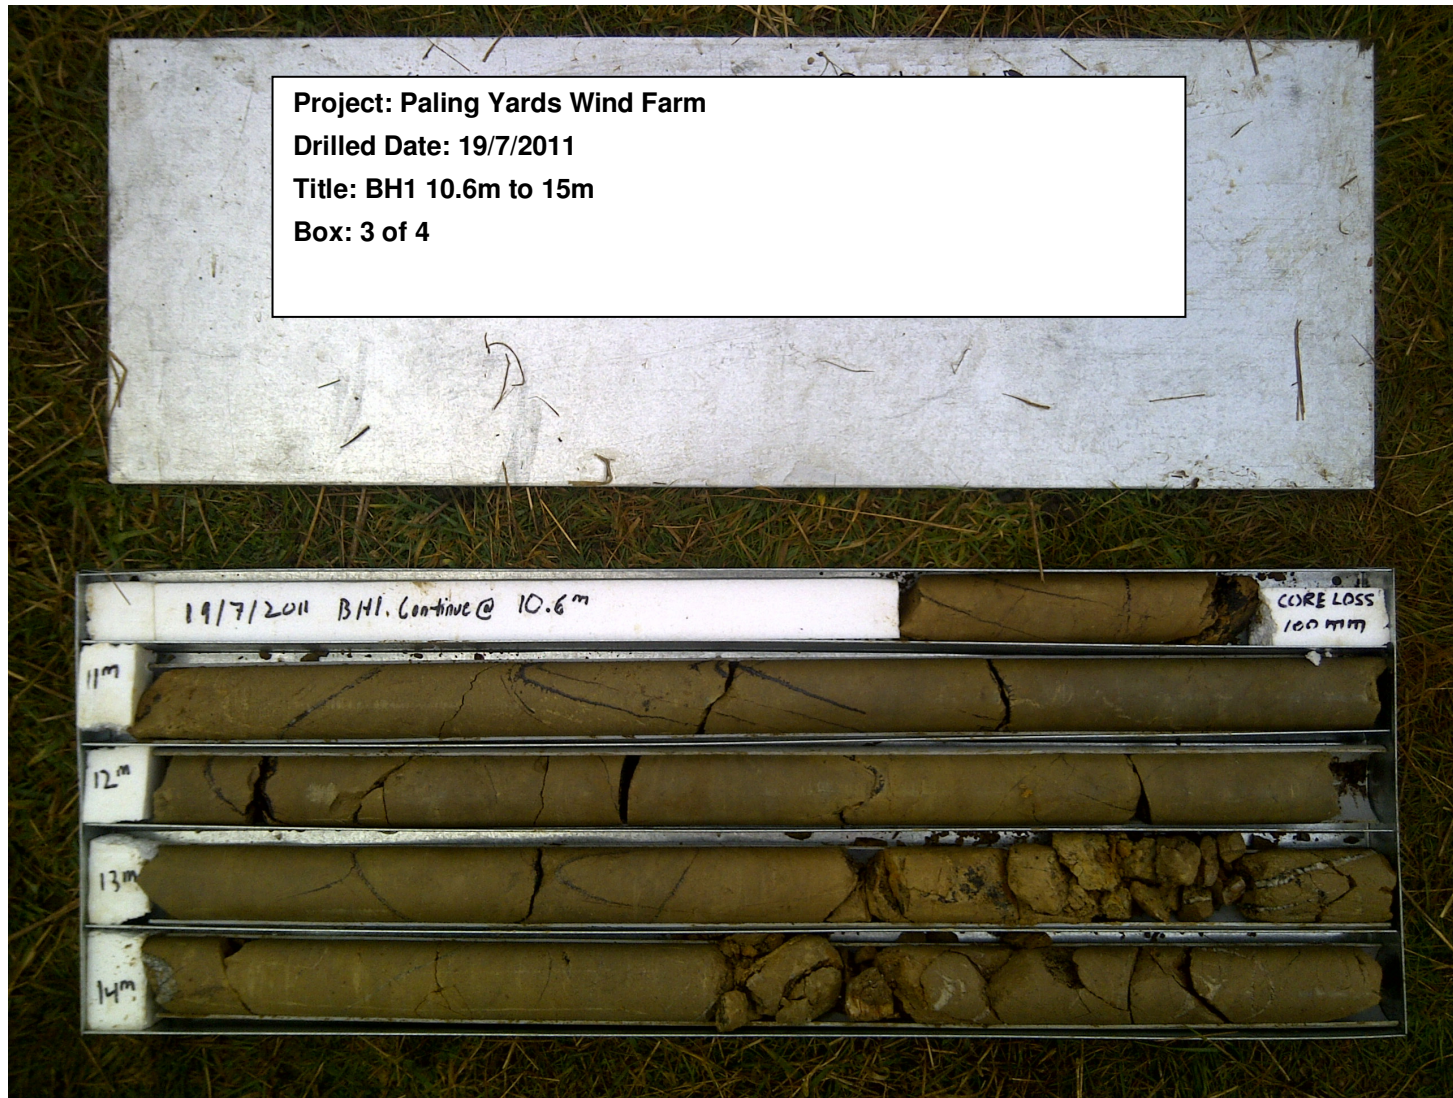
TITLE: CORE PHOTOGRAPHY BH1 10.6m to 15m Box 3 of 4	CLIENTS: Union Fenosa Wind Australia	PROJECT: Paling Yards Wind Farm	
			DATE: 26/07/2011	PROJECT NO: 43167888
