CONSERVATION MANAGEMENT PLAN & ASSESSMENT OF HERITAGE IMPACT

KAPAU HOLDINGS PTY LTD

285-287 George Street, Sydney

GRAHAM BROOKS AND ASSOCIATES PTY LTD
ARCHITECTS AND HERITAGE CONSULTANTS

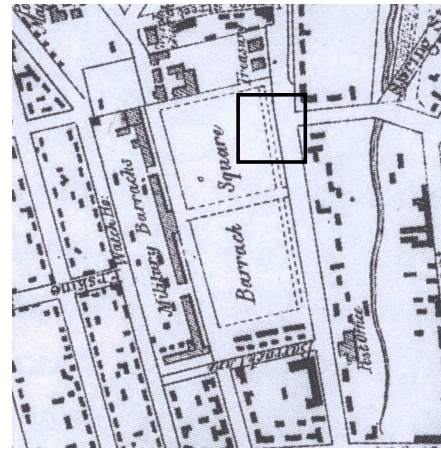
Figure 2-2 Detail of the Plan of Sydney, 1836 by J. Basire, showing the approximate location of the subject site within the Military Barracks ground. (Source: Ashton & Waterson, 2000)

The two-storey barrack blocks stood back from George Street, and there were gates on the four sides of the walls. The main gate, with guardhouse, was in George Street, close to the present Wynyard Station ramp.

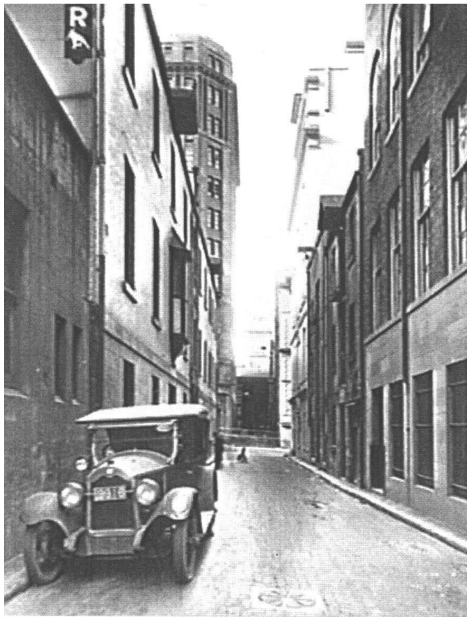
Figure 2-18 Looking north in Wynyard Lane, 1926. The subject building is on the right side. Note original configuration of the ground floor façade (Source: The Archives of the City of Sydney)

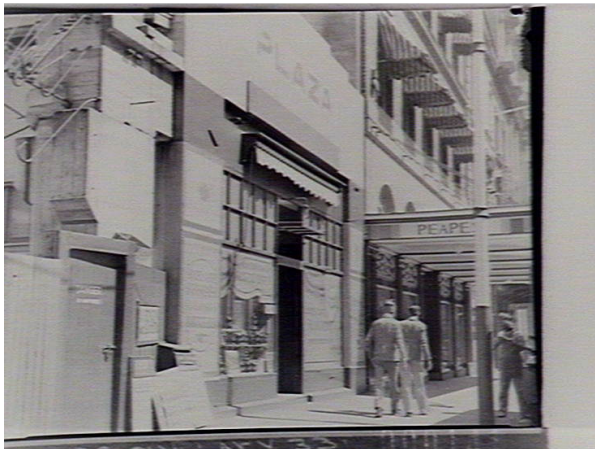
Figure 2-19 Looking north in George Street towards Peapes Menswear, c. 1935. Note original configuration of the ground floor featuring elaborated columns and suspended awning. (Source: State Library of NSW)

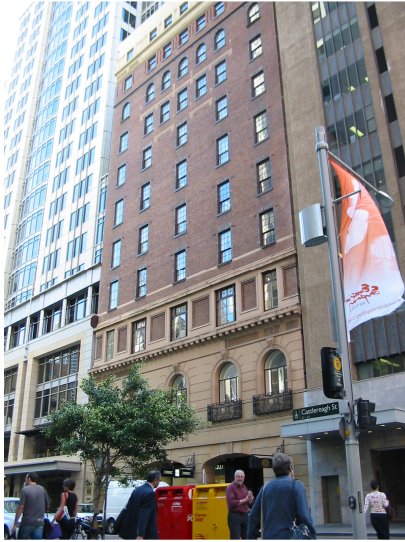
Figure 2-34 *Attributed to Wilson Neave & Berry (although there is no proof of this attribution), the Usher Private Hotel (present British Airways House) was erected in c 1914. The polychrome brick and sandstone façade of the building represents the Commercial Palazzo with Georgian Revival detailing, which is an uncommon combination.*

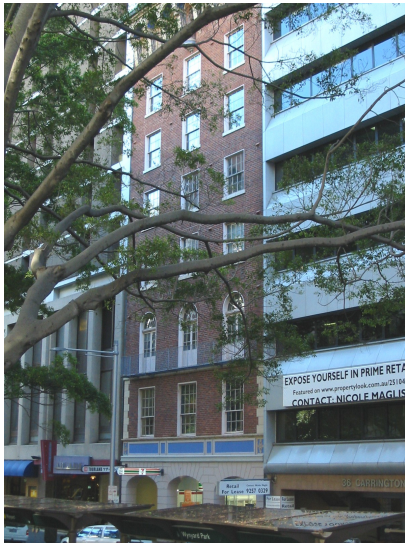
Figure 2-35 *Lisgar House was designed by Gilbert Hughes & Maloney in 1927. The relatively tall scale of this Georgian Revival style building and its unusual cornice treatment make it a rare example of the period. It is an important contributor to the townscape character around Wynyard Park.*

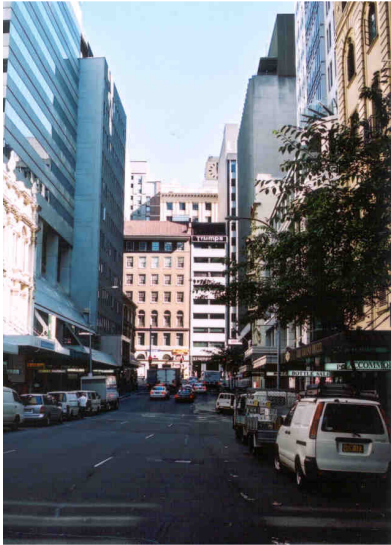
Figure 3-1 The urban context of Beneficial House dramatically changed in the last 30-40 years. The building, which at the time of its construction in 1923 was the only “high rise” structure on this section of George Street, now is dwarfed by its neighbours. Its well-proportioned brick façade, however, is a distinctive feature in the townscape.

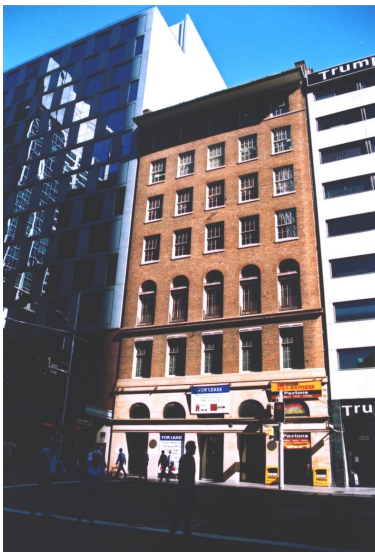
Figure 3-2 Beneficial House is a seven storey load bearing brick building in the Inter-War Georgian Revival style. The building is a blown up version of a three-storey Georgian shop front with sandstone base and face brick upper floors. The distinctive tiled roof is not visible from George Street, but is impressive when viewed from Hunter Street.

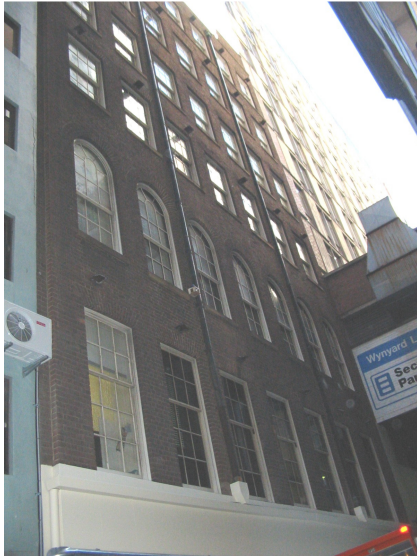
Figure 3-3 The rear façade retains its face brick upper section and multi-paned timber windows.

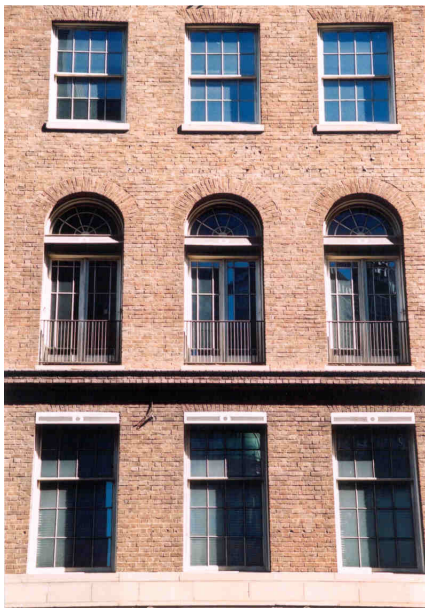
Figure 3-4 Detail of the upper section of the façade featuring excellent materials and detailing. Note multi-paned timber framed windows and semi-circular fanlights to second floor windows.

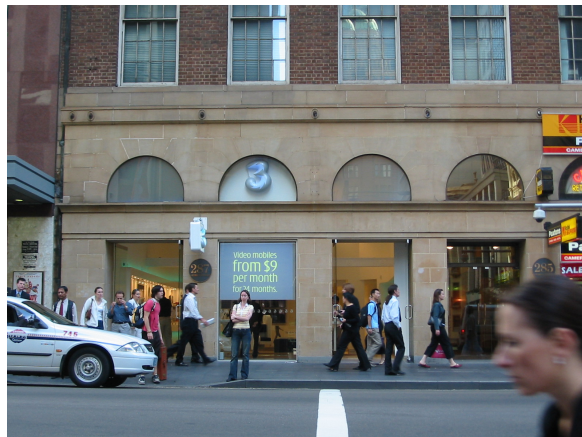
Figure 3-5 The ground floor façade was modified a number of times since the 1960s, when the original shop front was removed and replaced with sandstone arcade. Components of the original fabric including the awning and characteristic Georgian type glazing bars of the semi-circular fanlights have also been lost.

- Missing glazing bars to fan lights at ground floor (George Street facade)

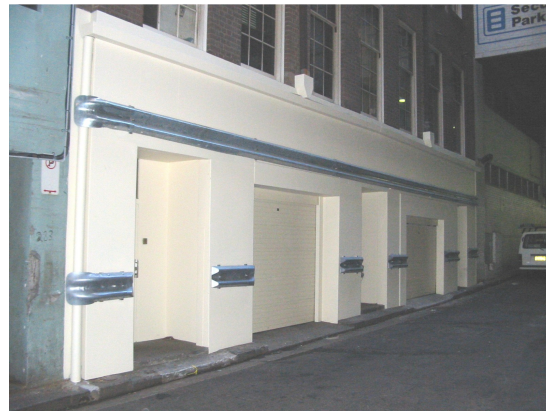
Figure 3-7 The stone base of the rear façade has been altered, covered with metal plates for protection and painted over. A new rear entrance was formed in 1971, one loading dock created in 1995 and another in 2003.

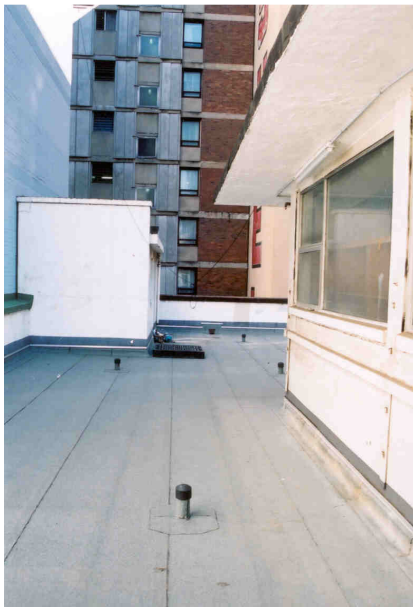
Figure 3-8 Looking west towards Wynyard Lane on roof level. Note the small structure on the left that accommodated former fire stairs. With the introduction of a new fire stair in 1971 it was converted to a store. The store on the right dates from 1971 and was built on the top of the former light area.

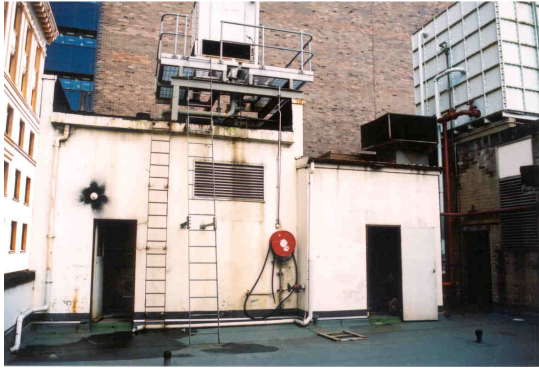
Figure 3-9 Looking north along the wester side of the roof. This structure accommodated the goods lift, which was demolished in 1971

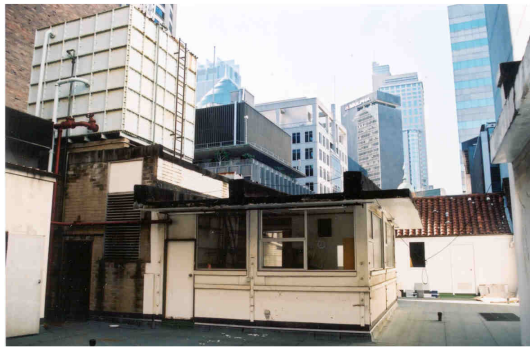
Figure 3-10 Looking east on the roof. Note 1971 store structure, which was built on the top of the former light area. The tiled roof in the background is part of the original design. The timber wall is later addition.

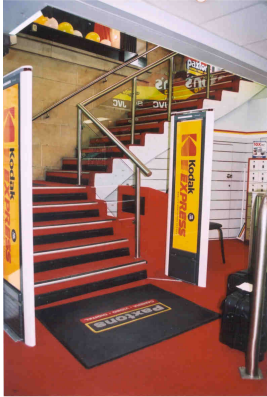
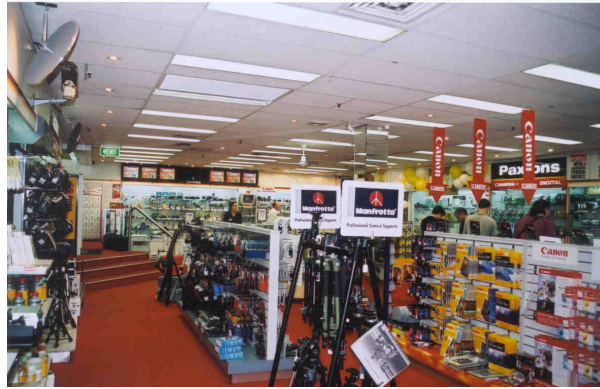
Figure 3-11 Entrance and stairs from George Street to the basement were formed in 1971. The basement is presently used as a retail space. All visible finishes and fixtures of the interior are contemporary.

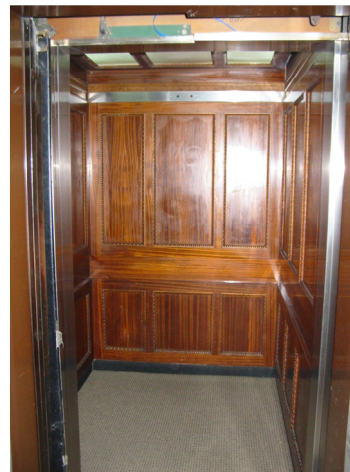
Figure 3-13 One of the two lifts, which replaced the original unenclosed lift in 1971

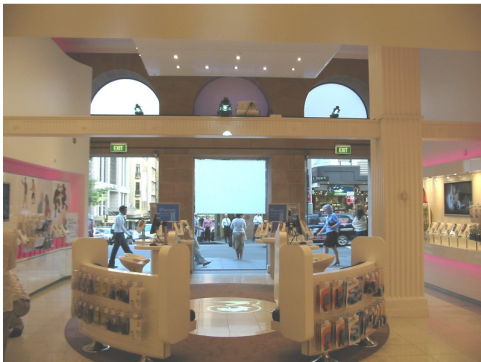
Figure 3-14 Looking east in the ground floor retail space, which was recently refurbished and re-fitted. This space has been altered several times since the 1960s, when the original shop front was removed. The retail area was converted to office space in the 1970s, which alteration included the removal the majority of original fabric and finishes. The only components of the present space that date from the initial construction are the timber-clad columns.

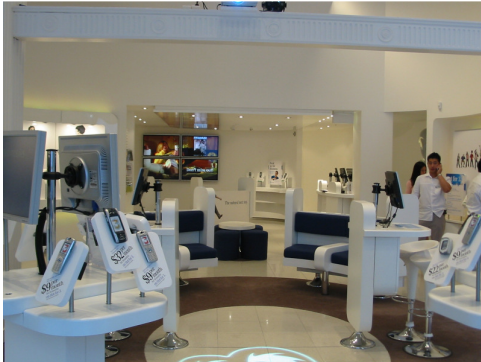
Figure 3-15 Looking west in the ground floor retail space. The spatial qualities of the original ground floor retail area were degraded, when the oval-shaped opening in the ceiling was filled in in the 1950s. The subsequent remodelling of the building, which included the construction of tenant entrance, enclosed lift and fire stairs and mezzanine level and the removal of much of the original finishes and fixtures, further degraded the qualities of the original ground floor retail space.

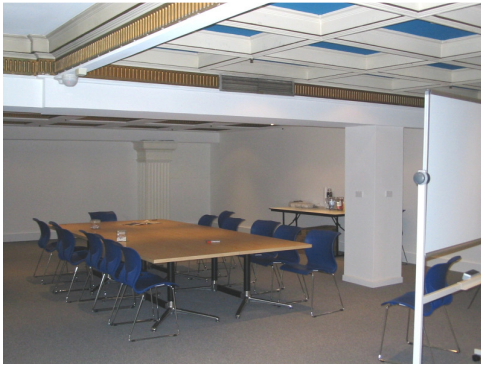
Figure 3-16 Looking east at mezzanine level, which was created in the 1970s. Note the coffered ceiling, which date from the 1971 remodelling of the interior.

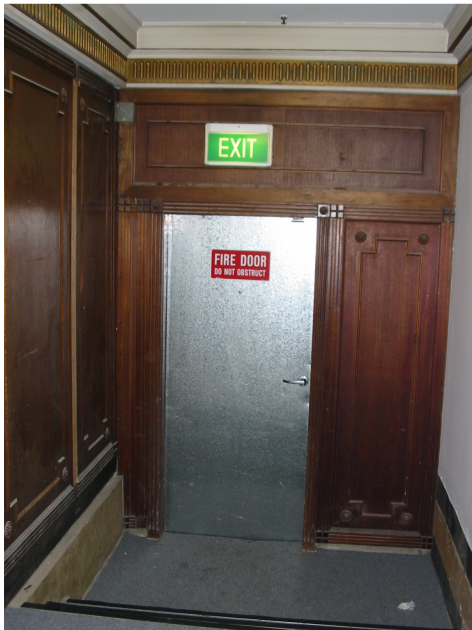
Figure 3-18 This rear entrance to the mezzanine level from Wynyard Lane was created in 1971, replacing the central window at the rear façade. Timber wall panelling and ceiling dates from the same alteration. The panelling of the north wall was probably removed in 1995 for the construction of the loading dock.

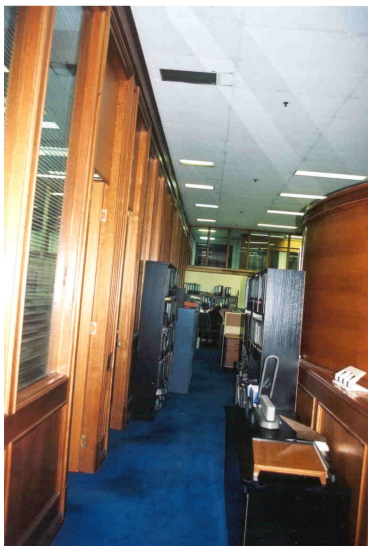
Figure 3-19 The fitout of first floor office space appear to date from the 1971 major refurbishment. Note full-height timber and glass partitions and false ceiling

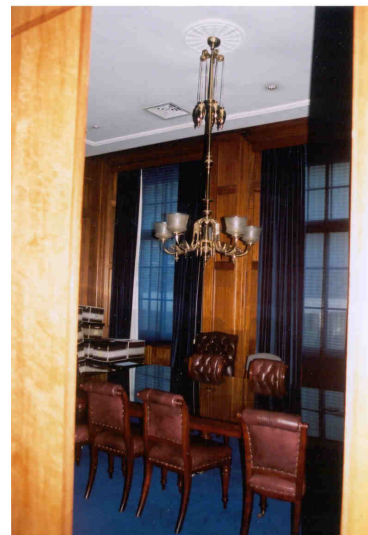
Figure 3-20 Conference room, located at the George Street side of the first floor office space. Note original windows. Timber wall panelling and ceiling lining, however, dates from the 1970s

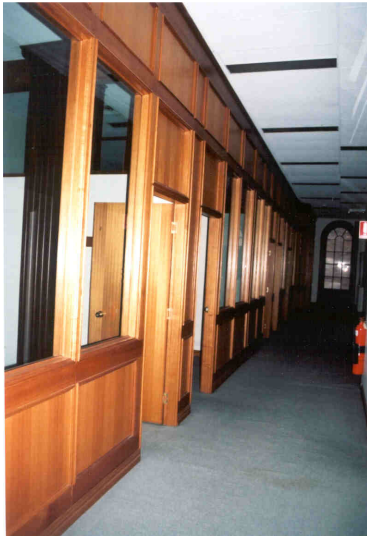
Figure 3-21 Timber and glass full-height partitions at second floor. This level is presently vacant

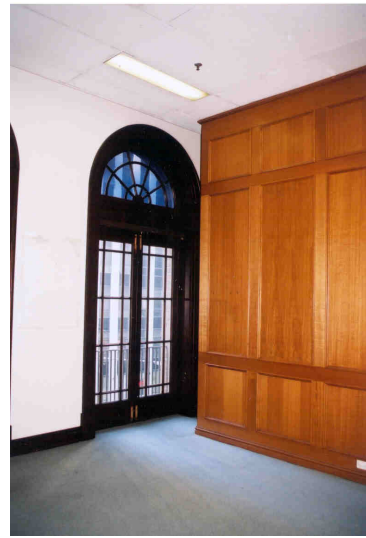
Figure 3-22 Office space facing George Street. Note original timber door with semi-circular fanlight

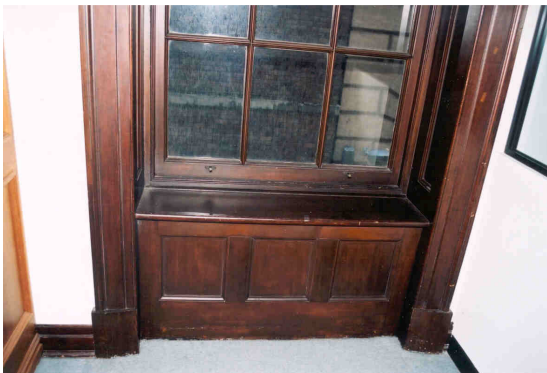
Figure 3-23 Joinery associated with windows and doors on both facades survived throughout the building

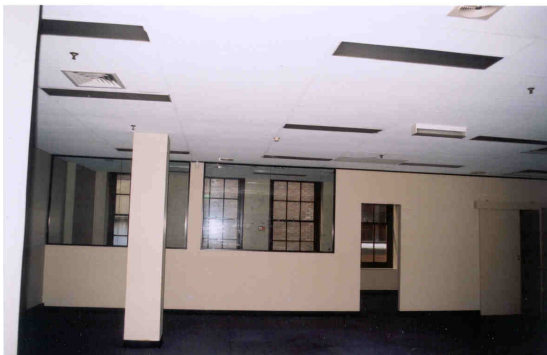
Figure 3-24 Looking west at the third floor office space. This level features lightweight partitions suspended ceiling and carpeted floors. Presently the office space is unoccupied.

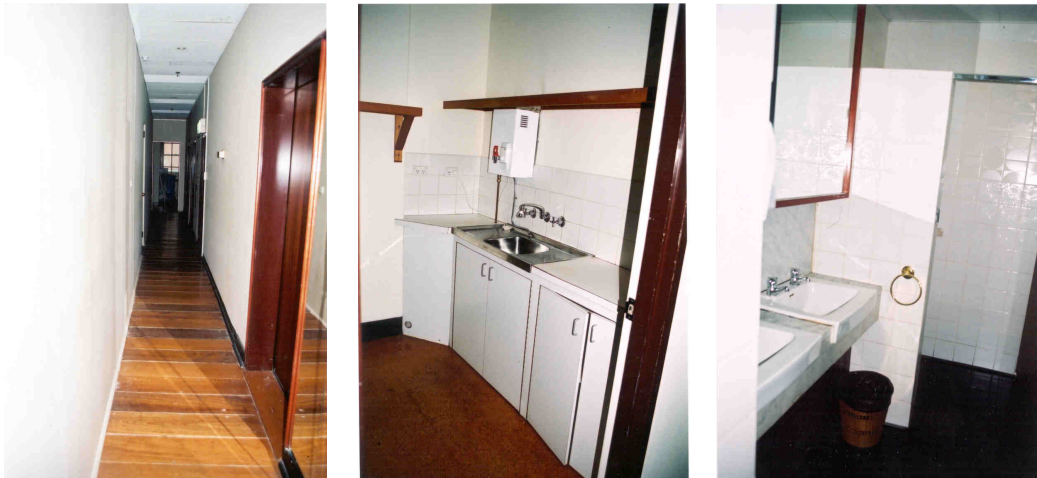
Figure 3-25 The exposed timber floor at third level may be part of the original 1923 fabric of the building. Kitchen and toilet fitouts date from 1971 or more recent alterations throughout the building.

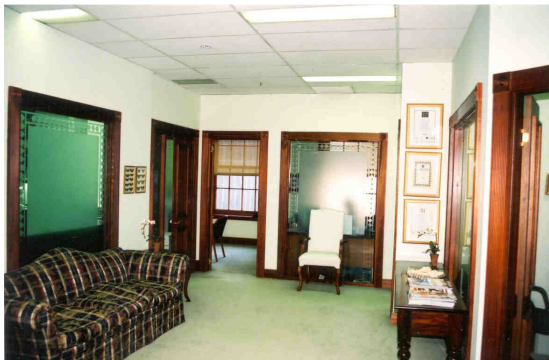
Figure 3-26 View of the fourth level office space, looking east, towards the George Street frontage. This level features painted light-weight partitions, suspended ceilings, carpeted floor and glazed timber internal doors
