NO. 2-12 CARRINGTON STREET, SYDNEY
FORMER SHELL HOUSE
DRAFT CONSERVATION MANAGEMENT PLAN

PREPARED BY
HBO+EMTB HERITAGE PTY LTD
FOR
THAKRAL HOLDINGS GROUP PTY LTD
SEPTEMBER 2005

Project no. 280121

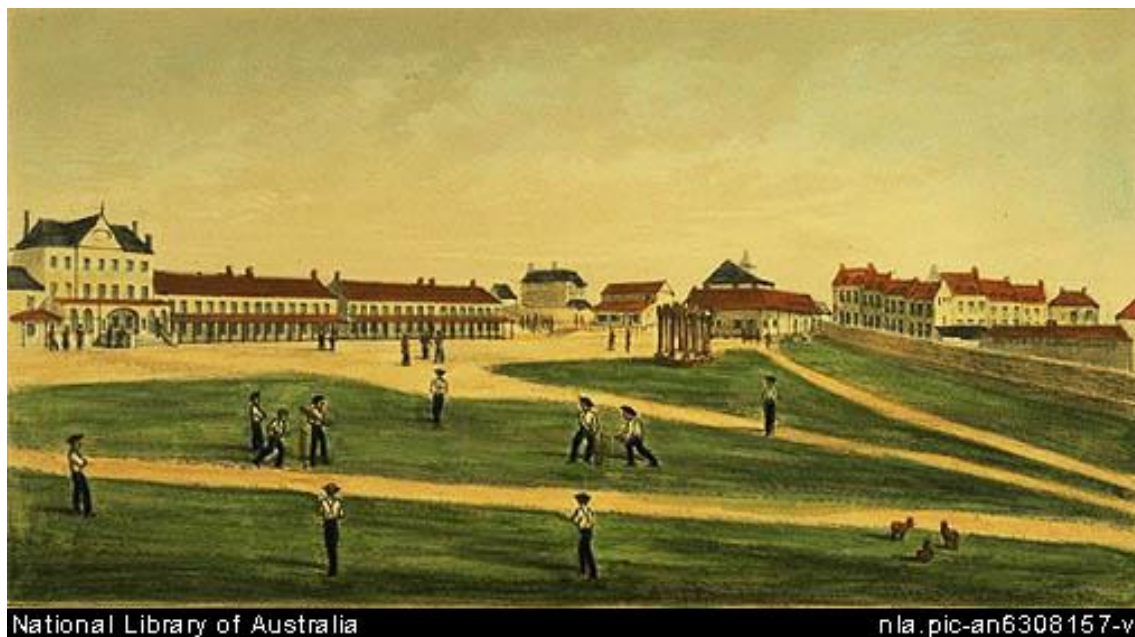
Figure 2.3 :
Sydney Barracks, York Street, Sydney, illustration of Lithograph c 1845.
(source: National Library of Australia, PIC PIC U3546 NK421/E LOC 3308)

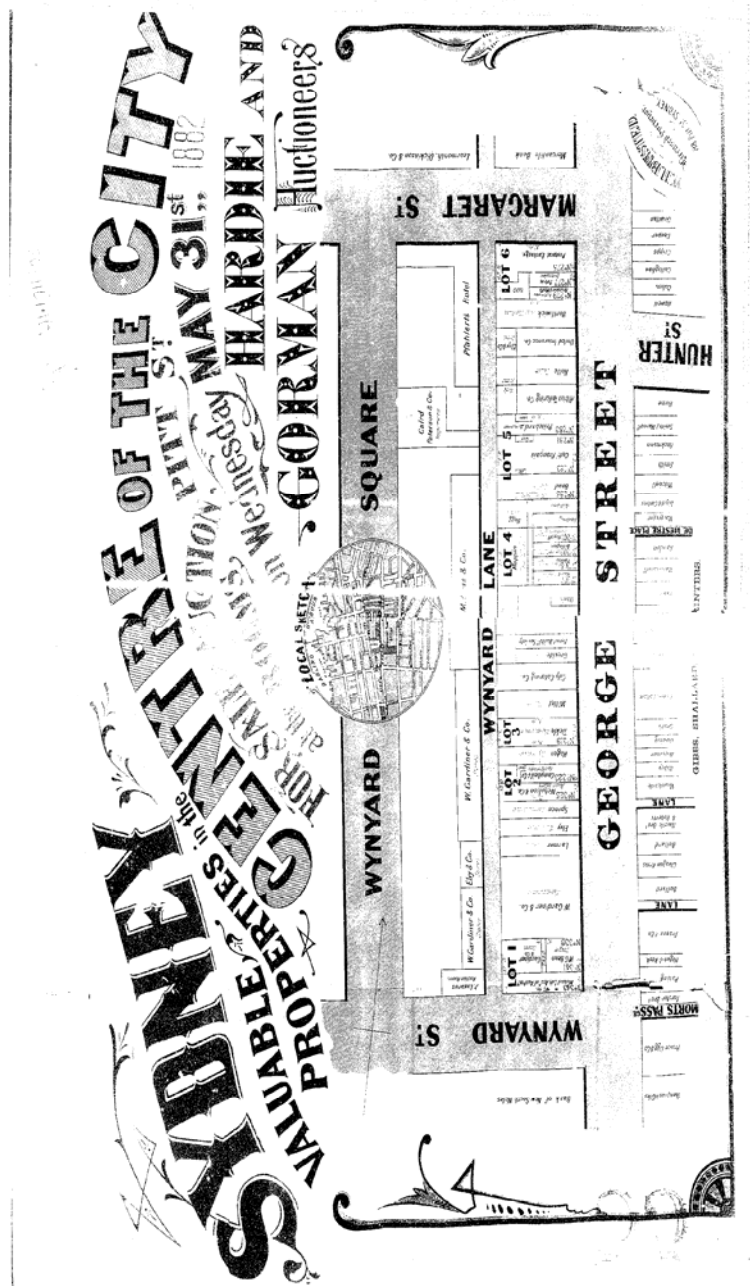
Figure 2.8:
Hardie and Gorman Auctioneers 1882
(source: City of Sydney archives)

⁸ See figure 2.7, 2.8, and 2.9.

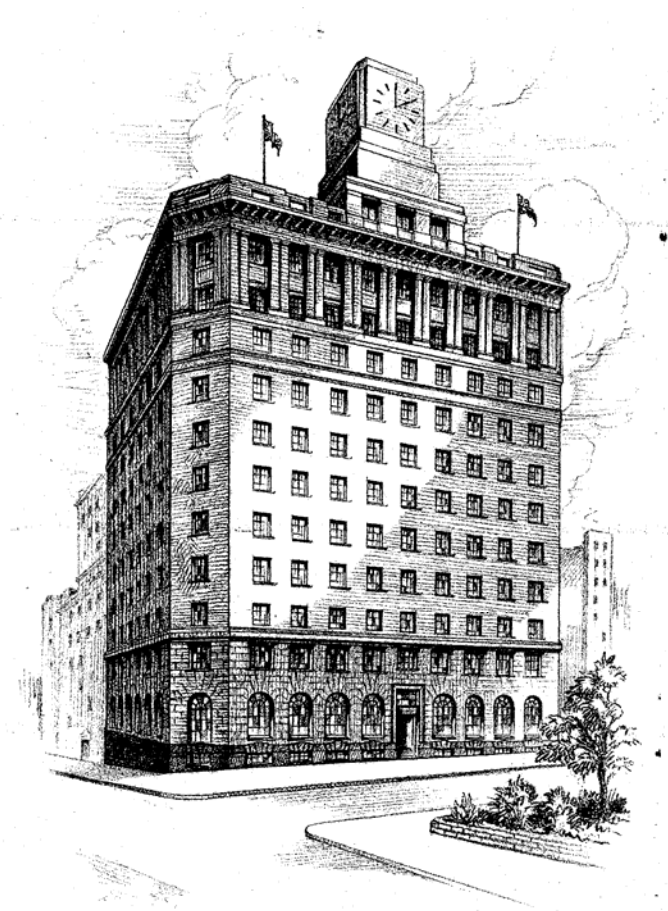
Figure 2.12: No 2-12 Carrington Street, Sydney , former Shell House.

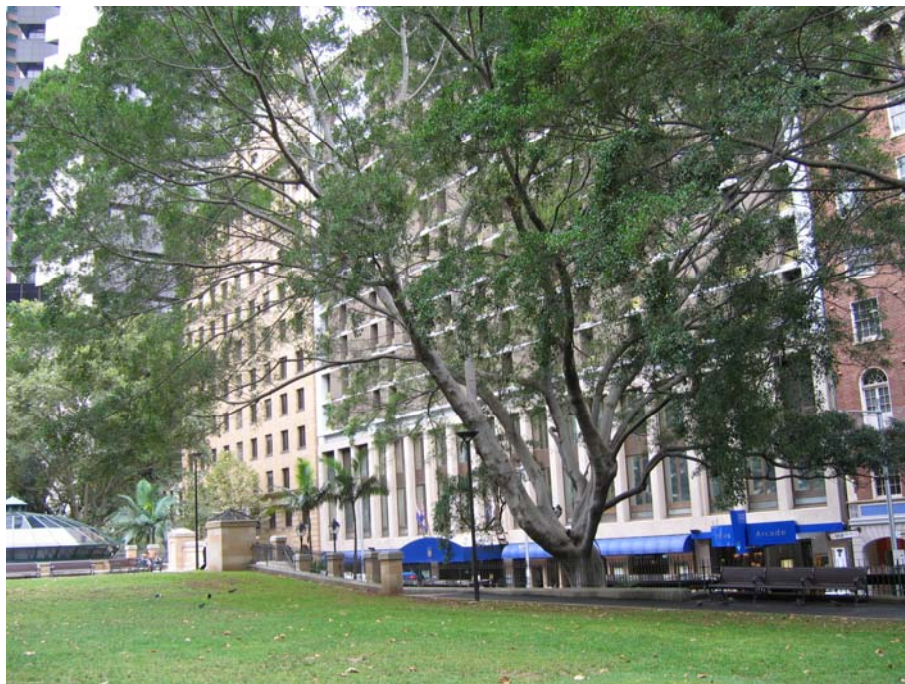
Photograph 3.1 Illustrates a view from Wynyard Park, north east towards Menzies Hotel, No. 2-12 Carrington Street, (north wing of Menzies Hotel and former Shell House) and 14 Carrington Street, Menzies (Sydney) Hotel. (source: Brian McDonald of HBO+EMTB Heritage Pty Ltd, February 2005)

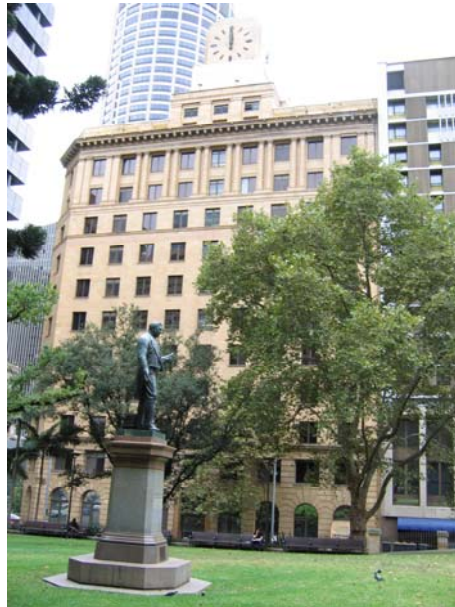
Photograph 3.2 Illustrates No. 2-12 Carrington Street, (north wing of Menzies (Sydney) Hotel and former Shell House). (source: Brian McDonald of HBO+EMTB Heritage Pty Ltd, February 2005)

The former Shell House has a street address of No. 2-12 Carrington Street, Sydney. The site is located on a corner bound by Carrington Street to the west, Margaret Street to the north, Wynyard Lane to the east and a neighbouring property, 14 Carrington Street to the south, which is the major portion of the Menzies Hotel.

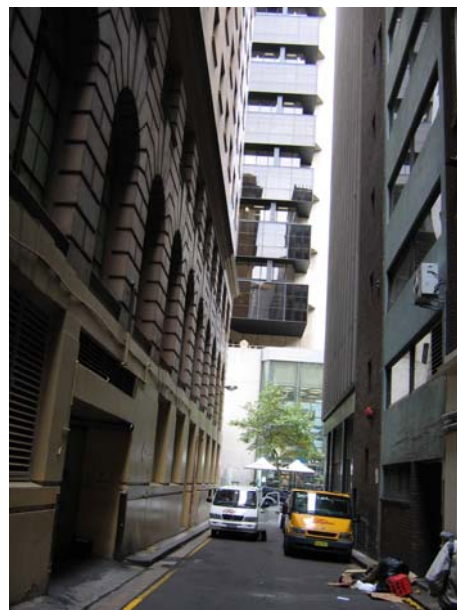
Photograph 3.5 Taken from Wynyard Lane looking north with No. 2-12 Carrington Street to the left, showing a render finish to the east façade. (source: Brian McDonald of HBO+EMTB Heritage Pty Ltd, February 2005)

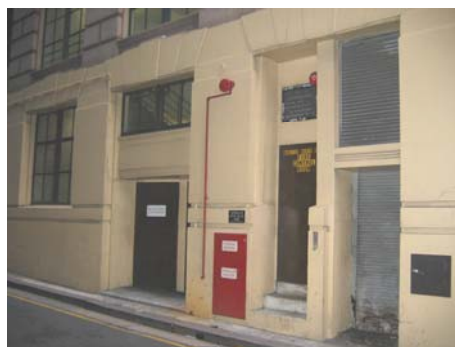
Photograph 3.6: illustrates fire doors on to Wynyard Lane. (source: Photograph taken by Brian McDonald of HBO+EMTB Heritage Pty Ltd, February 2005)

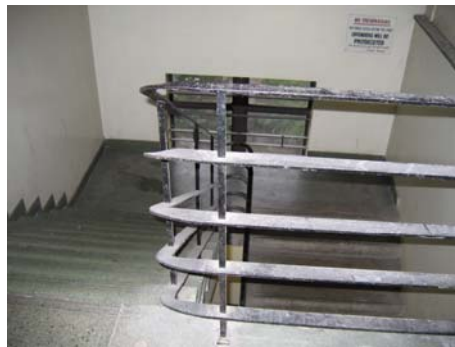
Photograph 3.7: illustrates typical metal balustrade to fire stair. (source: Photograph taken by Brian McDonald of HBO+EMTB Heritage Pty Ltd, February 2005)

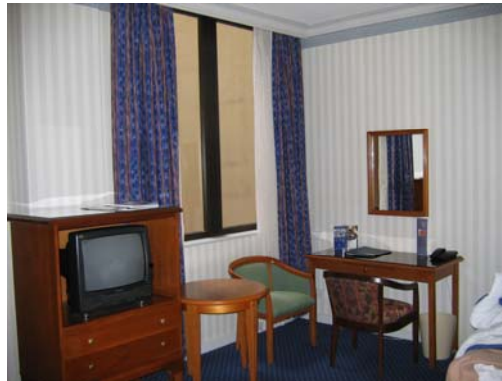
Photograph 3.9: illustrates typical hotel suite located along internal light well. (source: Photograph taken by Brian McDonald of HBO+EMTB Heritage Pty Ltd, February 2005)

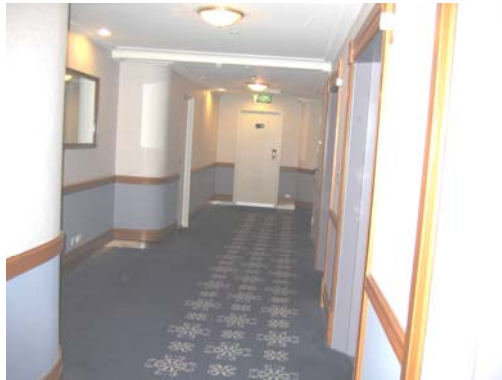
Photograph 3.10: illustrates typical internal corridor with lift core to the right (source: Photograph taken by Brian McDonald of HBO+EMTB Heritage Pty Ltd, February 2005)

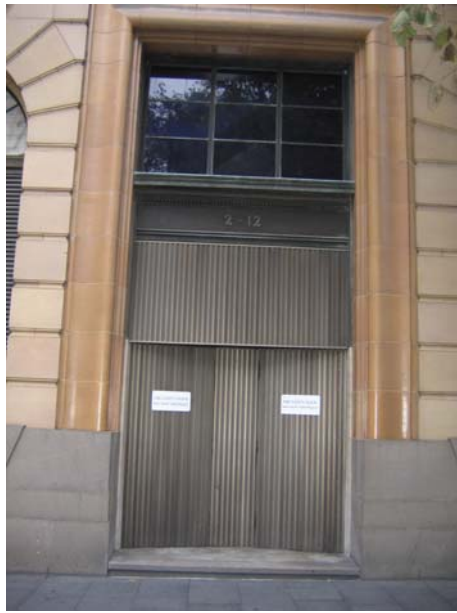
Photograph 3.12: illustrates fire doors onto Carrington Street, former Shell House principal entrance. (source: Photograph taken by Brian McDonald of HBO+EMTB Heritage Pty Ltd, February 2005)

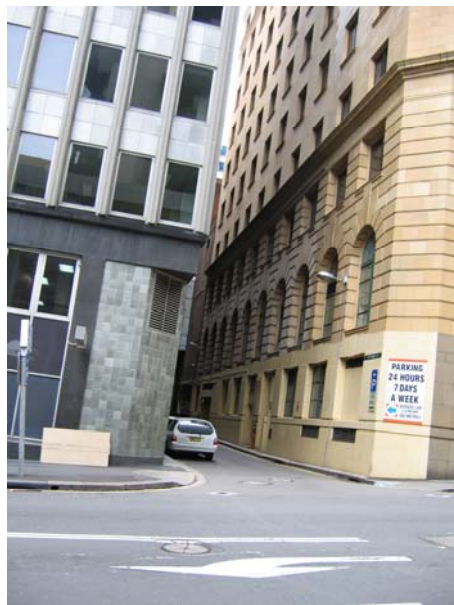
Photograph 3.13: illustrates northern entrance of Wynyard Lane. (source: Photograph taken by Brian McDonald of HBO+EMTB Heritage Pty Ltd, February 2005)

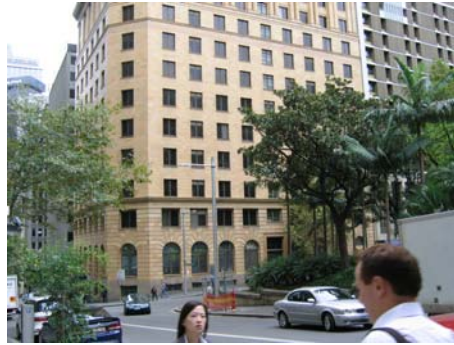
Photograph 3.14: illustrates north west corner of No. 2-12 Carrington Street, former Shell House (source: Photograph taken by Brian McDonald of HBO+EMTB Heritage Pty Ltd, February 2005)

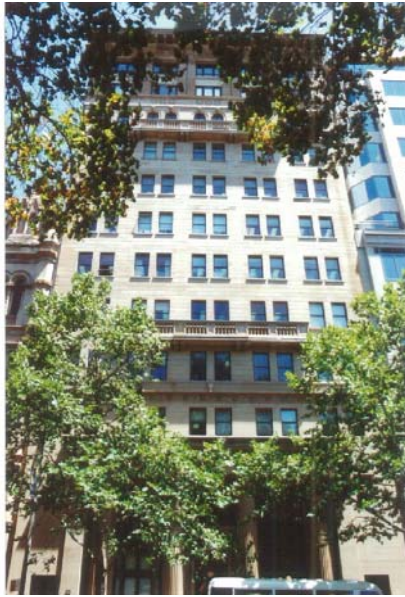
Figure 4.1
185 Elizabeth Street, Sydney
Architect: John P. Tate and Young
Construction: Concrete Frame, sandstone exterior
Inter War Commercial Palazzo, 1923
(source: Brian McDonald & Associates 1996)

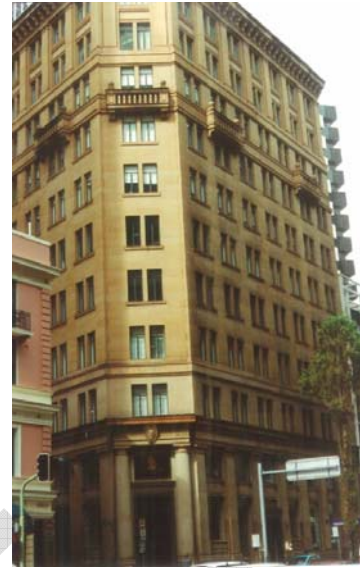
Figure 4.2:
Singapore House, 17-19 Bridge Street, Sydney,
Architect: Spain and Cosh Architects
Construction: sandstone exterior, reinforced concrete
Inter War Commercial Palazzo, 1925-1927
(source: Brian McDonald & Associates 1996)

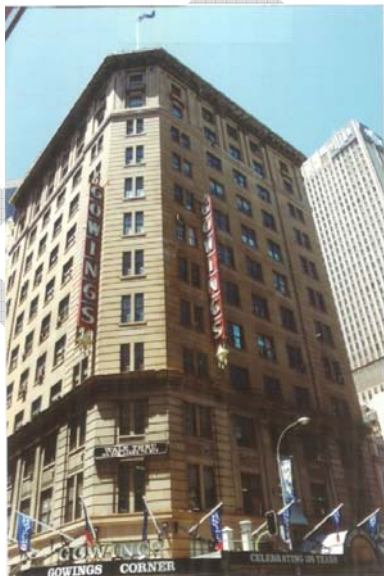
Figure 4.3
Gowings Department Store, 452-456 George Street, Sydney.
Architect: Robertson & Marks
Construction: Reinforced Concrete frame, sandstone exterior
Inter War commercial palazzo, 1912-1929
(source: Brian McDonald & Associates 1996)

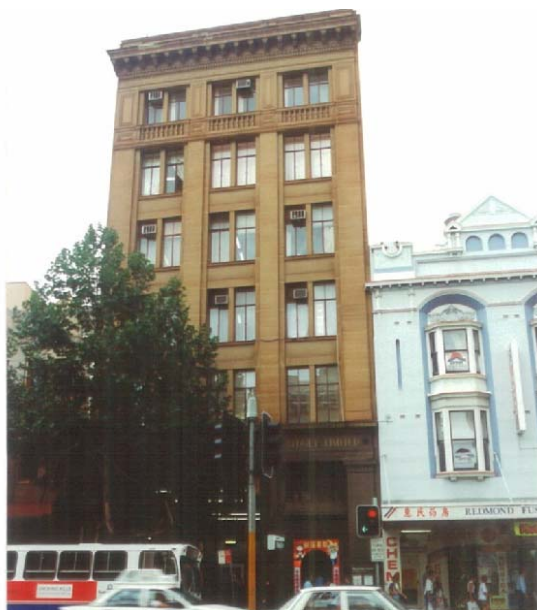
Figure 4.4
National Australia Bank, 661-663 George Street, Sydney.
Architect: Kent & Massie
Construction: Reinforced Concrete frame, sandstone and granite exterior
Inter War commercial palazzo, 1925
(source: Brian McDonald & Associates 1996)

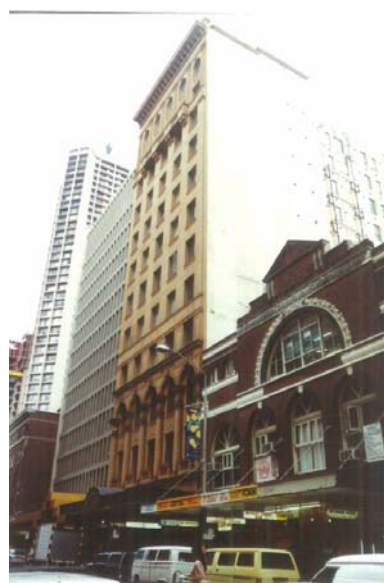
Figure 4.5
Masonic Club, 169-173 Castlereagh Street, Sydney.
Architect: C. W. Chambers
Construction: Reinforced Concrete frame, sandstone exterior with trachyte cladding to street.
Inter War commercial palazzo, 1925
(source: Brian McDonald & Associates 1996)

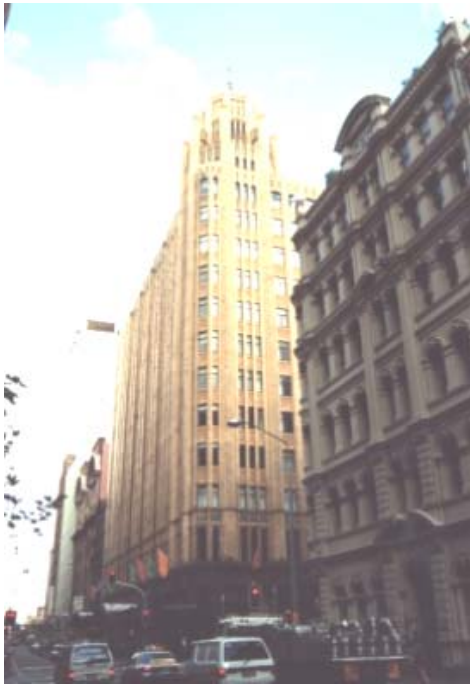
Figure 4.6:
Grace Building, 77-79 York Street, Sydney
Architect: Morrow and Gordon
Construction: 1928-10
Inter War Skyscraper Gothic Art Deco detail. –
Façade clad with - glazed terracotta tiles
(source-D. McBeath 1997)

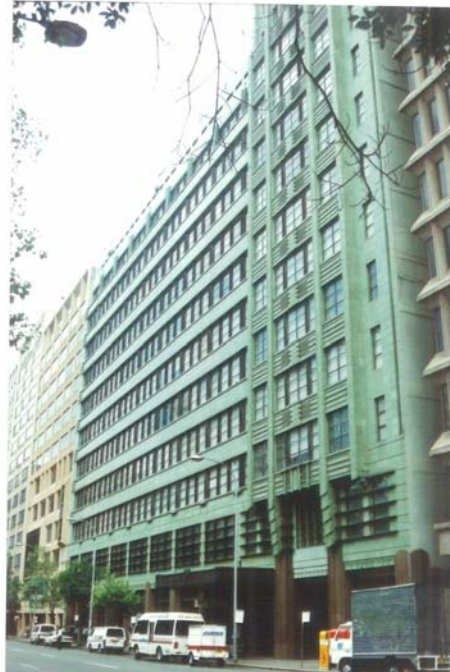
Figure 4.7
Transport House, 11-31 York Street, Sydney
Architect: H.E. Budden & Mackay
Construction: 1934-36
Inter War Art Deco. – Façade clad with -
Glazed terracotta tiles
(source-Brian McDonald & Associates 1996)
