Barangaroo Stage 1

Barangaroo Concept Plan Amendment (MP06_0162 MOD8)

Marine Ecology, Water Quality and Contaminated Sediment Impact Assessment

13 March 2015

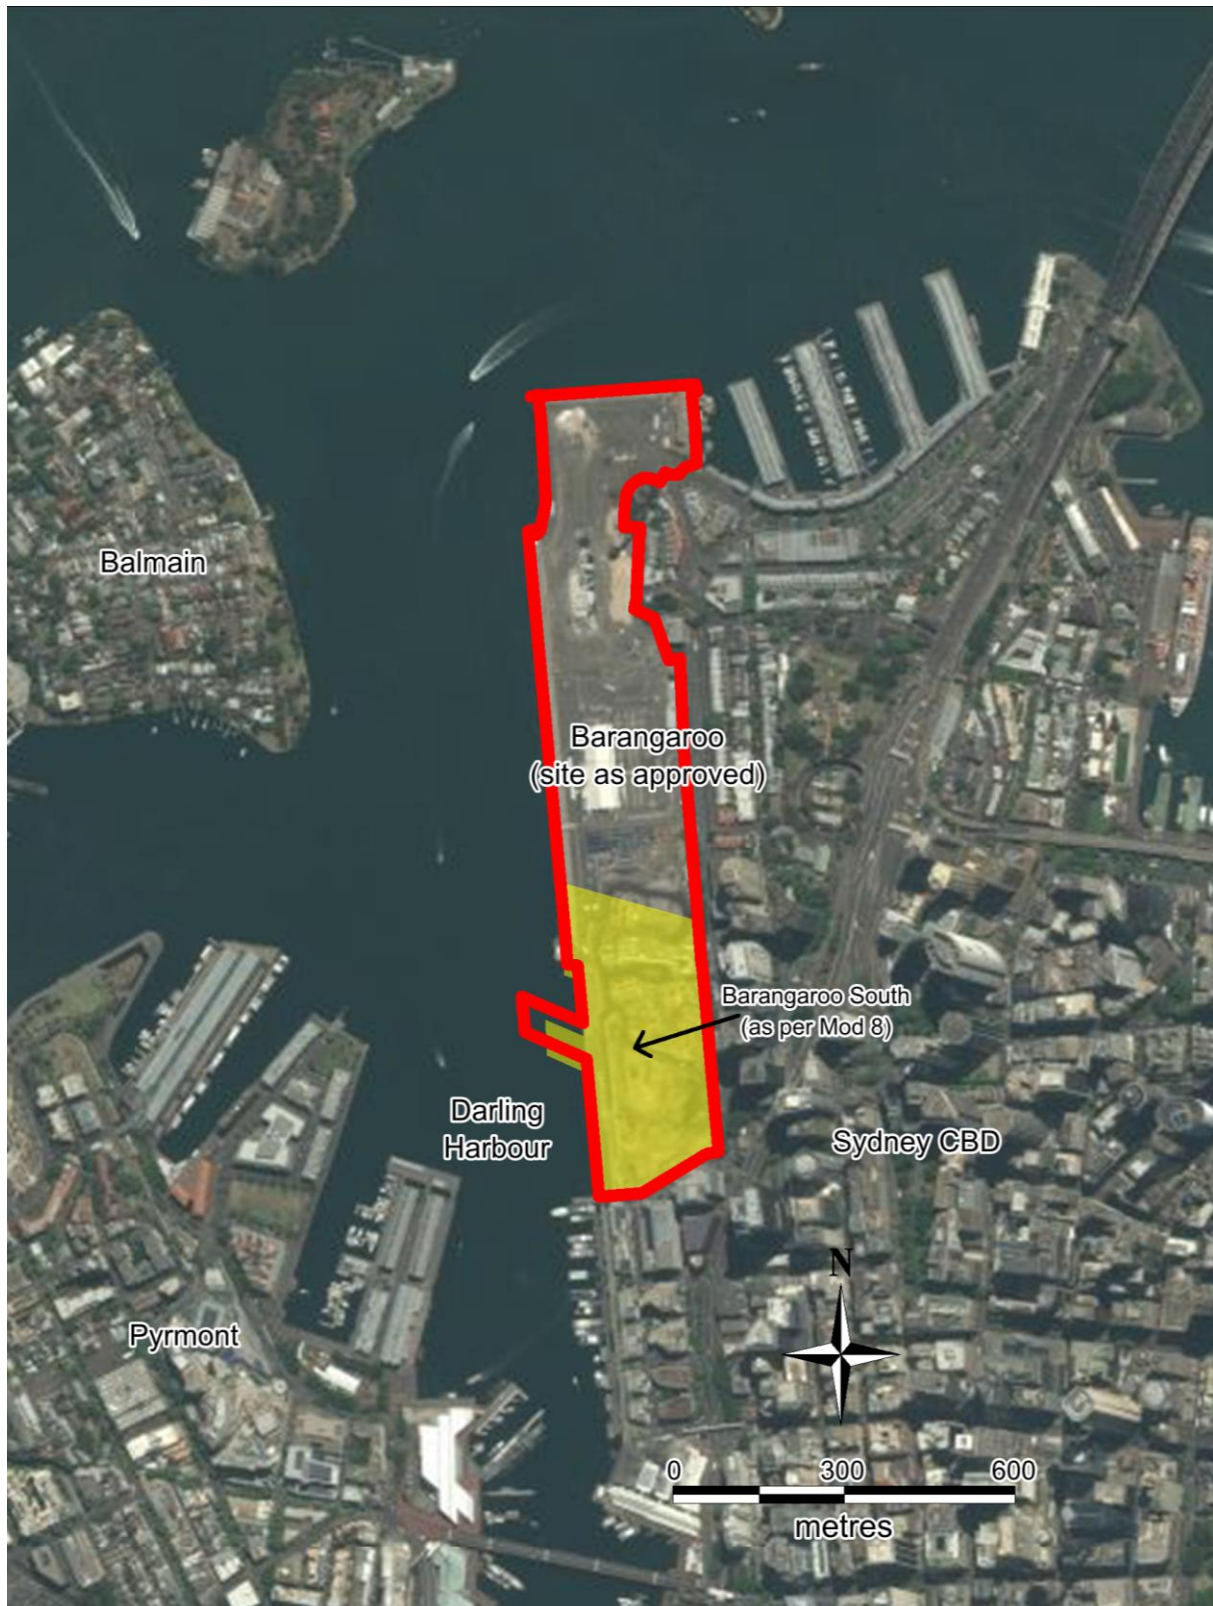
Figure 1: Location of Barangaroo site, with approximate location of Barangaroo South (as per Mod 8) shown shaded

The location of the Barangaroo site (as approved) is depicted in Figure 1, which also indicates the position of the Barangaroo South area (as per the Mod 8 Concept Plan Amendment).

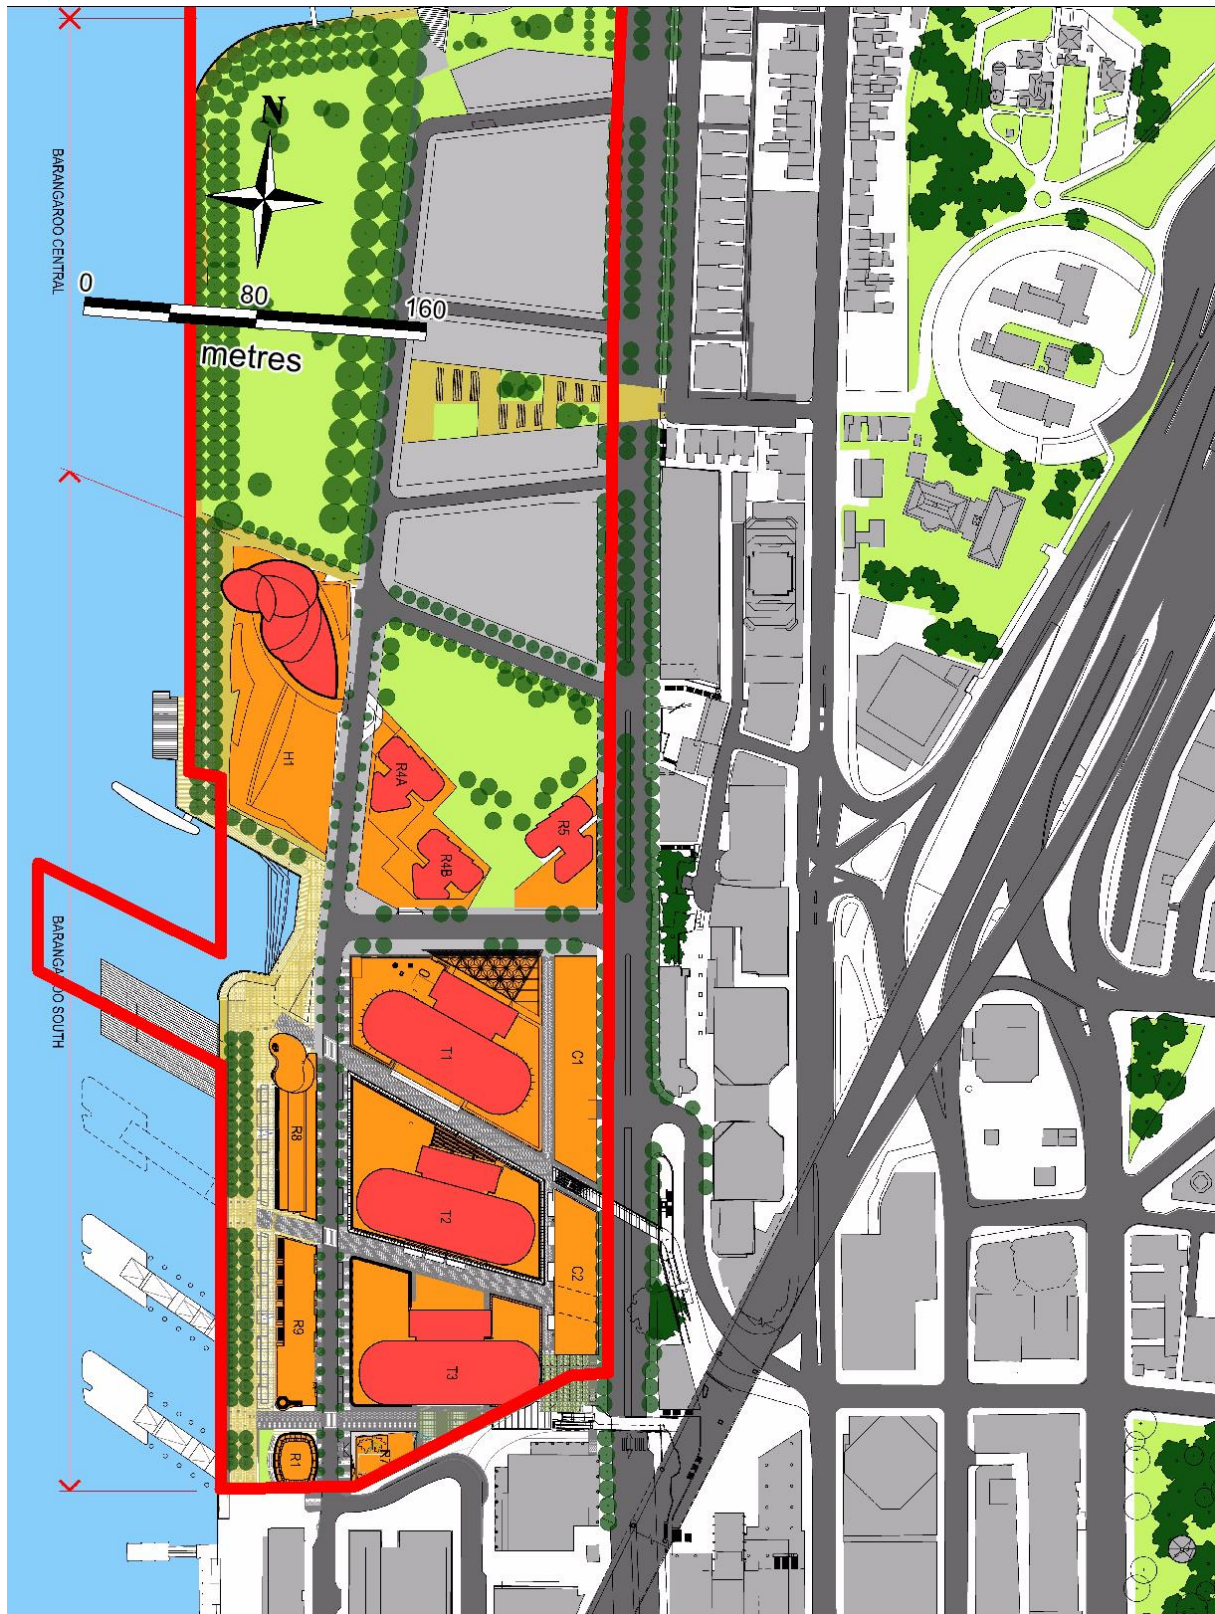
Figure 3: Mod 8 Concept Plan with approximate Mod 4 outline overlay shown in red (scale approximate)

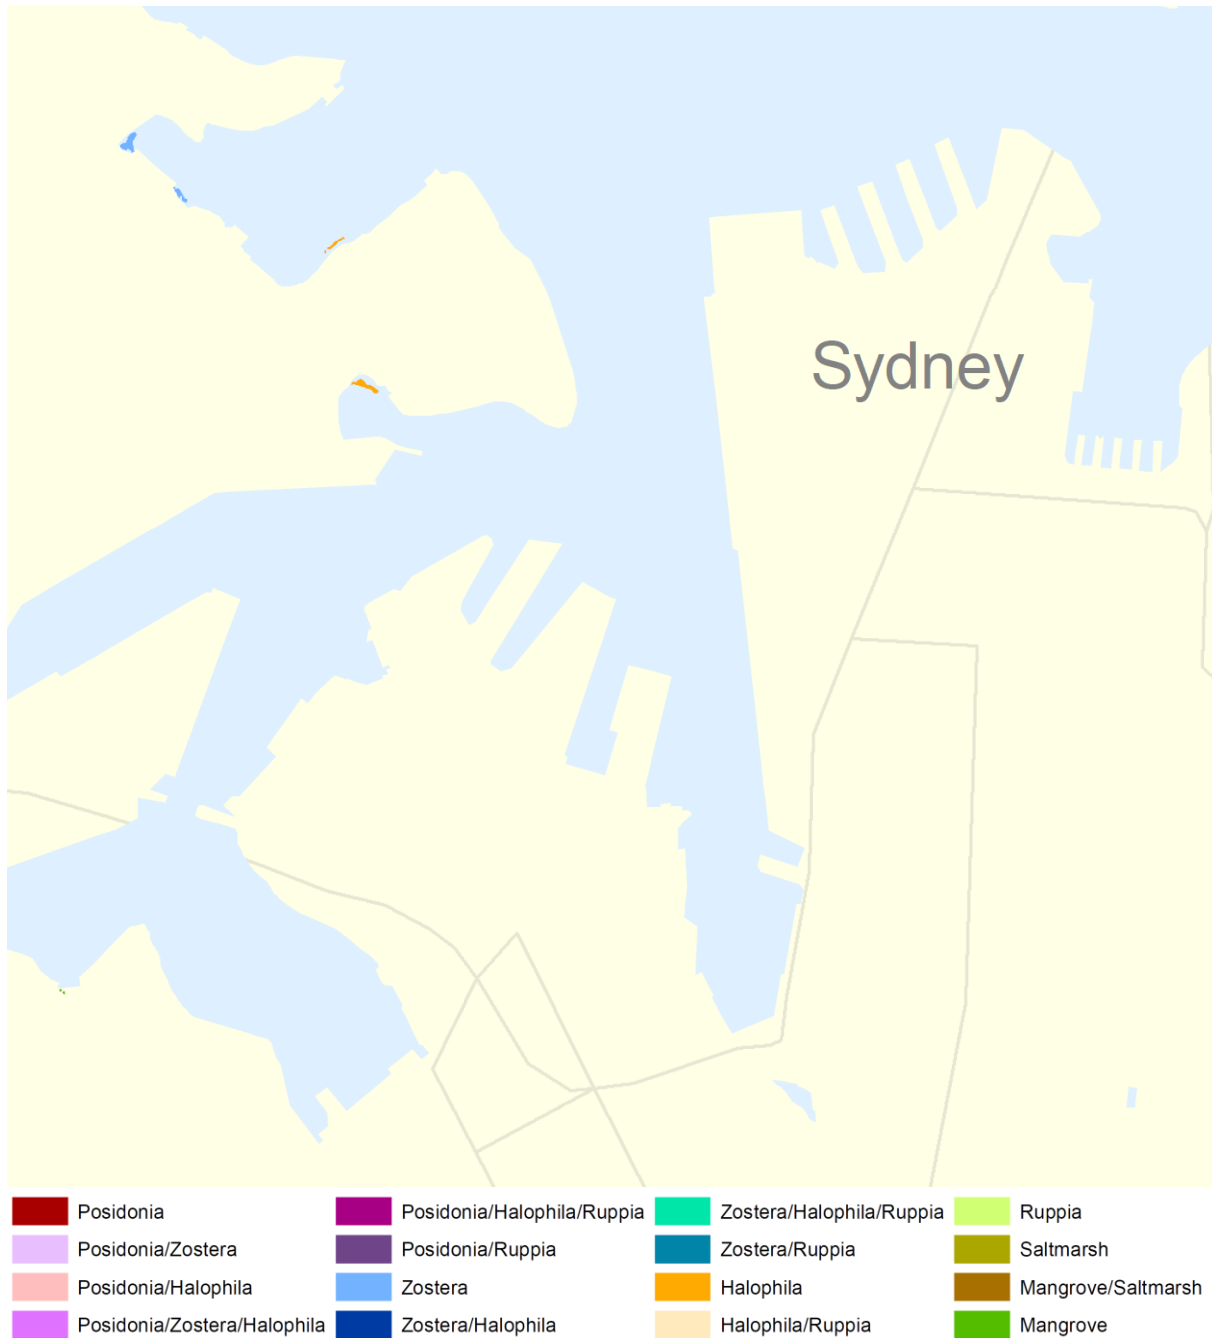
Figure 5: Aquatic vegetation in the vicinity of the study site, extract from DPI (2005) aquatic vegetation maps

The latest estuarine vegetation maps (DPI, 2005) indicate the absence of any mangroves in the vicinity of the study site (Figure 5). Also, no mangroves were observed at or near the Barangaroo South area during the site visit undertaken in May 2010 for the Mod 4 investigations.

The latest estuarine vegetation maps (DPI, 2005) indicate the absence of any saltmarsh in the vicinity of the study site (Figure 5). Also, no saltmarsh was observed at or near the Barangaroo South area during the site visit undertaken in May 2010 for the Mod 4 investigations.

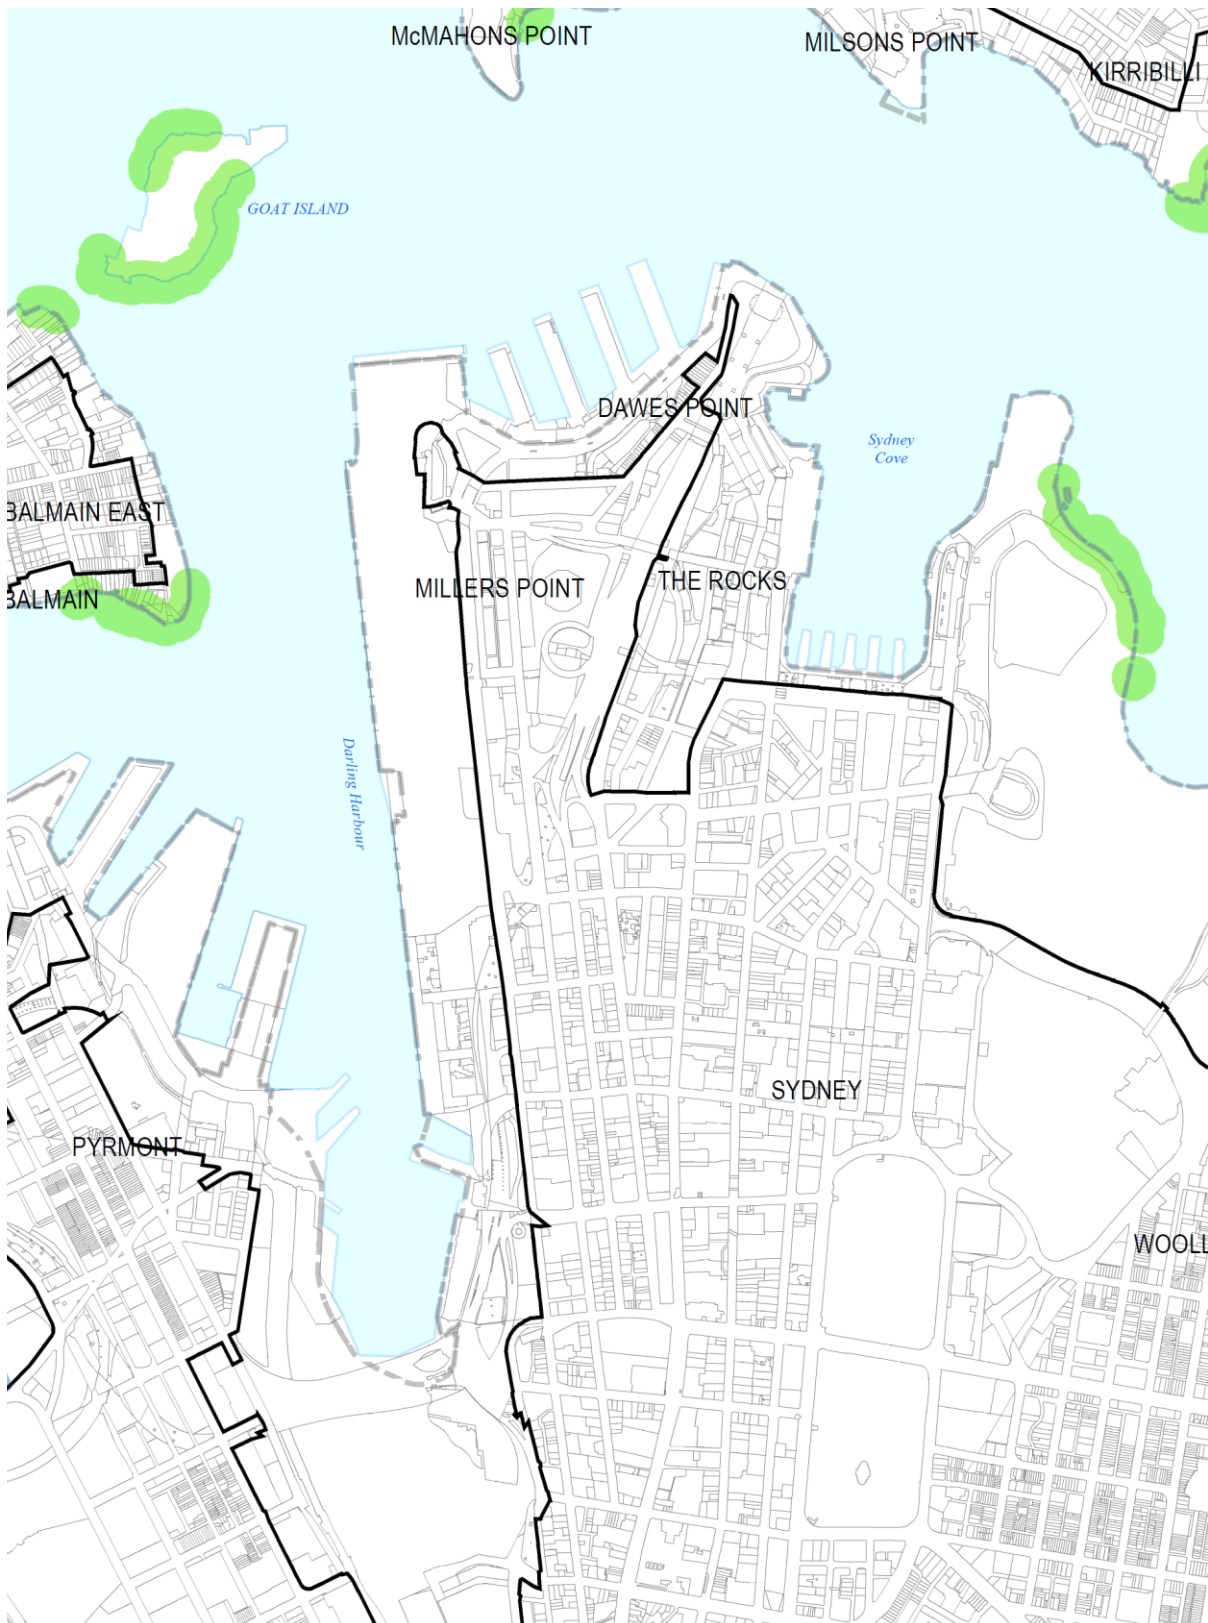
**Figure 6: Wetlands Protection Areas (green shading) in vicinity of Barangaroo from Harbour
REP 2005**

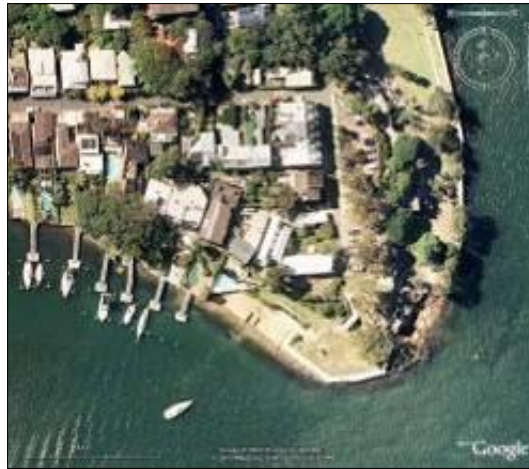
Figure 7: Aerial view of Balmain East area defined as a Wetlands Protection Area

However, the wetland area mapped at Balmain East was found to be dominated by seawalls and pontoons, rather than wetland vegetation (Figure 7).

During the site visit a sandstone seawall was found to extend for several hundred meters along the foreshore, where a Wetlands Protection Area is currently mapped at Balmain East. A number of private jetties also extended into the harbour there. Macroalgae was evident growing on subtidal rocks below the footing of the seawall. McLoughlin (2000) undertook a study examining the current extent of wetland vegetation along the Parramatta River, and suggested that some of the assumptions regarding the former extent of mangroves (which were based upon a variety of historical data sources), on which recent studies and foreshore plans were based, were inappropriate.

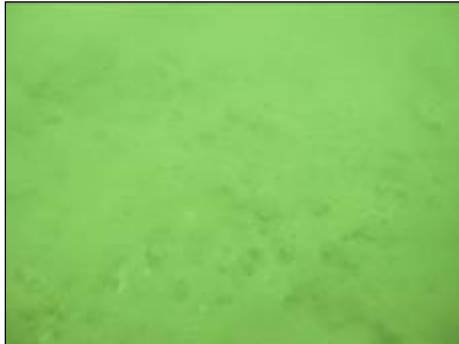
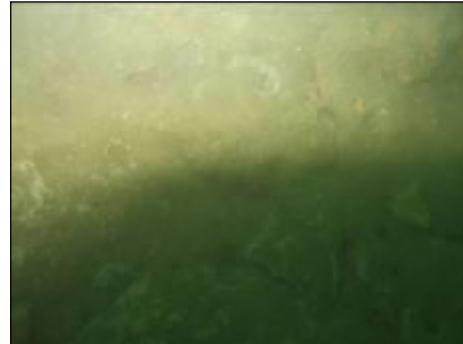
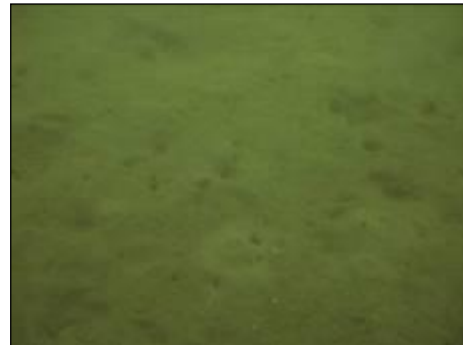
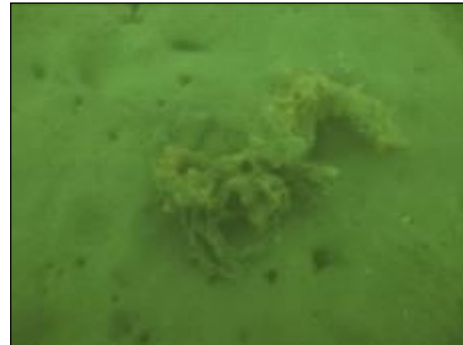
Figure 11: Benthic habitat at Barangaroo captured by diver photography

No seagrass was observed during spot dives, or on the video transects undertaken at the study site. The water depth (~ 13 m) and associated low light penetration would presumably restrict the growth of seagrasses in the footprint of the proposed Lend Lease development. No mangroves or areas of saltmarsh were observed at, or near, the proposed development during the site visit. The site currently lacks appropriate substrate and habitat for such vegetation to occur.

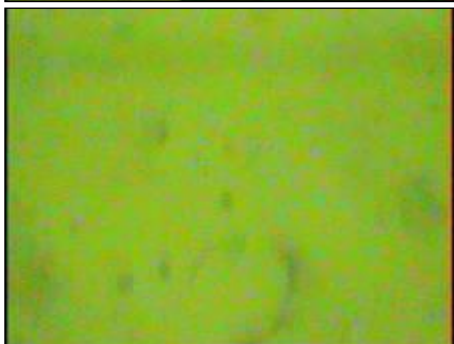
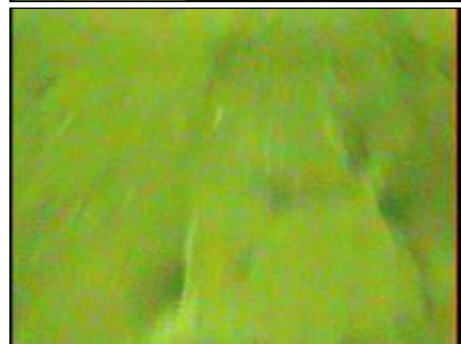
Figure 12: Benthic habitat at Barangaroo captured on video transects

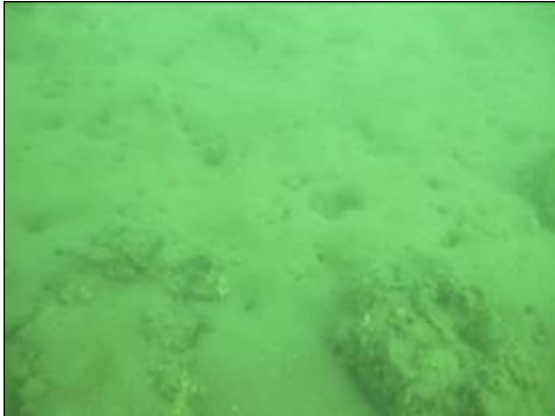
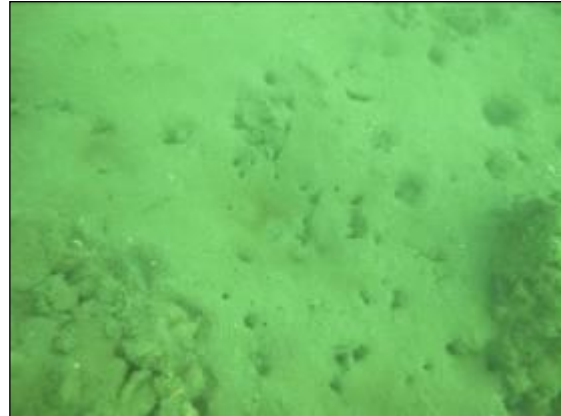
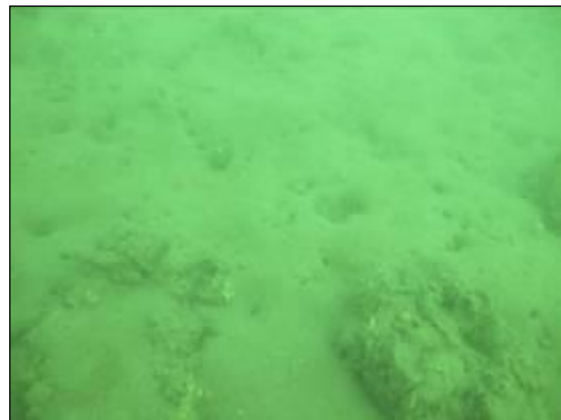
The benthic habitat at Berrys Bay consisted of silty sediments, with coral rubble and patchy subtidal reef evident at Sites 1, 2 and 4 (Figure 13). At these sites, sponges and colonial ascidians were present. Bioturbation of the sediments was observed at all sites within Berrys Bay, but no aquatic vegetation was observed during any of the spot dives that were undertaken.

Figure 13: Benthic habitat at Berrys Bay captured by diver photography

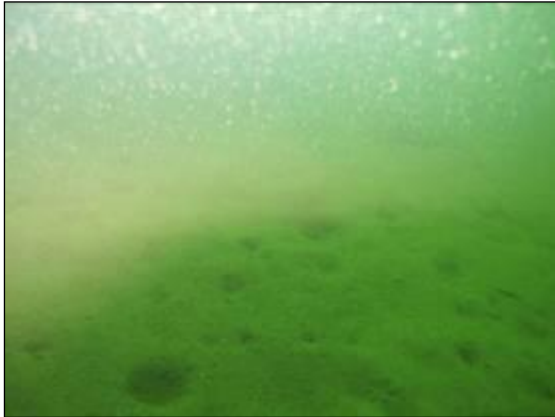
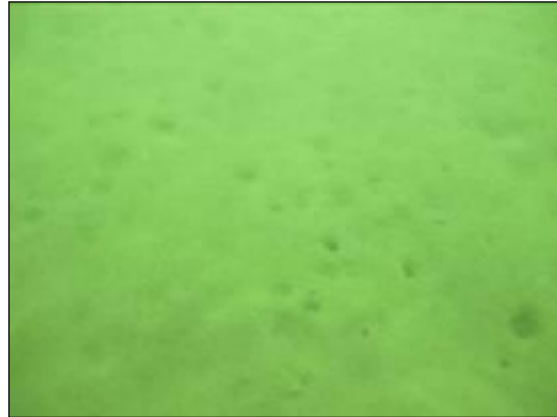
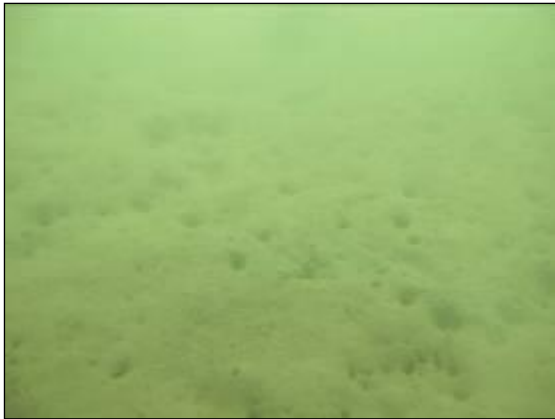
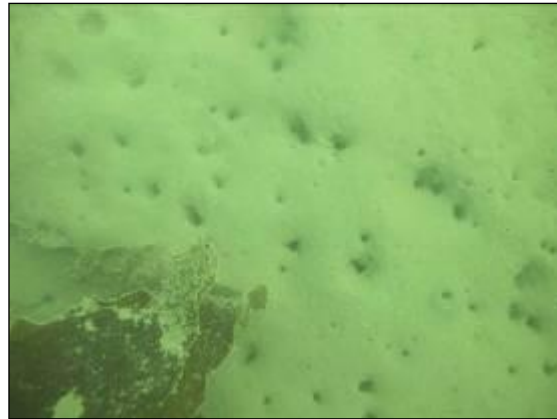
The benthic habitat at Snails Bay comprised soft silty sand. Bioturbation was apparent at all sites, with evidence of burrowing invertebrate crustaceans and polychaete worms. A small clump of the large brown macroalgae, *Ecklonia radiata*, was observed at Site 4, close to the shoreline. Aquatic fauna including a Numb Ray (*Hypnos monopterygium*) and a number of unidentified fish species were also observed in Snails Bay. Photographs of the benthic habitat at Snails Bay are provided in Figure 14.

Figure 14: Benthic habitat at Snails Bay captured by diver photography
