5. Assessment of construction issues

5.1 Terrestrial biodiversity

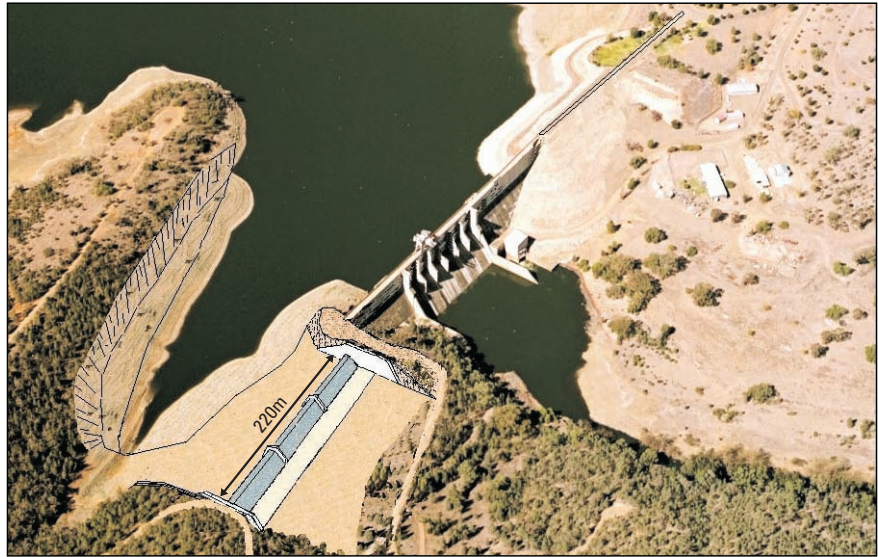
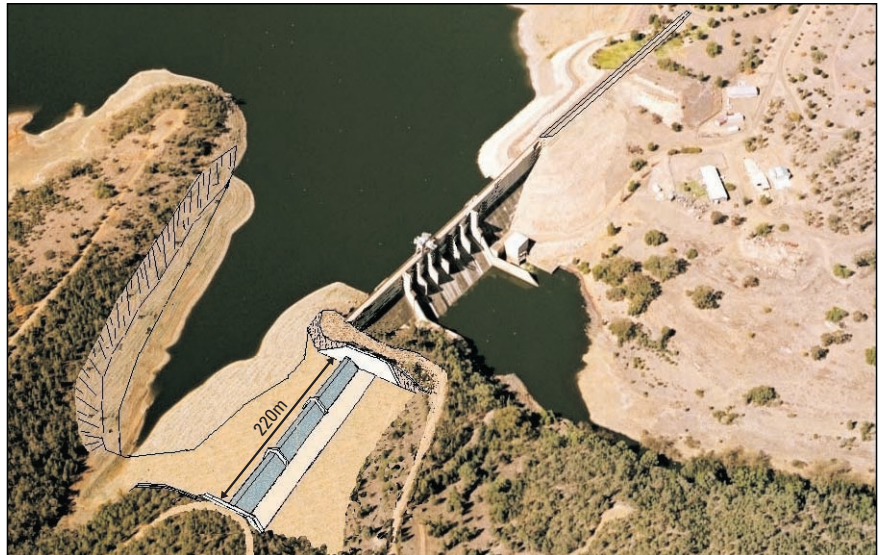
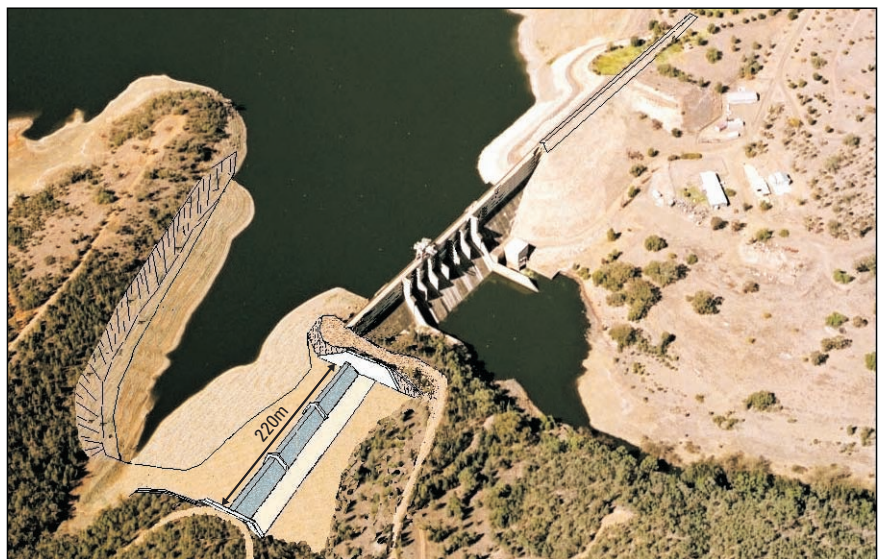
Figure 5-7 **Aerial perspectives of the right-hand abutment spillway and main dam wall raising**

Option B1

Option D2

Option D3

The right-hand abutment spillway and associated site works would be visible from many areas in the State Park and surrounding districts. The site of the proposed works for the right-hand abutment spillway is currently heavily vegetated with White Box Yellow Box Blakely's Red Gum Woodland and has a relatively natural visual appearance. The resulting landform would be strongly discordant with the existing area and would double the visible length of the dam crest. The construction of the right-hand abutment spillway would have a moderate to high visual impact at the various viewpoints considered.

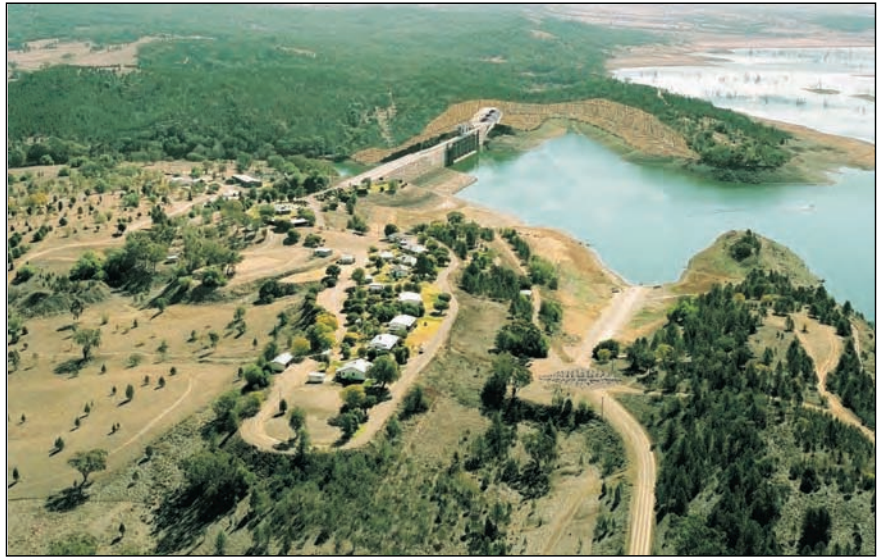
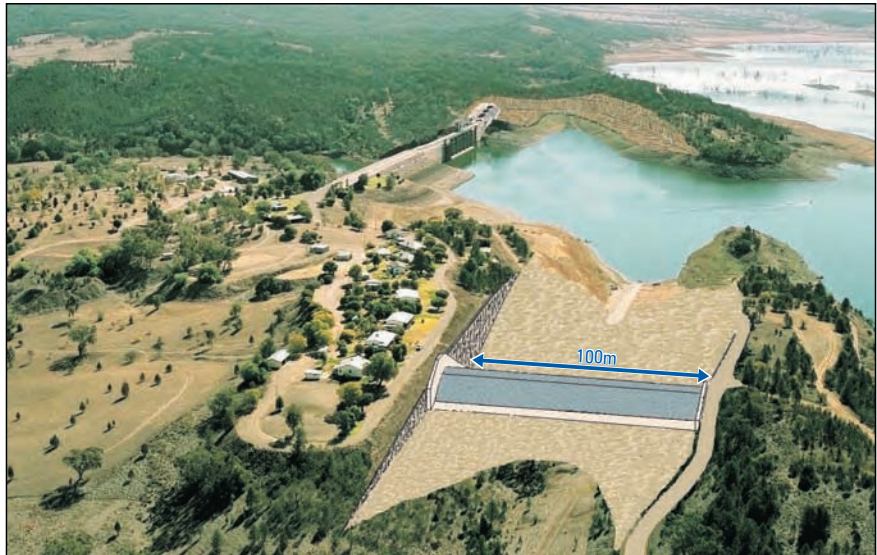
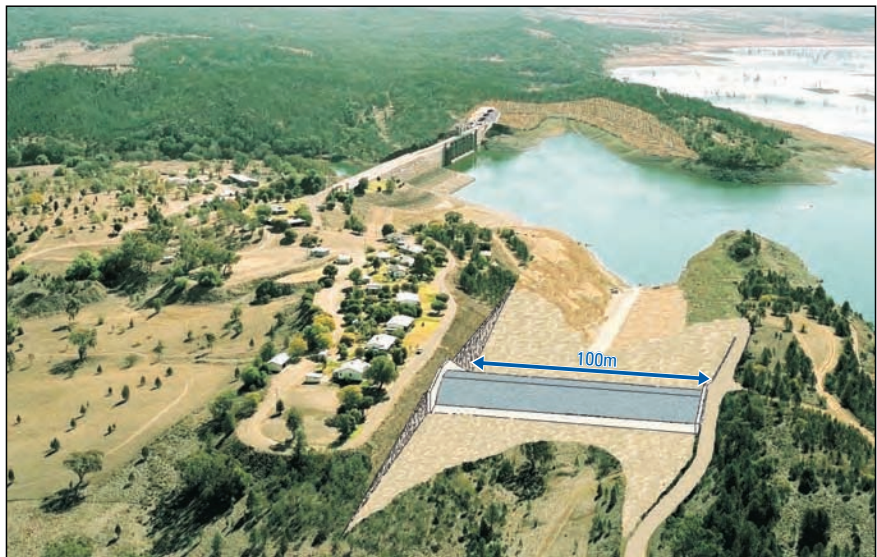
Figure 5-8 **Aerial perspectives of the boat ramp saddle dam/spillway**

Option B1 - 2.0m high saddle dam

Option D2 - Spillway alternative. Saddle dam alternative 1.4m higher than Option B1

Option D3 - Spillway alternative. Saddle dam alternative 2.3m higher than Option B1

The visual impact of works for the boat ramp saddle dam and spillway would be substantial as, although they would not be very visible from within the State Park area, they would have a high visual impact on viewers from some of the local residences (e.g. State Water employee housing.)

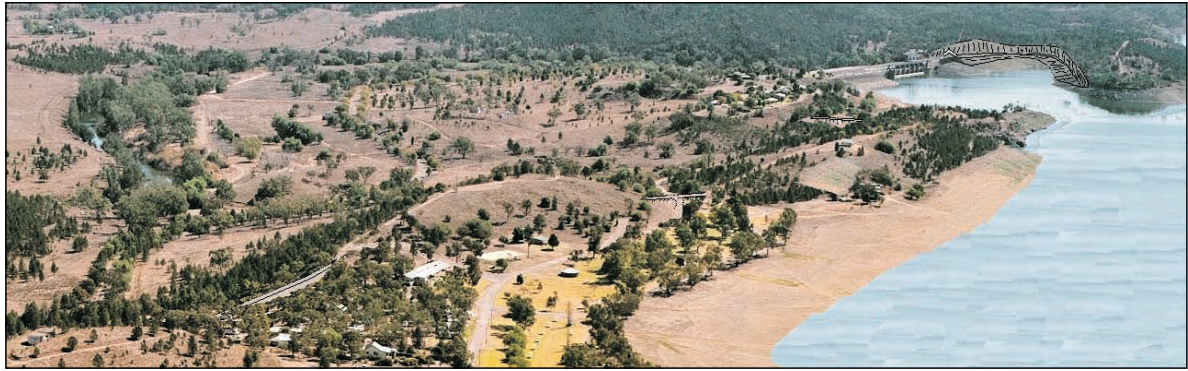
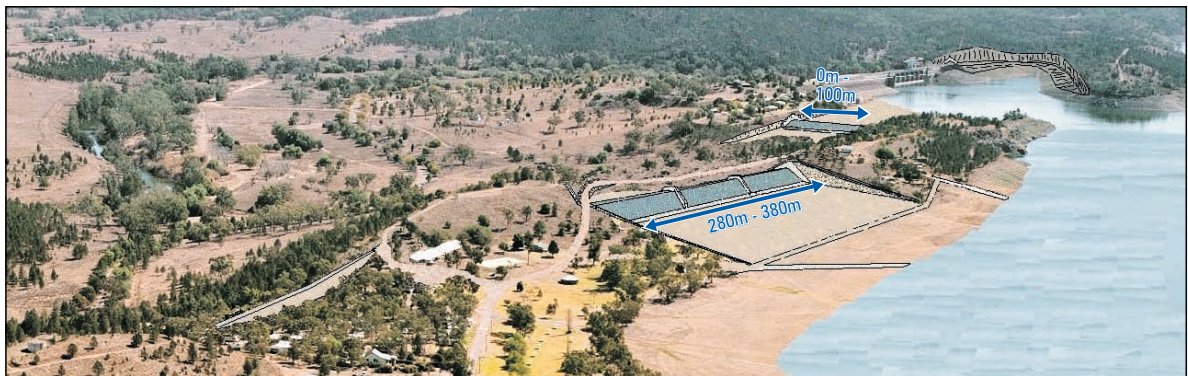
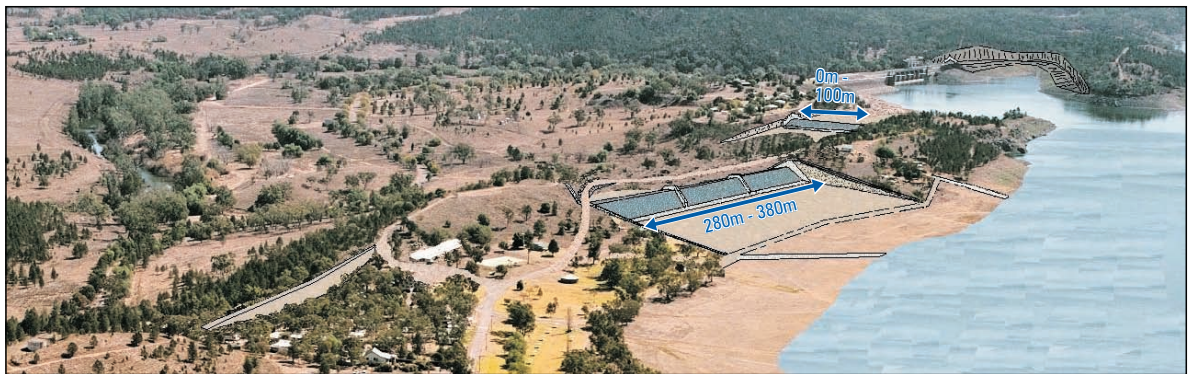
Figure 5-9 **Aerial perspectives of the boat ramp and sailing club saddle dams and spillways, as well as the caravan park saddle dam**

Option B1

Option D2

Option D3

Works associated with the sailing club saddle dam/spillway would be larger and would involve greater associated earthworks than Option B1. Subsequently, they would be more visible across the study area, with the spillway becoming a significant element in an otherwise relatively natural and intermittently vegetated landscape. Most viewers would see this spillway as a dominant foreground element.

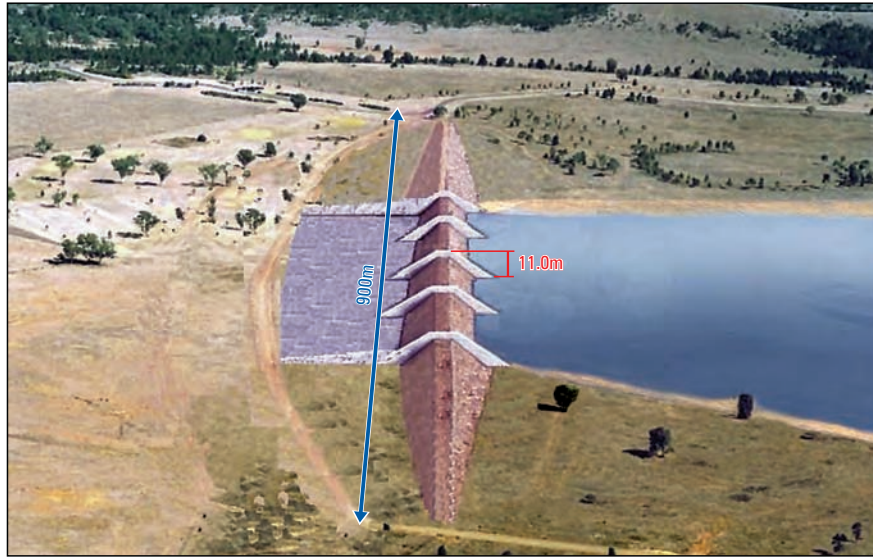
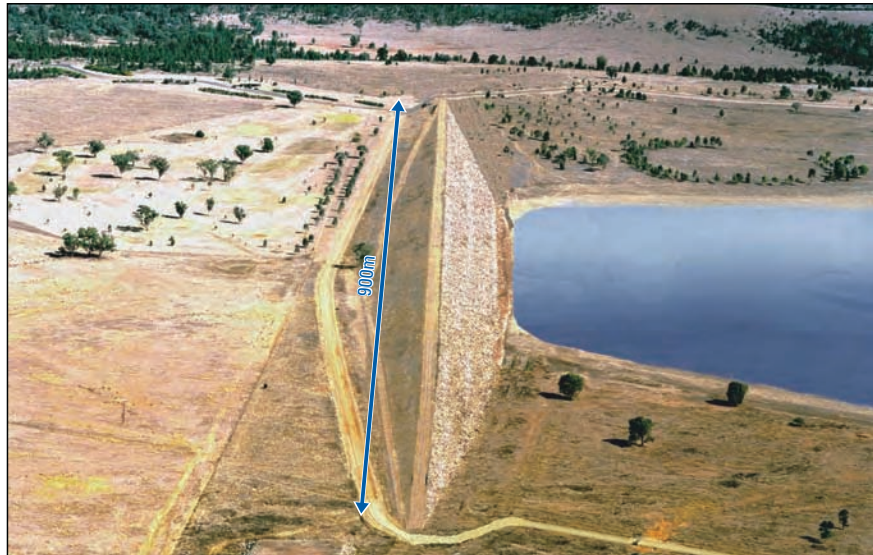
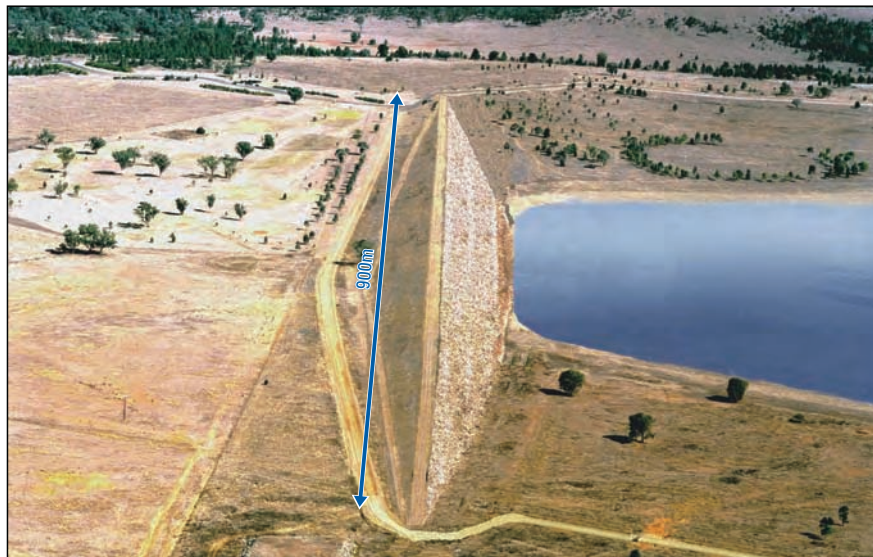
Figure 5-10 **Aerial perspectives of the subsidiary dam spillway and wall raising**

Option B1 - 11.0m high fuse plug spillway

Option D2 - Saddle dam 1.2m higher than Option B1

Option D3 - Saddle dam 2.1m higher than Option B1

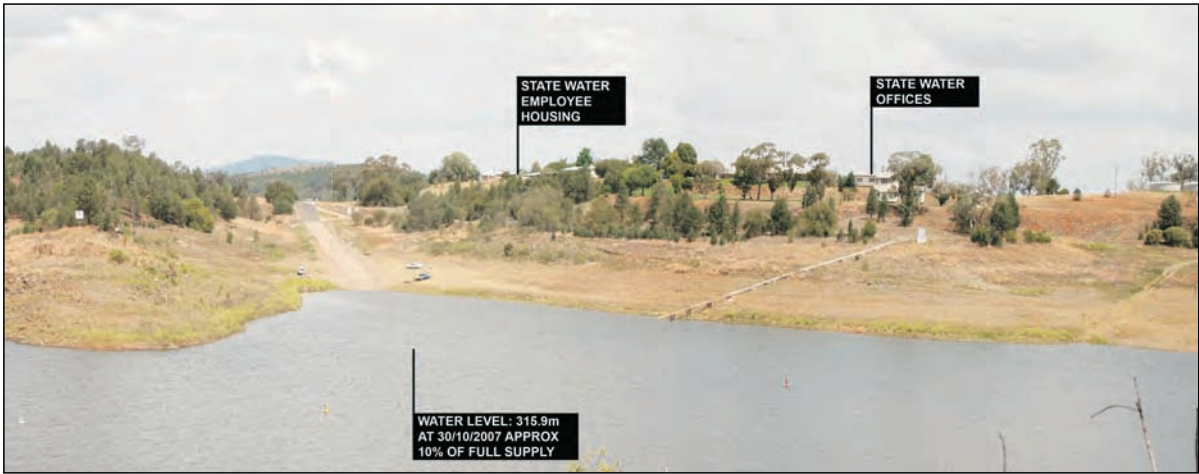
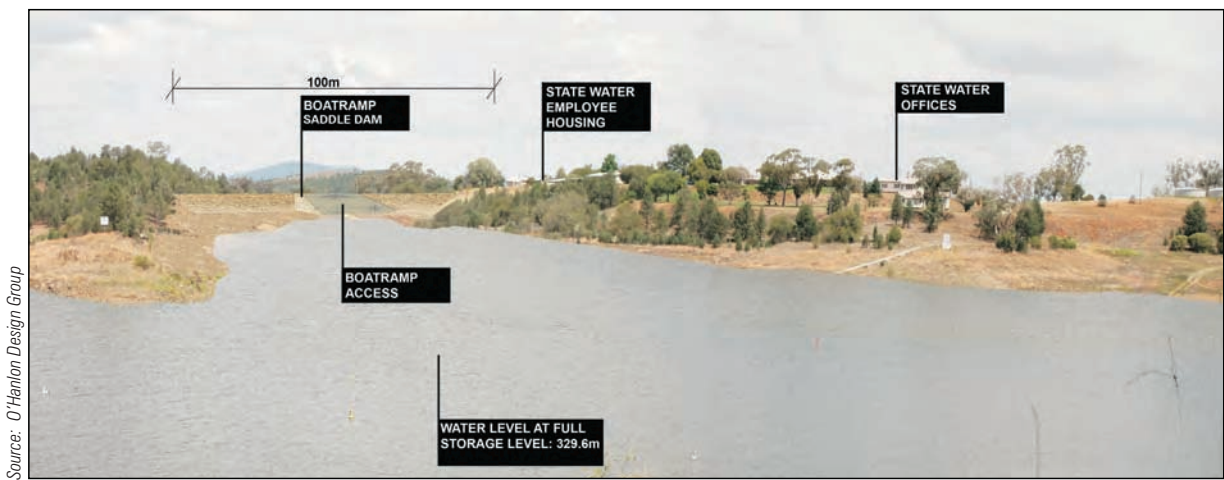
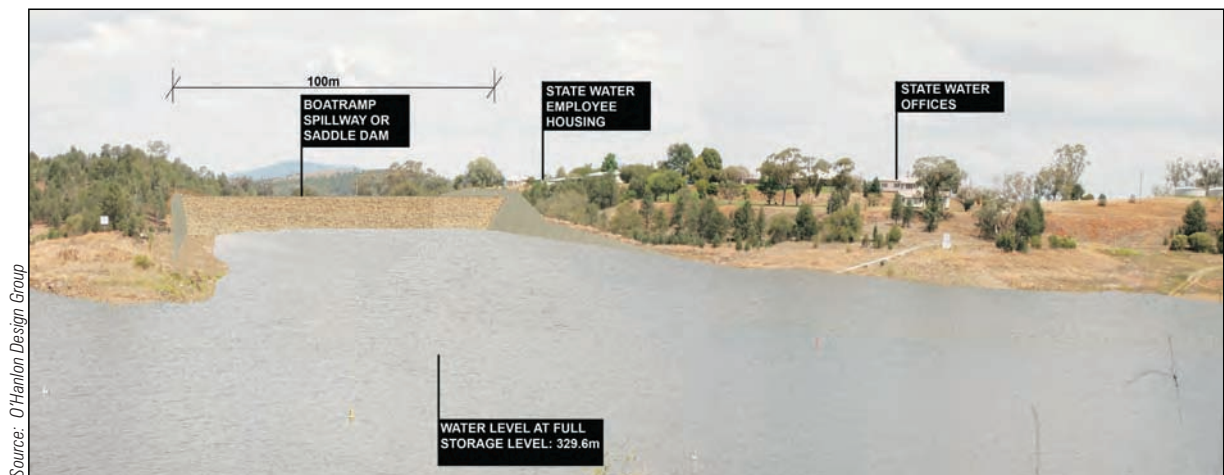
Figure 5-11 Photomontage of boat ramp saddle dam/spillway from VP1

Existing - Looking south east to boat ramp saddle dam/spillway from VP1

Option B1 - Looking south east to boat ramp saddle dam/spillway from VP1

Option D3 - Looking south east to boat ramp saddle dam/spillway from VP1. Option D2 levels 0.9m lower.

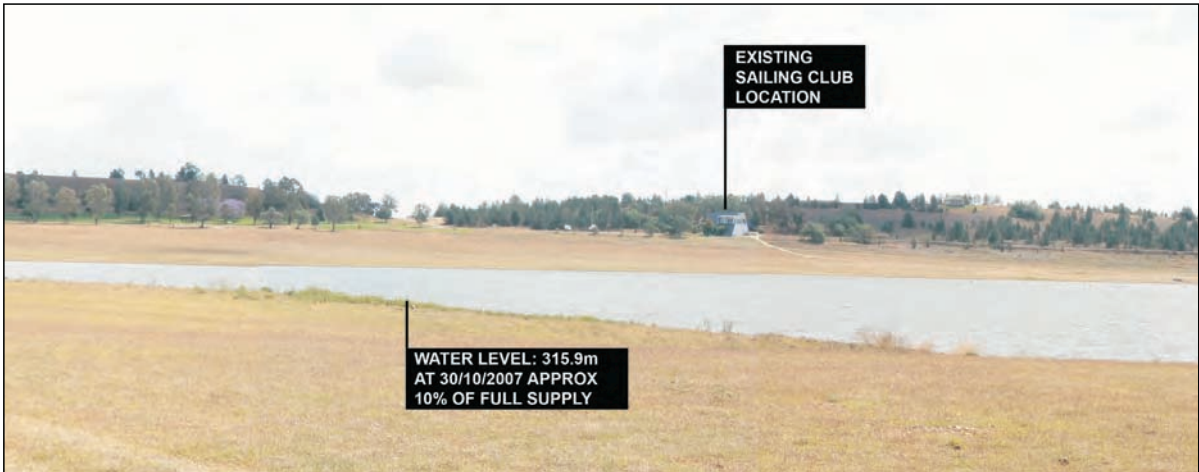
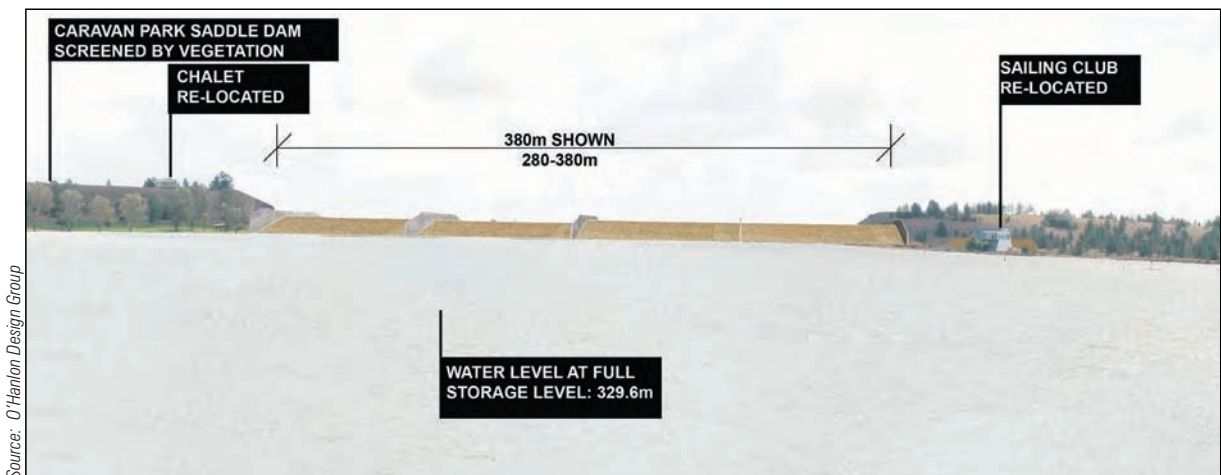
Figure 5-12 Photomontage of Sailing Club saddle dam/spillway and caravan park saddle dam from VP6

Existing - Looking south west to Sailing Club saddle dam and caravan park saddle dam from VP6

Option B1 - Looking south west to Sailing Club saddle dam and caravan park saddle dam from VP6

Option D3 - Looking south west to Sailing Club saddle dam and caravan park saddle dam from VP6. Option D2 levels 0.9m lower.

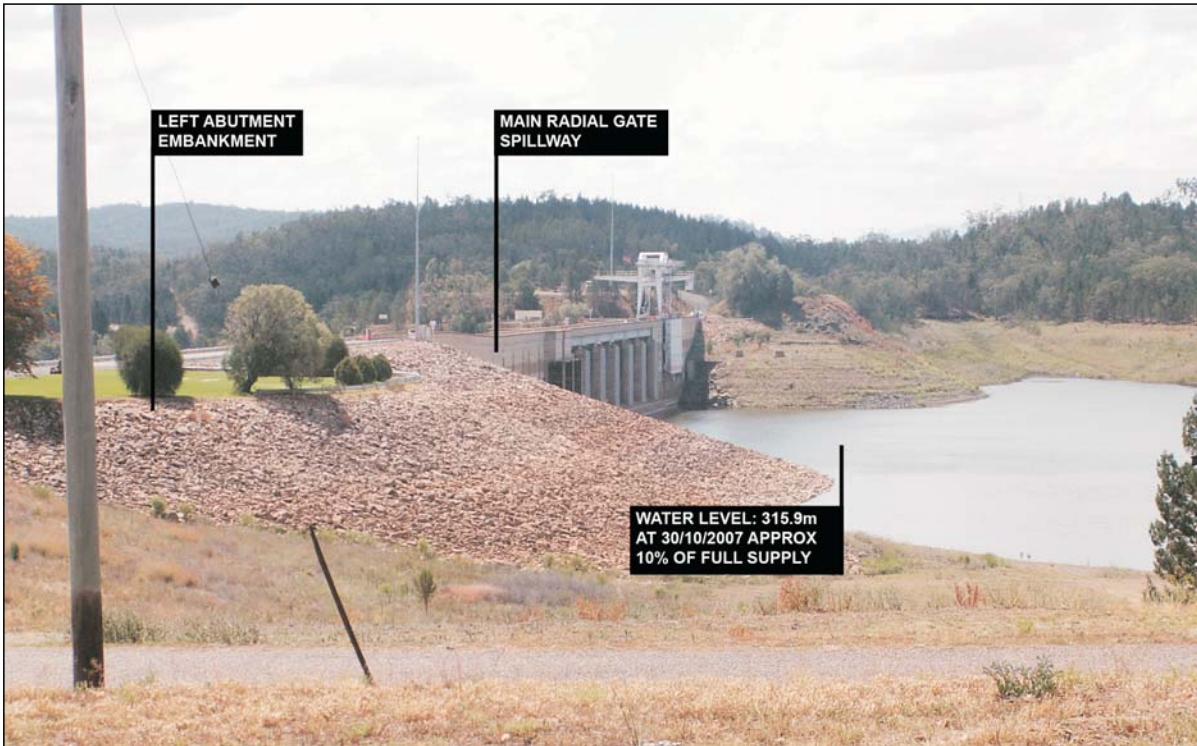
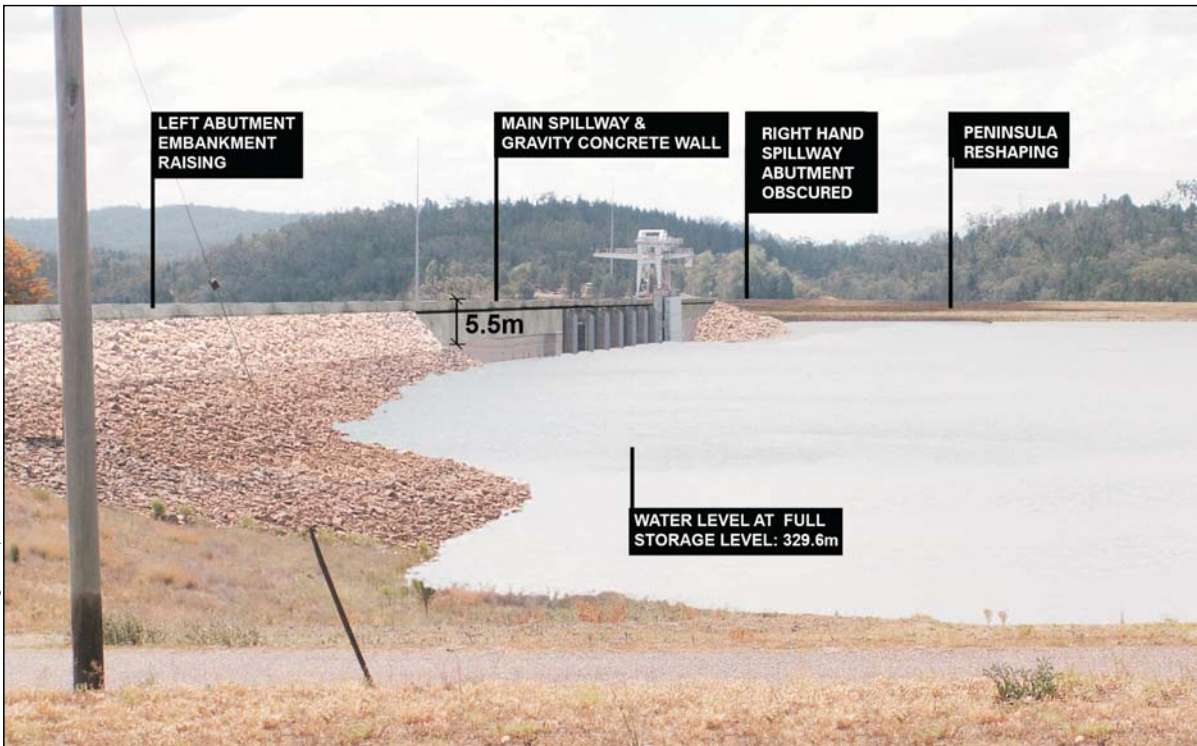
Existing - Looking north west to main spillway from VP7

Option D3 - Looking north west to main spillway from VP7. Option B1 levels 2.1m lower.
