Geotechnical Assessment:

Concept plan for the redevelopment
of Lot 11 DP 558723, Lot 1 DP 200697
and Lot 2 DP262213 Eastern Creek

P0601396JR01-V3
October 2006

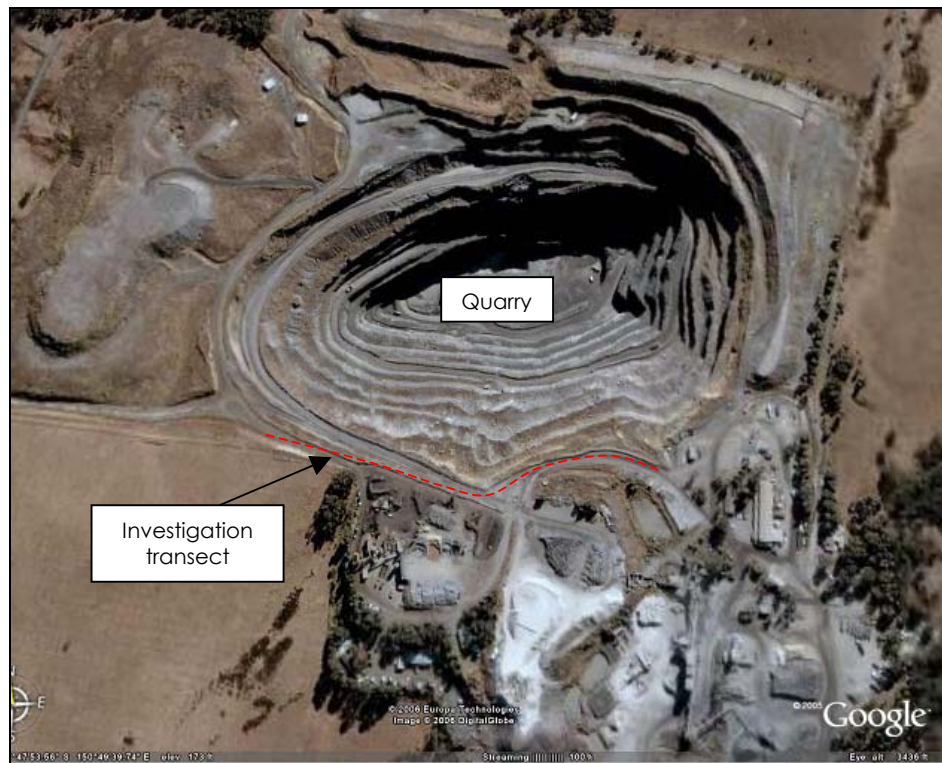
Figure 1: Eastern Creek Quarry and the existing road and investigation area (Google Earth).

The existing road is located on the southern side of the Quarry. Various material stockpiles and the Pioneer asphalt plant occur to the south of the existing road with the quarry located to the north (Figure 1). The existing road forms part of the quarry haul road as well as being the main road for vehicle access to the asphalt plant, stockpile areas and provides site access to areas west and north of the quarry.

Attachment A indicates locations of the proposed road with respect to the precinct road alignment and test boreholes undertaken. Vertical and horizontal road alignments for the proposed road and Precinct plan roads are provided in Attachment A.

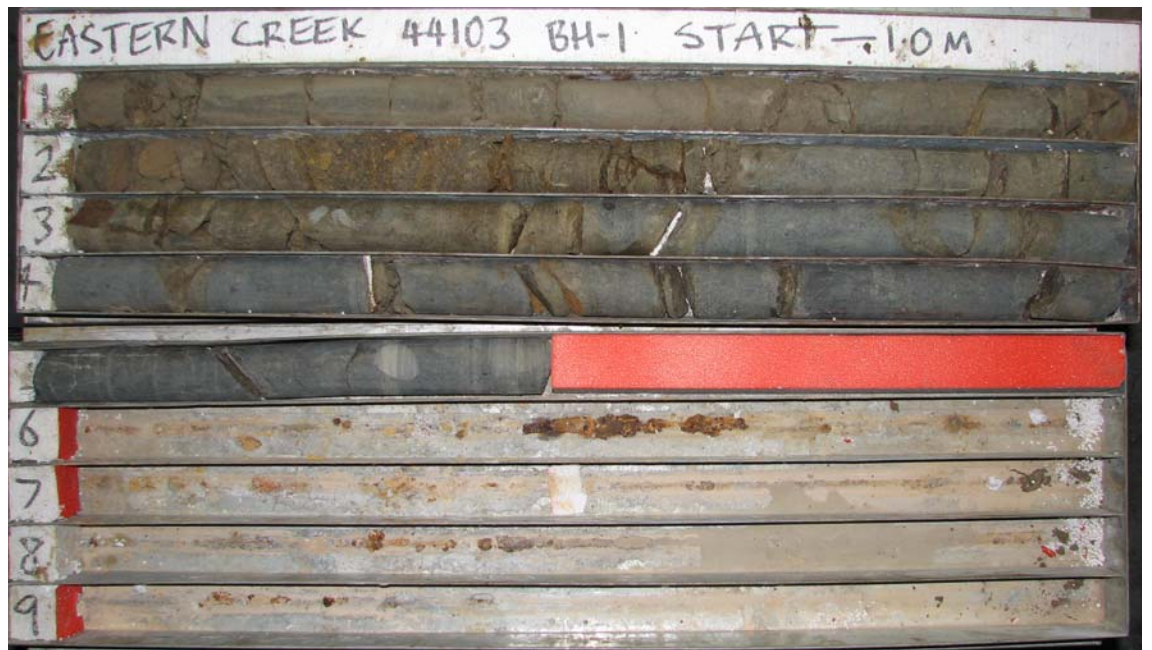
CLIENT		HANSON Pty Ltd		COMMENCED		2/7/06		COMPLETED		2/7/06		REF		BH1																																																							
PROJECT		Geotechnical Assessment		LOGGED		GT		CHECKED		DM		Sheet 1 of 1																																																									
SITE		Eastern Creek Quarry		GEOLOGY				VEGETATION		None		PROJECT NO. P0601396																																																									
EQUIPMENT				Auger/Rotary Drill				EASTING		150 49 41 (Deg/Min/Sec) E																																																											
DRILLING FLUID				Water				NORTHING		33 47 58 (Deg/Min/Sec) S																																																											
				ASPECT		West		SLOPE		0-5%																																																											
DRILLING DATA						MATERIAL DATA						SAMPLING & DEFECT DATA																																																									
METHOD	WATER	TCR	ROD (SCR)	DEPTH (M)	GRAPHIC LOG	DESCRIPTION OF STRATA Type, texture, structure, mottling, colour, oxidation, particle characteristics, organics, secondary & minor components, fill, contamination, odour.	WEATHERING	INFERRED STRENGTH Is ₅₀ MPa	DEFECT DESCRIPTIONS AND ADDITIONAL OBSERVATIONS				AVERAGE DEFECT SPACING (mm)

EW -0.03 -0.1 -0.3 -1 -3 -10																																																														
A	N					FILL - ROADBASE/GRAVELS																																																															
A	N			0.5m		FILL - Brown/Grey weathered Basalt

9.0m																																																																	
EQUIPMENT / METHOD N Natural exposure X Existing excavation HQ Diamond Core - 63 mm NMLC Diamond Core - 52 mm NQ Diamond Core - 47 mm A Auger														WATER N None observed X Not measured ▽ Water level △ Water outflow ▷ Water inflow														WEATHERING Rs Residual Soil EW Extremely Weathered HW Highly Weathered MW Moderately Weathered SW Slightly Weathered Fr Fresh Rock														CORE DATA TCR Total Core Recovery (%) ROD Rock Quality Designation (%) SCR Solid Core Recovery (%)														ROCK STRENGTH TEST RESULTS ▼ Point load strength index (Is50) - axial test (MPa) ► Point load strength index (Is50) - diametral test (MPa) ● Unconfined compressive strength (UCS) (MPa)													
EXCAVATION LOG TO BE READ IN CONJUNCTION WITH ACCOMPANYING REPORT NOTES AND ABBREVIATIONS

Assumptions for existing pavement conditions were based on site testing. Pavement varied along the investigation transect from a 0.3 m thick layer of road base gravels (BH1) to stiff to very stiff clays approximately 1.0 – 1.5 m thick (BH2, BH3 and BH4). On the basis of

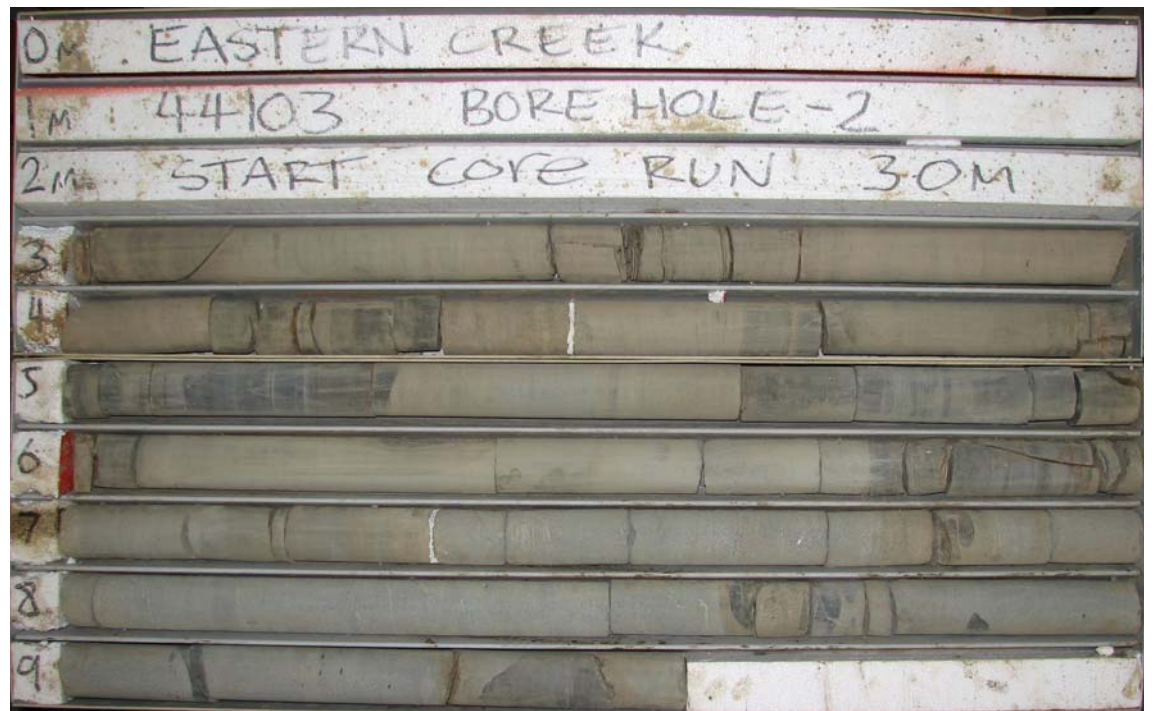
CLIENT		HANSON Pty Ltd		COMMENCED		2/7/06		COMPLETED		2/7/06		REF		BH2							
PROJECT		Geotechnical Assessment		LOGGED		GT		CHECKED		DM		Sheet 1 of 2									
SITE		Eastern Creek Quarry		GEOLOGY				VEGETATION		None		PROJECT NO. P0601396									
EQUIPMENT				Auger/Rotary Drill				EASTING		150 49 41 (Deg/Min/Sec) E				RL SURFACE		85.5 m AHD					
DRILLING FLUID				Water				NORTHING		33 47 58 (Deg/Min/Sec) S				ASPECT		West		SLOPE		0-5%	
DRILLING DATA						MATERIAL DATA						SAMPLING & DEFECT DATA									
METHOD	WATER	TCR	ROD (SCR)	DEPTH (M)	GRAPHIC LOG	DESCRIPTION OF STRATA Type, texture, structure, mottling, colour, oxidation, particle characteristics, organics, secondary & minor components, fill, contamination, odour.		WEATHERING	INFERRED STRENGTH Is ₅₀ MPa		DEFECT DESCRIPTIONS AND ADDITIONAL OBSERVATIONS		AVERAGE DEFECT SPACING (mm)								
A	N					FILL - ROADBASE/GRAVELS															
A	N			0.5m		CLAY- Grey, silty gravels, stiff to very stiff (FILL)

A	N			1.0m		CLAY- Brown/Grey, gravels 1-15mm approx 15%, firm (FILL)															
A	N			1.5m		CLAY- Brown/Grey with red mottling, gravels 1-15mm approx 15%, Stiff grading to hard at base (NATURAL SOILS)

9.0m																	
				EQUIPMENT / METHOD			WATER		WEATHERING		CORE DATA		ROCK STRENGTH TEST RESULTS								
				N Natural exposure			N None observed		Rs Residual Soil		TCR Total Core Recovery (%)		▼ Point load strength index (Is50) - axial test (MPa)								
				X Existing excavation			X Not measured		EW Extremely Weathered		RQD Rock Quality Designation (%)		► Point load strength index (Is50) - diametral test (MPa)								
				HQ Diamond Core - 63 mm			▽ Water level		HW Highly Weathered		SCR Solid Core Recovery (%)		● Unconfined compressive strength (UCS) (MPa)								
NMLC Diamond Core - 52 mm		△ Water outflow		MW Moderately Weathered																	
NQ Diamond Core - 47 mm		▷ Water inflow		SW Slightly Weathered																	
A Auger				Fr Fresh Rock																	
EXCAVATION LOG TO BE READ IN CONJUNCTION WITH ACCOMPANYING REPORT NOTES AND ABBREVIATIONS																					
MARTENS & ASSOCIATES PTY LTD 6/37 Leighton Place Hornsby, NSW 2077 Australia Phone: (02) 9476 8777 Fax: (02) 9476 8767 mail@martens.com.au WEB: http://www.martens.com.au

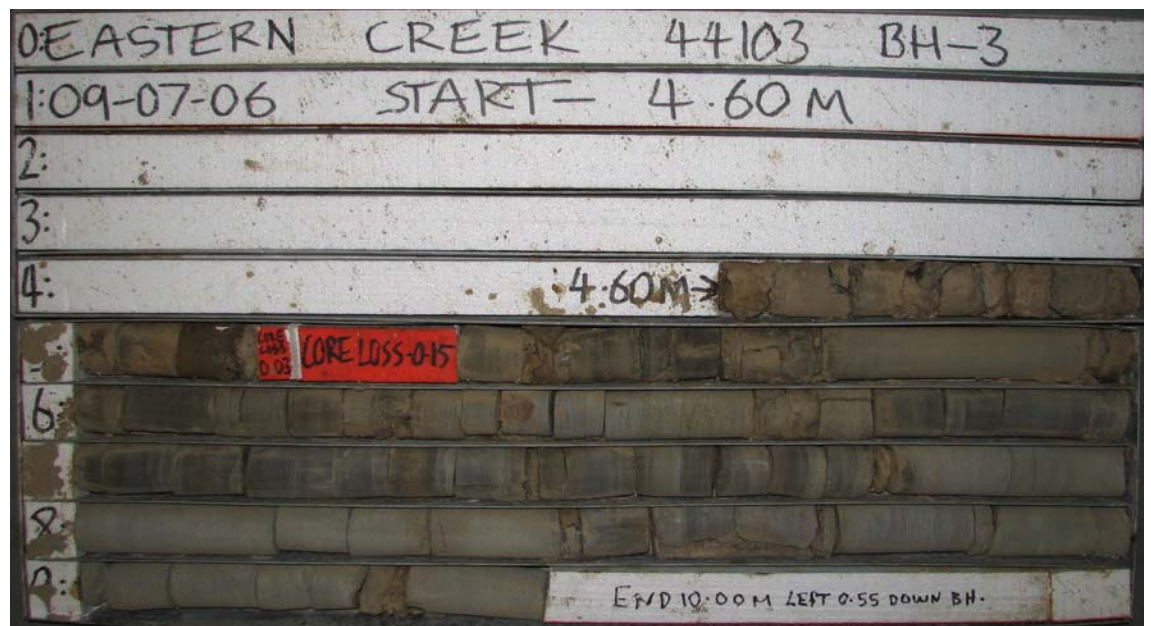
CLIENT		HANSON Pty Ltd			COMMENCED		9/7/06		COMPLETED		9/7/06		REF		BH3				
PROJECT		Geotechnical Assessment			LOGGED		GT		CHECKED		DM		Sheet 1 of 2						
SITE		Eastern Creek Quarry			GEOLOGY				VEGETATION		None		PROJECT NO. P0601396						
EQUIPMENT			Auger/Rotary Drill			EASTING			150 49 41 (Deg/Min/Sec) E			RL SURFACE			82.6 m AHD				
DRILLING FLUID			Water			NORTHING			33 47 58 (Deg/Min/Sec) S			ASPECT		West		SLOPE		0-5%	
DRILLING DATA					MATERIAL DATA					SAMPLING & DEFECT DATA									
METHOD	WATER	TCR	RQD (SCR)	DEPTH (M)	GRAPHIC LOG	DESCRIPTION OF STRATA Type, texture, structure, mottling, colour, oxidation, particle characteristics, organics, secondary & minor components, fill, contamination, odour.			WEATHERING	INFERRED STRENGTH Is(50) MPa			DEFECT DESCRIPTIONS AND ADDITIONAL OBSERVATIONS			AVERAGE DEFECT SPACING (mm)			
									EW VW W WS S VS ES	-0.03 -0.1 -0.3 -1 -3 -10							-10 -30 -100 -300 -1000 -3000

A	N					ROADBASE/GRAVELS (FILL)													
				0.5m															
A	N			1.0m		CLAY-Red/orange with gravels, 5-20mm, approx 15%, firm to very stiff at depth. (FILL)

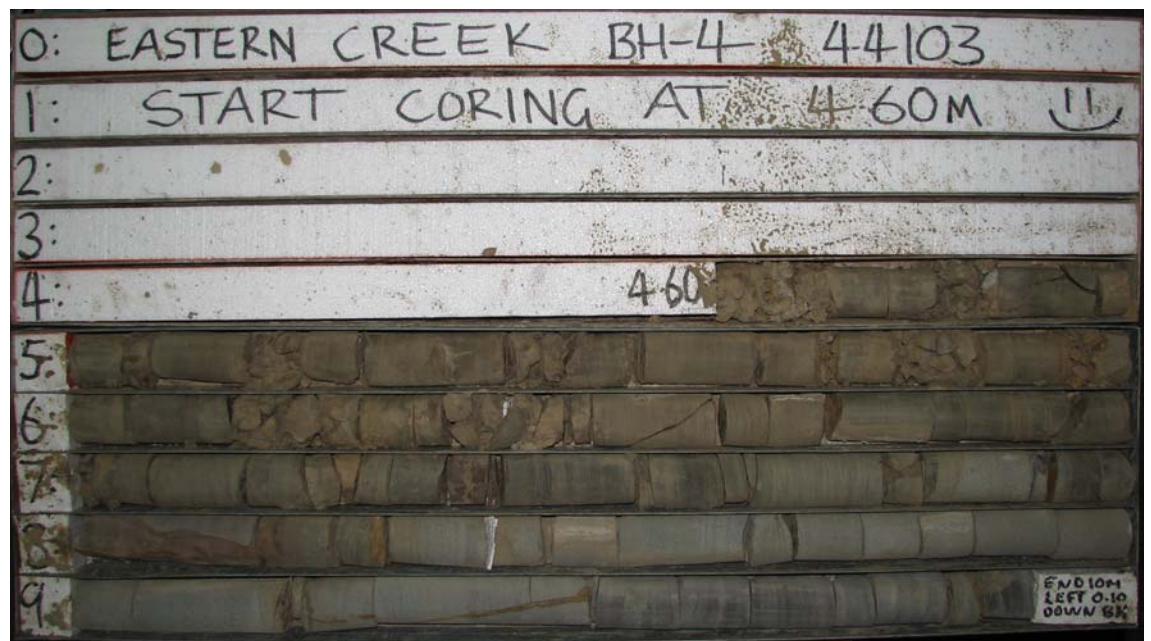
CLIENT		HANSON Pty Ltd		COMMENCED		9/7/06		COMPLETED		9/7/06		REF		BH4															
PROJECT		Geotechnical Assessment		LOGGED		GT		CHECKED		DM		Sheet 2 of 2																	
SITE		Eastern Creek Quarry		GEOLOGY				VEGETATION		None		PROJECT NO. P0601396																	
EQUIPMENT			Auger/Rotary Drill			EASTING			150 49 41 (Deg/Min/Sec) E			RL SURFACE			81.5 m AHD														
DRILLING FLUID			Water			NORTHING			33 47 58 (Deg/Min/Sec) S			ASPECT		West		SLOPE		0-5%											
DRILLING DATA					MATERIAL DATA					SAMPLING & DEFECT DATA																			
METHOD	WATER	TCR	RQD (SCR)	DEPTH (M)	GRAPHIC LOG	DESCRIPTION OF STRATA Type, texture, structure, mottling, colour, oxidation, particle characteristics, organics, secondary & minor components, fill, contamination, odour.			WEATHERING	INFERRED STRENGTH Is ₅₀ MPa			DEFECT DESCRIPTIONS AND ADDITIONAL OBSERVATIONS			AVERAGE DEFECT SPACING (mm)

12.0m																									
				12.5m																									
				13.0m																									
				13.5m																									
EQUIPMENT / METHOD					WATER					WEATHERING					CORE DATA					ROCK STRENGTH TEST RESULTS									
N Natural exposure					N None observed					Rs Residual Soil					TCR Total Core Recovery (%)					▼ Point load strength index (Is50) - axial test (MPa)									
X Existing excavation					X Not measured					EW Extremely Weathered					RQD Rock Quality Designation (%)					► Point load strength index (Is50) - diametral test (MPa)									
HQ Diamond Core - 63 mm

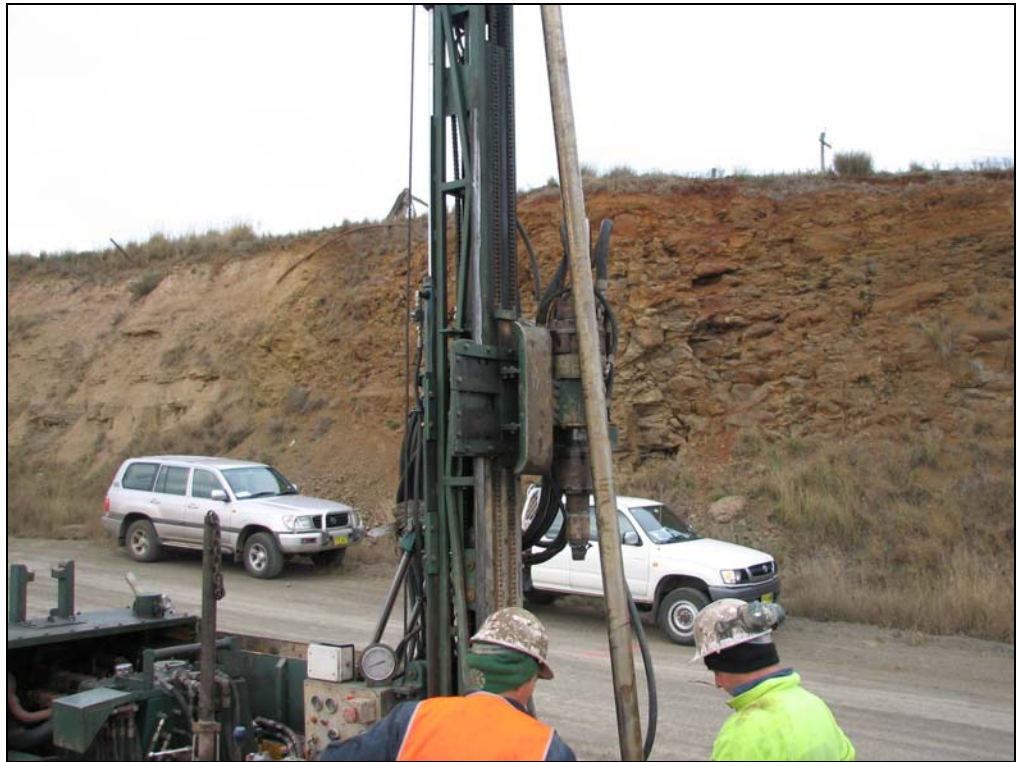
Plate 1: View looking west from Test Bore 1 at road and cut in local rock.

The amount of sub-surface soil or soil overburden (fill, road base and natural clays) above rock varied along the road. More generally, the western portion of the current road has been cut into the natural materials (Plates 1 and 2) while the eastern portion was on fill (Plates 3, 4 and 5). The road is in a serviceable condition with no obvious signs of excessive wear and tear or sub-surface stress. No evidence of past or recent slope instability was observed along the investigation transect. These observations suggest that sub-surface conditions are stable and suitable for heavy load traffic (which indeed has been the usage to recent times).

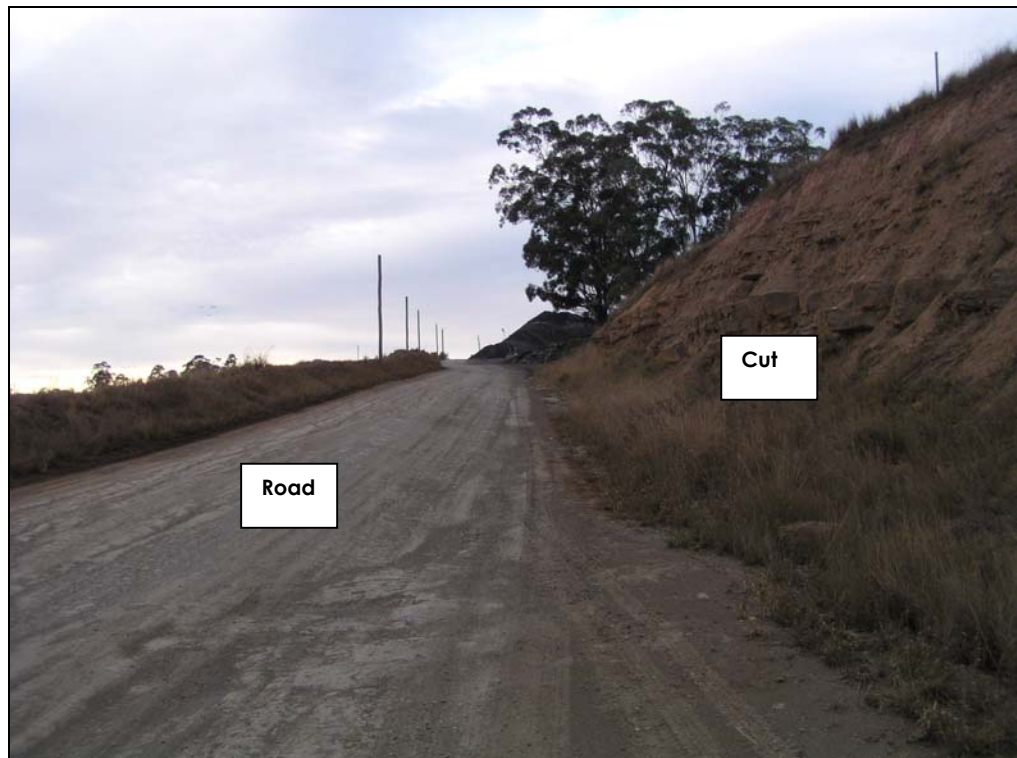
Plate 2: View looking east from Test Bore 1 at cut running adjacent to road.

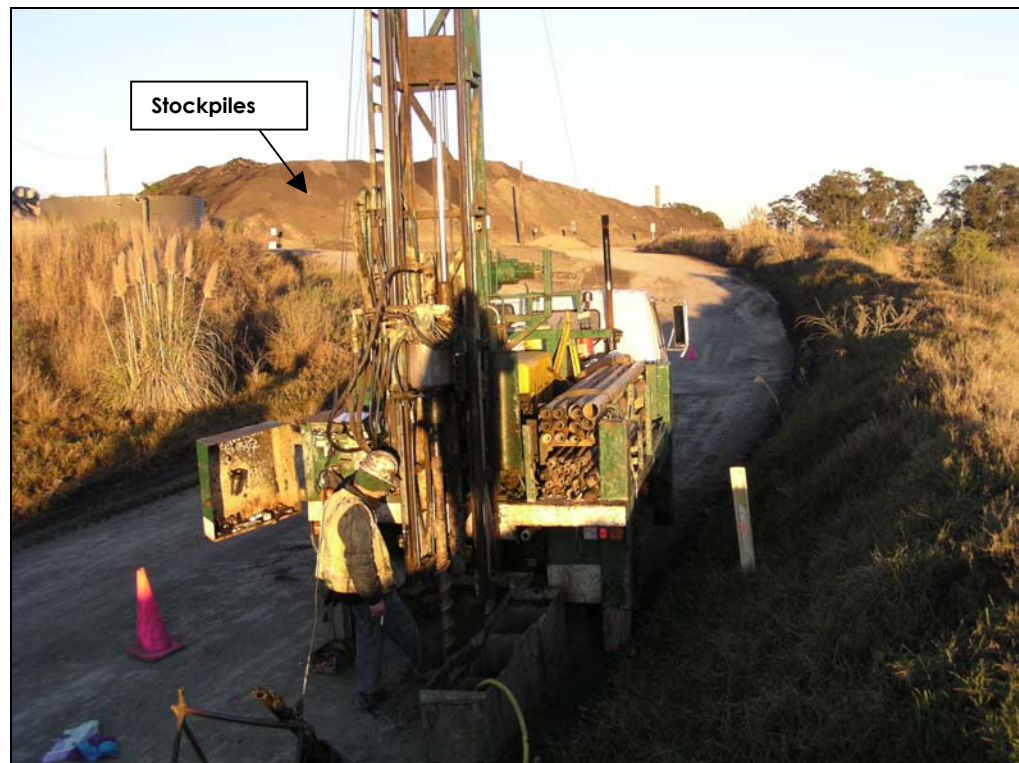
Plate 3: View looking west from Test Bore 3 at stockpiles.
