# Preliminary (Stage 1) Land Contamination Assessment:

Concept Plan for the redevelopment of  
Lot 11 DP 558723, Lot 1 DP 400697 and  
Lot 2 DP 262213, Eastern Creek, NSW.

P0601396JR02\_v1  
October 2006

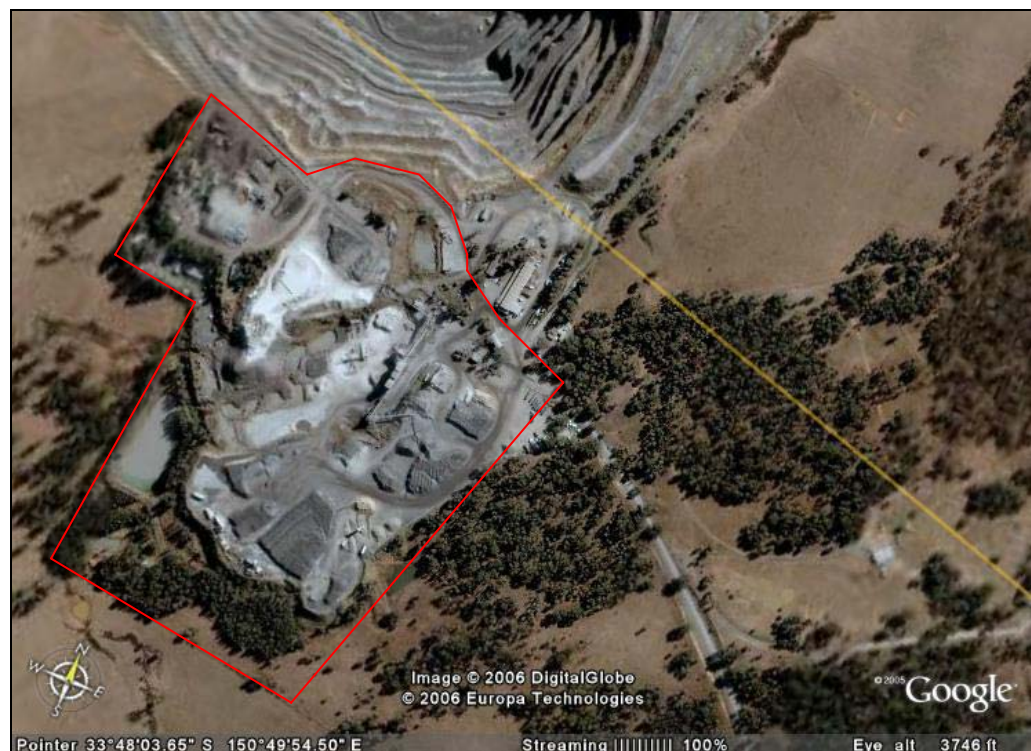
Figure 2: Aerial photograph of the proposed development site.

The site development proposal includes a boundary adjustment to Lot 11 DP 558723 and to include the relevant parts of the adjoining allotments Lot 1 DP 400697 and Lot 2 DP 262213. The new proposed lot is irregular in shape and has an area of approximately 27 hectares (Figure 2). A site plan showing the boundary arrangements is provided as Attachment A.

The site is characterised by mixed industrial operations, predominantly asphalt and concrete plants and stockpiling of mining products. Specific site land uses and surrounding land uses are detailed in Sections 3.3 and 3.2 respectively.

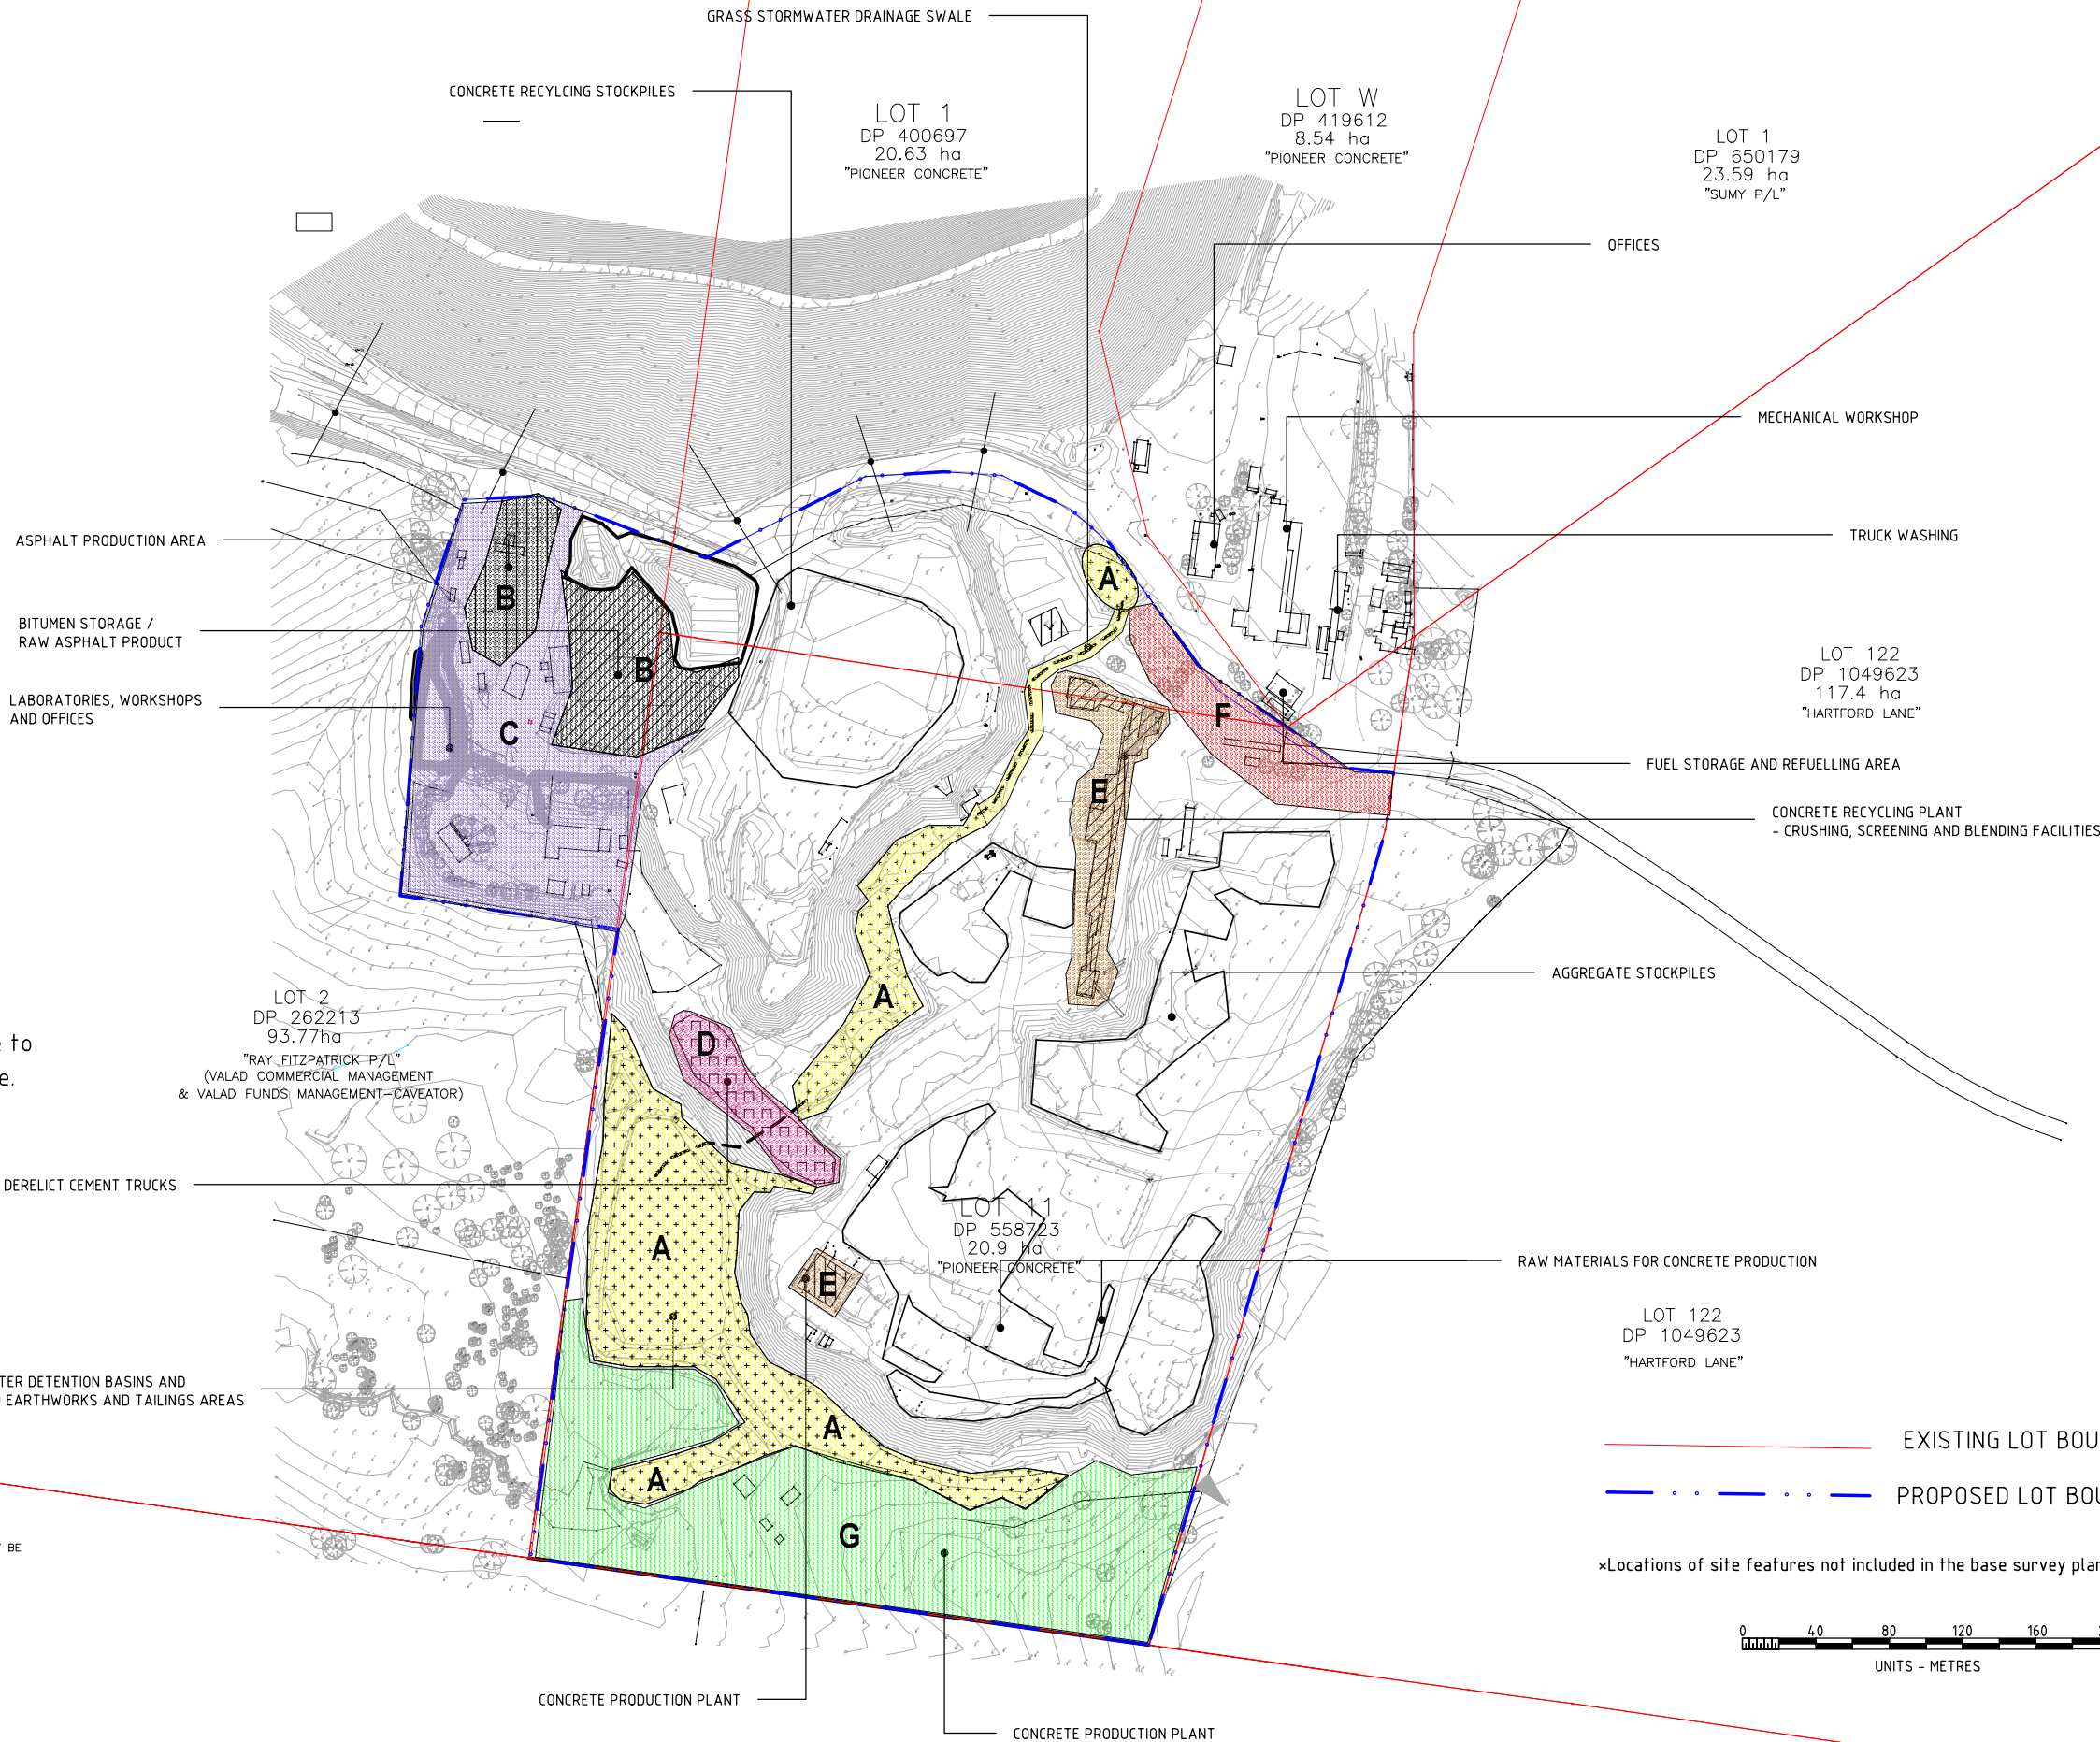
## **6          Attachment A – Site Plan**

Area (shown on site plan)	Source Activities	Potential Contaminants
A	Stormwater detention basins: Any site contamination could be found amongst the sediment at the bottom of these basins since they are the receptacle for site stormwater surface runoff.	The stormwater detention basins are potentially subject to any and all of the contaminants potentially released on-site: Heavy metals, hydrocarbons, solvents, acids.
B	Asphalt production and bitumen storage areas.	Hydrocarbons and heavy metals.
C	Workshops, offices, and technical laboratories associated with production of asphalt and concrete.	Solvents, acids, other laboratory chemicals, and asbestos used as construction material.
D	Abandoned and derelict cement trucks.	Hydrocarbons from vehicle fuels, oils and hydraulic fluids. Heavy metals, metal oxides and solvents from the decomposition of vehicle bodies.
E	Concrete production plant and concrete recycling plant.	Chemical admixtures used in the concrete production process and hydrocarbons from oils associated with the machinery.

F	This area is adjacent to and downslope of a mechanical workshop, fuel storage and refuelling area and truck washing facility.	Heavy metals, hydrocarbons, and acids resulting from spills and leaks and subject to minor transport.
G	Previously agricultural land. Also, this land is close to areas of industrial activities at the site.	Heavy metals, hydrocarbons, organochlorines and organophosphates.

AREAS REQUIRING SAMPLING AND TESTING  
(STAGE 2 ASSESSMENT)

- A** Stormwater detention basins, drainage swales and assorted tailings areas.
- B** Asphalt production and bitumen storage areas.
- C** Workshops, offices and laboratories.
- D** Abandoned and derelict cement trucks.
- E** Concrete production plant and concrete recycling plant.
- F** Downslope of workshops, fuel storage and refuelling area and truck washing.
- G** Previously agricultural land. Also close to areas of industrial activities at the site.

On the basis of Stage 1 investigation results, further site assessment (Stage 2 - soil sampling and testing) is recommended to characterise site contamination and determine the need for site remediation. Areas considered to require Stage 2 assessment are shown on the site plan (Attachment A) and are based on the main potential sources of contamination identified by the preliminary assessment. Site contamination is not necessarily limited to only the specified areas. Any excavated material which is removed off-site will require a waste classification.
