Report to:
Johnson Property Group

Aquatic Habitat Survey
Boat Ramp at Pitt Town Residential Precinct

29 November 2007

Report Number: 36/0708

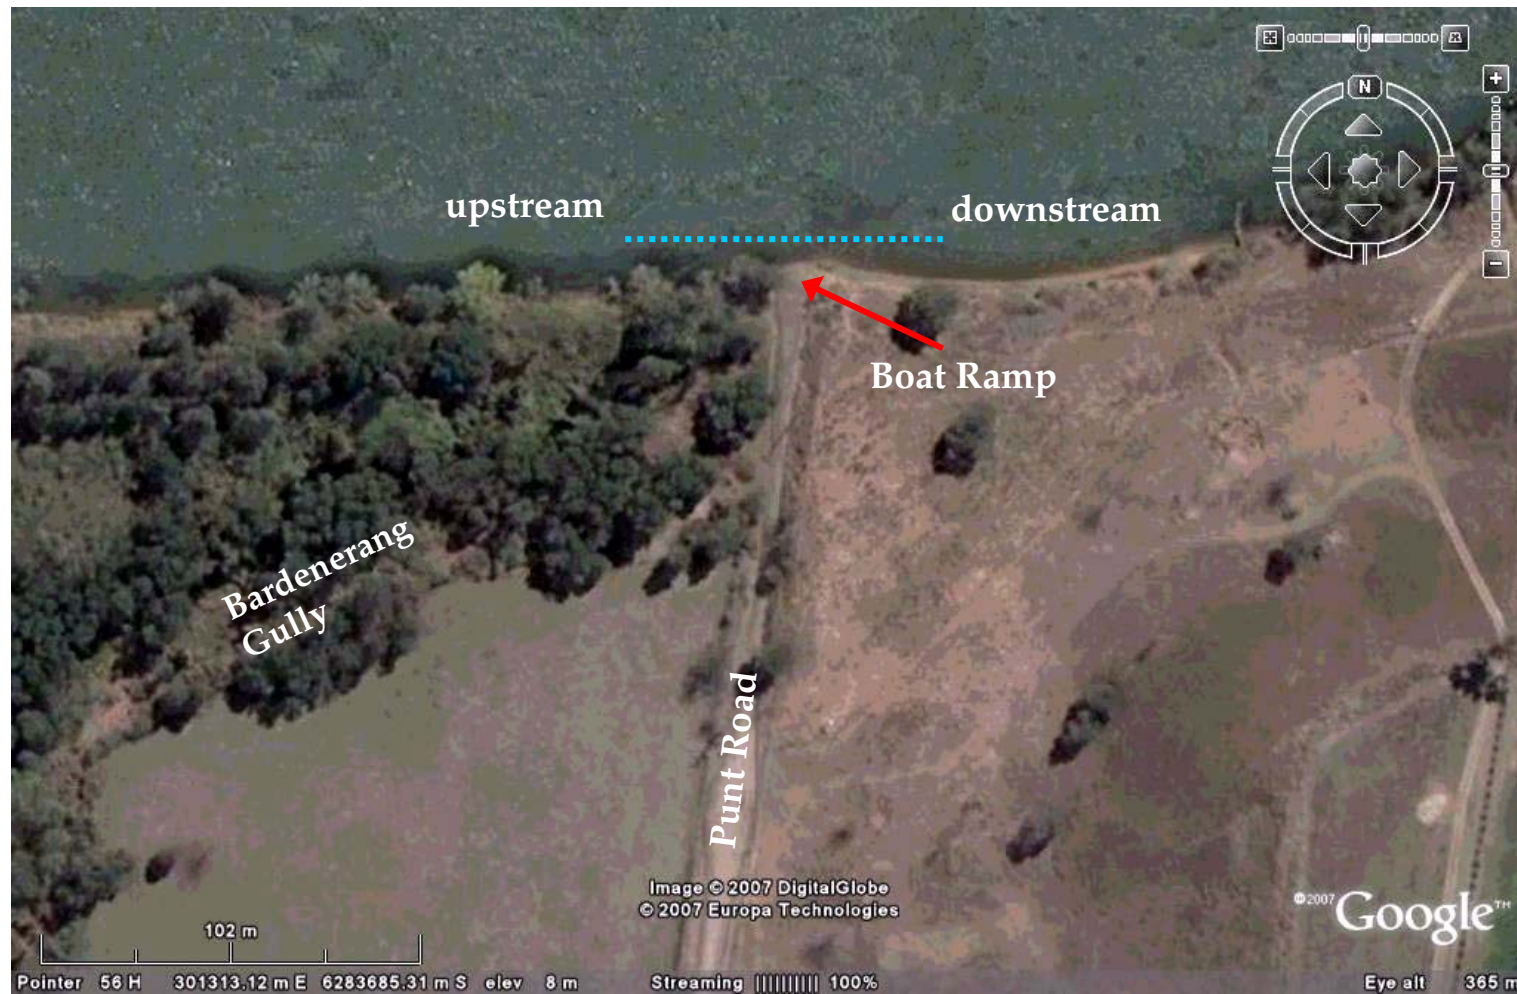
Figure 2. Aerial image of Pitt Town boat ramp and surrounding areas, with survey area indicated by a blue dotted line (source: GoogleEarth)

The study site included the area of the proposed boat ramp upgrade and extended a further 20m in both directions up and downstream (see Figure 2). The riparian vegetation survey was conducted from the riverbank and macrophytes were identified and assessed instream using a viewing tube. Macrophytes not readily identifiable in the field were collected and identified using the relevant literature (Sainty & Jacobs, 1981). Photos of each habitat and species were taken and species of riparian and aquatic vegetation observed were recorded.

Approximately 20 m upstream of the ramp is the mouth of a creek called Bardenerang Gully that is fed by Pitt Town Lagoon, located 2 km south of the river (Figure 2 and Plate 1d). The creek and its banks are located such that they should not be adversely impacted by the construction and operation of the new boat ramp.

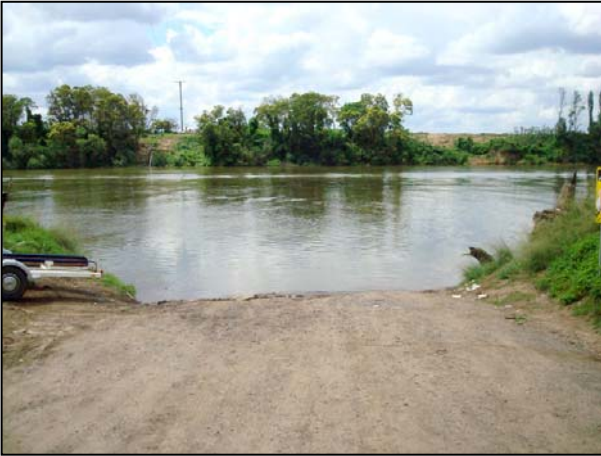
a.

Plate 1. (a.) existing unformed boat ramp on Punt Road, Pitt Town; (b.) unsealed Punt Road leading down to the existing boat ramp (with area to be levelled for future car park at left); (c.) eroded edge of boat ramp along with dirt alcove used currently for trailer parking; (d.) creek (Bardenerang Gully) located approximately 20 m upstream of the boat ramp.

The access road to the boat ramp (Punt Road) consisted of loose gravel and dirt, with the edge of the unformed boat ramp at the water's edge consisting of a mixture of loose gravel and broken chunks of concrete (Plate 1). There is space for one car/trailer to park on a grassy and dirt verge, just off to the upstream side of the boat ramp (Plate 1c).

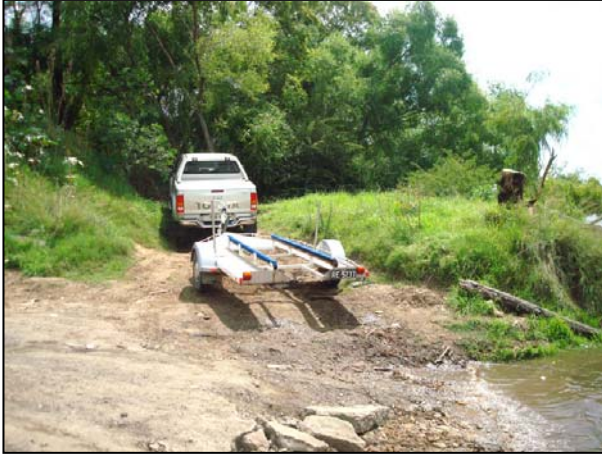
c.

At present, due to the nature of the un-sealed road and dirt car-parking alcove, there is a potential for sedimentation in the immediate vicinity of the river due to run-off and erosion of the boat ramp edge due to car and trailer activities. However, this area of the Hawkesbury River is prone to high turbidity levels anyway (see section 2.2).

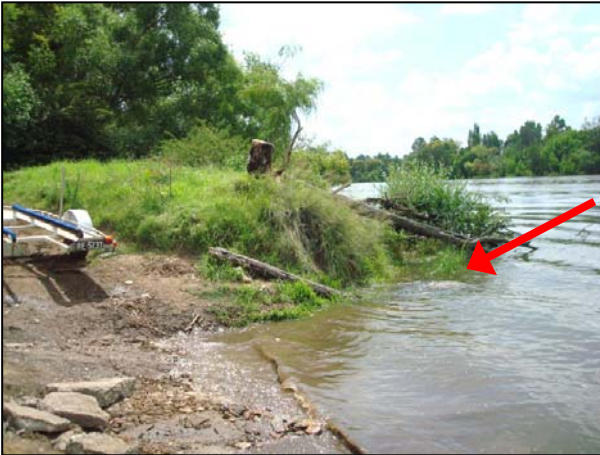
a.

Plate 2. (a.) riparian and aquatic vegetation on the upstream side of the boat ramp – the position of the Common Rush (*Juncus usitatus*) is indicated by a red arrow; (b.) close up of same patch of common rush (red arrow) just out from the boulder (timber snag can be seen in background); (c.) privet trees and timber snag on upstream side of the ramp; (d.) small patch of aquatic vegetation (*Elodea*) upstream of the ramp.

- iv. Construction workers should be made aware of the position of the nearby common reeds, 1 metre upstream of the boat ramp, so as to reduce potential damage to these plants.

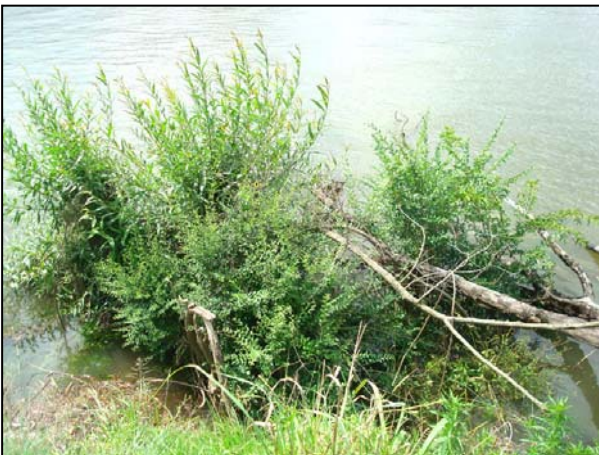
c.

In-stream habitat consisted of moderately sloping silt and sandy banks, dropping into a broad river channel greater than 100 m wide. The turbidity of the river at the time of the survey was relatively high – this may have been due to recent rains in the preceding week. Aquatic vegetation in the survey area was minimal. Several small patches (< 0.5 m²) of the introduced Elodea (*Elodea canadensis*) were present close to shore between the ramp and the creek (Plate 2d). Three small patches of the native Common Rush (*Juncus usitatus*) were observed in the creek and a single small patch (approximately 0.5 m²) was observed just on the upstream side of the ramp (indicated by red arrow in Plate 2a-b). The native Common Reed (*Phragmites australis*) was observed in a small area of the creek (approximately 1.5 m²). A fallen dead tree (located approximately 3 m upstream of the ramp; Plate 2) and a dead log

- v. Where possible, the movement of the two existing dead timber snags (a key threatening process) should be avoided. If this cannot be avoided, then snags should be moved a small distance along the bank and placed the same distance off the bank.

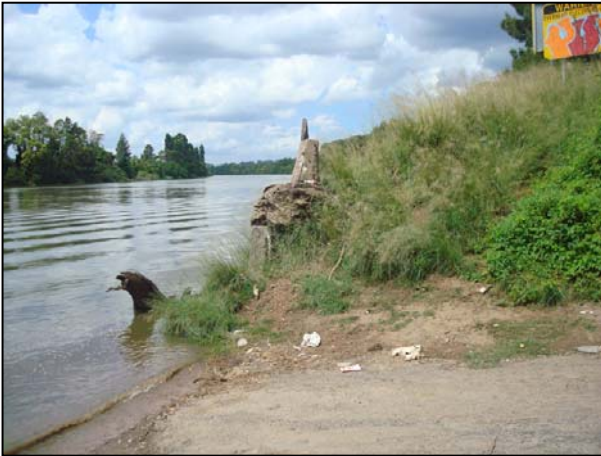
a.

(located 1 m downstream of the ramp; Plate 3), provided an in-stream timber snag. There were very few other timber snags along this area of the river's edge.

Plate 3. (a.) riparian vegetation and dead log timber snag on the downstream side of the boat ramp; (b.) steep bank edge covered in couch grass on the downstream side of the ramp.
