**PROPOSED RESIDENTIAL AND RECREATIONAL DEVELOPMENT
HALL STREET, PITT TOWN**

GEOTECHNICAL INVESTIGATION

REPORT NO 11124/1-AA

26 JUNE 2006

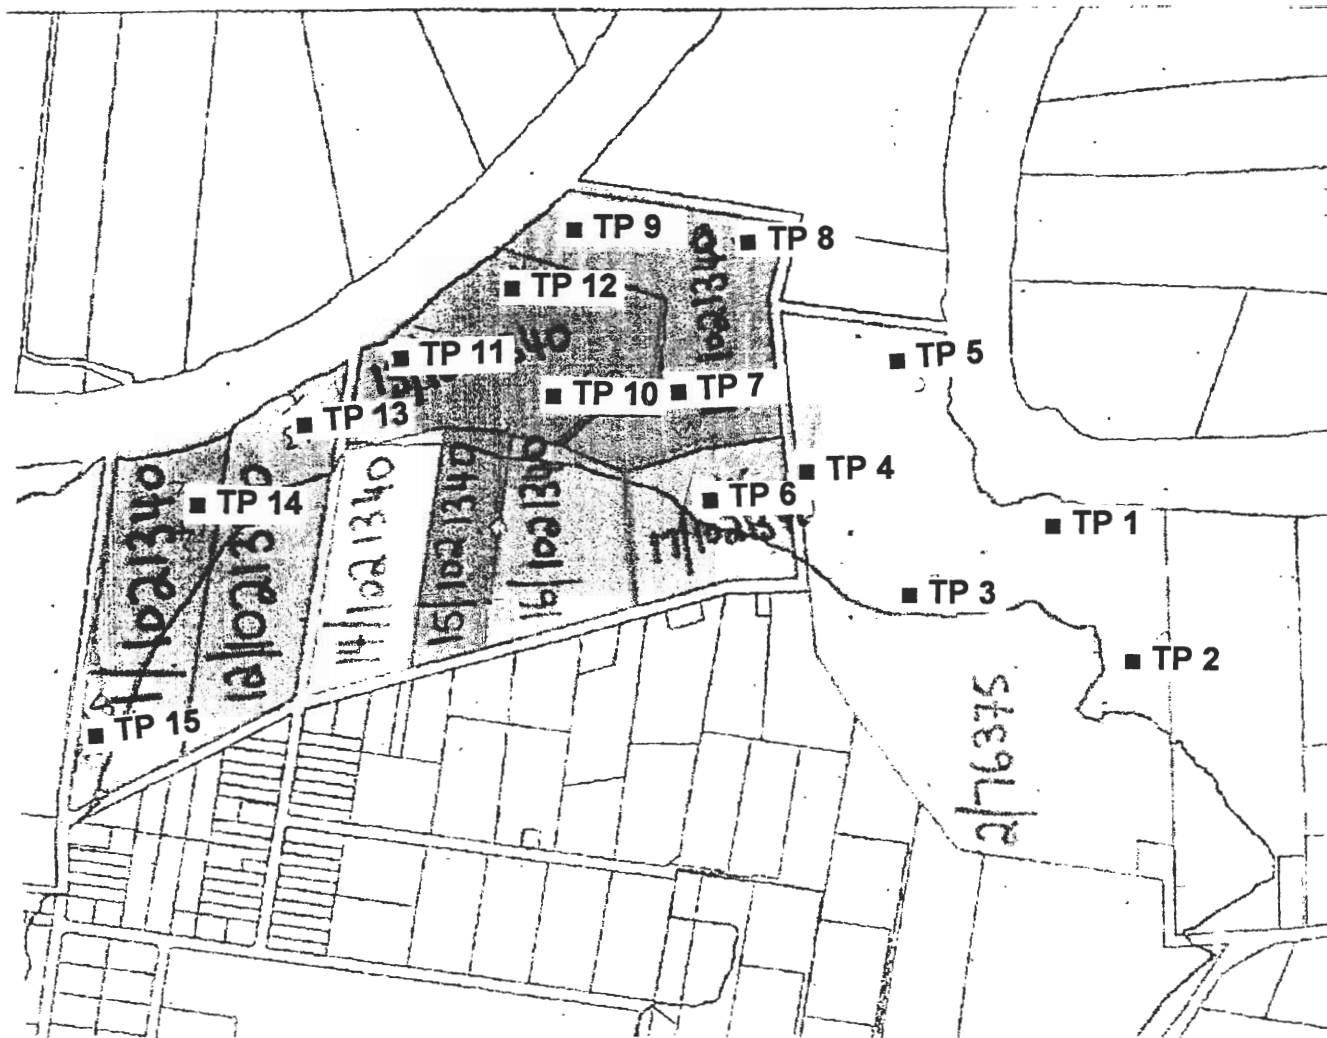
TEST PIT LOCATION PLAN
(Drawing No 11124/1-1)

- Walk over survey of the site to assess geological and geomorphological conditions as well as types of soil encountered across the site.
- Excavation of fifteen test pits (TP1 to TP15) using a backhoe. Test pits were uniformly distributed across the site ensuring at least one test pit is located in all types of soils and landforms. Test pits were terminated at backhoe refusal or depth of about 2.0m, whichever occurs first. Approximate test pit locations are indicated on Drawing No 11124/1-1 presented in Appendix A. Excavation logs are also presented in Appendix A.
- Collect representative soil samples for visual assessment and laboratory tests
- Measuring depth to groundwater level or seepage in test pits, where encountered.

- Soils to depth of about 1.5m are unlikely to be acid sulphate soils across the site. Therefore, an Acid Sulphate Soils Management Plan will not be required if proposed development works involves excavation to depths shallower than 1.5m from existing ground surface.
- Soils at depths exceeding depth of 1.5m are potentially acid sulphate soils in some portions of the site, especially in vicinity of test pits TP3 and TP14. Therefore, an Acid Sulphate Soils Management Plan may be required if proposed development works involves excavations to depths exceeding 1.5m in vicinity of test pits TP3 and TP14. Therefore, we suggest for additional sampling and testing of samples to delineate areas with potentially acid sulphate soils, if any, and provide recommendations on treatment of acid sulphate soils, if depth of excavation exceed 1.5m in vicinity of test pits TP3 and TP14
