GEOTECHNICAL INVESTIGATION

PROPOSED RESIDENTIAL DEVELOPMENT

PITT TOWN, NSW

June 2005

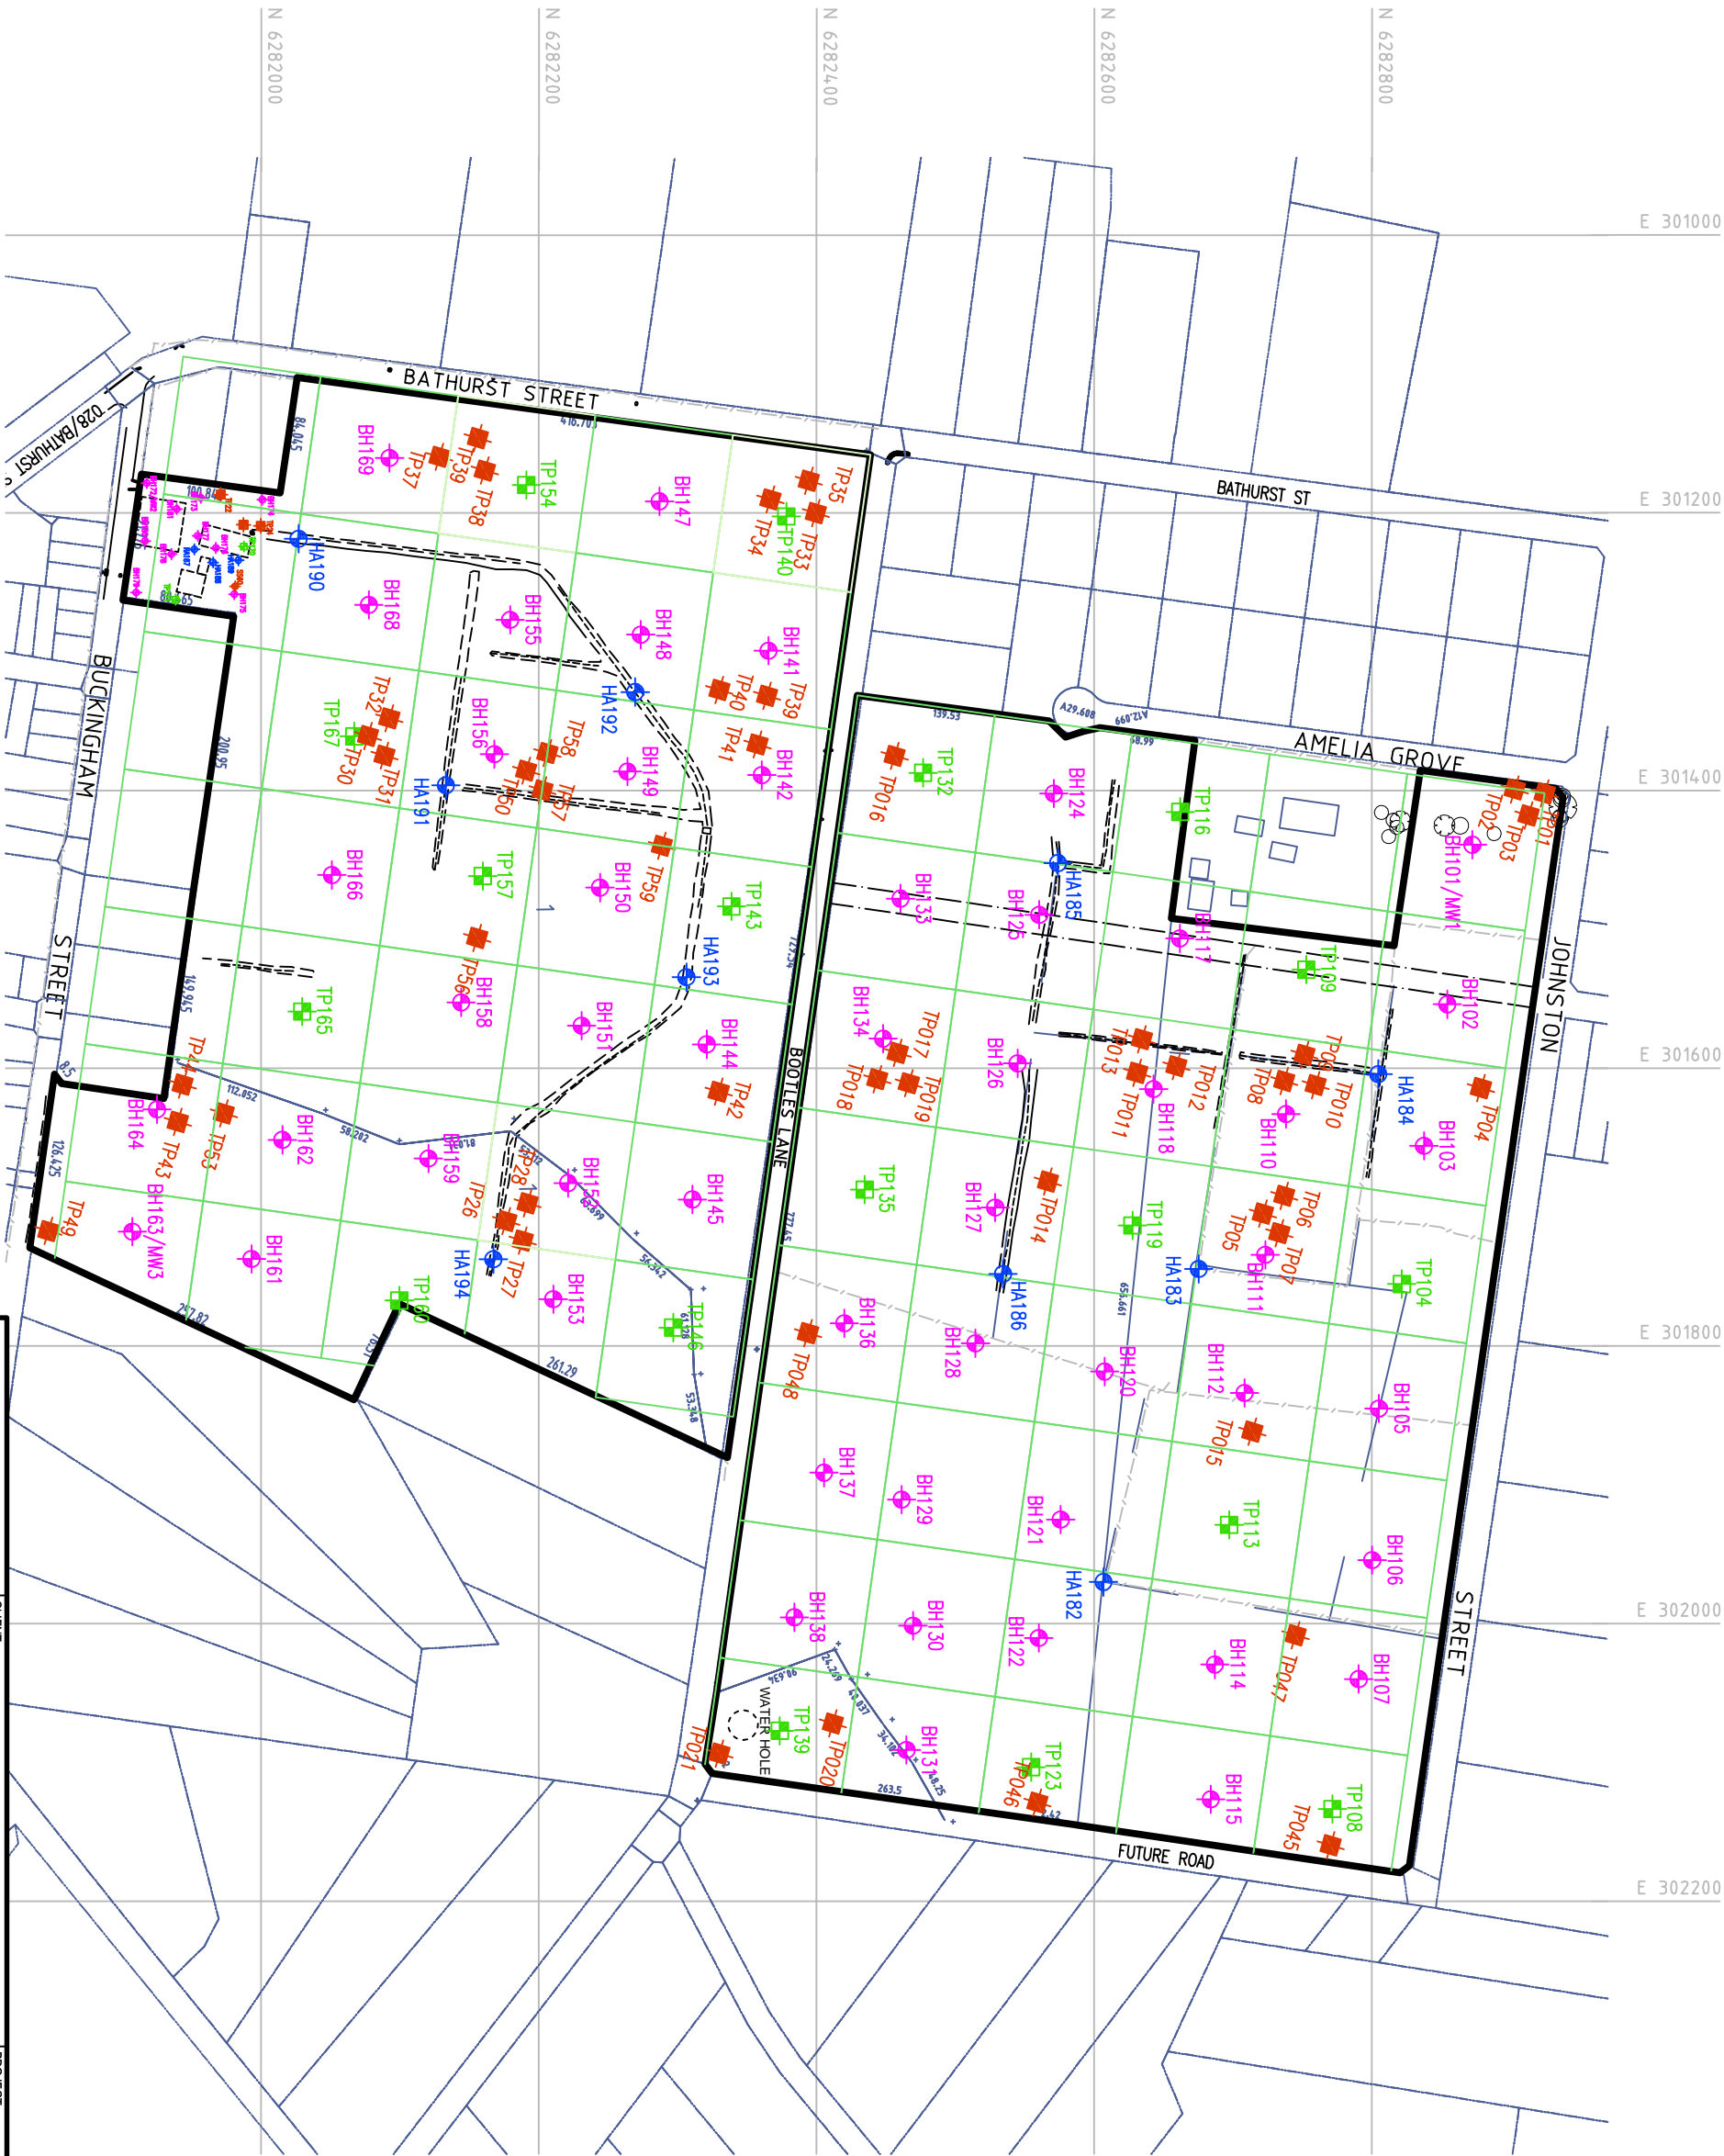
Infiltration testing was carried using the Talsma Hallam or shallow well permeameter method (Boesma, 1965b, Reference 4). This method was chosen over the double ring infiltration test method as the preferred method for dryland soils such as those encountered on the site. Test locations are illustrated on Figure 3.

Several drainage depressions / ditches were observed on both Sites, ranging in depth from 0.5 m to about 2.0 m depth. The major depressions / ditches were surveyed by Brown Consulting and are shown in Figure 3.

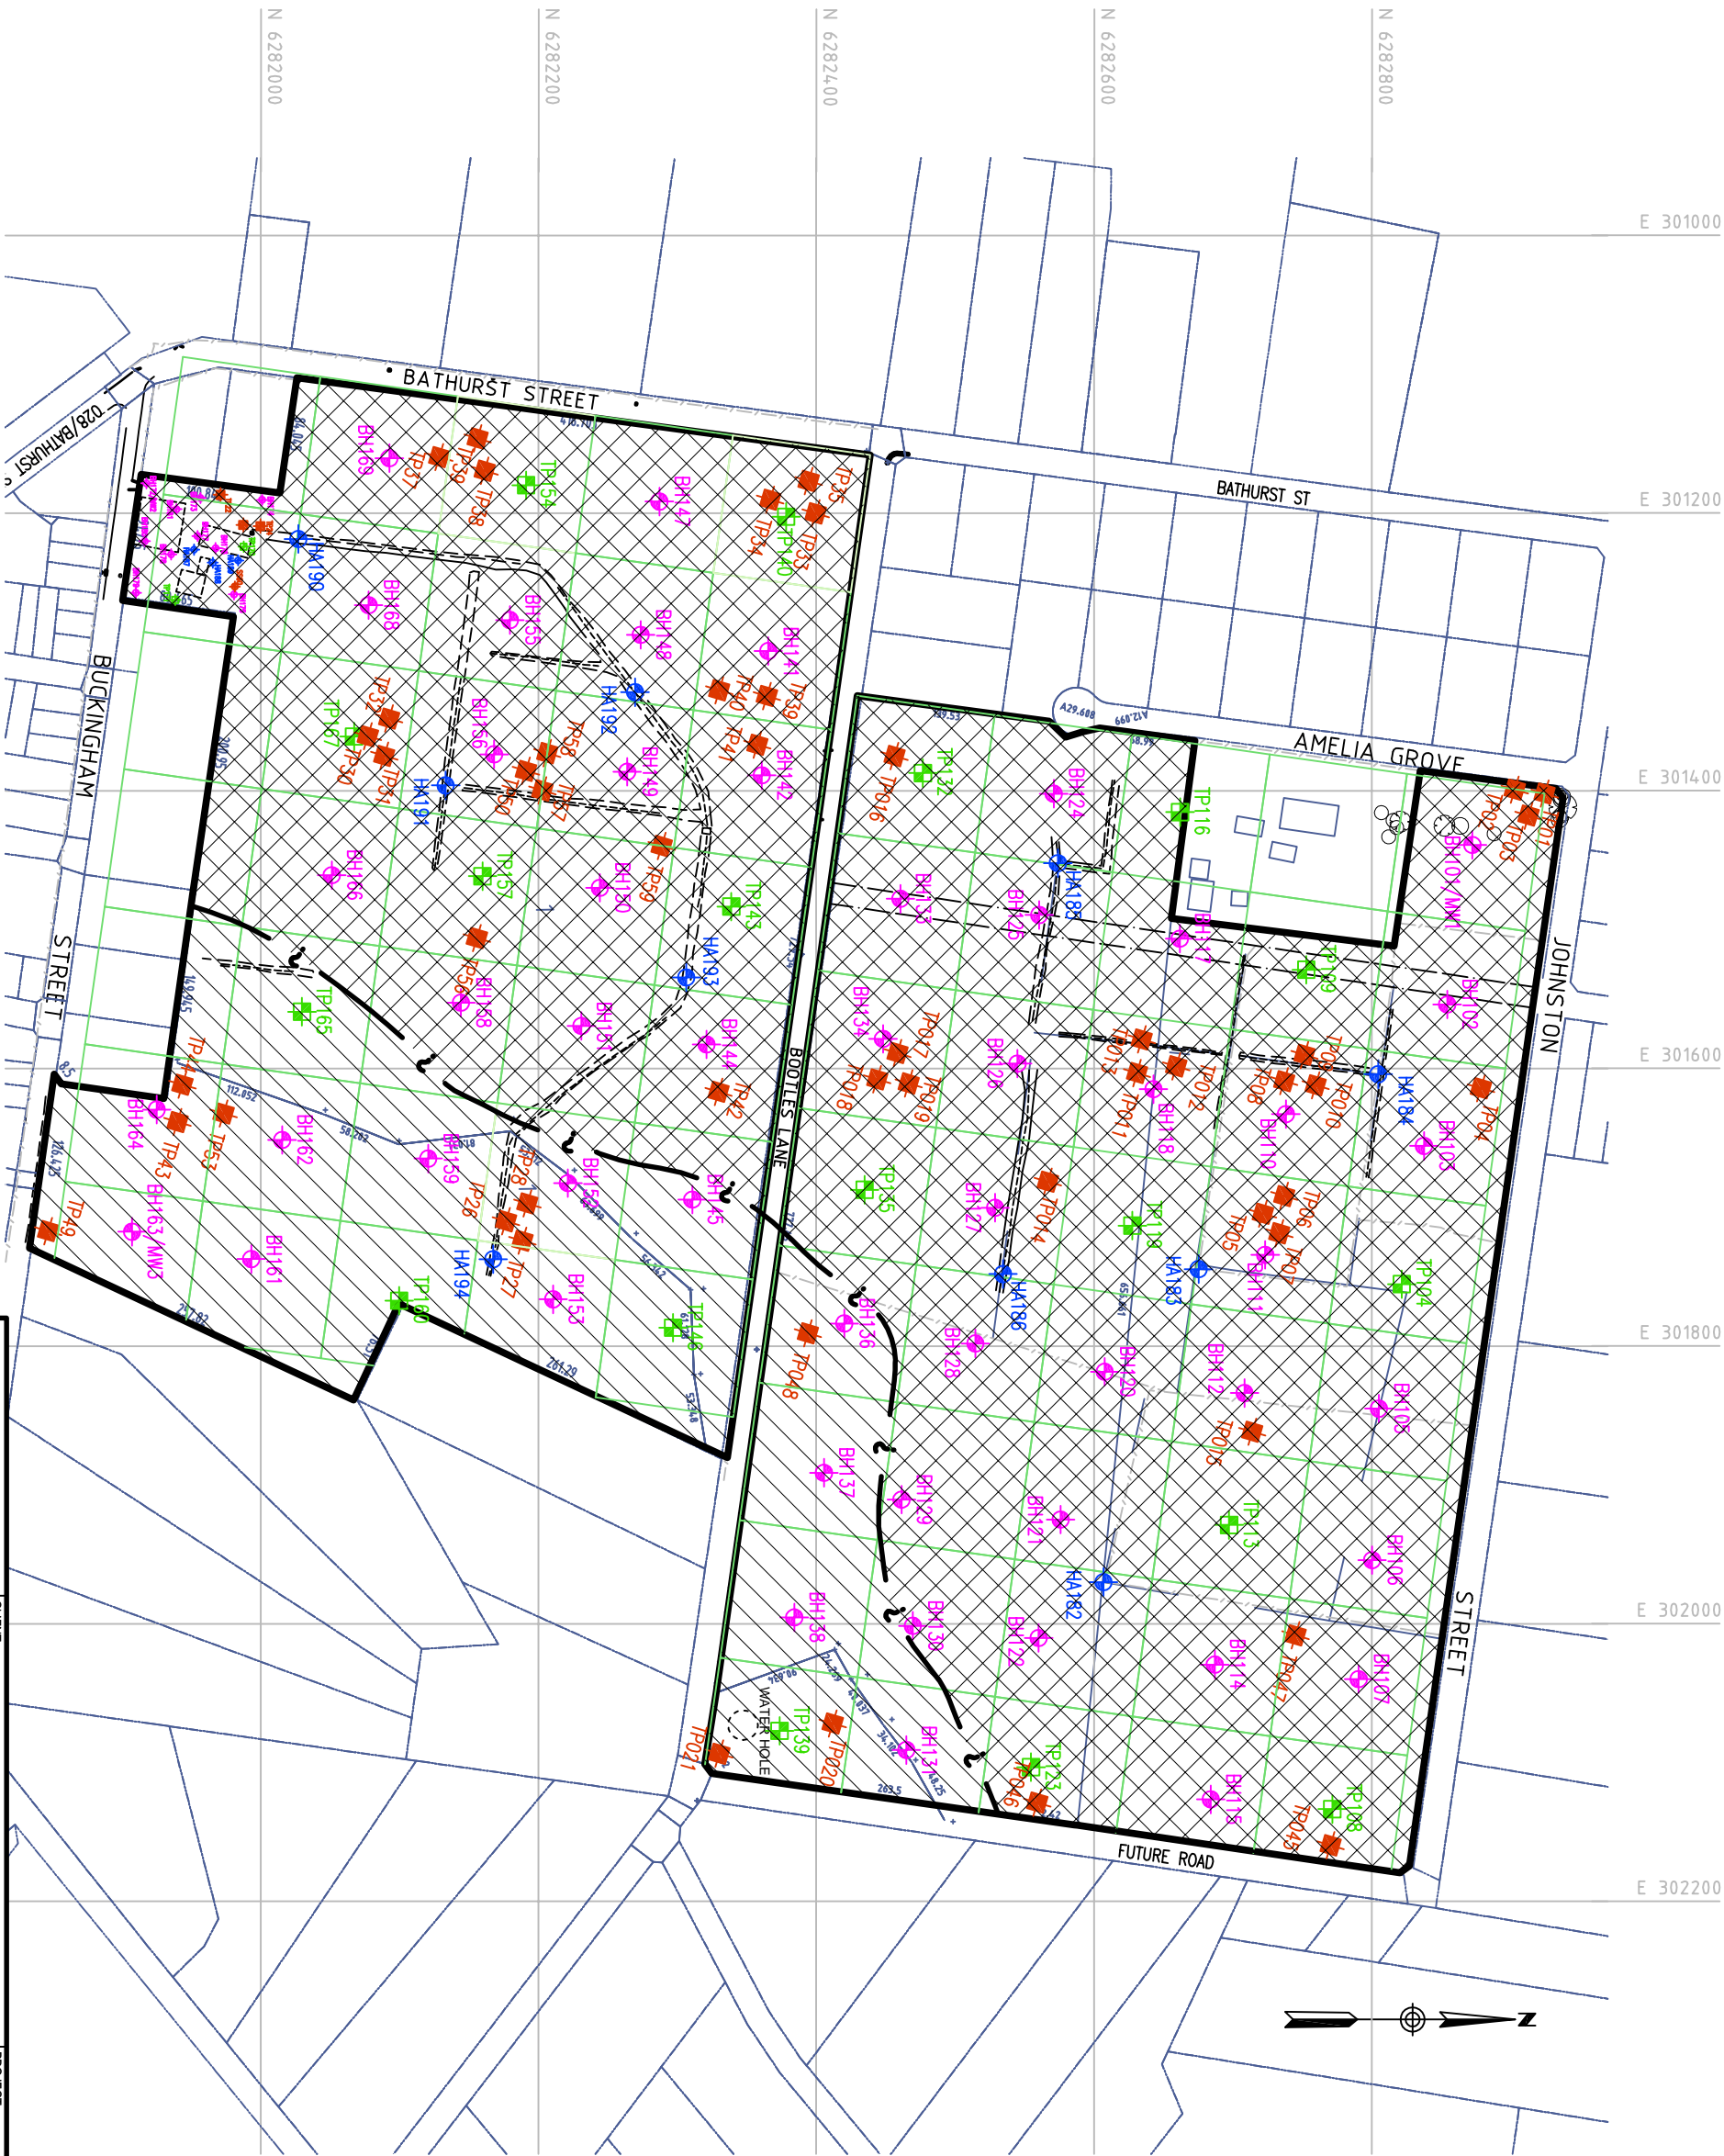
- LEGEND:
- SITE BOUNDARY
 - FENCE
 - DRAINAGE LINE
 - APPROXIMATE LOCATION OF EASEMENT
 - APPROXIMATE GEOLOGY BOUNDARY
 - PRELIMINARY LOT CLASSIFICATION 'M'
 - PRELIMINARY LOT CLASSIFICATION 'S'

- 'S' Class, where the near surface soils and bearing stratum soil is sand: and
- 'M' Class, where the near surface soils and bearing stratum is clay, subject to good drainage being provided – refer also to our discussion on possible impacts of stormwater infiltration in Section 5.8.

Sites to be filled should be classified on the basis of the nature, thickness and level of compaction of the fill. If the fill compaction is controlled then 'S' and 'M' classification may be adopted. If uncompacted fill or boggy conditions result in weak, compressible foundation material remaining on lots then a 'P' classification would be required.
