**HERITAGE LANDSCAPE
AND VISUAL ASSESSMENT OF
PART OF THE SITE OF
GOVERNOR BLIGH'S 'MODEL FARM' *BLIGHTON*
NEAR PITT TOWN, NSW**

Prepared for the Johnson Property Group

Mayne-Wilson & Associates
Conservation Landscape Architects
Paddington NSW

November 2005

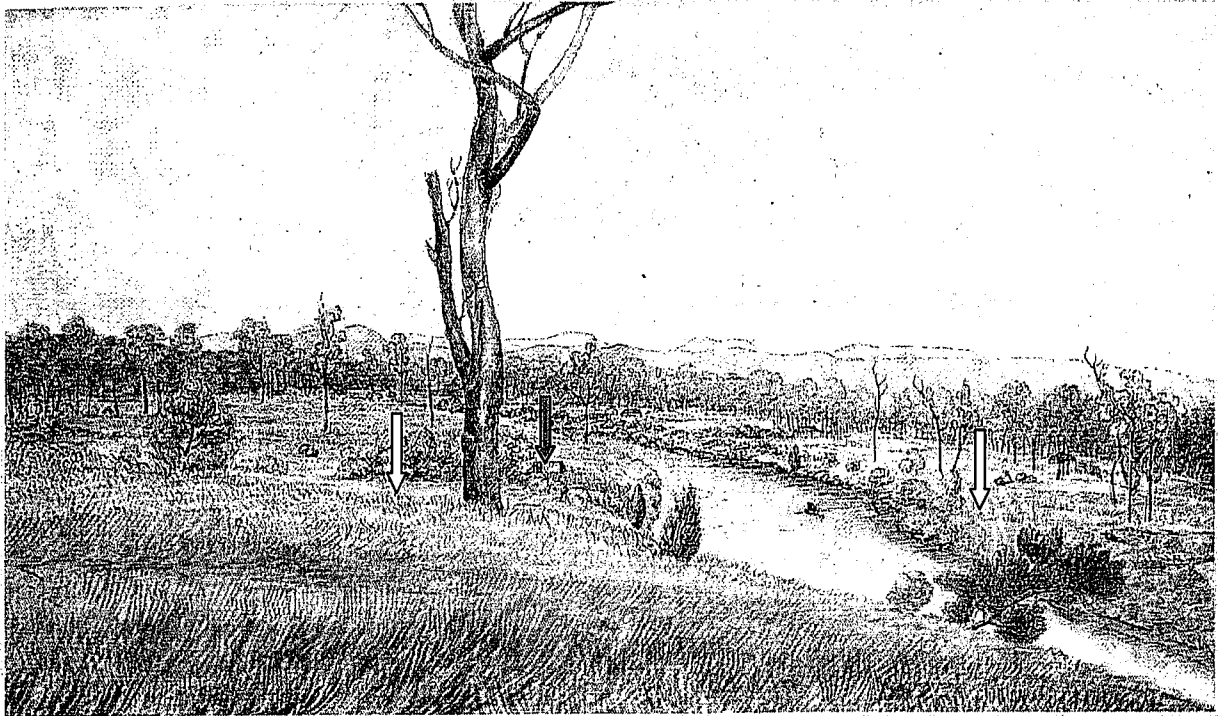
Figure 4 This earlier painting by J. W. Lewin c.1806-08, also made from the east, also shows a mild bend of the Hawkesbury River northward from the York Reach before making a broader curve toward the Wilberforce Reach that tends south-west. Unlike Evan's painting, this image shows the farmland virtually depleted of trees, and no buildings on it – perhaps because Bligh's buildings had not yet been erected. There are, however, small farm cottages on the far side of the river, and a shed on the flats of Blighton (blue arrow) - possibly the same building as that arrowed in Fig. 2 above. A track appears to run down the slope (arrowed white, just behind the large gum tree in the center of the painting) toward the river, and a corresponding track appears to have been constructed opposite it. This 'prospect' to the Blue Mountains was highly valued at the time.

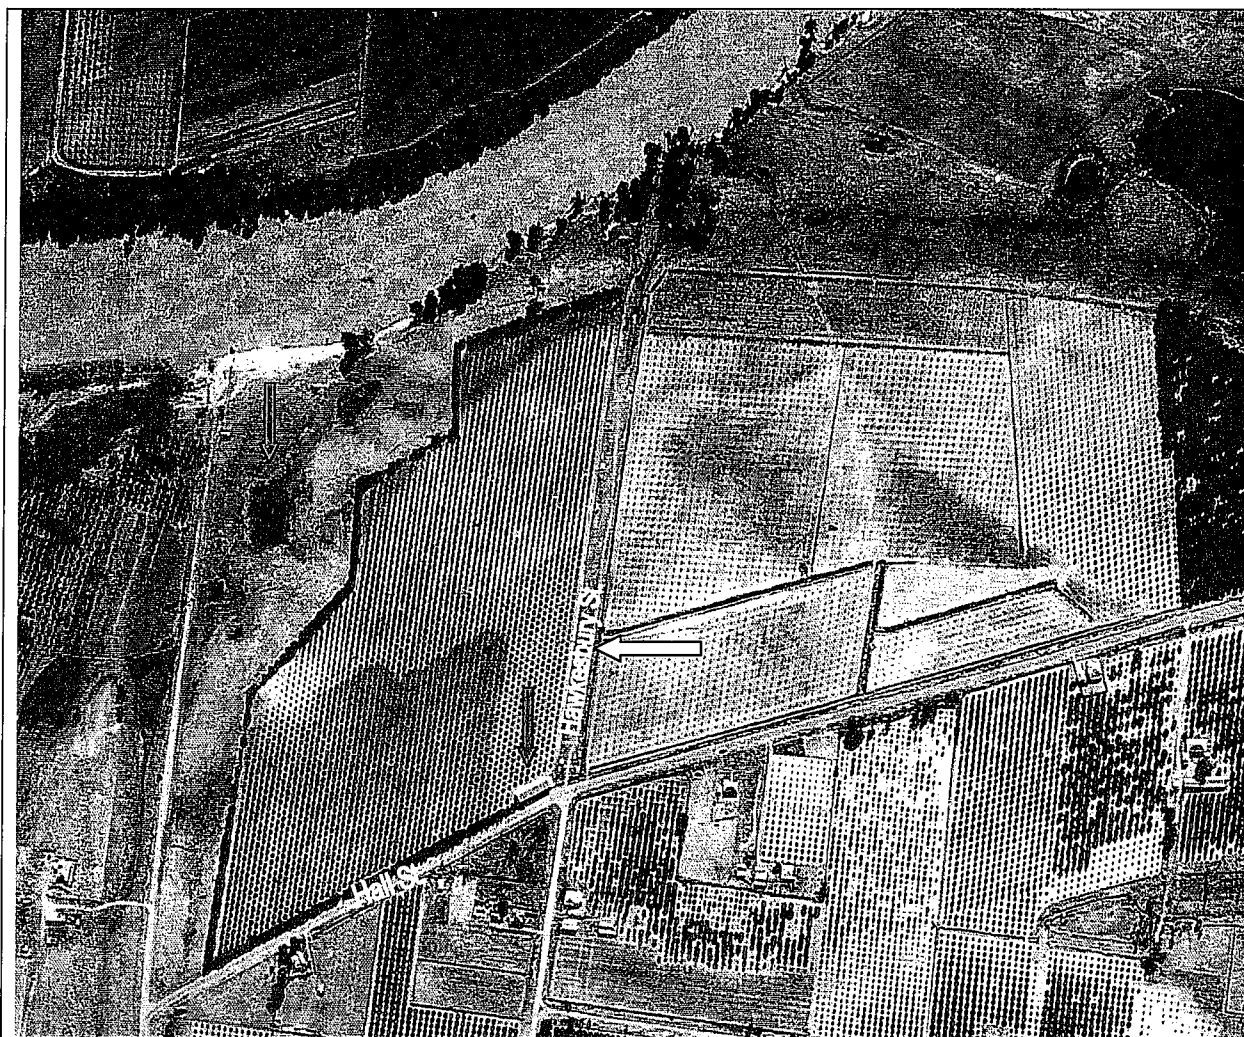
Figure 7 - 1955 Aerial photograph, showing the intensive planting of fruit trees on the ridge area of lots 11 and 12. Note the boundary plantings of pine trees, which judging by their size, must have been planted in the late 1940s (but after the 1947 aerial photograph was taken). Hawkesbury St. (yellow arrow) has now developed a form more like a road reserve. The first section of the fruit packing shed (red arrow) is now in place along Hall St. Note the rectangular dam in the north-west corner of lot 11 (blue arrow).

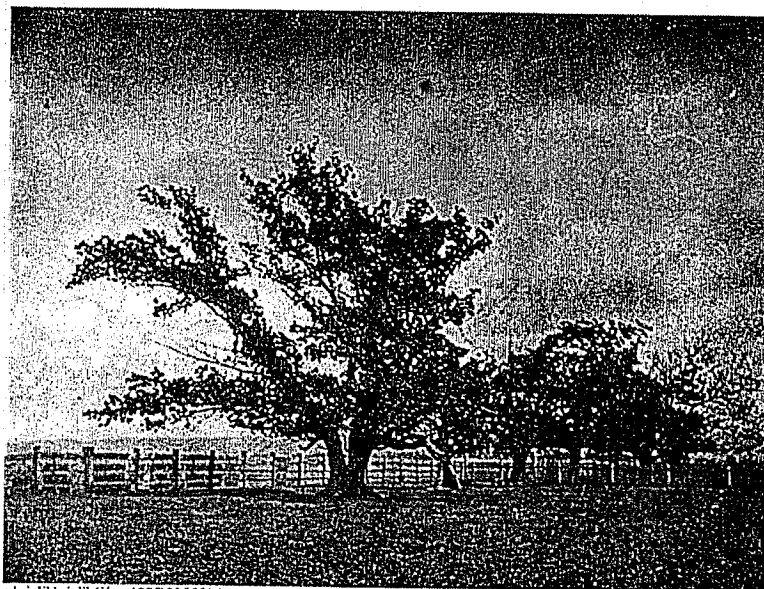
Figure 11 - These trees appear to be viewed from the east, along the top of the ridge, with what appears to be the Blue Mountains along the horizon. This photograph shows more trees were present, and the post and rail

fence still in place, than the later images below. Source: 'Bligh's oaks at Pitt Town' (n.d.) FILMNUM: PITT TOWN Hawkesbury City Council Library (original Collection of Coral Cleary)

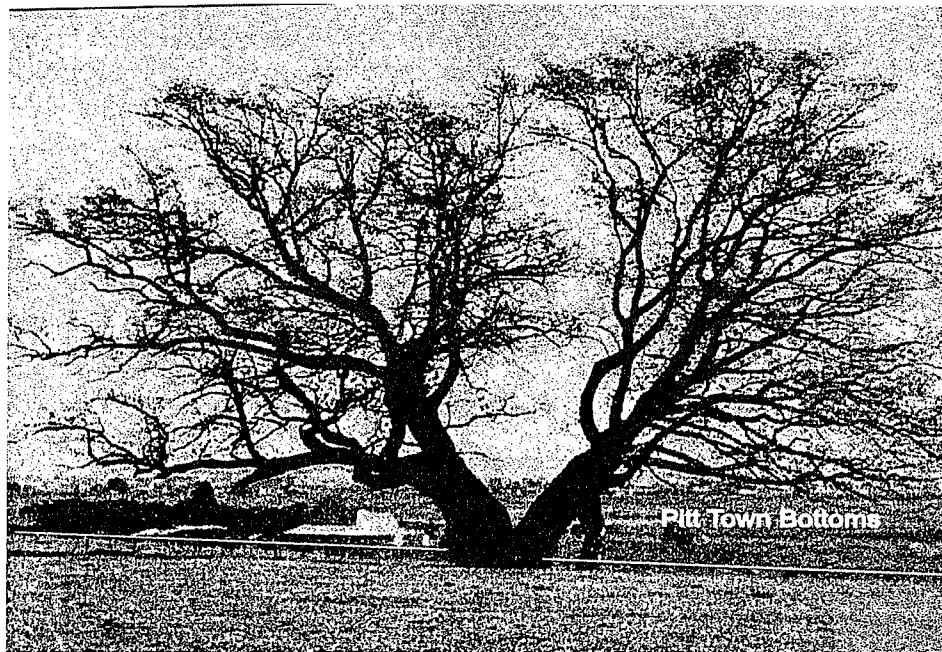
Figure 13 - "Bligh's Oaks" (n.d.) This image also suggests that this oak was on the western edge of the ridge, (indicated by the dashed white line) where the land slopes down toward Punt Road. The building on the left is considered to be the Manse, and the land behind it Pitt Town Bottoms. The bifurcated trunk is the same as that of the tree in Figures 10 and 11 above.

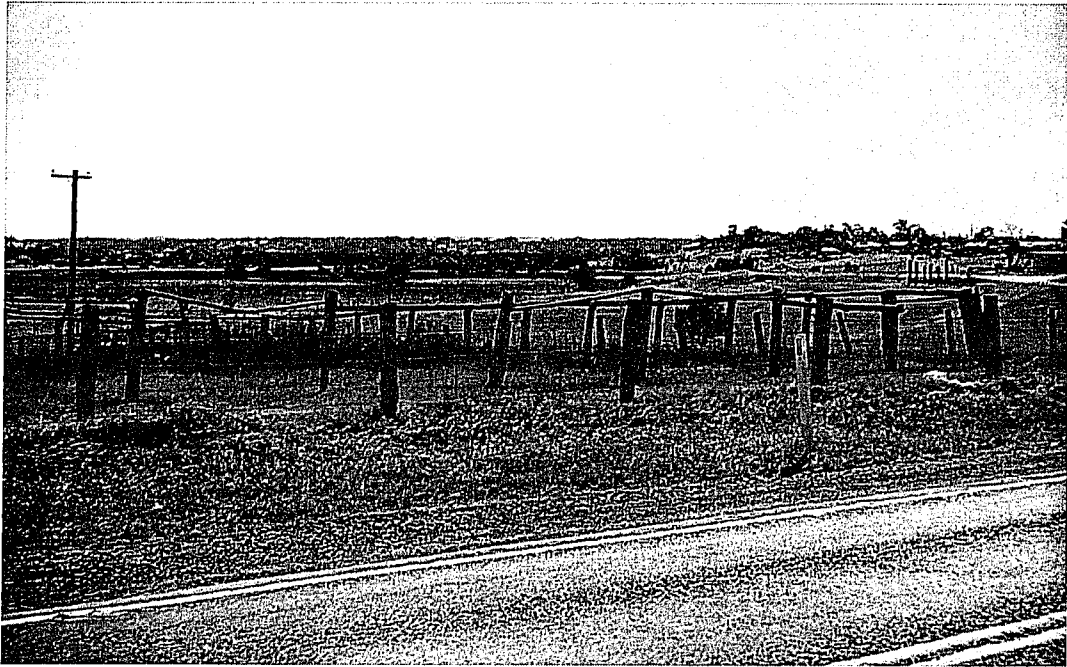
Viewpoint G2 – Looking north from Pitt Town Road towards the ridge on which Pitt Town is located (in the right middle distance). Note that from a distance the level change between the Pitt Town Bottoms (at left) and the ridge to the east does not appear very substantial. Buildings on the military crest (below the ridgeline) are not intrusive. Photo: MWA, September 2004.

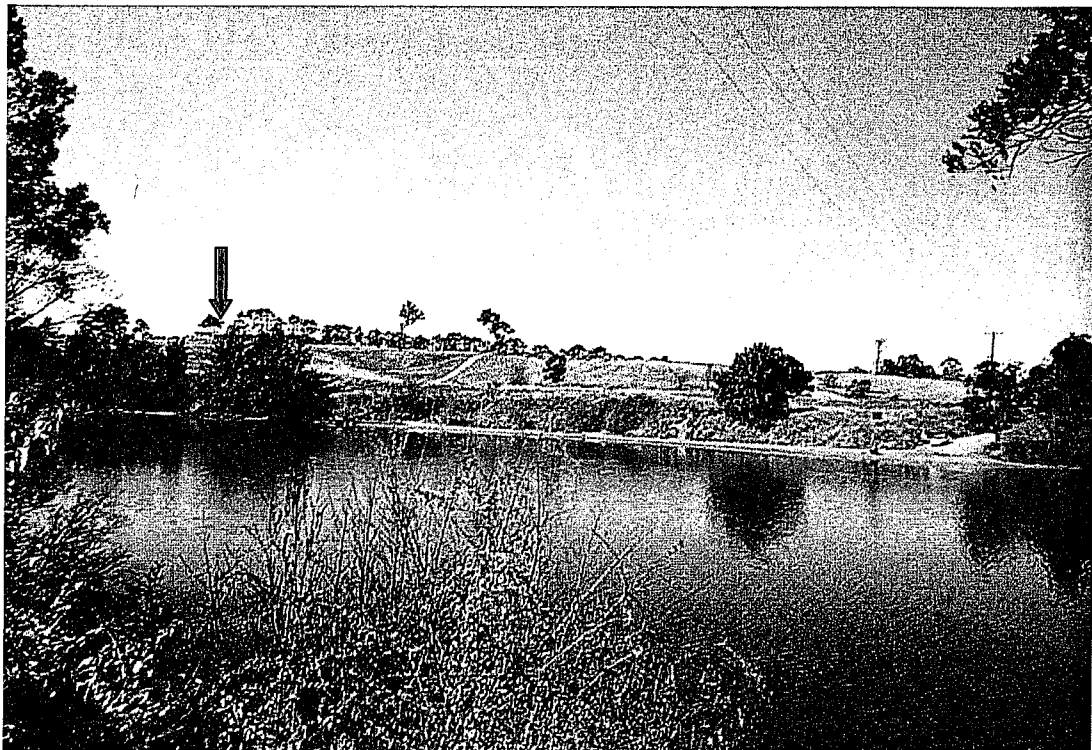
Viewpoint G3 – Looking across the Hawkesbury River towards the site from Pitt Town Ferry Road, on the northern side of the river. Note the recently constructed residence (arrowed) on the ridge within Lot 12 at the left of the picture, and the gentle fall of the ridge to the west (right). Photo: MWA, September 2004.

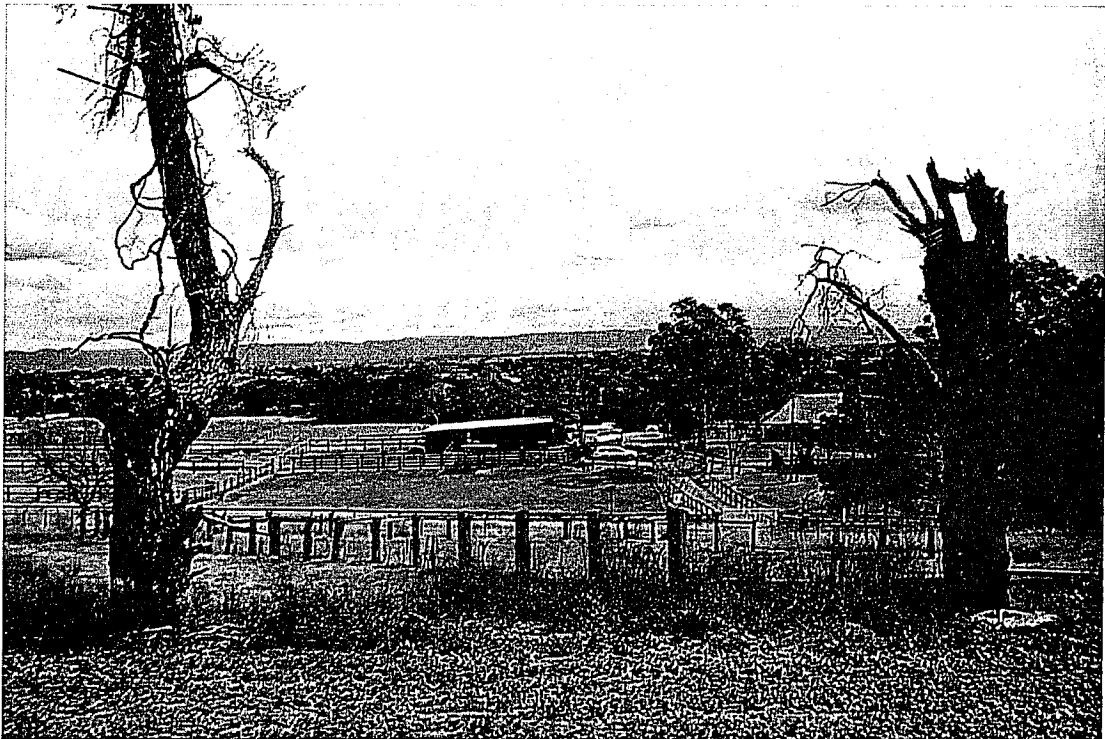
Viewpoint S1 – View west from the south-west corner of the site, showing in the middleground the Old Manse Farm property. Note in the foreground two of the burnt *Pinus radiata* which are located on the edge of the ridgeline around the site. Photo: MWA, September 2004.

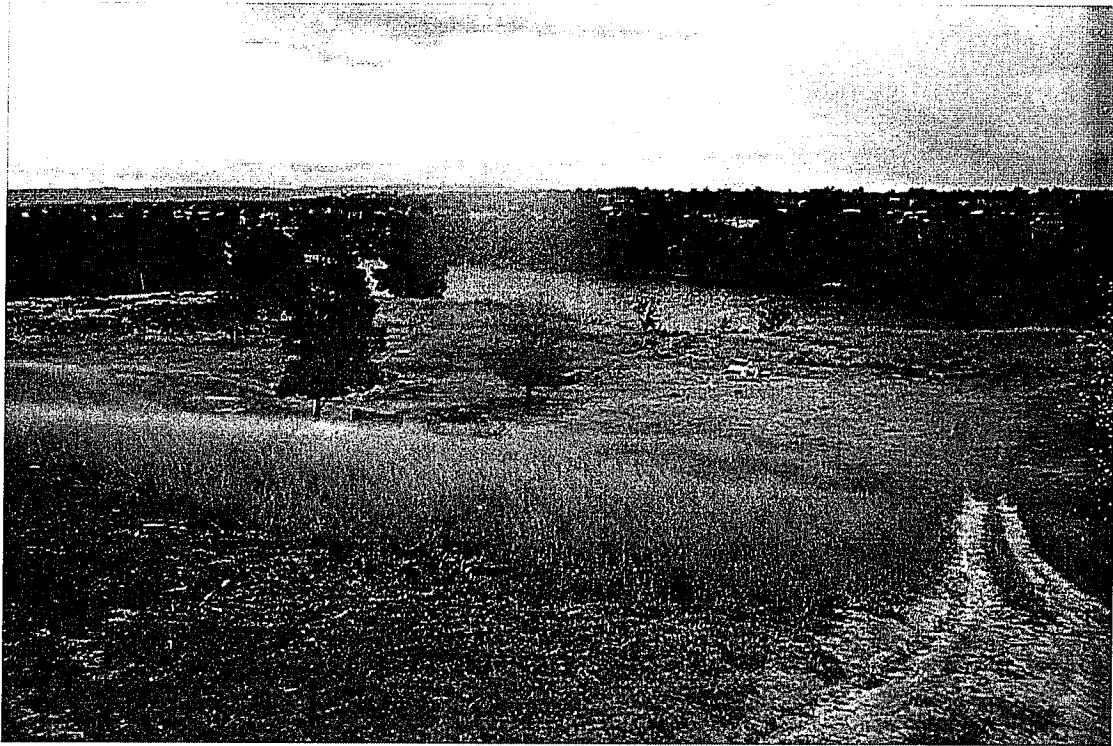
Viewpoint S2 – View towards the river and Wilberforce from the ridge through the site, the photographer standing to the west of the recently constructed residence on Lot 12. Photo: MWA, September 2004.

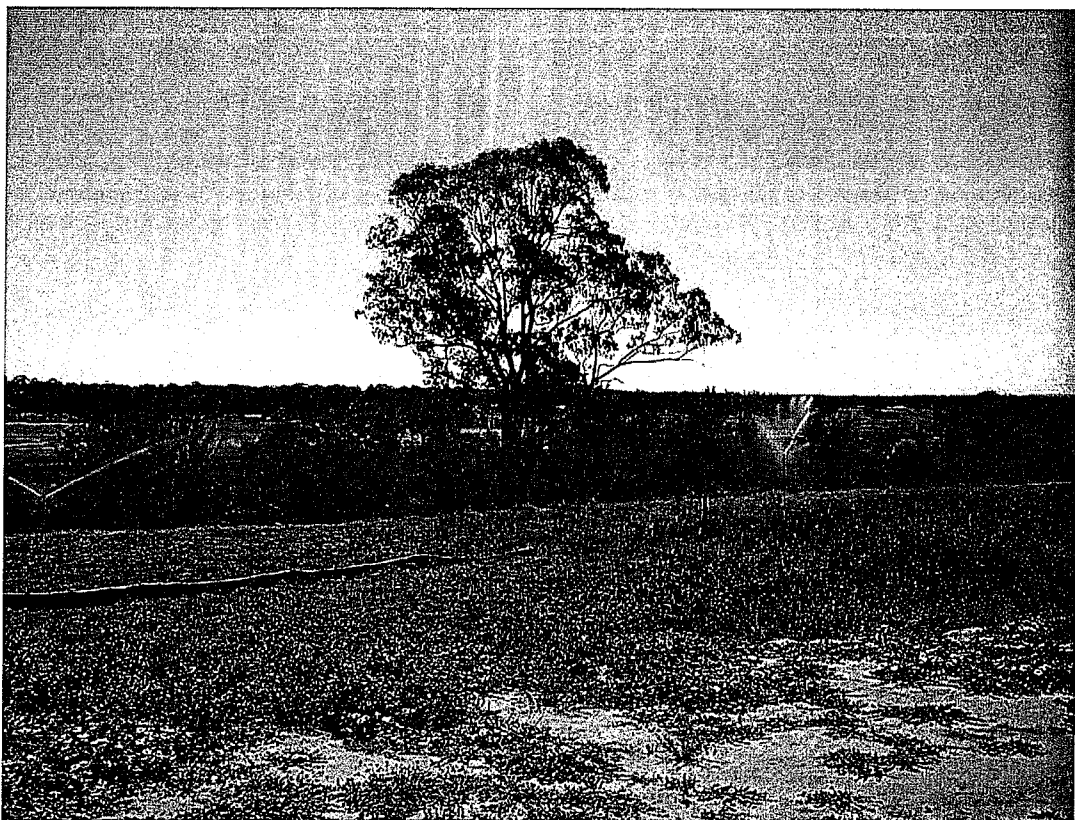
Viewpoint S7 – Looking north from the front of the new house on Lot 12, as the ridge falls away towards the River in the middleground. The large Eucalypt at centre is the only tree on the slopes to the north of the house. However, it is not of heritage value. Photo: MWA, September 2004.

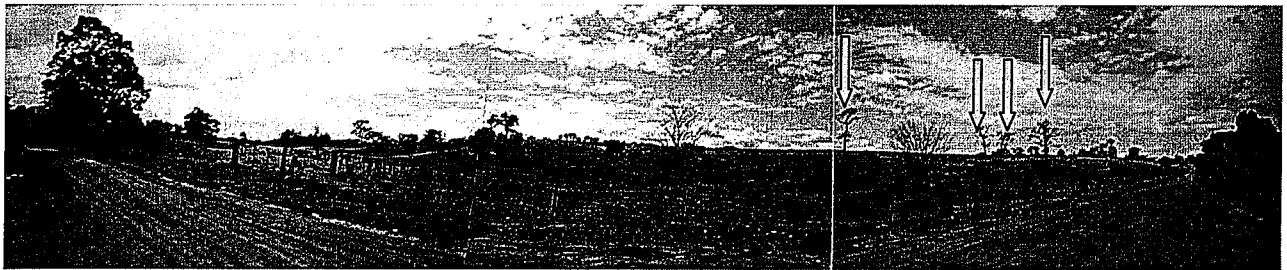
Viewpoint P1 – Panoramic view into the site from Punt Road, showing the ridge extending through the middle of Lot 11 (the western half of the site). Note the remaining mature *Pinus radiata* (burnt by bushfire) dotted along the ridgeline - they are arrowed green. Photo: MWA, September 2004.

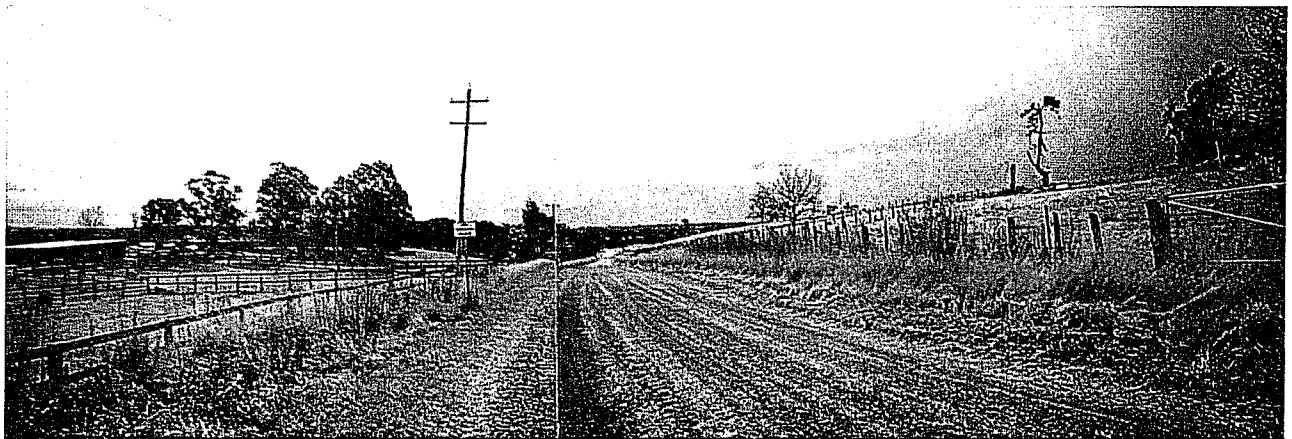
Viewpoint P2 – View north along Punt Road, from its junction with Hall Street. Lot 11, the western half of the site, is on the right of the image. The Old Manse Farm property is on the left, marked by the group of the trees in the middleground. Photo: MWA, September 2004.

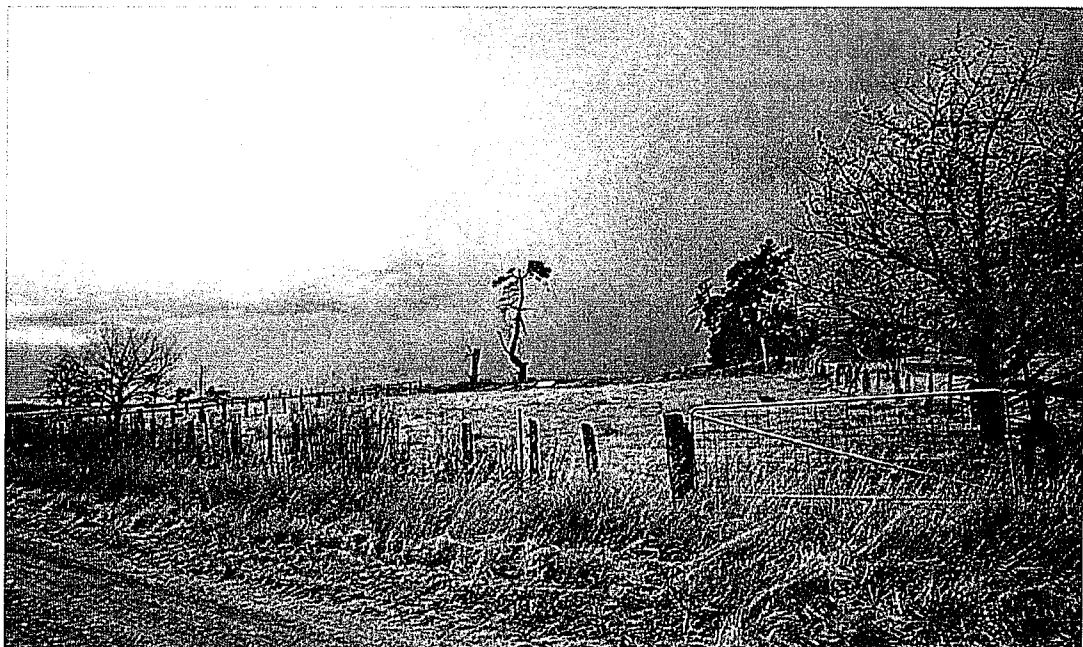
Viewpoint P3 - View of the south-western corner of the site, the area said by some to be the location of Bligh's famous Oak trees. This consultant, however, considers they were more likely located near where the dead Pine trees are located (center of photo) None of the trees present pre-date 1947.
Photo: MWA, September 2004.

None of the vegetation present on the site today is older than fifty five years, the Pine trees having been planted in the late 1940s. None of Bligh's Oaks, the subject of several photographs and a painting or two, survived since the late 1940s. Their original location is not certain, although it would seem they were along the western edge of the ridge, on lot 11, not far from Punt Road.

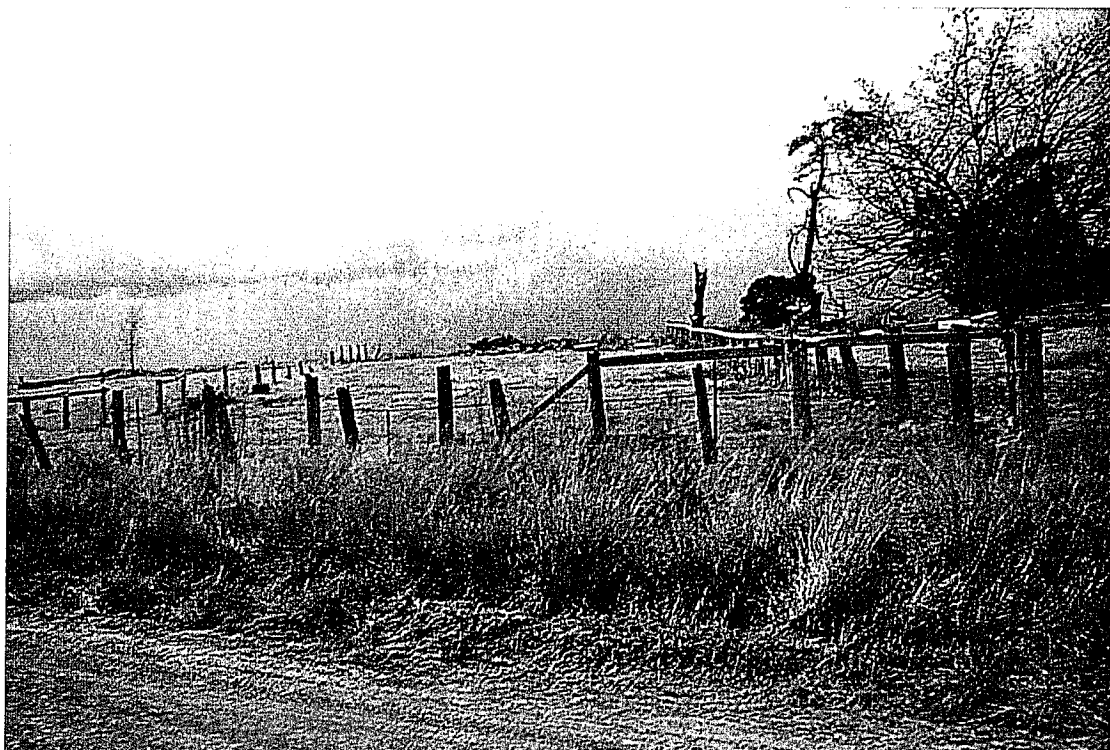
Viewpoint P4 – View from Punt Road into the south-western corner of the Lot 11, showing former post and rail paddock fences and one of two small Oak trees near the junction of Hall Street (at far right), presumably planted in this location to invoke a sense of Bligh's Oaks. Photo: MWA, September 2004.

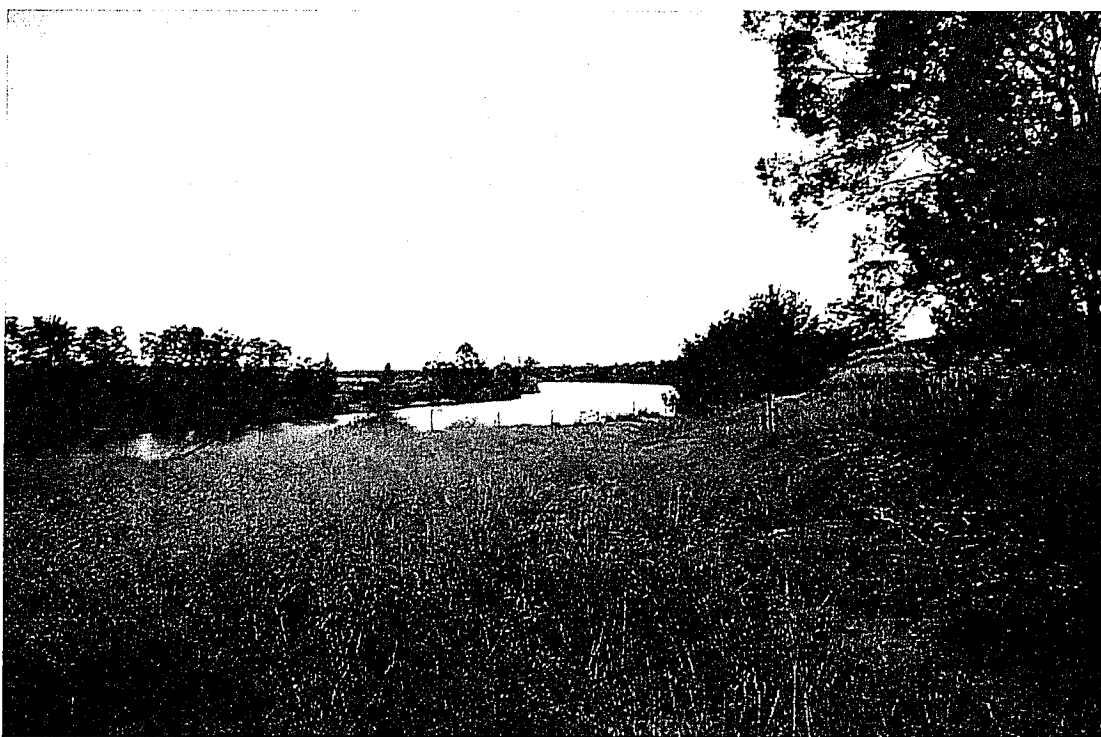
Viewpoint P5 – Looking north-east along the York Reach of the Hawkesbury River from the top of the riverbank on the northern edge of Lot 11. Dense Casuarina and Wattle clumps camouflage easterly views of the river from the top of the riverbank in Lot 12. Photo: MWA, September 2004.

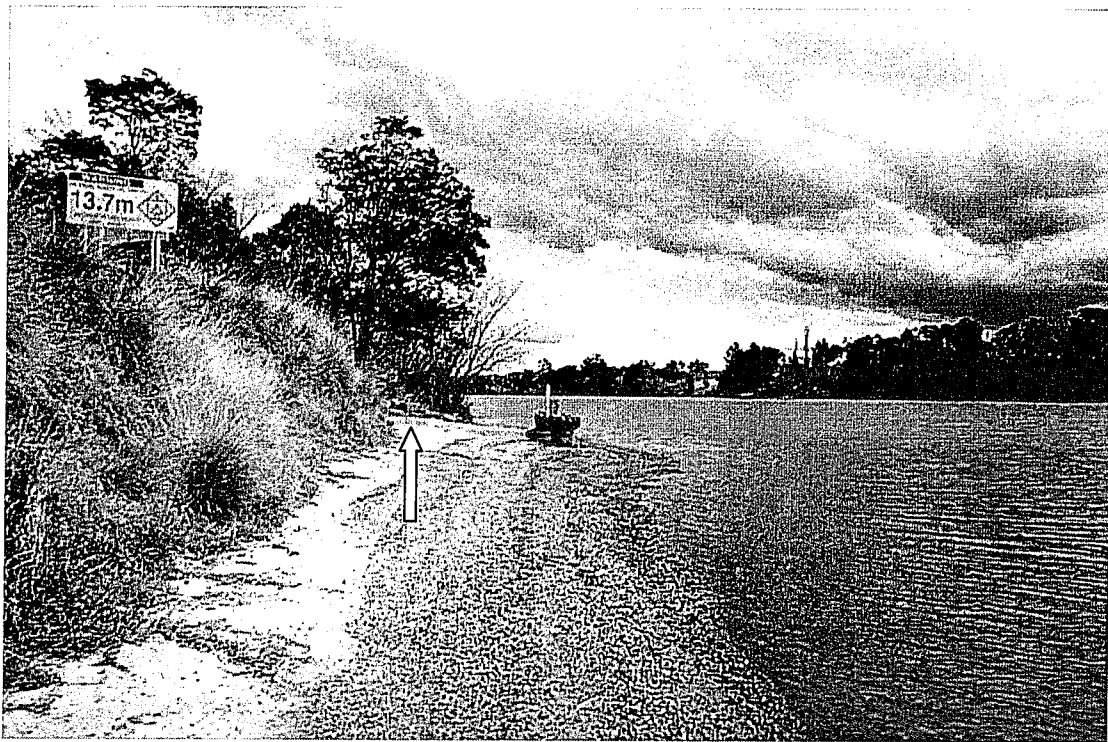
Viewpoint P6 – View west along the Hawkesbury River from its southern banks at the base of Lot 11 (the western half of the subject site). The end of Punt Rd. is indicated by the arrow.

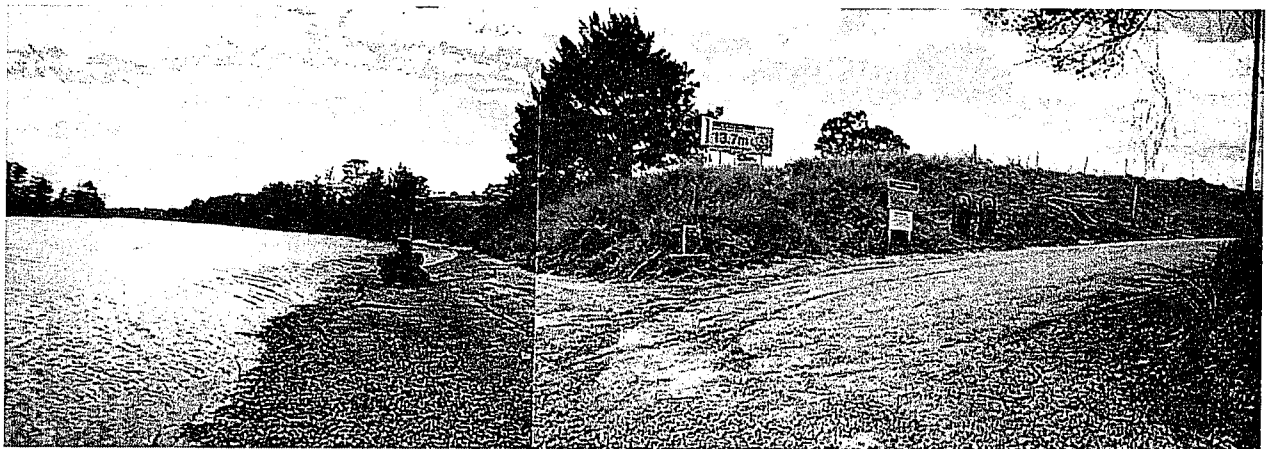
Viewpoint P7 – The junction of the northern end of Punt Road with the Hawkesbury River. The large Casuarina at centre is the only visually significant tree at the north-western corner of the site.

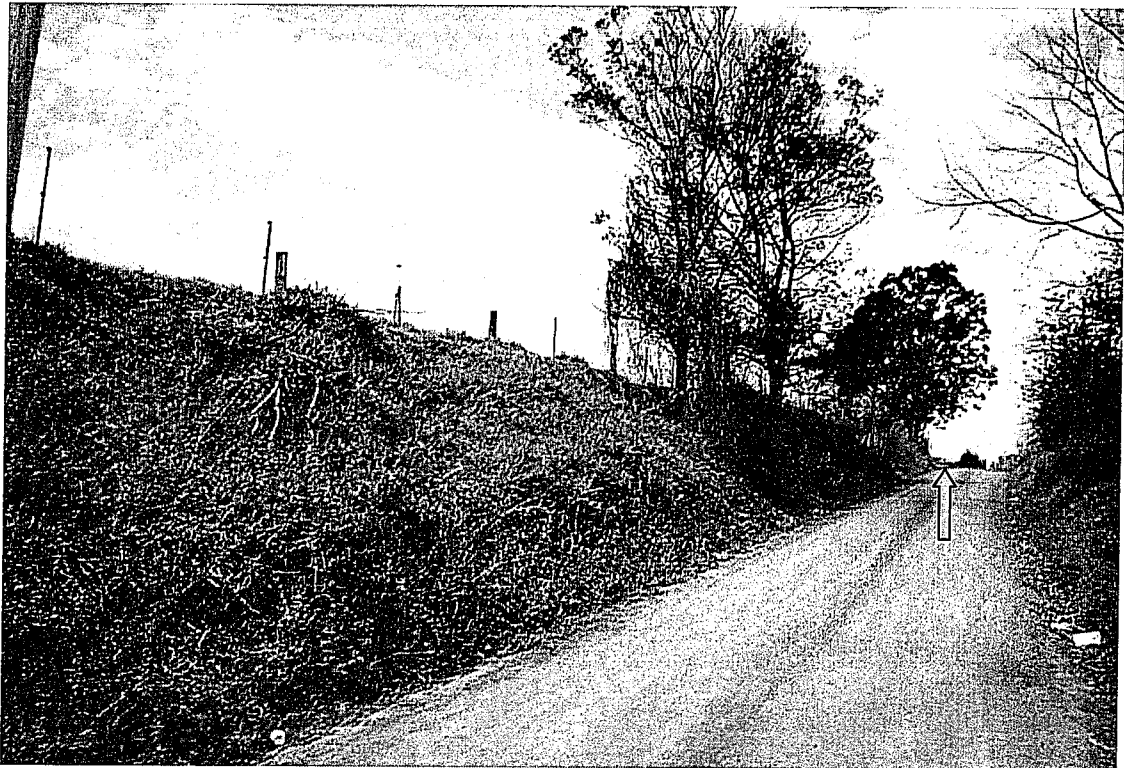
Viewpoint P8 – The northern end of Punt Road, along the western perimeter of the site. The high bank along the eastern edge of the road, at left, does not allow views into the site until the viewer reaches the top of the rise from the river, marked on this image by the green arrow.
Photo: MWA, September 2004.

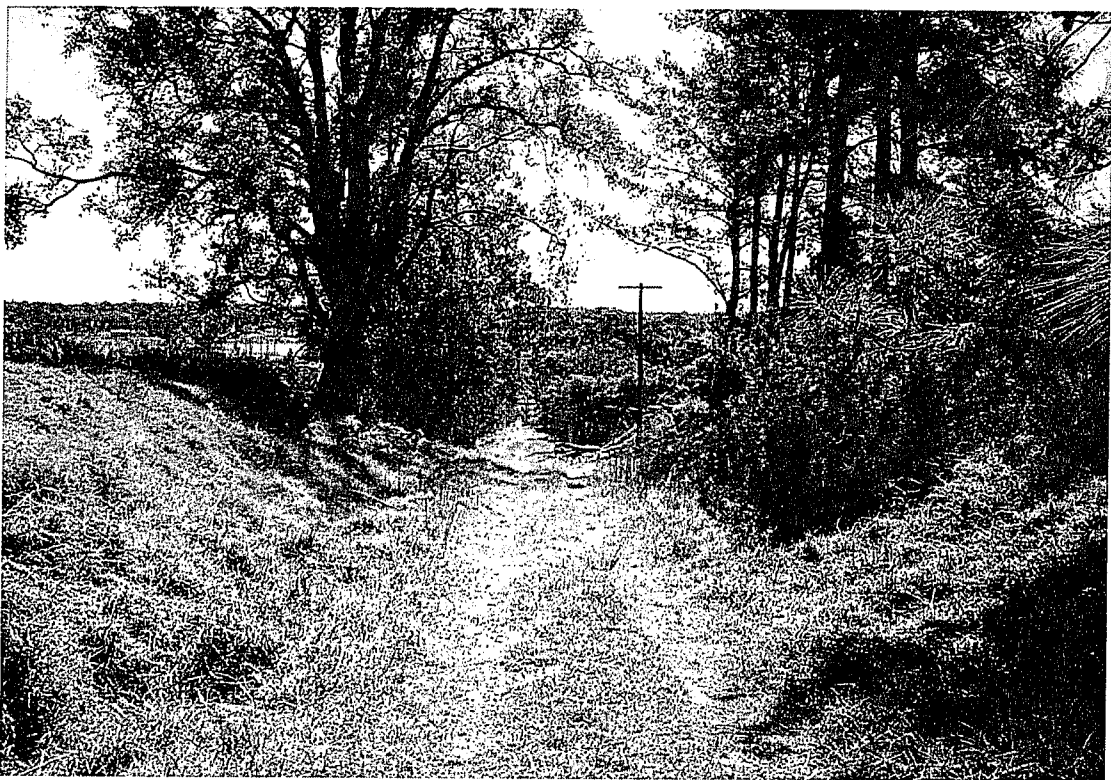
Viewpoint P9 – Looking north along the Hawkesbury Street road reserve which extends along the eastern side of the site. Photo: MWA, September 2004.

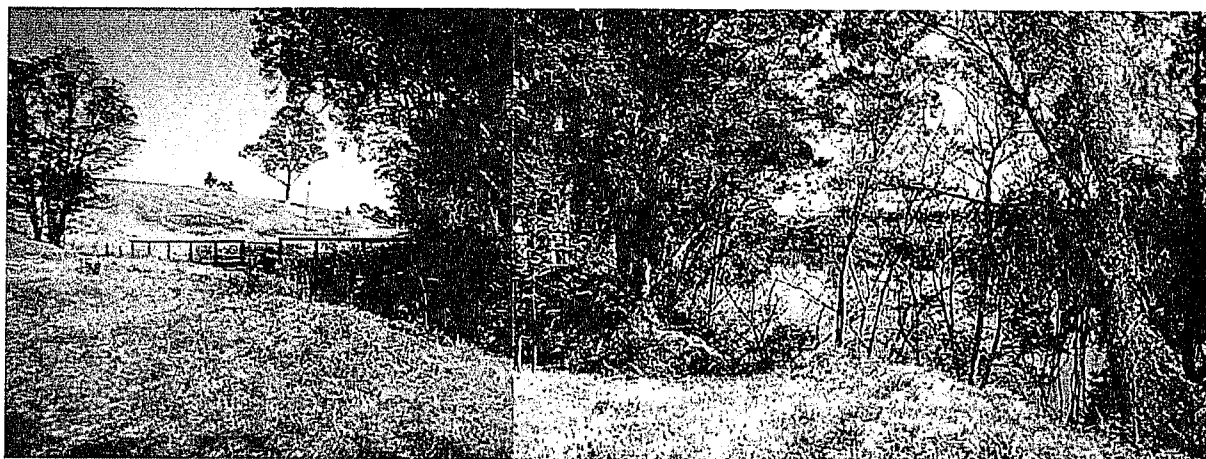
Viewpoint P11 – The north-eastern corner of the site at the junction with the Hawkesbury River. This photograph was taken from the unformed Hawkesbury Street road reserve. Photo: MWA, September 2004.

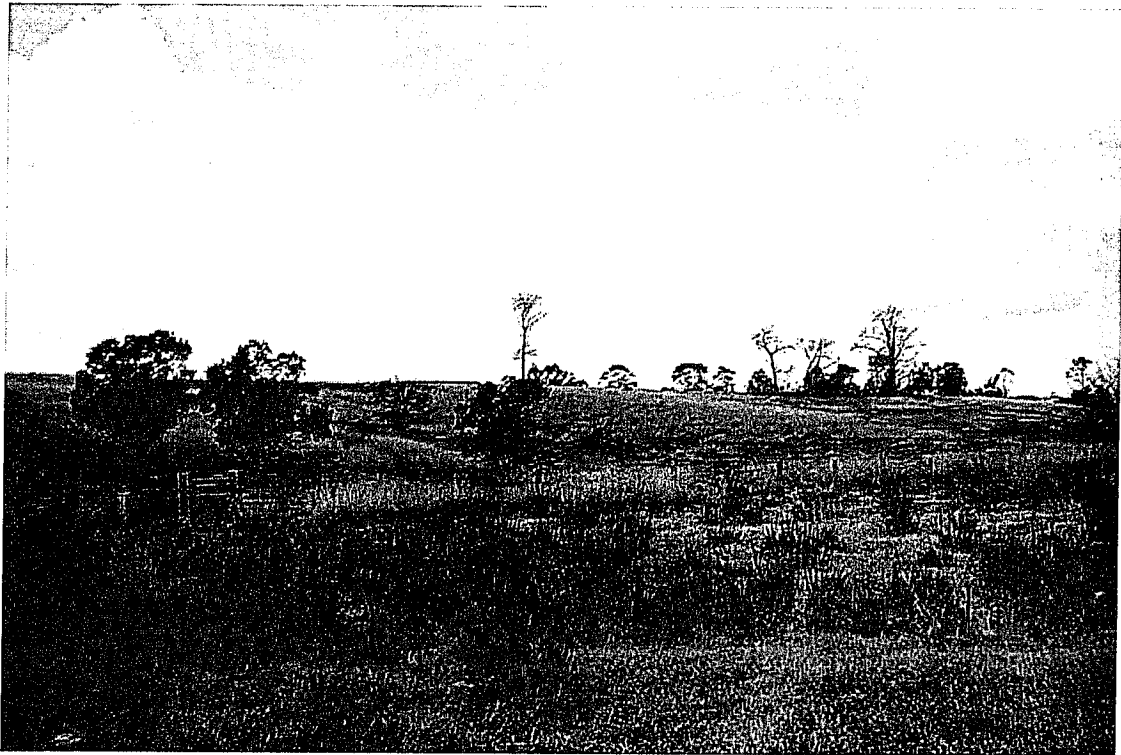
Viewpoint A1 – Looking south-east up the ridge from the north-west corner of the site, near the large Wattles above the northern end of Punt Road. Photo: MWA, September 2004.

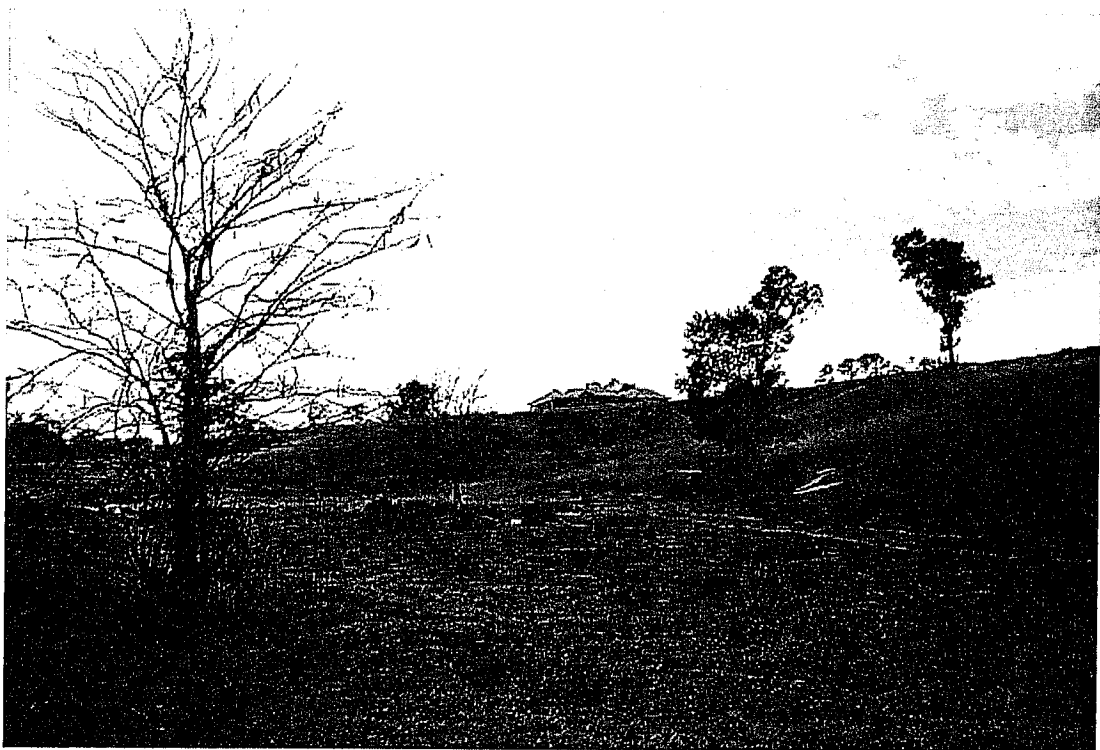
Viewpoint A2 – Looking east from the north-west corner of the site, showing the recently built residence on the ridge within Lot 12 and two post 1950 Eucalypts (to the west of the house) which identify the ridgeline from afar. The bare trees are remnants from the orchard period. Photo: MWA, September 2004.

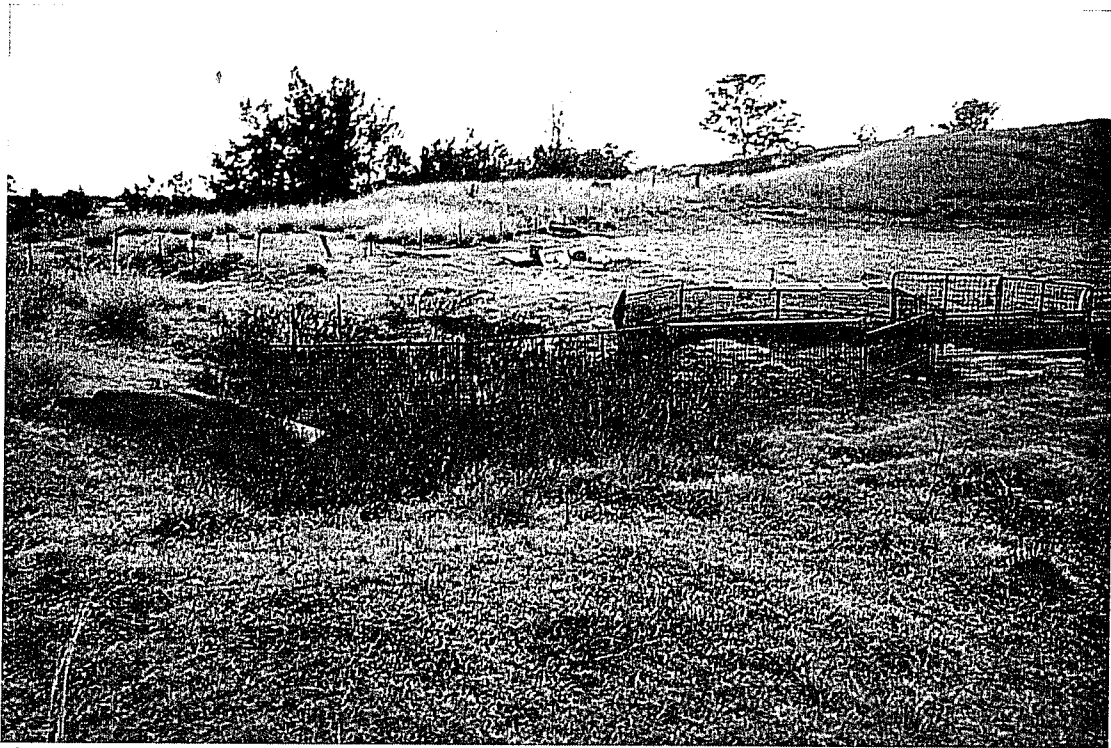
Viewpoint A3 – Looking NNE from the northern end of Lot 11 The fenced-off area in the foreground may have once been the site of the small dam present in the 1950s. Photo: MWA, September 2004.

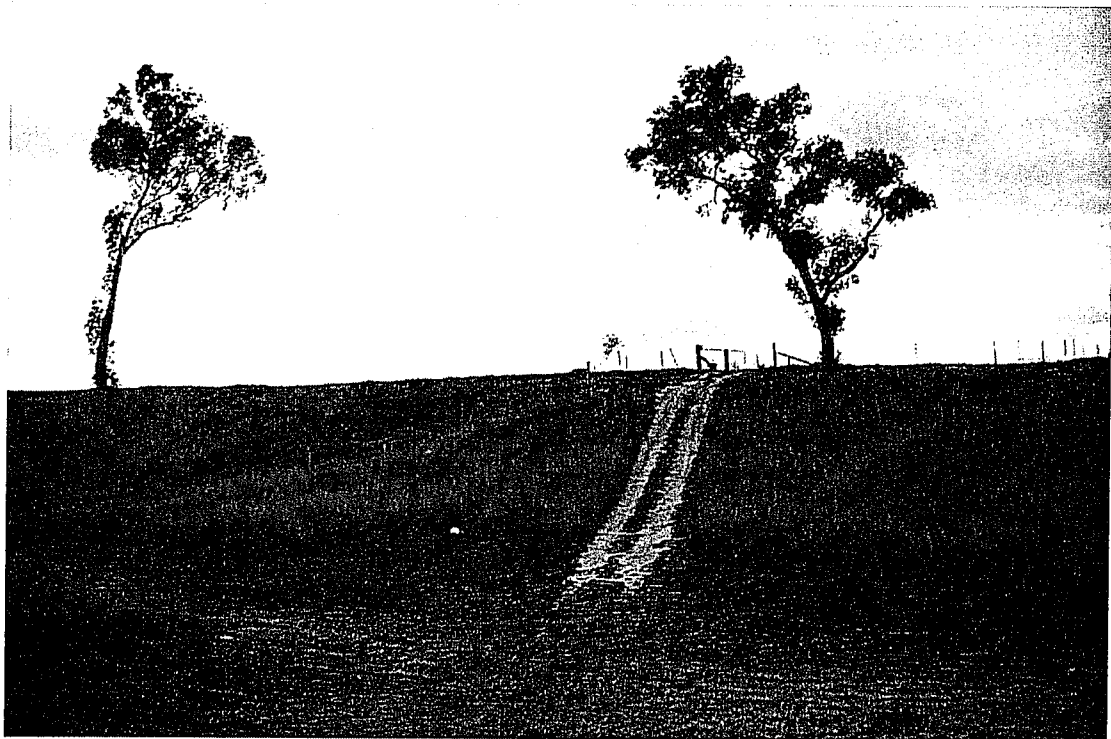
Viewpoint A4 – Looking east up the ridgeline which extends through Lot 11, with two large Eucalypts identifying the top of the ridge. The vehicular track provided access from the lower portion of Lot 11, adjoining Punt Road, onto the ridge and along the fenceline which divides Lots 11 & 12. Photo: MWA, September 2004.

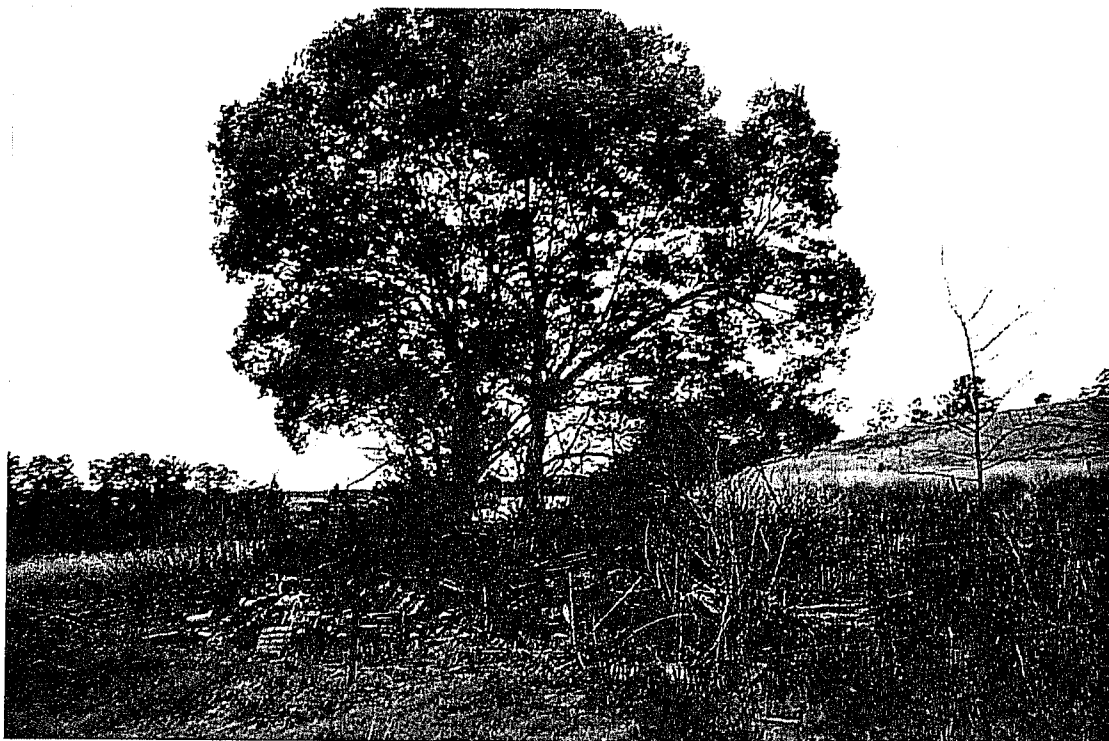
Viewpoint A5 – The two large Wattles which are located towards the north-western corner of the site. Note the building rubble beneath the trees, the source of which may be ascertained through oral history investigations. Photo: MWA, September 2004.

The only above-ground evidence of old buildings was seen dumped around a couple of wattle trees in the lower, northern section of Lot 11. The origin of this structure is not known to this consultant, but it may be related to the removal of the small cottage, possibly that which once housed the punt operator. An oral history source may be able to throw light on that.

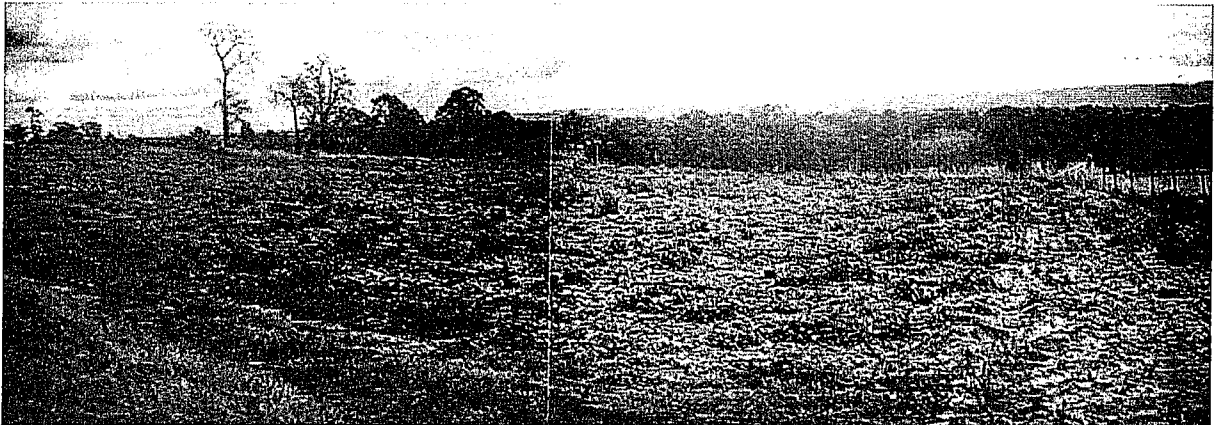
Viewpoint A9 – Looking west from the fenceline between Lots 11 & 12. The top of the ridge through the site roughly follows the barbed wire fence in the middleground of this image.
Photo: MWA, September 2004.

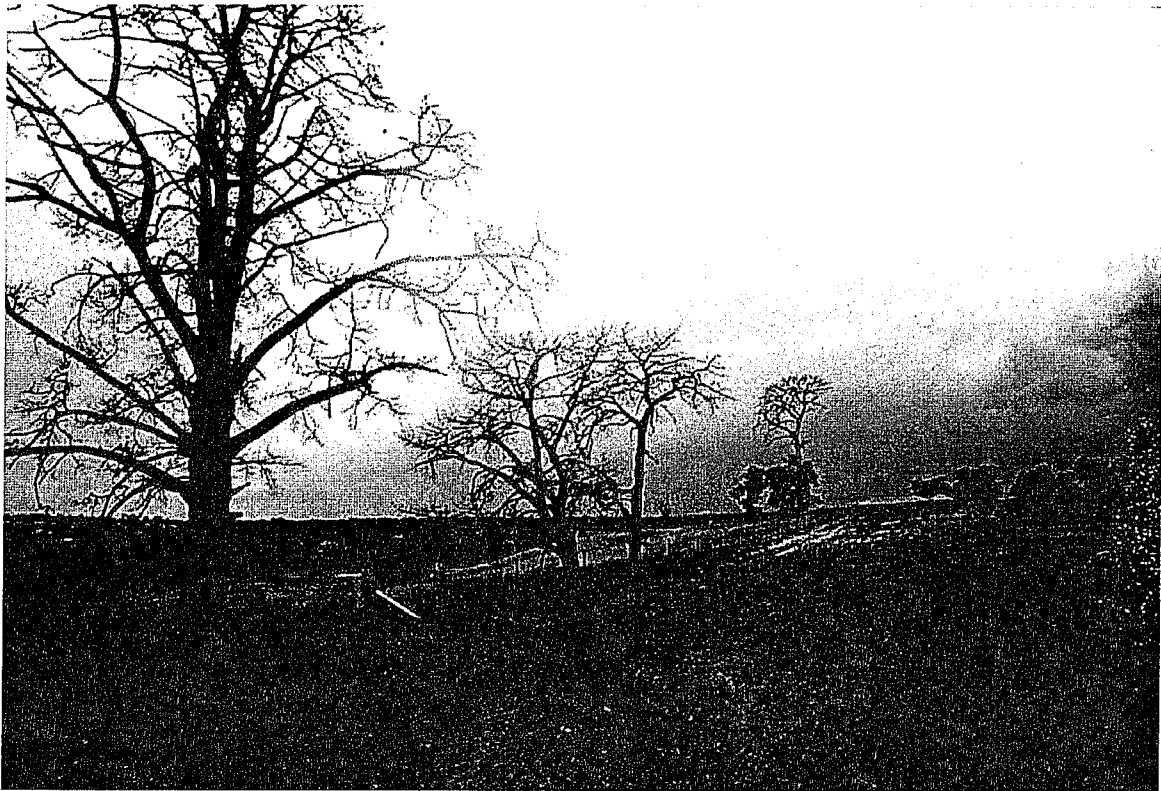
Viewpoint A11– Looking along the northern edge of the ridgeline within lot 11, showing four dead *Pinus radiata* (planted c.1950) beside the track running along that edge. These marked the western limit of the orchard plantings, for which the Pines were used as a windbreak. It is surmised that the Oaks were planted more or less along the same alignment as these Pine trees. Photo: MWA, September 2004.
