**HERITAGE LANDSCAPE
AND VISUAL ASSESSMENT OF
PART OF THE SITE OF
GOVERNOR BLIGH'S 'MODEL FARM' *BLIGHTON*
NEAR PITT TOWN, NSW**

Prepared for the Johnson Property Group

Mayne-Wilson & Associates
Conservation Landscape Architects
Paddington NSW

November 2005

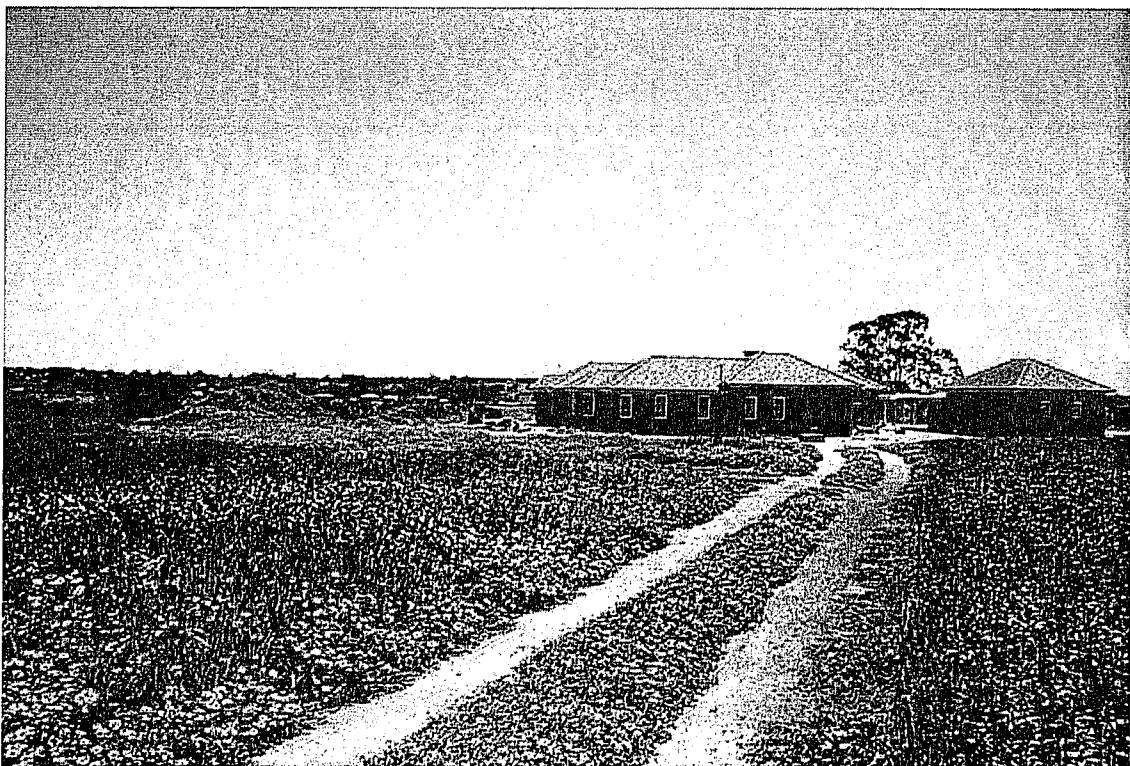
Viewpoint A12 – Looking north towards the recently constructed house on the edge of the ridge in Lot 12 of the subject site. Photo: MWA, September 2004.

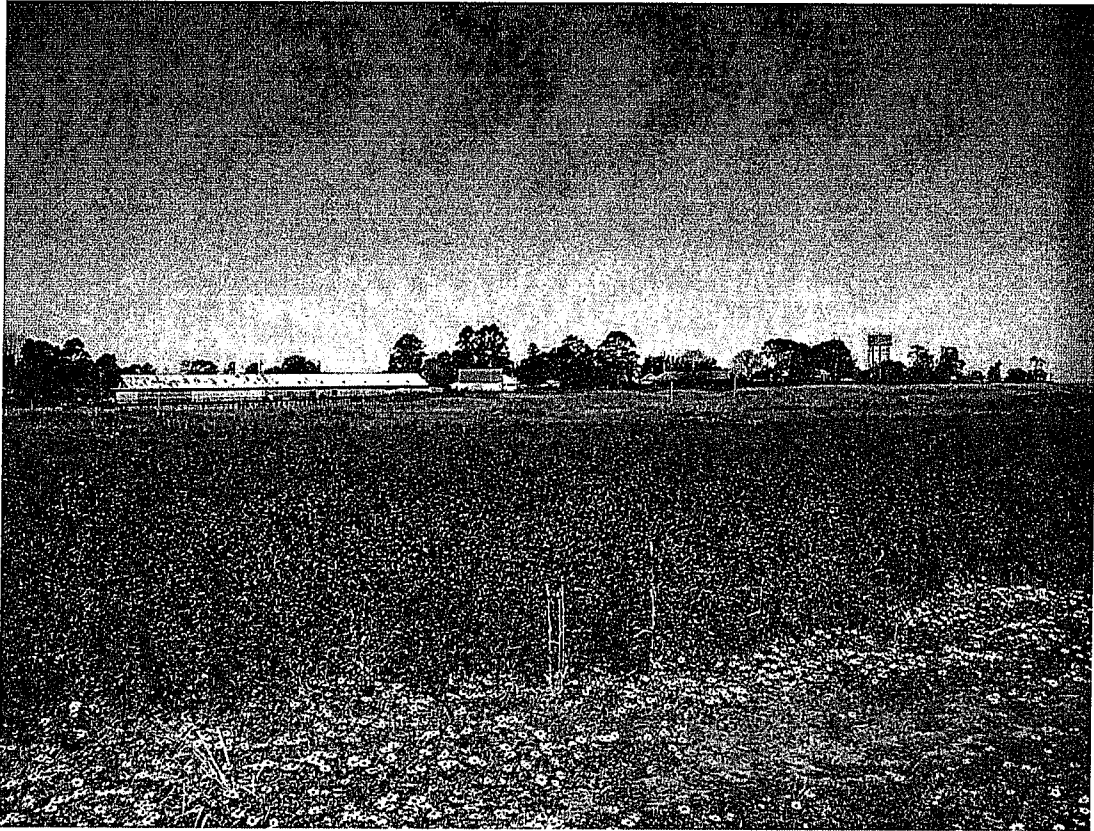
Viewpoint A15 – Looking south through Lot 12 of the subject site towards the large fruit packing shed on Hall Street (at left). Note the gentle rise of the land up toward Hall St. Photo: MWA, September 2004.

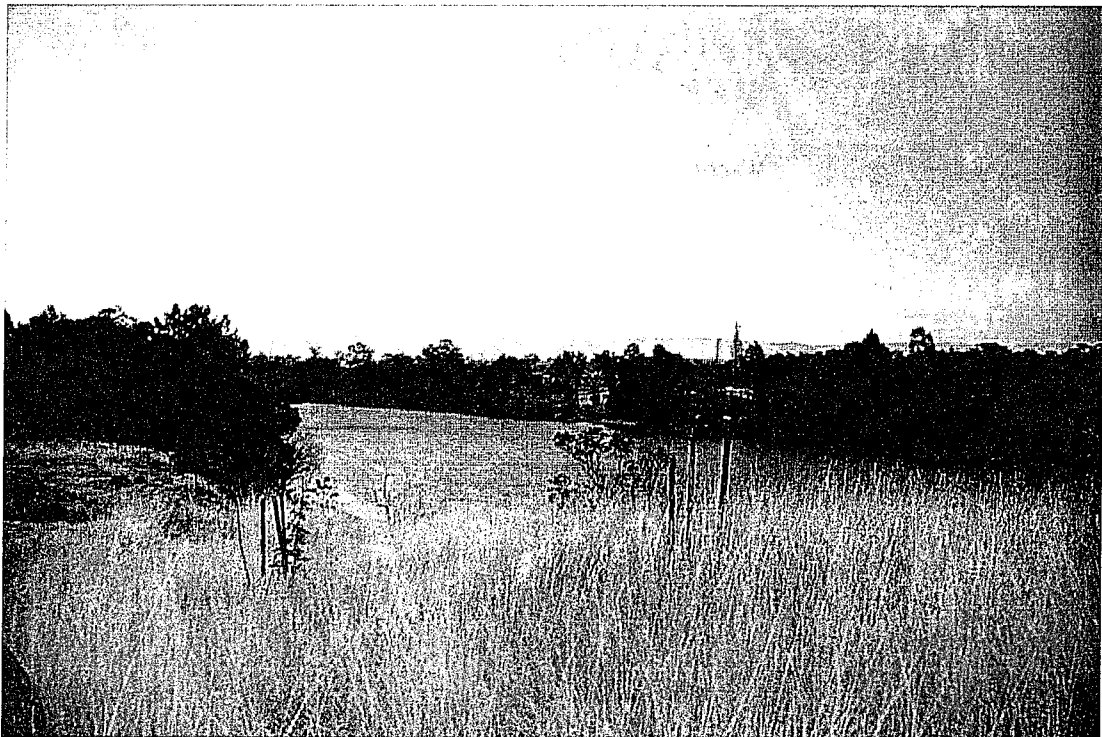
Figure C1 – A contemporary view west along the Hawkesbury River from the north-eastern corner of Lot 11 (the western half of the subject site). Although it has similarities with the Lewin painting - see below, the latter appears to have been painted from a location further to the east, and higher, since more of the ridge is visible in the foreground of that painting. Photo: MWA. Sept. 2004

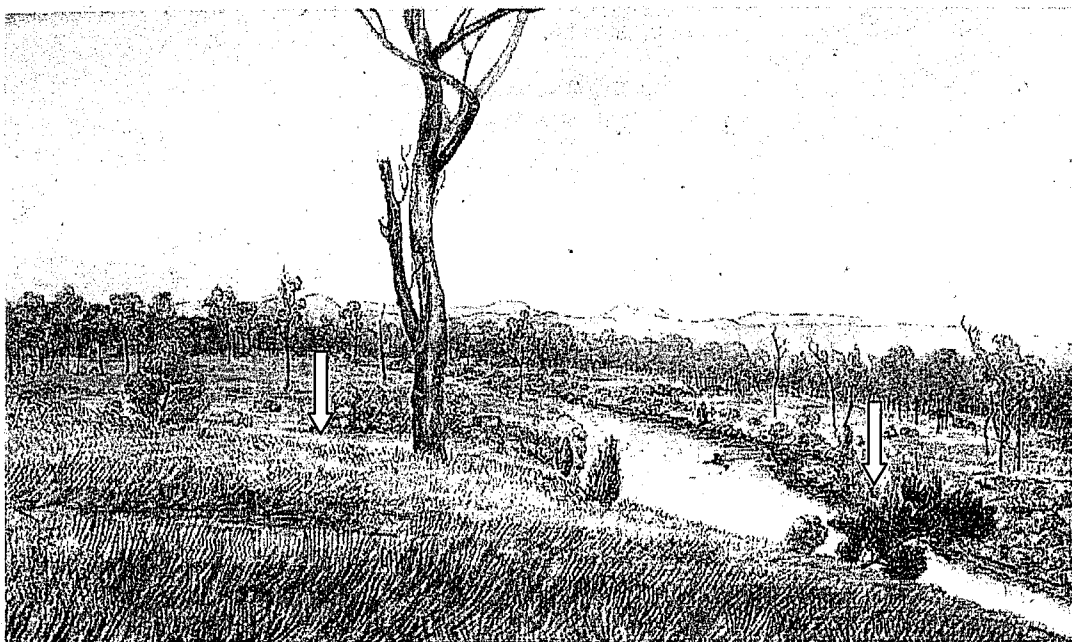
Figure C2 - The above painting by J.W. Lewin, clearly titled "View from Governor Bligh's farm Hawkesbury, New South Wales" c. 1807-08, appears to have been painted from a location approximately between that of the Lycett and Evans paintings – see below. It is a much less romanticized view than the others, showing how savage the tree clearing had been by the early settlers. Some simple cottages and sheds are visible in the distance, but (interestingly) none of those of Blighton. The track to the Punt and its counterpart of the opposite bank can be discerned (arrowed). The tall grass in the foreground could be wheat, with pasture beyond.

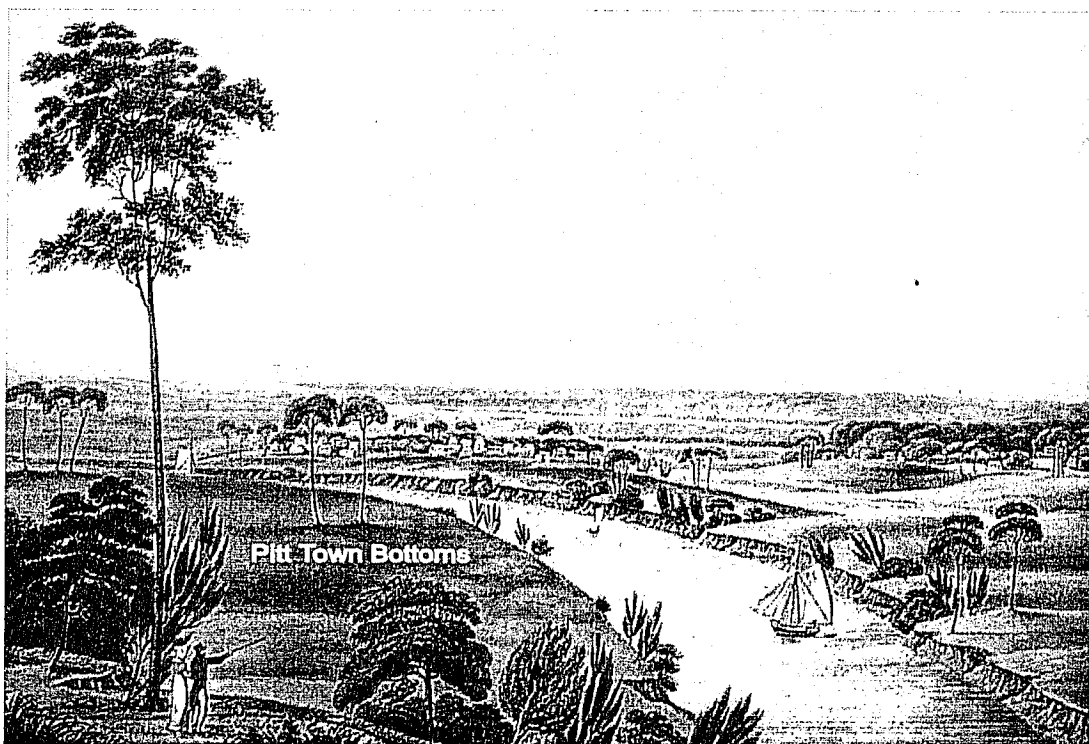
Figure C4 - This painting by Lycett in 1820-22 appears to have been made from a position somewhat to the west of the site of the new house on Lot 12, since it shows much more of the river flats (Pitt Town Bottoms) than is visible from that house. It also shows clearly the south-western curve (Wilberforce Reach) of the river.
