EMIRATES WOLGAN VALLEY RESORT AND SPA

Flora and Fauna Assessment for the Upgrade of Power Services

Final Report

Report No. 6078RP1

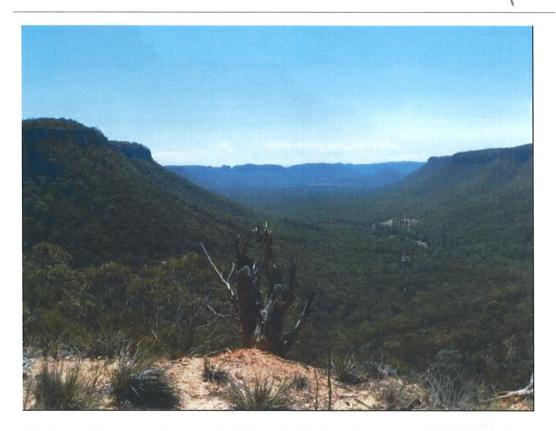
Photograph 3.1 A view into Wolgan Valley from the top tower at Wolgan Gap.

The transmission tower on the edge of the sandstone plateau was in an area that was largely cleared, as shown in Photograph 3.1, containing regenerating native species from the adjoining bushland. Species included: Cassinia arcuata, Poa sieberiana, Podolobium ilicifolium (Native Holly), Hakea dactyloides, Patersonia sericea (Purple Flag) and Lomandra multiflora (Many-flowered Mat-rush).

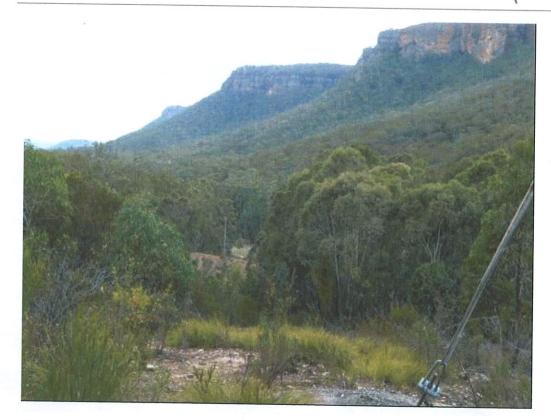
Photograph 3.2 A view north-east from the first tower location in the valley.

The second valley tower can be seen in the background. Note the shrubs but no trees which occur in this existing corridor.

The first two transmission tower locations in the valley were located on two stony rises with silty sandy soil, as shown in Photograph 3.2. The vegetation had largely been cleared from the vicinity of the transmission towers but was regenerating and contained some plants up to three metres in height. Species included: Cassinia arcuata, Podolobium ilicifolium, Acacia buxifolia, Lissanthe strigosa (Peach Heath), Bursaria spinosa (Blackthorn) and Lomandra spp.

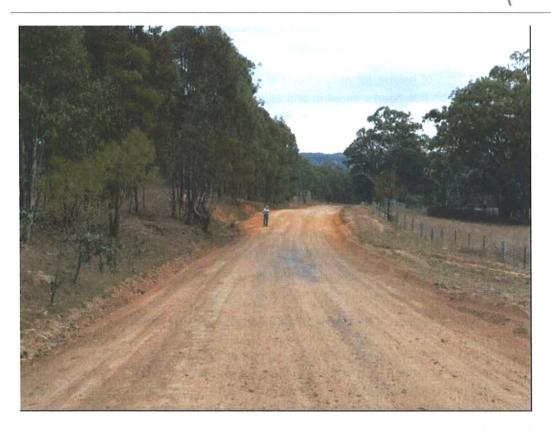
Photograph 3.3 A typical example of survey section 3 where a cleared road verge adjoins pasture land on the northern side of the road.

The vegetation in the section where a powerline corridor is proposed to be constructed had been largely cleared in the road reserve, although numerous scattered mature trees were present. The land adjoining the road reserve contained bushland in several areas, separated by exotic and native pasture, as shown in Photograph 3.3. The proposed powerline would require clearing of trees in some locations.

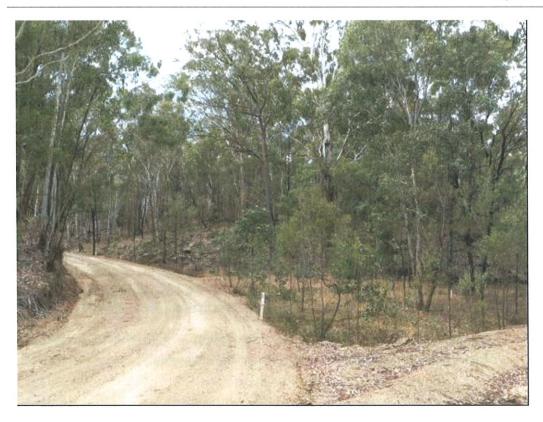
Photograph 3.4 A view north of the first bend in survey section 4. Note the low point at the side of the road where a drainage line occurs (right hand side view).

A small number of larger Eucalypts occur on the southern side of the road as does a small drainage line, which was dry at the time of survey.
