GROUNDWATER INVESTIGATION

SHEPHERDS BAY URBAN RENEWAL PROJECT, MEADOWBANK NSW

Report No. E2008 AC

29 January 2014

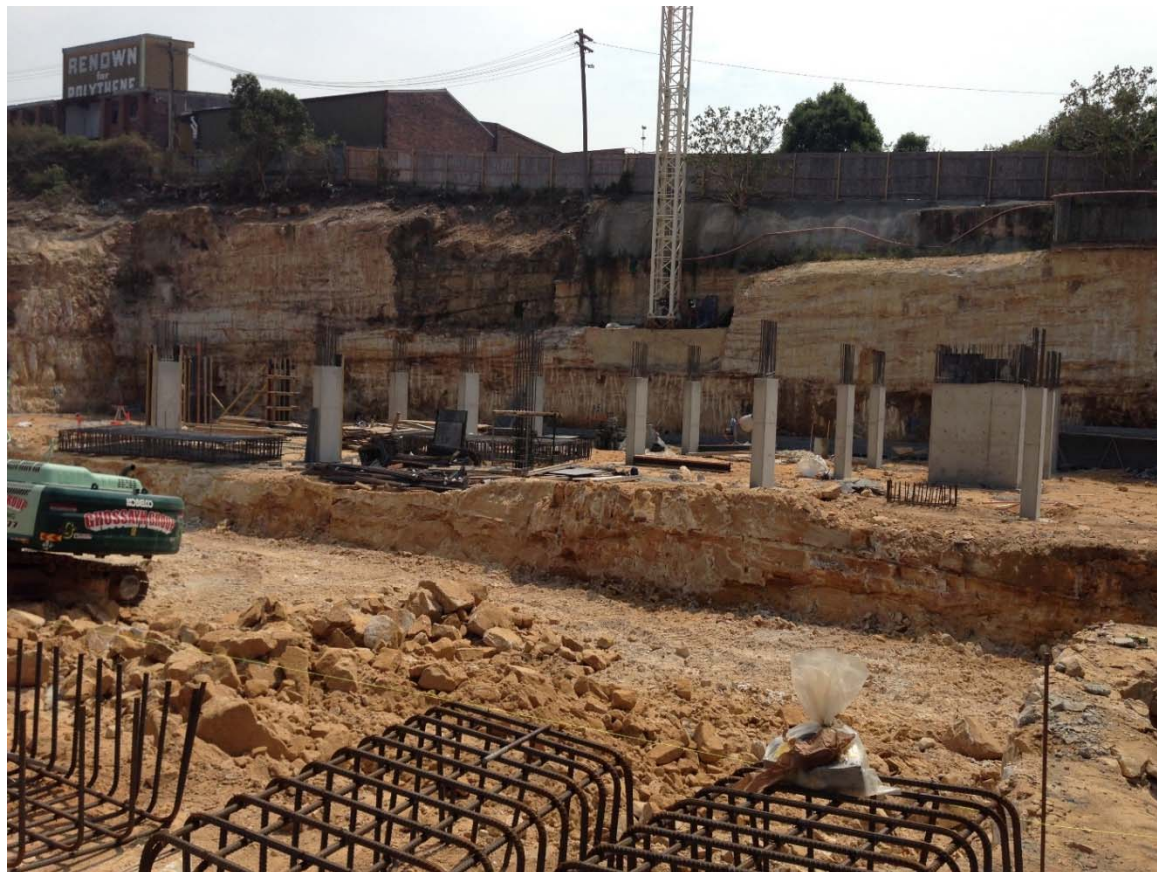
Plate 1 Hawkesbury Sandstone visible in Stage 1 excavation down gradient from Stage 4-5.

The monitoring wells installed in Stage 1 (MW1 to MW6) all encountered Hawkesbury Sandstone at the surface. The general Hawkesbury Sandstone geology profile can also be observed in the Stage 1 excavation in the eastern section of the Shepherds Bay Urban Renewal project (see Plate 1). The photo shows the

shallow surficial soils (fill in residual soils) overlying the cross bedded sandstone. The iron staining on main of the major bedding planes indicates seepage zones may be present resulting from infiltration from periods of prolonged rainfall.

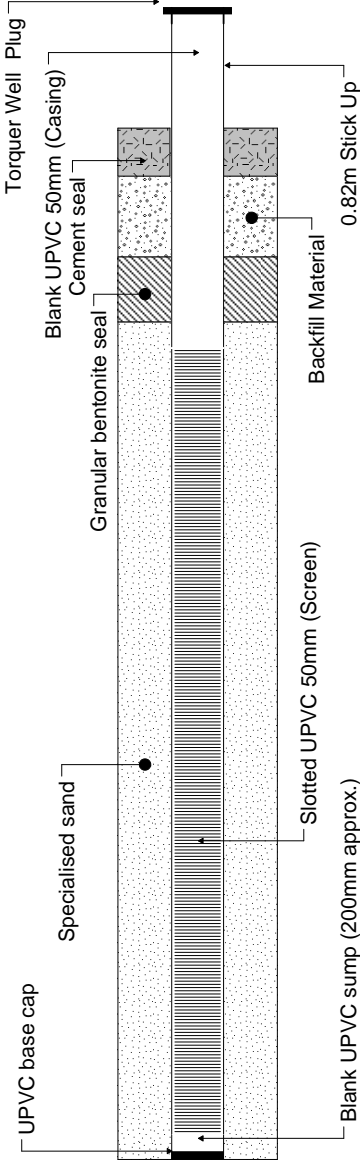
BH5-1	0	
				Borehole ended at 8.21m		GW5-1	0

SUBSURFACE PROFILE					Sample ID	FCR	PID Readings (ppm)
SWL (m)	Depth (m)	Symbol	Description	Bore construction details			
2.45m BGL (09-05-13)	-1.00 -0.80 -0.60 -0.40 -0.20 0.00 0.20 0.40 0.60 0.80 1.00 1.20 1.40 1.60 1.80 2.00 2.20 2.40 2.60 2.80 3.00 3.20 3.40 3.60 3.80 4.00 4.20 4.40 4.60 4.80 5.00 5.20 5.40 5.60 5.80 6.00 6.20 6.40 6.60 6.80 7.00 7.20 7.40 7.60 7.80 8.00 8.20 8.40 8.60 8.80		Ground Surface Sandstone Orange/brown- light brown/grey, highly weathered with minor clay bands, fine-medium grained, dry-moist, no odour

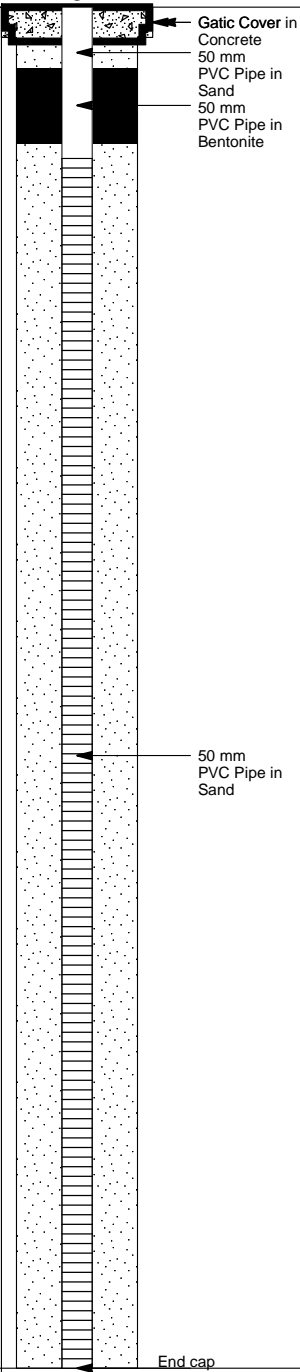
Drilling				Sampling		Field Material Description							PIEZOMETER DETAILS	
METHOD	PENETRATION RESISTANCE	WATER	DEPTH (metres)	DEPTH RL	SAMPLE OR FIELD TEST	RECOVERED	GRAPHIC LOG	USCS SYMBOL	SOIL/ROCK MATERIAL DESCRIPTION	MOISTURE CONDITION	CONSISTENCY DENSITY	ID GW101 Static Water Level		
ADT	M-H	L	0	0.15	PID 0.50 m 200 ppm GW101-2 D 0.50-0.60 m PID m 200 ppm	X	X	-	FILL: CONCRETE: 150 mm.	-	-	GW101

0.25	FILL: SAND; medium to coarse grained, poorly graded, light brown-orange.										
			2.33	SANDSTONE; inferred low to medium strength, inferred distinctly weathered, light brown-orange.										
			1	At 1.5 m becoming inferred medium to high strength, inferred distinctly weathered.										
			2											
			3											
			4											
			5											
			6											
			7	6.50					From 6.5 m grading orange-brown with red mottling, possible iron stone band.					
8	7.50	From 7.5 m grading light brown-orange.												
9	9.00	Hole Terminated at 9.00 m Target depth reached, monitoring well installed.										End cap

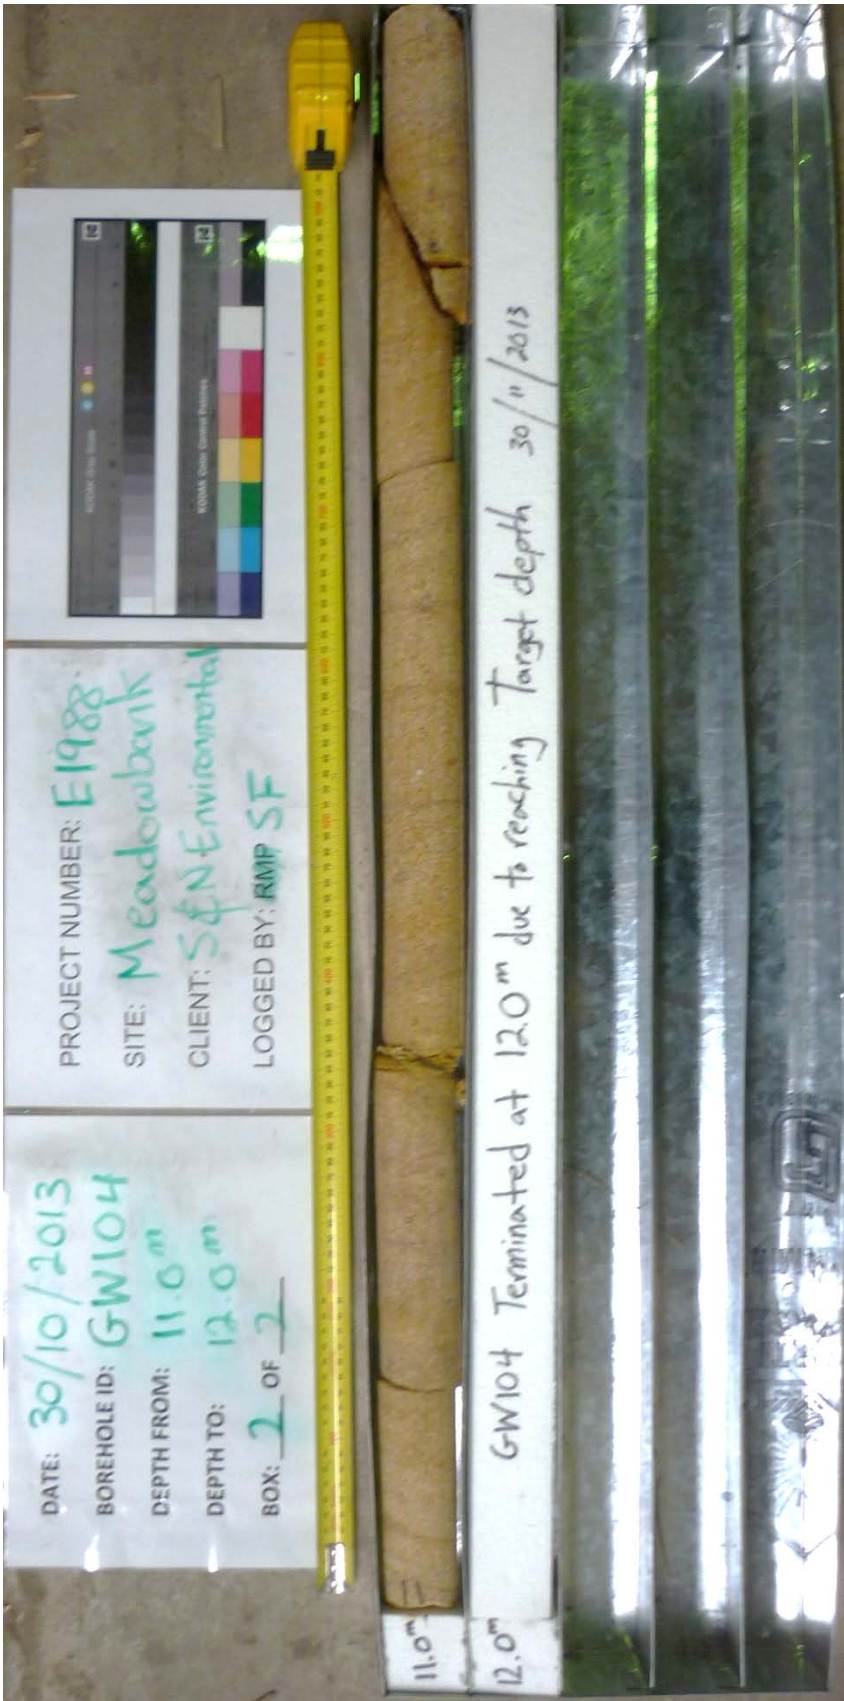
REPORT OF BOREHOLE: GW104

CLIENT: S&N Environmental	COORDS: N/A	DEPTH RANGE: 11.00 to 12.00 m
PROJECT: Shepherds Bay	DATUM: N/A	DRILL RIG: AUSROC4000
Urban Renewal Projects	SURFACE RL: N/A	DRILLER: Terratest
LOCATION: Meadowbank, NSW	INCLINATION: -90°	LOGGED: SF
JOB NO: E1988	HOLE DEPTH: 12.00 m	CHECKED: RE
		DATE: 30/10/2013
		DATE:-

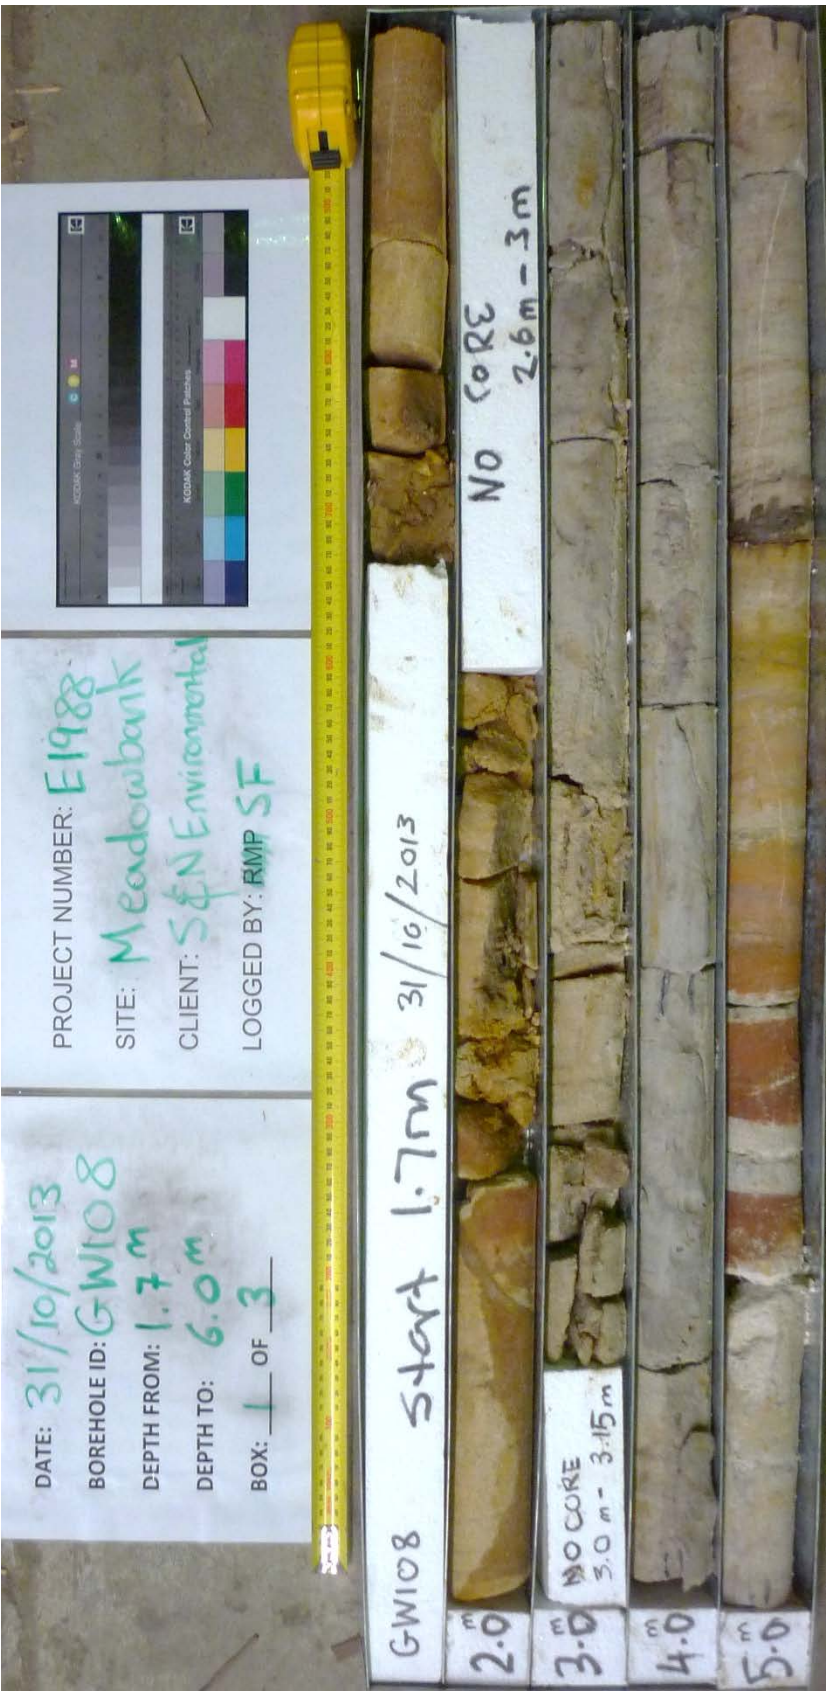
REPORT OF BOREHOLE: GW108

CLIENT: S&N Environmental	COORDS: N/A	DEPTH RANGE: 1.70 to 6.00 m
PROJECT: Shepherds Bay	DATUM: N/A	DRILL RIG: AUSROC4000
Urban Renewal Projects	SURFACE RL: N/A	DRILLER: Terratest
LOCATION: Meadowbank, NSW	INCLINATION: -90°	LOGGED: SF
JOB NO: E1988	HOLE DEPTH: 12.10 m	CHECKED: RE
		DATE: 31/10/2013
		DATE:-

CLIENT: S&N Environmental	COORDS: N/A	DEPTH RANGE: 6.00 to 11.00 m
PROJECT: Shepherds Bay	DATUM: N/A	DRILL RIG: AUSROC4000
Urban Renewal Projects	SURFACE RL: N/A	DRILLER: Terratest
LOCATION: Meadowbank, NSW	INCLINATION: -90°	LOGGED: SF
JOB NO: E1988	HOLE DEPTH: 12.10 m	CHECKED: RE
		DATE: 31/10/2013
		DATE:-

DEPTH RANGE: 11.00 to 12.10 m
DRILL RIG: AUSROC4000
DRILLER: Terratest
LOGGED: SF
CHECKED: RE
DATE: 31/10/2013
DATE:-

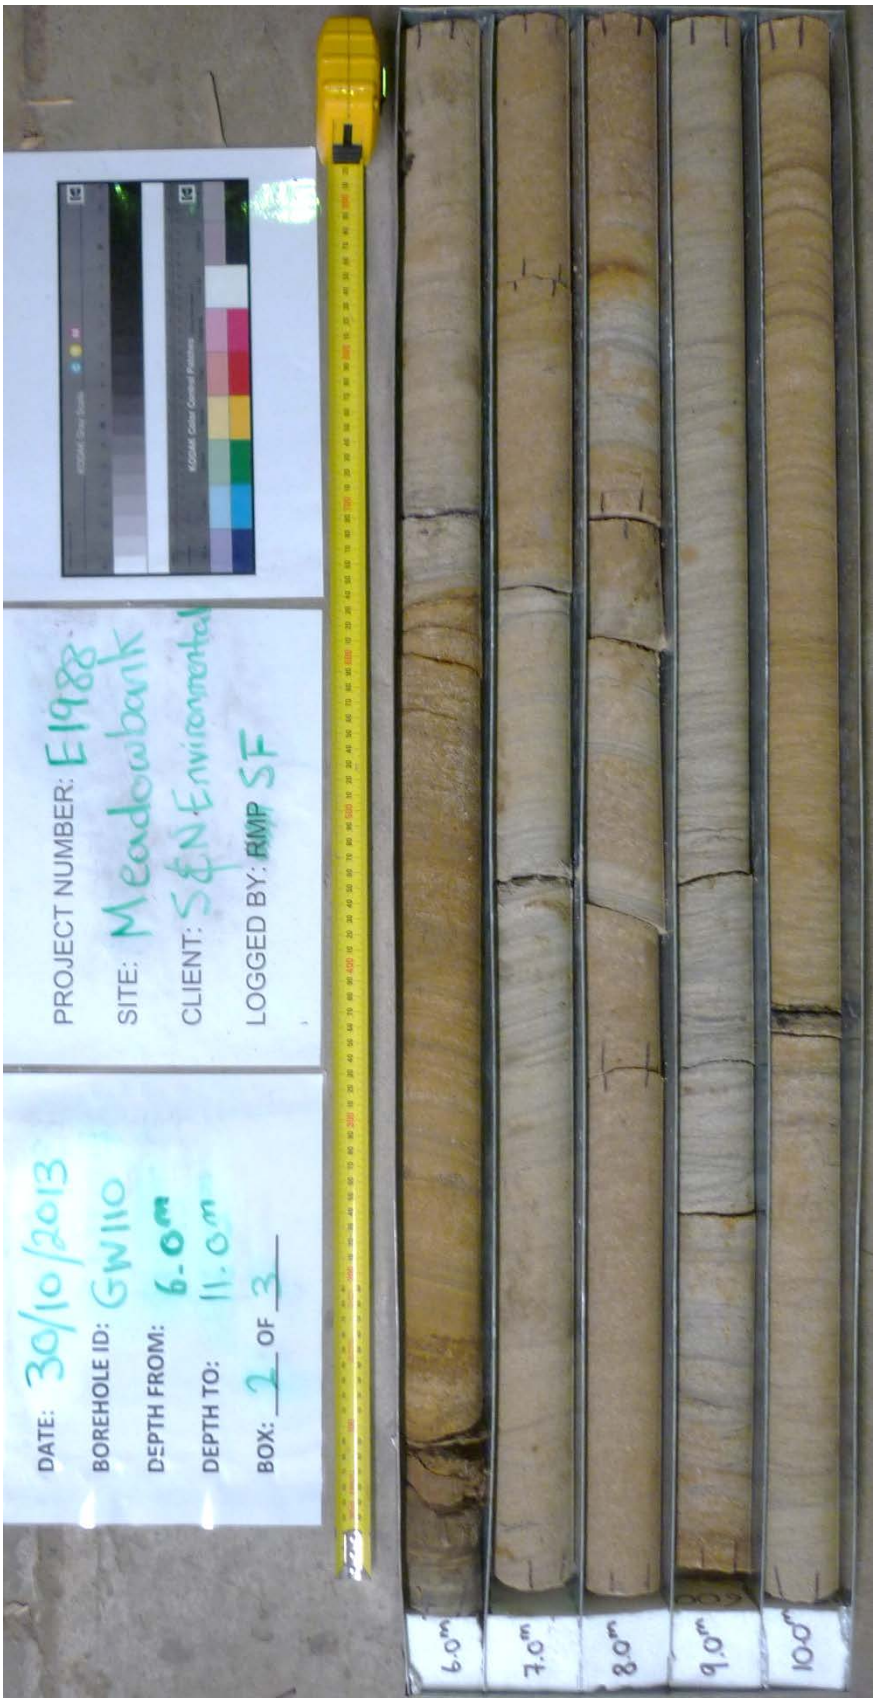
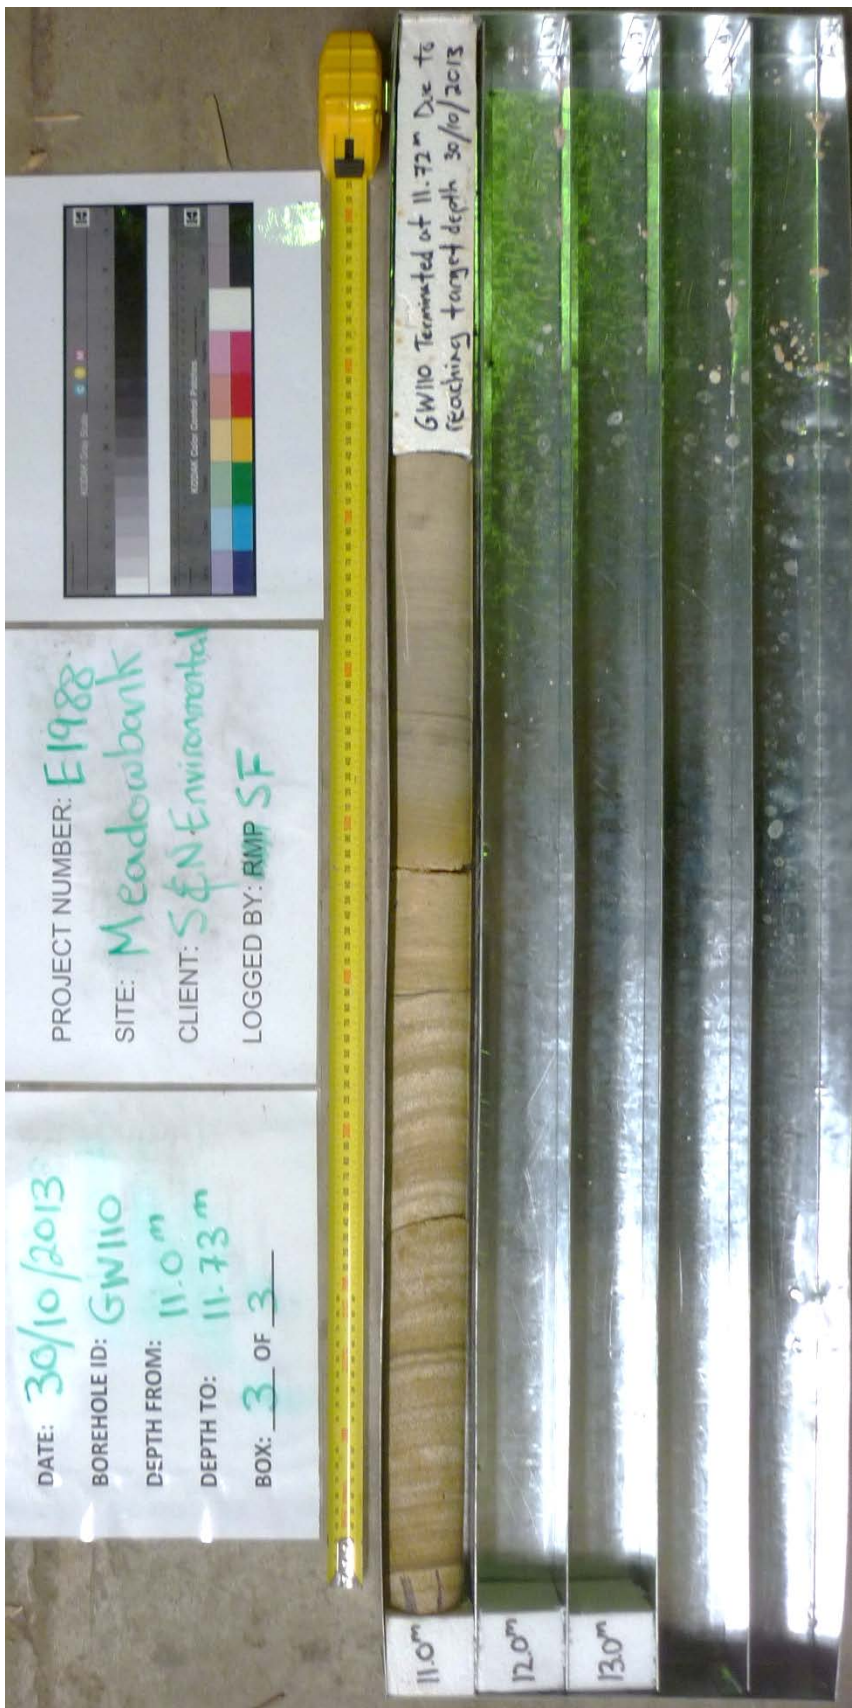
REPORT OF BOREHOLE: GW110

CLIENT: S&N Environmental	COORDS: N/A	DEPTH RANGE: 1.95 to 6.00 m
PROJECT: Shepherds Bay	DATUM: N/A	DRILL RIG: AUSROC4000
Urban Renewal Projects	SURFACE RL: N/A	DRILLER: Terratest
LOCATION: Meadowbank, NSW	INCLINATION: -90°	LOGGED: SF
JOB NO: E1988	HOLE DEPTH: 11.73 m	CHECKED: RE
		DATE: 30/10/2013
		DATE:-

CLIENT: S&N Environmental	COORDS: N/A	DEPTH RANGE: 6.00 to 11.00 m
PROJECT: Shepherds Bay	DATUM: N/A	DRILL RIG: AUSROC4000
Urban Renewal Projects	SURFACE RL: N/A	DRILLER: Terratest
LOCATION: Meadowbank, NSW	INCLINATION: -90°	LOGGED: SF
JOB NO: E1988	HOLE DEPTH: 11.73 m	CHECKED: RE
		DATE: 30/10/2013
		DATE:-

CLIENT: S&N Environmental	COORDS: N/A	DEPTH RANGE: 11.00 to 11.73 m
PROJECT: Shepherds Bay	DATUM: N/A	DRILL RIG: AUSROC4000
Urban Renewal Projects	SURFACE RL: N/A	DRILLER: Terratest
LOCATION: Meadowbank, NSW	INCLINATION: -90°	LOGGED: SF
JOB NO: E1988	HOLE DEPTH: 11.73 m	CHECKED: RE
		DATE: 30/10/2013
		DATE:-

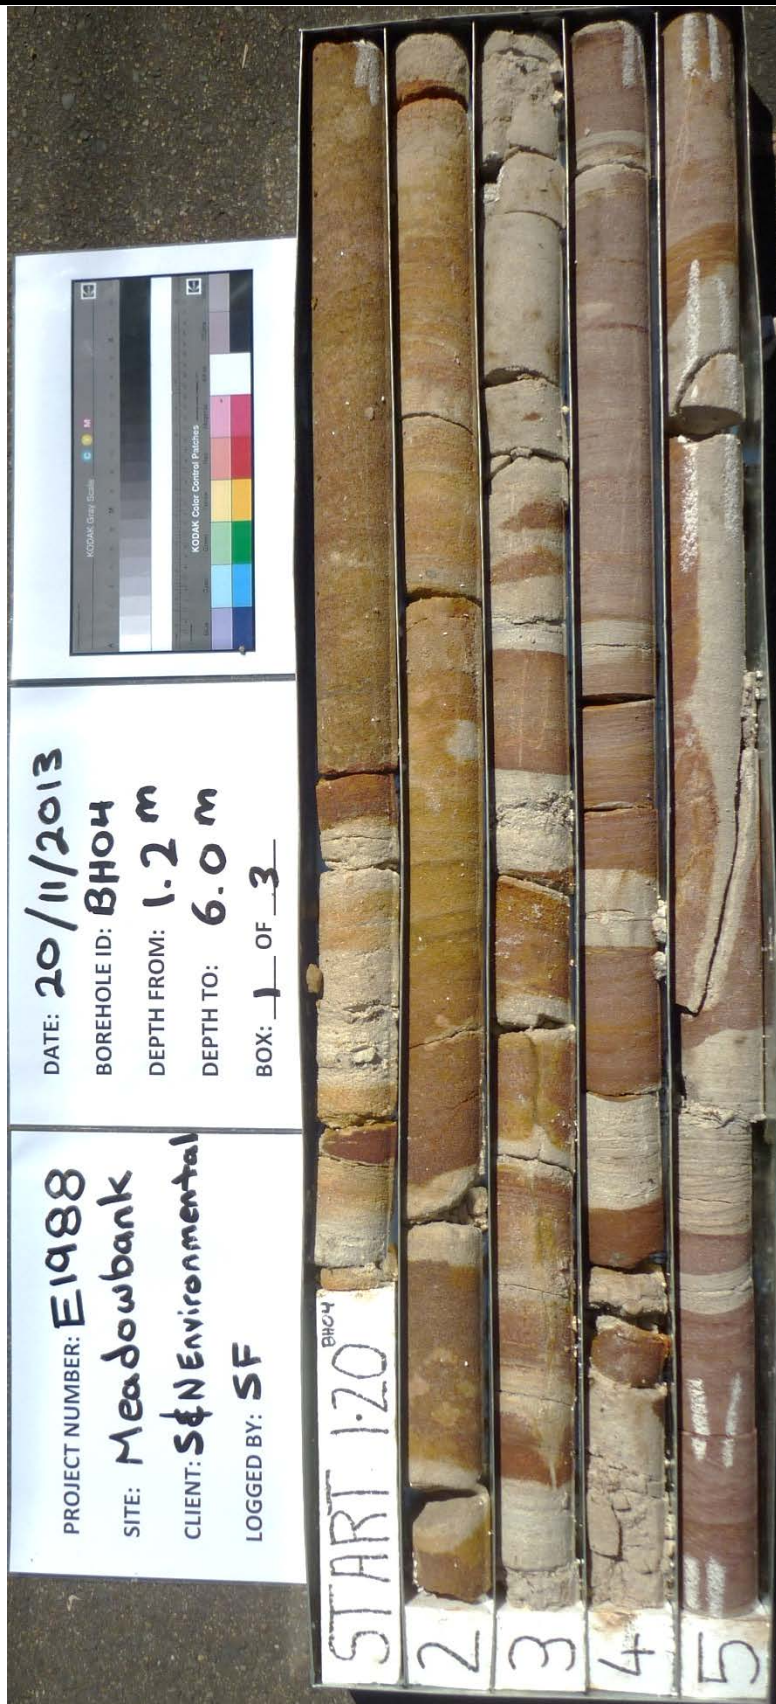
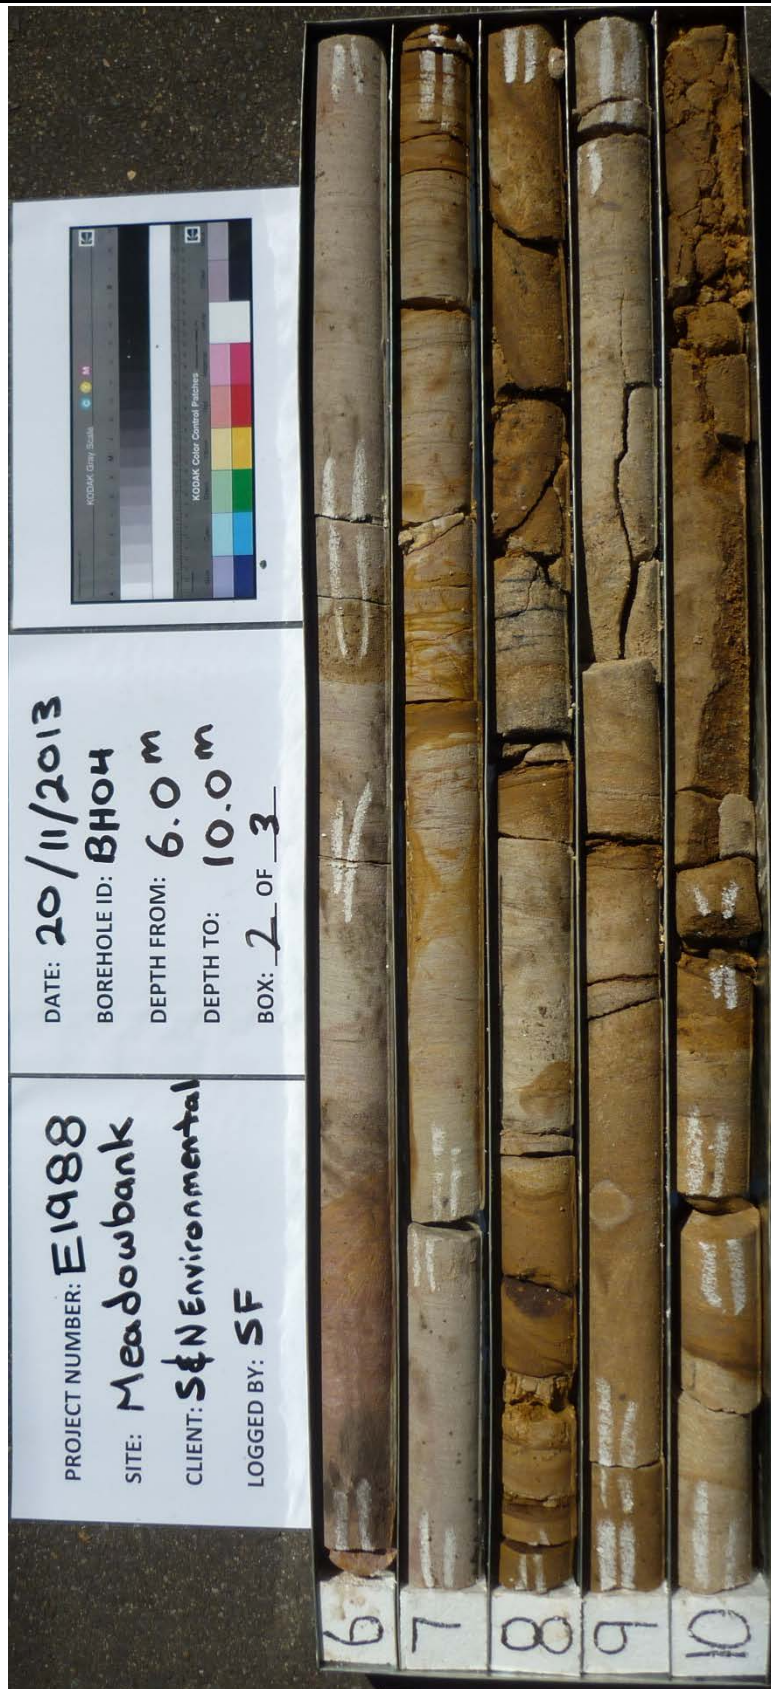
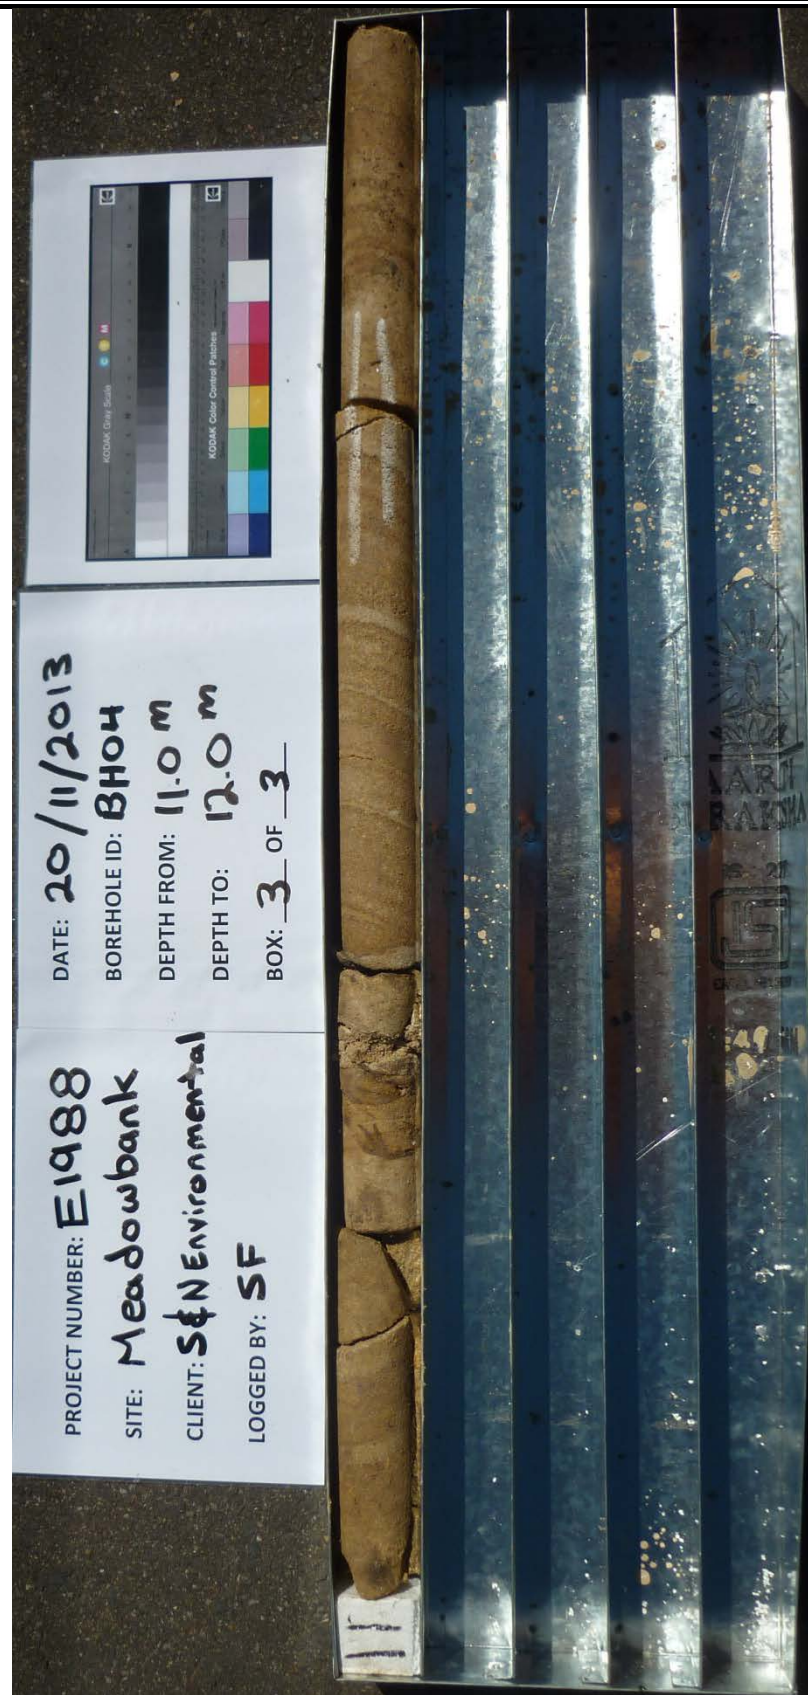
REPORT OF BOREHOLE: BH04

DEPTH RANGE: 1.20 to 6.00 m
DRILL RIG: Multidrill - Truck Mounted
DRILLER: Traccess
LOGGED: SF
CHECKED: RE
DATE: 20/11/2013
DATE:-

DEPTH RANGE: 6.00 to 11.00 m
DRILL RIG: Multidrill - Truck Mounted
DRILLER: Traccess
LOGGED: SF
CHECKED: RE
DATE: 20/11/2013
DATE:-

DEPTH RANGE: 11.00 to 12.00 m
DRILL RIG: Multidrill - Truck Mounted
DRILLER: Traccess
LOGGED: SF
CHECKED: RE
DATE: 20/11/2013
DATE:-
