# HERITAGE IMPACT STATEMENT

**Buildings 7 and 9**  
**Royal North Shore Hospital**  
**St. Leonards**

**November 2014**

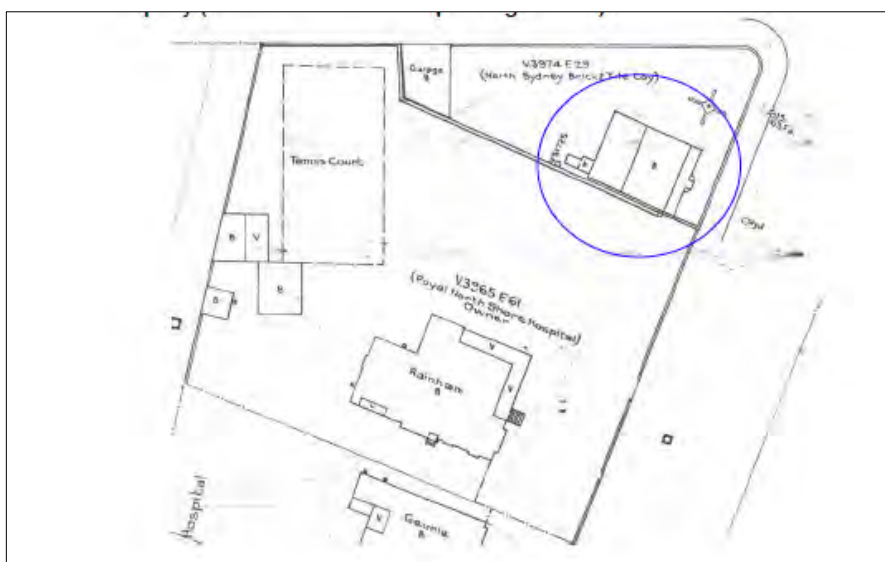
**Figure 5: Water Board survey of the site, October, 1943.**

The North Sydney Brick and Tile Company altered the office at Yard 2 (Building 7) over time. The earliest footprint available for this building is dated 1926 (Figure 4). Note how the front verandah runs around three sides of the building, whereas the existing verandah runs across the eastern elevation only. The style of the existing verandah suggests that it was added during the interwar period, perhaps to showcase some of the products of the Company. It had certainly been added by 1946, when the Water Board surveyed the site (Figure 5). A brick garage had also been added to the rear of the site by this time.

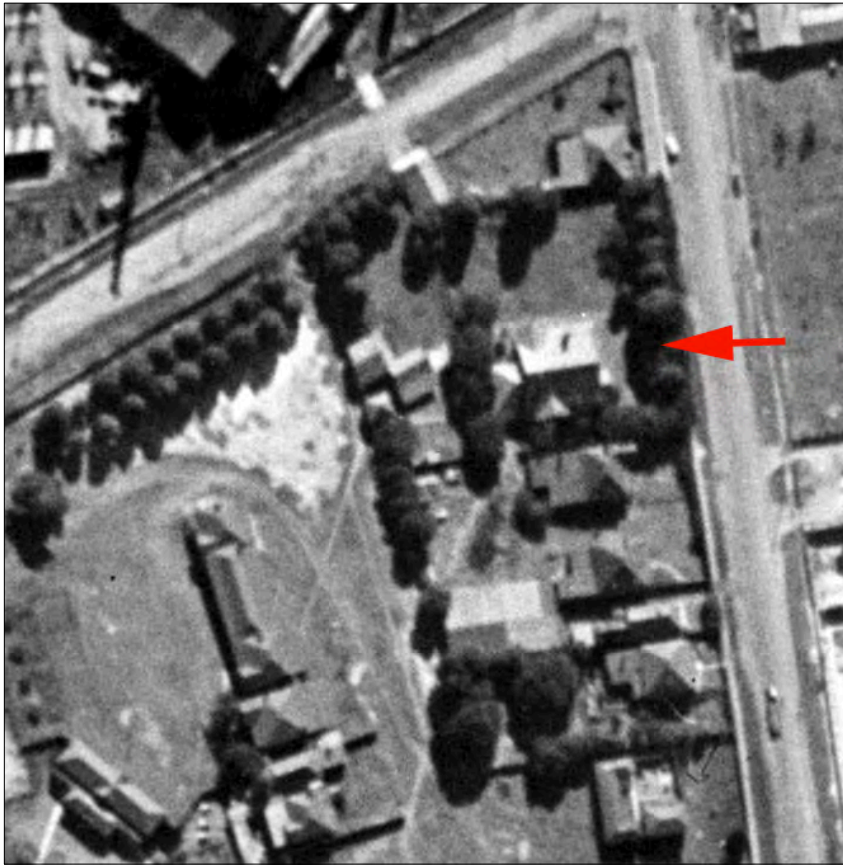
**Figure 11: Aerial photograph over Building 9 in 1943.**  
SIXMaps.

*Rainham* (Building 9) was used by the Hospital for a variety of purposes, such as accommodation for nursing staff, junior resident staff, midwifery staff and isolation ward staff, and, at a later date, various Community Health Services. An aerial photograph over the site (Figure 11) and a Water Board survey from 1946 (Figure 12) indicates that the building retained some of its earlier garden setting, including a tennis court, what appears to be a garden pavilion overlooking the tennis court and a croquet lawn to the north of the dwelling.

Historically, the most significant view corridors towards this building were obtained from outside of the site on Herbert Street. Historic photographs (refer to Figure 11) suggest that views would have been partially screened by vegetation. The construction of Building 8 would have reduced view corridors on approach from the north. View corridors out of the building would have been primarily to the east and north, over the gardens and croquet lawn and Herbert Street.

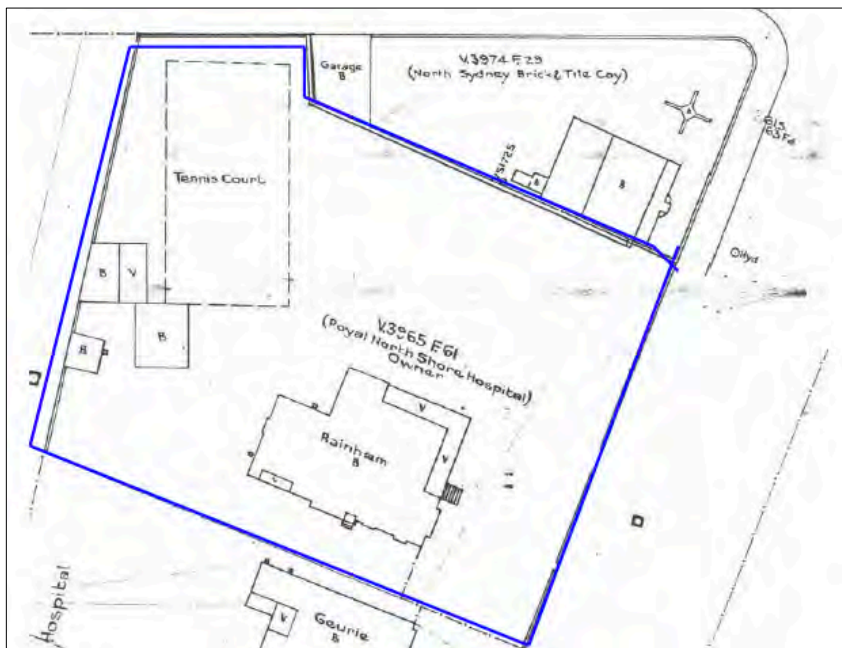
**Figure 12: Water Board Survey dated 14 October, 1943.**  
Willoughby Local Studies cited in City Plan Heritage Assessment.

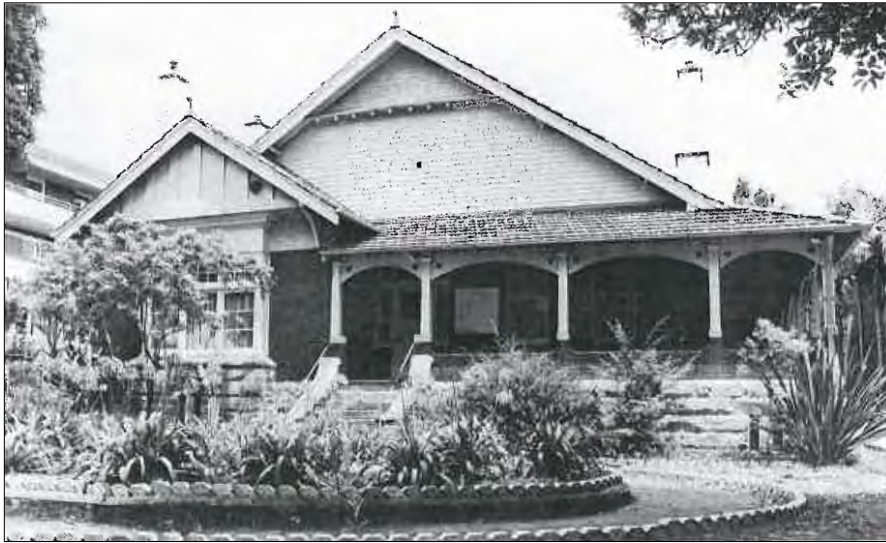
**Figure 14: Lanceley Cottage, Royal North Shore Hospital, 1988 (?)**

*Rainham*, renamed *Lanceley Cottage*, has been altered over time to suit hospital purposes. Few of these alterations, however, have been documented. In 1981, the building became Community Health Services and from 1986 was used by the satellite renal dialysis service. Figure 14 provides a photograph of Building 9 from c.1988,

showing what appear to be brick or terracotta garden edging around a circular driveway and garden.

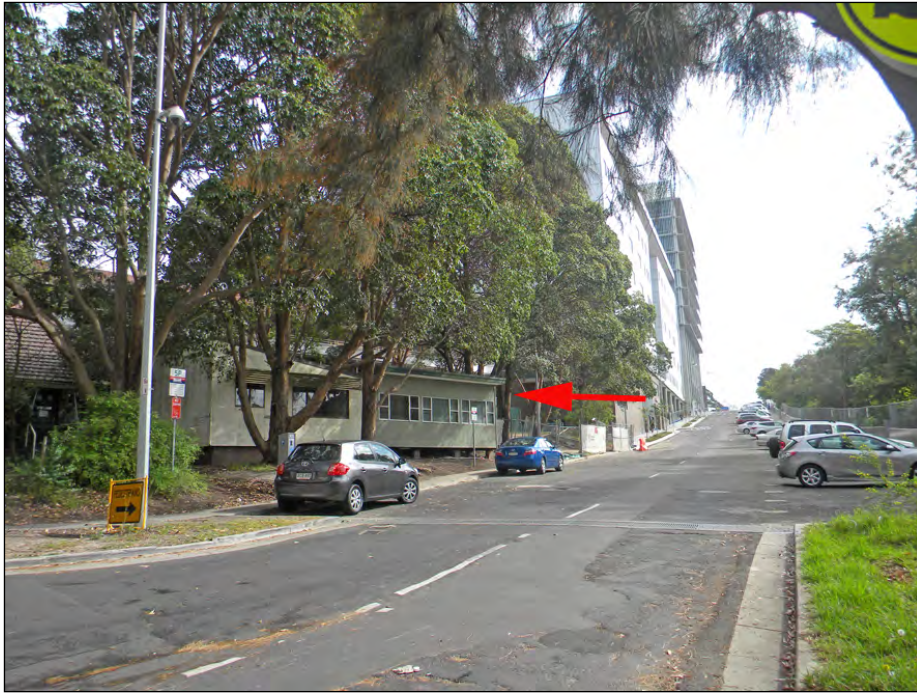
**Figure 18: Looking west up Westbourne Street. The later additions attached to Building 7 are marked by the arrow.**

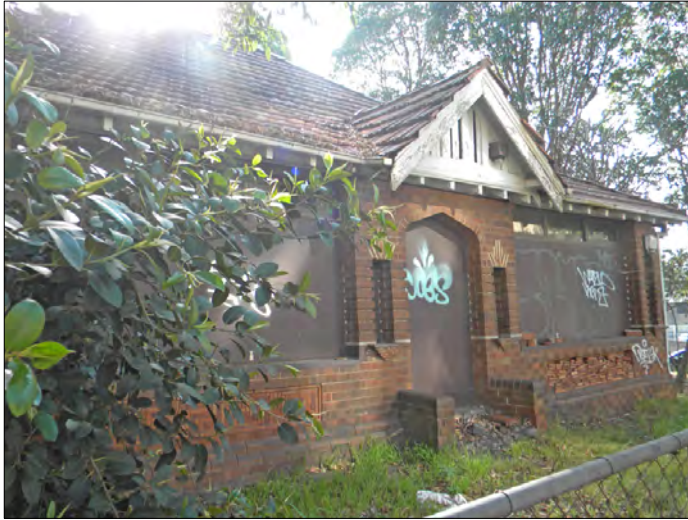
The principal elevation is the **eastern elevation**, addressing Herbert Street. Refer to Figures 24 to 27. This elevation is symmetrical. The roof continues over the narrow front verandah that runs across the length of the elevation. The verandah has a brick balustrade; brick piers support the roof. As illustrated by the photographs below, the brick balustrade and piers feature coloured and decorative brickwork. A gable-roofed porch interrupts the centre of the verandah. This porch has a Tudor arched opening. The gable above is finished in vertical timber battening and has wide timber barge boards. The porch and verandah openings are boarded up. There is a band of horizontally aligned aluminium framed windows above the boarding in the verandah openings. The brickwork and timberwork is in poor condition.

**Figure 24: Front, eastern, elevation of Building 7.**

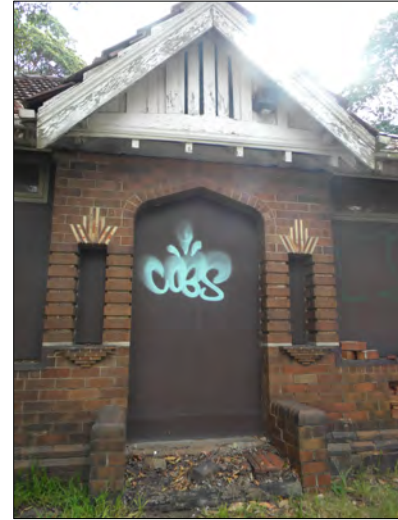
**Figure 25: Detail of the front entrance porch.**

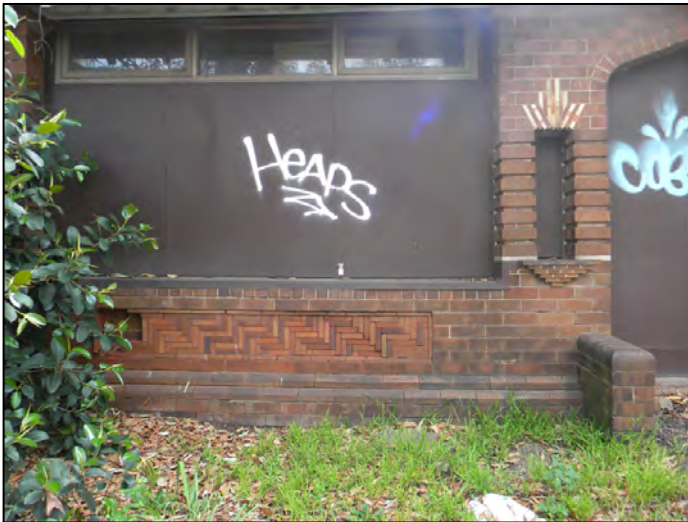
**Figure 26:**  
Detail of the southern side of the front elevation, showing the decorative brickwork and enclosed opening of the front verandah.

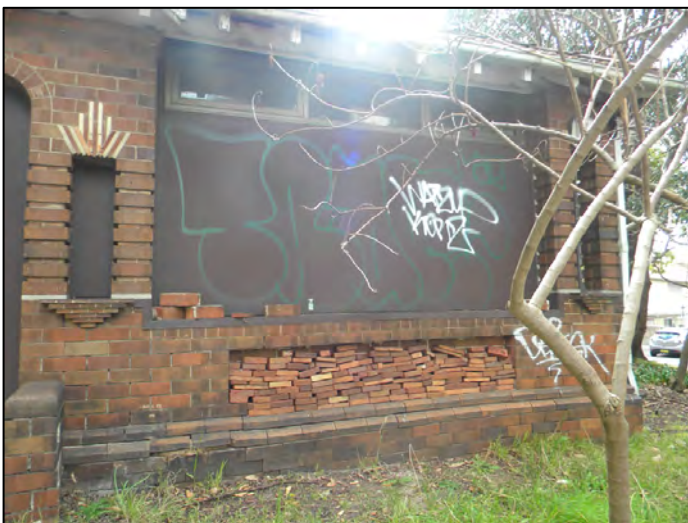
**Figure 27:**  
Detail of the northern side of the front elevation. The brickwork is in poor condition.

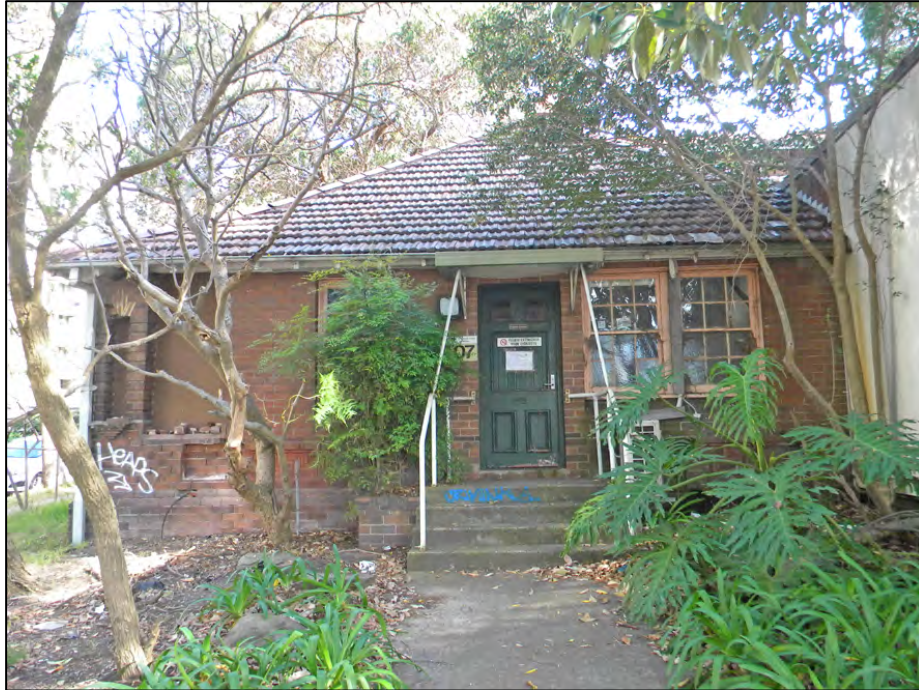
The **northern elevation** of this part of the building, addressing Westbourne Avenue, is asymmetrical. Concrete stairs lead up to a small concrete landing and a timber panel door. There is a metal awning above the door, with metal supports. Windows are timber framed, double hung sash windows with six panes to each sash. The brickwork features decorative brick panels, which match the decorative brickwork of the verandah balustrade. Refer to Figure 28.

**Figure 28: The northern elevation of the principal building form**

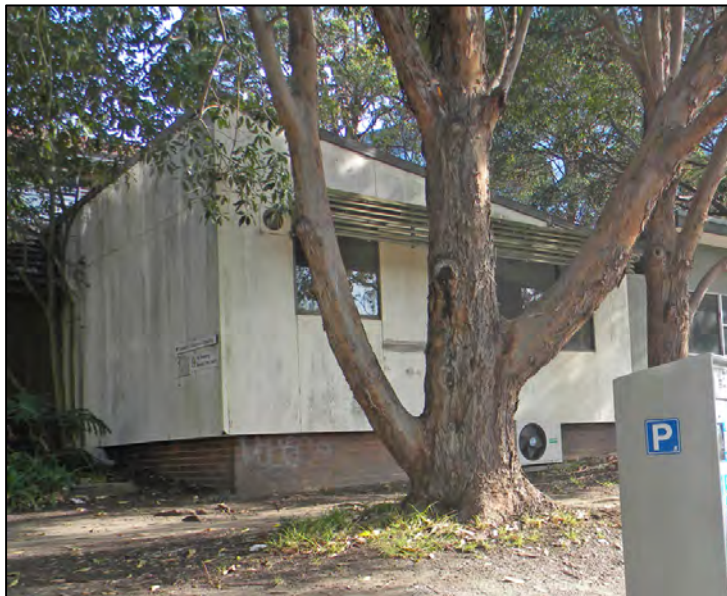
Attached to the northern side of the principal building form is the **c.1977-78 addition**. This addition is single storey in height and lies on a low face brick base. The walls are clad in asbestos sheeting (or equivalent). The addition has a skillion roof and metal-framed windows of different sizes with slatted sun hoods. Refer to Figures 29 and 30.

**Figure 29:  
Northern  
elevation of the  
c.1977-78  
addition.**

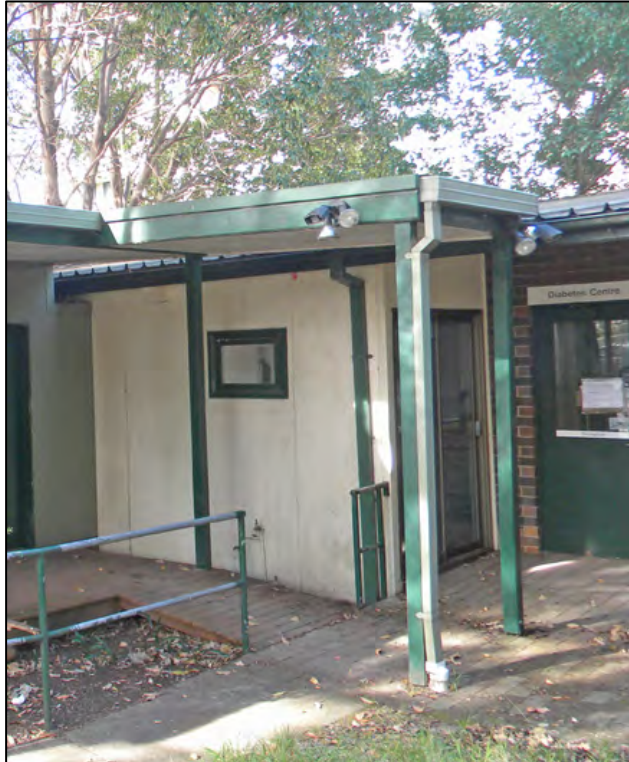
**Figure 30:**  
**Rear of the c.1977-78**  
**addition.**

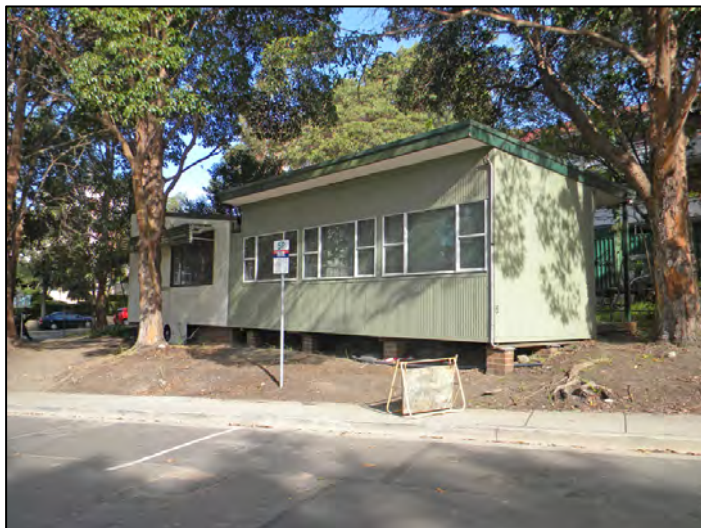
Attached to this addition, is the **c.1990s extension**. This extension is single storey and constructed on brick piers. The walls are clad in corrugated metal sheeting. The skillion roof is clad in metal sheeting. There is a wide eaves overhang on the northern side. This elevation is characterised by three large window sets, each comprised of a fixed central window flanked by two double hung windows to either side. The roof extends over the southern elevation, over a narrow timber verandah, and is supported by timber posts. This elevation is characterised by single panel doors. Refer to Figures 31 and 32.

**Figure 31:**  
**Northern and**  
**western elevations of**  
**the c.1990s addition**  
**on the northern side**  
**of Building 7.**

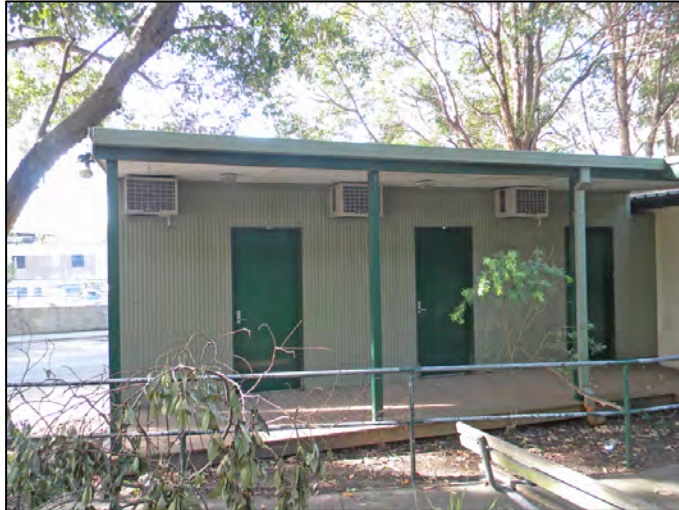
**Figure 32:**  
Southern elevation of  
the c.1990s addition  
on the northern side  
of Building 7

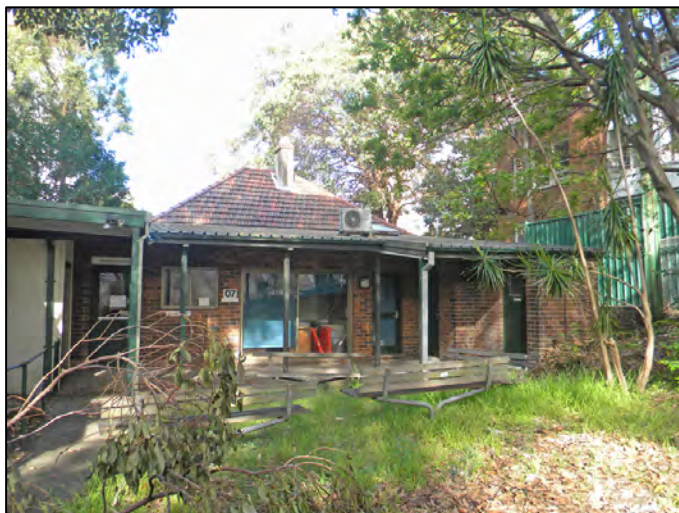
The **western, rear, elevation** of the principal building form is characterised by metal framed windows and doors of varying sizes and styles. The elevation lies under a verandah with a timber floor and wide metal-deck roof supported by timber posts. The metal roof extends on the southern side over a set of brick toilets/storerooms, which open onto the verandah. Refer to Figures 33 and 34.

**Figure 33:**  
Rear, western,  
elevation.

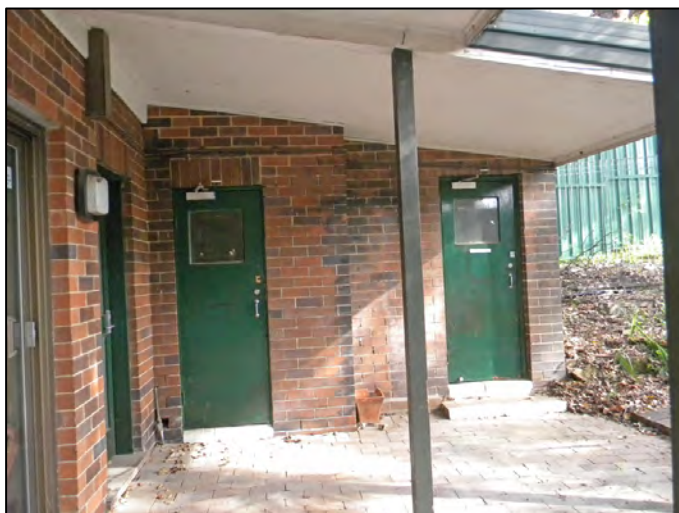
**Figure 34:**  
Toilets on the  
southern side of the  
rear elevation. This is  
an early brick  
skillion, modified by  
later works.

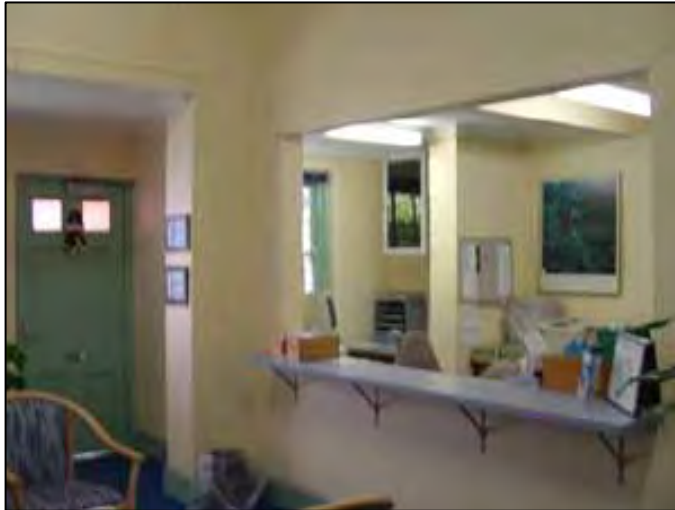
**Figure 35: Reception desk and waiting area. The entrance off Westbourne Street is visible on the left hand side.**

Figures 35 to 39 provide a selection of images from the interior from the City Plan Heritage Assessment of 2005, showing typical interiors. None of the ceilings shown in these photographs is typical of the Federation period. Some appear to be interwar period ceilings, likely to have been added when the verandah was remodelled. Internal fireplaces were also remodelled at this time.

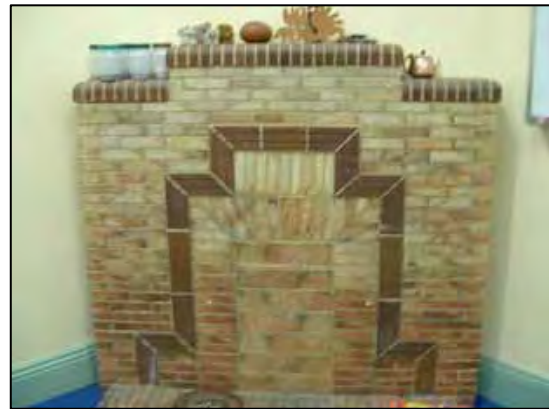
**Figure 38: Art Deco Style brick fireplace (later bricked up) in one of the office rooms. This fireplace was likely to have been added when the verandah was remodelled.**

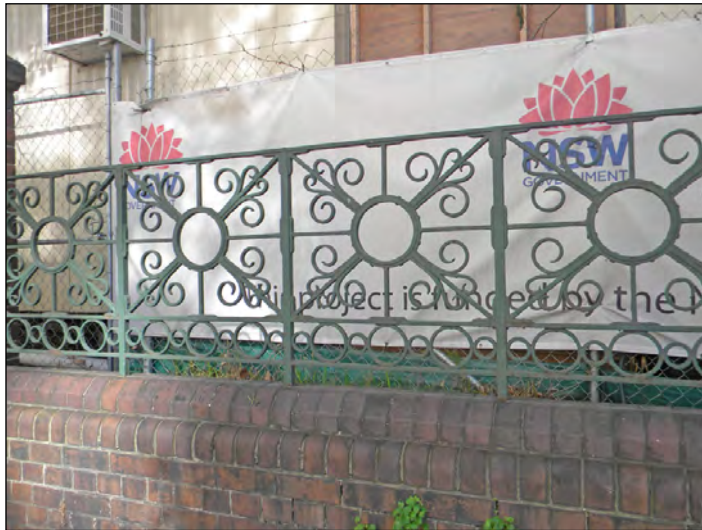
**Figure 41: Detail of the wrought iron panels in the front fence.**

The original layout and detailing of the surviving front portion of the garden survives as does most of the original brick and iron fencing along the Herbert Street boundary. The surviving brick and iron fence is one of the best examples of its kind to be found in suburban Sydney.

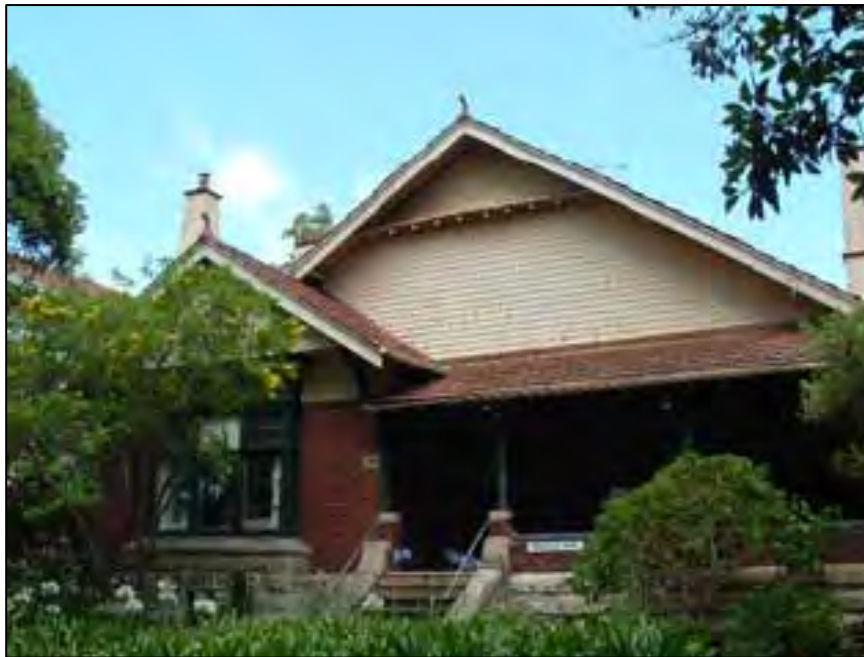
**Figure 44: Eastern elevation in 2005.**

The **verandah** has a separate roof, clad in terracotta tiles. The underside of the roof is timber lined; the rafters are exposed. The verandah has a brick balustrade, with a curving top of dark contrasting brick. The roof is supported by squared timber posts. There is a simple timber valence with heart-shape cut-outs to the corners. The verandah floor is clad in small square ceramic (or brick?) tiles. The verandah is approached up a flight of wide stone-topped stairs.

The eastern elevation and verandah are difficult to photograph because of the surrounding demountable units. Figure 44 provides a photograph of the front elevation dated 2005. Few alterations appear to have been made since this time. Figures 45 and 46 are details of this elevation and taken in October 2014.

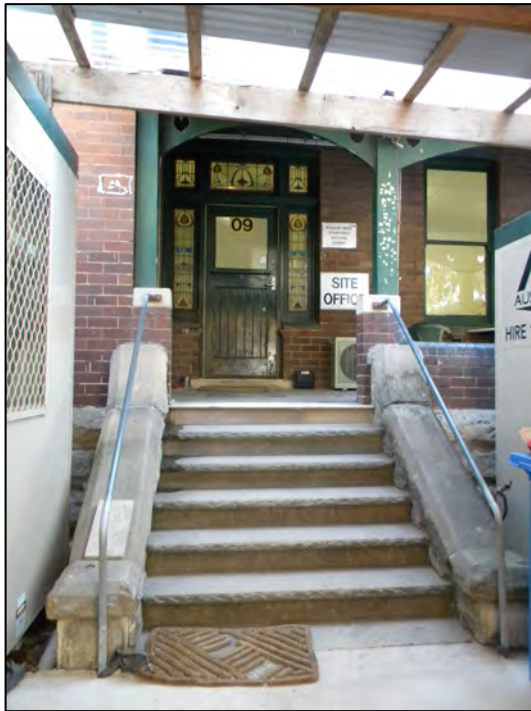
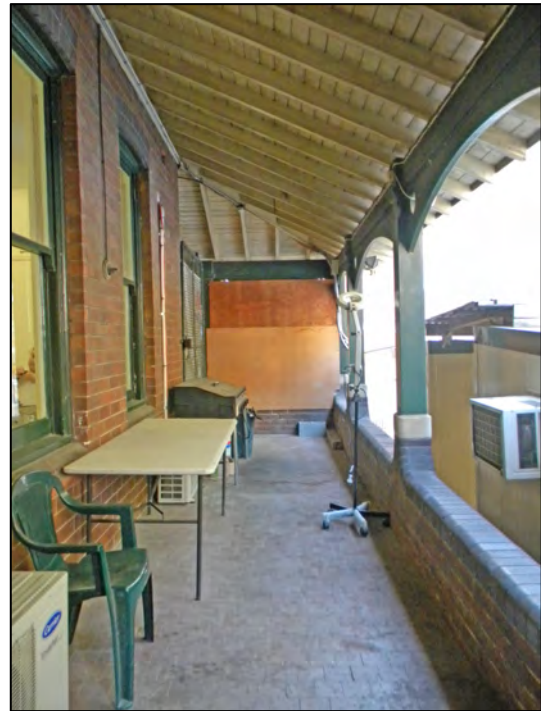
**Figure 45: Detail of the stone capped stairs leading up to the verandah and of the front door.**

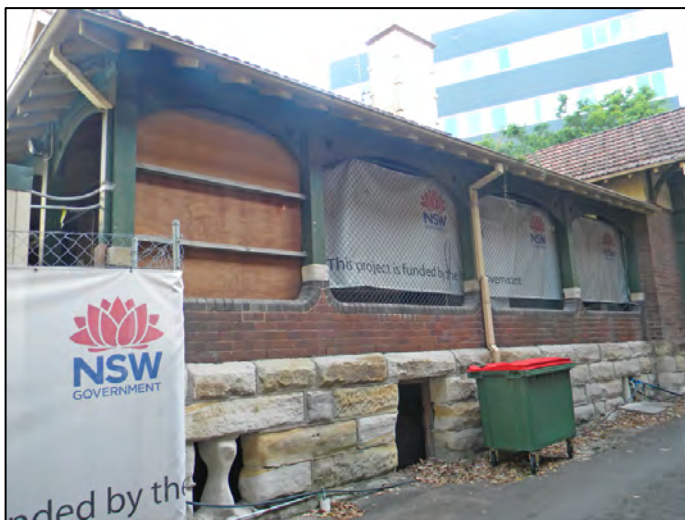
The **northern elevation** is similarly asymmetrical. The front verandah returns as far as a projecting bay. The gable above the bay projects forward and is supported on simple timber brackets. The gable is finished in vertical timber battening and has wide timber barge boards. There is a timber-framed box window in the northern face of the bay, fitted with fixed and casement windows with horizontal glazing bars. Beneath the verandah, timber framed and glazed doors provide access onto the verandah. This verandah has been enclosed with wire, hoarding and signage. Refer to Figures 47 and 48.

**Figures 47 and 48: Northern elevation.**

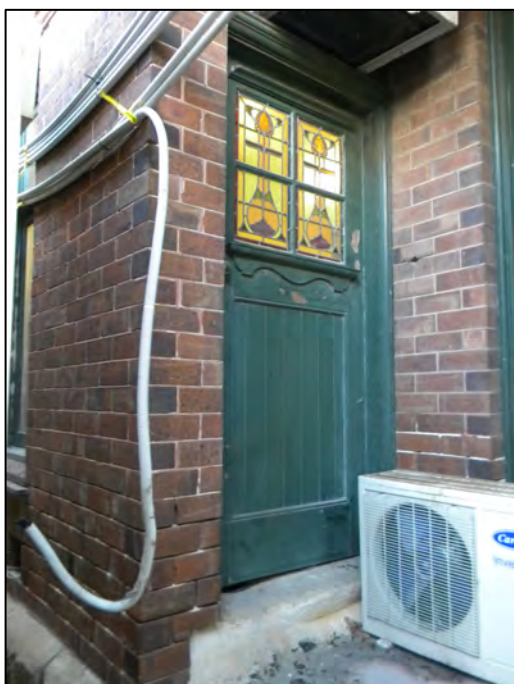
**Figure 49: Timber panel door with leadlight in the southern elevation.**

The **southern elevation** similarly has a gabled bay towards the rear. This gable is finished in a similar manner to the northern gable. There are two timber framed, double hung sash windows with moulded brick sills in the southern face of this bay. There is a timber panel door with leadlight in the eastern face of this bay. Other window types along this elevation vary and include a multiple paned, timber-framed

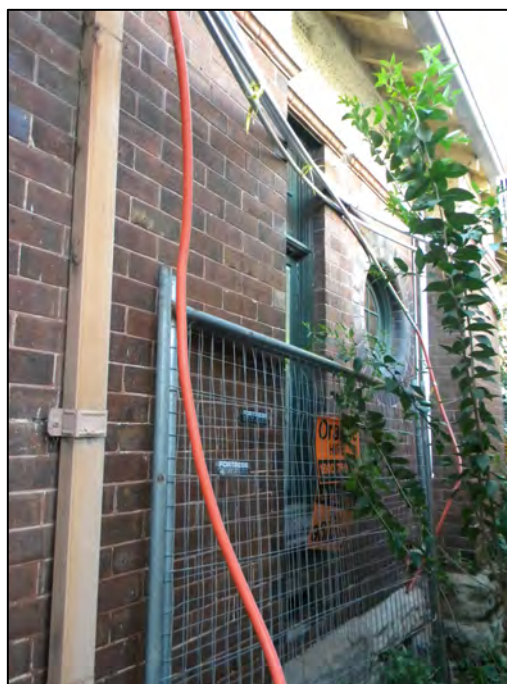
**Figure 50: Looking east along the eastern end of the southern elevation towards the oriel window.**

oriel window and narrow timber framed double hung windows. This elevation is difficult to photograph because of demountable units and is concealed in photographs taken by City Plan Heritage in 2005 by vegetation. Figures 49 and 50 illustrate details from this elevation.

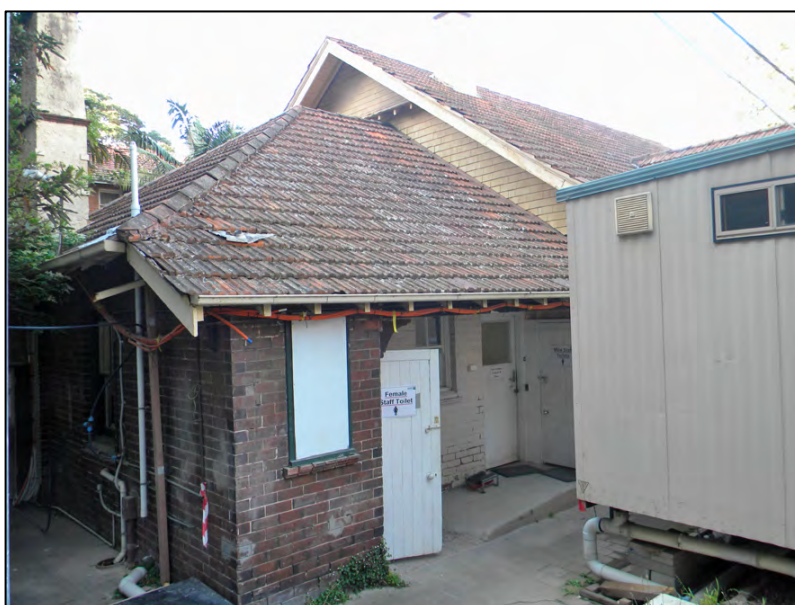
**Figure 51:  
Southern elevation of  
the rear wing.**

The **rear wing** is located on the southern side of the building and is constructed of face brick and, in one small section on the southern side, painted brick. Windows are timber framed, double hung sash windows or casement windows. Figures 51 to 53 illustrate the rear wing.

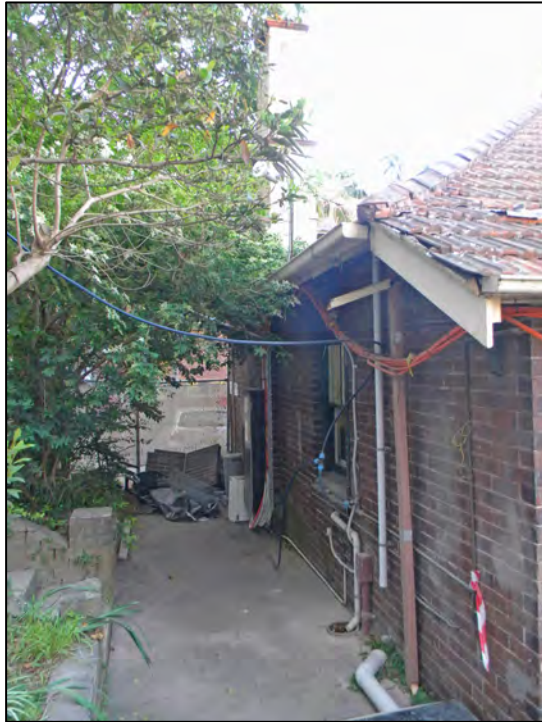
**Figure 52: Looking along the western elevation of the rear wing**

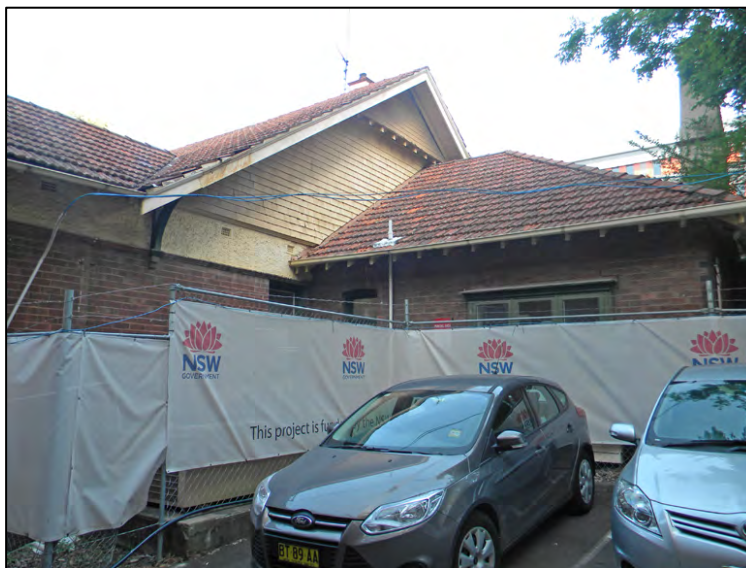
**Figure 53:**  
The eastern elevation of the rear wing. The City Plan Heritage Report of 2005 states that the casement window has a shingle apron, currently concealed by the fence.

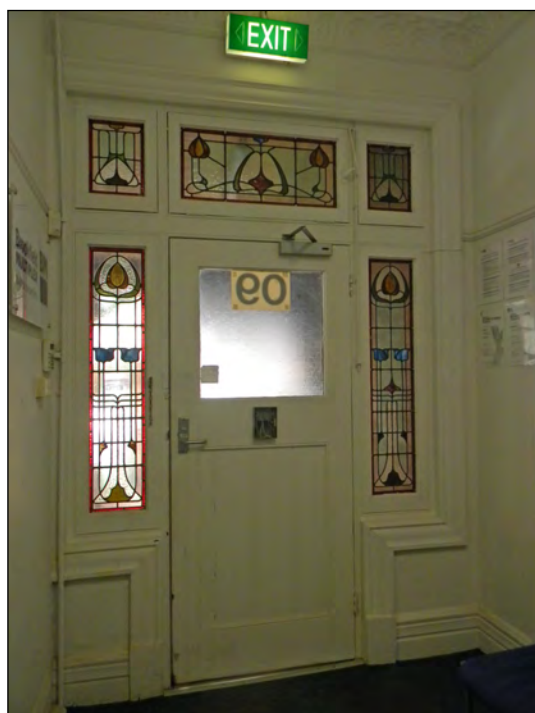
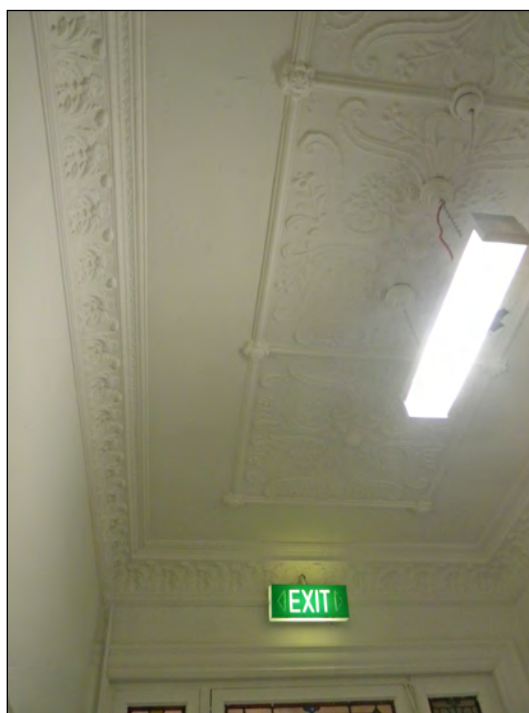
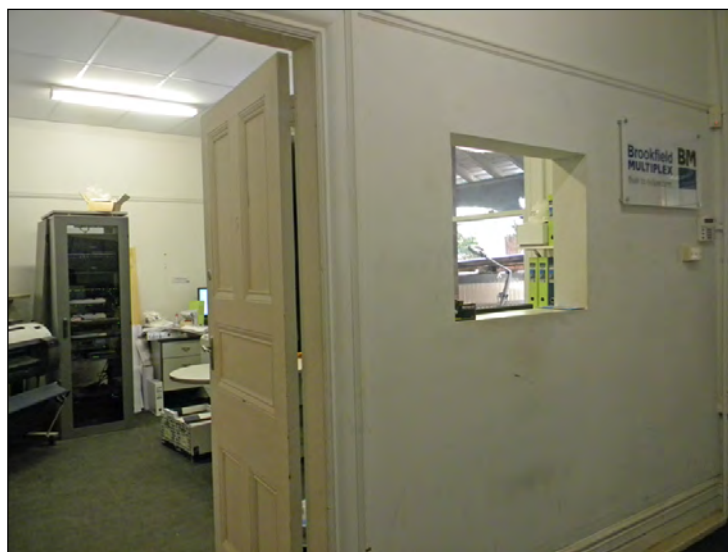
**Figure 55:**  
Area 1: front door- interior.  
Note also the profile of the  
skirting boards and  
architraves.  
**Figure 56:**  
Detail of the plaster cornice  
and ceiling in Area 1.  
**Figure 57:**  
Northern wall in Area 1  
showing an original timber  
panel door.

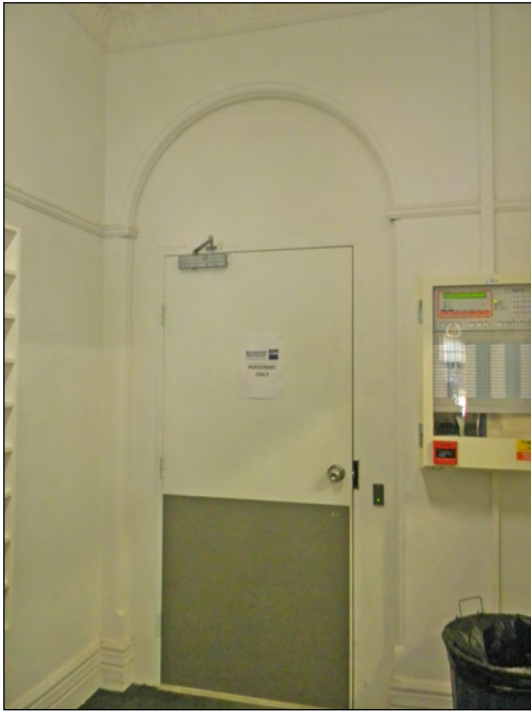
**Figure 58: Fire door separating Areas 1 and 2. Note the arch in the wall.**

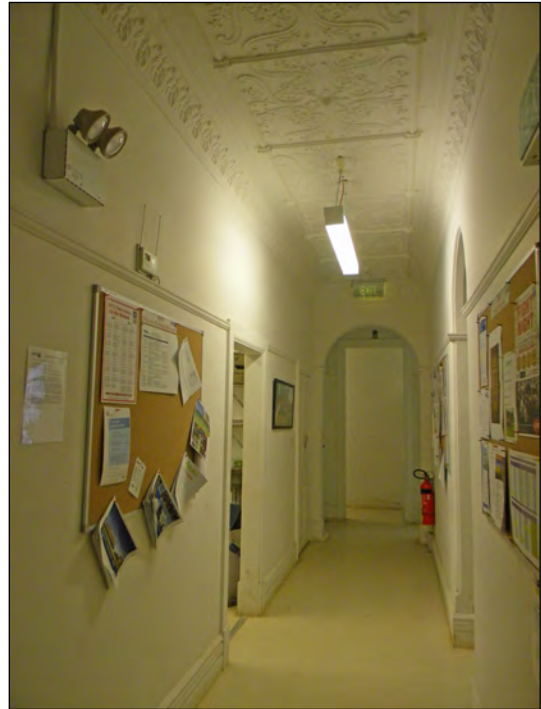
**Figure 59: Area 2, looking west, showing the profiled timber architraves, skirting boards and picture rail and the decorative plaster ceiling and cornice.**

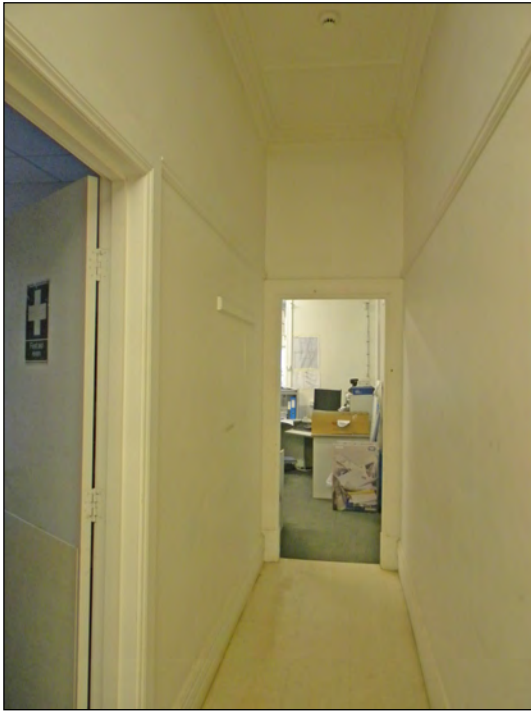
**Figure 62: Area 3, looking north, showing simpler finishes. Note the single panel door (not original).**

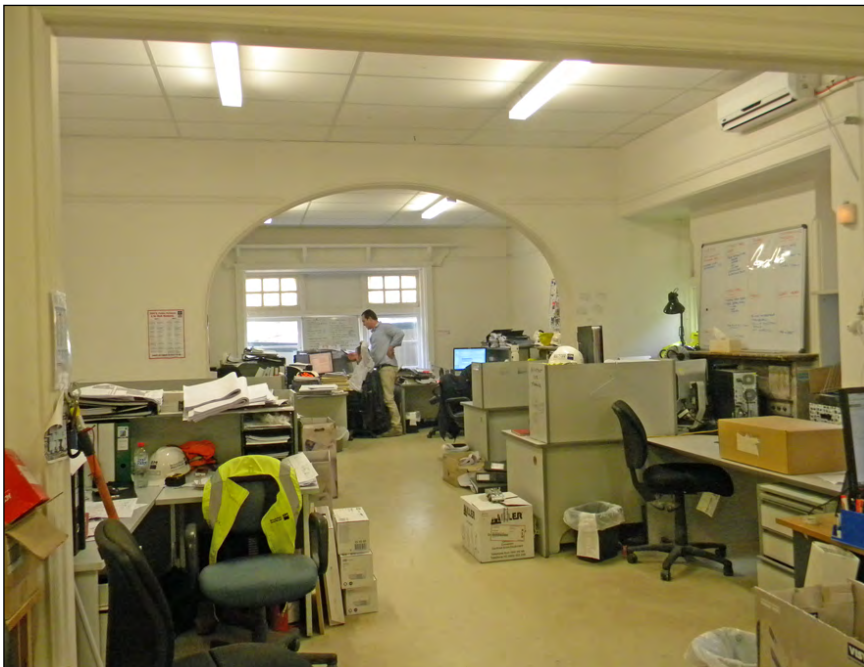
**Figure 64: Area 5, looking east.**

Area 5 comprises a series of enfilade rooms. These rooms have profiled timber skirting boards and architraves, picture rails and drop-in panel ceilings. Each room has a marble fireplace, the opening of which has been blocked in. Figures 64 to 72 illustrate this area.

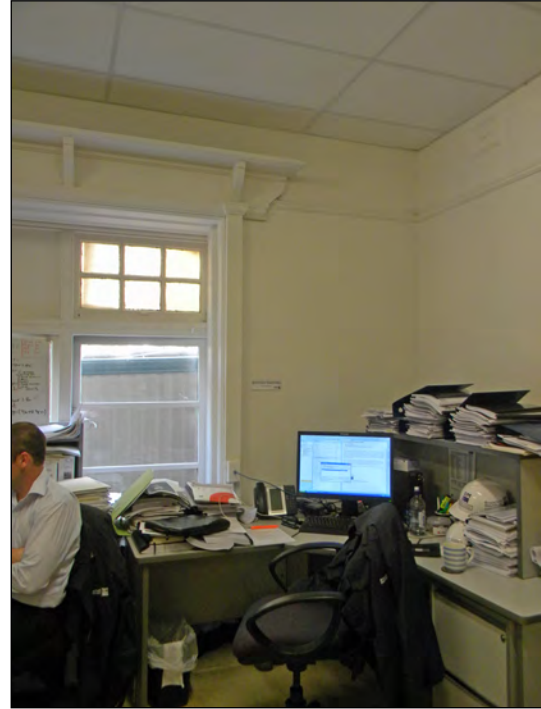
**Figures 65 and 66: Area 5A, windows in the eastern wall.**

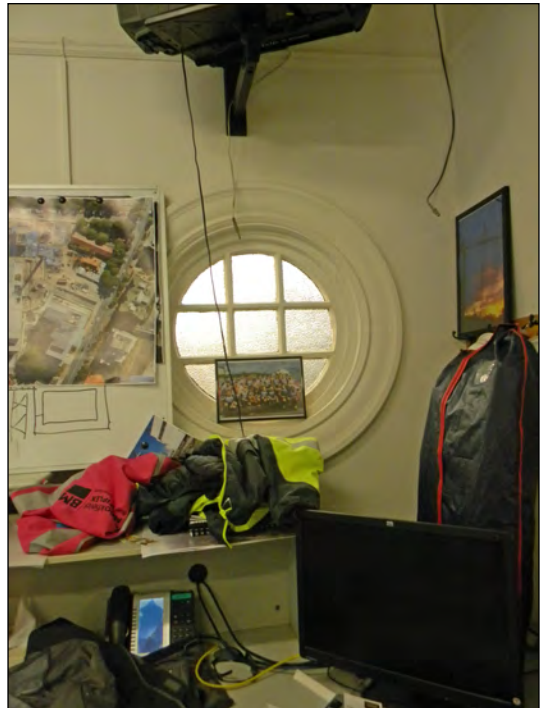
**Figure 67: Fireplace in Area 5A, southern wall.**  
**Figure 68: Oriel window in Area 5A, southern wall.**

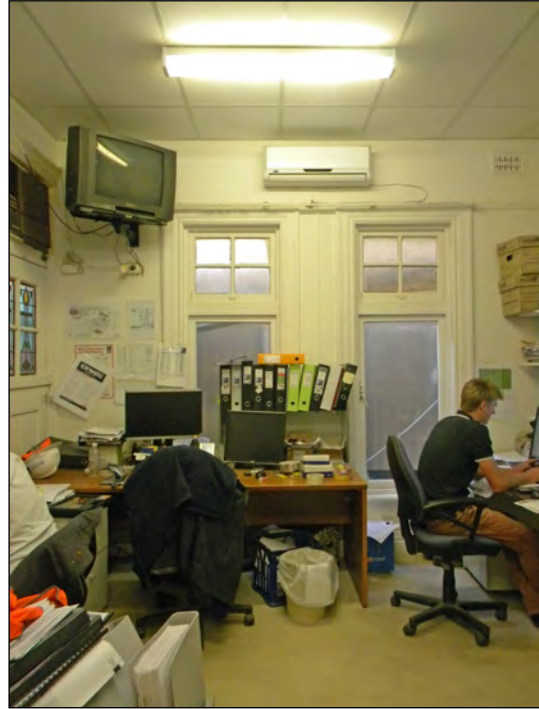
**Figure 70: Windows in Area 5C, southern wall.**

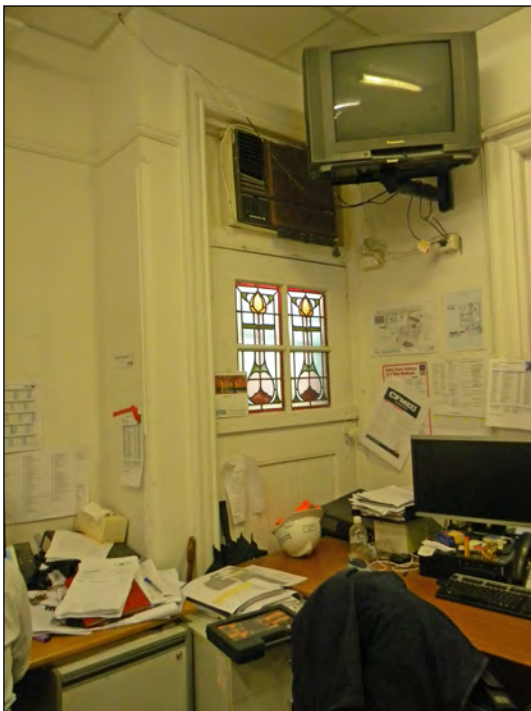
**Figure 71: Door with leadlights on the southern side, Area 5B.**

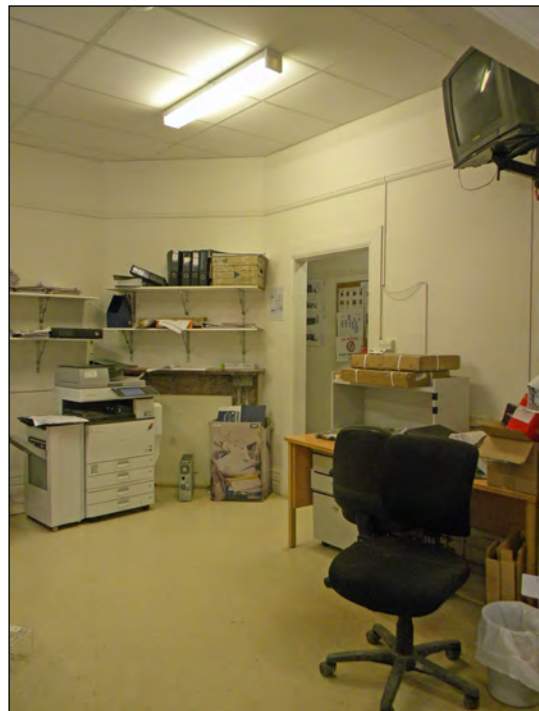
**Figure 72: Area 5C, looking towards the marble fireplace.**

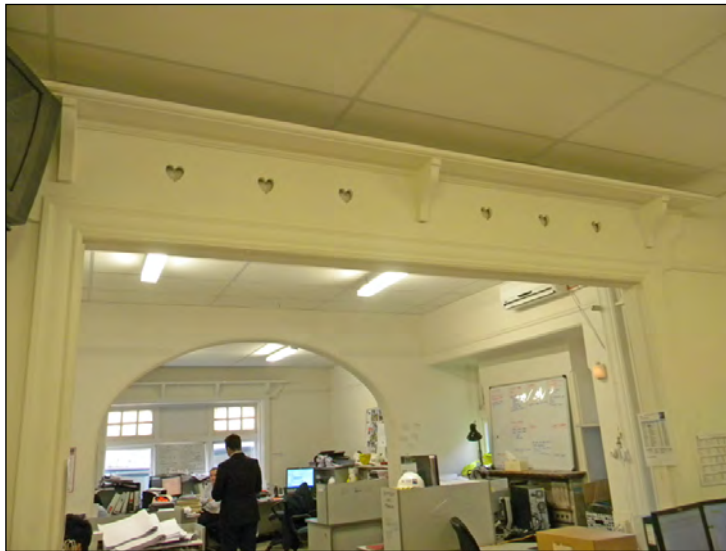
**Figure 73:**  
**Fretwork in the opening**  
**between Areas 5C and 5B.**

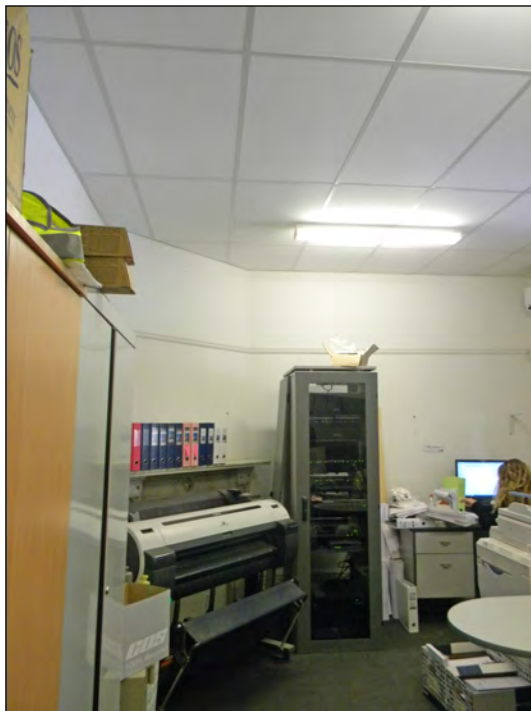
**Figure 74: Area 6, showing the drop down panel ceiling and fireplace.**

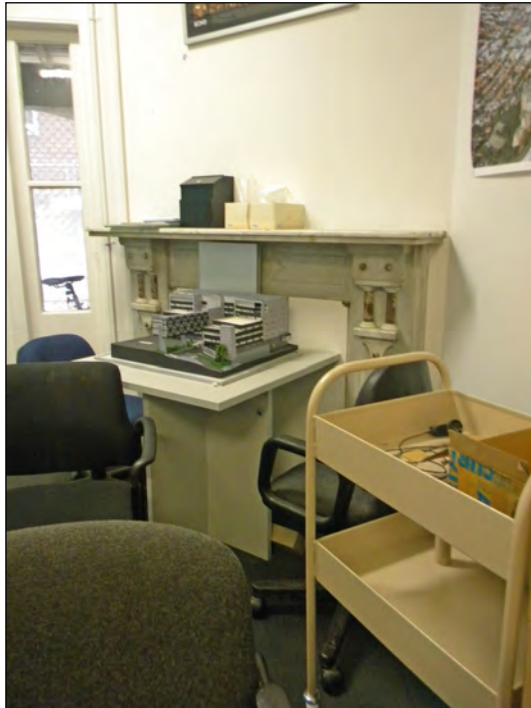
**Figure 76: Area 7, showing the blocked-up fireplace with boarded-in opening.**

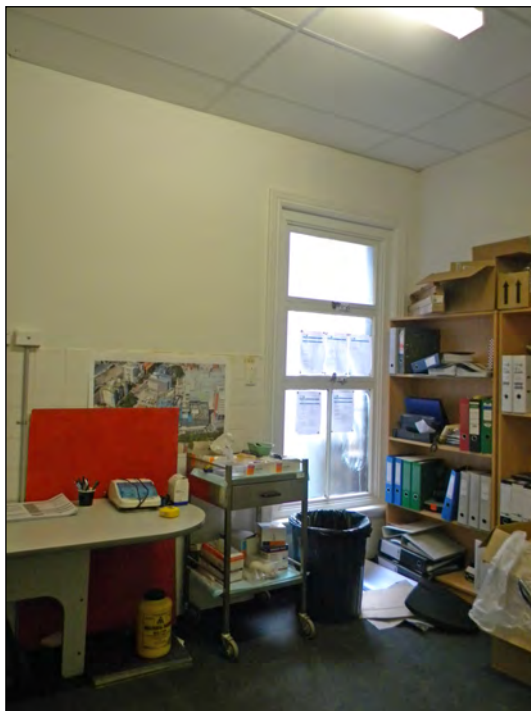
**Figure 78: Area 9.**

Areas 9 and 10 are located off the secondary hallway, Area 3. These rooms have profiled timber joinery and drop-in panel ceilings. Area 9 has a small area of wall tiling, indicating a wet use at some phase. Area 10 has a northern facing box window and a set of french doors, with fanlight, opening onto the northern facing verandah. Refer to Figures 78 to 80.

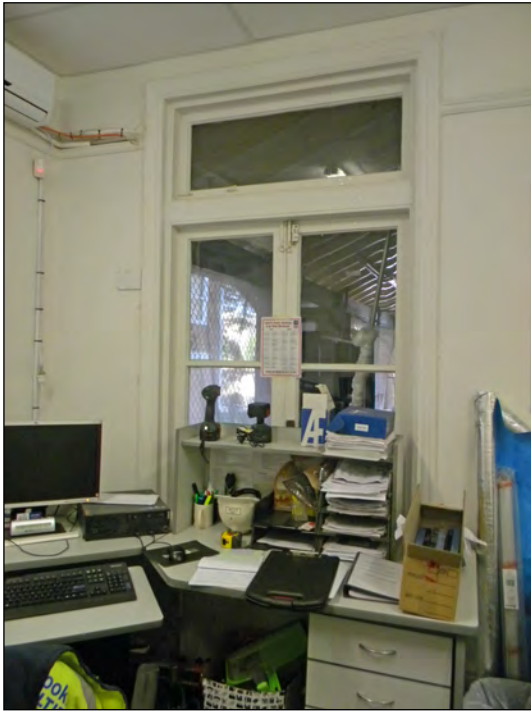
**Figure 80: French doors in Area 10 opening onto the verandah.**

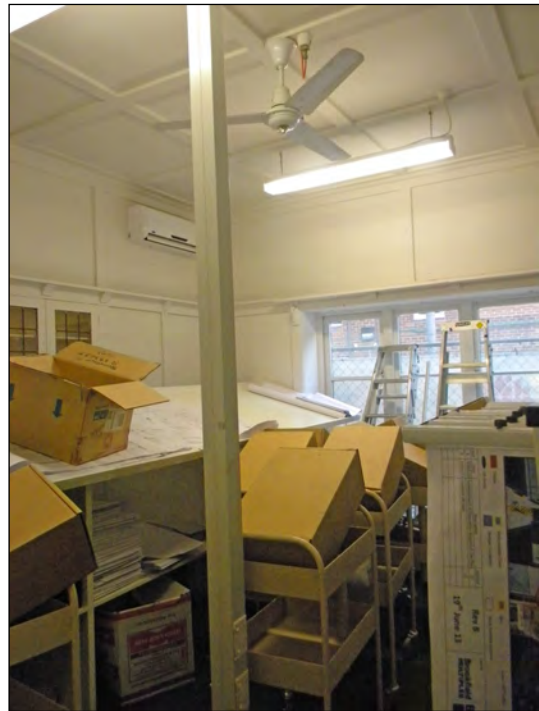
**Figure 81: Area 12.**

Area 11 is a small wc with post-1980 fit-out. The walls and ceilings of Area 12 are lined with fibro sheeting with timber battening. This room has a timber plate rail. Refer to Figure 81. Area 13 has painted brick walls, timber architraves (no skirting boards) and a square set ceiling. It has a modern kitchen fit-out. Refer to Figure 82. Area 14 similarly has painted brick walls, square set ceiling and timber architraves. Refer to Figure 83.

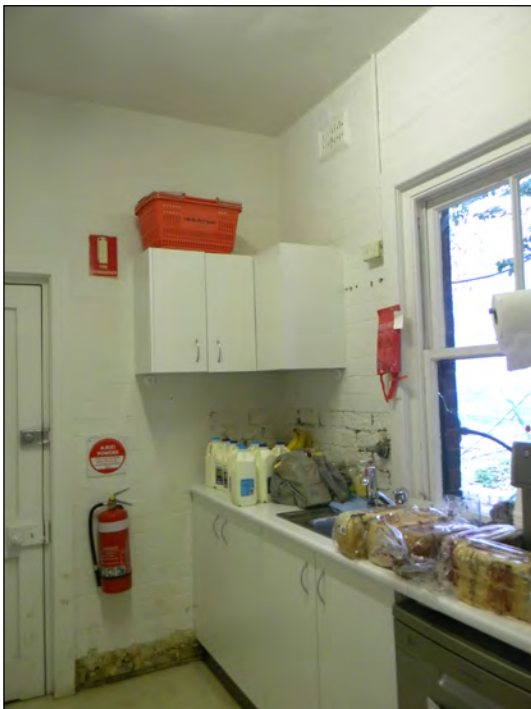
**Figure 82: Painted brick walls, square set ceiling and kitchen fit out in Area 13.**
