Eastern Creek, Rainbow Beach Project, Ocean Drive, Bonny Hills

Geotechnical Assessment

Report No. RGS20337.1-AD

1 December 2015

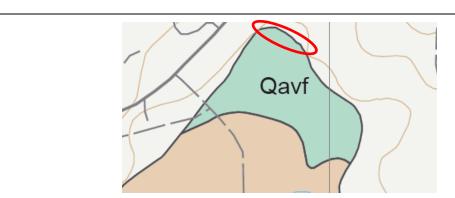
Plate 3: Excerpt from the 1:25,000 Laurieton Coastal Quaternary Geology Sheet. Approximate location of the ssessment area outlined in red and is situated at the transition from residual slopes to a Qauternary alluvial floodplain.

Reference to the Laurieton Coastal Quaternary Geology 1:25,000 Sheet (Troedson et al 2008) indicates the subject area of is located near the interface between a Quaternary alluvial and colluvial fan (Qavf) to the south and residual soils to the north. An excerpt of the Sheet is reproduced in Plate 3.

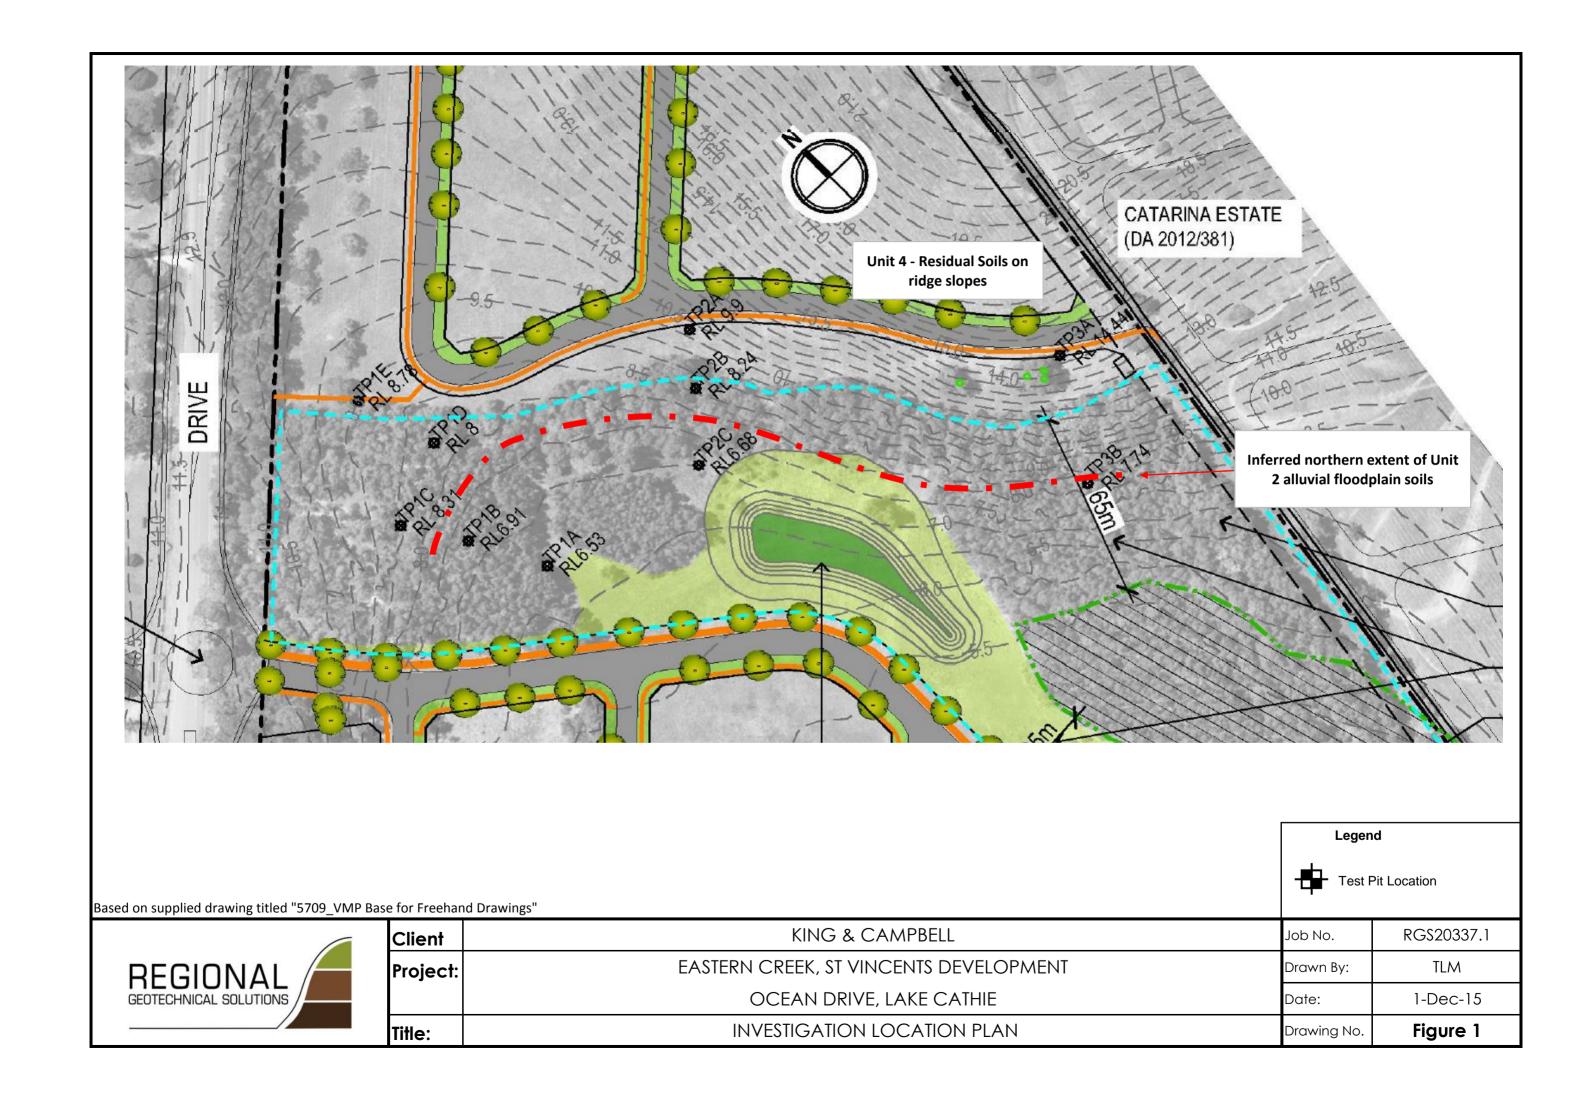
Engineering logs of the test pits are presented in Appendix A. The locations of the test pits are shown on Figure 1. They were obtained on site by measurement relative to existing site features. Coordinates of each location were recorded by hand held GPS and are shown on the logs. RL's of each test location obtained by survey are shown on Figure 1

The inferred extent of the Unit 2 soils based in the investigation is shown on Figure 1.
