SGD1 Pty Ltd
C/- Tattersall Lander Pty Ltd

Geotechnical Assessment: Riverside Estate, Tea Gardens, NSW.

P1404136JR03V01
October 2015

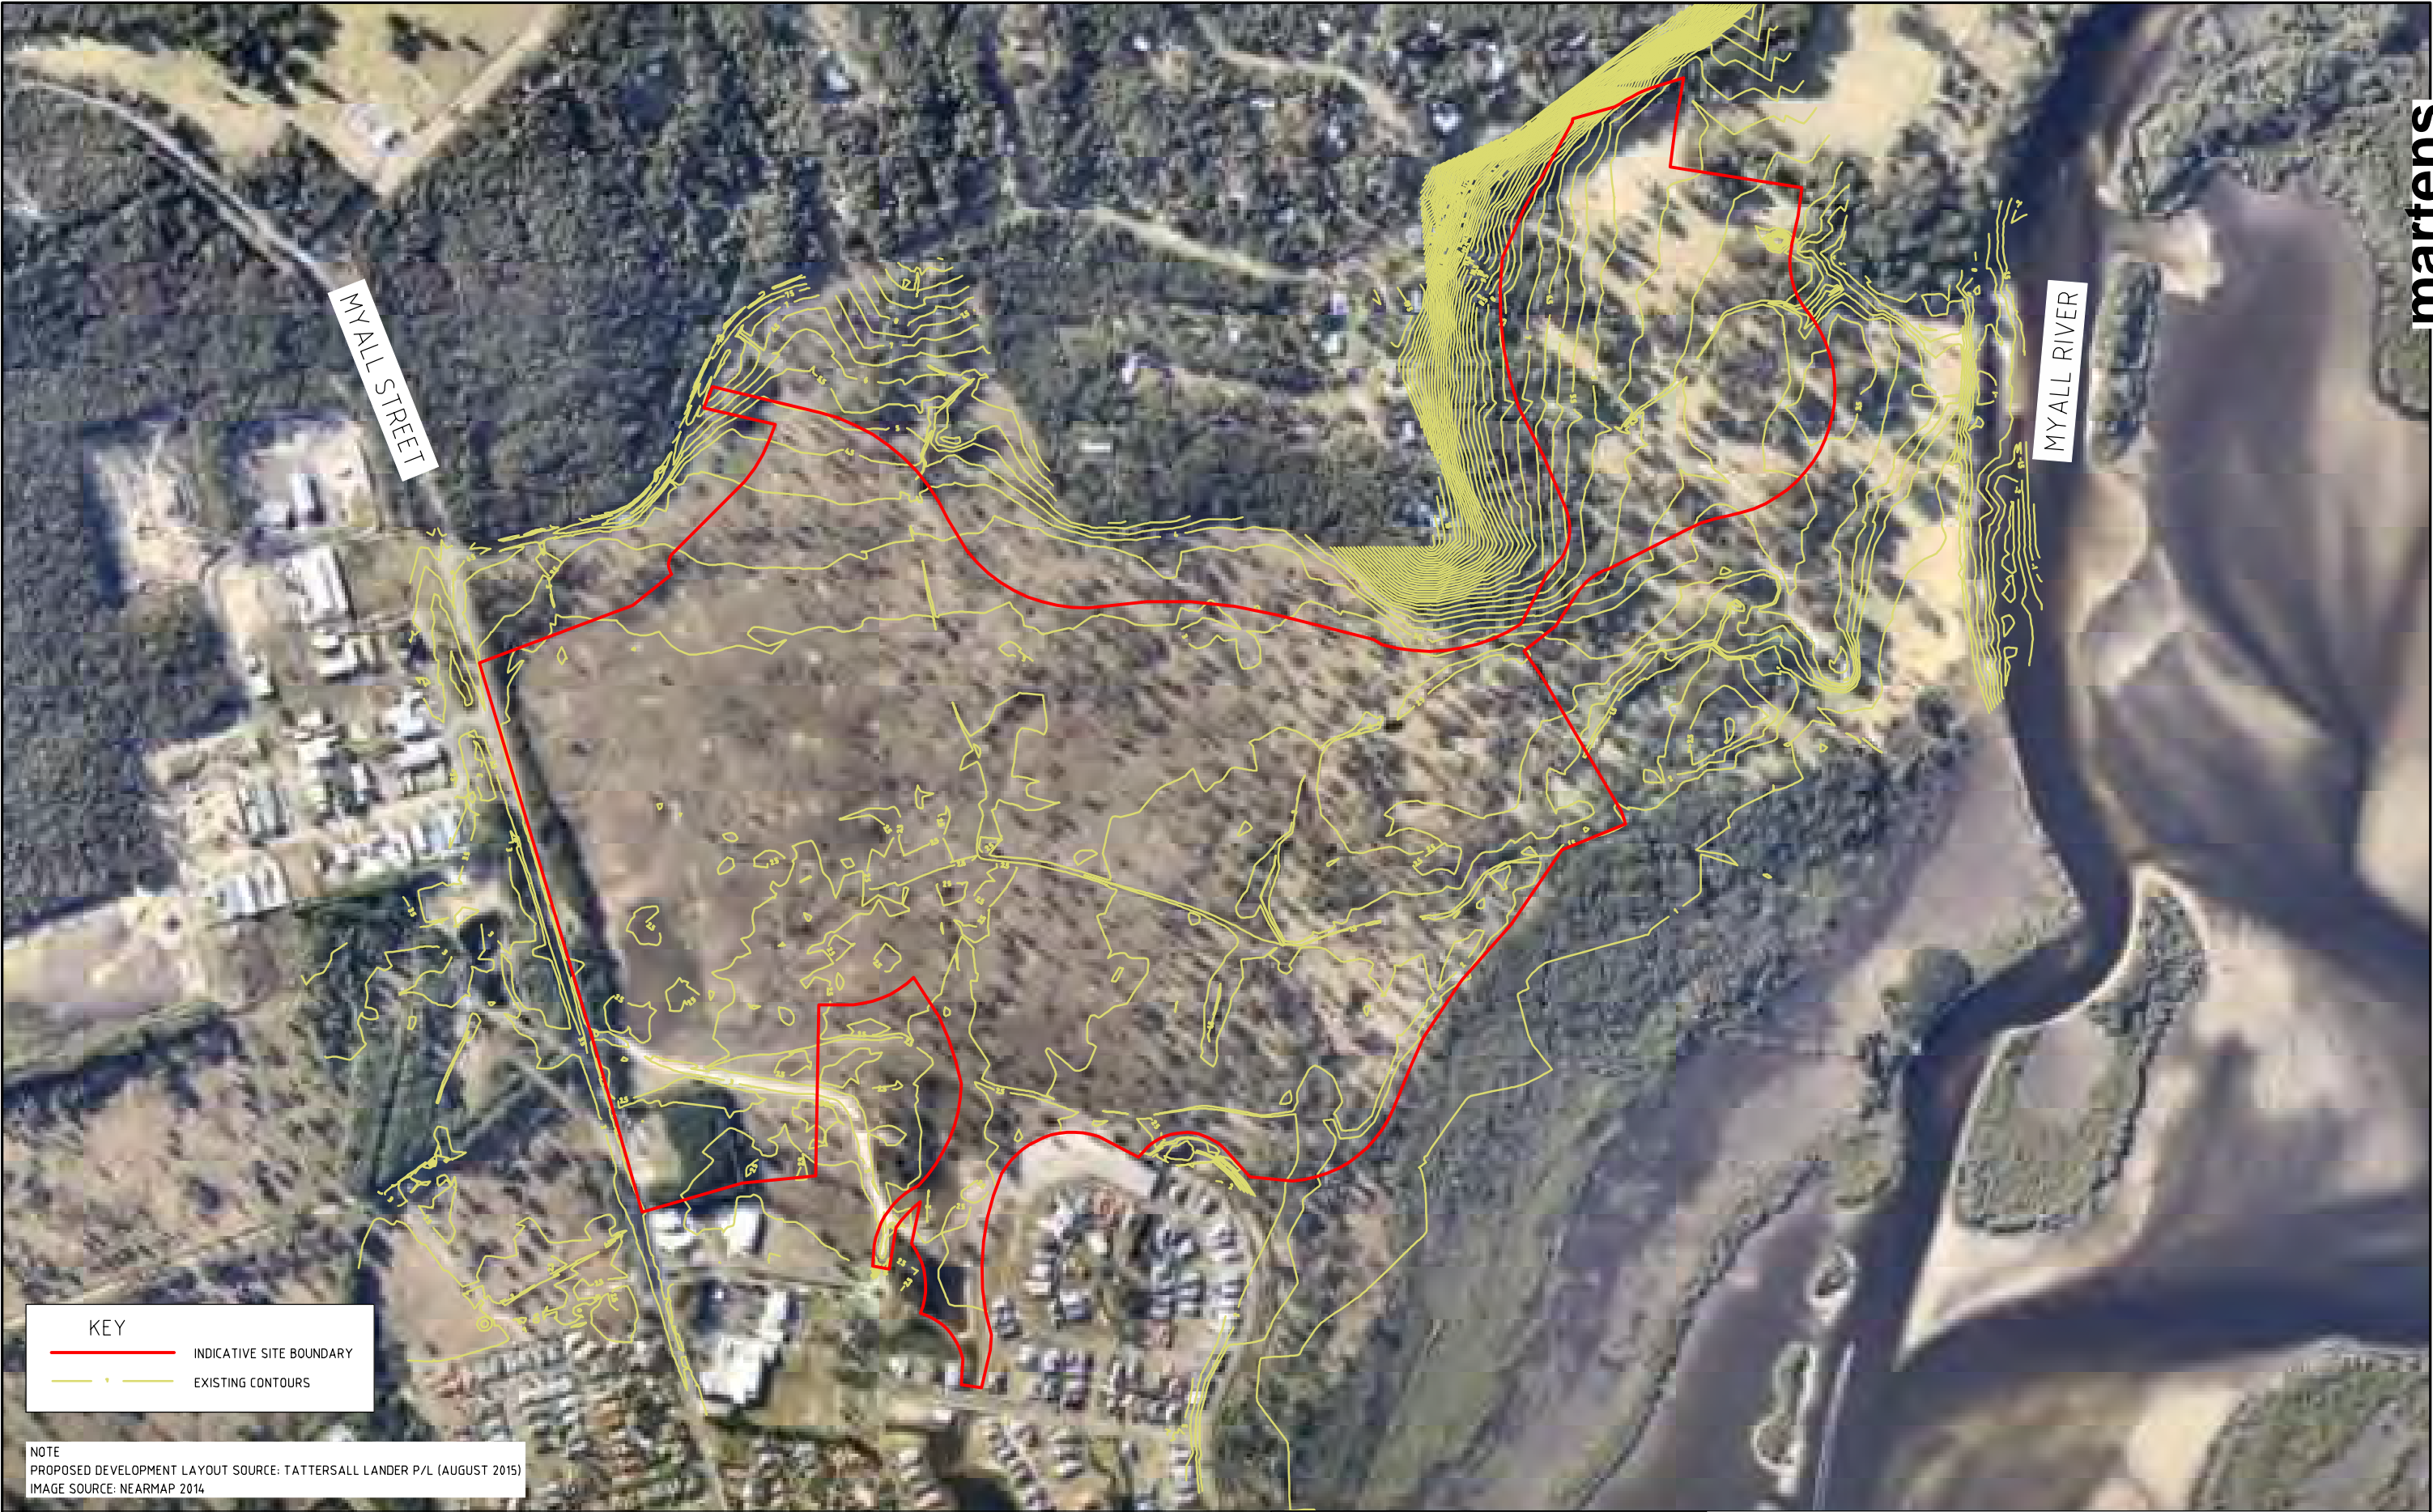
Martens & Associates Pty Ltd		ABN 85 070 240 890	Environment Water Wastewater Geotechnical Civil Management				
Drawn:	KT	EXISTING SITE CONTOURS: RIVERSIDE ESTATE, TEA GARDENS, NSW			Drawing No./ID:		
Approved:	RE				Figure 4		
Date:	07.09.2015						
Scale @ A3:	1:7500	Suite 201, 20 George St, Hornsby, NSW 2077 Australia Phone: (02) 9476 9999 Fax: (02) 9476 8767 Email: mail@martens.com.au Internet: http://www.martens.com.au			Project: P1404136	File: JD02V01	Revision: A

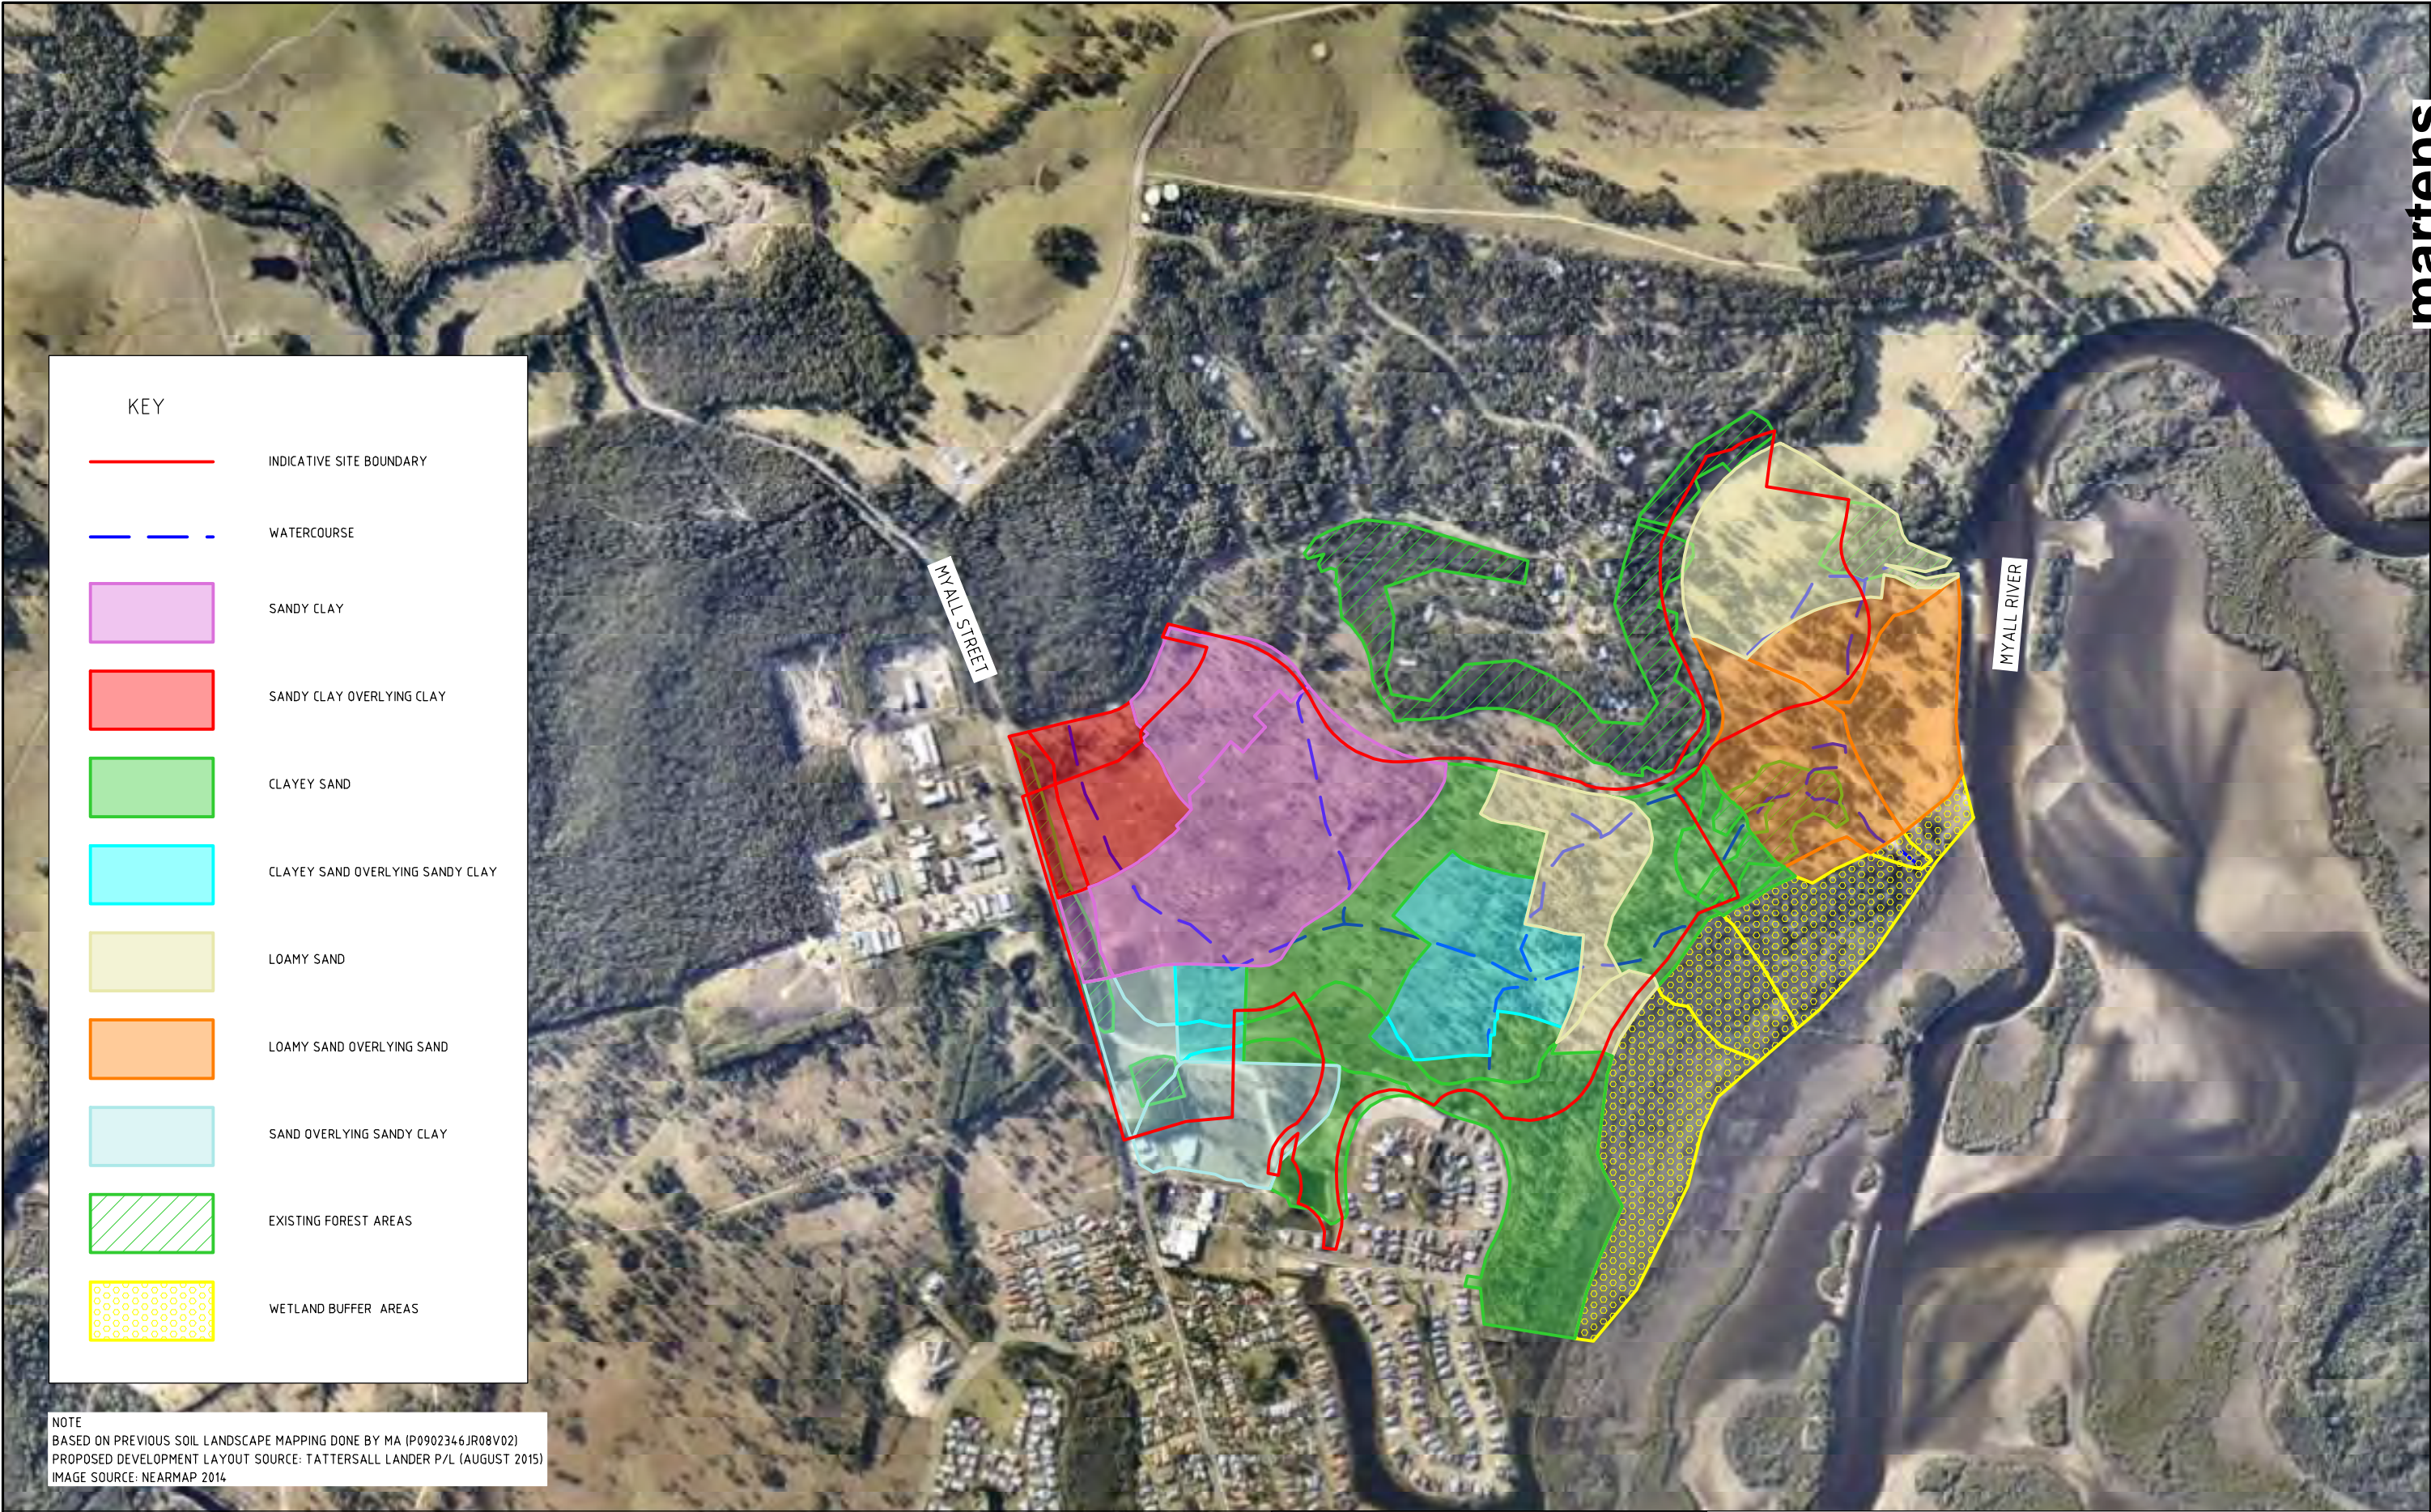
NOTE
BASED ON PREVIOUS SOIL LANDSCAPE MAPPING DONE BY MA (P0902346JR08V02)
PROPOSED DEVELOPMENT LAYOUT SOURCE: TATTERSALL LANDER P/L (AUGUST 2015)
IMAGE SOURCE: NEARMAP 2014

Table 1, overleaf, presents a summary of general site details. Existing site features are shown in Figure 3, Attachment B. Existing site contours are shown on Figure 4, Attachment B.
