**Re: Pacific Pines Estate, Lots 215, 216 & 217 in DP1017615, North  
Creek Road, Lennox Head ~ Preliminary Site Investigation**

**PRELIMINARY SITE INVESTIGATION**  
for: Pacific Pines Estate

**Lots 215, 216 & 217 in DP1017615**  
**North Creek Road**  
**Lennox Head**

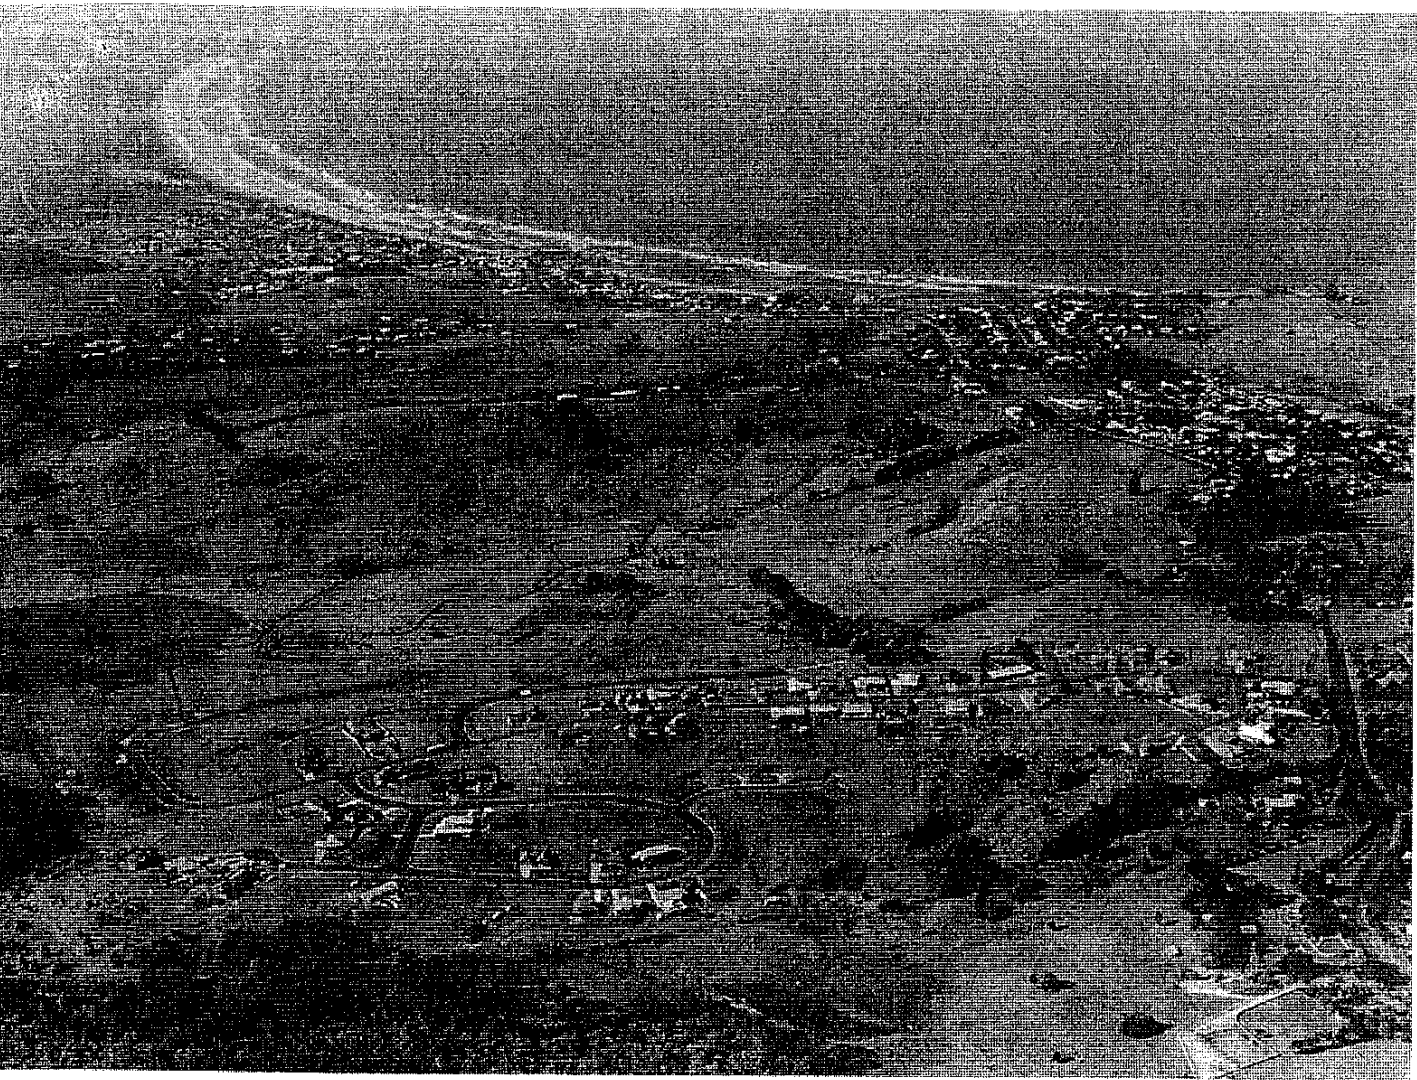
# **Aerial Photographs**

Aerial photographs taken prior to this development show the subject site to be cleared, grassed grazing land that is generally free of rubbish or other foreign material. An aerial photo taken after completion of the initial portion of residential development shows the areas that have been filled as described above. Copies of the photos are attached in Appendix C.
