**Urban Growth NSW**

**Remedial Action Plan**

**Sewage Treatment Plant  
Former Defence Ingleburn Site  
Campbelltown Rd, Edmondson Park,  
NSW**

**20 April 2015  
43008-57149 (Rev 1)**

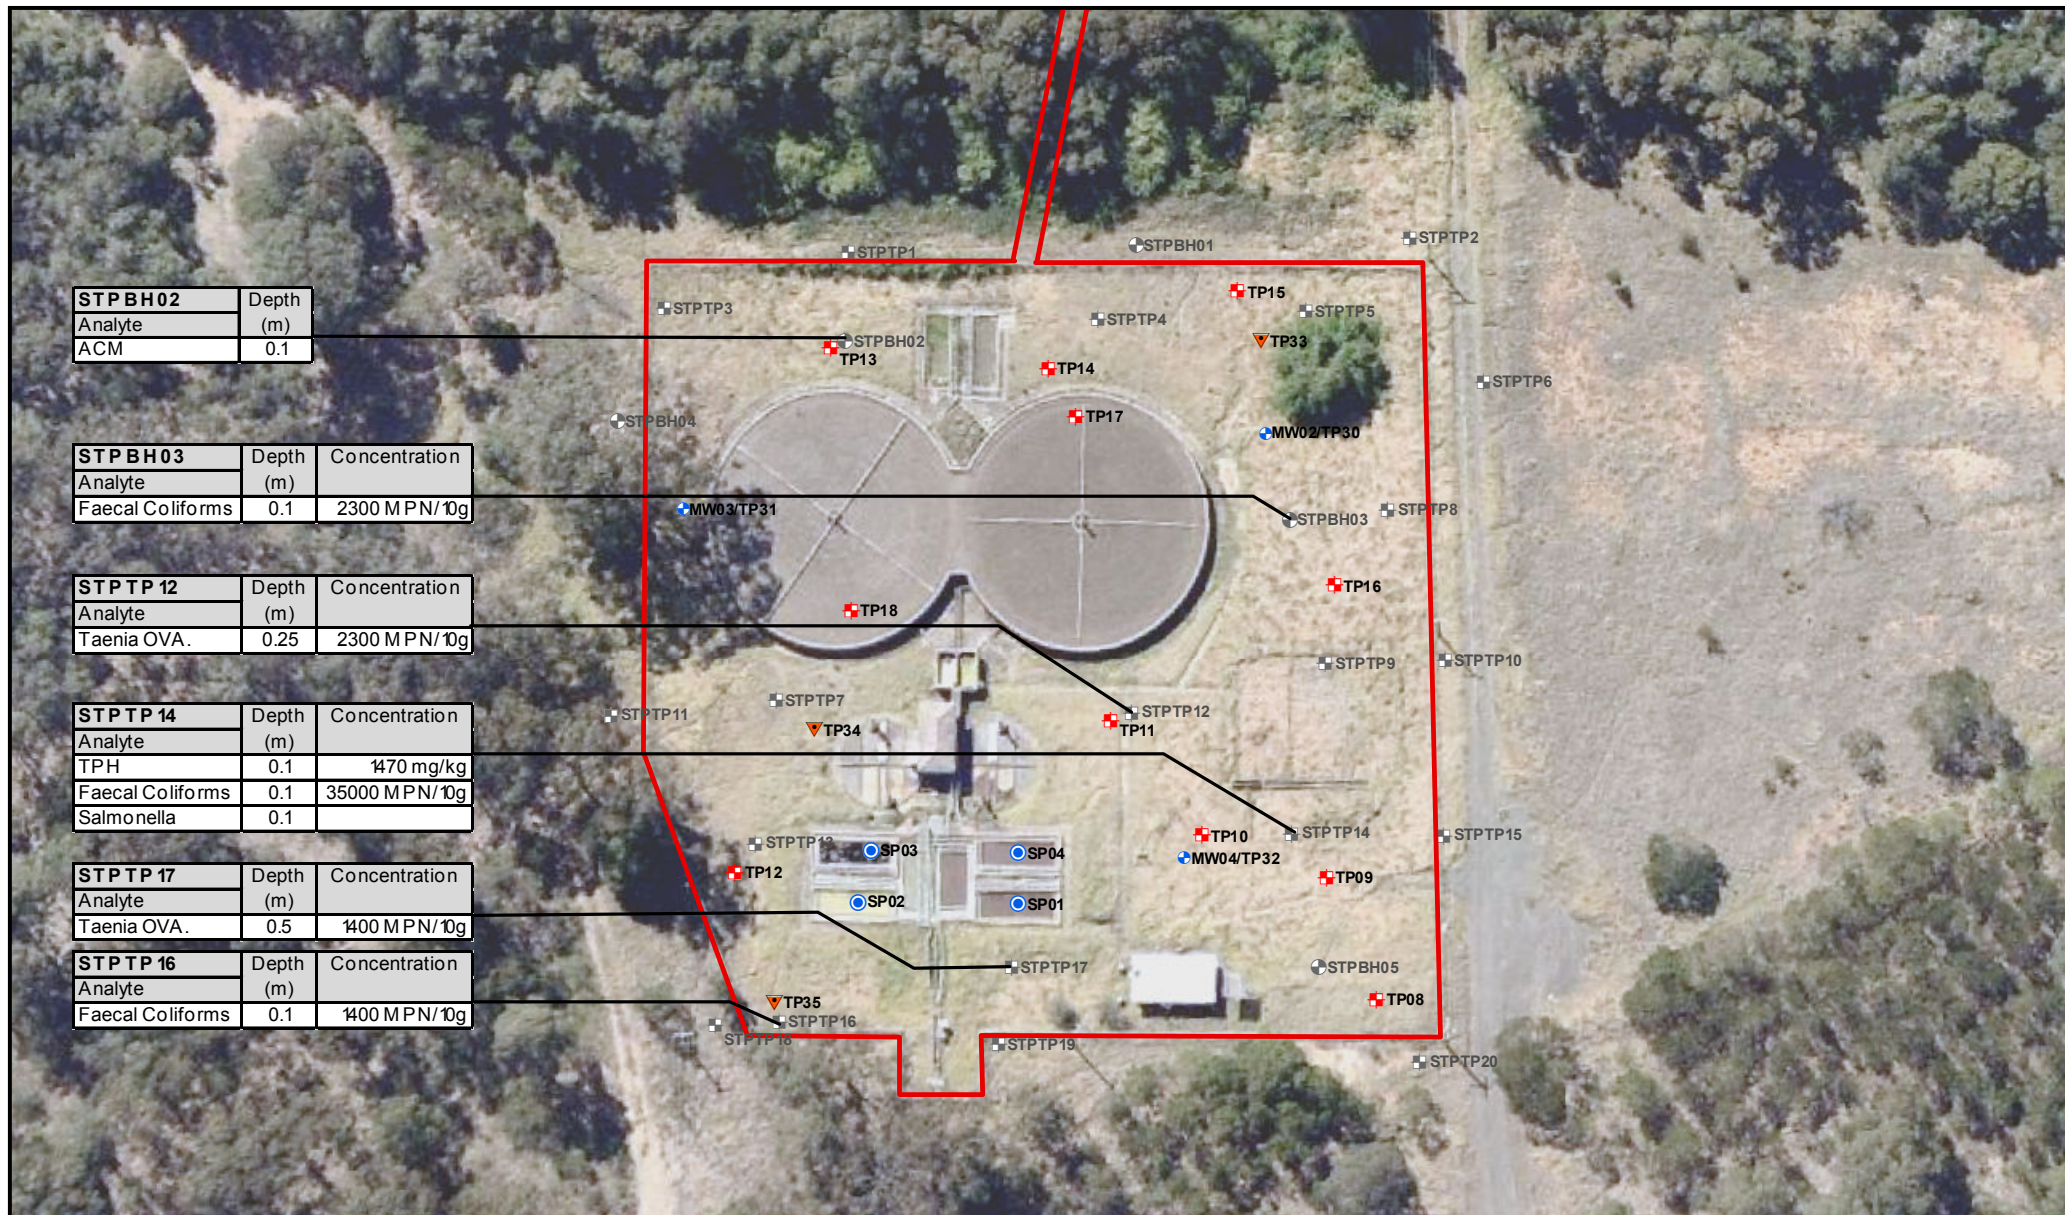
File Name: 43008\_04a

<b>STPBH02</b>	Depth
Analyte	(m)
ACM	0.1

<b>STPBH03</b>	Depth	Concentration
Analyte	(m)	
Faecal Coliforms	0.1	2300 MPN/10g
