**Urban Growth NSW  
Environmental and Geotechnical Site  
Investigation**

**Sewage Treatment Plant  
Former Defence Ingleburn Site  
Campbelltown Rd, Edmondson Park,  
NSW**

**13 December 2013  
43008-56443 (Rev A)**

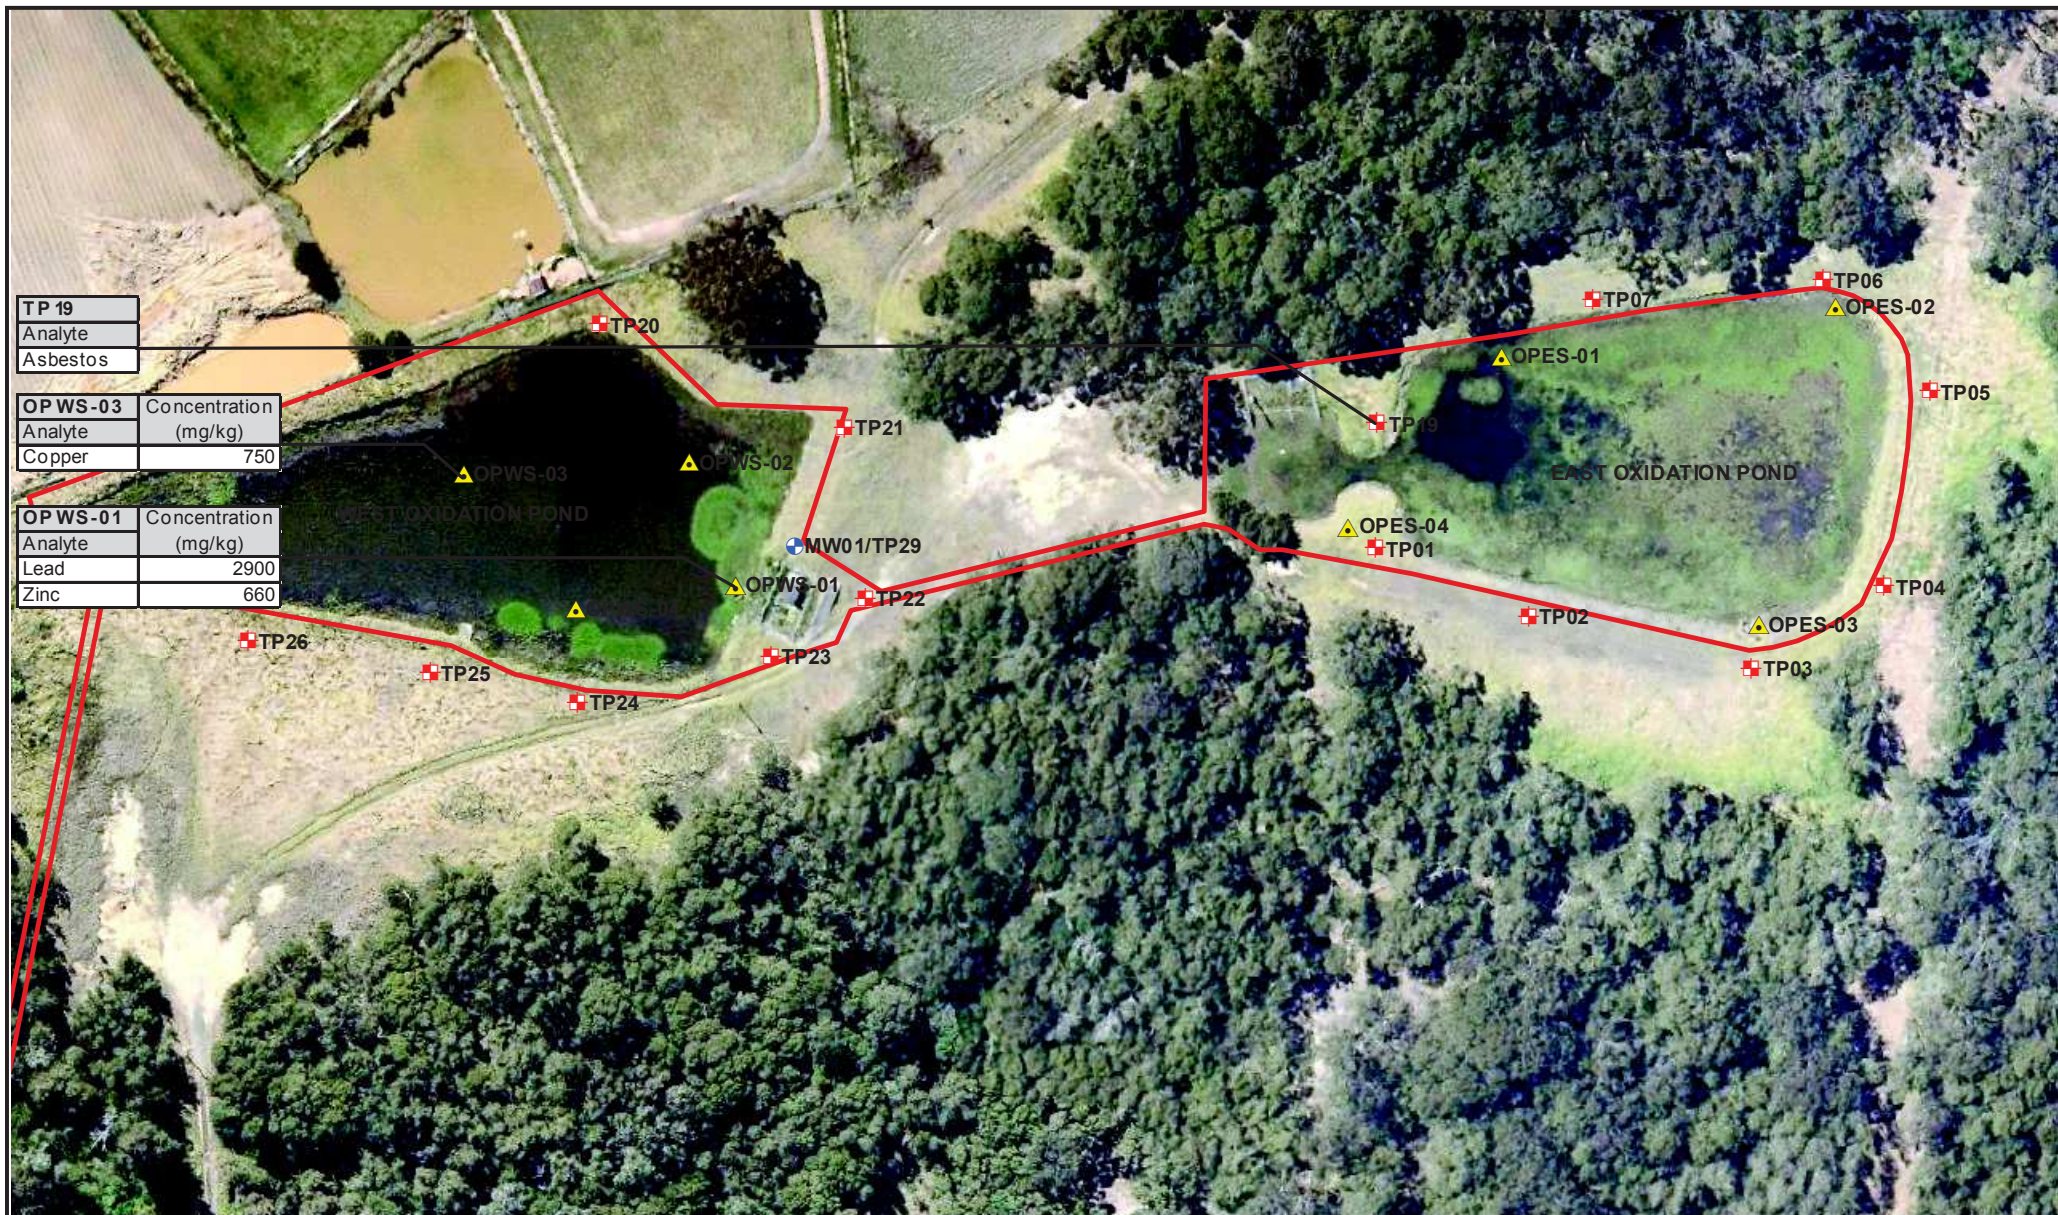
File Name: 43008\_05

Suspected asbestos containing materials (ACM) was noted in spoil during site investigation activities at location TP19 at a depth of 0.4-0.5 m bgs at the western end of the east oxidation pond.

<b>TP 19</b>
Analyte
Asbestos

<b>OPWS-03</b>	Concentration
Analyte	(mg/kg)
Copper	750

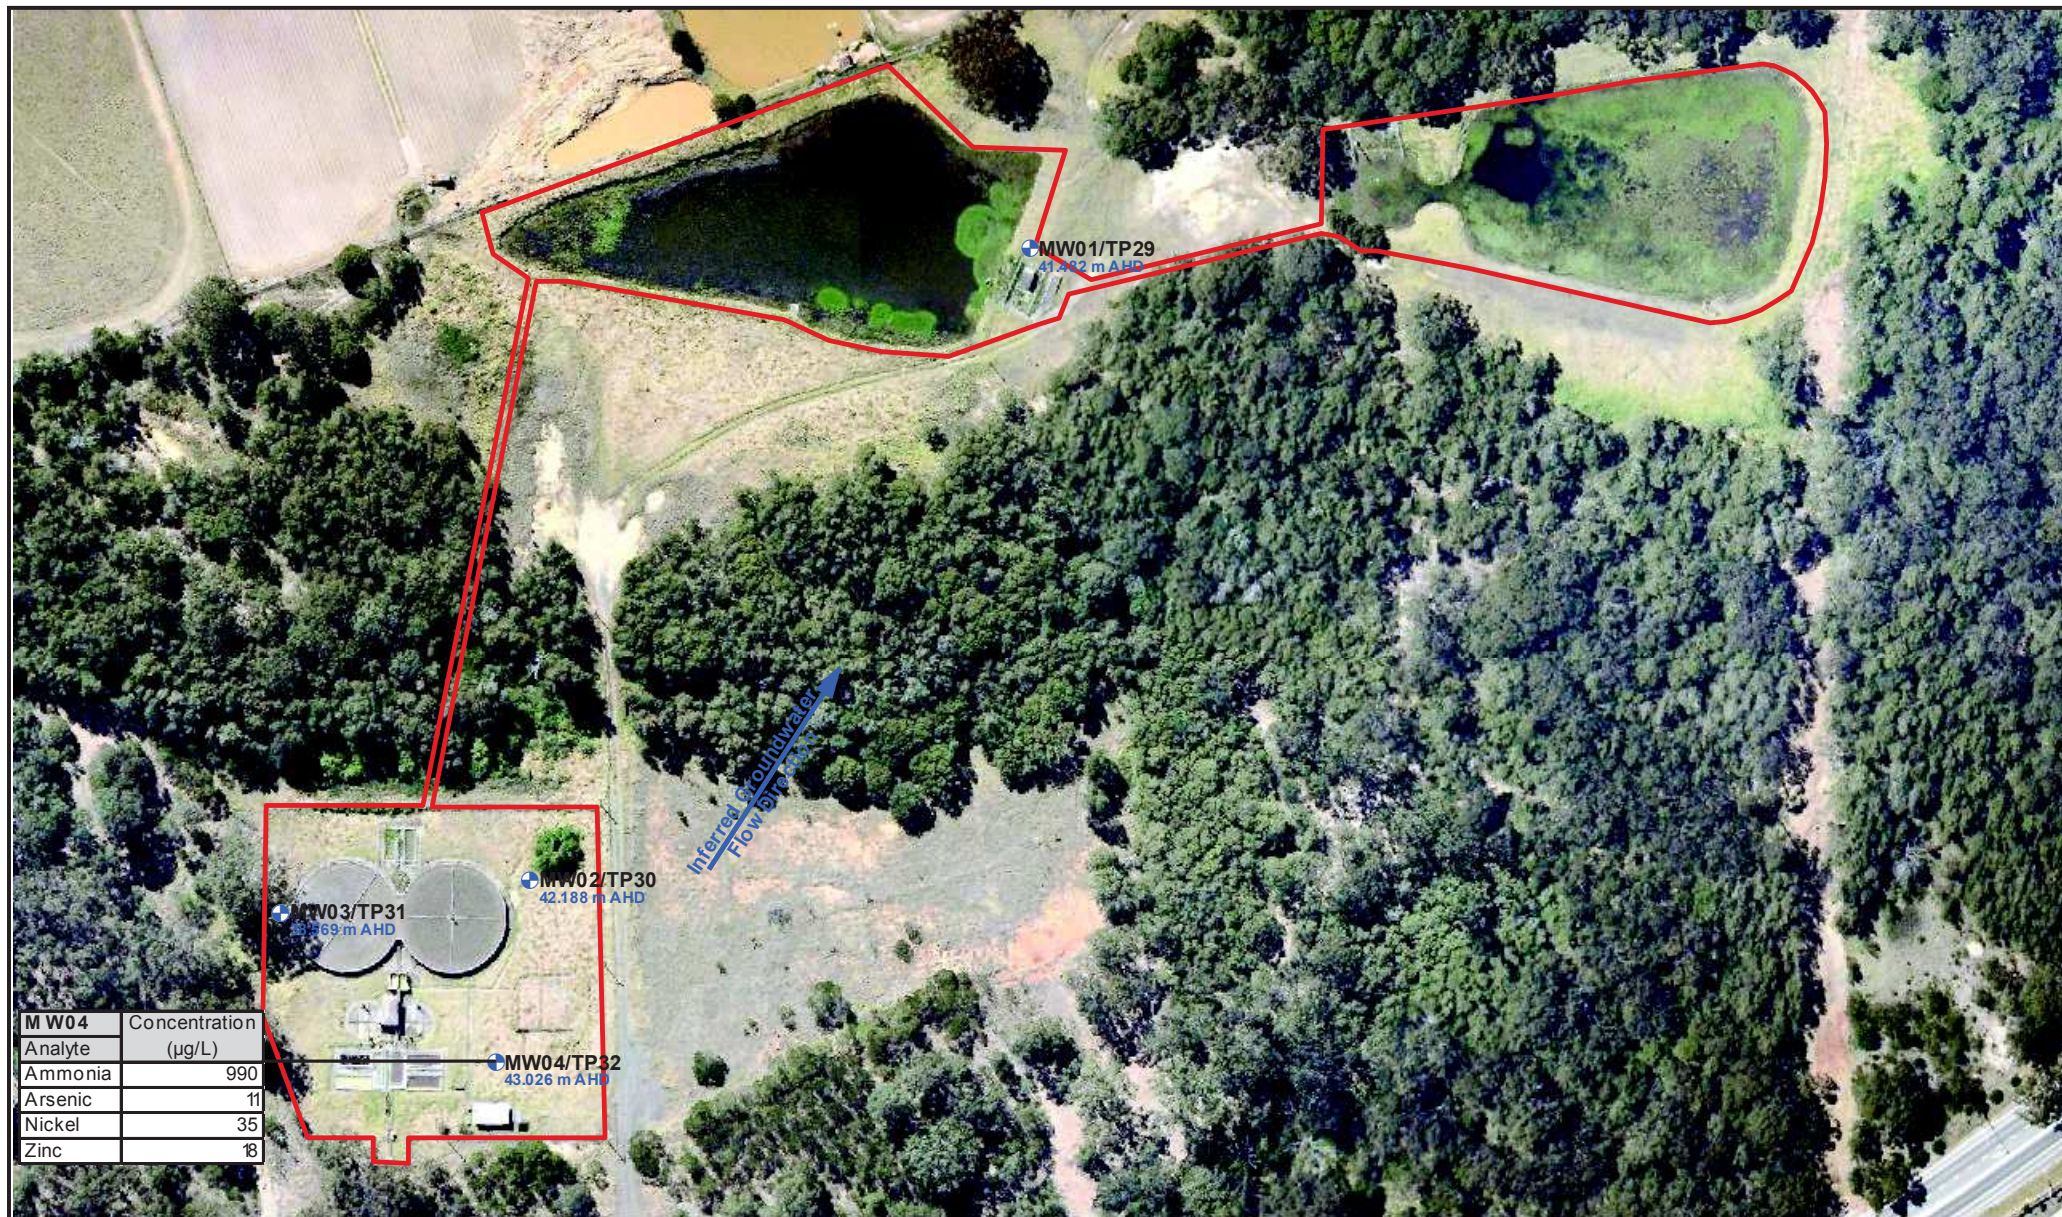
File Name: 43008\_06a

- Ammonia with a concentration of 3,800 ug/L compared to the criteria of 900 ug/L in the west oxidation pond (OPW\_01), with this likely attributed to decomposition of algae from observed algal blooms in the water.

MW04	Concentration
Analyte	(µg/L)
Ammonia	990
Arsenic	11
Nickel	35
Zinc	18

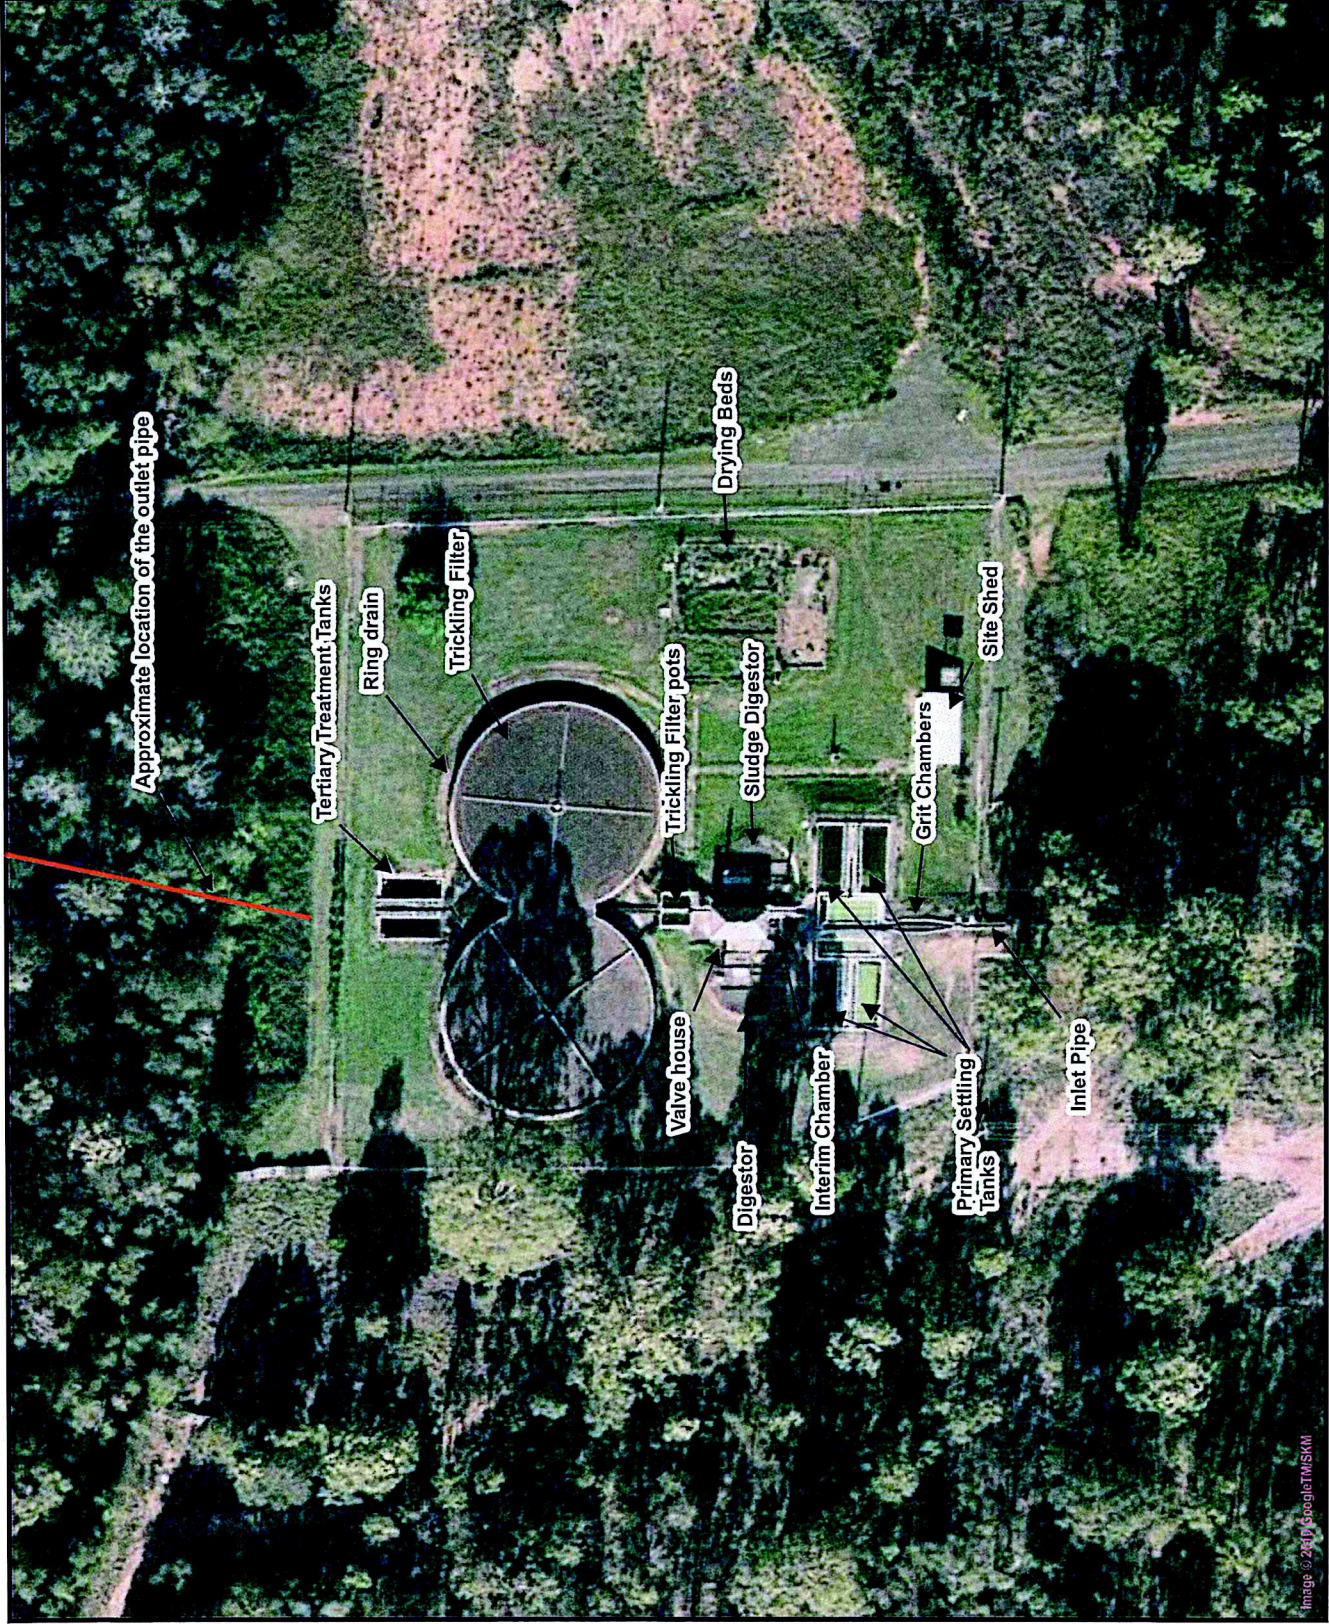
**Figure 3a**  
**STP Infrastructure**

The STP area slopes to the north and northeast, other than flat areas presumably excavated level for placement of STP infrastructure, which includes several buildings, primary treatment ponds, pipes, tanks, two large circular trickle filters and associated infrastructure. ERM 2010 provides a description of the STP infrastructure and process, while ERM (2011<sup>5</sup>) provides further detail on the infrastructure. The following is noted:
