Figure 8B: Potential Containment Cell Layout - Viewing North East

Project: Remediation and Validation Edmondson Park

RE: SEWER TREATMENT PLANT – EDMONDSON PARK, NSW
GEOTECHNICAL INVESTIGATION

**SEWER TREATMENT PLANT,
CAMPBELLTOWN ROAD, EDMONDSON PARK, NSW
GEOTECHNICAL INVESTIGATION**

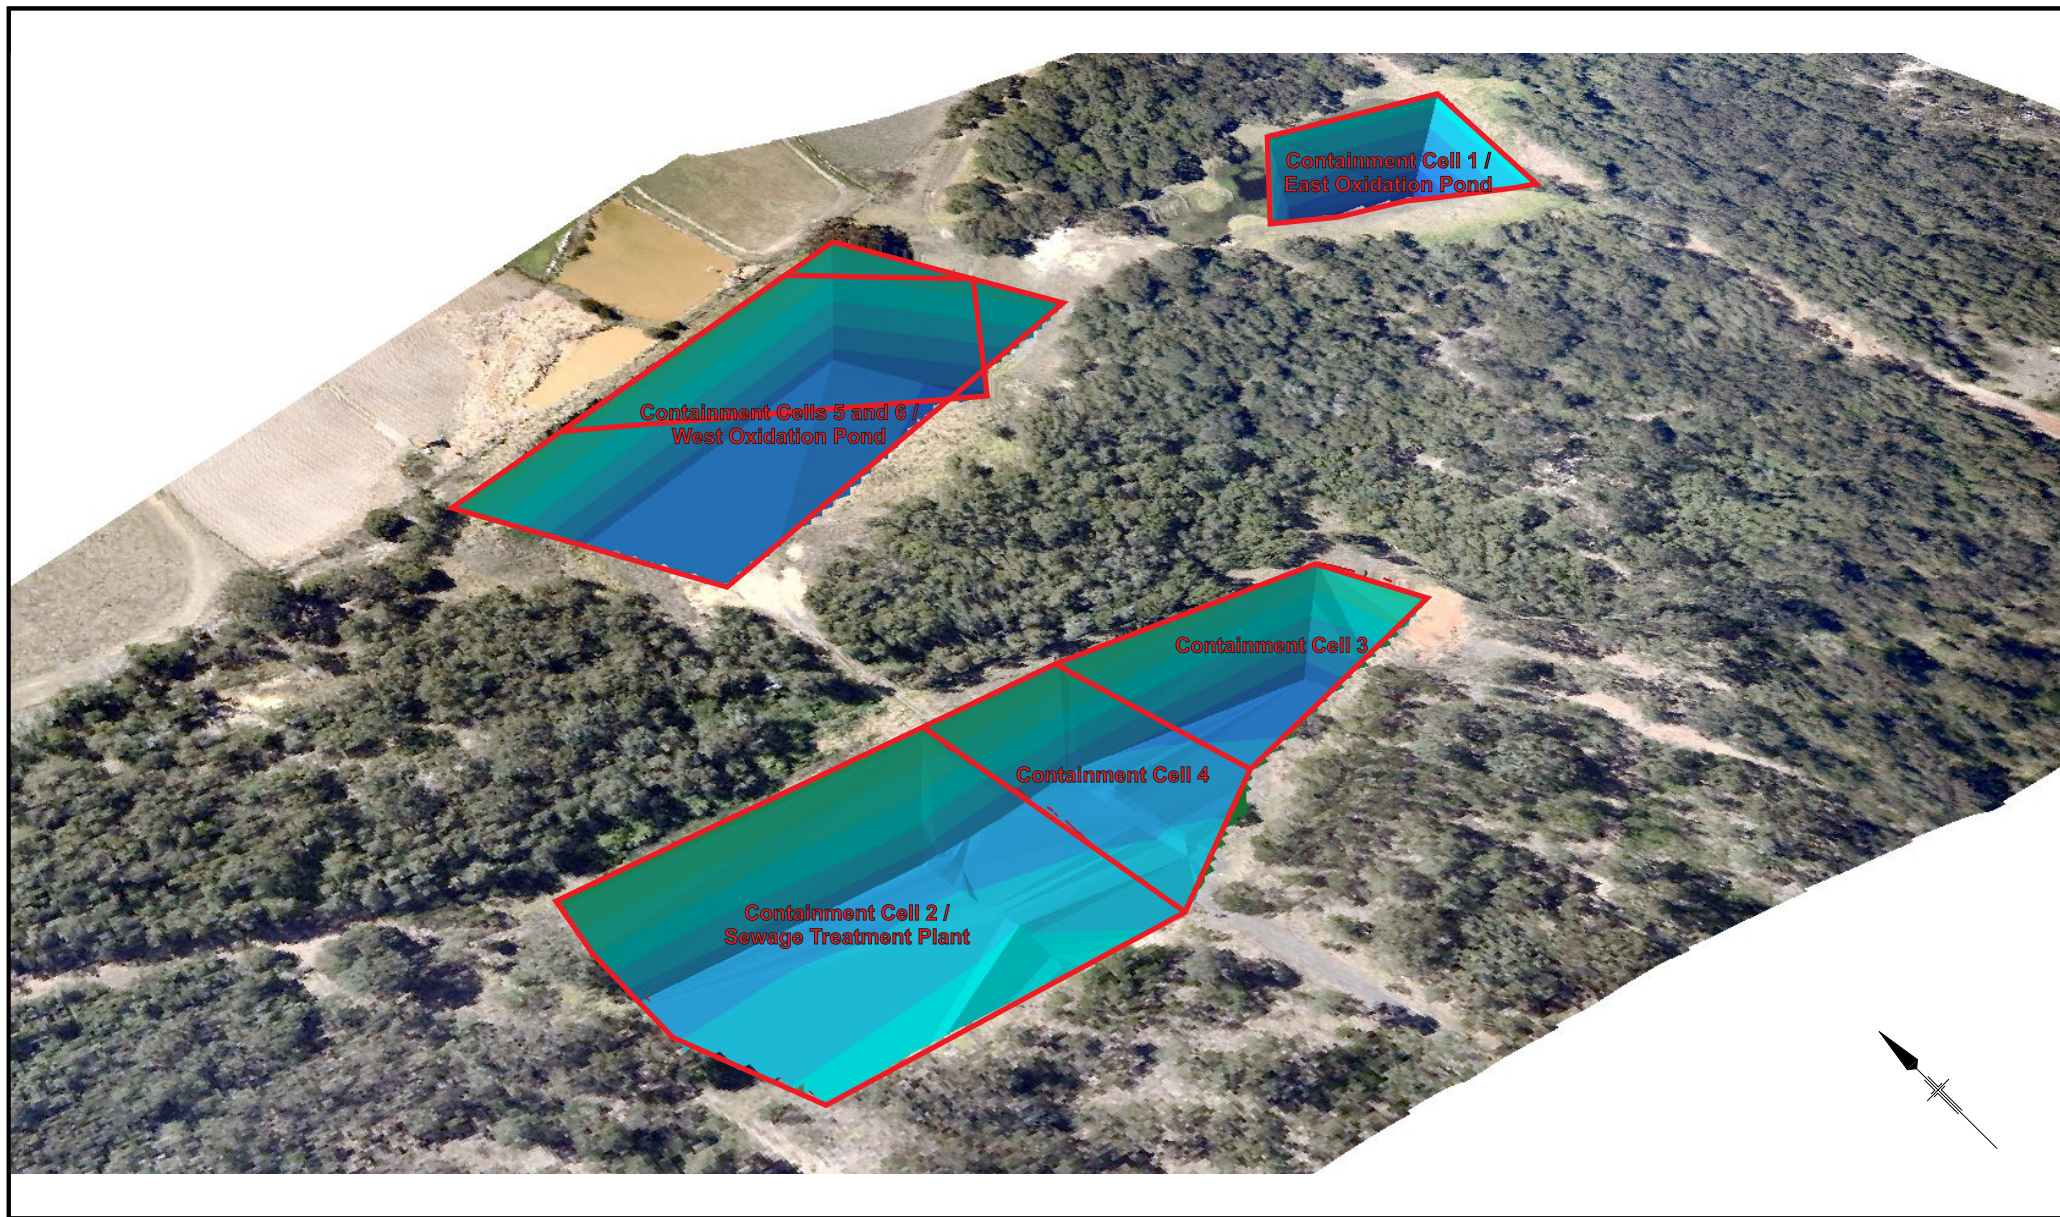
— Containment Cell Boundary
50m AHD

35m AHD
