PRELIMINARY ASSESSMENT OF MULDOONS QUARRY  
KELSO NEW SOUTH WALES  
FOR CONTAMINATION  
MARCH 2005  
CENTRAL WEST ENVIROTECH  
LABORATORY REPORT

Prepared for:	Gary Sloan Slobobax P/L c/- Bruce Bolam 243 Keppell Street BATHURST NSW 2795
Submitted by:	Central West Envirotech Level 1, 202 Anson Street PO Box 2519 ORANGE NSW 2800
Project Manager:	J.D. Milson, B.Sc.(Hons), M.Sc.Agr.
Date submitted:	2 <sup>nd</sup> July 2005
Reference protocol:	0512GS March 2005
Report number:	0512GS

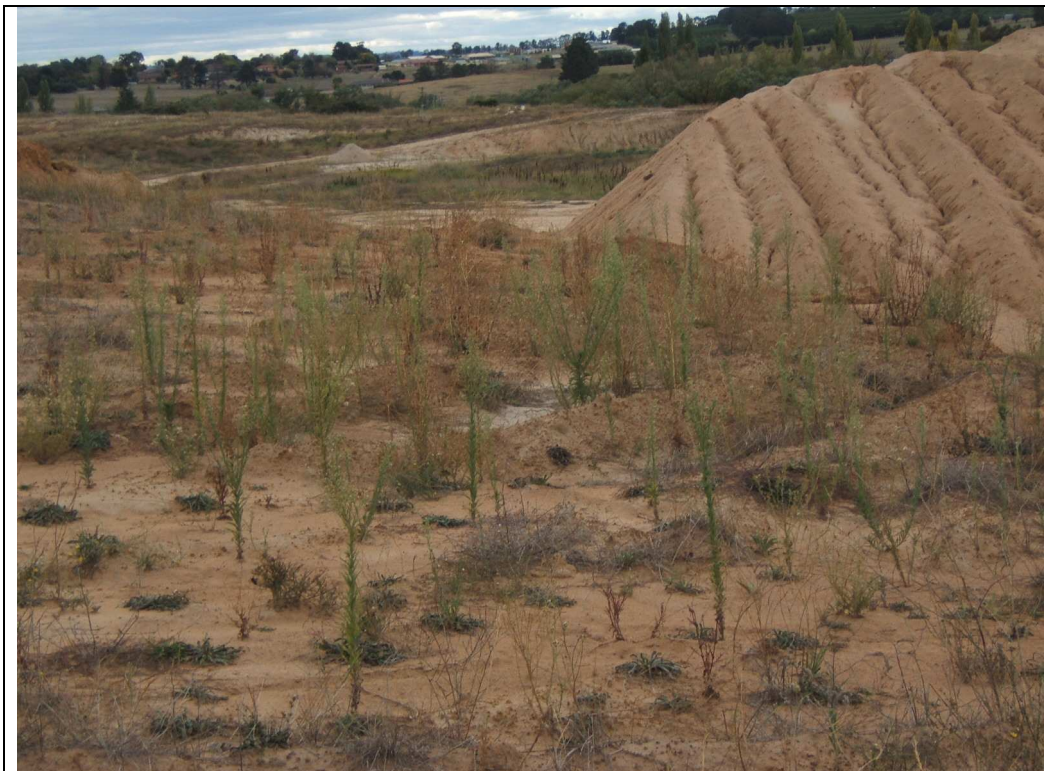
**Figure 1** Kelso Gravel Quarry SE corner. View NW toward Kelso

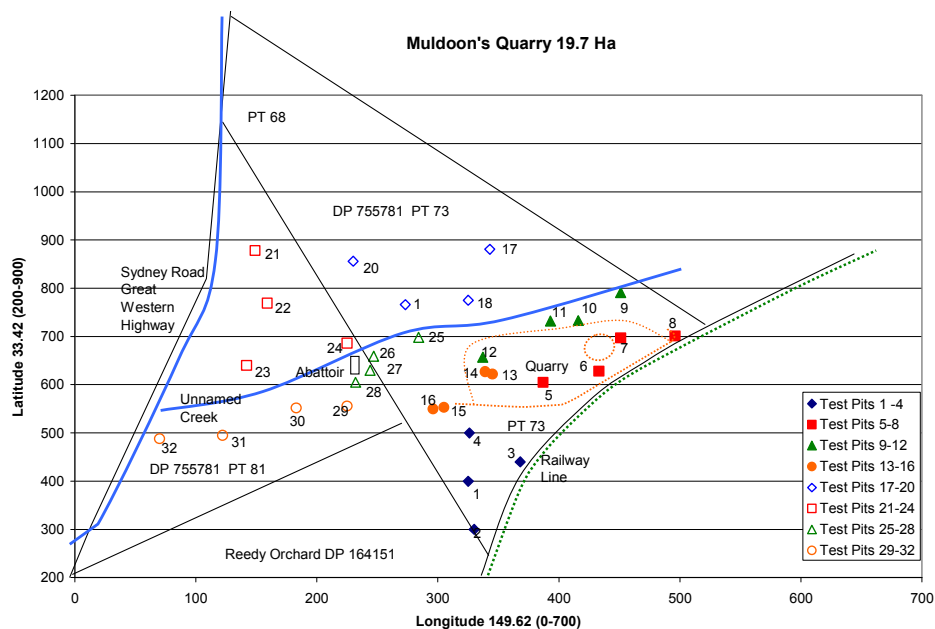
**Figure 1 Sampling Points in D. P. 755781 – Muldoon’s Quarry**

Two samples from a depth of about 2.6 m at test pits 1 and 14 were analysed for hydrocarbons and eight heavy metals. The soil pits were excavated in a loose grid formation. The location of each test pit is shown in Figure 1, and the composite sample locations ( 1:25 000 topographic map) summarized in Table 3.

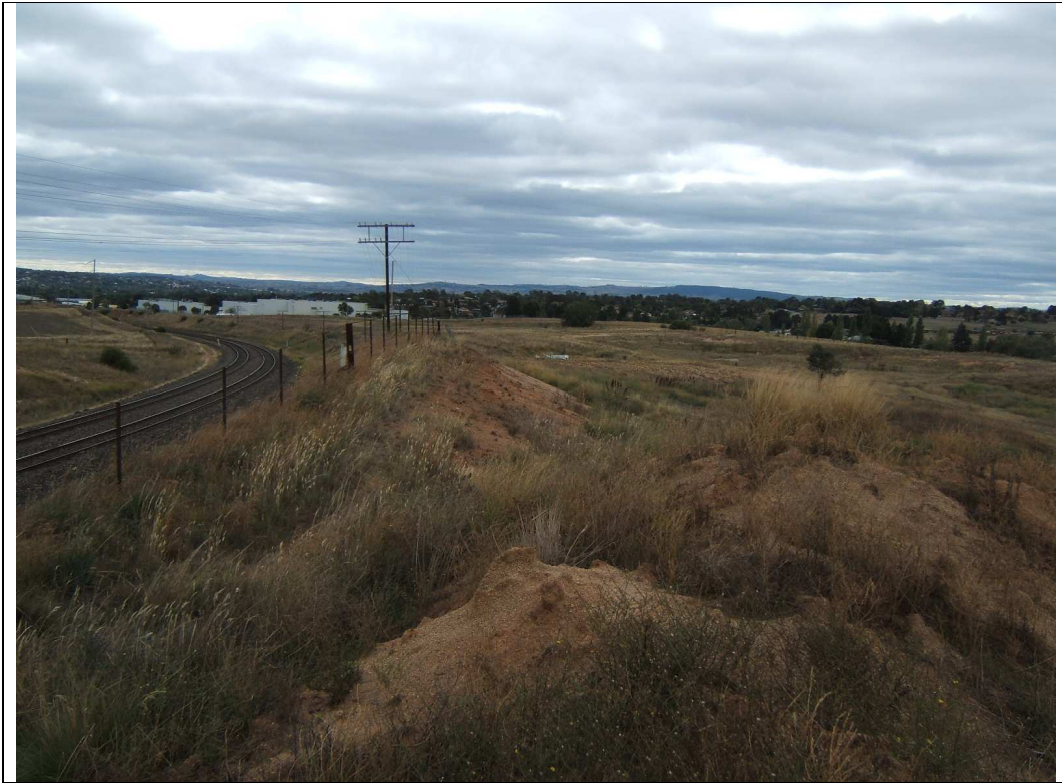
**Figure 2** View of south boundary showing vegetation on disturbed soil

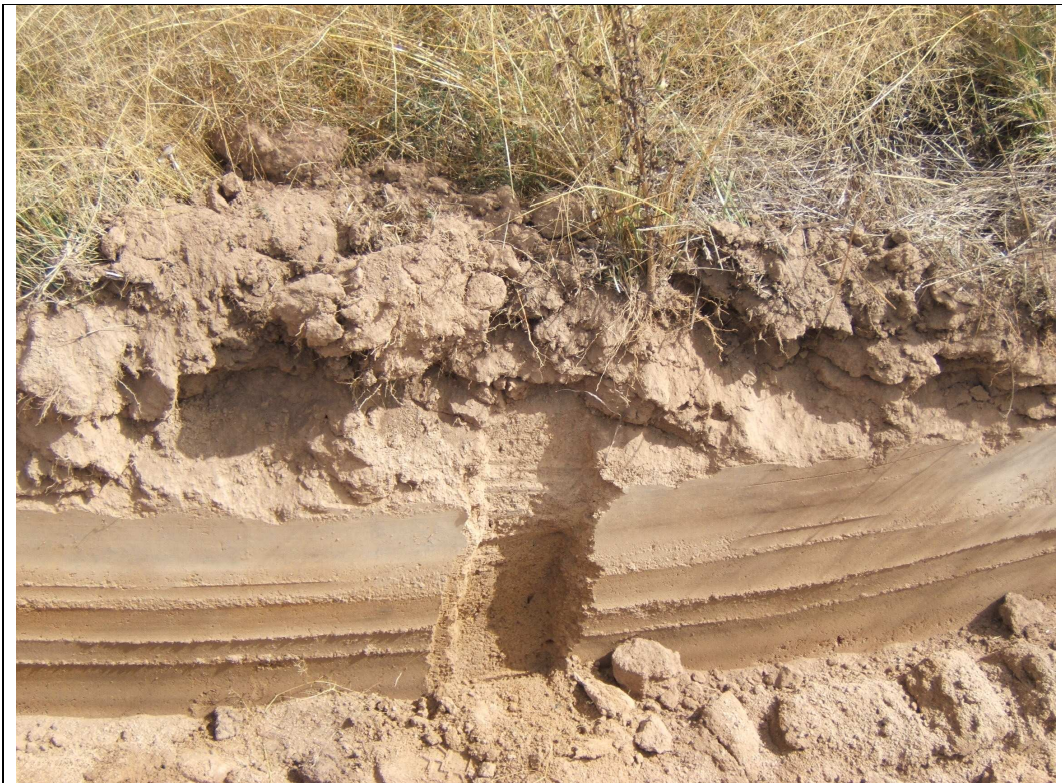
The greyish brown, brown and yellowish brown soils encountered were indicative of yellow solodic and non-calcic brown soils typical of the Bathurst and neighbouring Raglan soilscapes. The reddish brown soil on higher ground to the west was typical of red solodic soils, also present in these soilscapes.

**Figure 4** Test pit from east side of the central Unnamed Creek upslope showing shallow sandy profile above weathered granite (Test pit 20)

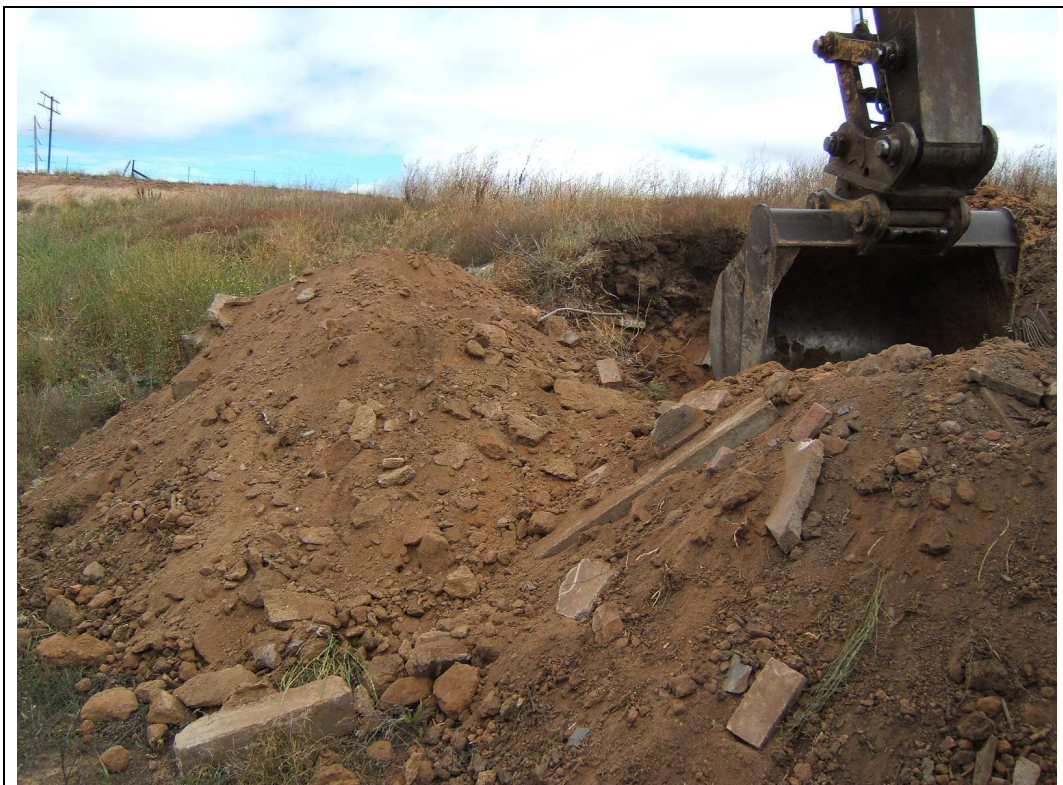
isobutylene equivalents was obtained for blue-grey (stained) heavy clay at a depth of 2 – 2.5 m in test pit 1. A sample from this test pit (01/2.6) was submitted for hydrocarbons and heavy metals analysis.

Test Pit 1, as mentioned earlier was found to have a hydrocarbon signature, but analysis for benzene, ethylbenzene, toluene and xylene (BTEX), total petroleum hydrocarbons (TPH) and heavy metals showed no significant residues at 2.6 m depth. This pit was associated with concrete and brick rubble, but fill soil samples were not excessively saline or alkaline. A check pit excavated 5 m further east did not reveal further hydrocarbon contamination.

**Figure 5** Test Pit 1 – Concrete and brick rubble underlain by fuel-stained soil

**Recommendation: Mechanical turning of soil from Pit 1 during soil works to increase aeration facilitating further reduction in hydrocarbon residues.**

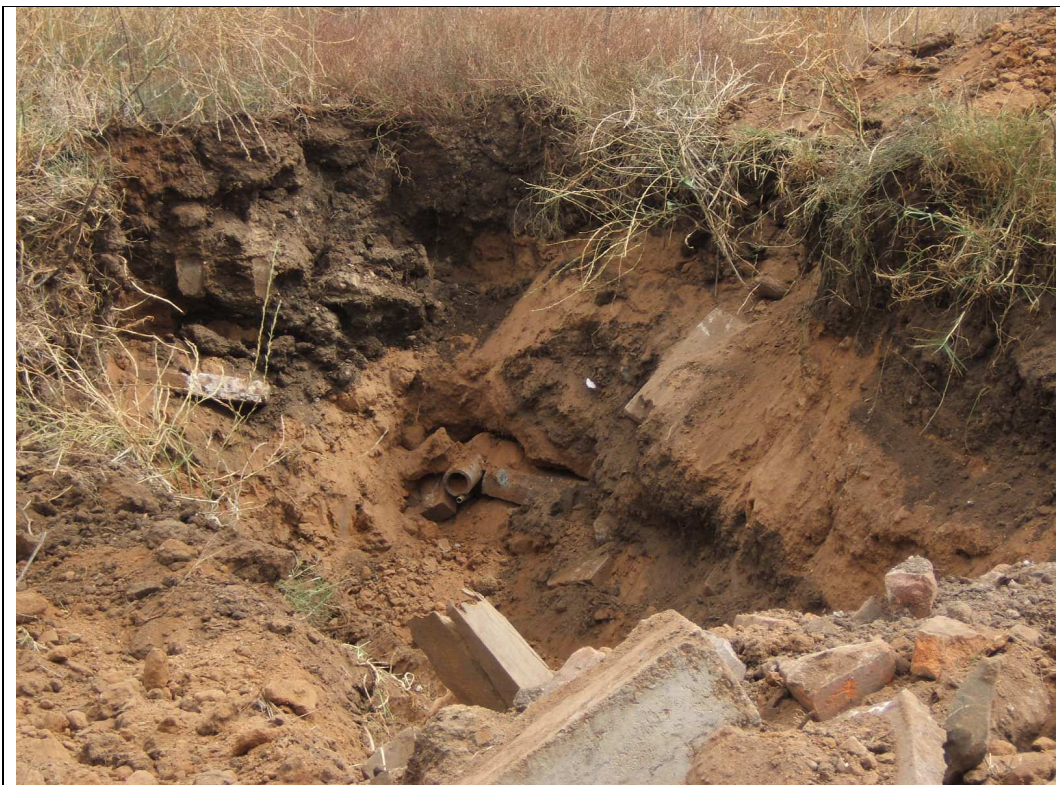
**Figure 6** Test Pit 5 had multiple fill layers. Debris included asbestos pipe

A contaminant of concern is asbestos, as pipe and sheet fragments were detected in Pits 5 and 6. If the area circumscribed by the five pits is uniformly contaminated with asbestos, the issues of inhalable fibres becomes more significant. Since the fill is heterogeneous, poorly compacted and mixed with formwork, wood and roots, excavation is likely to increase the risk of fibre generation if coarse sources are pulverized.

**Recommendation: Collect representative soil samples of profiles with evidence of asbestos. Analyse the sub-samples for asbestos fibres.**

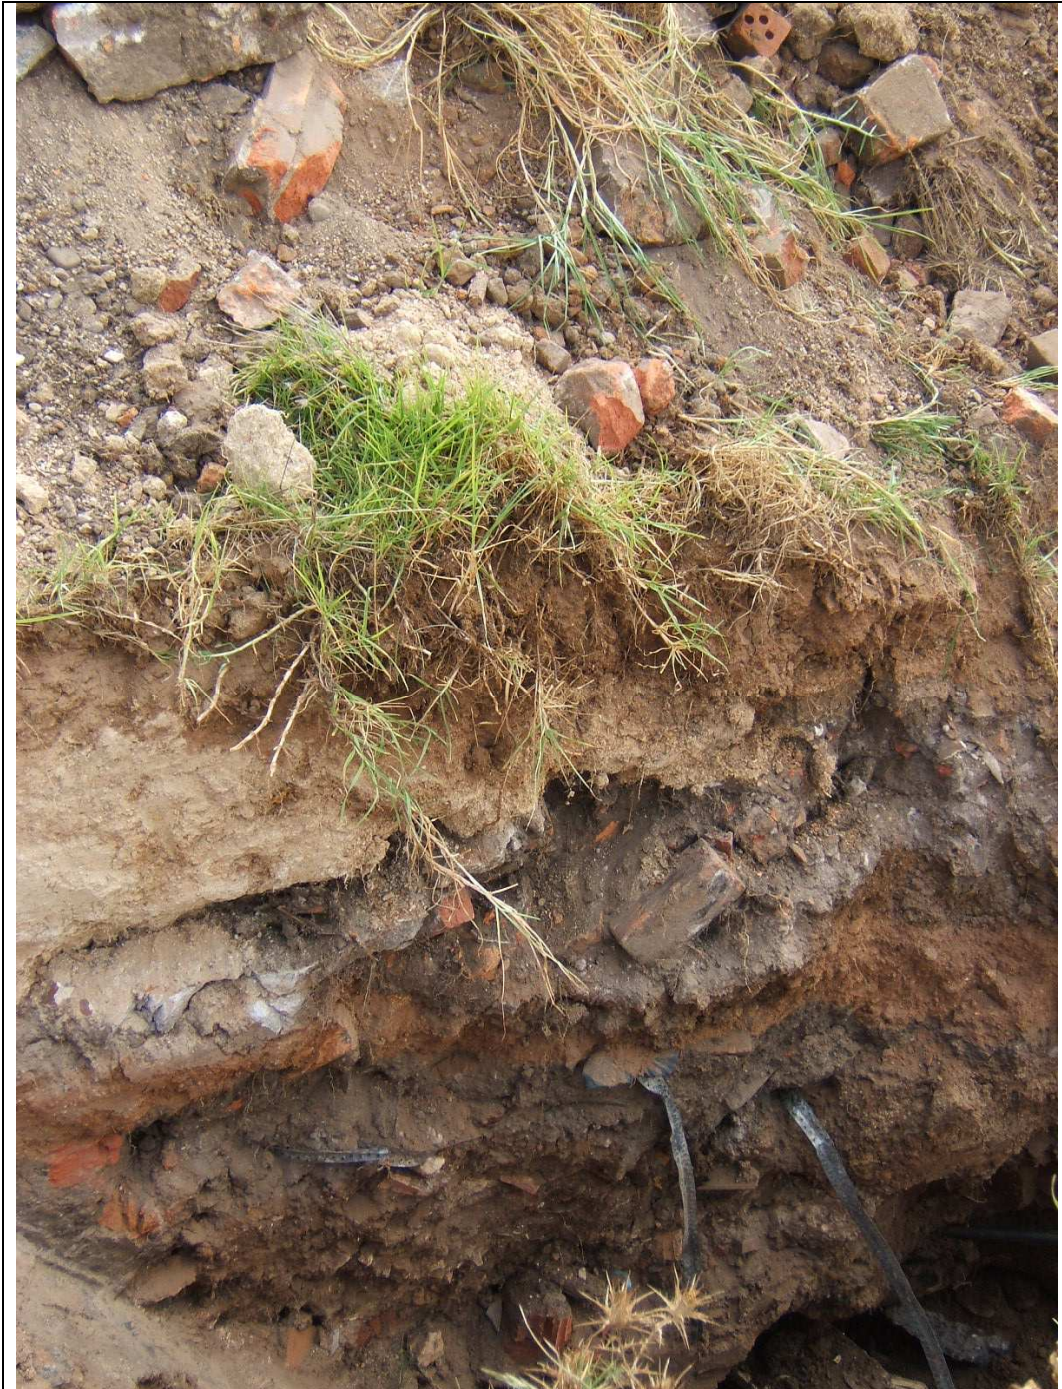
Six pits (1, 5, 6, 7, 12 and 14 ) were associated with significant amounts of introduced fill that contained building materials that were remnants of demolition: bricks, concrete, asbestos sheet and pipe, copper and plastic pipe, plastic bags and strapping. Specific details are listed in the Test Pit logs in Appendix 7.4.

**Figure 7** Test Pit 7 showing multiple soil and fill layers

**Recommendation: Test Pit 5, 6, 7, 12 and 14 soil for heavy metals.**

**Recommendation Assess volume of fill; quantify compaction; design removal or remediation strategies**
