**PRELIMINARY ASSESSMENT OF REEDY'S ORCHARD
KELSO NEW SOUTH WALES
FOR CONTAMINATION
APRIL 2005
CENTRAL WEST ENVIROTECH
LABORATORY REPORT**

Date submitted: 4th July 2005

Report number: 0513GS

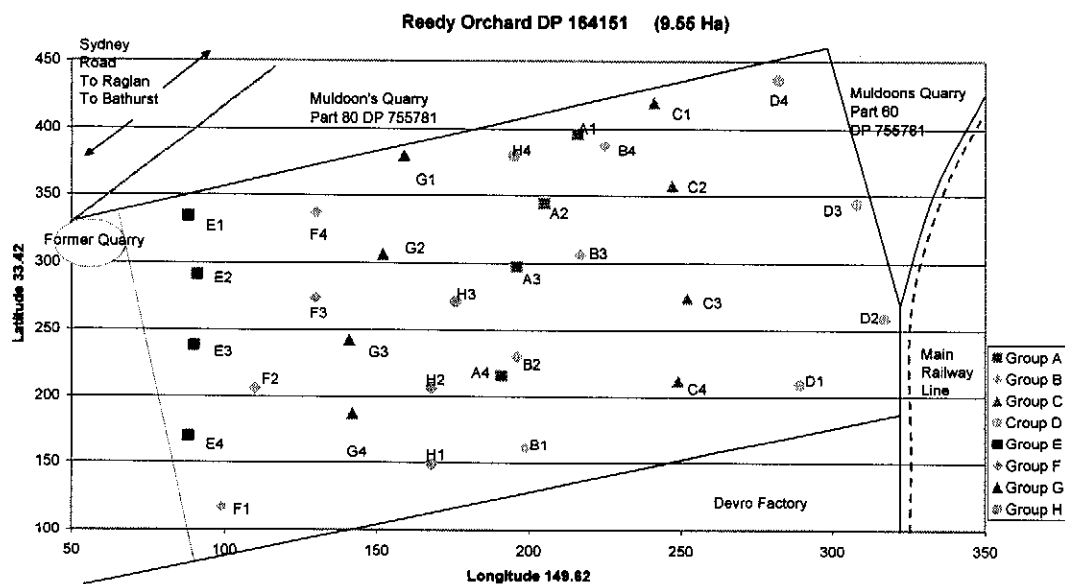
Figure 1 Sampling Points in D. P. 164151 – Reedy's Orchard

At the time of conduct of the study, the land of DP 164151 was vacant agrarian land, predominantly vegetated with introduced perennial grasses and broad leaf weeds. Four remnant fruit trees were located centrally at G3 and H2 (see Map).

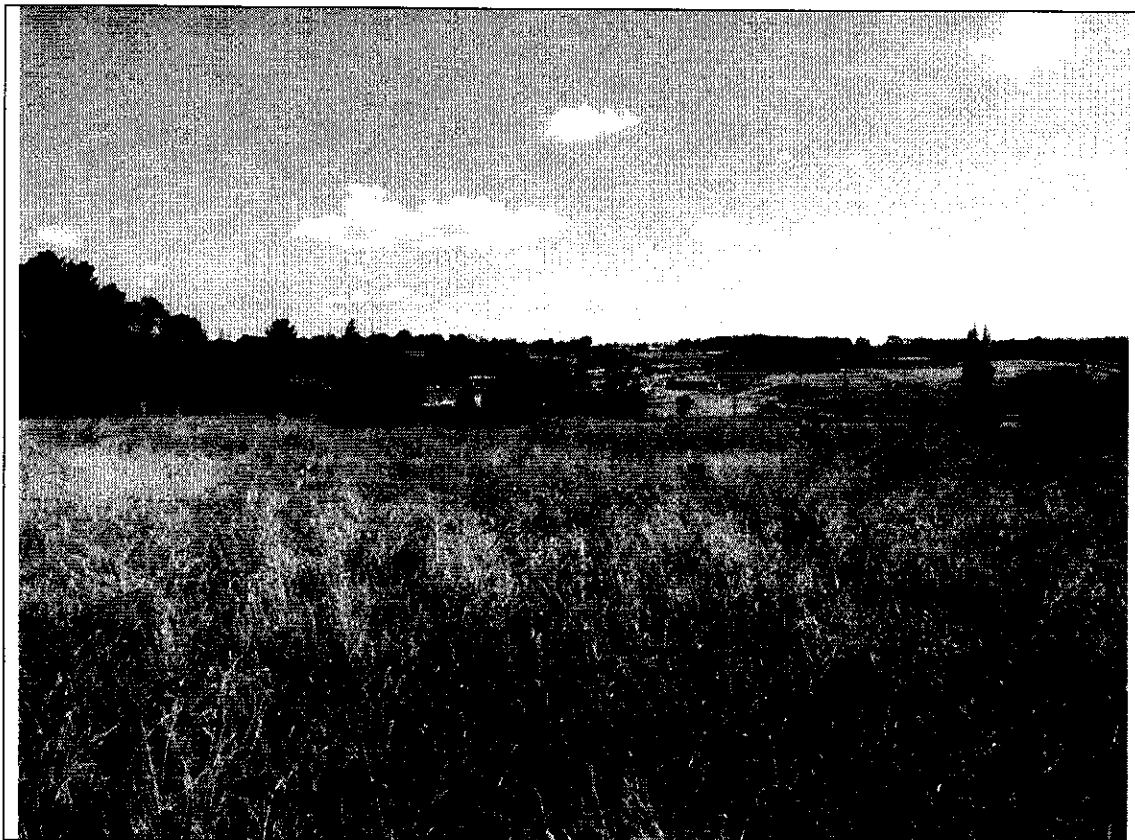
Figure 2 Former Reedy's Orchard View North West to Packing Shed

A retail fruit outlet and storage shed occupied the Sydney Road Frontage at the north west corner of the site. Three residential blocks also abutting with Sydney Road were situated on the north east side of the site adjacent to a small former quarry, which occupied the north east corner of the site.
