HUTCHINSON BUILDERS PTY LTD

**CASUARINA BEACH
NORTH PRECINCT**

DETAILED SITE INVESTIGATION REPORT

JOB NO: 7079/1-77

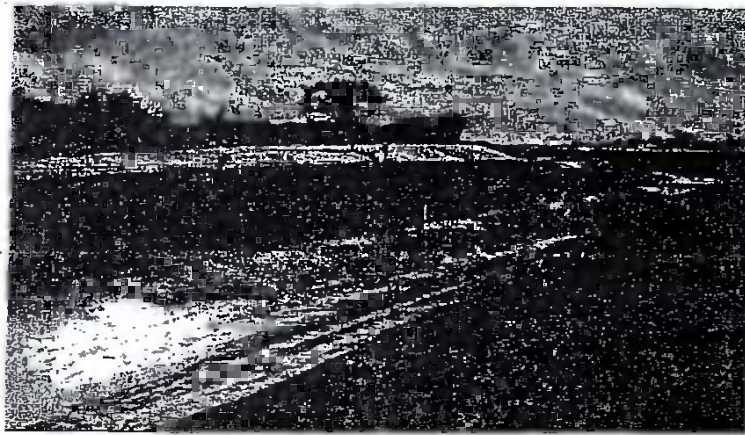
Photographic Illustration 5.1: Black mineral staining exposed in stormwater swale

Visual inspection confirmed black mineral staining in the base of the eastern swale being, outlet 11 in the north precinct, and extended along the swale for approximately 50 metres. The full extent of the black mineral sand could not be determined due to the mulching present on the swale embankments (Refer to Photographic Illustration 5.1). A small amount of mineral staining was also discovered on the adjacent lot to the north of the swale.

The black mineral sand observed in the stormwater infiltration basin is associated with naturally occurring radioactive materials and based upon the site history and the localised nature of the material, suggests that the area under investigation may have been used as a tailings dam generated from the former mineral sands processing activities in the area.

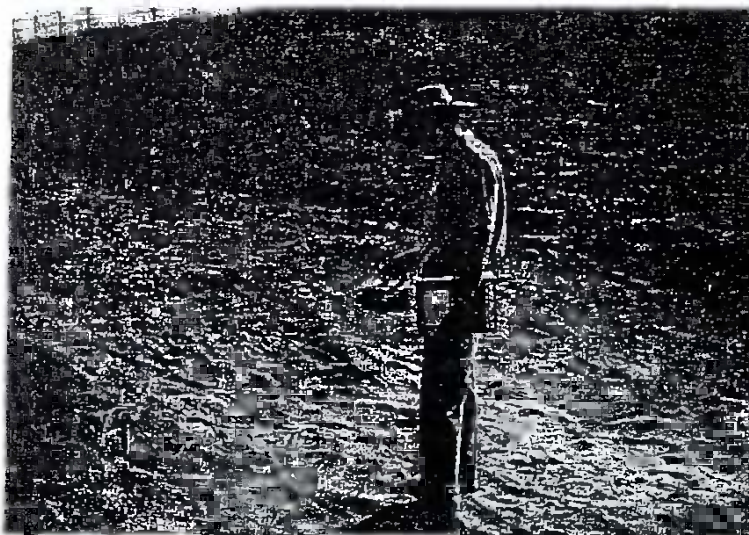
Photographic Illustration 5.2: Surface gamma radiation readings being taken.

The radiation survey was conducted using a calibrated Bicon Micro Sievert survey monitor to measure surface gamma radiation levels. Four transects were walked and gamma radiation surface levels were recorded at approximate 10 meter intervals. The surface radiation results are presented in Attachment II.
