Preliminary Geotechnical Investigation

PRELIMINARY GEOTECHNICAL INVESTIGATION

**PROPOSED WARNER INDUSTRIAL PARK
CORNER HUE HUE ROAD AND SPARKS ROAD
WARNERVALE**

PROJECT 41615
APRIL 2008

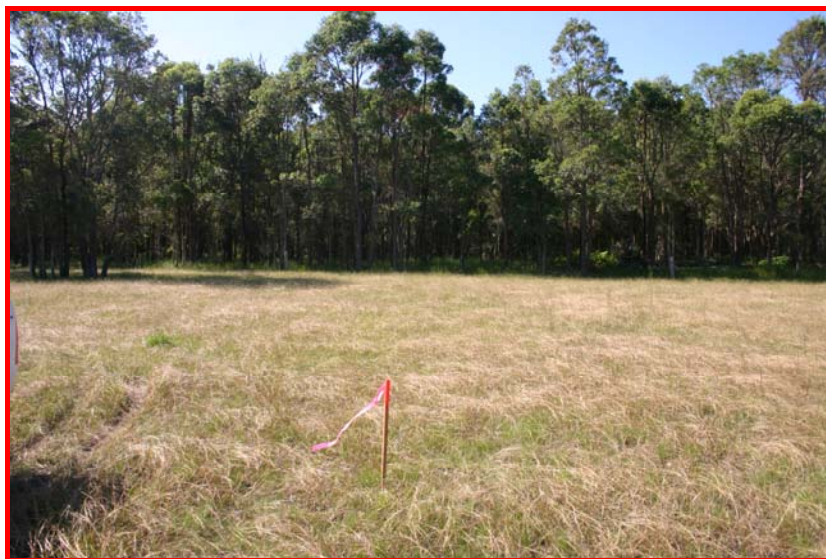
Photo 1 – Low lying cleared area in eastern section of Lot 18

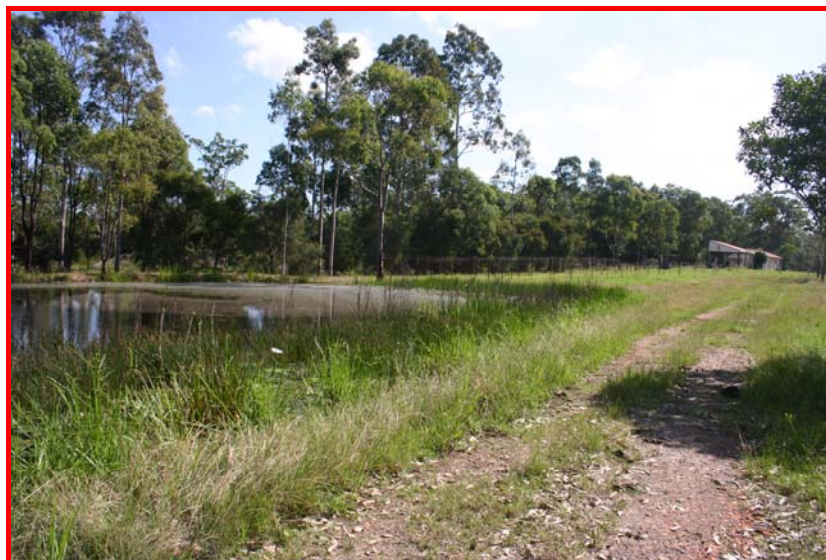
Numerous farm dams (in excess of twenty) are located throughout the site (refer Drawing 3). The majority of these have been formed by a combination of cut and fill operations and are in the order of 10 m to 30 m in diameter (refer Photo 4 below).

Photo 4 – Existing farm dam on Lot 19 in DP 259530, looking south-west

Any existing filling, such as encountered in Pits 6 and 6A and the filling platform in Lot 7, or the soils associated with the embankments or interior of the existing dams on the site should not be relied upon for support of structural loads and all foundations should be constructed to derive uniform support from the underlying stiff to hard natural clay, controlled filling or bedrock.

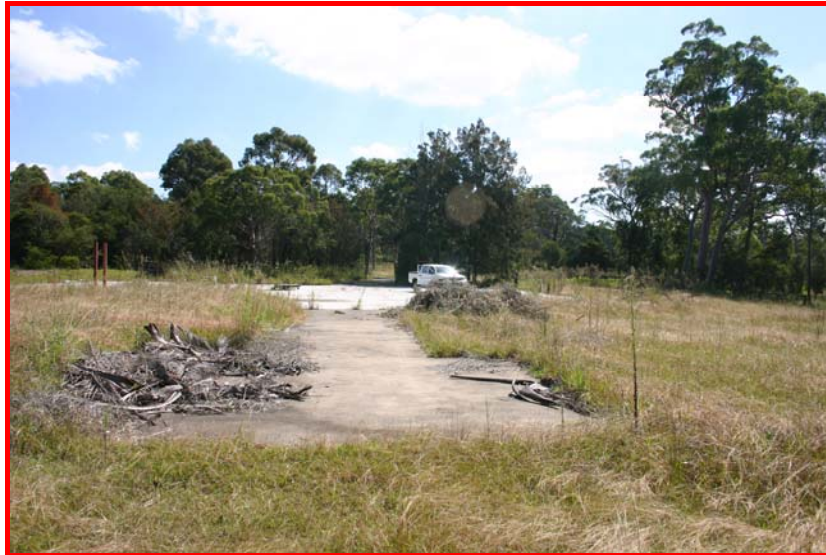
Other developments throughout the site include a former heli-pad in the south-eastern corner (refer Photo 5).

Photo 5 – Former heli-pad

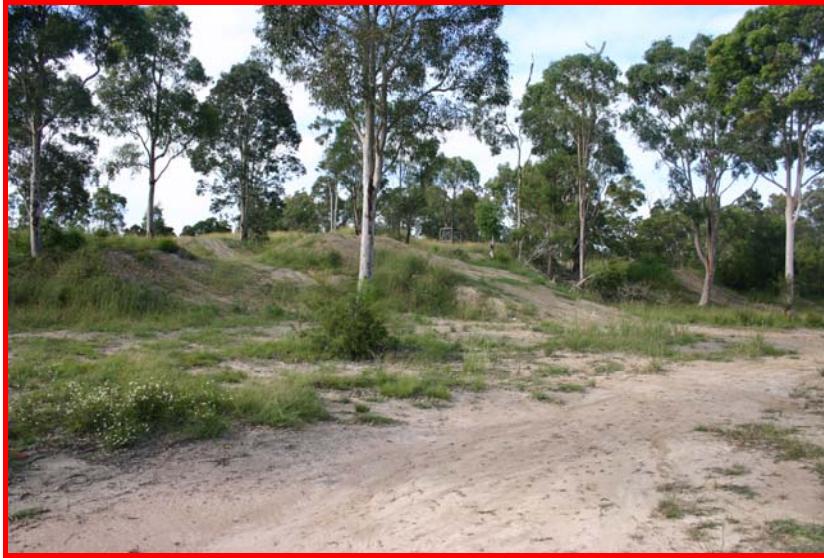
Photo 6 – Filling in south-eastern corner of Lot 5 (believed to be associated with construction of F3)

Filling platforms or stockpiles were observed in several areas throughout the site, including within the south-eastern corner of Lot 5 in DP259531 where filling, understood to have been won from excavations in connection with the construction of the F3 freeway, has been placed (refer Photo 6 below) and also surrounding a number of the existing residences, such as in Photo 7, located to the north of the residence in Lot 7. In absence of specific investigations of this filling, it is also considered unsuitable for the support of engineered filling, footings or pavements. Further assessment would be required to assess the suitability of the filling to either remain in place or for re-use as engineered filling elsewhere on site.

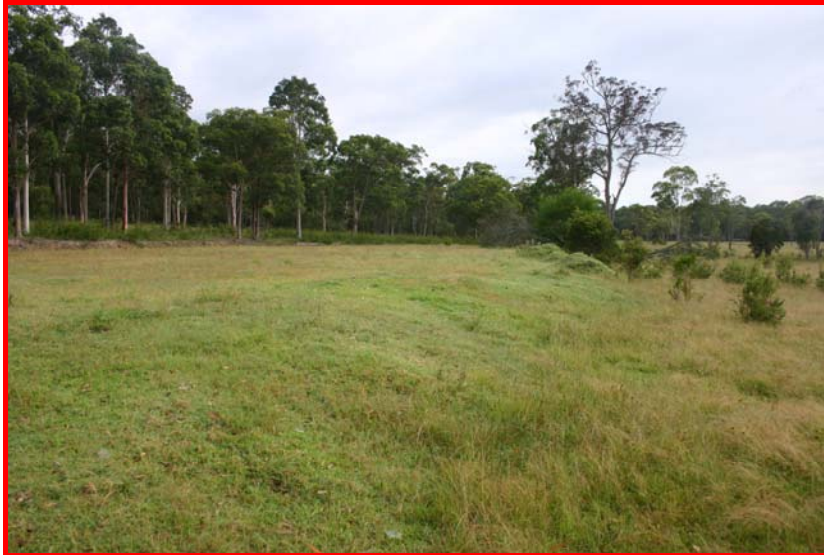
Photo 7 – Filling platform in Lot 7 – Looking north

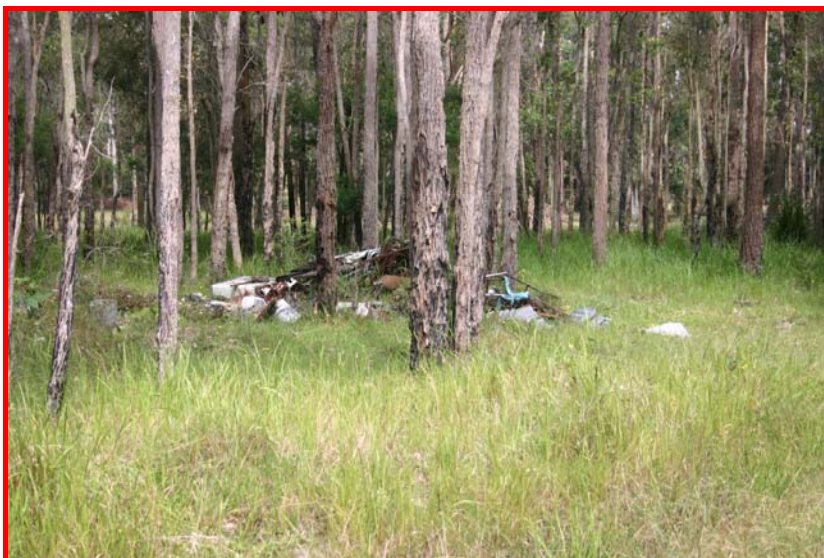
Photo 8 – Rubbish and filling scattered throughout the bush

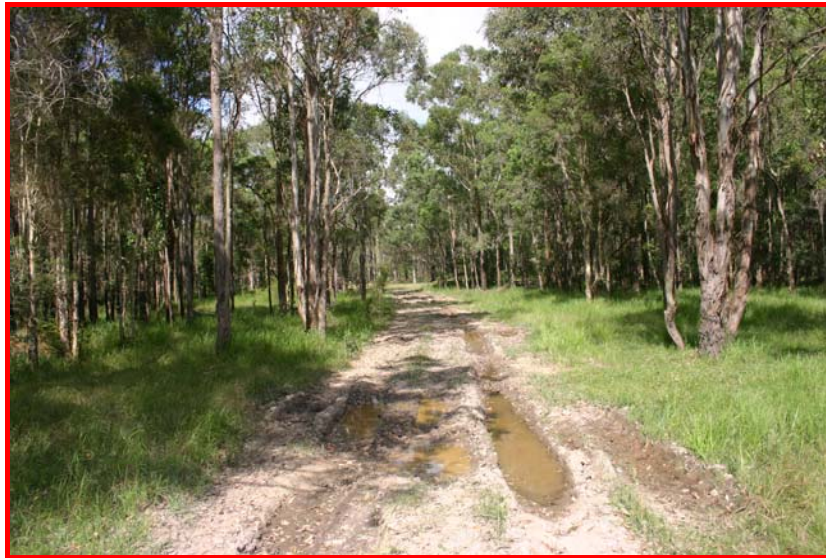
Photo 9 – Access track to former residence in Lot 4 – looking south

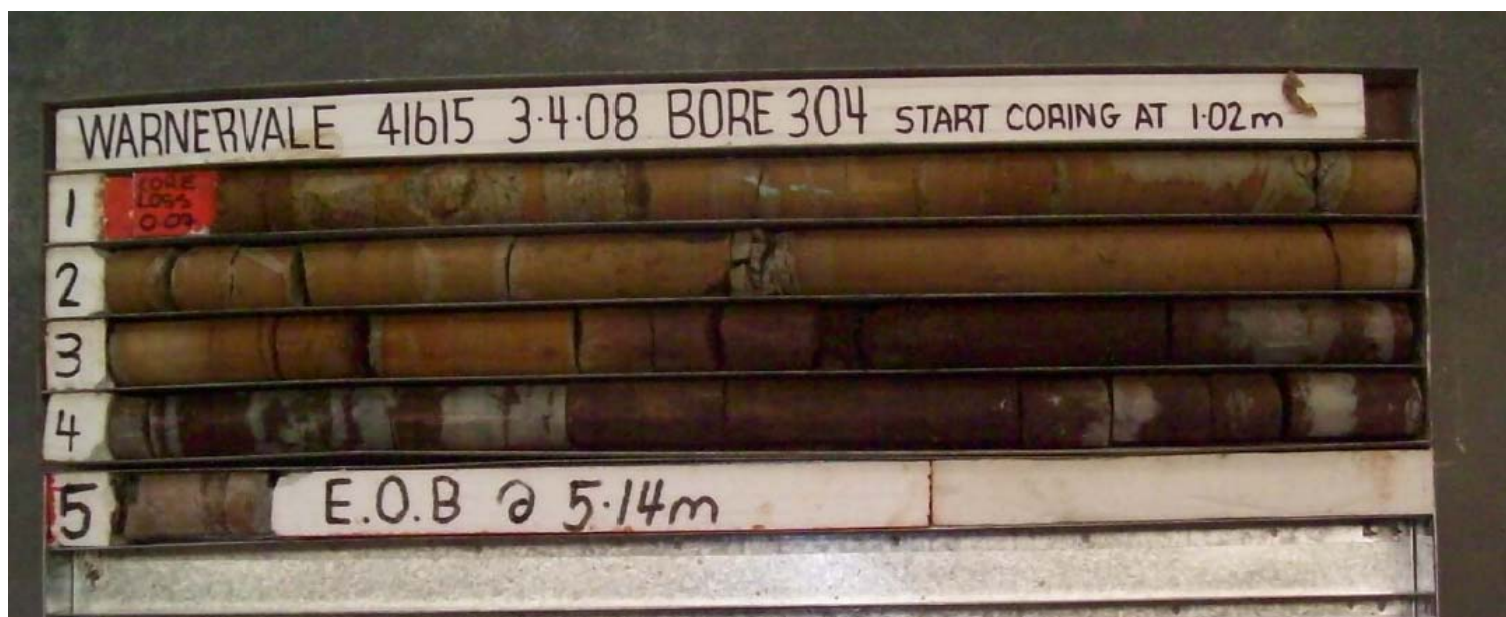
| Proposed Business and Industrial Park Warnervale | PROJECT: 41615 | Date April 2008 | PLATE 1 |

Bores 304 and 305 were drilled within the anticipated area of Hue Hue excavation. The conditions encountered in these bores included residual clayey sand and clay overlying either sandstone or claystone bedrock at a depth of 0.9 m and 3 m respectively. The strength of the bedrock retrieved in the cored section of Bore 304 ranged from extremely low to medium strength. Auger drilling within Bore 305 encountered v-bit auger tip refusal at 3.5 m depth, which may be indicative of low to medium strength bedrock, and tungsten carbide auger tip refusal at a depth of 4.8 m, which may be indicative of medium strength or stronger bedrock.

Bore 304 from 1.02 m to 5.14 m

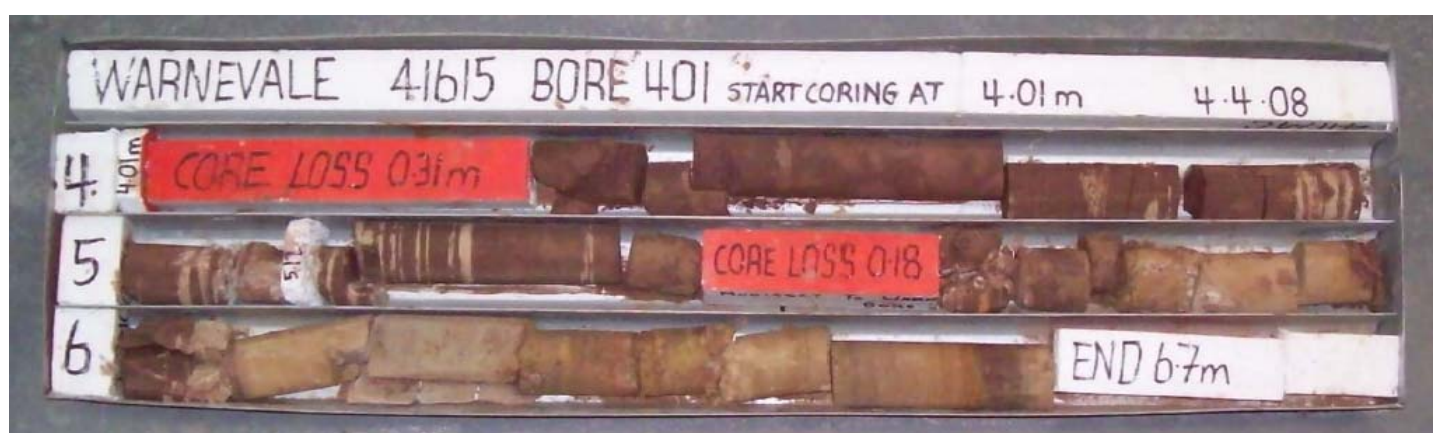
| Proposed Business and Industrial Park Warnervale | PROJECT: 41615 | Date April 2008 | PLATE 2 |

The results of the acid sulphate screening tests undertaken on samples retrieved from Bores 401 and 402 (refer Table 5), located adjacent to the banks of Buttonderry Creek indicated that acid sulphate conditions are not present within these soils.

Bore 401 from 4.01 m to 6.7 m
