Warner Industrial Park Concept Plan and Project Application

**REPORT
on
TARGETED PHASE 2
CONTAMINATION ASSESSMENT**

**PROPOSED WARNER INDUSTRIAL PARK
CORNER HUE HUE ROAD AND SPARKS ROAD
WARNERVALE**

***PROJECT 41615.01
May 2008***

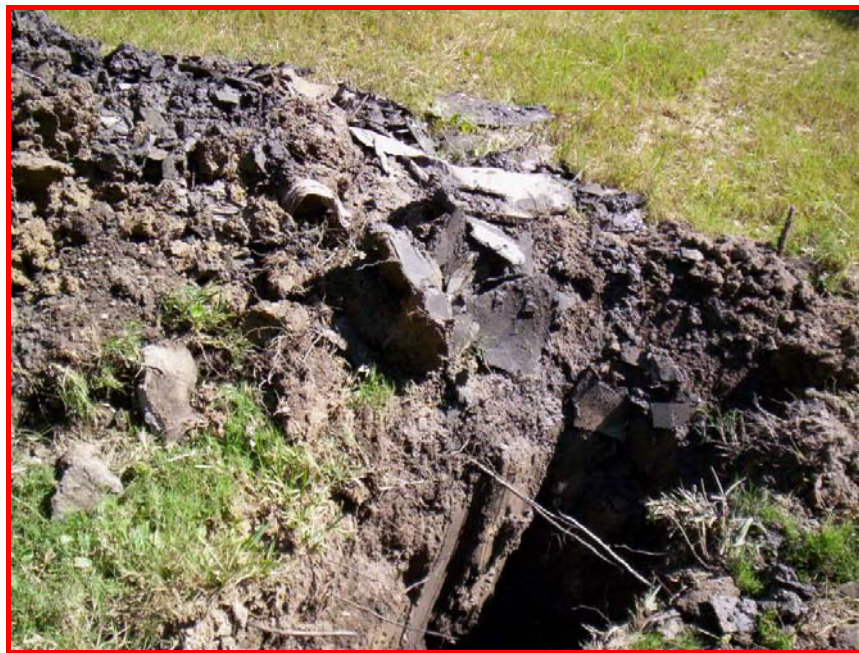
The filling encountered in Pit 6 and 6A is considered unsuitable under proposed building areas for the support of engineered filling, footings or pavements and should be removed and replaced. It is noted that fibrous sheeting was present within the filling. No testing for the presence of asbestos or chemical contaminants were undertaken in this area.

Photo 1 – Waste materials excavated from Pit 6

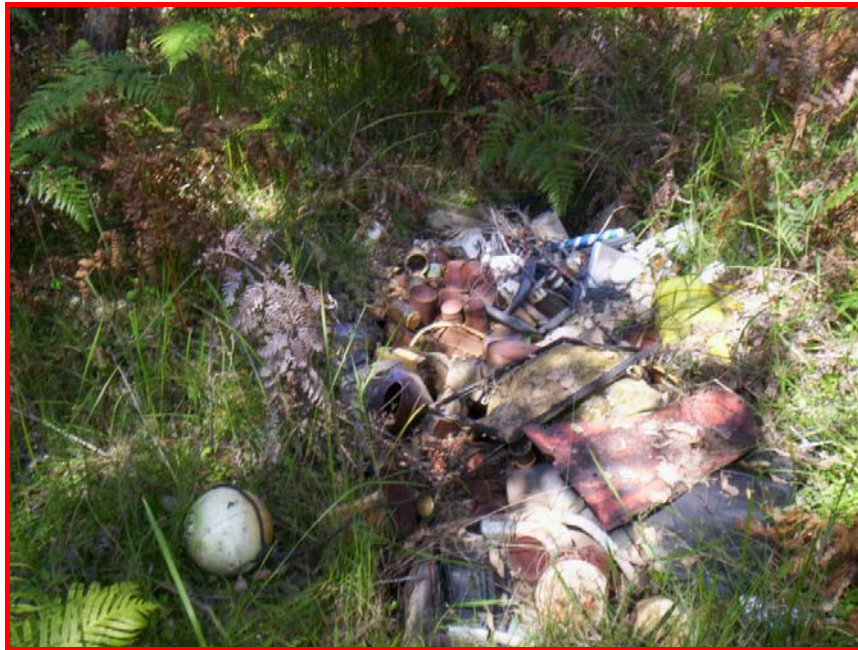
Partially buried waste materials were also noted in the vicinity of Pit 6 as shown in Photo 2.

Photo 2 – Partially buried waste materials located in the vicinity of Pit 6

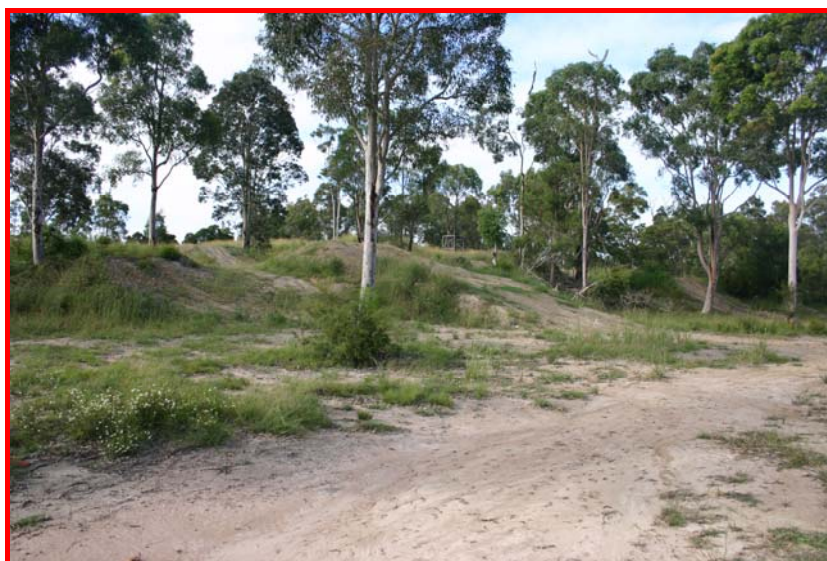
- Within the south-eastern corner of Lot 5 in DP259531 where filling is understood to have been won from excavations in connection with the construction of the F3 freeway has been placed (refer Photo 3 below);
- Surrounding a number of the existing residences, such as in Photo 4; and
- Scattered throughout the bush in numerous locations throughout the site (refer Photo 5).

Photo 3 – Filling in south-eastern corner of Lot 5 (believed to be associated with construction of F3)

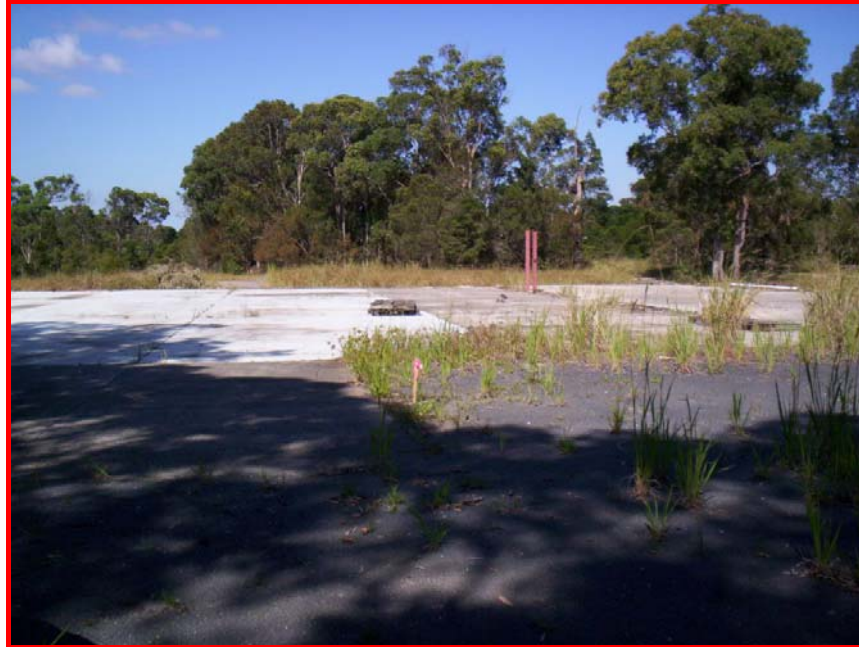
Visual inspection of the workshop area noted some minor staining of the concrete slab and some fibrous cement fragments, possibly containing asbestos, scattered near the edges of the concrete slab.

Photo 6 – Former “Heli Aust” operations, Pit 103 located in the foreground

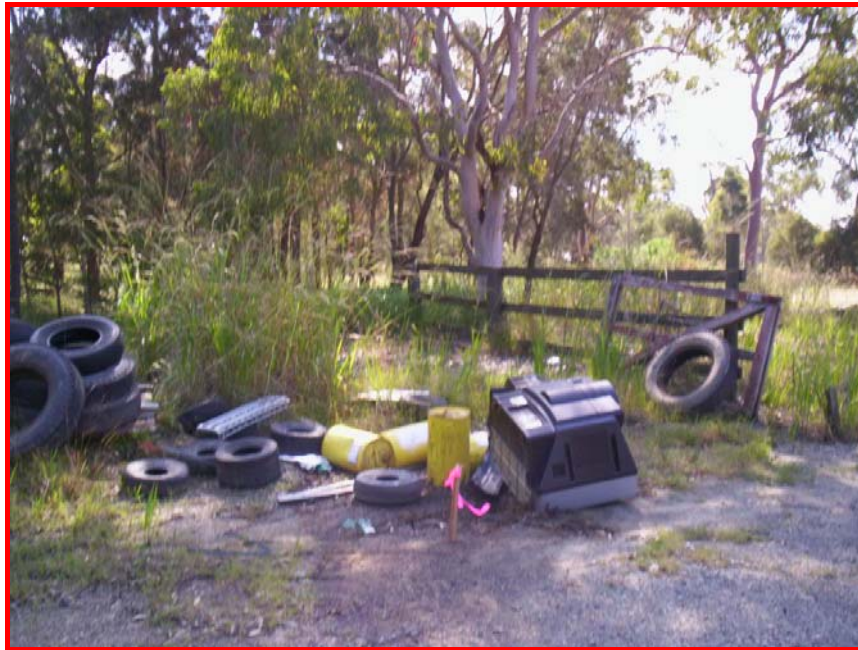
No significant soil odours or elevated PID results were noted at any of the investigation locations with PID results ranging between 0.0 – 0.3 ppm, although surface staining was noted in the vicinity of Pit 102 adjacent to “fly tipped” drums labelled as turbine oil. With the exception of waste materials encountered in Pit 108, no significant signs of deleterious inclusions were noted in the filling. Minor inclusions observed included clay roof tile fragments at the ground surface in Pit 101 and a single piece of timber and metal in the filling at Pit 103. Groundwater seepage was not encountered in any of the CA pit locations, with the exception of Pit 108 where some seepage was encountered within the filling at a depth of 1.3 m. This seepage was thought to be related to the inclusions within the filling below 1.3 m and also the proximity of the pit to the nearby dam.

Visual inspection also identified some recent fly tipping comprising tyres, televisions and partially filled oil drums. Some staining of the surface soils was observed in the area surrounding the oil drums. Other, recent fly tipping comprising generally soils was observed between Sparks Road and the former workshop.

Photo 7 – Fly tipping (including drums containing turbine oil), Pit 102 located in the foreground

In summary, based on the conclusions of the PLCA (Ref 1) and the Target Phase 2 Contamination Assessment the “Warner Industrial Park” site is considered to be generally compatible with the proposed industrial land use on the proviso that the “data gaps” identified are further assessed and remediated (if required) and also the areas found to be contaminated (i.e. Pit 102 & Pit 108) are remediated and validated.

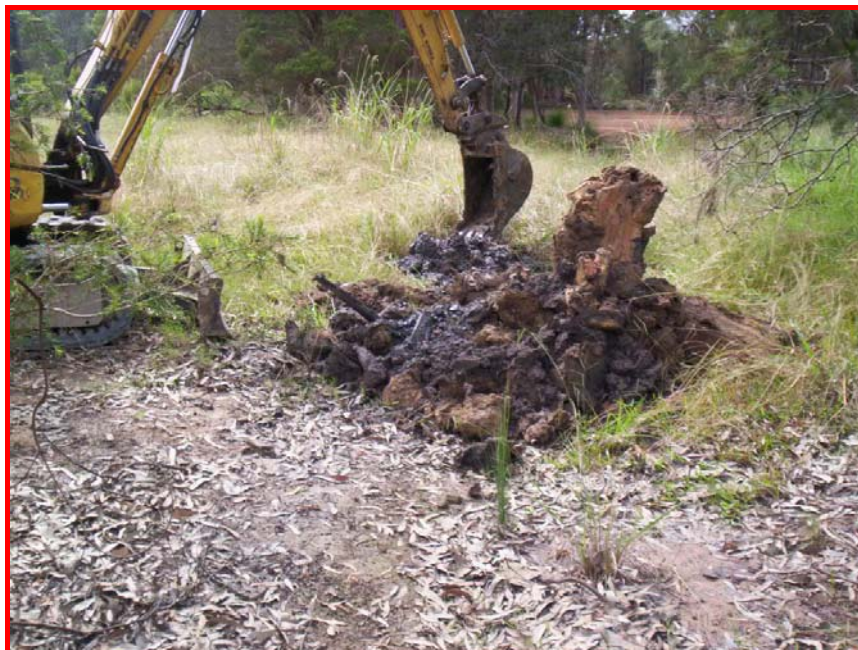
With respect to the CA, soil/sediment chemical contaminant levels were generally low, with levels less than the health-based assessment criteria for commercial/industrial land use (Ref 7 & 8) with the exception of TRH C₁₀ – C₃₆ concentration encountered in the surface soils at Pit 102 (sample ID 102/0.1). The pit was positioned adjacent to drums labelled as turbine oil and also corresponded to an area of surface staining. No asbestos was detected in any of the soil samples tested as well as in the fibrous cement building material fragment collected from materials scattered across the workshop slab. The fibrous cement fragment (sample ID 108/FC) encountered in the filling in Pit 108 at a depth of 1.5 m was reported to contain asbestos fibres.

Photo 8 – Waste materials excavated from Pit 108

With the exception of Pit 108 and the gravel inclusions at the ground surface in some of the pits no signs of deleterious inclusions were observed. Pit 108 encountered a clayey silt filling mixed with waste materials including fibrous cement pipe fragments, possibly containing asbestos, timber, rail ballast and plastic to the maximum depth of the pit (1.7 m).

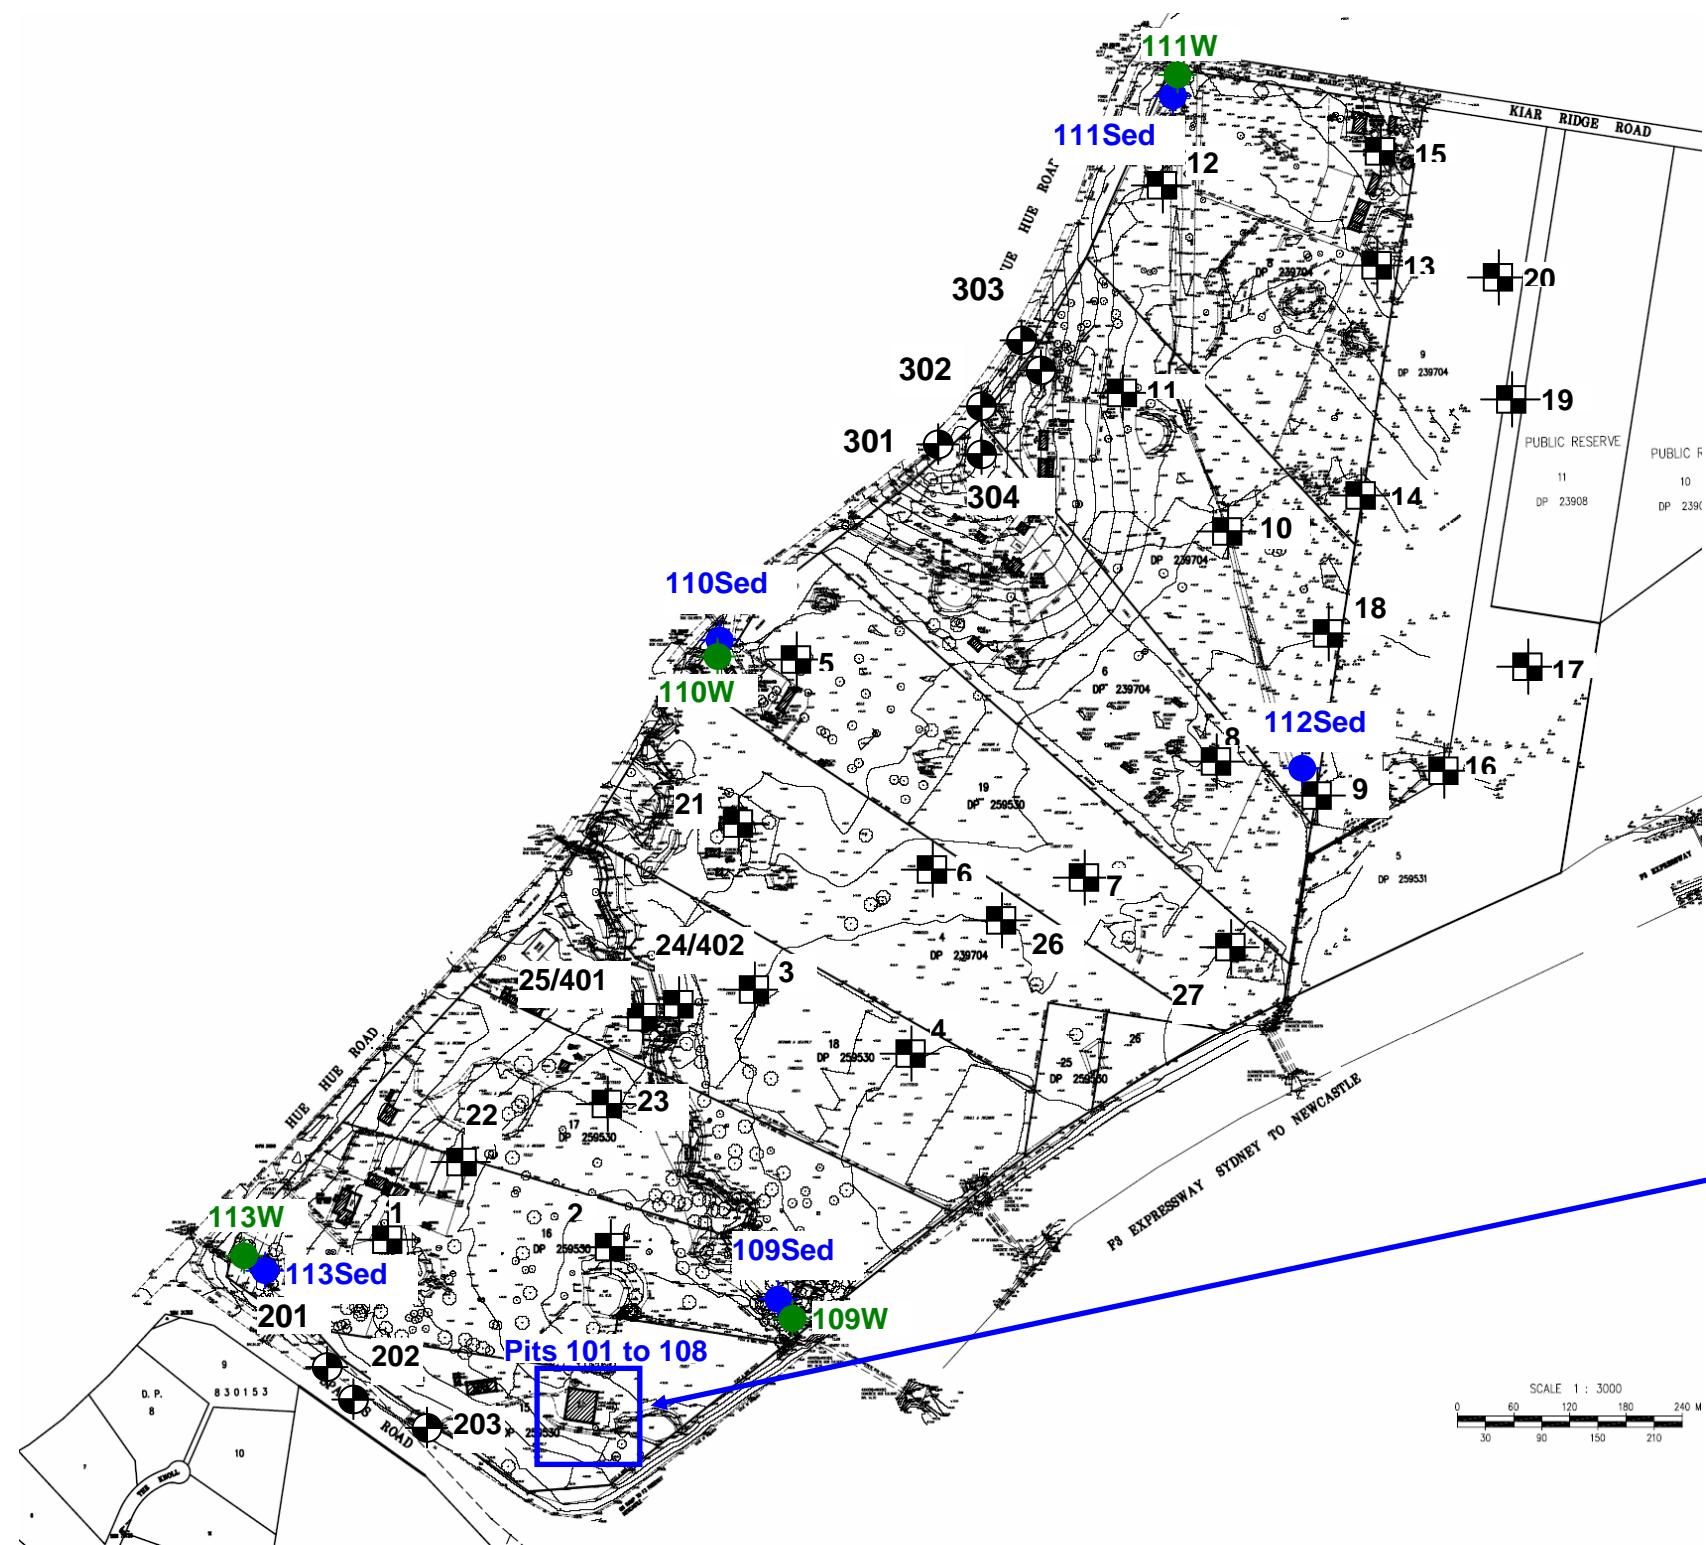
APPROVED BY: KERRY DATE: MAY 2008 DRAWING No: 1

1. Test locations are approximate only and are shown with reference to existing site features.
2. Drawing adapted from plan provided by Trehy Ingold Neate & Aerial Photograph sourced from Google Maps Web Site
