Statement of Environmental Effects

Remediation of Fig Tree Park Stage 2

Marina Precinct, Honeysuckle

June 2006

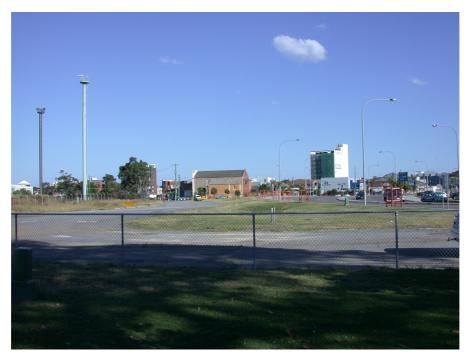
Photo 1: Southern perspective of site.Fence in foreground delineates Stage 1 from Stage 2.

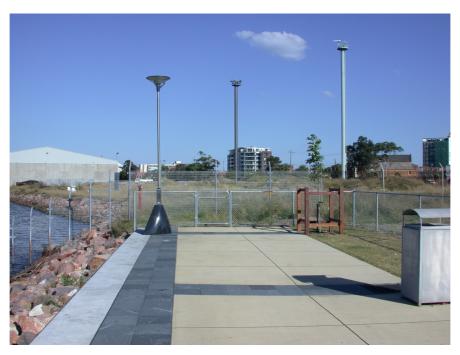
Photo 3: Southern Perspective. Showing promenade and Throsby Shed in background.
