Tallawarra Lands Concept Plan
Approval Modification

Geotechnical Considerations

Tallawarra Concept Approval
Modification

Prepared for
Bridgehill (Tallawarra) Pty Ltd

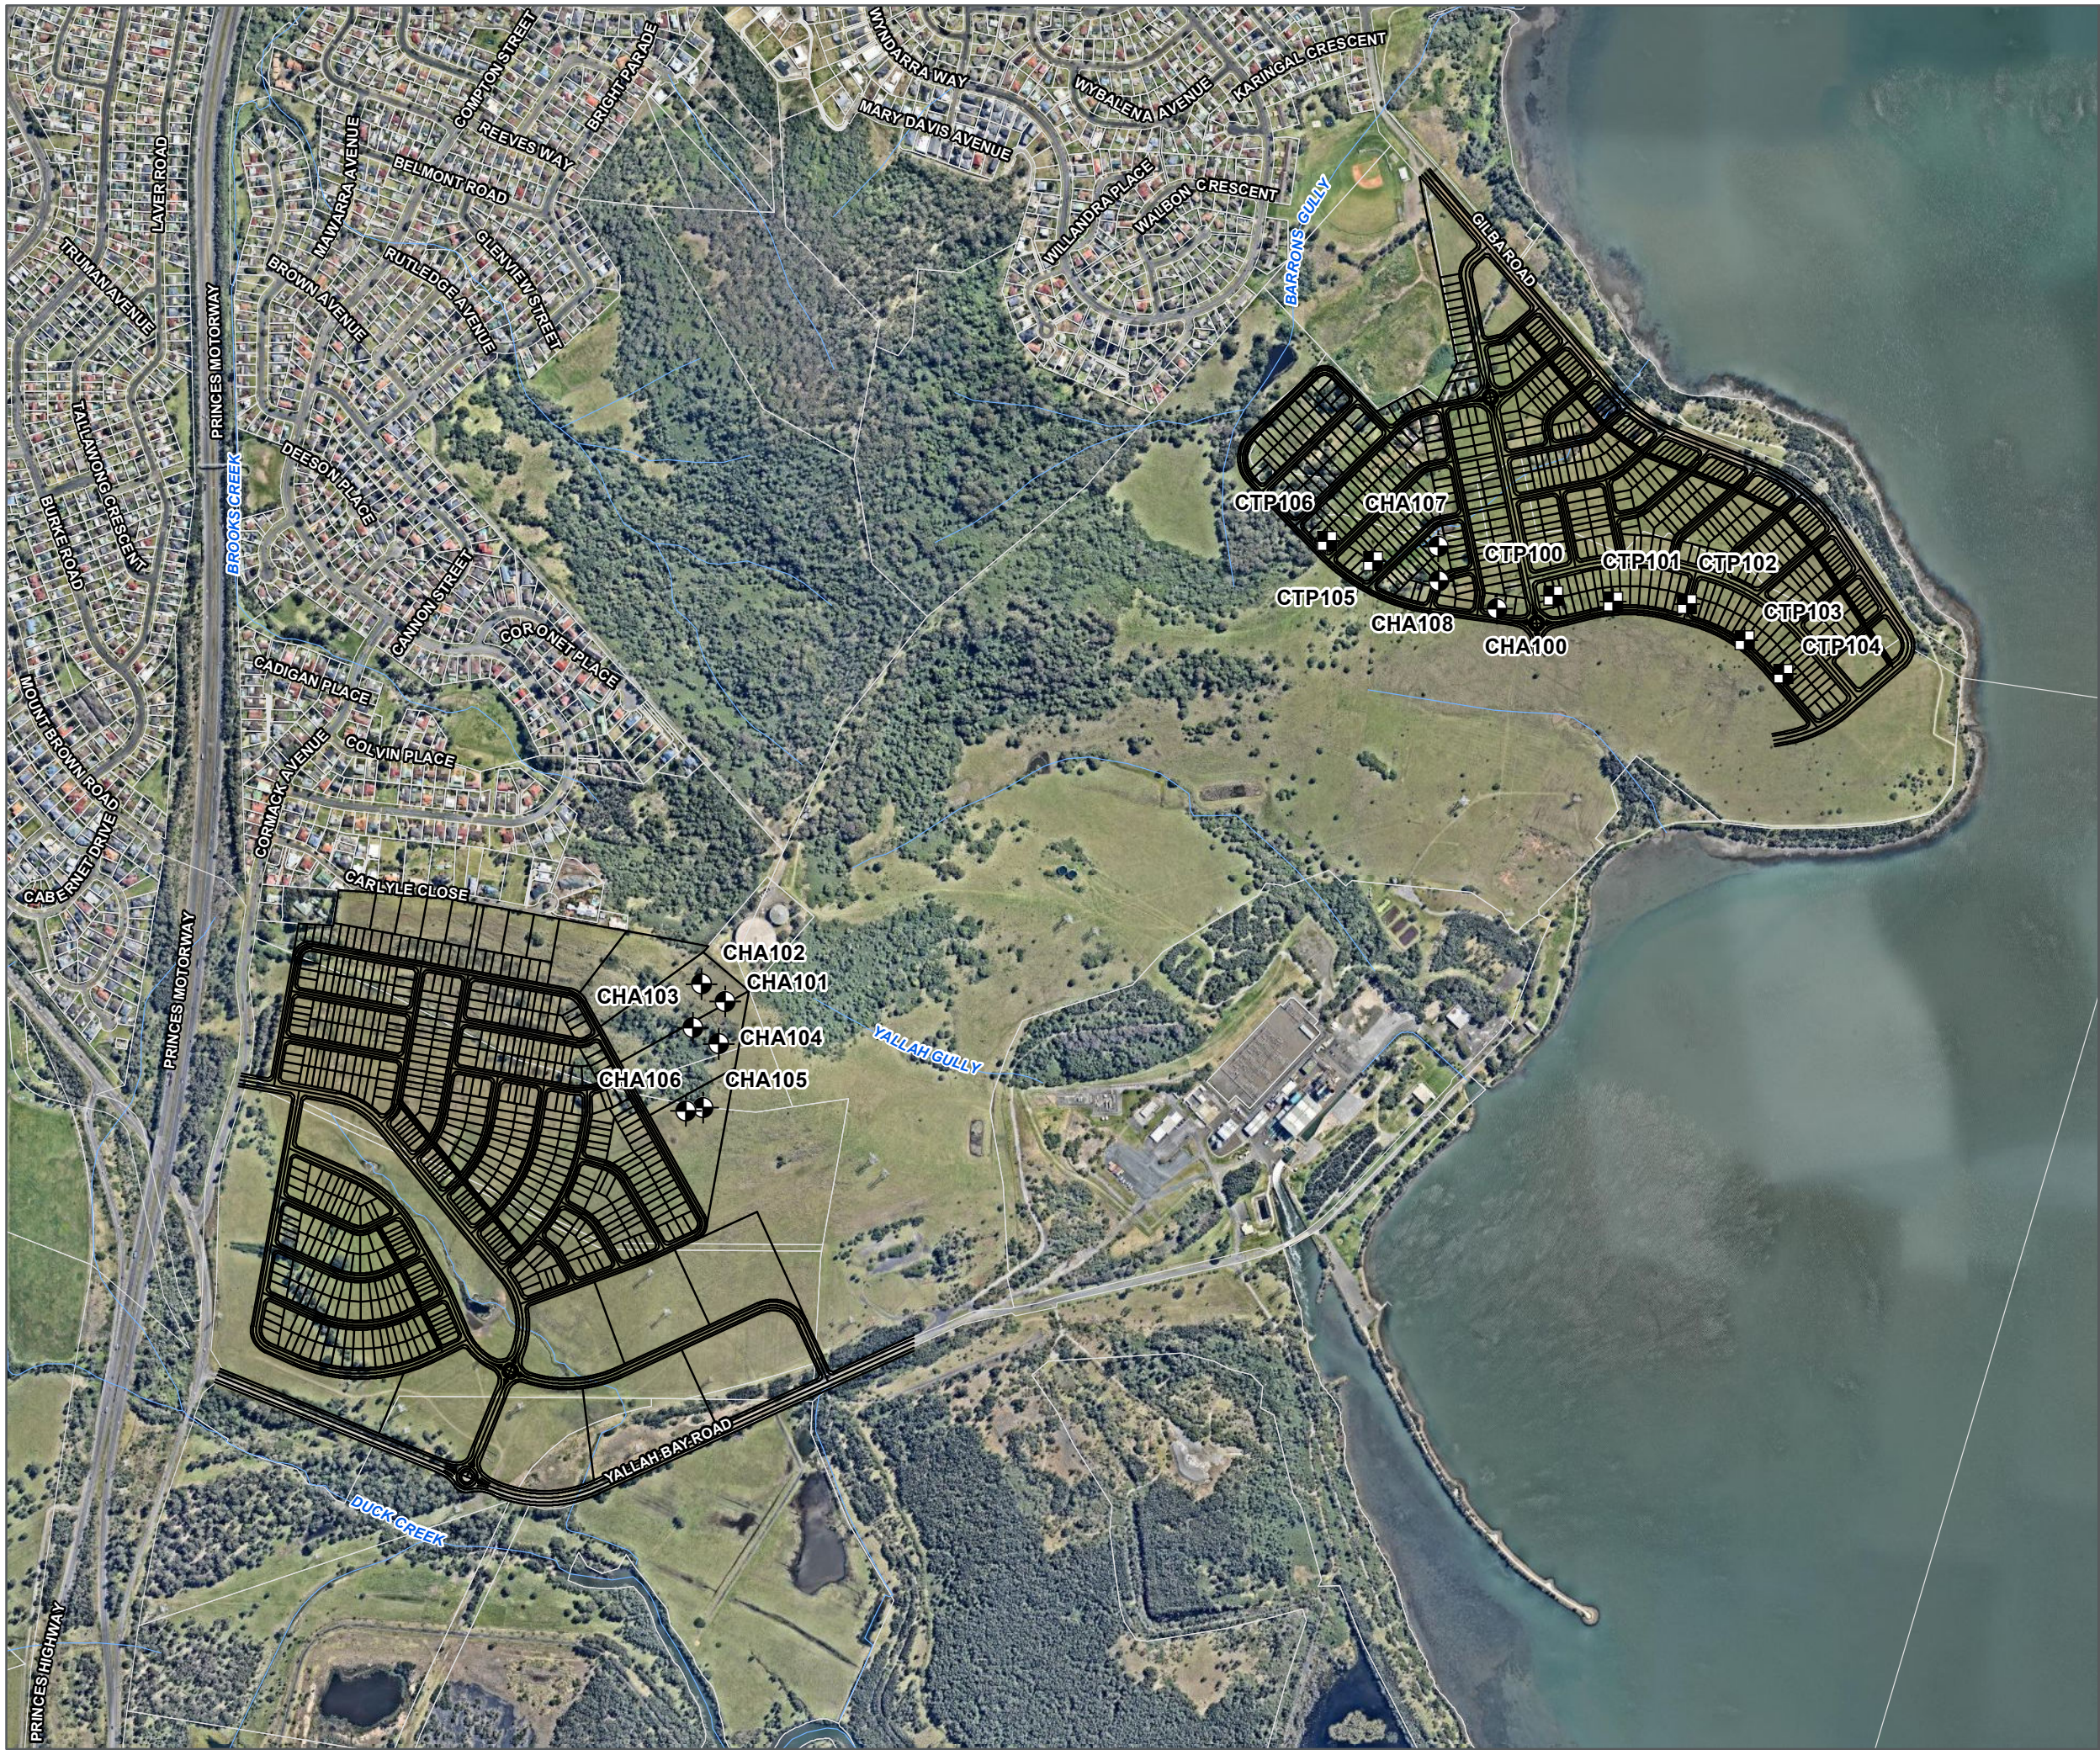
Site Plan

Site investigation consisted of six (6) hand augured test pits. Test pits CHA 101, CHA 102, CHA 103, CHA 104, CHA 105 and CHA 106 were excavated using hand excavation tools – shovel. Encountered subsurface stratum and rock levels are presented in the table below.

During site walkover, undulating slopes were observed on site. Several dams were located in northern precinct. Additional site investigation consisted ten (10) hand augured or excavated test pits. Test pits CTP 100, CTP101, CTP102, CTP103, CTP 104 and CTP 106 are excavated with a 5 tonne excavator and the remaining of the test pits, CHA100, CHA105, CHA107 and CHA108 were excavated using hand augers. DCP test was undertaken on following test pits: CHA100, CTP100, CTP101, CTP102, CTP103 and CTP104. Test pit logs are attached. Encountered subsurface stratum and rock levels are presented in the table below.
