3.2 *Investigation of House Site*

St. John of God, Morisset
Archaeological Investigation of Bailey Residence

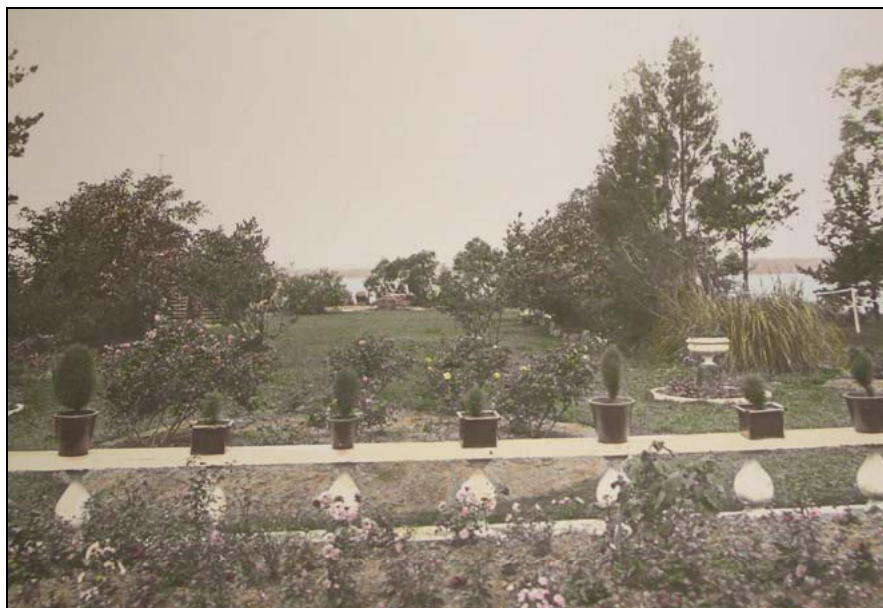
Plate 0.4 View from house to the sundial (looking east).

The photographs of the interior of the house show timber-panel walls with high picture-rails. The floors appear to be of polished wood. Judging from the position of the sundial in relation to the front door of the house, 'Kendall Grange' stood in the vicinity of the present-day Chapel.

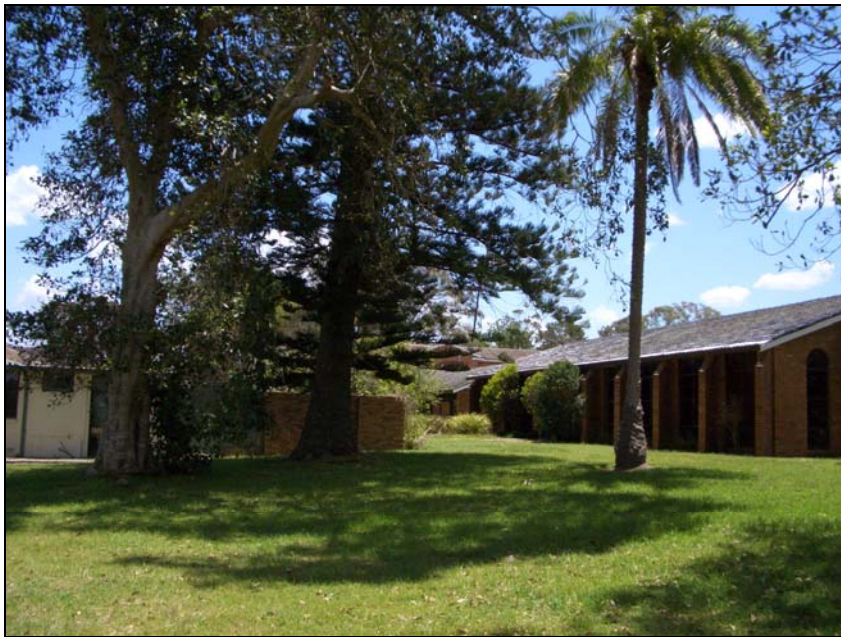
Plate 0.1 View of chapel and monastery, facing northwest [December 2005].

The Chapel, a grassed area and part of the walled monastery courtyard occupied the house location indicated by historical photographs (Plate 3.1 p.27). Most helpful was a Norfolk pine growing during the Bailey period (see Plate 2.6 p.21) and still standing near the courtyard. Location relative to the sundial was also indicative (Plate 3.2 p.27, compare with Plate 2.8 p.22).

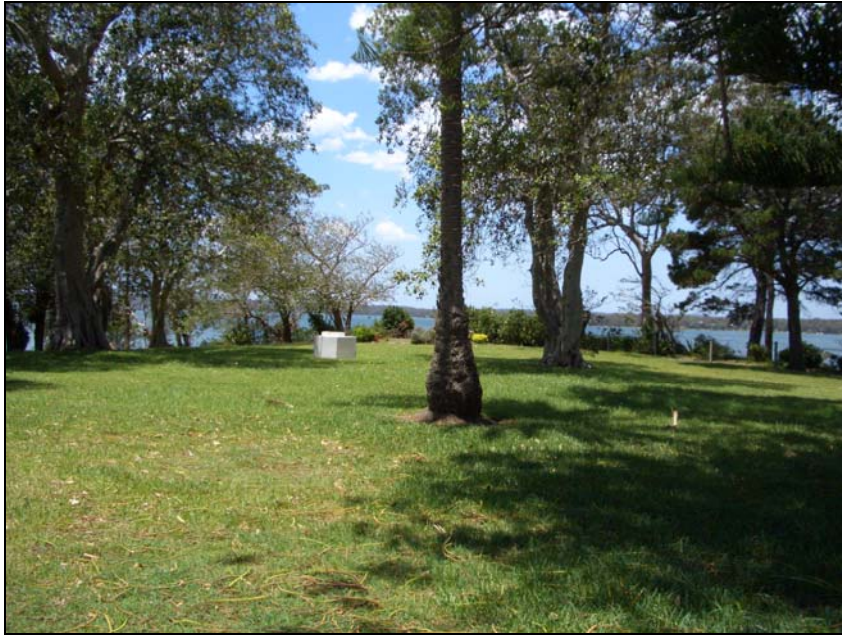
Plate 0.2 View from the Chapel to the sundial, facing east [December 2005].

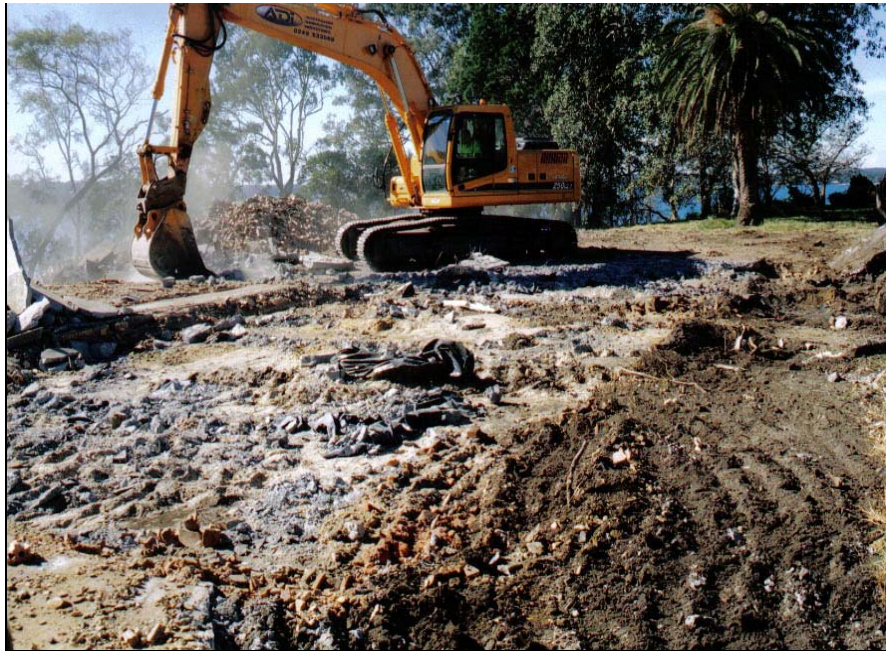
Plate 0.3 Machining removal of residual demolition debris and overburdens [Roll 1:9, facing E].

Subsequent to demolition of the chapel and monastery, residual rubble and turf were removed by machine (Plate 3.3 p.28). Deeper machining revealed the uppermost levels in the courtyard and open area to be imported topsoil (002) over sand fills (fine yellow 007b, coarse orange-brown 010).

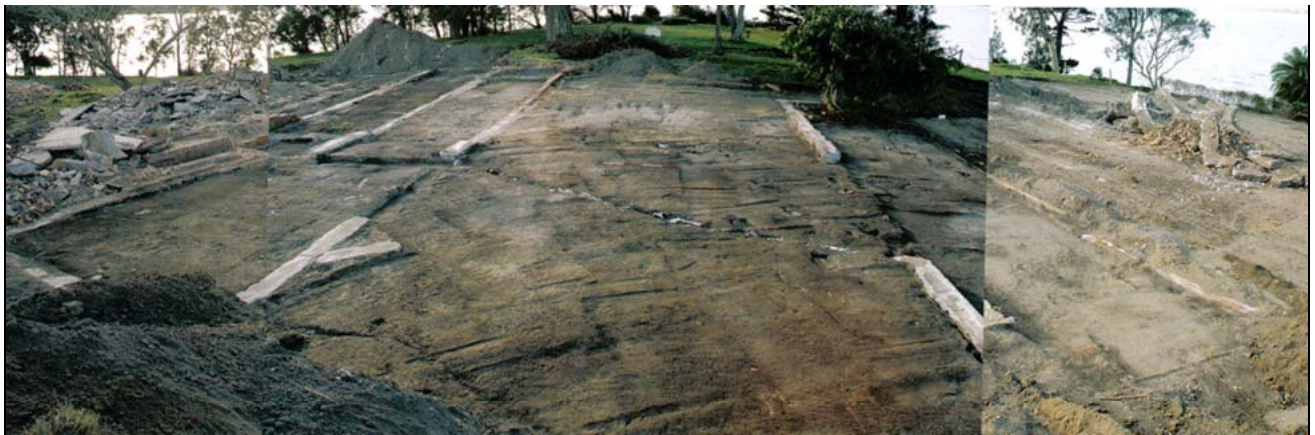
Plate 0.4 View of excavation area after removal of overburdens and cleaning [Roll 2:18,19,21]

Outside the Chapel the sand fills overlay a deposit of dark grey loam rich in structural debris (003). The loam also occurred across the south part of the Chapel, but at the north sand bedding (007a) for the concrete slab sealed structural debris. The debris in 003 included dry press bricks and fragments, small pieces of timber and much asbestos fibro. While several archaeological features were partially visible at this level, most were exposed only by removal of the loam deposit. It also sealed infrequent patches of A1 topsoil (004), the underlying A2 topsoil (005) or the leached B-horizon (006). Intact natural profiles were preserved along the north. Plate 3.4, p.28 show the site after removal of the overburdens and cleaning.

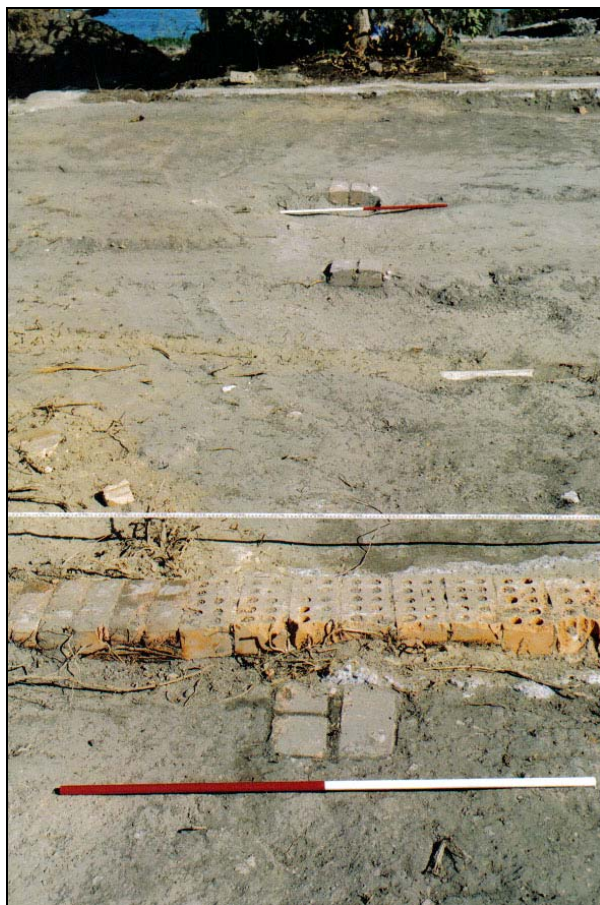
Plate 0.5 View across pier bases 015a-c and part of chapel footing 008 [Roll 2:16, facing S]

Remains of the structure were limited to the bases of brick piers, ghost of piers and cuts for piers. All bricks were an earlier form of dry press and the mineral lime mortar weak and sandy.

Several short lines of piers were observable (see site plan Figure 3.1 p.33, contexts 015a-b, 018a-c, 021a-e). Piers 021c and 021d at the central south appeared to cut a patch of A1 topsoil remnant in this location. The vast majority of piers were missing.

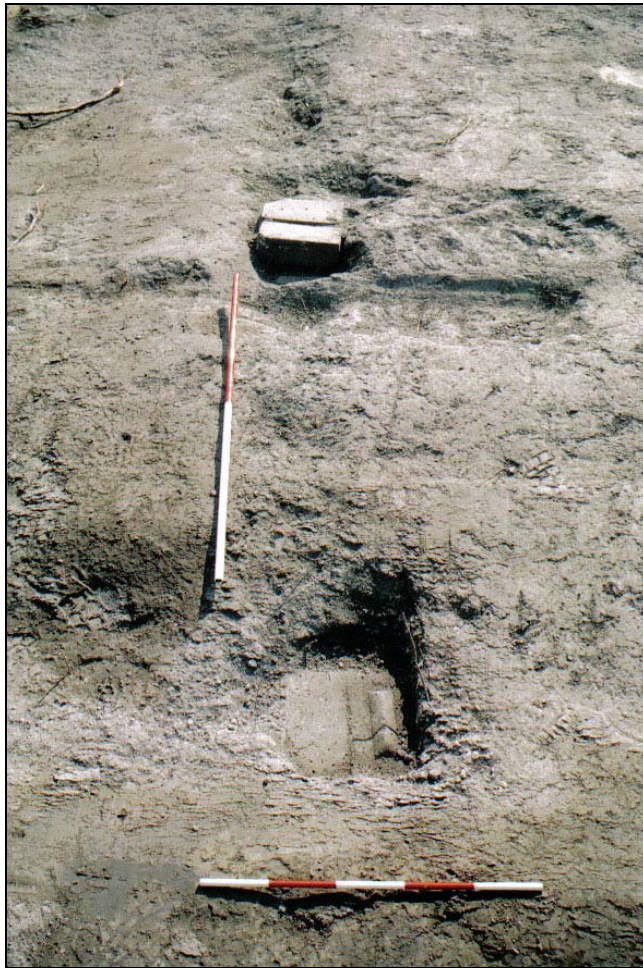
Plate 0.6 Brick pad 024b & ghost 024a [Roll 2:8, facing W]

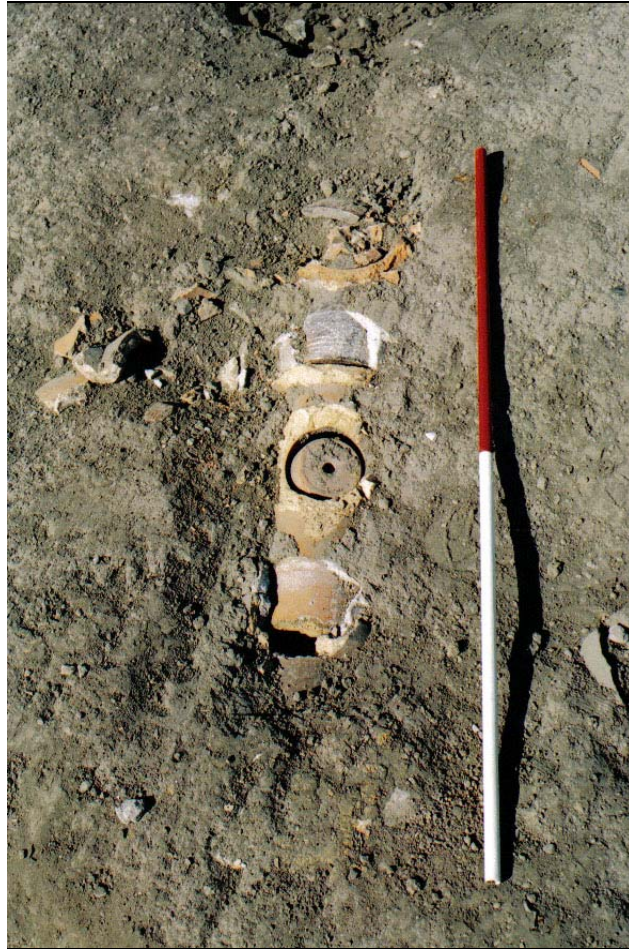
Plate 0.7 Service 047 with base of flower pot in broken up pipe [Roll 3:22, facing E]

At the west were several services - 025, 047, 047a, 050 - that probably connected as a single system. At the base of a broken up-pipe in Service 047a was the inverted base of a flowerpot (Plate 3.8, below). Three artefacts were recovered from soil (052) inside the pipe. Two services partially revealed towards the northeast (043) and southeast (013) appeared to be separate. All were salt-glazed ceramic, and one pipe in Service 025 carried a partial oval stamp with the inscription "[N or W?] F. B C L Thornton" (Plate 3.9 p.35). A ferrous water pipe (048) of 4.4cms (1¾ins) diameter was also evident near Service 047a, and another (053) of the same diameter near Service 050 may be part of the same system. A later PVC service (016) ran along the southeast side of the chapel footings. Initially identified as a service, partially exposed ceramic pipe (014) in the central east area proved to be impressed debris.

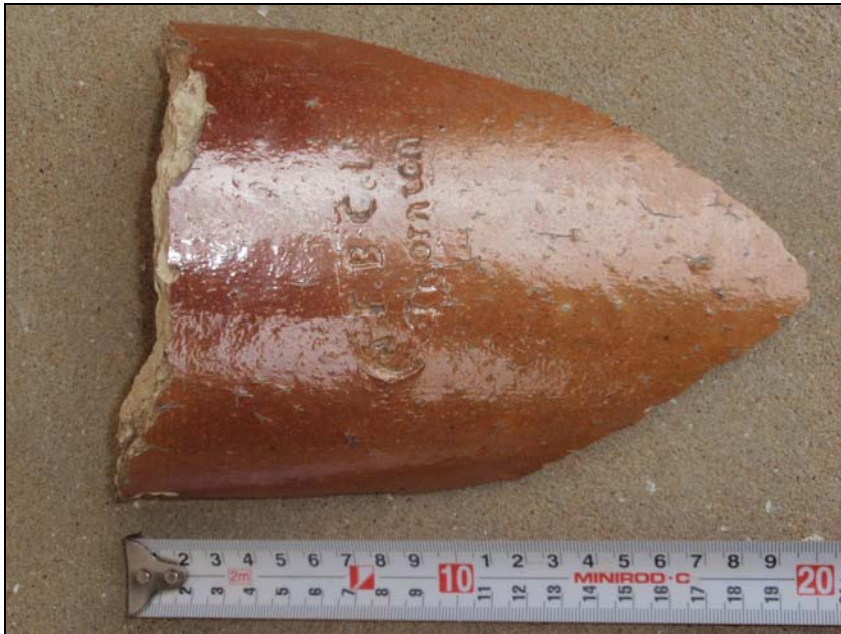
Plate 0.8 Service 025, fragment with manufacturer's stamp [DB.No.002, SJOG 069]

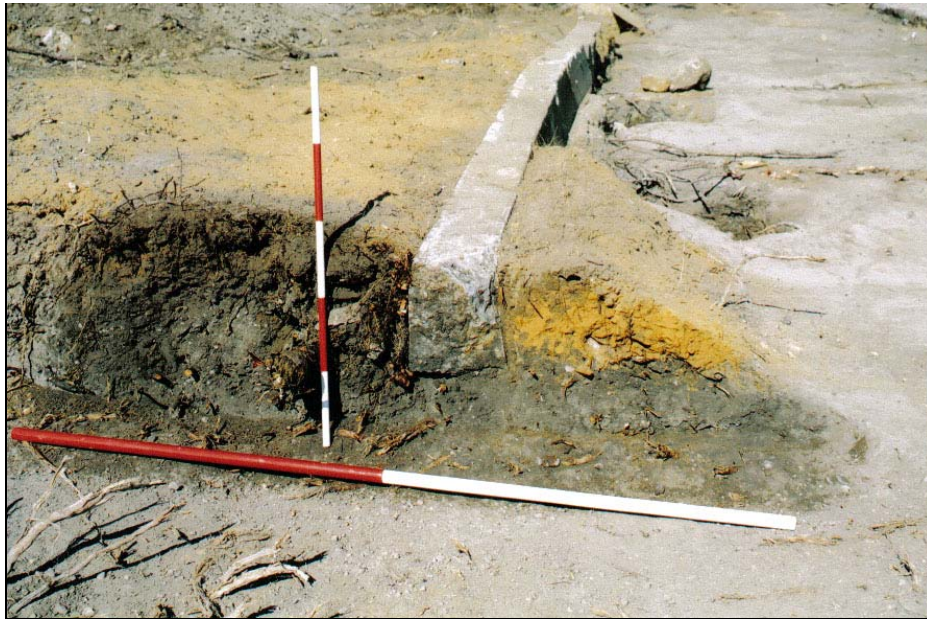
*Plate 0.9 Concrete path edging 011, north end, also showing natural soil profile on east (left) side
[Roll2:6, facing S]*

At the east sat the remains of concrete edging (011, 011a, 012) for a path running north-south. A trench (032) had been cut and the concrete poured into formwork; the base was rough but the upper portion smooth, with a slightly trapezoidal profile 14cms high and 11cms wide at the top (Plate 3.10 p.36). While the soils along the outside (east) or edging 011 appeared to be the natural profile, any original path material seems to have been robbed. Orange sand (010) along the inner side of edging 011 containing fragments of sheet plastic suggested it was late fill. The same sand filled the upper parts of post pipes and packing in two postholes (028, 031) on the east side of the path. This appeared to be the result of partial excavation of the postholes for removal of the posts, just before the sand was laid. While the sand could be bedding for concrete path, debris from its removal was lacking. The sand being post-demolition fill appears more likely.
