ACID SULPHATE SOIL ASSESSMENT

***PROPOSED TRINITY POINT MARINA AND
TOURIST DEVELOPMENT***

49 LAKEVIEW ROAD, MORISSET PARK

Project 39823A

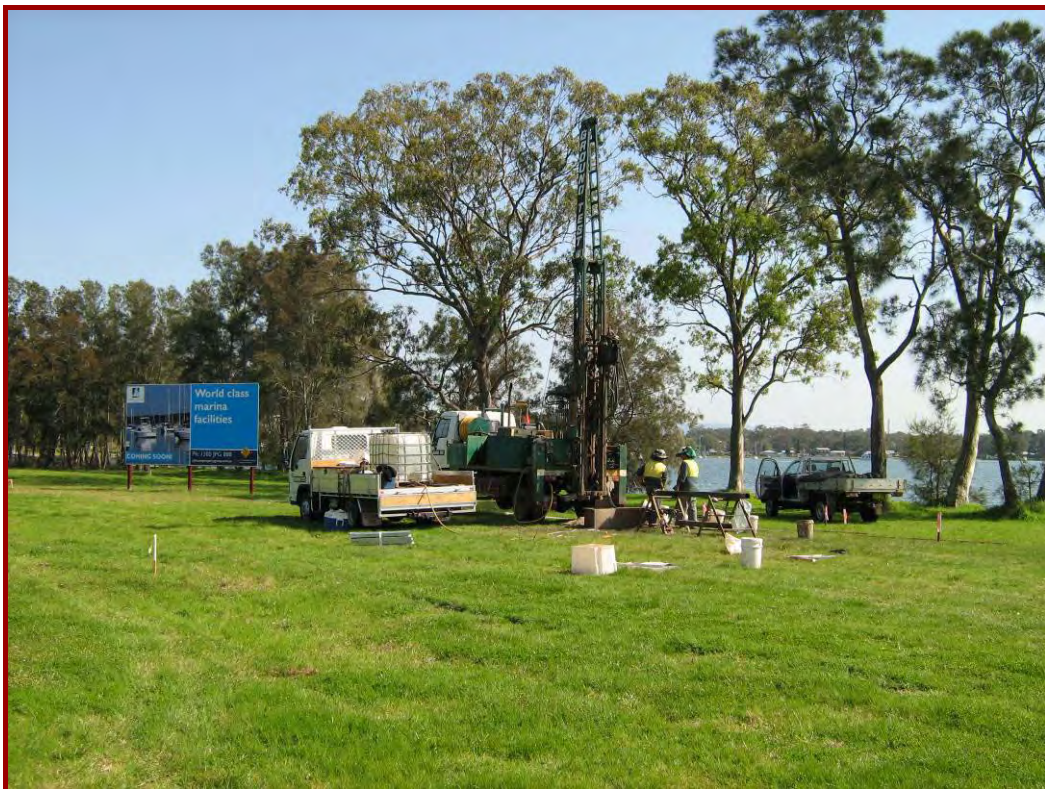
Photo 1 – set up on Bore 101, in the area of the proposed marina village
