**Concept Plan for Trinity Point Marina
and Mixed Use Development**
Aquatic Ecological Investigations

Revised Final
November 2008

The Ecology Lab Pty Ltd

Report Number – 41/0607F

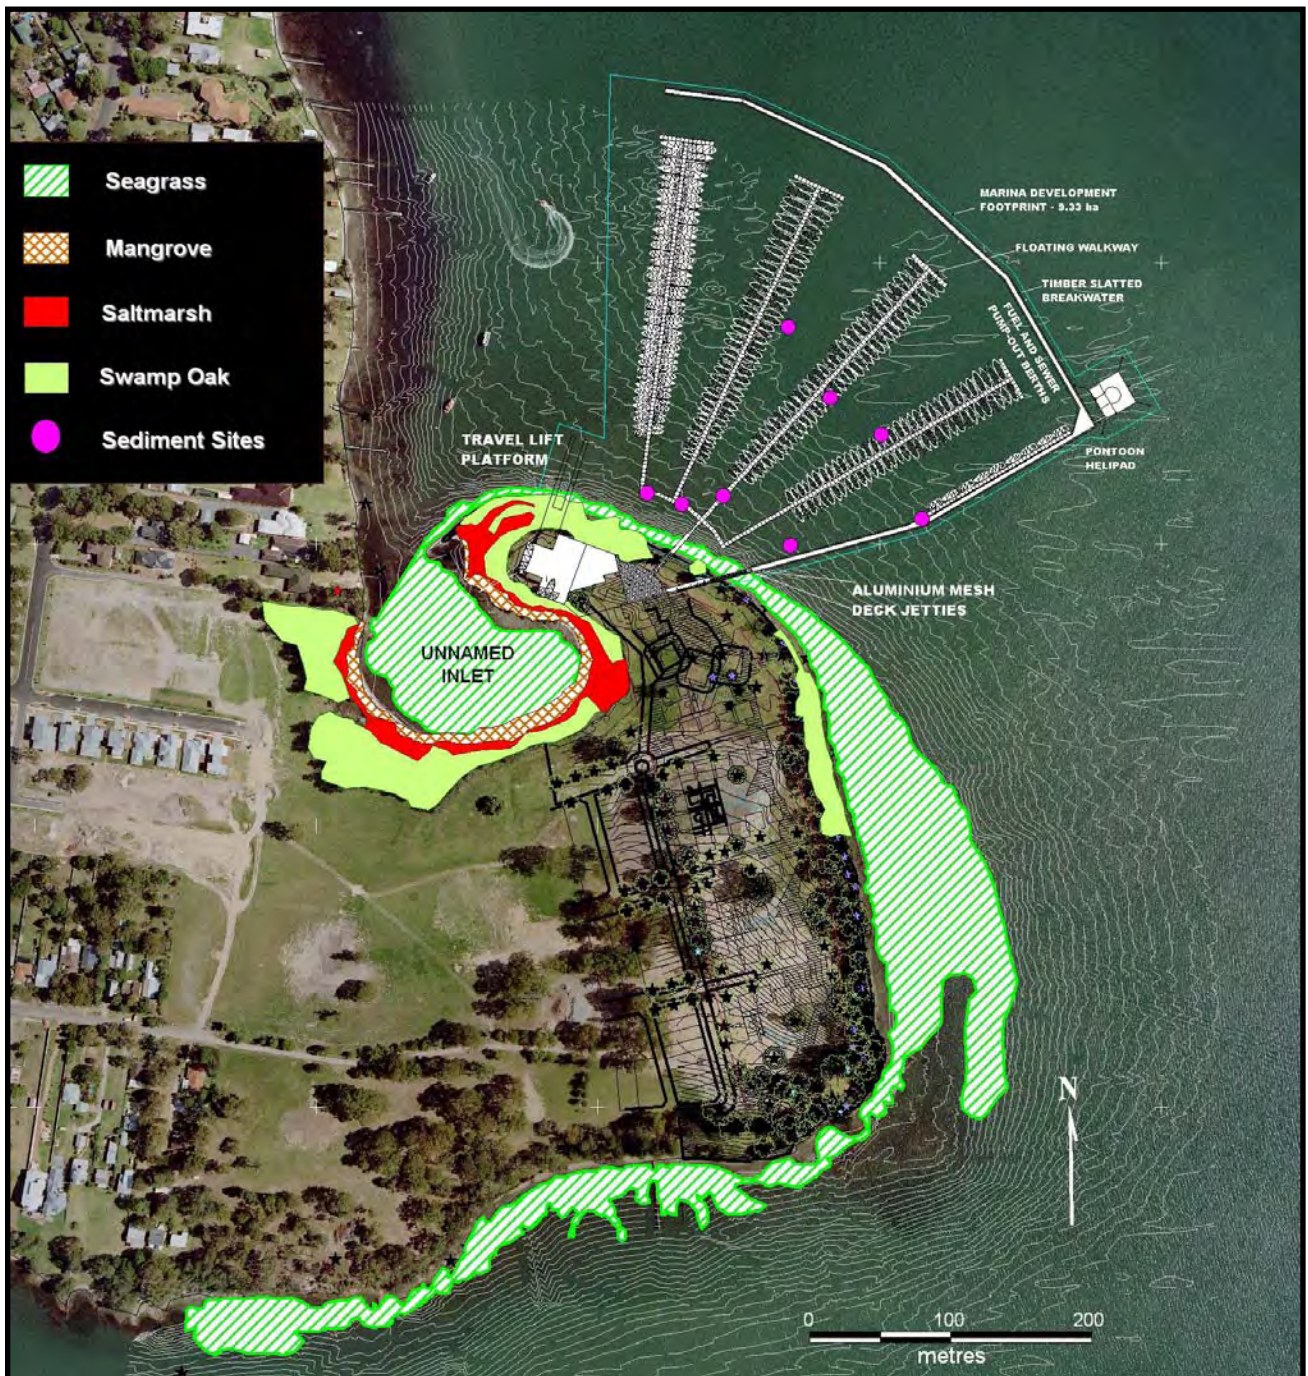
Figure 1a. Aquatic vegetation at Trinity Point in Lake Macquarie. Seagrass mapped by The Ecology Lab in January 2007; all other vegetation mapped by RPS Harper Somers O’Sullivan in October 2008.

The distribution of aquatic vegetation within the vicinity of the development site is shown in Figure 1. All three vegetation types of aquatic vegetation (i.e. seagrasses, mangroves and saltmarsh) were present within the study area. In addition, a number of species of algae were also observed within seagrass habitat.

Saltmarsh was generally found on the landward side of the mangroves, with some overlap in several areas (Figure 1; Plate 3). Similarly, there was some areas of overlap with swamp oak (*Casuarina glauca*) community. The saltmarsh distribution was continuous around the entire Unnamed Inlet to the west of the marina development site (Figure 1). At its widest point the saltmarsh community was approximately 35 m, while at its narrowest point was only a couple of metres.

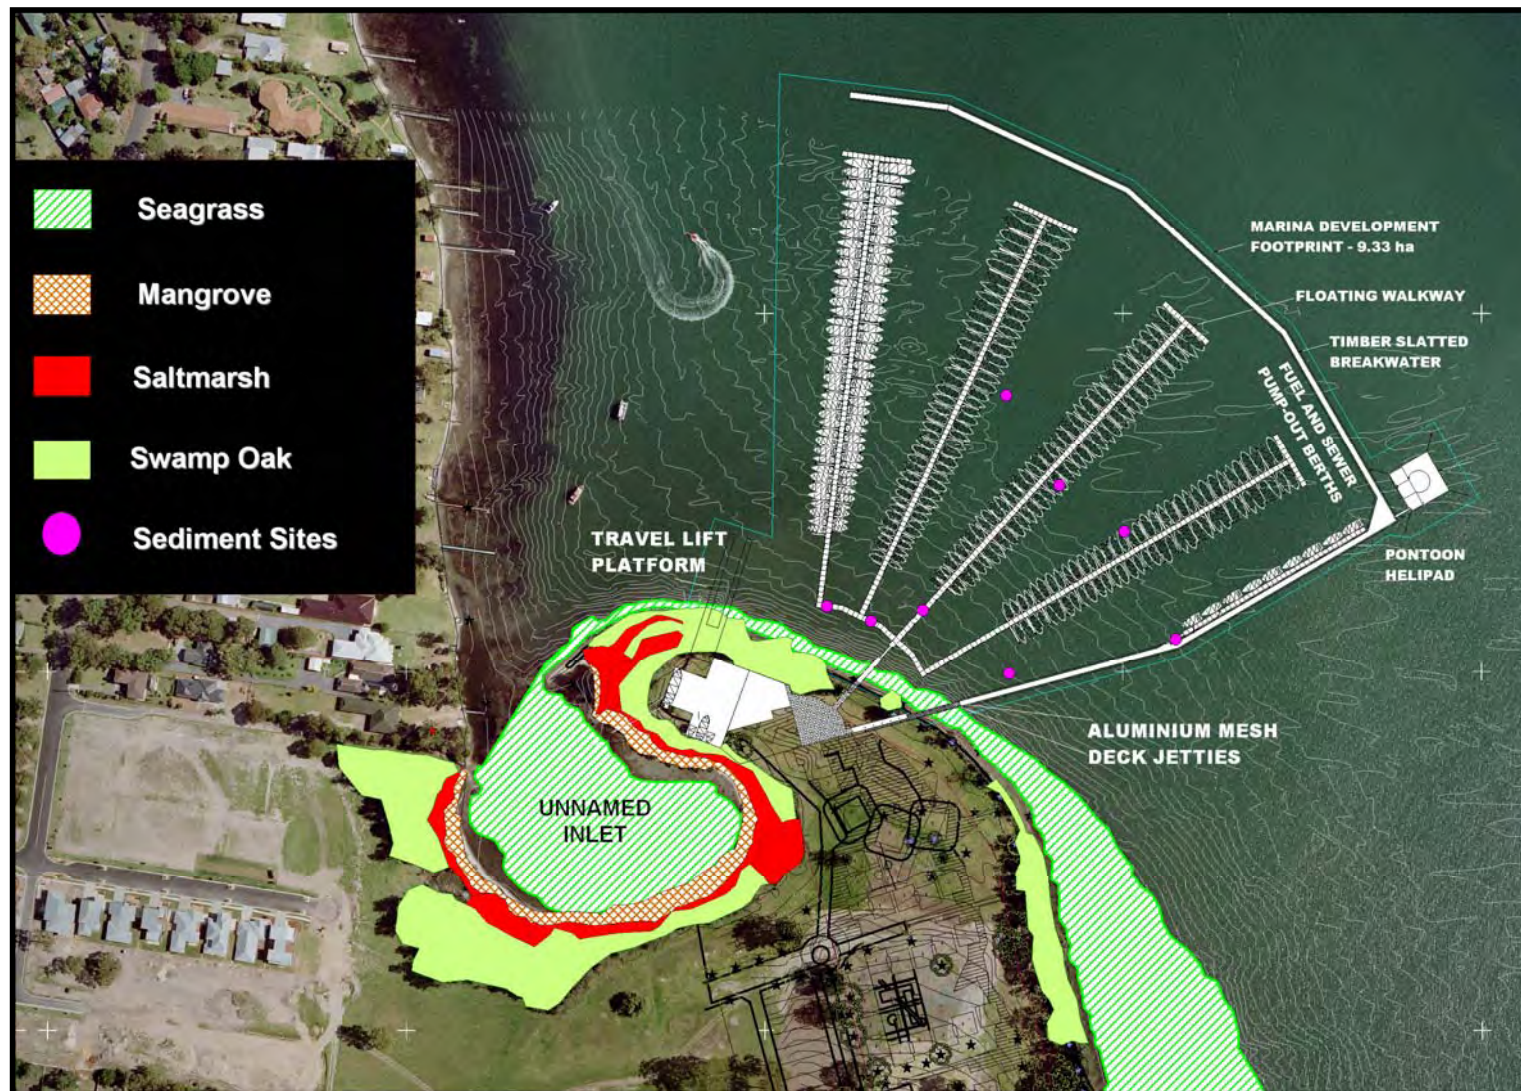
Figure 1b. Aquatic vegetation at Trinity Point in the vicinity of the proposed marina footprint, and positions of sediment samples (collected in October 2007). The saltmarsh area includes a community of species (as indicated in the text). Seagrass mapped by The Ecology Lab in January 2007; all other vegetation mapped by RPS Harper Somers O'Sullivan in October 2008.

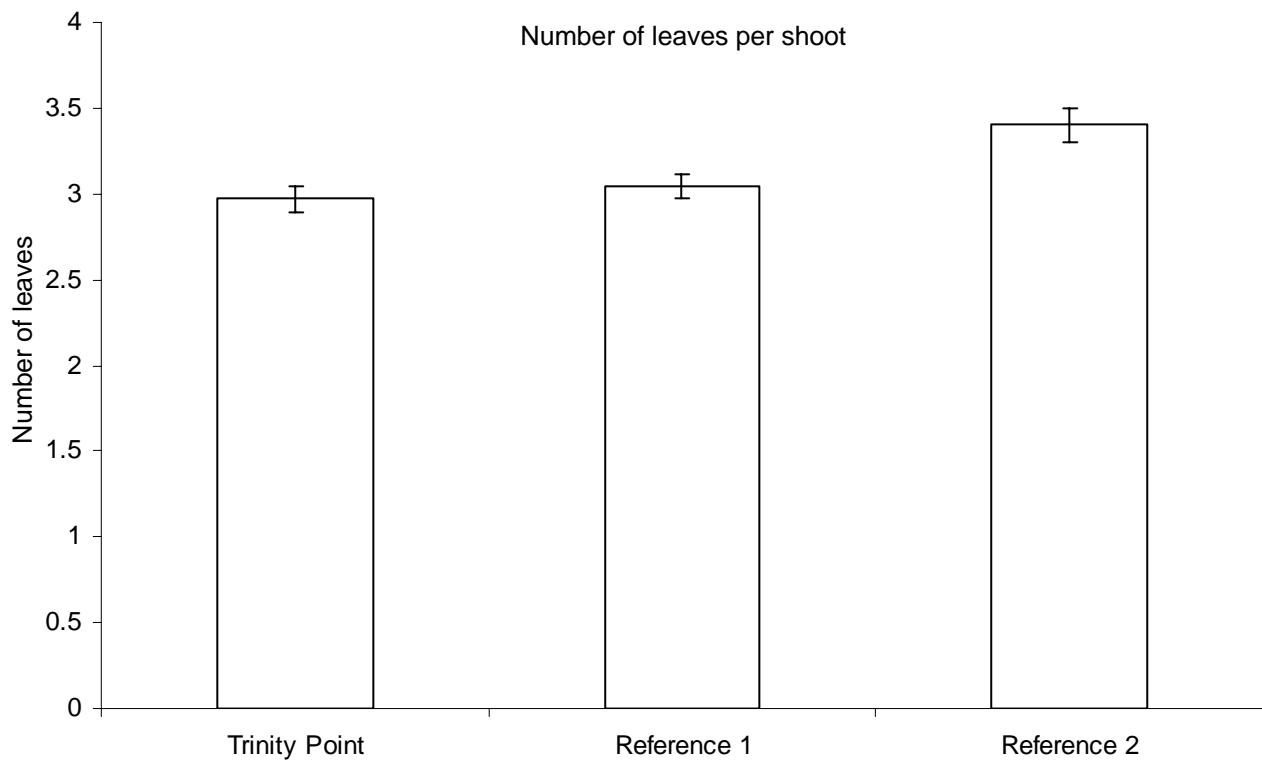
Figure 3. Continued.

Figure 3. Mean leaf length, width and number of leaves per *Zostera* shoot at Trinity Point and two reference locations ($n = 100$). Ref 1 = Frying Pan Point, Ref 2 = Wyee Point.

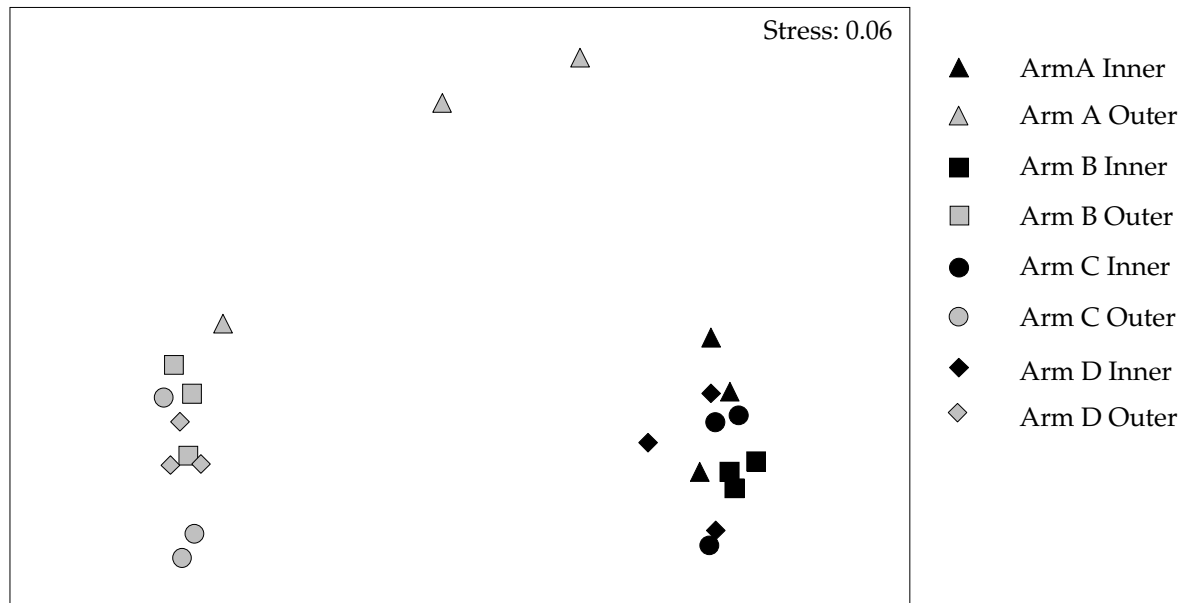
Figure 4. MDS plot comparing infaunal assemblages in the inner and outer sites at each of the four arms (A - D) of the proposed marina.
