3.3 Site Analysis

3.4 The Site

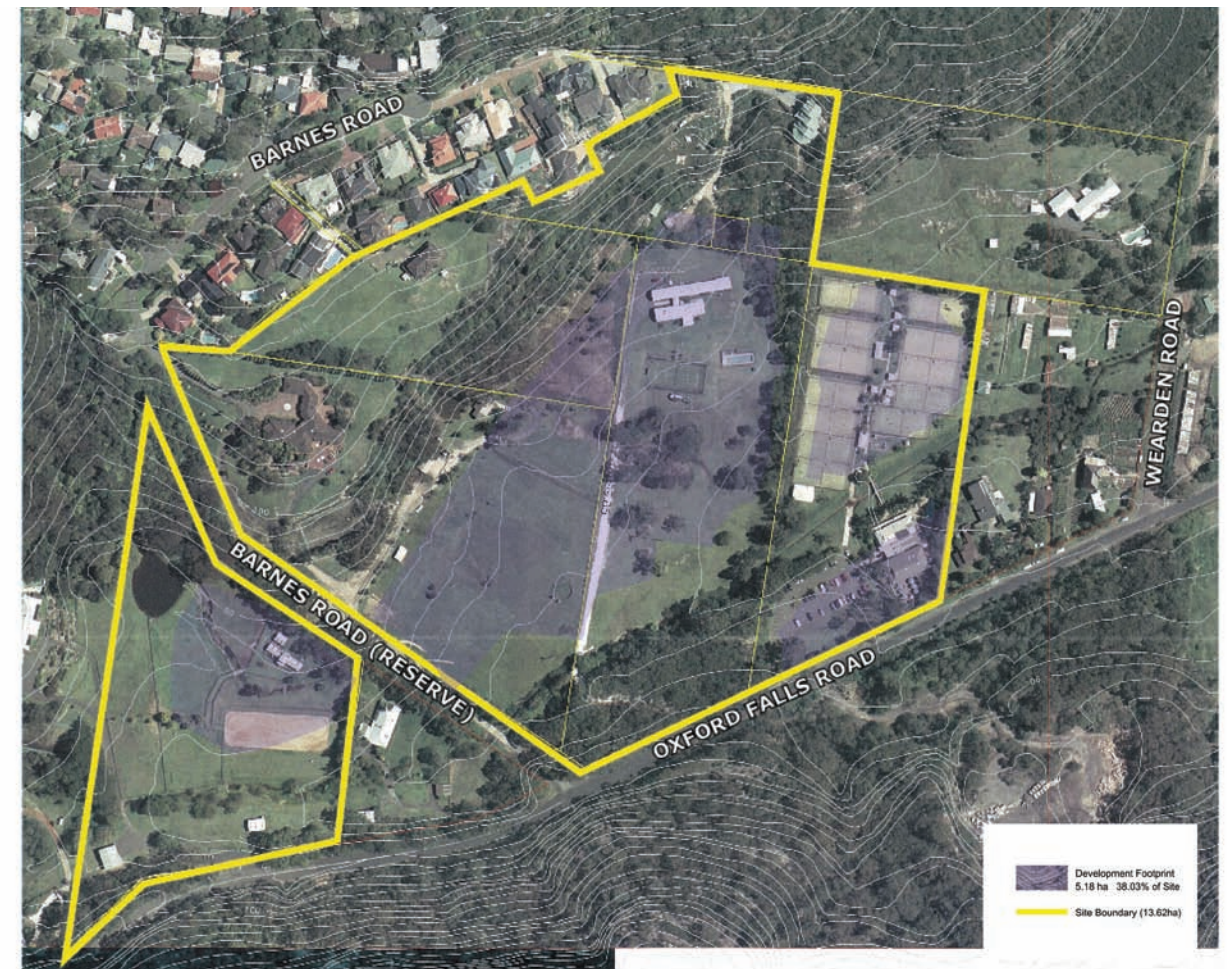
Figure 5 - Development Footprint

As a result of the detailed site analysis undertaken, a developable footprint area emerged, as outlined in Figure 5 below.

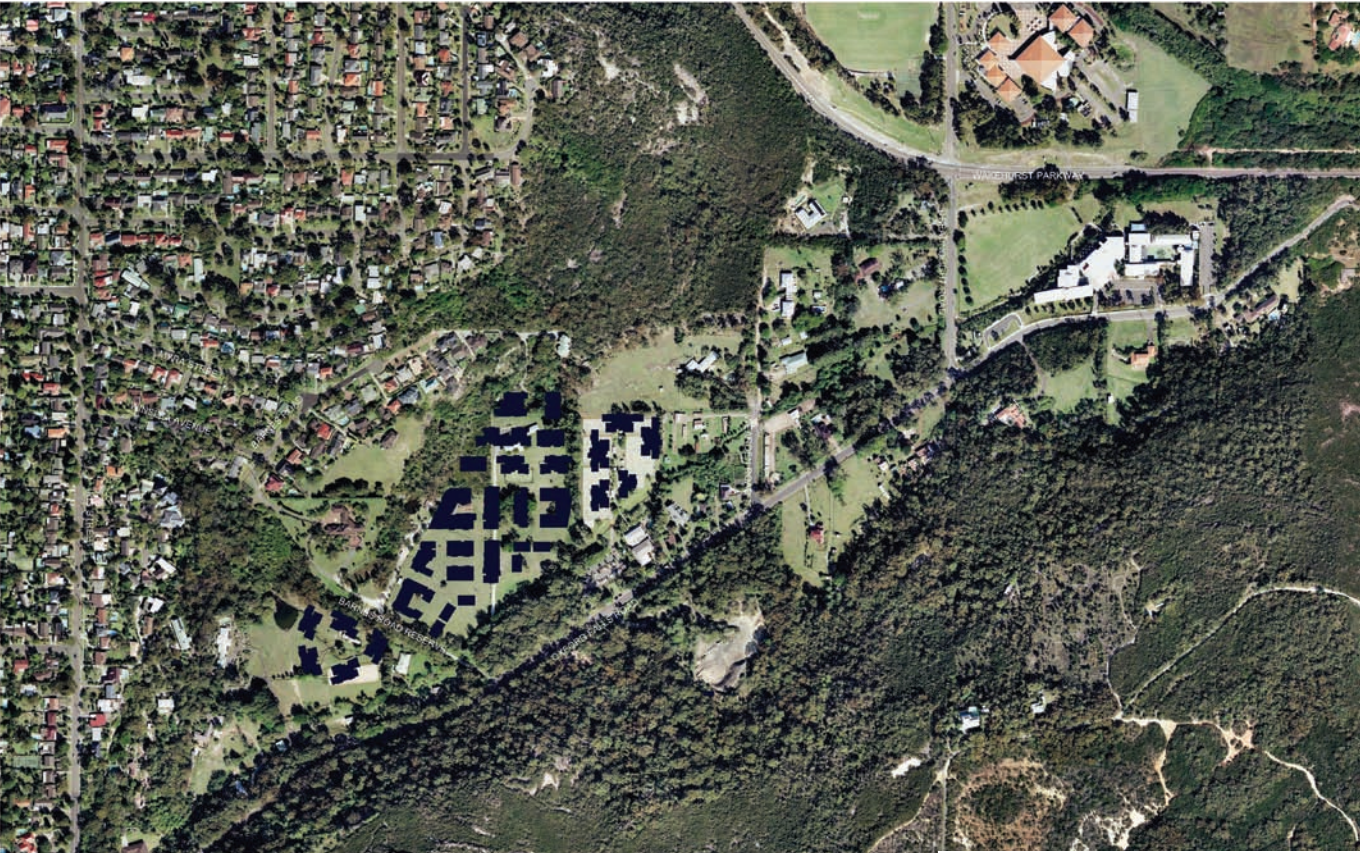
Figure 6 - Desired Future Character

The layout of buildings took over from the ecological constraints of the site and the character of other development with the Oxford Falls Valley. The resultant footprint confines the buildings to the central pontue of the site and ensures a significant curtilage of landscape buffer. This landscape buffer ensures that the built form will have low impact upon the character of the area (refer to **Figure 6**).
