# Doonside Residential Parcel, Western Sydney Parklands Conservation Management Plan

Report prepared for Landcom  
May 2007

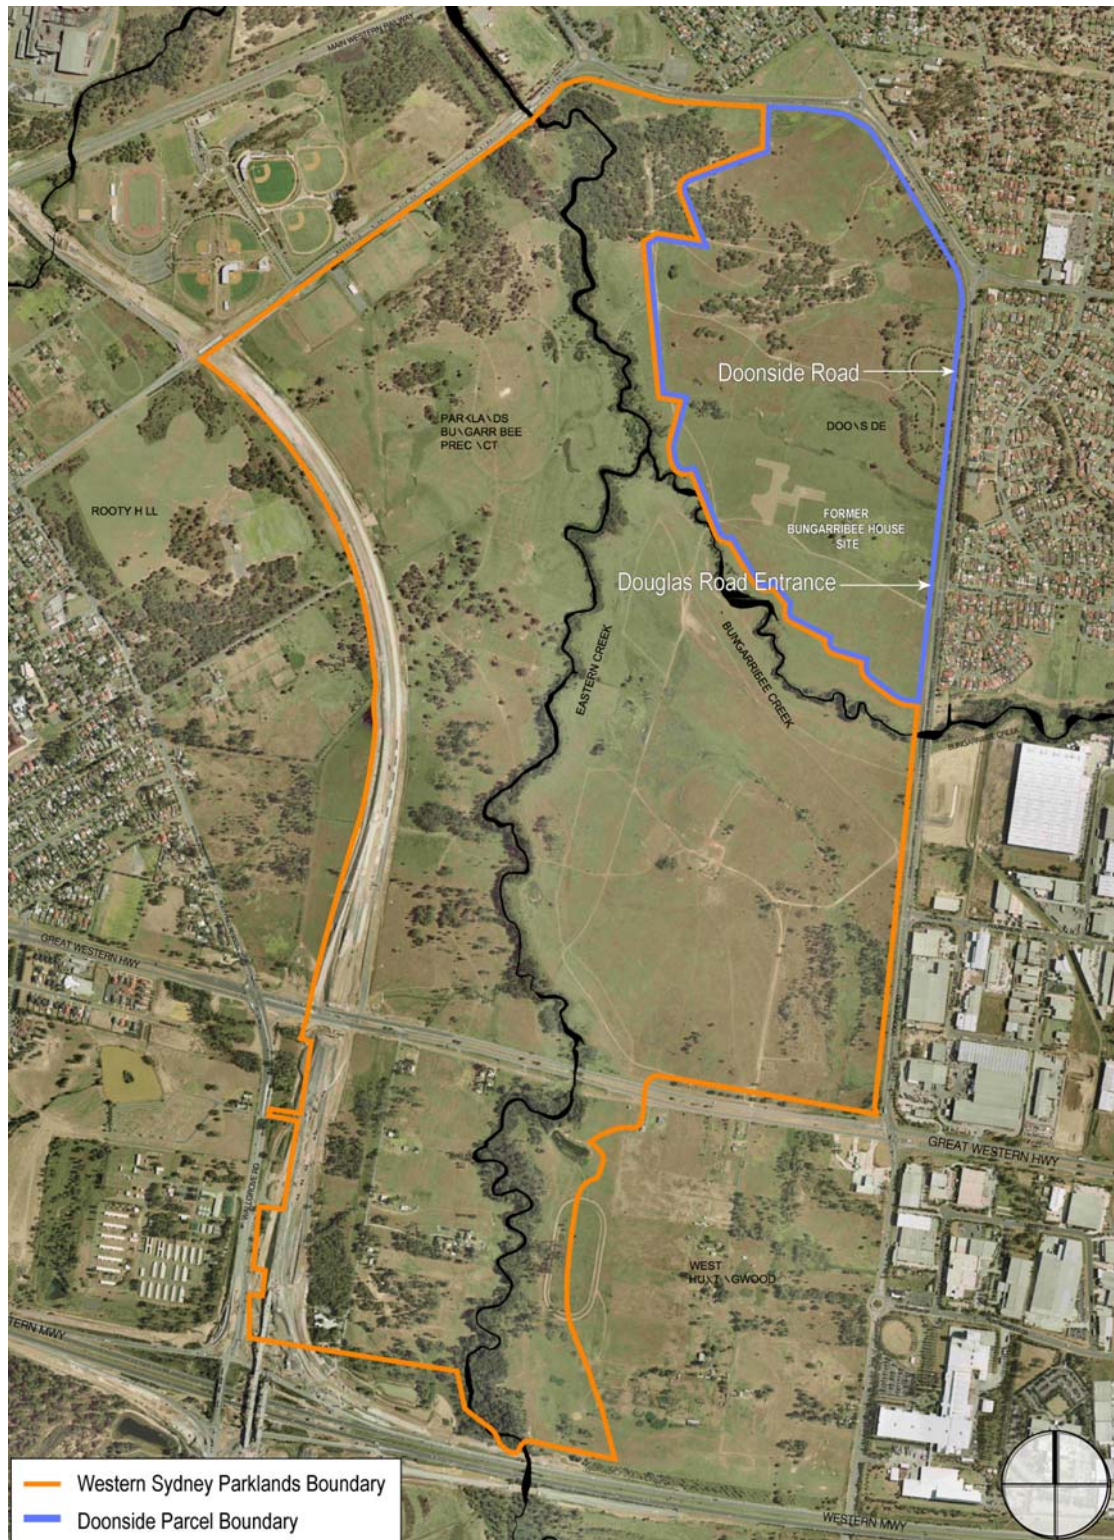
**Figure 1.1** Map of the Western Sydney Parklands area showing the Doonside Parcel in the upper right (north-east) corner. The archaeological site of the former Bungarrabee House is noted as the 'Former Bungarrabee House site' on the map to the west of the Douglas Road site entrance.

The Doonside Parcel consists of approx. 79.24 hectares of relatively undeveloped, previously mostly Commonwealth owned land south west of Doonside Railway Station in the Blacktown Local Government Area, western Sydney. The Parcel is bounded on the north by Eastern Road, to the east by Doonside Road and to the south by Bungarribee Creek and west by Eastern Creek beyond both of which are the Bungarribee Precinct of the Western Sydney Parklands. The Doonside Parcel site is shown in Figure 1.1. The Core Heritage Area identified in this CMP is shown in Figures 3.13 and 3.18.

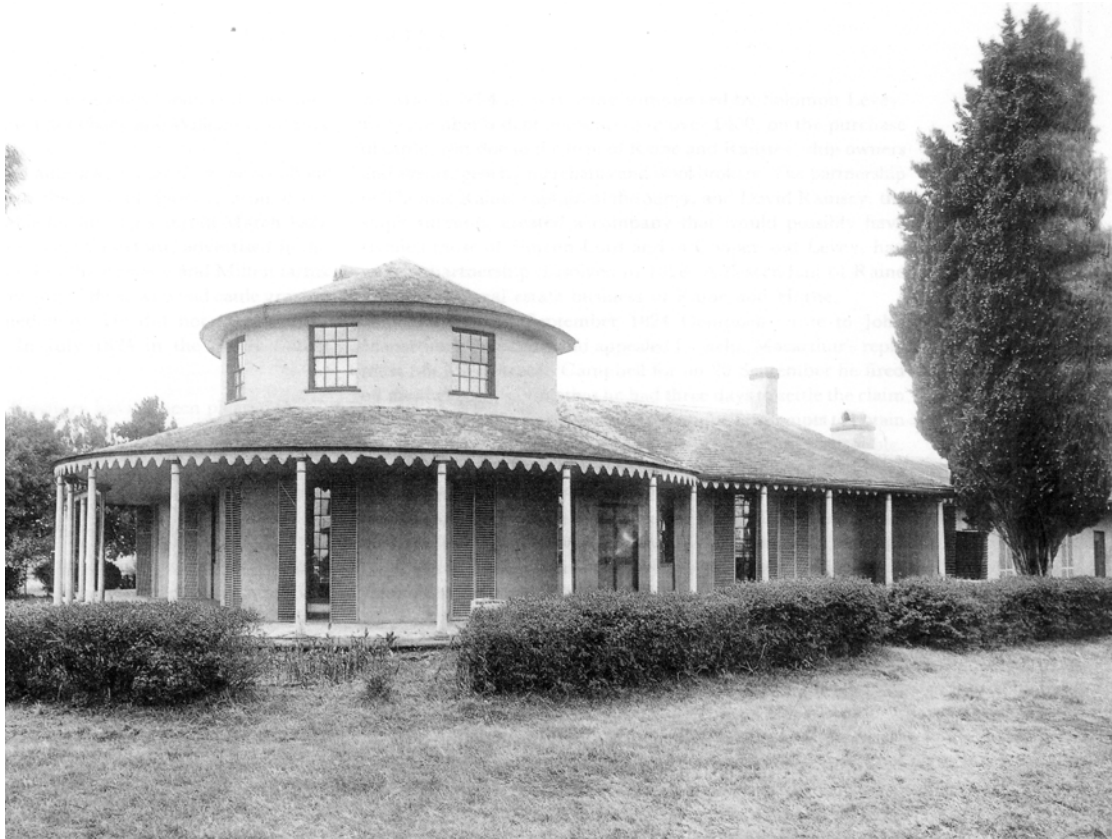
**Figure 2.2** Bungarribee House 1918. The round tower was a distinctive feature of the house and provided views to the Blue Mountains in the west. The Mediterranean cypress on the right remains on site, marking the position of the demolished house. (Source: Blacktown Library)

Bungarribee House was part of a larger complex of buildings, constructed as part of Campbell's farm estate development. By 1828, as well as the main house the estate included a large two-storey brick barn, store rooms, ham house, stable, carpenter and blacksmith shop and convict men's barracks.<sup>15</sup> All of these structures, as well as some large exotic tree plantings, were collected together on the rise that the house was on, adding to the visual prominence of the estate in the surrounding landscape. Like many of the colonial estates on Sydney's outskirts, the collection of buildings and residents, from the gentleman Campbell and his extensive family, to domestic servants, convict labourers and farm workers, created a mini village on the estate, with each building devoted to a distinct function. Food was produced for the consumption of the residents, a small industrial area was created with the blacksmith and carpentry shops, stock yards and store were provided and variety of residential accommodations were provided depending on a person's standing or status, the grand home of the master, servants quarters and convict barracks. The site was a microcosm of the larger colonial society surrounding it (see Figures 2.2–2.7).

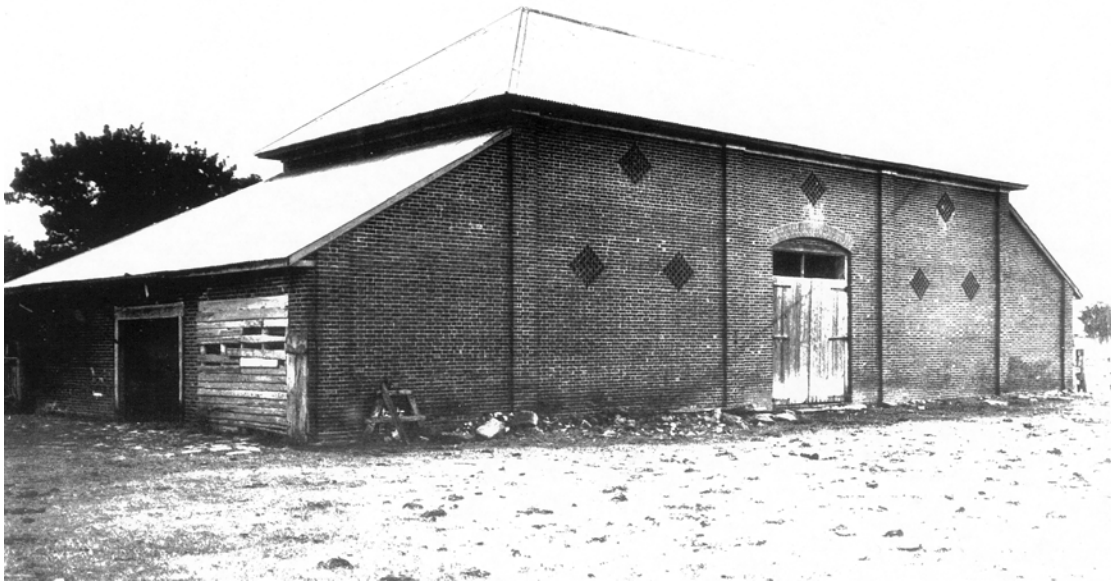
**Figure 2.4** The brick barn at Bungarribee House (eastern facade) in 1918. The large barn was built during Campbell's ownership (c1825) and remained on site until the 1970s. The extension wings for feed lots can be seen on either end. The barn was constructed using convict labour with bricks made locally. The Moreton Bay Fig visible on the left remains on site. (Source: Blacktown Library)

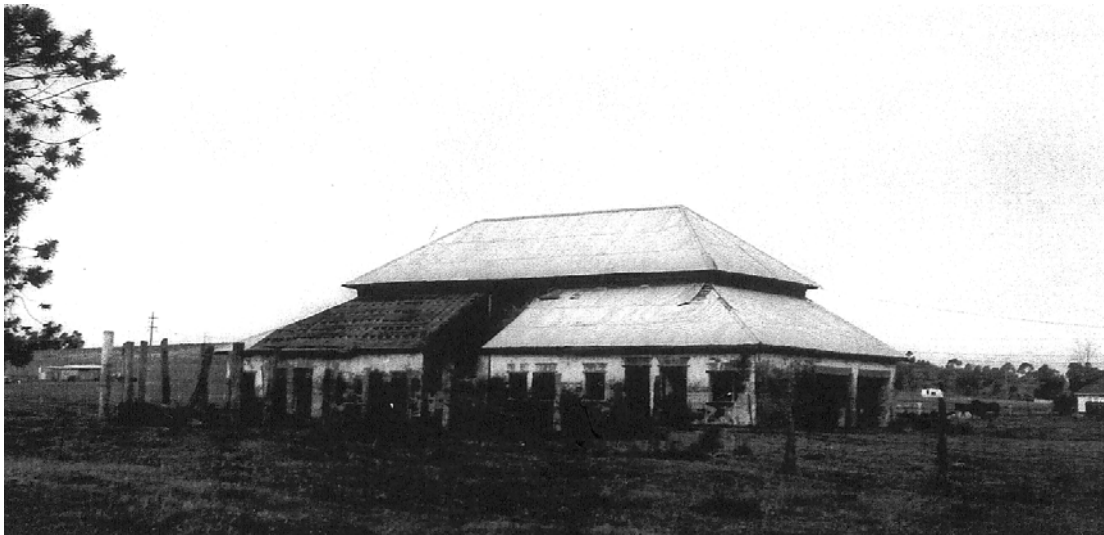
**Figure 2.5** Looking to the western facade of the barn showing the wings containing feed lots and stalls. Doors to each individual stall can be seen. A number of smaller outbuildings can be seen in the background on either side of the barn. The large pine on the left remains on site. (Source: Blacktown Library)

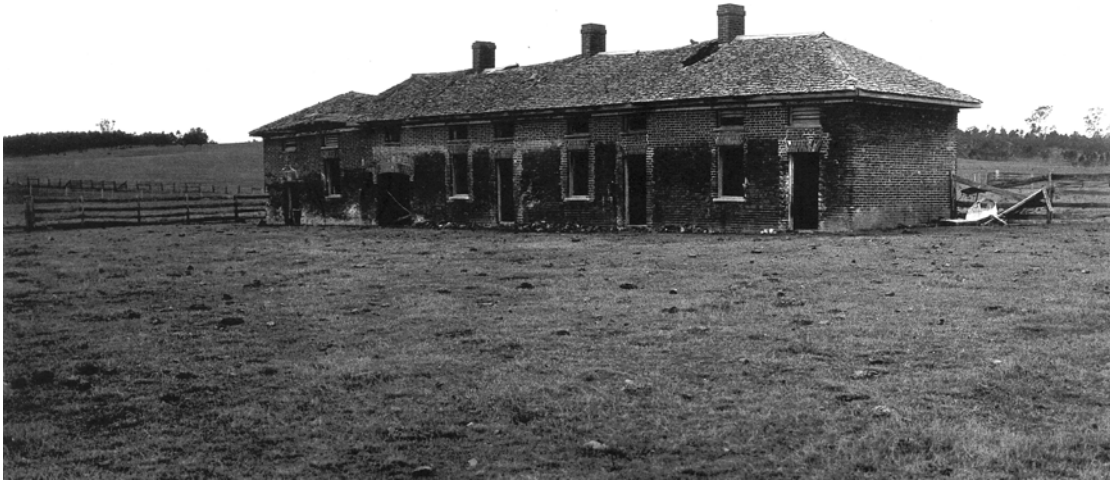
**Figure 2.6** Convict Barracks at Bungarabee in 1918. Built by Campbell in c1825 the barracks housed convicts and was later used by Boyd to house Islander labourers. Its later use is unknown but may have been used as farm storage or accommodation for farm workers. Note the post and rail fencing delineating the stockyards around the barrack building. The barracks was demolished soon after this photograph. (Source: Blacktown Library)

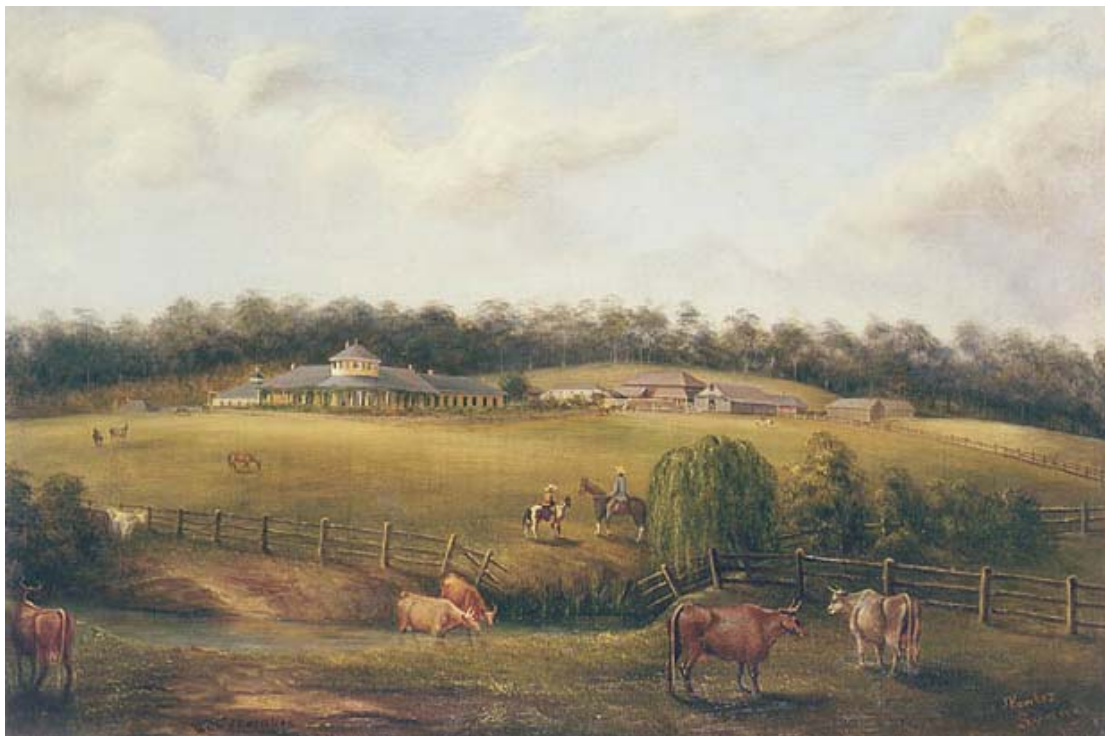
**Figure 2.9** Painting by Fowles, Bungaribee 1858 showing the house and outbuildings, with Bungaribee Creek in the foreground. The two storey barn is visible, as are a number of other outbuildings. Of note are the buildings to the left (north) of the main house, two of which are visible. (Source: Mitchell Library)

By 1858 the house and estate had passed to the John Kingdom Cleeve and his family. The Cleeve family remained in residence until the end of the nineteenth century. Cleeve continued the tradition of horse breeding on the property, with a number of successful race horses being reared during Cleeve's ownership (see Figure 2.9). During their ownership a number of changes were made to the property.

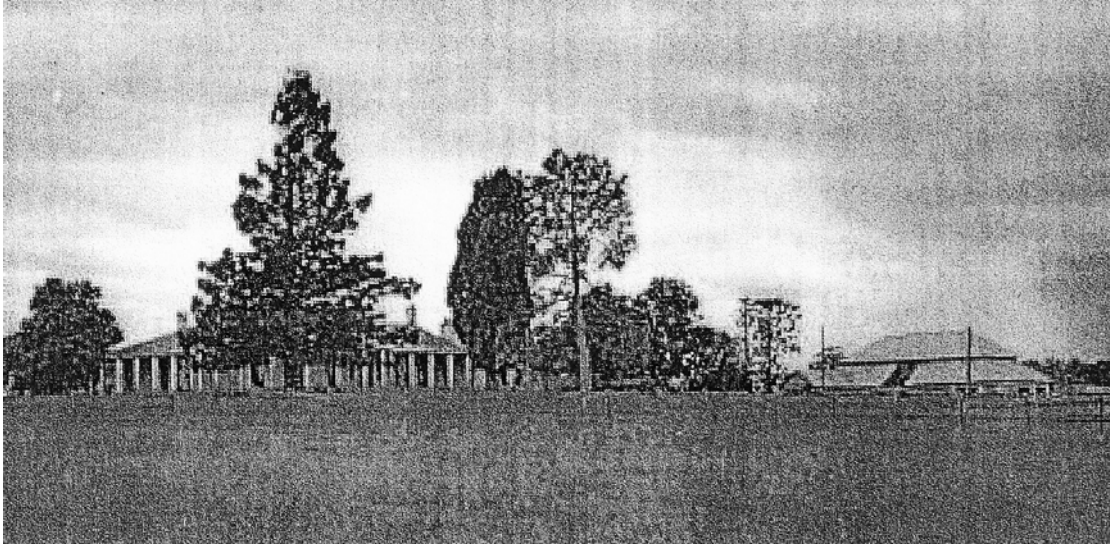
**Figure 2.10** Photograph c1940s of the house and barn showing the spatial relationship between the two buildings. A number of the trees in this image, including the tall Hoop pine in front of the house, are still present on the site. (Source: Kell and Kitson)

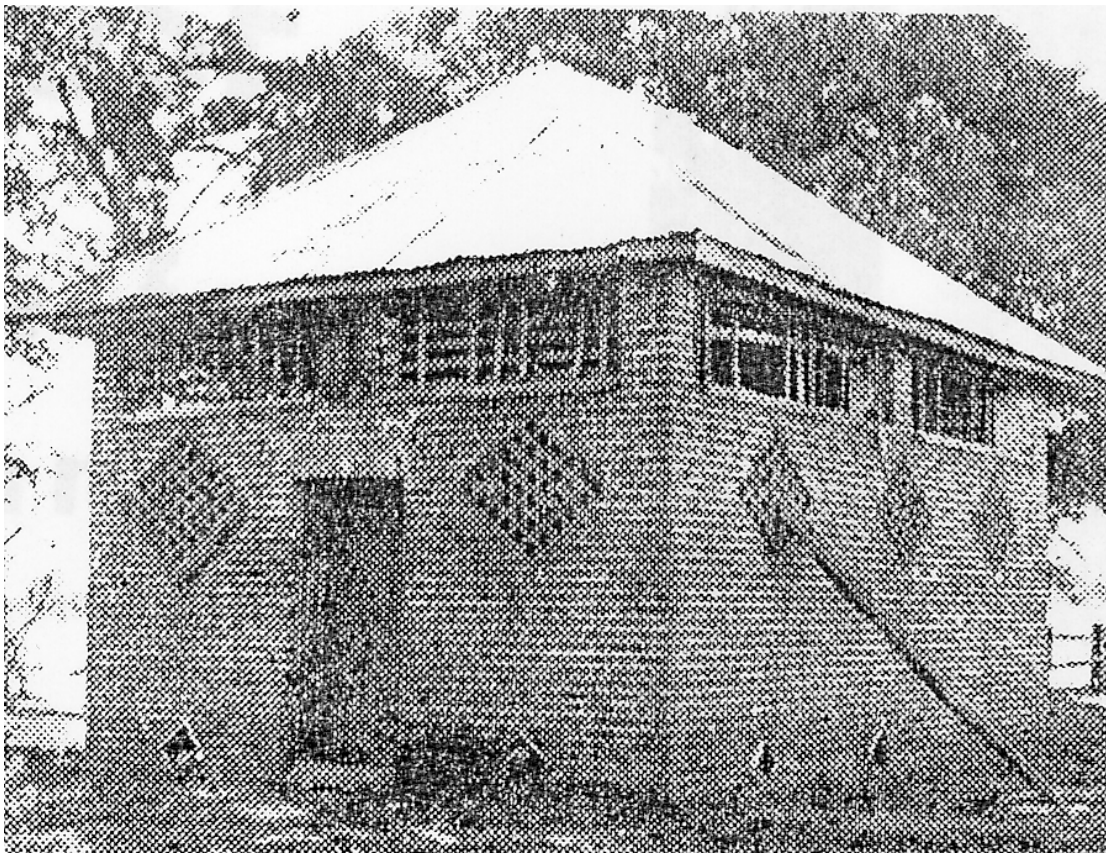
**Figure 2.13** The meat house or slaughter house near the barn in 1950. The detail of the brick work is similar to the barn detailing. This was one of a number of outbuildings on the Bungarrabee estate dating from its earliest European occupation. (Source: Blacktown Library)

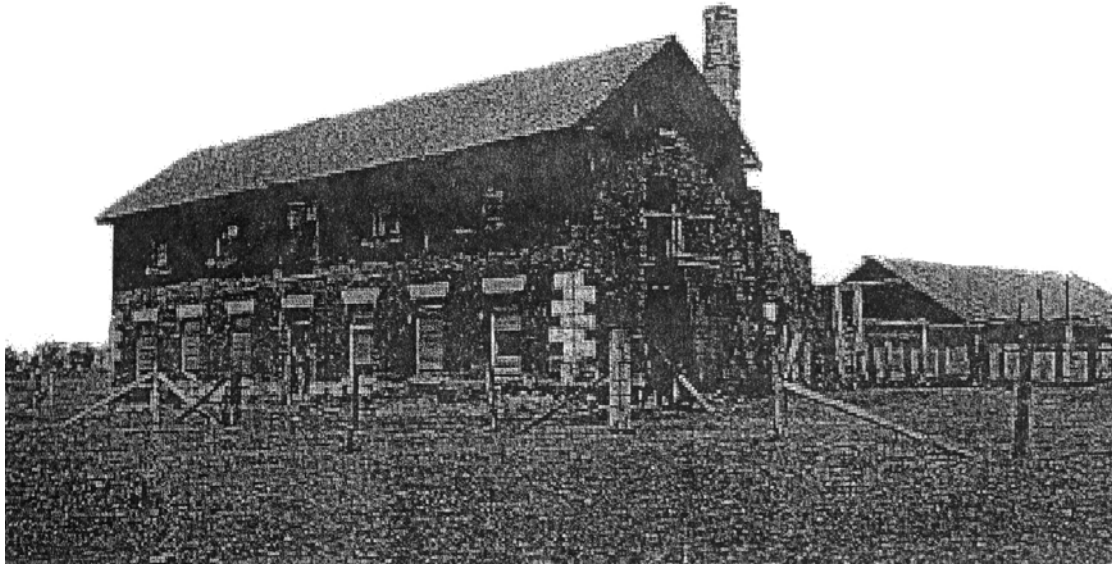
**Figure 2.14** An unidentified outbuilding at Bungarribee, possibly a large stable with hay loft. The size and solid nature of the construction give some indication to the activity generated by the estate. (Source: Blacktown Historical Society)

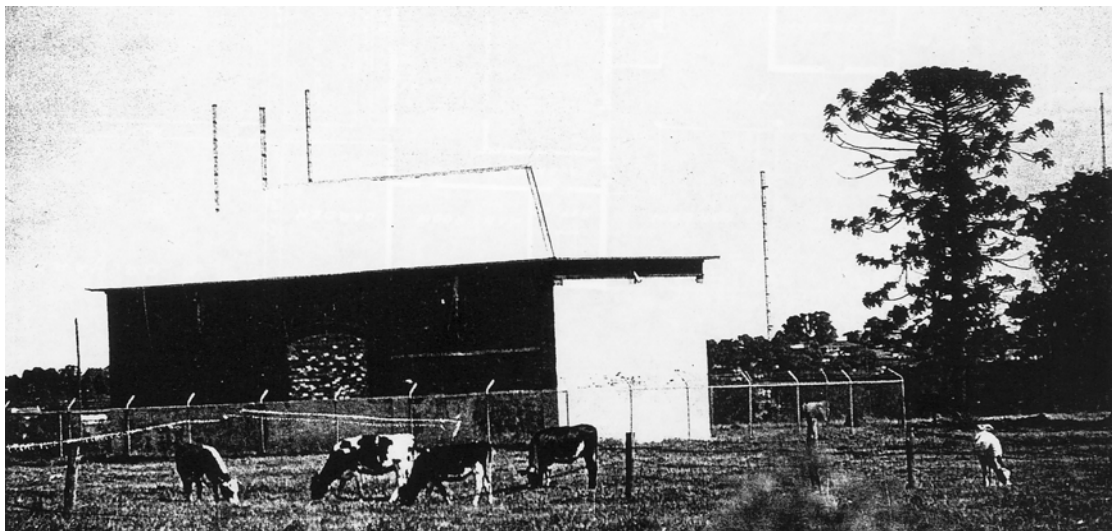
**Figure 2.15** The Barn c1960. The barn has been stripped back, the wings removed by the OTC and the door bricked up. In the background the OTC towers can be seen. Local farmers were permitted to graze their cattle on the site after the OTC resumed the property. Note the Bunya pine to the right of the picture which remains on site today. (Source: OTC Archive)

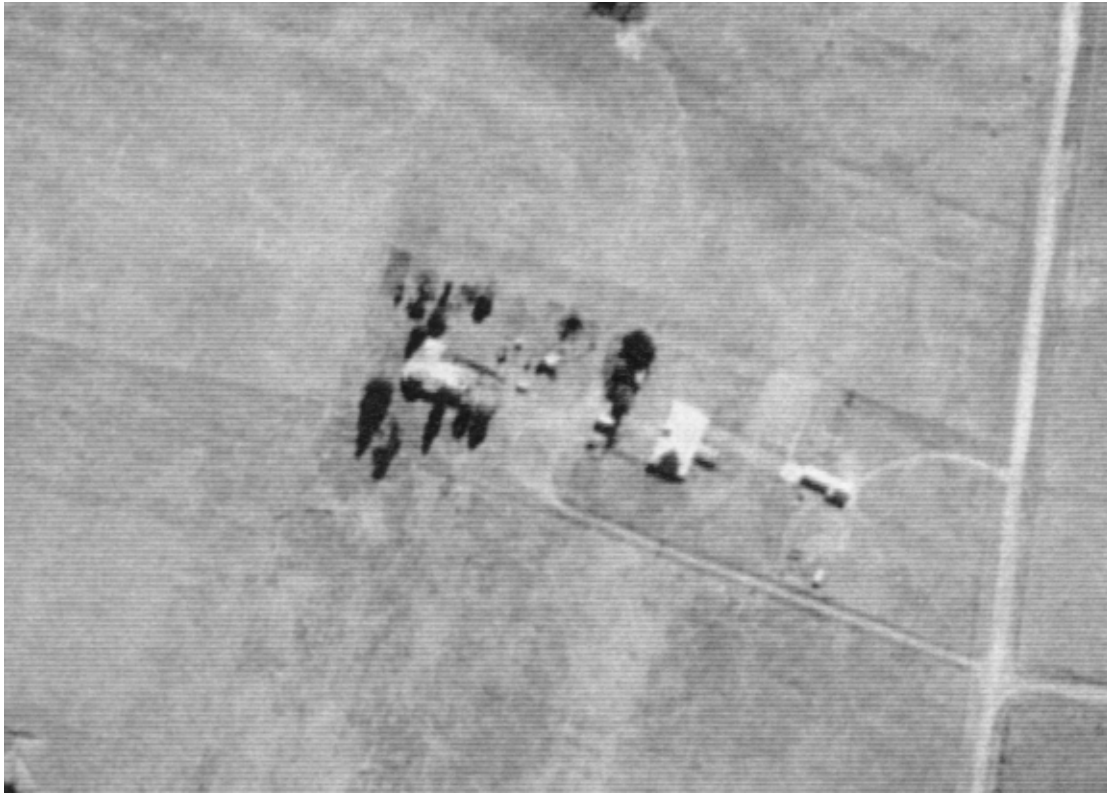
**Figure 2.16** 1951 aerial photograph of the Bungarabee House with the surviving barn and some outbuildings. The rectangular building to the right is a dairy built c1920 close to the site of the earlier convict barracks. (Source: Land and Property Information)

There are two areas of extant concrete slabs within this portion, likely to be associated with OTC use and occupation. The larger slab, located in the north of this portion, consists of a rectangular concrete slab measuring approximately 18m x 11m, with a lower 3m wide slab surrounding the main slab on its north, eastern and southern sides (see Figures 3.3 and 3.4). This concrete slab is likely to be the location of the Bungarribee barn. The barn was utilised for storage during the OTC occupation of the site until 1977 (see Section 2.3.2). The floor surface of the barn may have been resurfaced with concrete during this period. Aerial photographs dating from 1951 indicate the barn in this location (see Figures 2.16 and 3.16).

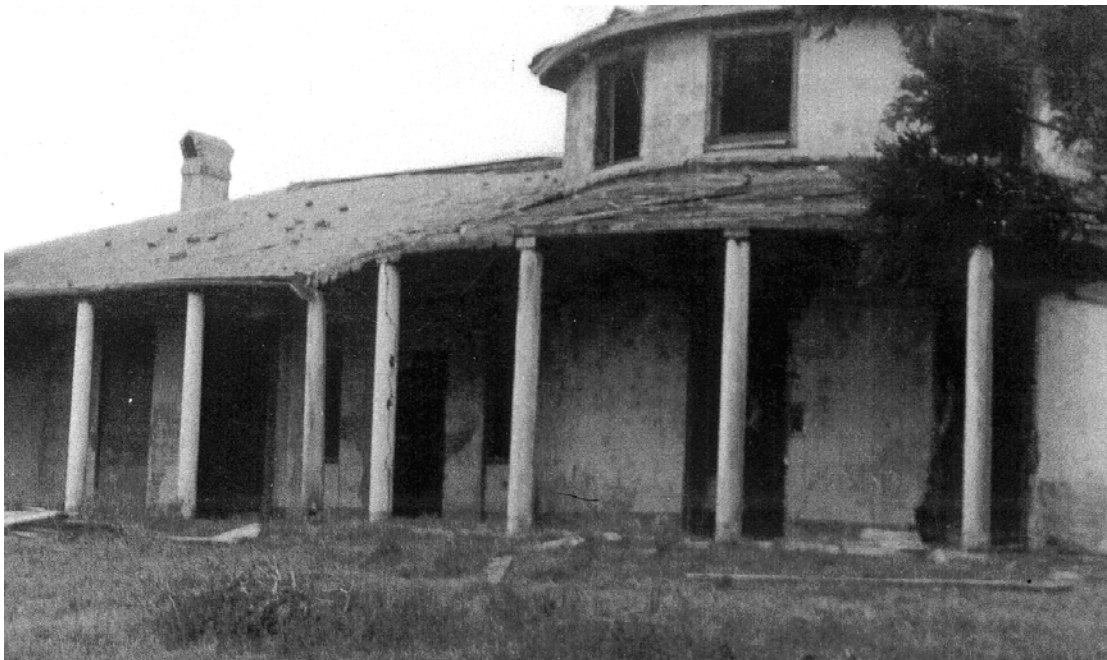
**Figure 2.17** c1954 photograph of the main house immediately prior to demolition. With no occupants the house quickly deteriorated through exposure to the weather and the removal of windows, doors and other joinery. (Source: OTC Archives)

The house, now unoccupied began to fall further into disrepair by the mid-1950s. Photographs of the site at this time show holes in the roof and missing doors and windows. Concern over its future was raised by the newly formed National Trust of Australia (NSW) and negotiations between the National Trust and OTC began in 1954 over the house's future. The founder of the National Trust, Annie Wyatt, took a personal interest in the house as she had grown up nearby and stayed in the house during her childhood.<sup>36</sup>

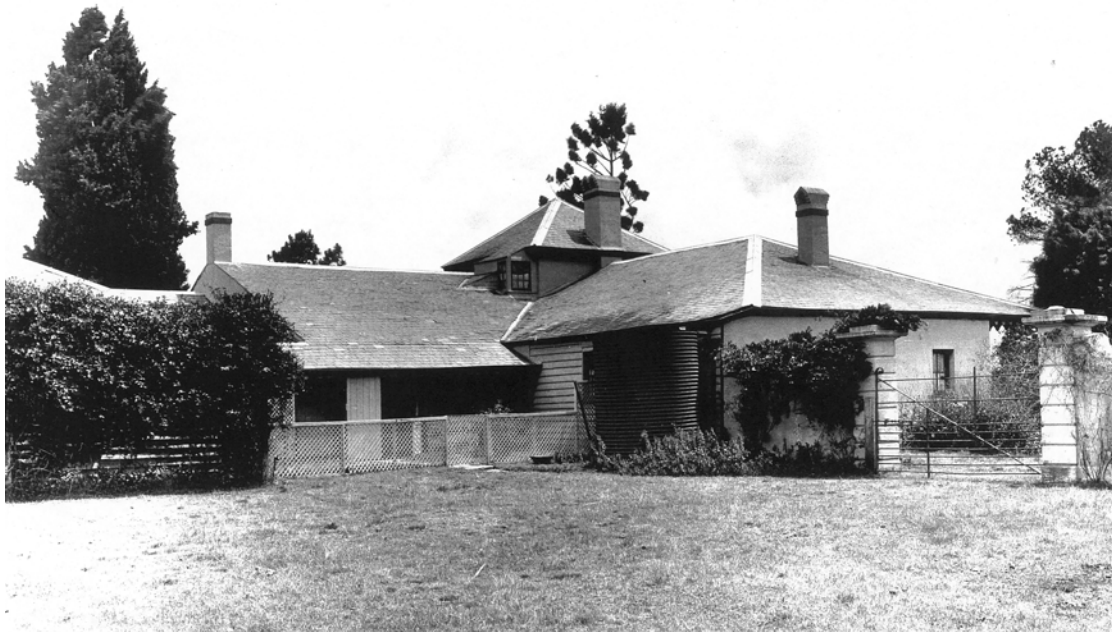
**Figure 2.18** View showing the rear of Bungarribee House in 1918. Notice the circular tower is squared at the back. (Source: Blacktown Library)

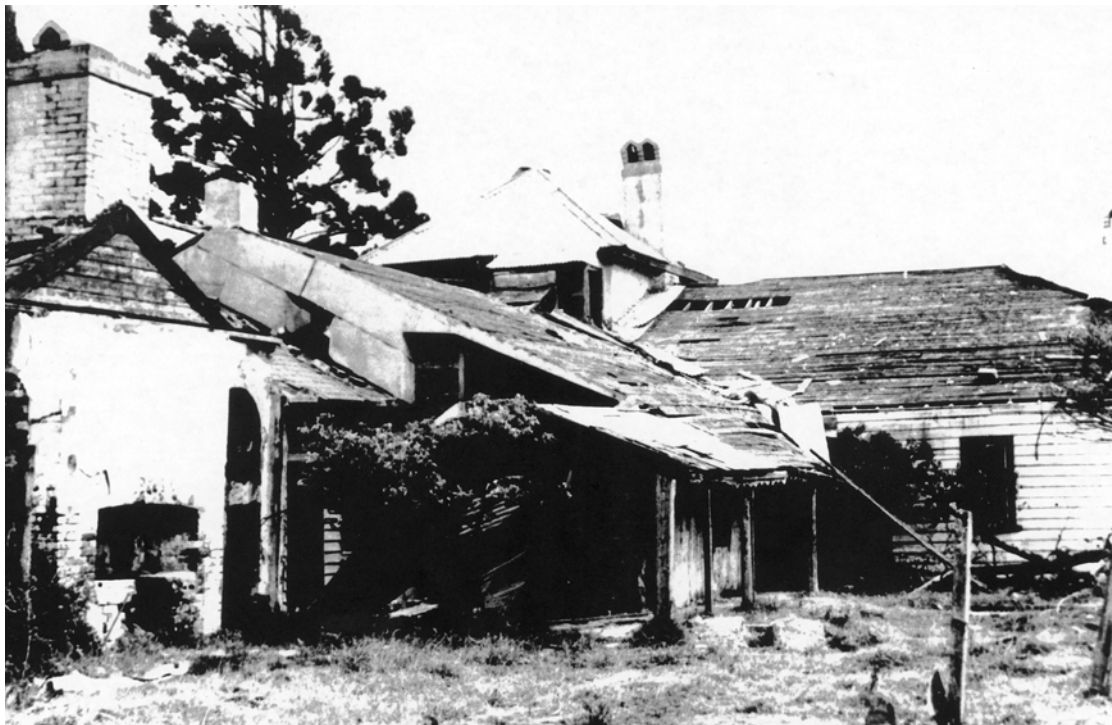
**Figure 2.19** Looking to the rear of the house in 1954 prior to demolition. Note the exposed oven in the wall on the left in what was the kitchen. The left side of the house was the original cottage built by Campbell prior to the main house being built and was later used as the servants' quarters. (Source: Mitchell Library)

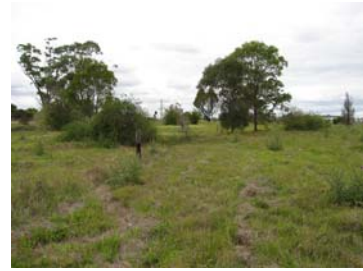
Figure 3.1 View to east showing OTC site garden plantings and fence posts.

**The eastern portion** directly adjacent to Doonside Road, was most recently utilised by the OTC for some of its staff housing (another larger OTC Staff housing area was to the north). There are no visible remains of that housing and the ground is relatively flat with some furrowing evident and a low grass and thistle cover. Fences and garden plantings mark the locations of the former housing, in addition to services and entranceways off the bitumen road (see Figures 3.1 and 3.2).

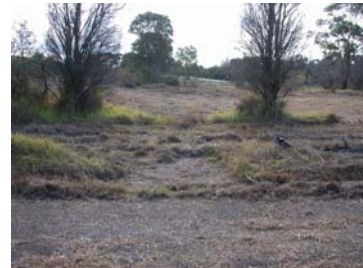
Figure 3.2 View to north showing entrance driveway into OTC house site off the bitumen road.

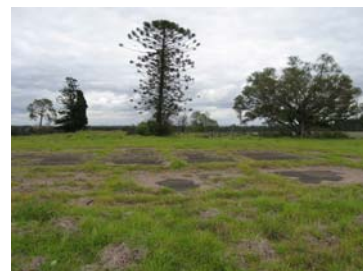
Figure 3.3 View to west showing extant concrete slab (likely to be the site of the Bungarribee barn) with the cultural plantings and uneven ground of the homestead site in the background.

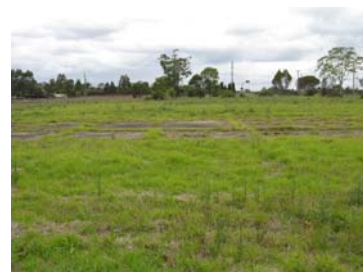
Figure 3.4 View to the east showing extant concrete slab (likely to be the site of the Bungarribee barn) with the cultural plantings of the OTC housing alongside Doonside Road in the background.

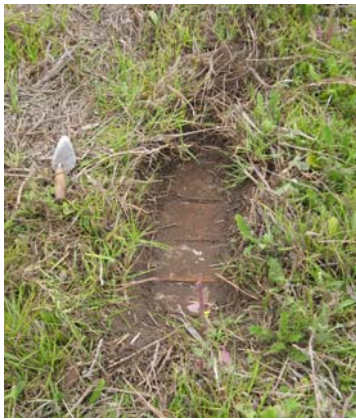
Figure 3.6 View to the east showing laid bricks, likely to be remains associated with the dairy building.

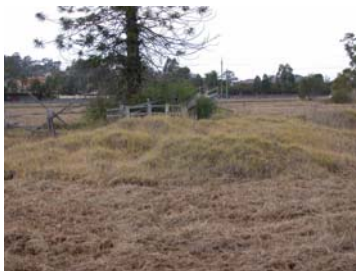
Figure 3.7 View to the northeast showing cultural tree plantings, extant stockyard remains and low grassed mound.

The central portion, to the immediate east of the site of the Homestead remains, is characterised by low grassed uneven mounds containing sandstone blocks and dips in the ground surface, indicating potential locations for remains of outbuildings. In addition, there are further cultural plantings and remains of a stockyard in this area (see Figure 3.7).

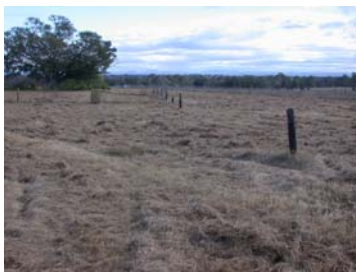
Figure 3.8 View to the west showing remains of post and rail fence along the northern edge of the site of the former Bungaribee House.

Along the northern side of the former Bungaribee House site are the remains of several fences oriented approximately southeast to northwest. These may indicate locations of early fence lines (see Figure 3.8).

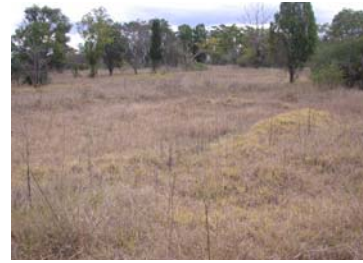
**Figure 3.9** View to north showing potential OTC house site. The rectilinear shape of the building formed by low mounds (indicating the wall footings) around a flat area can be seen.

There are several low mounds, often forming a rectilinear arrangement around a flat area, within the area between the dirt road and the western boundary trees (see Figure 3.9). These mounds may indicate the locations of the footings of

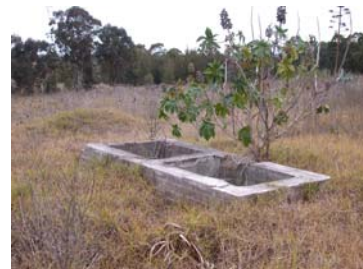
**Figure 3.12** View to the southwest showing service utilities at the northern house site.

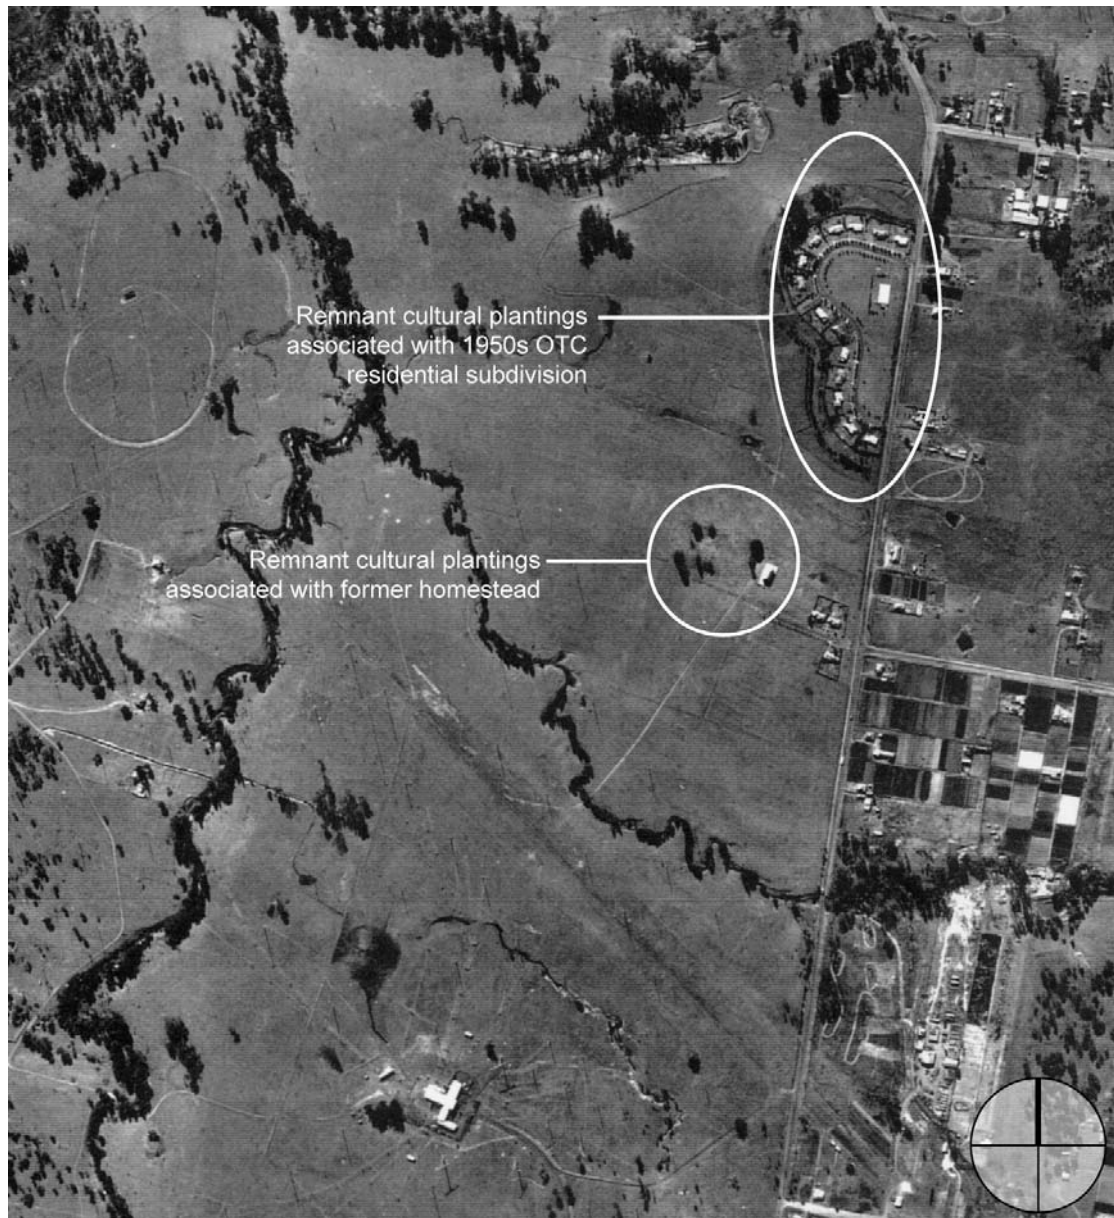
**Figure 4.16** 1970 aerial photograph showing remnant cultural vegetation associated with the former Bungarribee House site and the 1950s OTC residential subdivision.

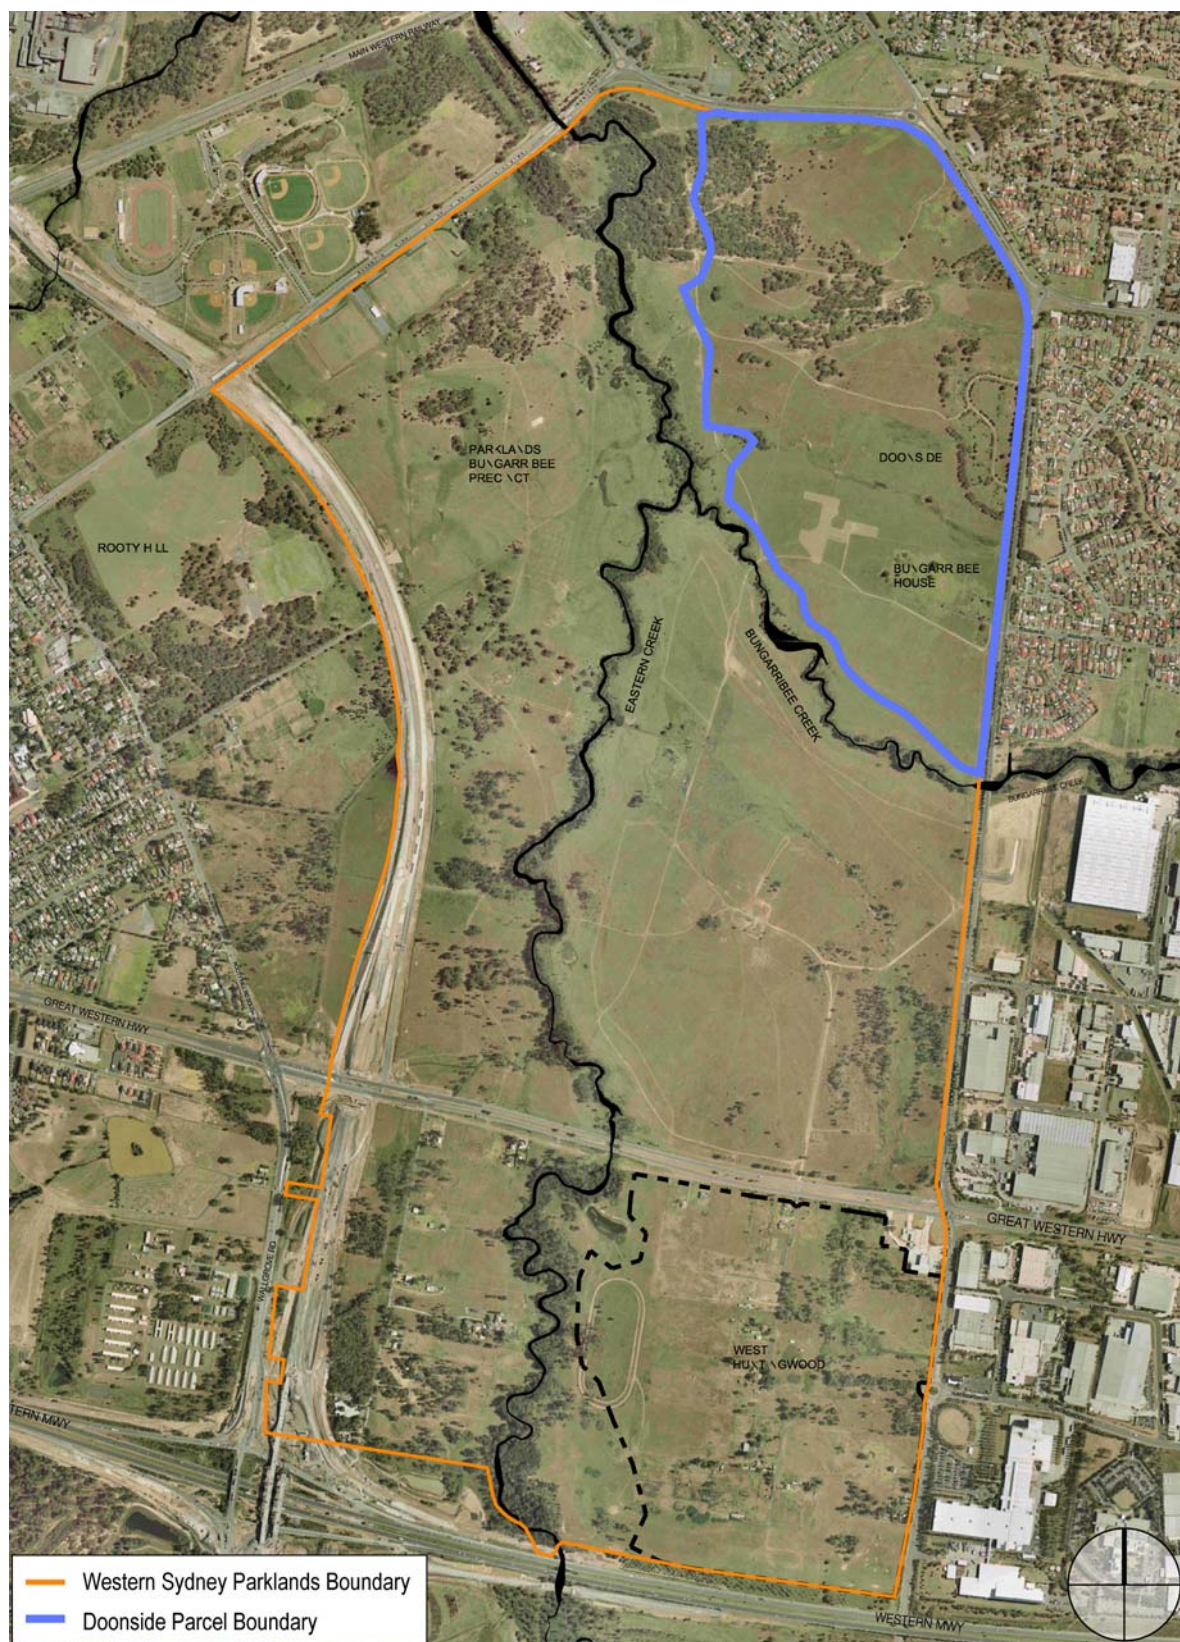
**Figure 2** Map of the Western Sydney Parklands area showing the Doonside Parcel, which is the subject of this report, in the upper right (northeast) corner. The archaeological site of the former Bungarribee House is noted as 'Bungarribee House' on the map to the west of the Douglas Street site entrance.

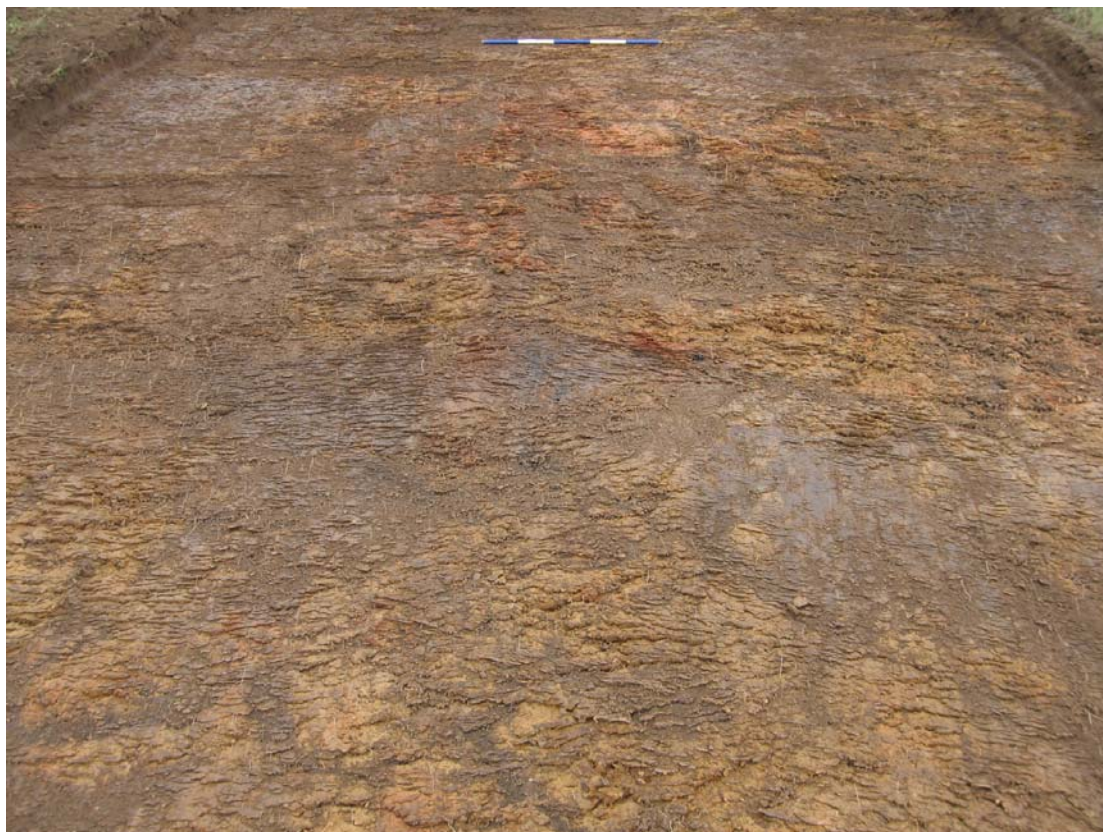
**Figure 11** Test Trench 1 view to south post-excavation showing exposed natural deposits (scale = 1m).

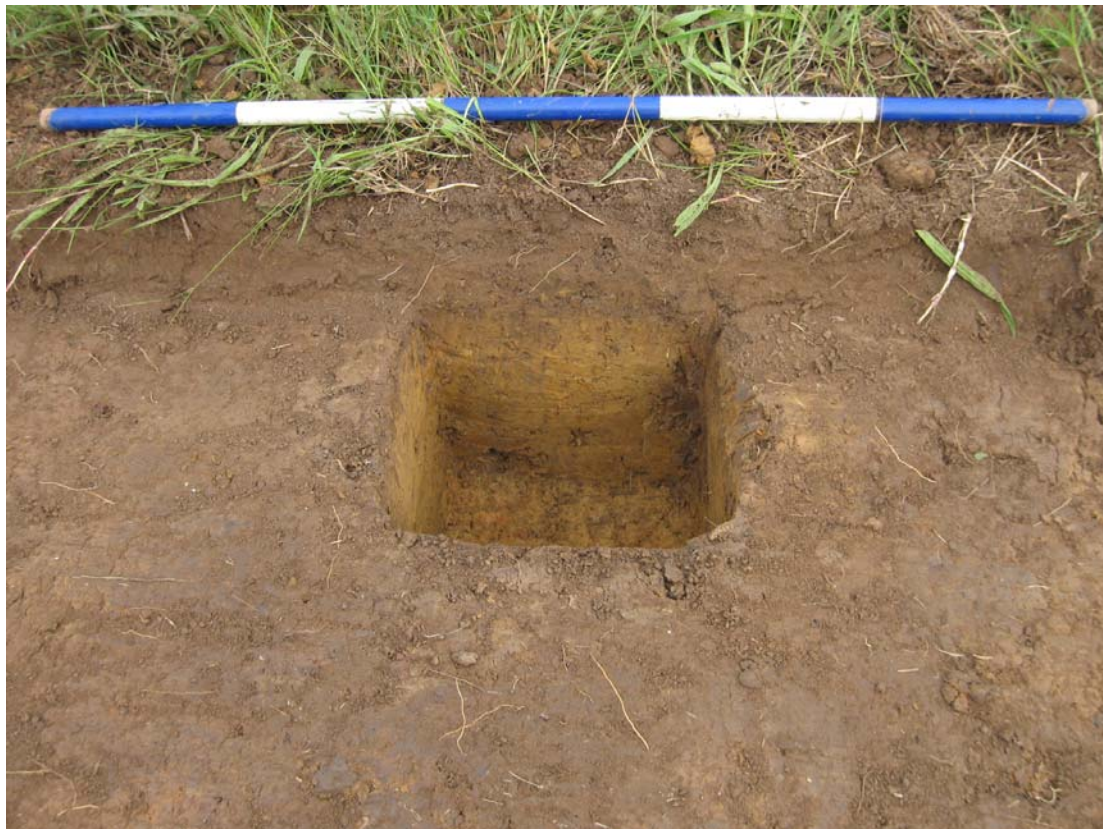
**Figure 12** Test Trench 2 view to west showing shovel pit excavated through natural deposits and section of trench (scale = 1m).

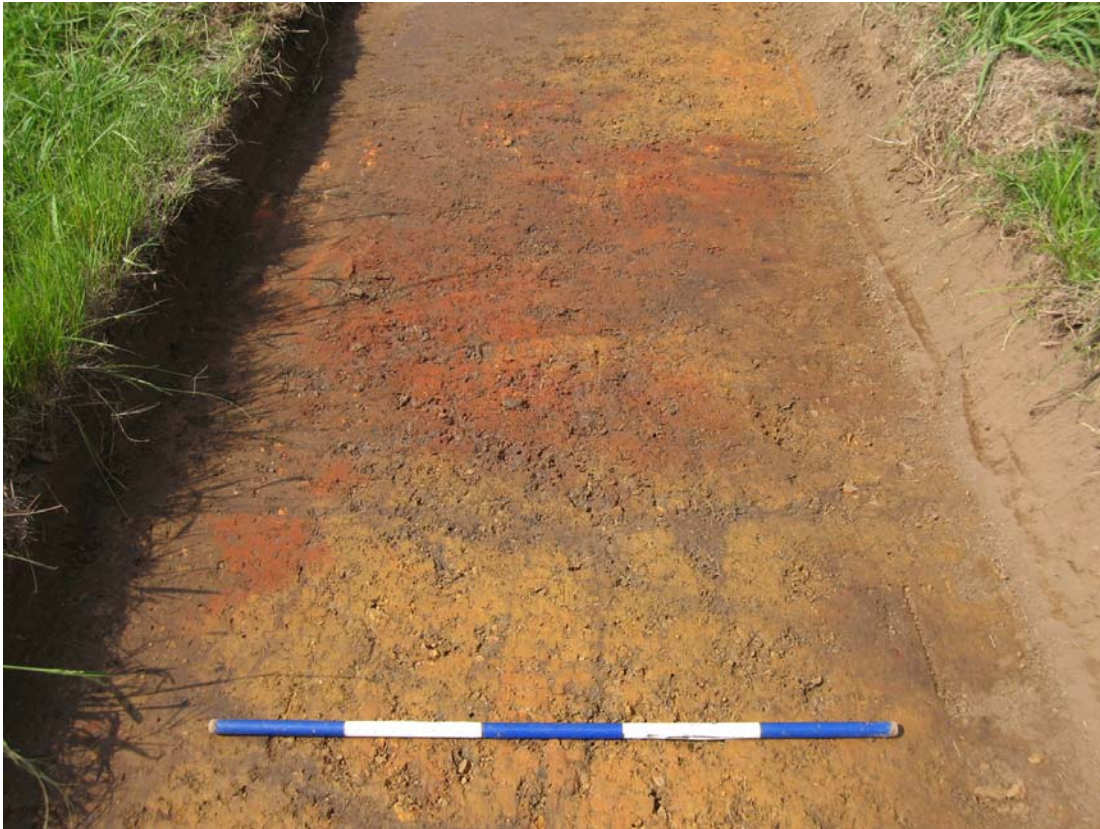
**Figure 13** Test Trench 4 view to east post-excavation showing detail of 'scorched earth' (scale = 1m).

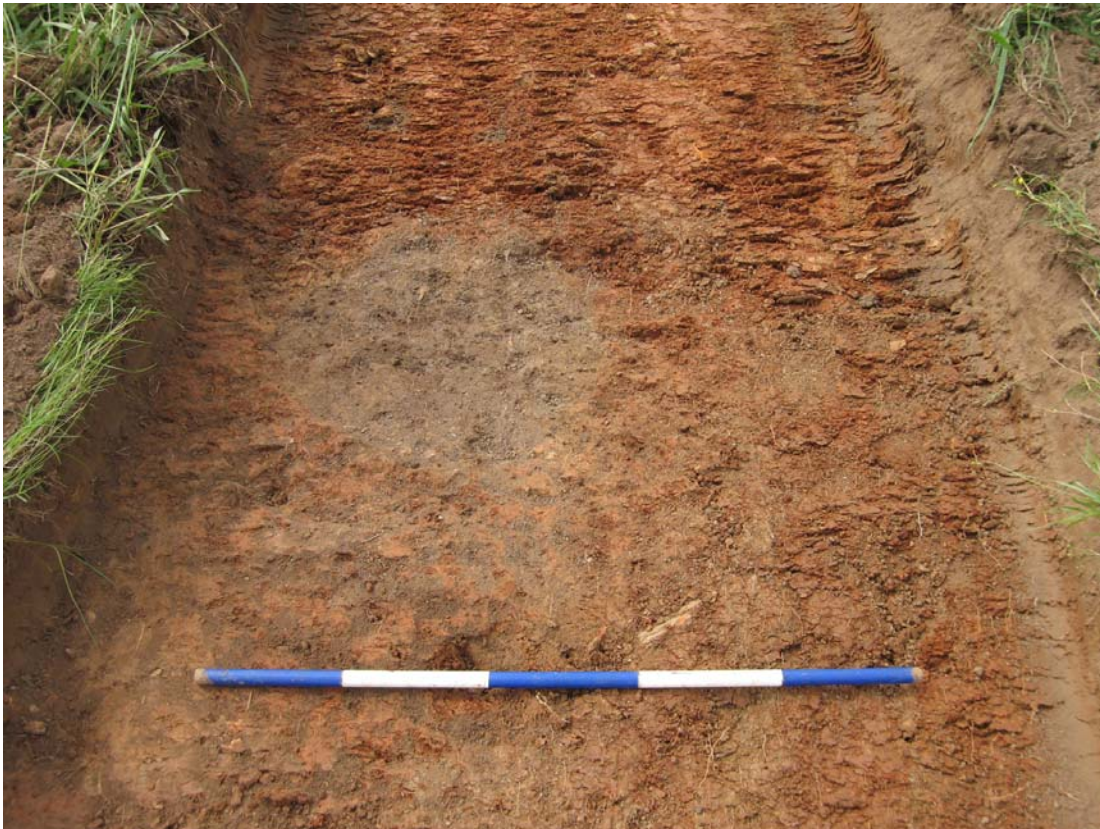
**Figure 14** Test Trench 3 view to east post-excavation showing detail of posthole (scale = 1m).

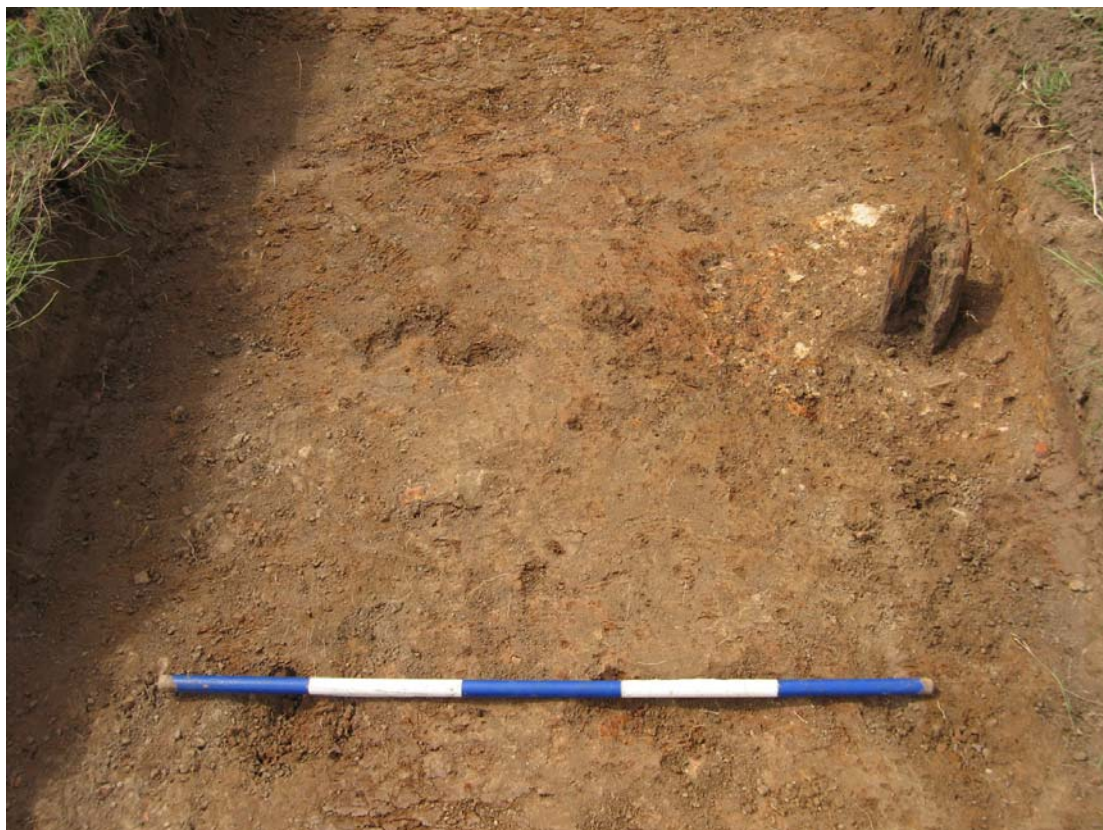
**Figure 15** Test Trench 3 view to east post-excavation showing detail of posthole with remnant post (scale = 1m).
