# Doonside Residential Parcel, Western Sydney Parklands Conservation Management Plan

Report prepared for Landcom  
May 2007

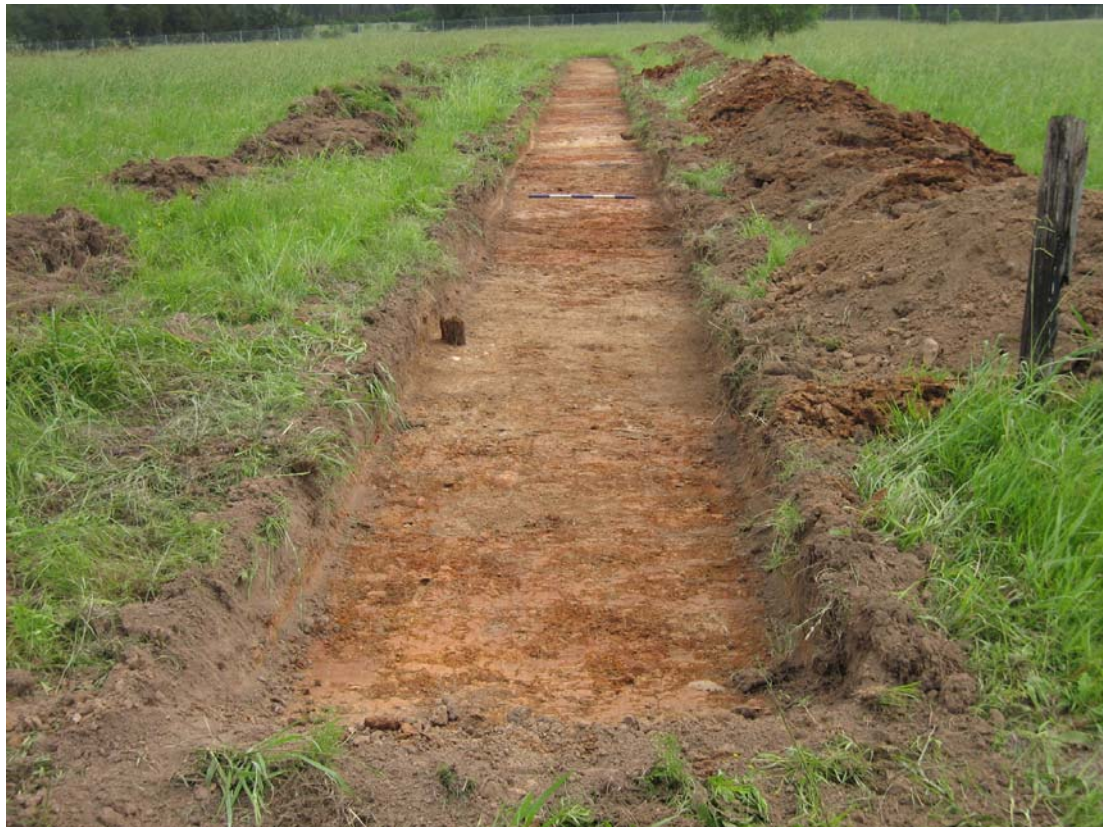
**Figure 16** Test Trench 3 view to west post-excavation showing detail of posthole at eastern end of trench and extant post to north of trench (scale = 1m).

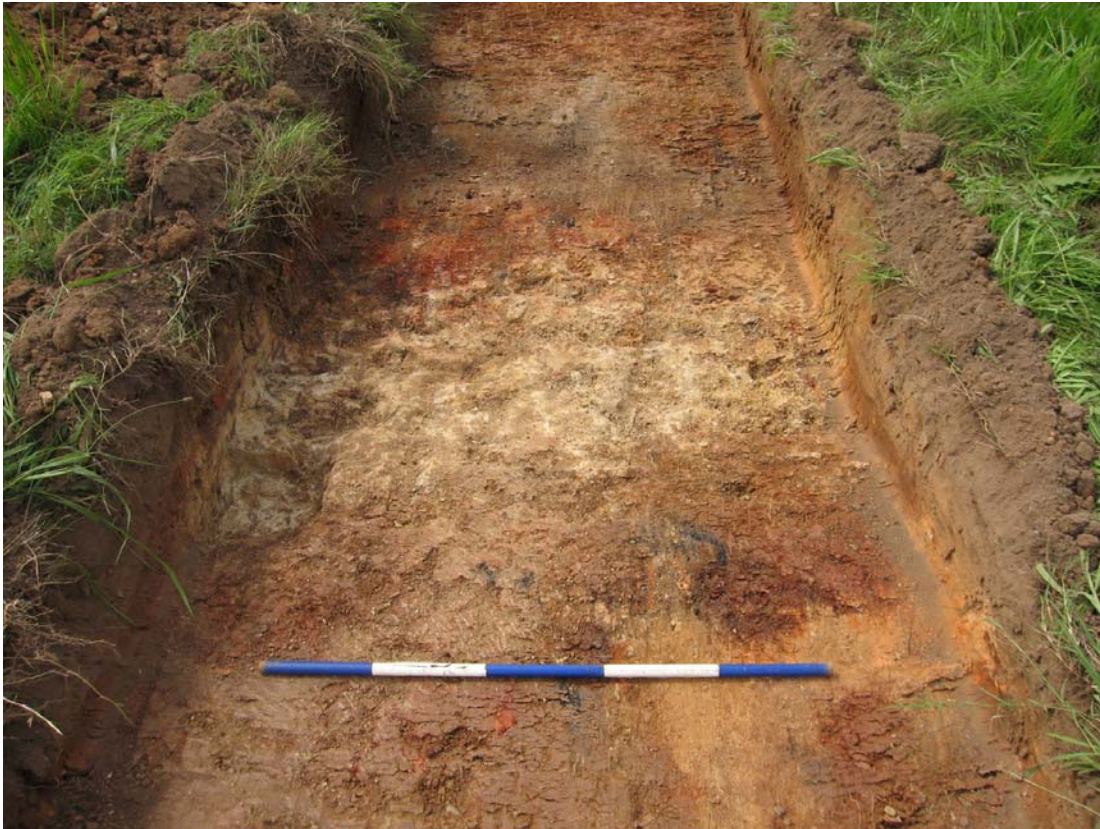
**Figure 17** Test Trench 3 view to east post-excavation showing detail of service trench (scale = 1m).

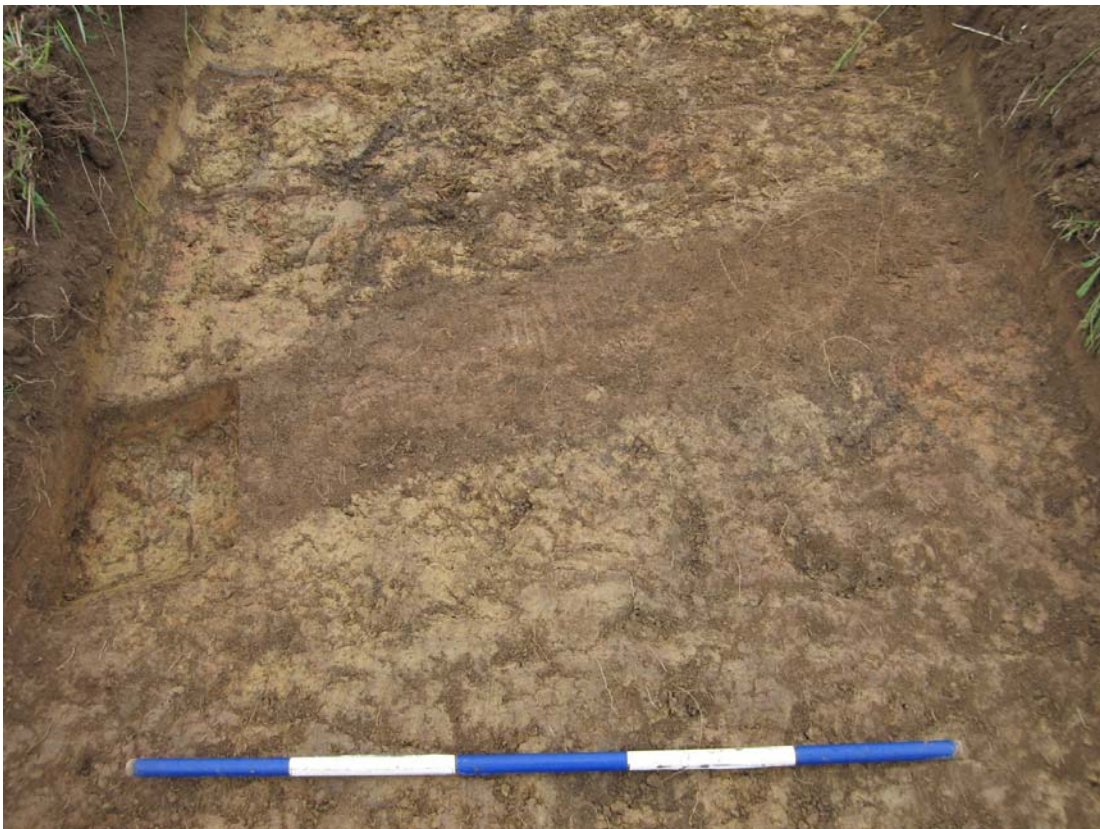
**Figure 18** Test Trench 4 view to east post-excavation showing detail of channel (scale = 1m).

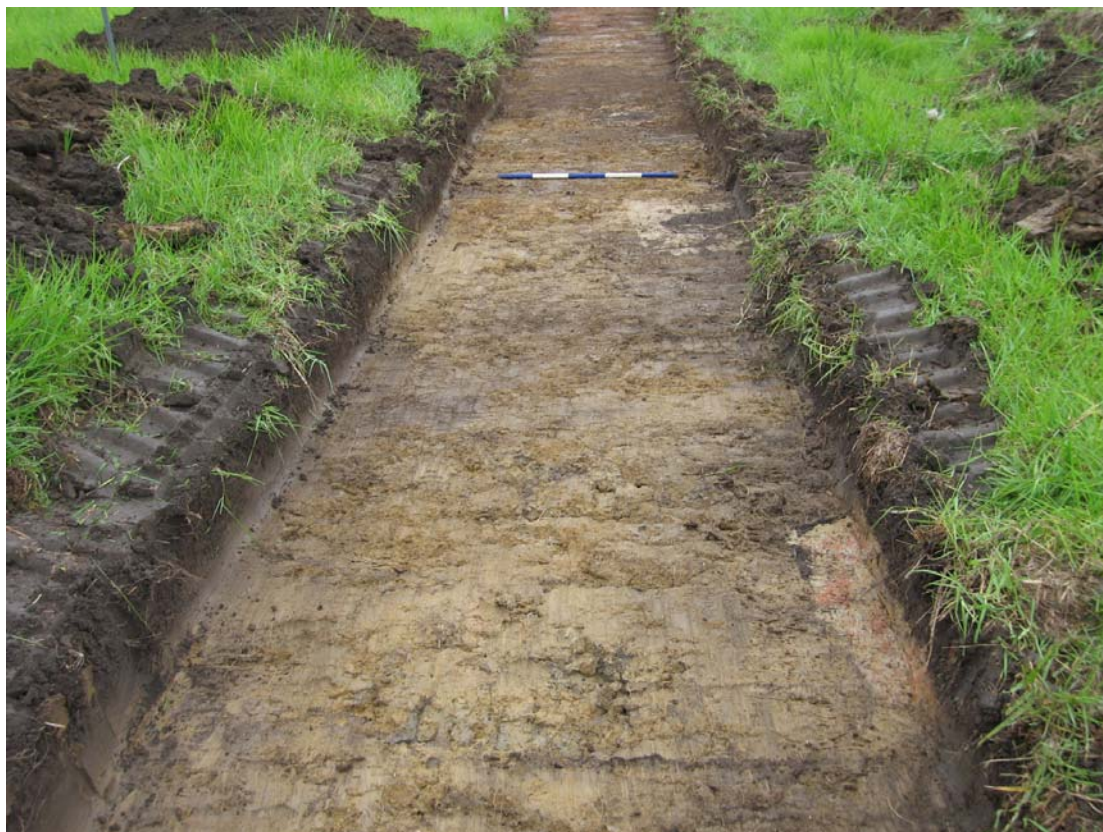
**Figure 19** Test Trench 4 view to east post-excavation showing row of three postholes (scale = 1m).

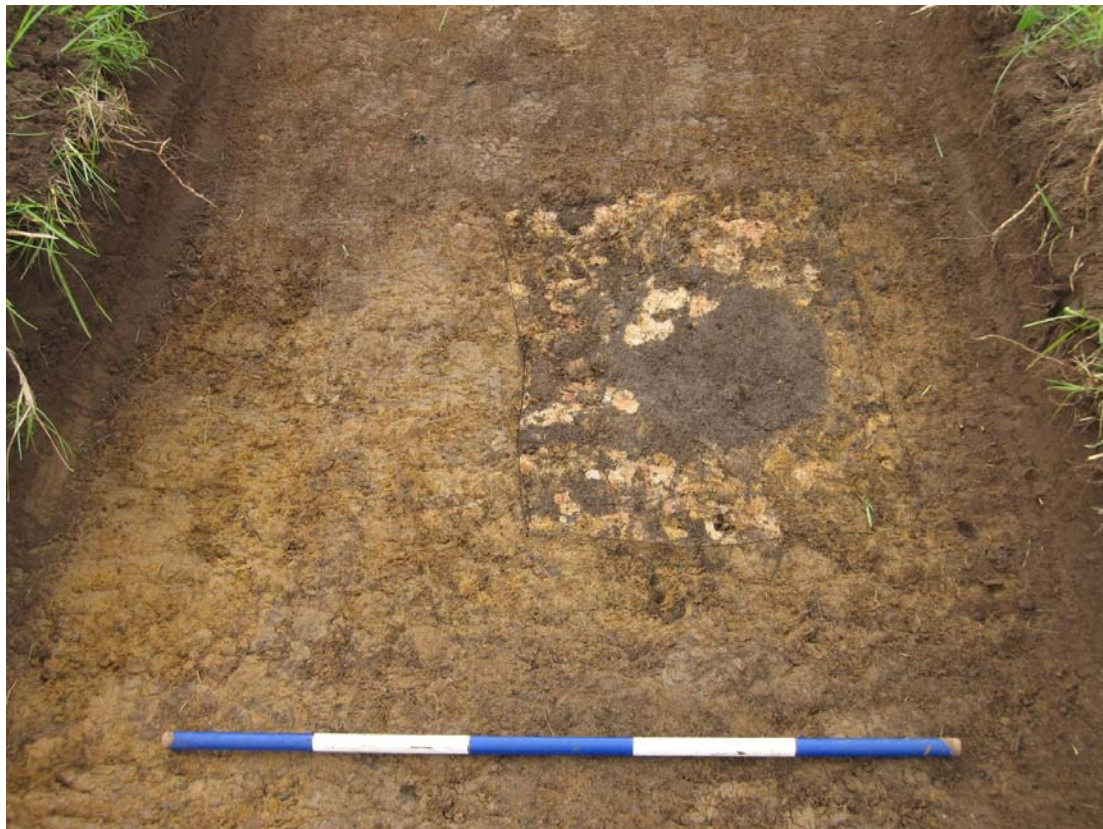
**Figure 20** Test Trench 4 view to east post-excavation showing detail of posthole (scale = 1m).
