Godden Mackay Logan

Doonside Residential Parcel and Parklands Bungarribee Precinct, Western Sydney Parklands Heritage Impact Statement

Report prepared for Landcom
August 2007

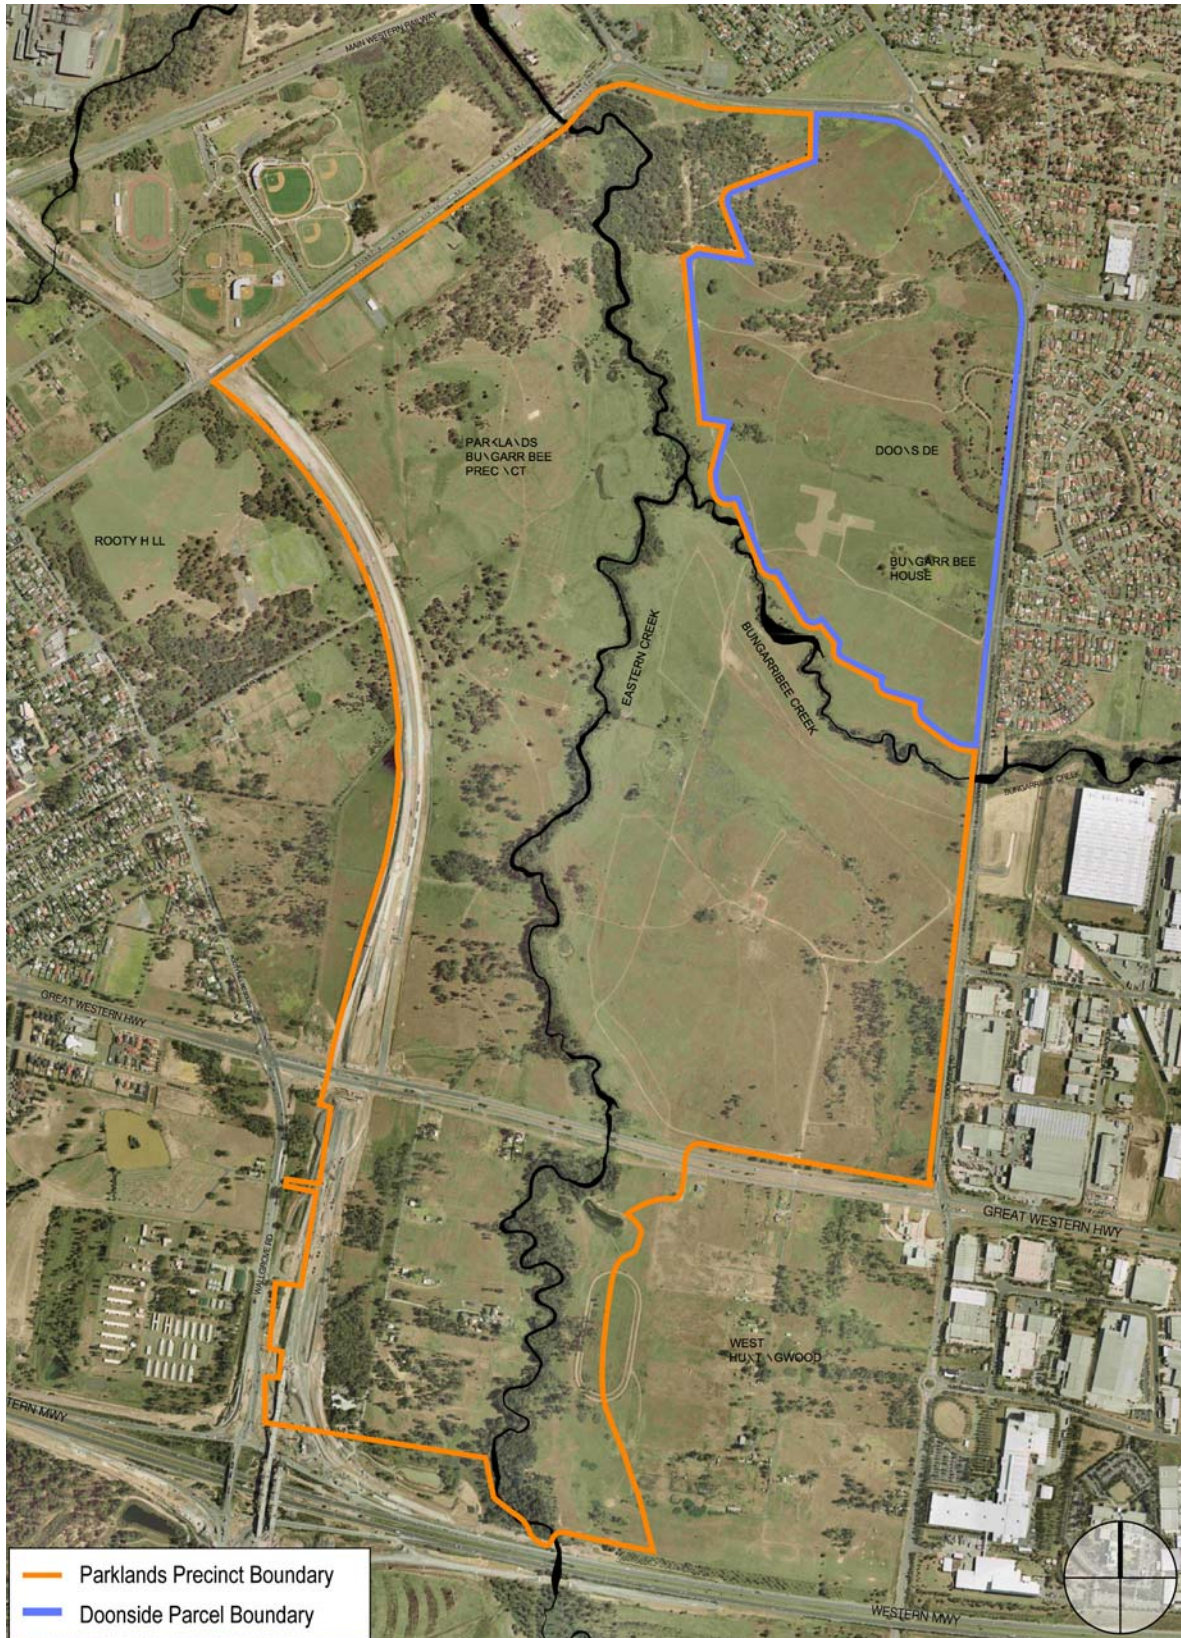
Figure 1.1 Aerial view of the Western Sydney Parklands area showing the location of the Doonside Parcel and the Parklands Precinct.

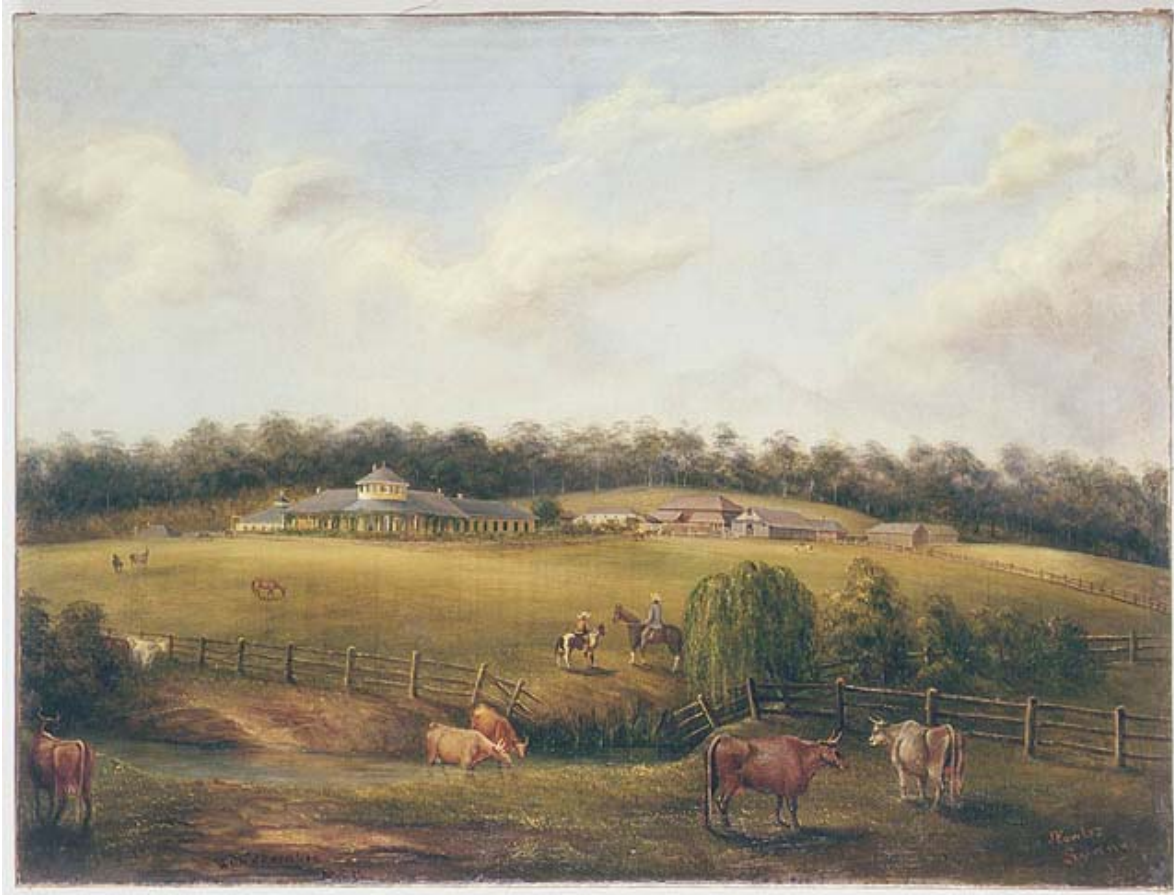
Figure 2.2 Joseph Fowles' painting of Bungaribee House during the occupation of the East India Company in the 1850s. This view, looking from the south near the junction of Eastern Creek and Bungaribee Creek, shows the house prominent on the ridge, with an extensive collection of outbuildings extending east towards present day Doonside Road. The house was clearly visible from the Western Road (Great Western Highway) and was a landmark to travellers along it. (Source: Mitchell Library)

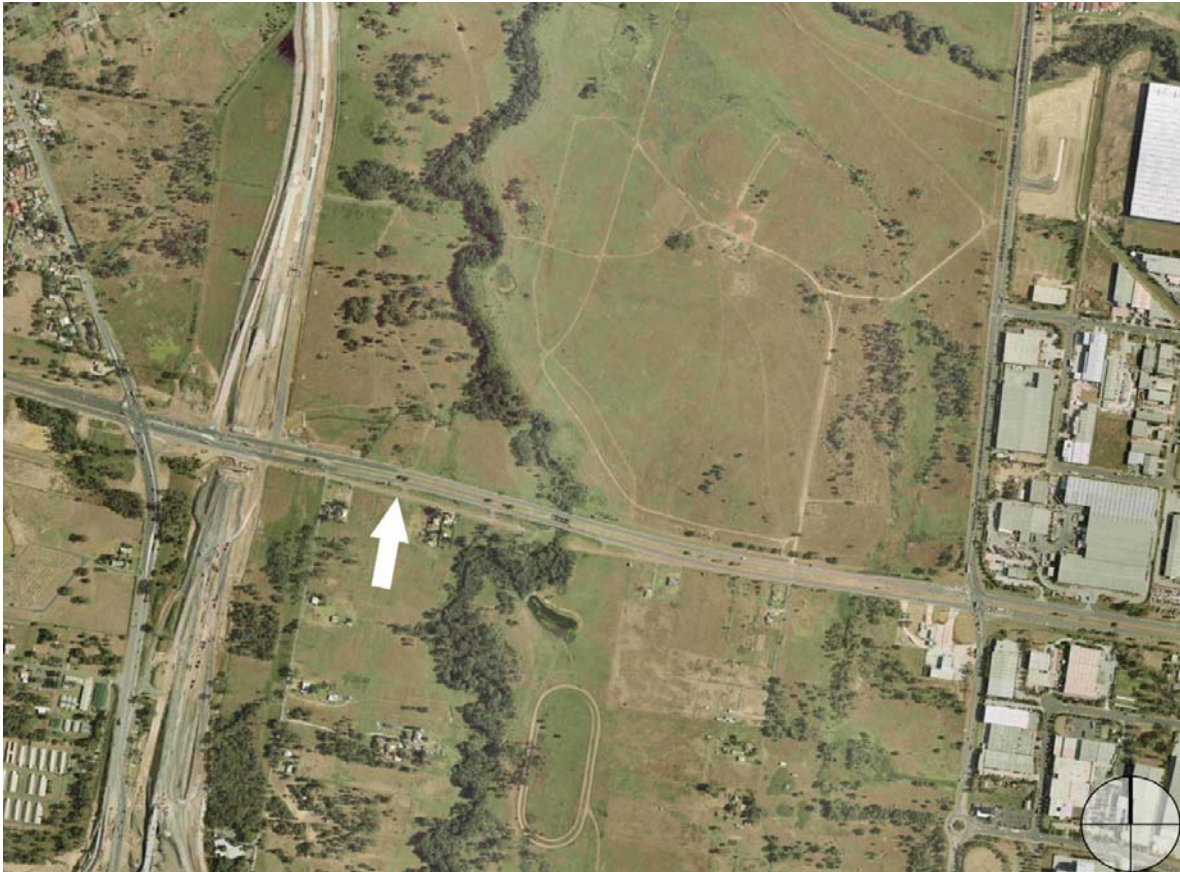
Figure 2.10 2006 aerial photograph of the Great Western Highway near the junction with the new M7 motorway, which marks the western edge of the study area. The arrow indicates the former Western Road alignment. Directly opposite was the site of the Garrison/Hollinsworth house, and is the site of the existing brick cistern/well which may date to the garrison period. Comparison to Figures 2.7 and 2.8 show the effect of the widening of the highway and the demolition of most buildings on the southern side of the road. (Source: Department of Lands)

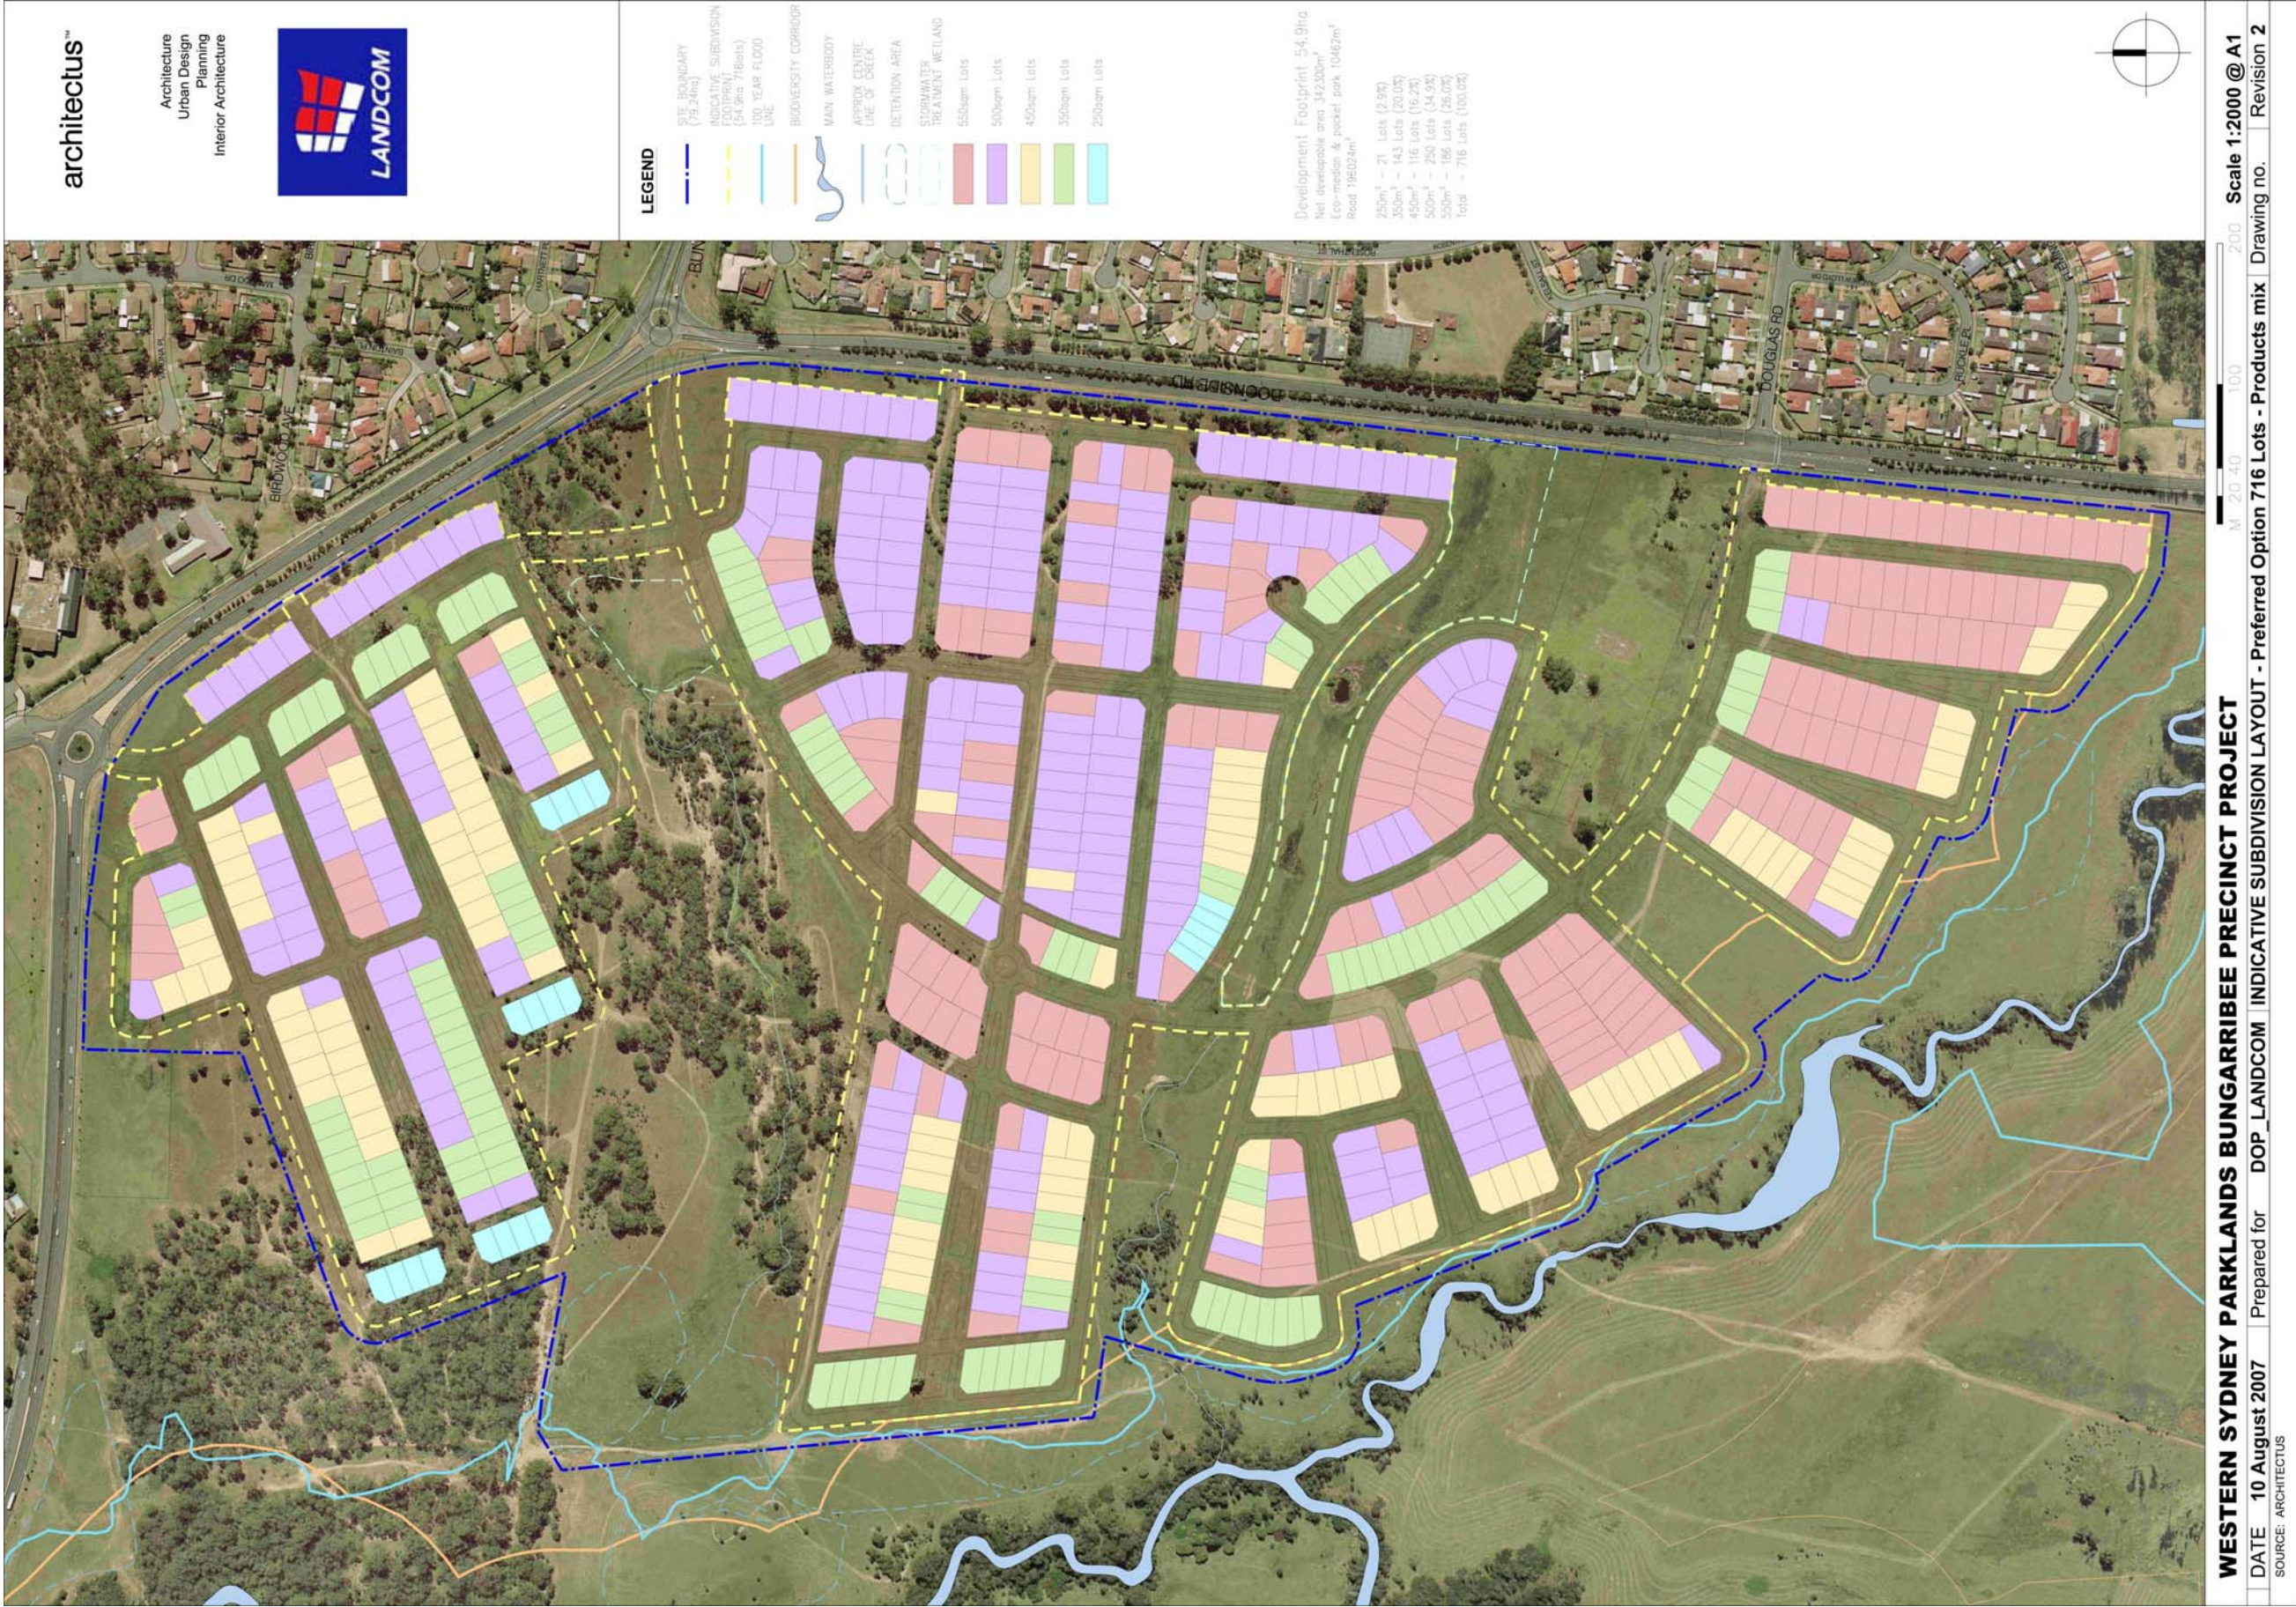
Figure 3.1 Proposed Concept Layout Plan showing the proposed subdivision of the Doonside Parcel.

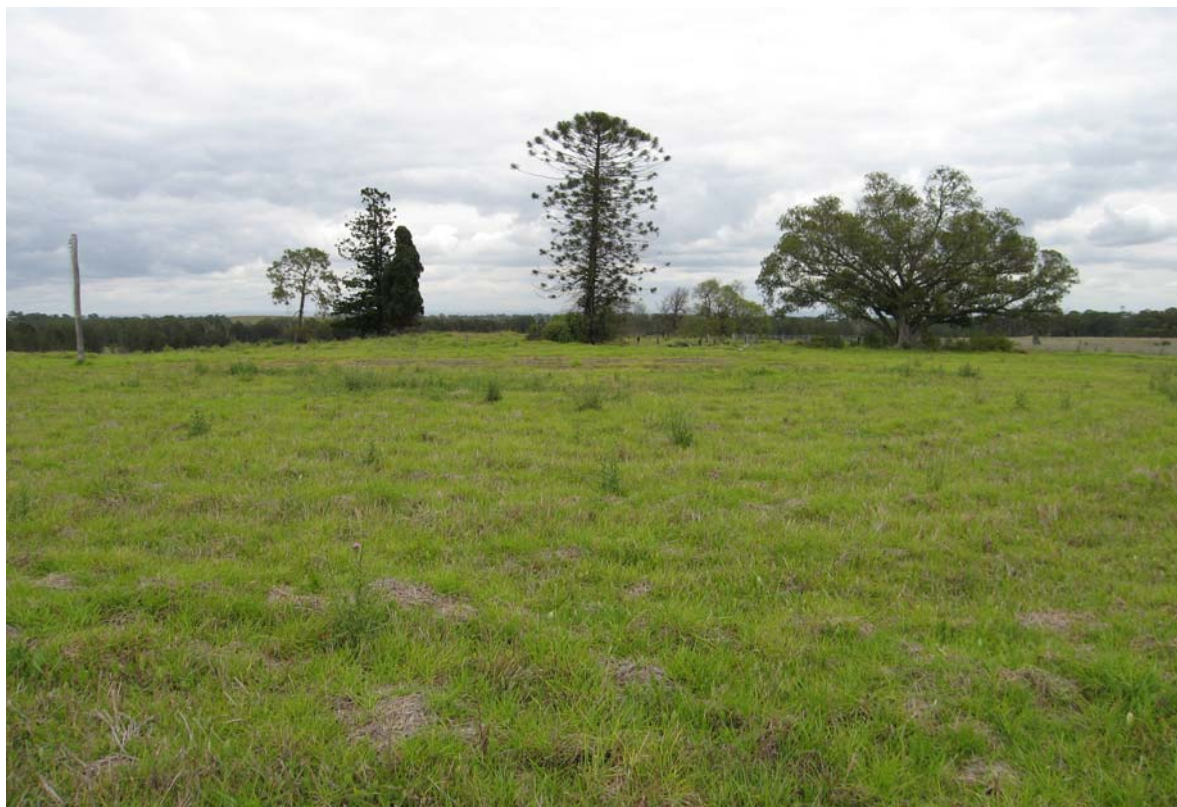
Figure 4.9 View looking west across the former Bungaribee House site. Note the Bunya pine in the middle of the picture and the Port Jackson fig to its immediate right which mark the eastern boundary of the former stockyard.

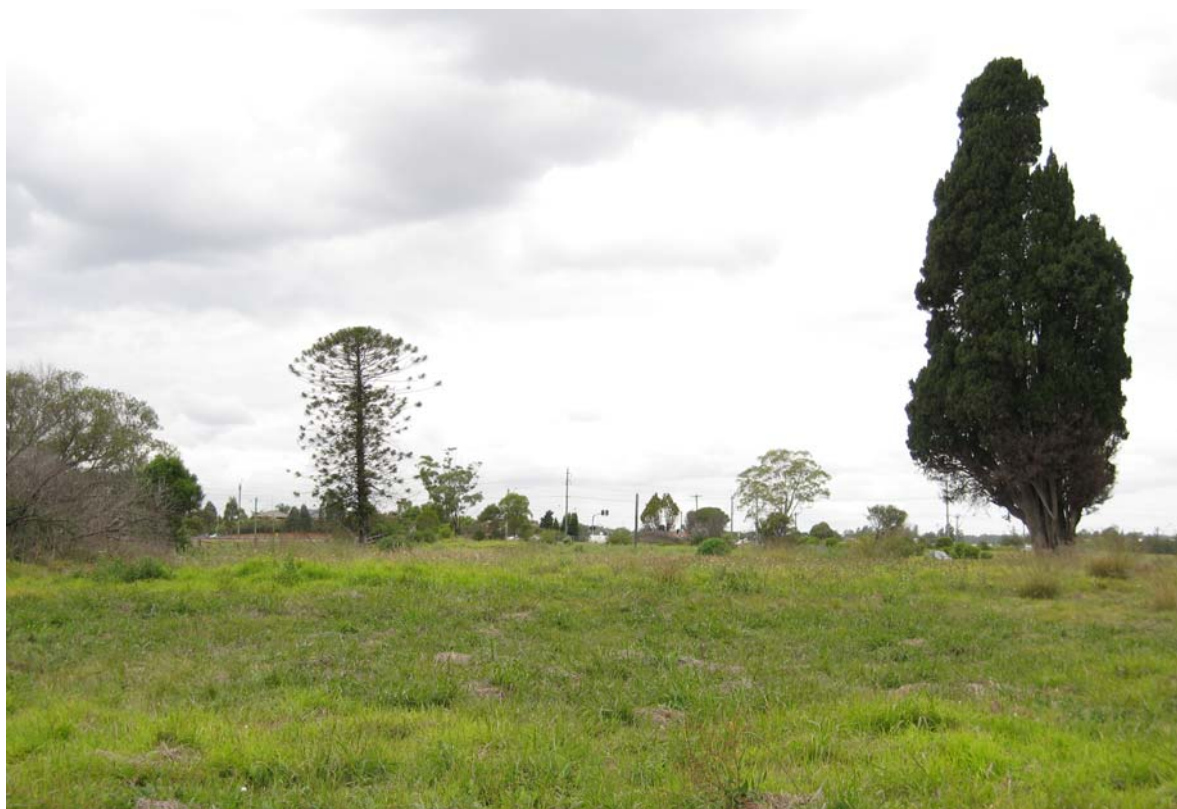
Figure 4.10 View looking east across the former Bungaribee House site. Note the Mediterranean cypress pine to the far right of the picture which marks the southeast corner of the former homestead.

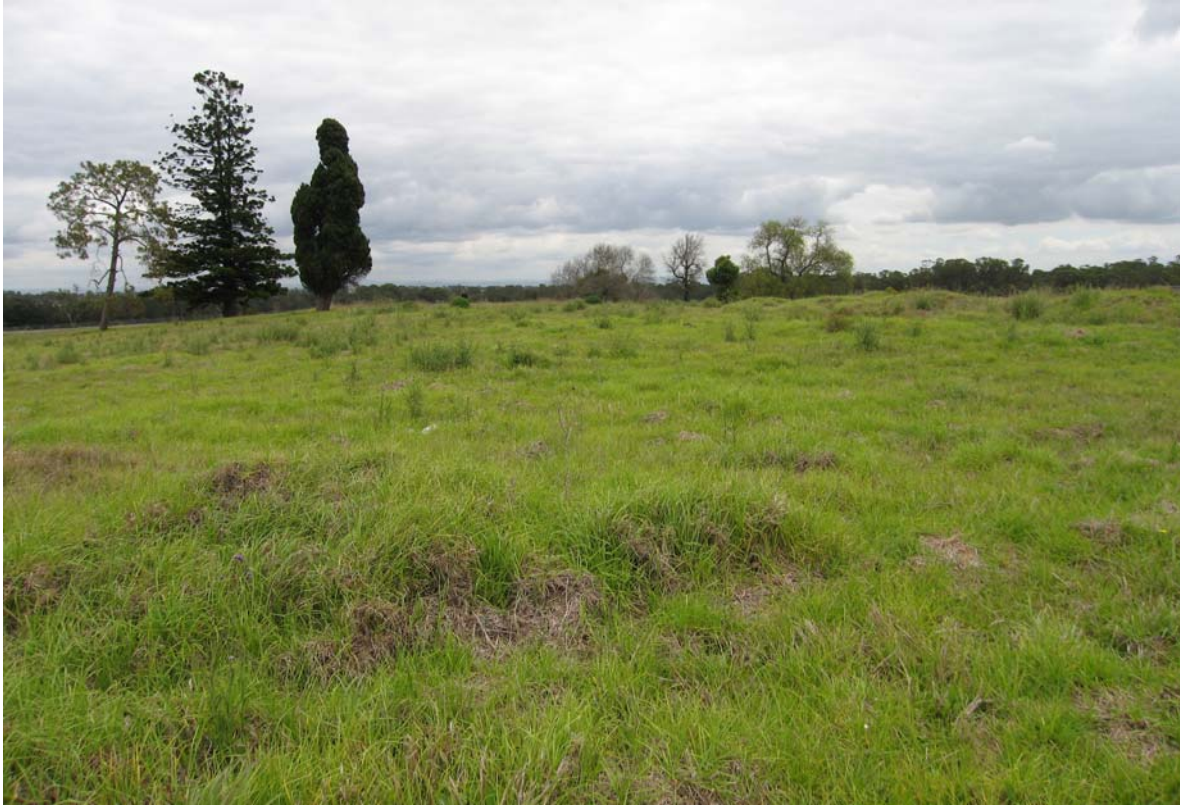
Figure 4.11 View looking northwest across the former Bungarribee House site. Note the group of cultural plantings to the left of the picture which mark the southern boundary of the former homestead.

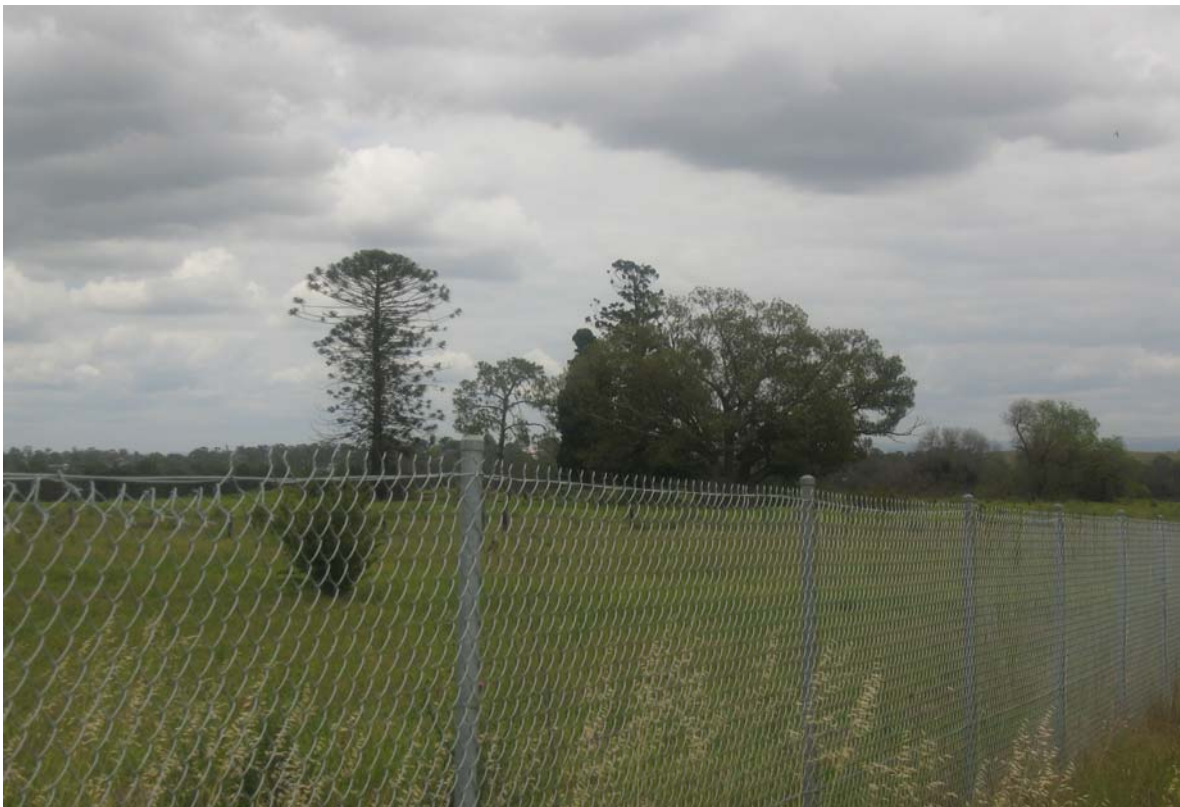
Figure 4.12 View looking southwest across the former Bungarribee House site. Note the Port Jackson fig and Bunya pine in the middle distance.

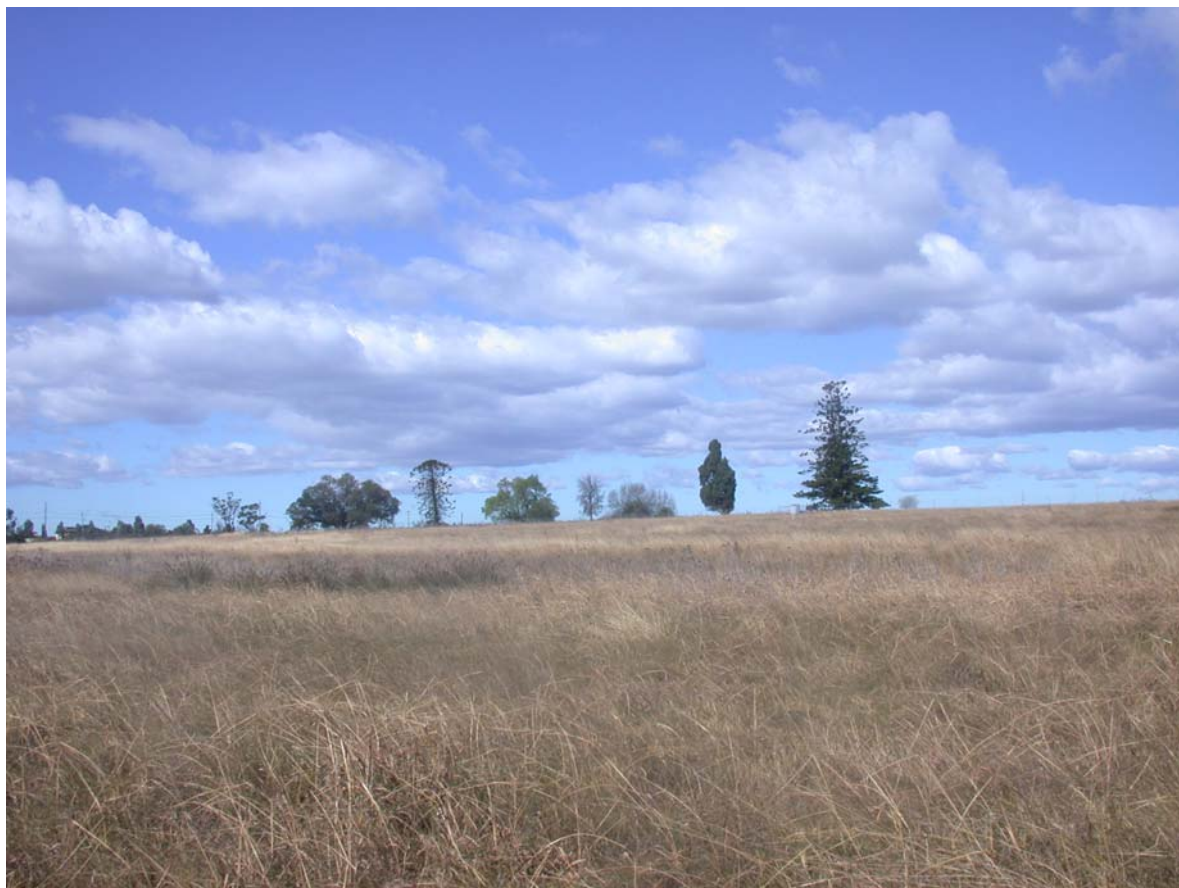
Figure 4.13 View looking southeast across the former Bungarribee House site. Note the Hoop pine to the middle right of the picture marks the southwest corner of the former homestead.

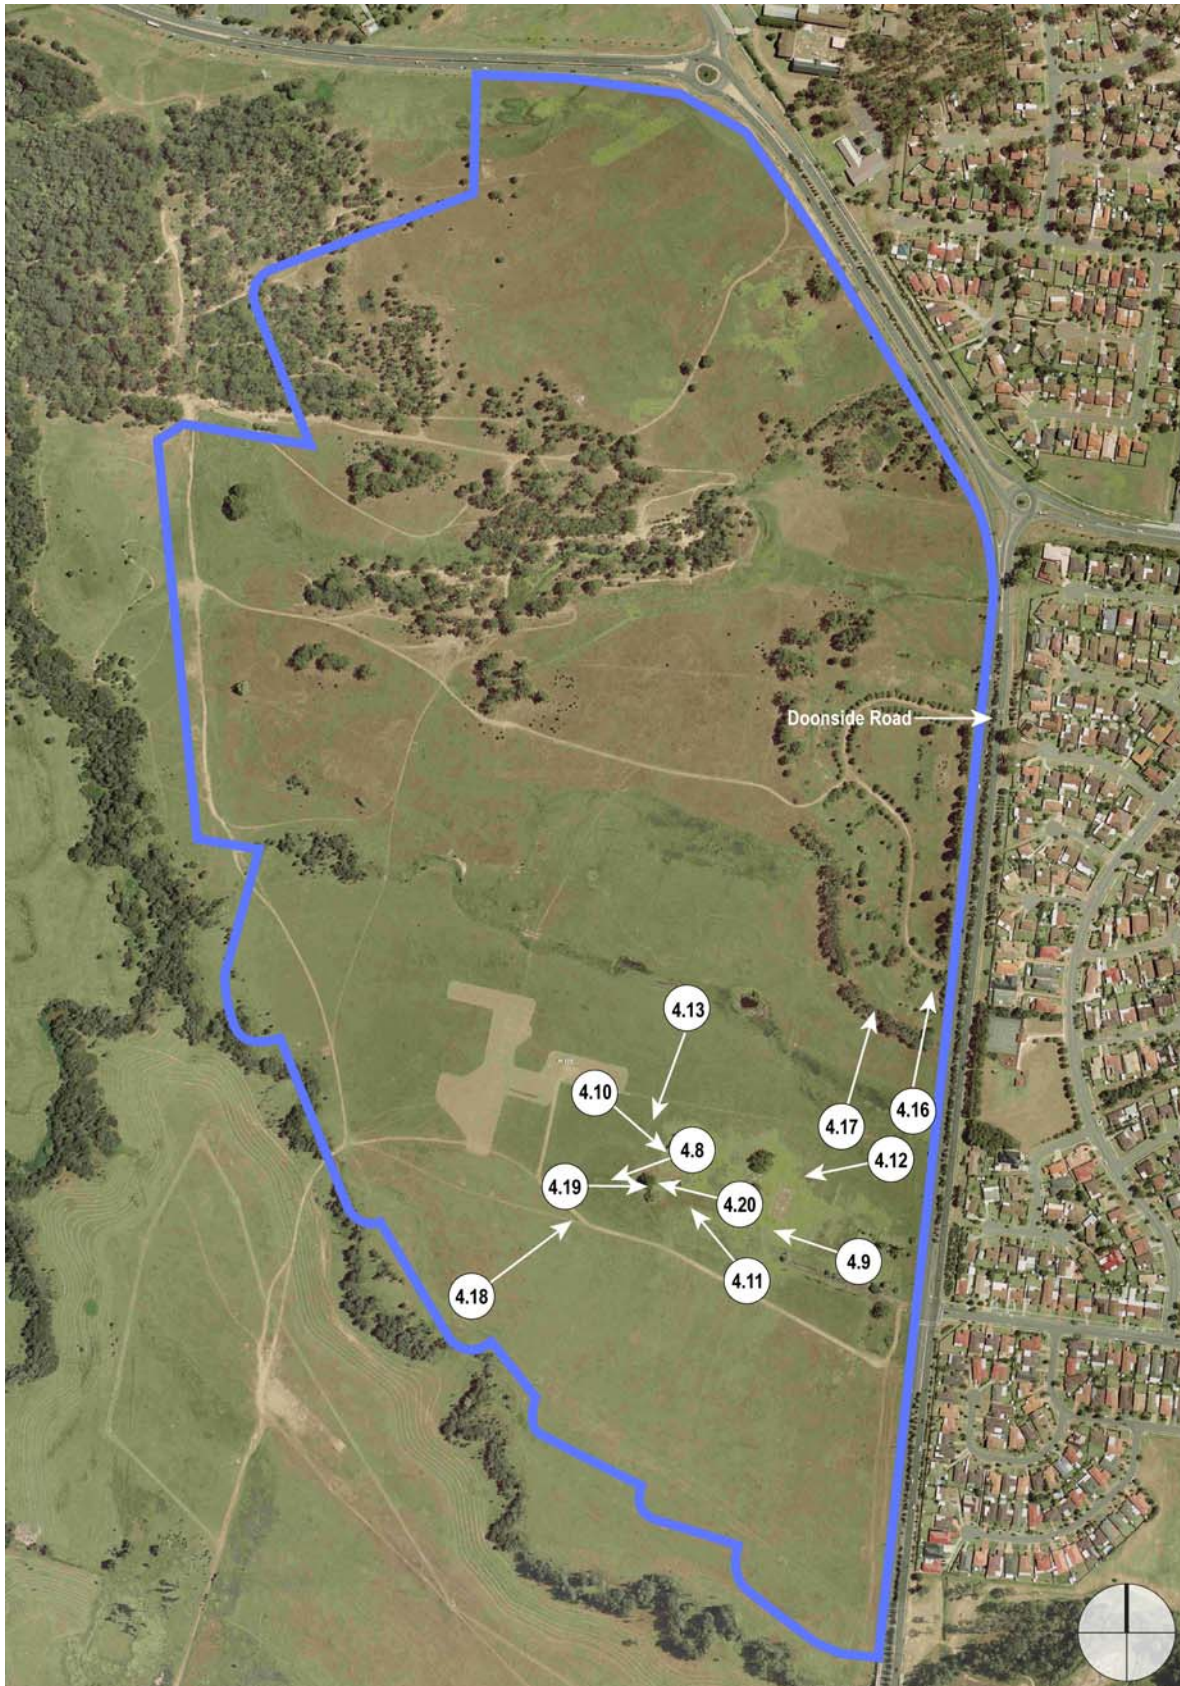
Figure 4.14 Key vantage points from which photographs have been taken within the Doonside Parcel. Refer to the relevant figure numbers for a photograph.

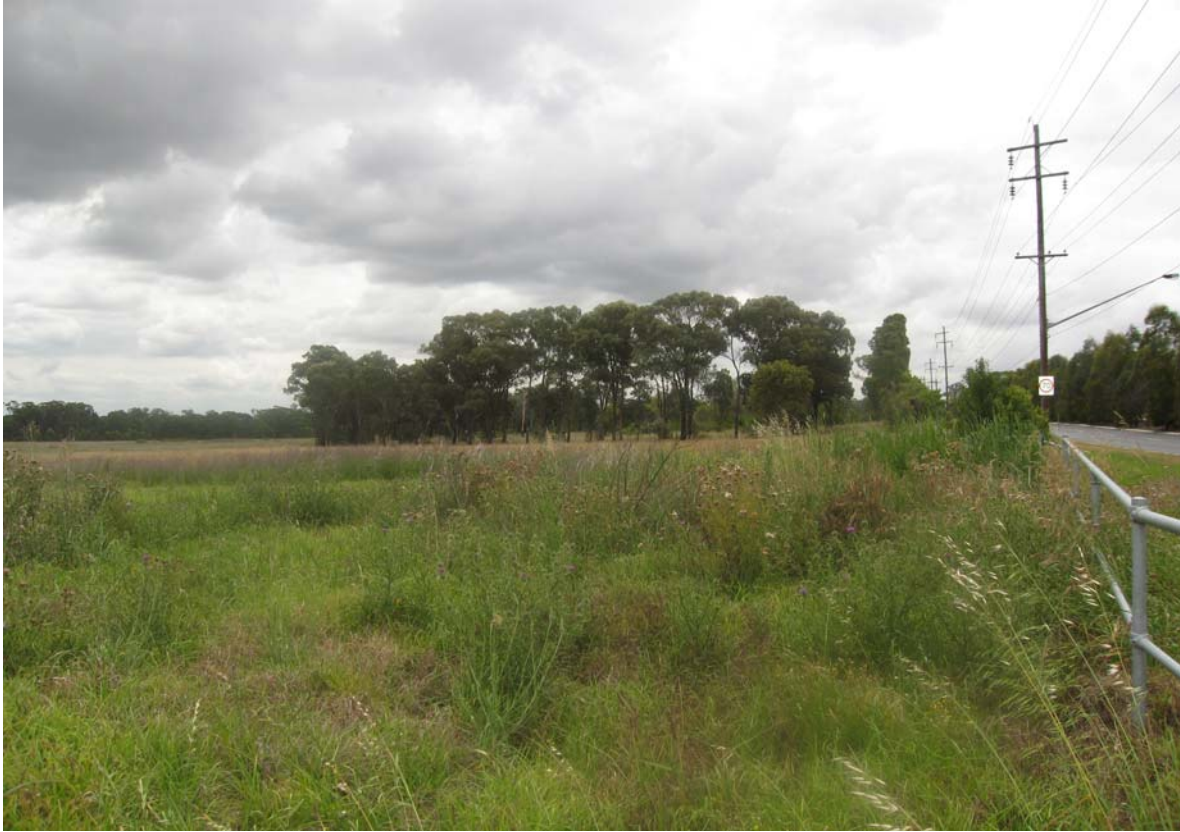
Figure 4.16 View looking north from the northeast corner of the former Bungarribee House site towards the southern edge of the cultural plantings associated with the former OTC residential subdivision site. Note Doonside Road in the far right of the picture.

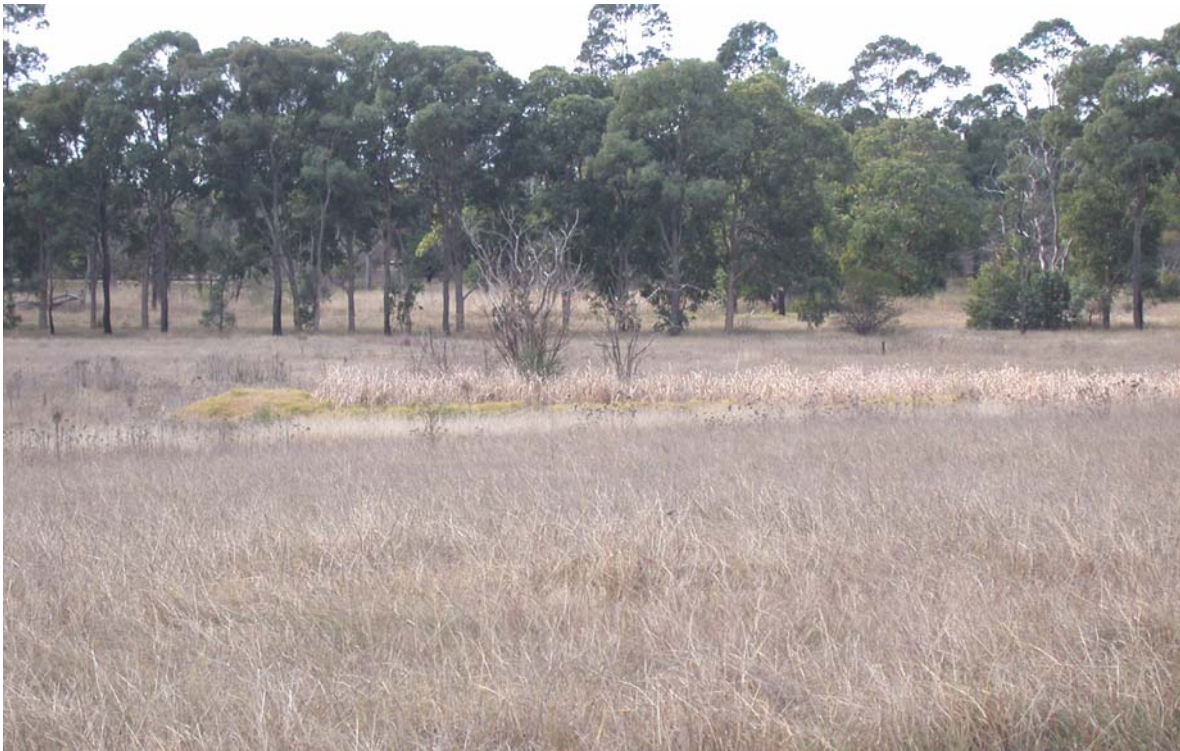
Figure 4.17 View looking northeast from the former Bungarribee House site towards the southern edge of the cultural plantings associated with the former OTC residential subdivision site across the former Bungarribee House site.

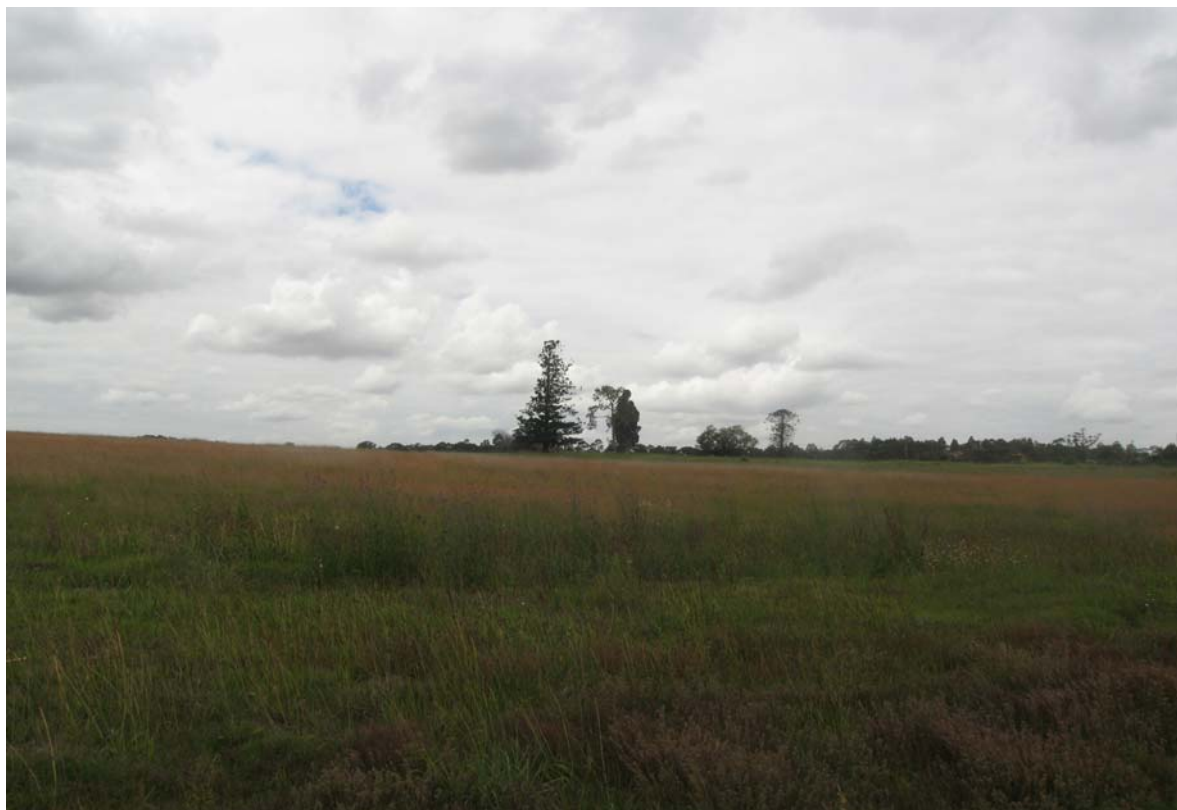
Figure 4.18 View looking northeast from Bungaribee Creek towards the former Bungaribee House site. Note the group of remnant cultural plantings associated with the former homestead are very prominent.

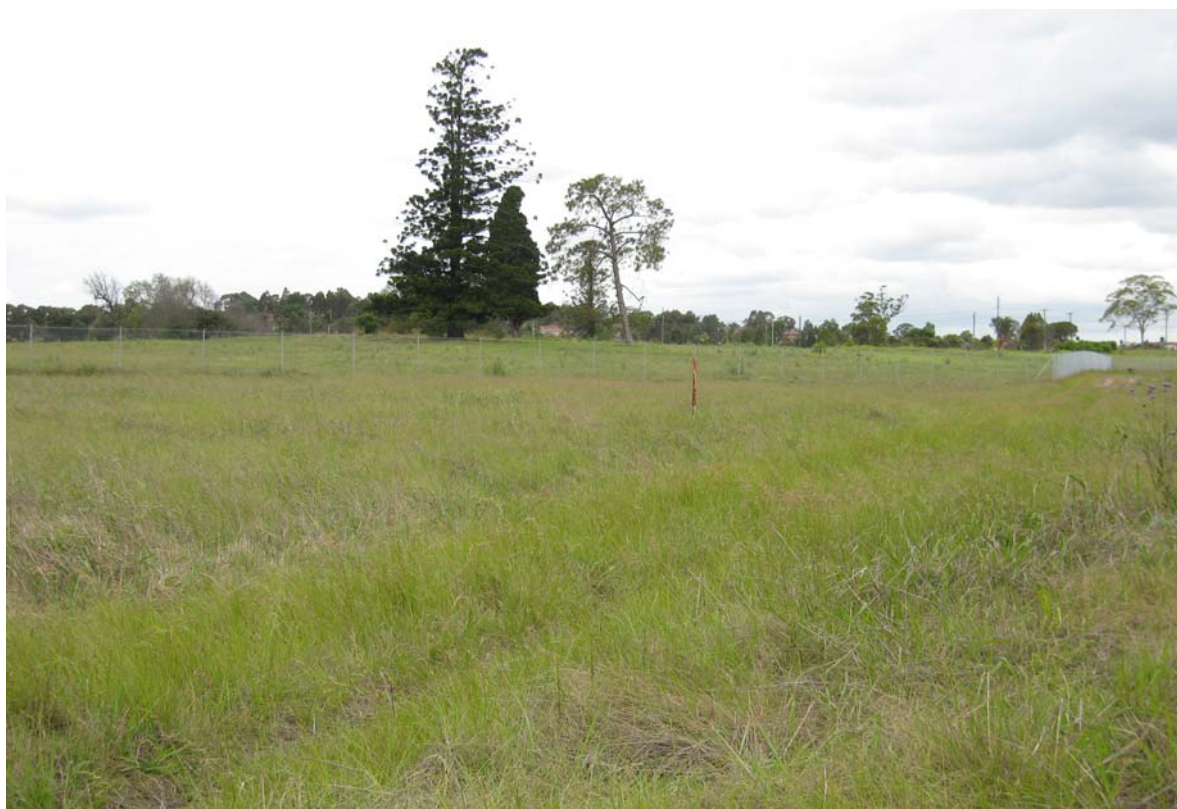
Figure 4.19 View looking east towards the former Bungaribee House site. Note the prominence of the cultural plantings associated with the former homestead.

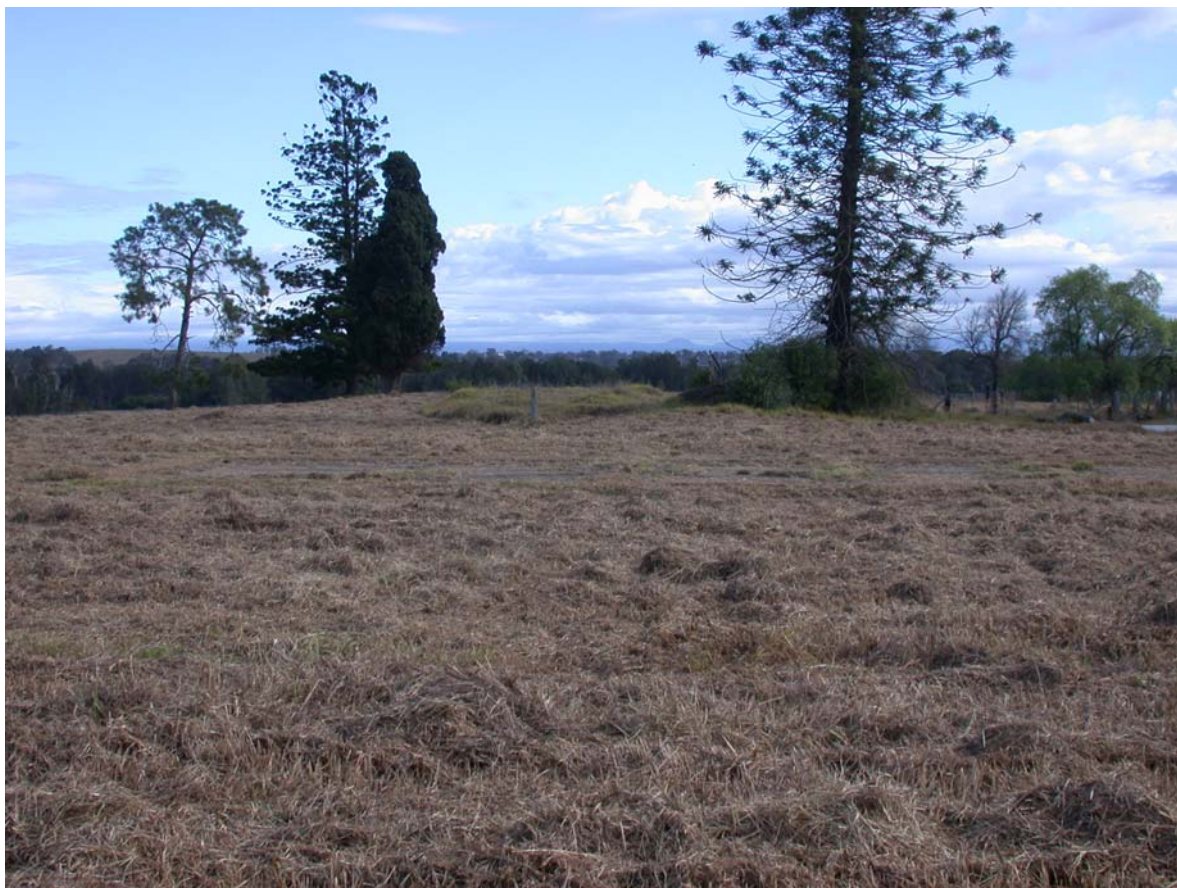
Figure 4.20 View looking west across the former Bungarribee House site. Note the visual prominence of the Blue Mountains in the far distance.

itself looking west towards the mountains (see Figures 4.8 and 4.20). As noted above, this visual link marks the view from the former house which was orientated west.

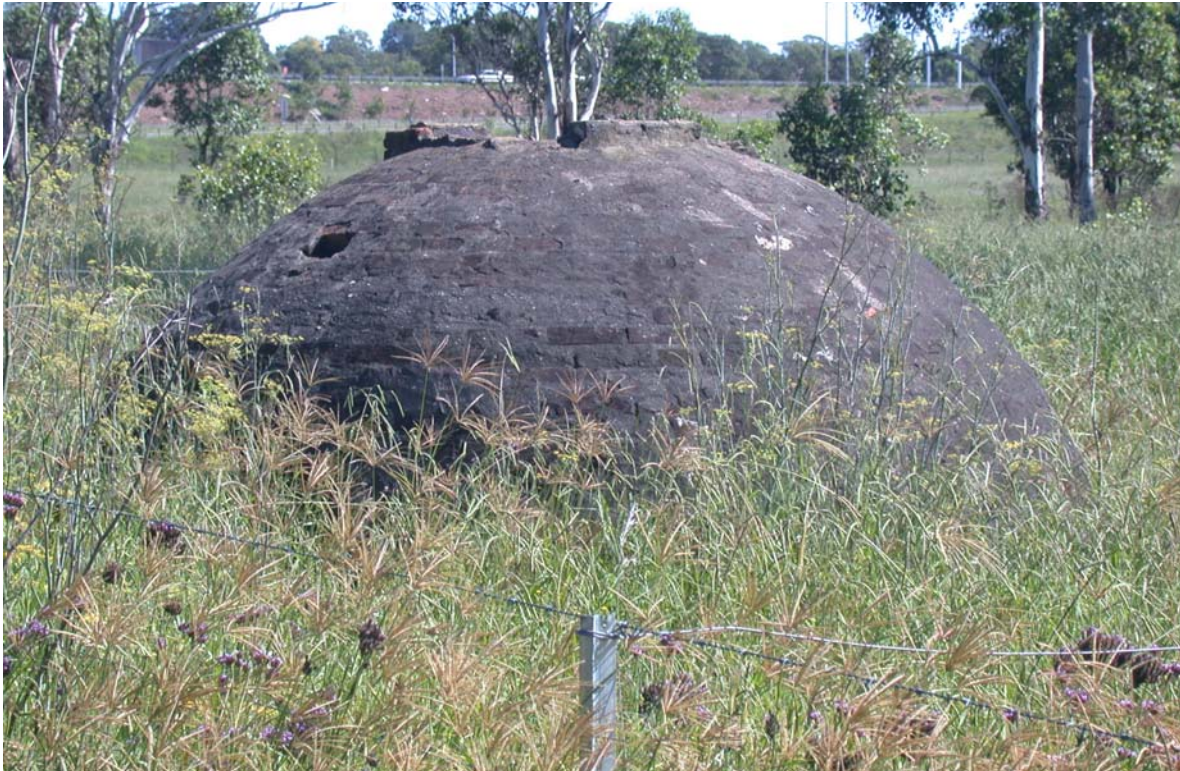
Figure 4.22 View to west showing brick cistern (identified by Austral Archaeology as site B/6) located alongside the Great Western Highway. The trees behind the cistern indicate the location of the creek running southwest from Eastern Creek. The cistern would have been part of the group of buildings shown on the 1943 aerial (see Figure 2.7), which also shows the creek running behind the buildings. These buildings may indicate the location of the garrison (later Dean family residence), the post office and the blacksmith's forge. The M7 can be seen in the background.

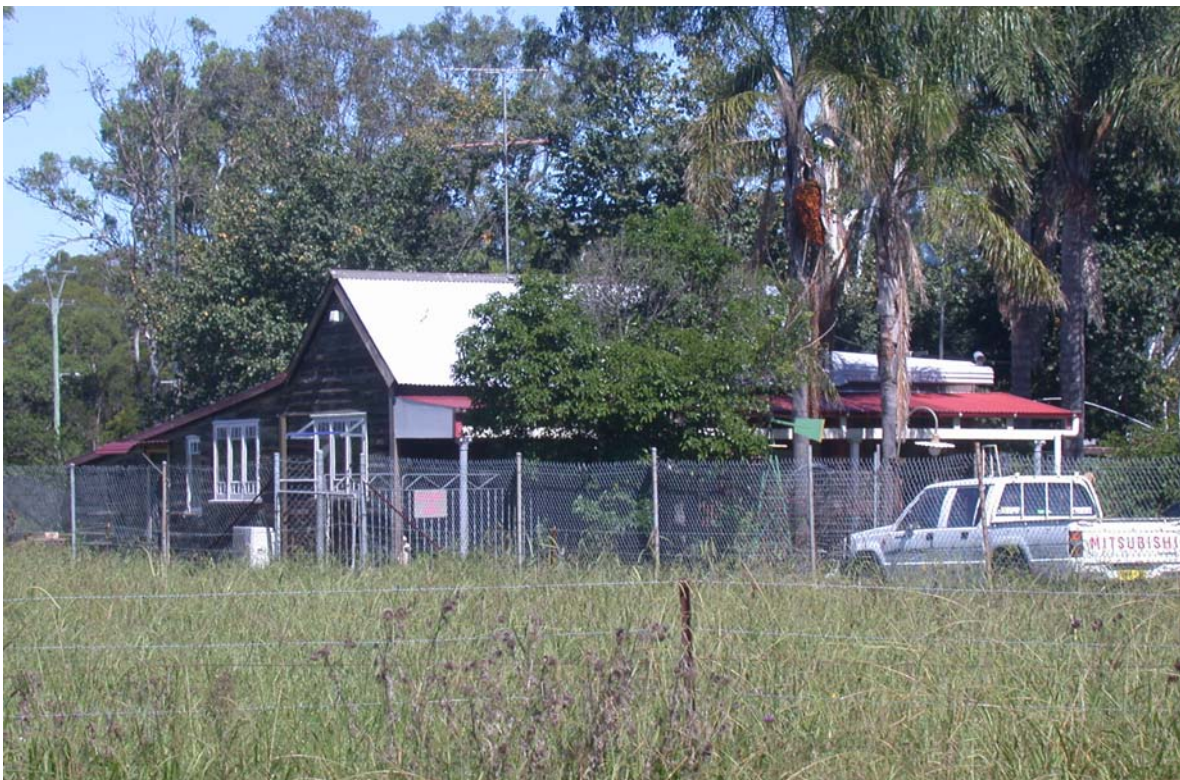
Figure 4.23 View to the southwest taken from the Great Western Highway showing 733 Great Western Highway.

The extant structure at 733 Great Western Highway with a large front yard area is possibly related to the early Dean phase (see Figure 4.23). The location of the Red Lion Inn is likely to be on the highway at the eastern edge of the Parklands Precinct (to the east of Eastern Creek), in the approximate location of the extant fibro house at 671 Great Western Highway (see Figure 4.24).
